## **Appendix 3.5.3, Excerpted from Safety Analysis Report for the Century Champion Type B Package Thermal Test**

### **Introduction**

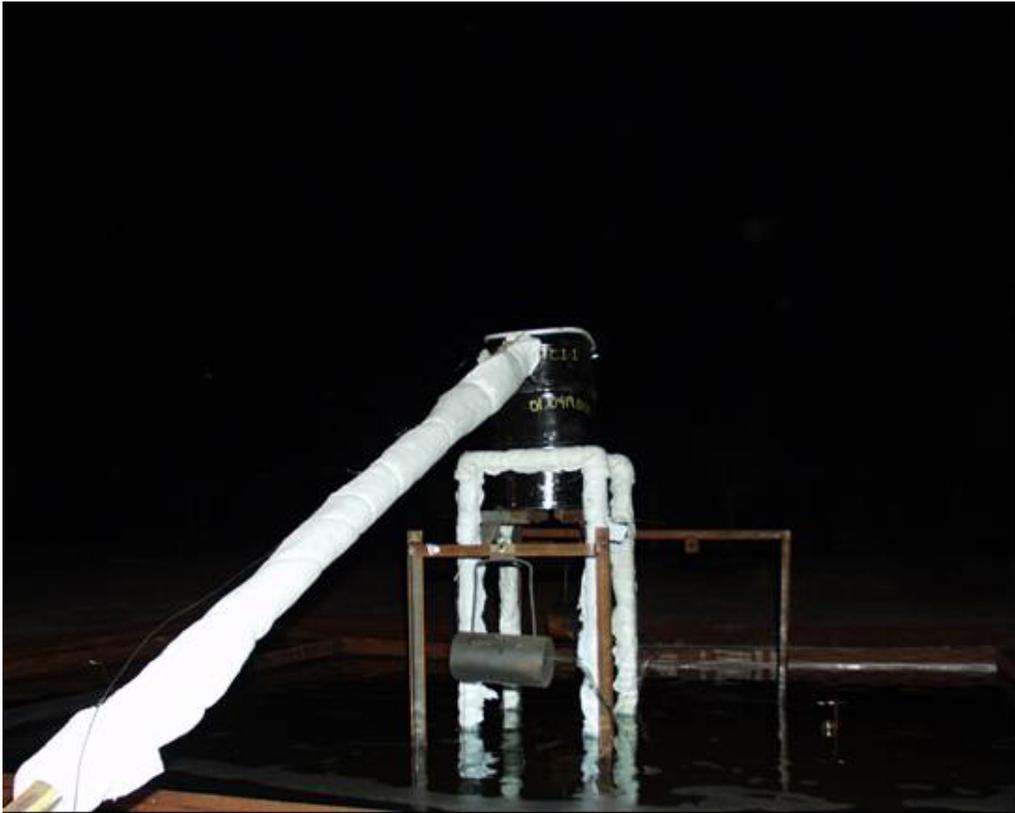
Figure 3.5.3-1 Champion Package on Test Stand – View from Thermocouple Shielding Tube

Figure 3.5.3-1 shows the Century Champion Package rigging for the thermal test. Figure 3.5.3-2 displays a typical view of the package during the 30 minute 1475°F thermal test phase. Figure 3.5.3-3 displays the package upon completion of the thermal testing prior to conduct of the immersion test.

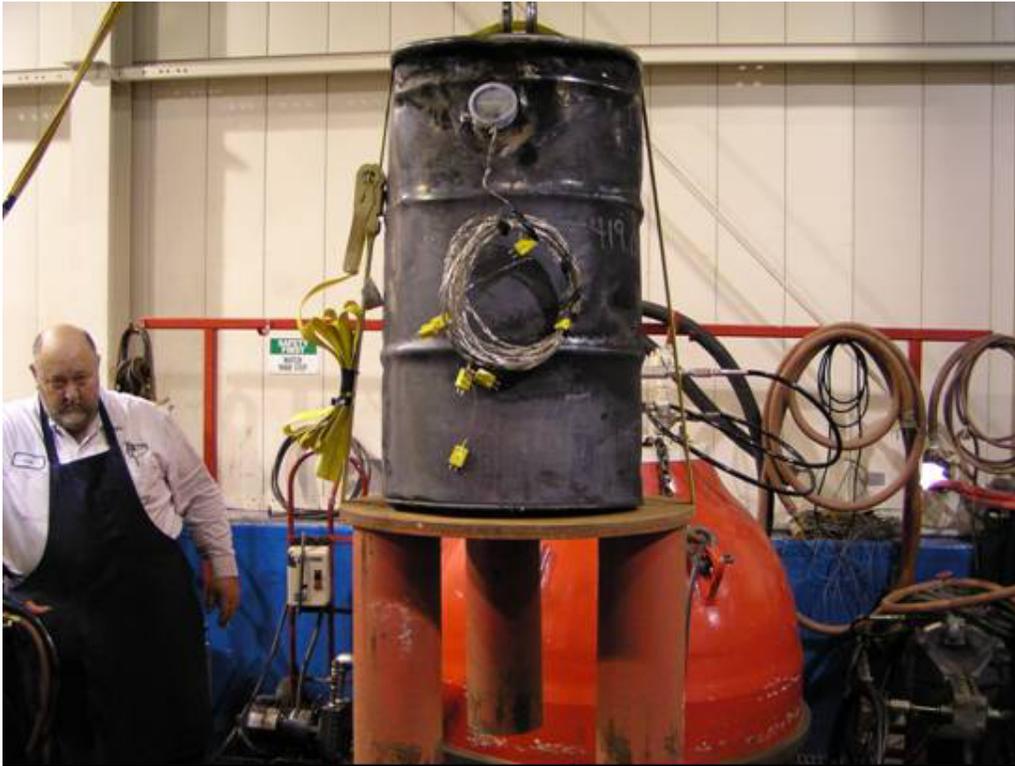
**Figure 3.5.3-3 Champion Package Post-Thermal Test**

The metallic components of the package, as shown in Figure 3.5.3-3, do not show any signs of failure or fatigue at the conclusion of the thermal test. This demonstrates that thermal stresses induced during thermal testing are low and within the structural capacity of the components. The polyurethane insulation is considered to be a sacrificial component, and in performing its function its structure is broken down by the heat of the fire. However, the polyurethane components (including the internal polyurethane plug utilized in the Versa-Pac) do provide load-carrying capability for the packaging, and the steel components provide the strength and structure required to maintain the packaging intact following the event. The 30 minute thermal test including the post-test natural cool-down did not cause any seam or closure separation in the package. The package structure including outer closure drum does not show any signs of failure or fatigue. These observations from the testing of the Century Champion are directly applicable to the Versa-Pac design since their outer structures are identical. Therefore, the Versa-Pac design is not anticipated to be subject to deleterious thermal stresses during the required 30 minute thermal test at 1475°F.
