**Section 3**  
**Withlacoochee and Hillsborough**  
**River Watersheds**

# Withlacoochee and Hillsborough River Watersheds

Boarshead Ranch (BHR), in Pasco County, Florida, will provide all mitigation for wetland impacts in the Hillsborough River Watershed and the Withlacoochee River Watershed south of the CFBC (**Exhibit 3-4-1**). All of these impacts are associated with transmission projects. The Withlacoochee watershed impacts at the LNP Site (north of the CFBC) will be mitigated on-site.

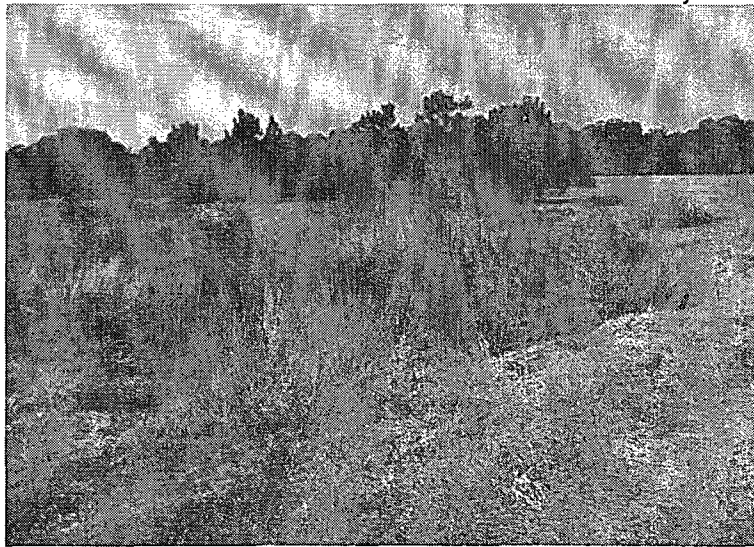
Ditch in Activity Area 1

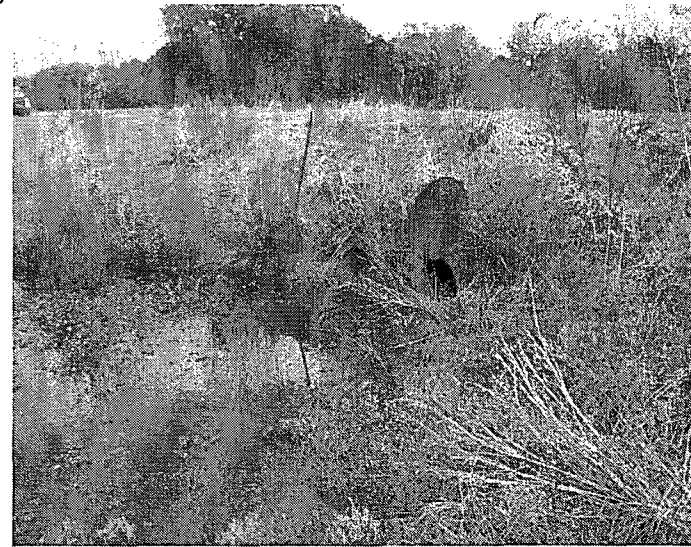
Culvert in Activity Area

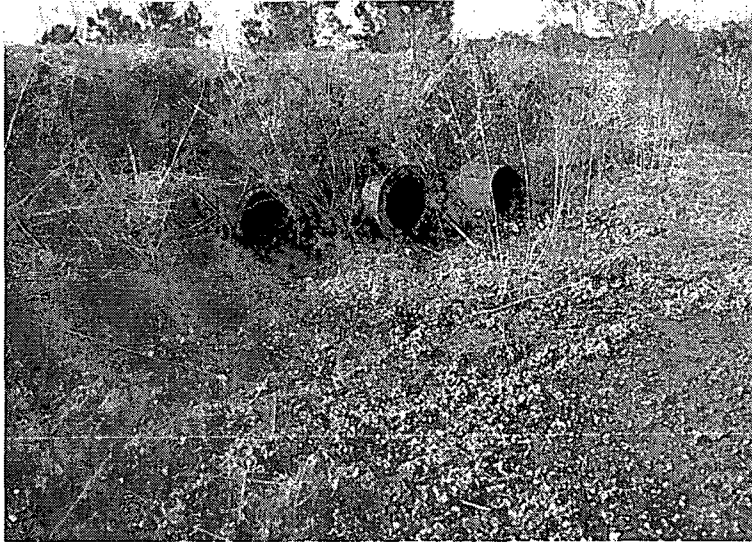
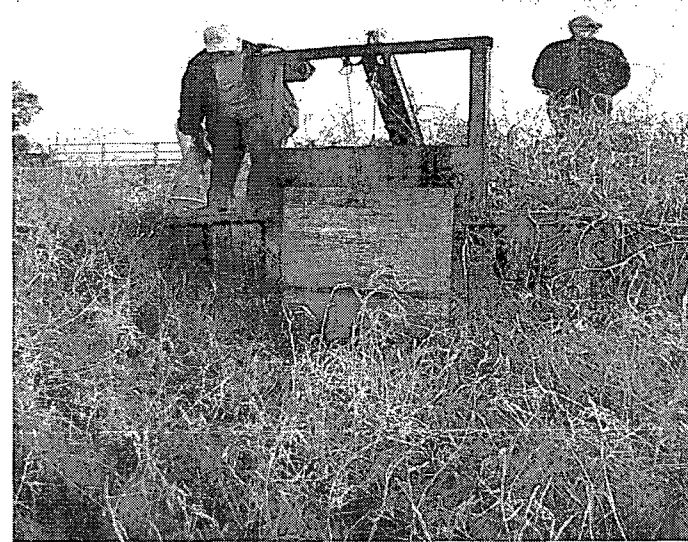
Ditch in Activity Area 1

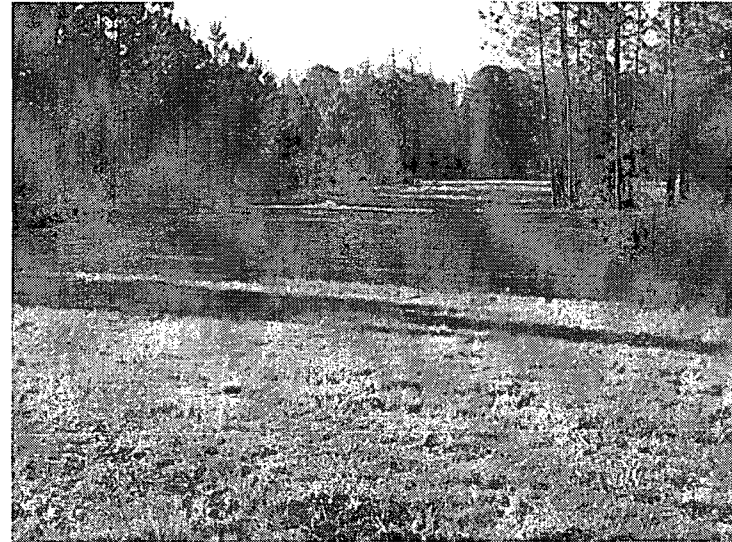
Typical wetland creation area - pine plantation and/or pasture  
upland adjacent to existing wetlands

Current uplands will be graded down to an appropriate elevation and replanted with species suitable to the target habitat type. Wetland creation has been designed to occur in areas where soils, elevations, drainage, proximity to wetlands, and historic conditions lend themselves to the development of a successful wetland system. Because of the site specific planning for wetland creation, those areas designated to be graded will not require significant alterations of elevations. Additionally, nearby intact wetland systems will supply support by providing seed source and benchmarks for hydrology. Creation will be in the form of both forested and herbaceous wetlands and plantings will mimic the vegetation of similar nearby/on-site intact systems. If necessary, nuisance and exotic plants will be treated with herbicide prior to planting.

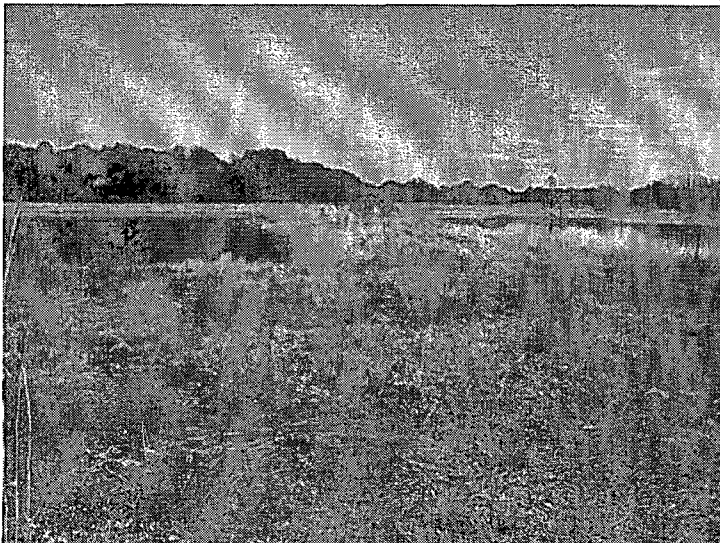
Typical berm removal area

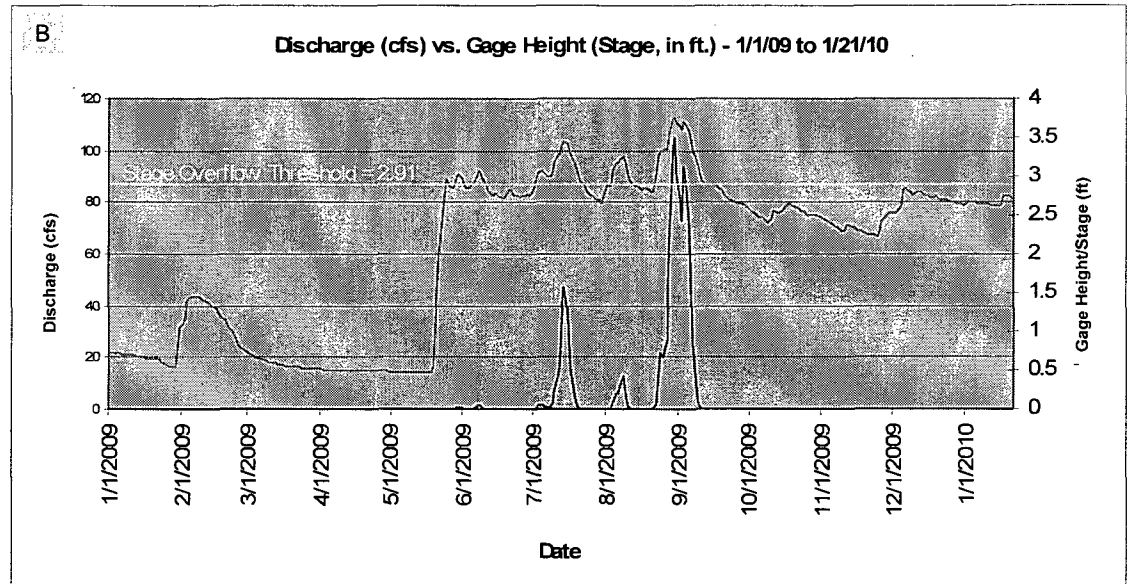
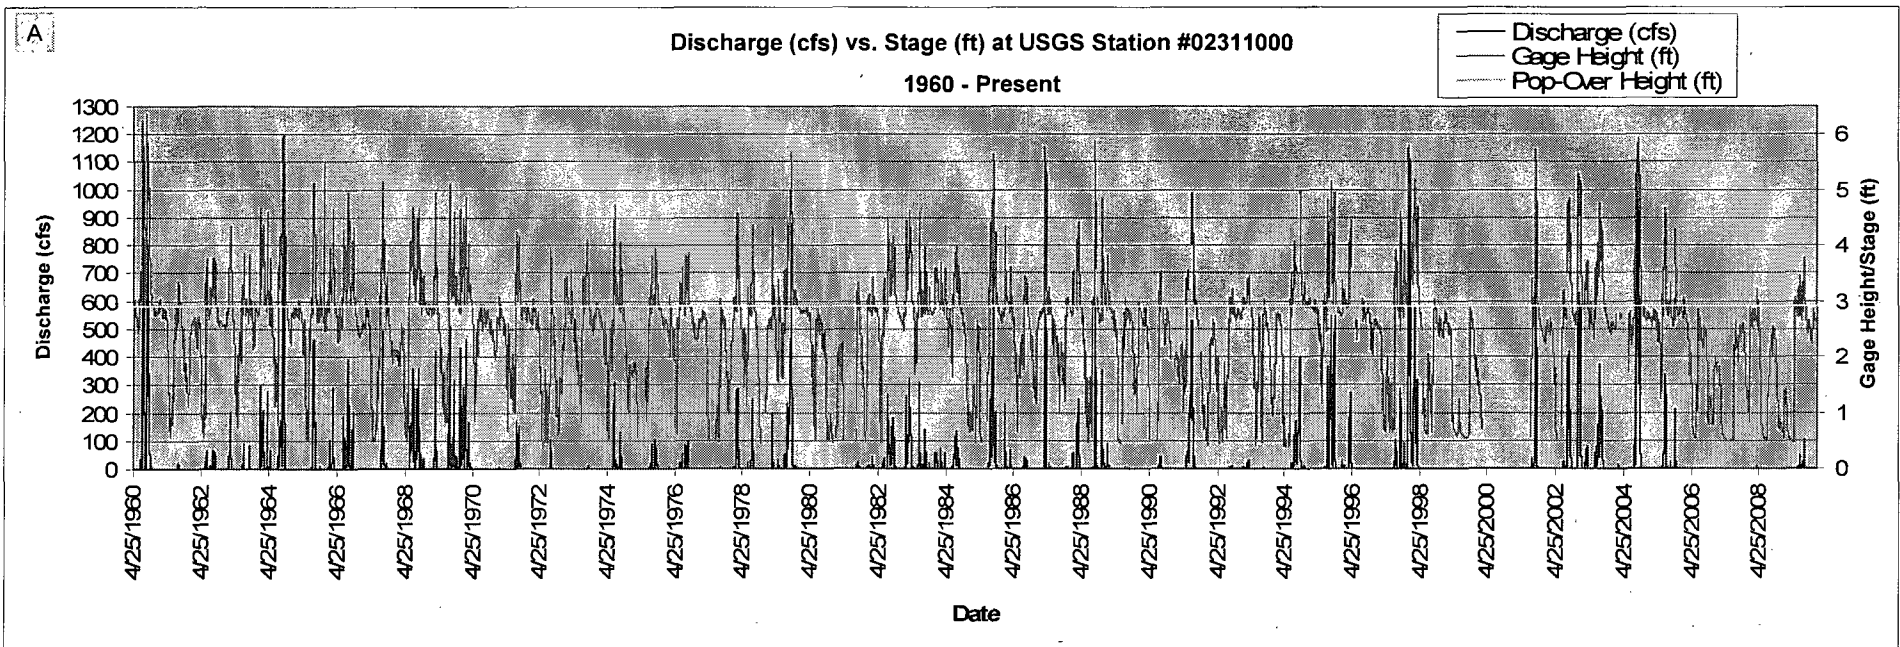
- Discharge is plotted on the left Y-axis and stage is plotted on the right Y-axis. Additionally, the stage at which overflow occurs (2.91) corresponds to the right Y-axis.
- Graph A contains data for the period of record 1960 to present (1/21/10). Graph B depicts data from 1/1/09 to present (1/21/10).
- In Graph B, note that whenever Stage (shown in pink) rises above the overflow height (shown in yellow) discharge (shown in blue) across the basin divide occurs.

- USGS Station 02311000, the Withlacoochee-Hillsborough Overflow near Richland, FL, is located at the overflow feature and measures stage and discharge over the divide. The stage must reach approximately 2.91 feet before measurable discharge occurs from the Withlacoochee to the Upper Hillsborough basin.

- As measured at USGS Station 02311000, the watersheds appear to communicate on approximately 99 days (27% of the time) in an average year.
