# **Upper Coastal Watershed**

## 4.1 INTRODUCTION

The Upper Coastal Watershed mitigation plan (Upper Coastal Plan) has two components: 1) wetland enhancement at the Homosassa Tract of the Withlacoochee State Forest (WSF) and 2) restoration and enhancement at Five Mile Creek which is owned by Pasco County (**Exhibit 4-1-1**).

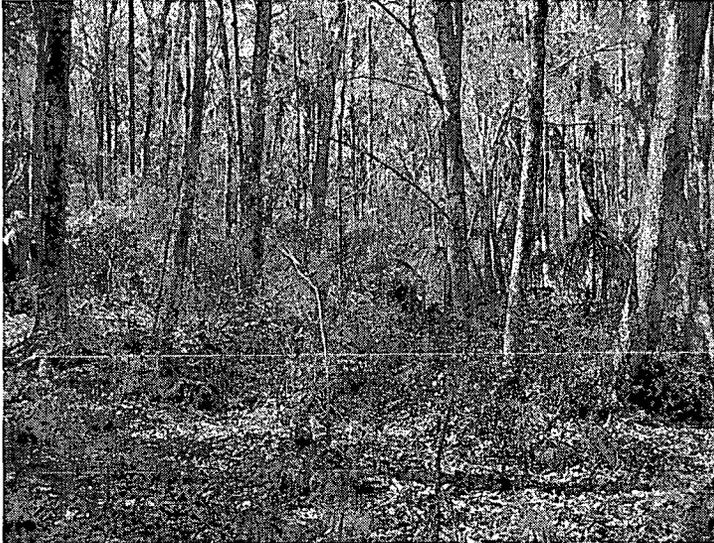
Basin Swamp Downstream of Fill Road

The bisecting wetland fill road appeared to be culverted sufficiently for the normal flow conditions of the system. The fill road bisects the wetland partially severing up and downstream hydrologic connectivity and essentially act as a dam during storm events. Soil oxidation was commonly observed downstream of the wetland fill road. Tree fall and subsequent mortality was occasionally observed and may be attributed to weakened rooting strength following soil oxidation. Wetlands upstream of the fill road appear to experience hydroperiods appropriate or longer than typical for this type of system. Lichen lines on trees were often well defined and water stain lines appeared to match fill road elevations upstream of the wetland fill road where hydrologic connectivity to areas downstream of the road is insufficient.

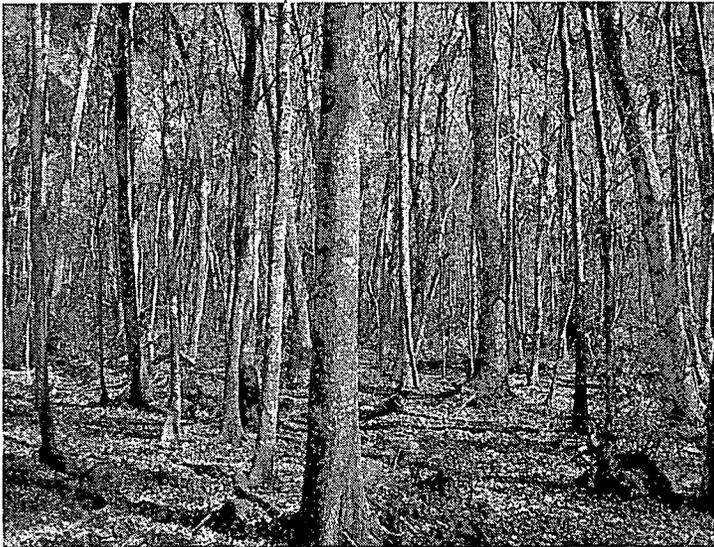
Basin Swamp Upstream of Fill Road

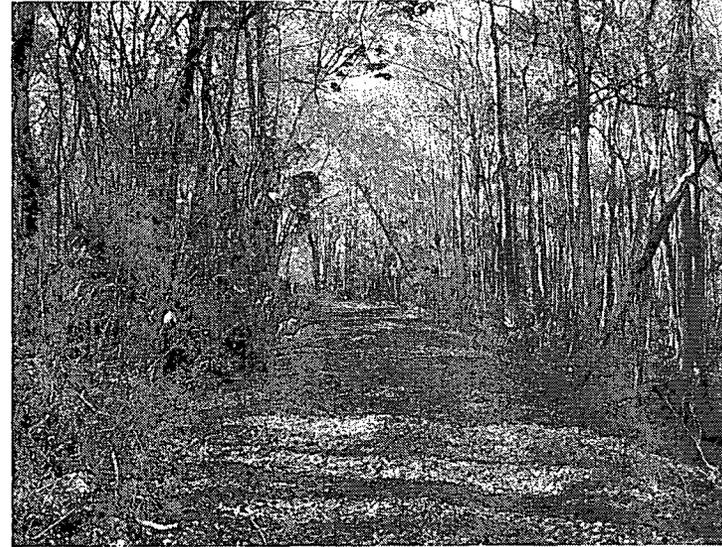
Fill Road Down and Upstream Changes in Vegetative Structure

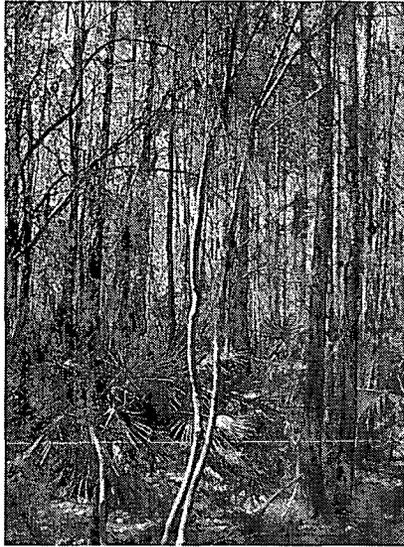
Historic Wet Flatwoods Planted in Pine

Several dense stands of planted longleaf pine occur within the assessment area. Stands were planted in 1993 and 2000. Historically these lands were sparsely canopied, herbaceous mesic and wet flatwoods. These were converted to pastureland then to pine plantation. The majority of the understory was herbicided with glyphosate and triclopyr in fall 2009 to eliminate bahia grass. Currently, understory and herbaceous vegetation is primarily absent although bahia grass was observed within some stands. No relict flatwoods woody or herbaceous species were observed.

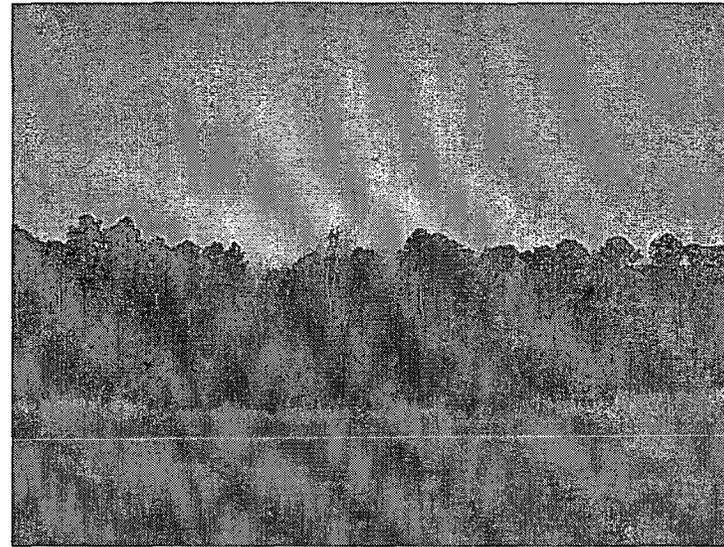
Improved Pasture Foreground Basin Swamp-Pine Encroachment  
(background)

Several small disjunct areas of pasture land occur within the assessment area. Historically these lands were mesic and wet flatwoods. Currently these areas contain bahia grass, broomsedge grasses (*Andropogon* spp.) and numerous other common herbaceous pastoral species. Some areas appear to be occasionally maintained through mowing or prescribed burns. Areas allowed to go fallow contain small early successional woody shrubs and trees.

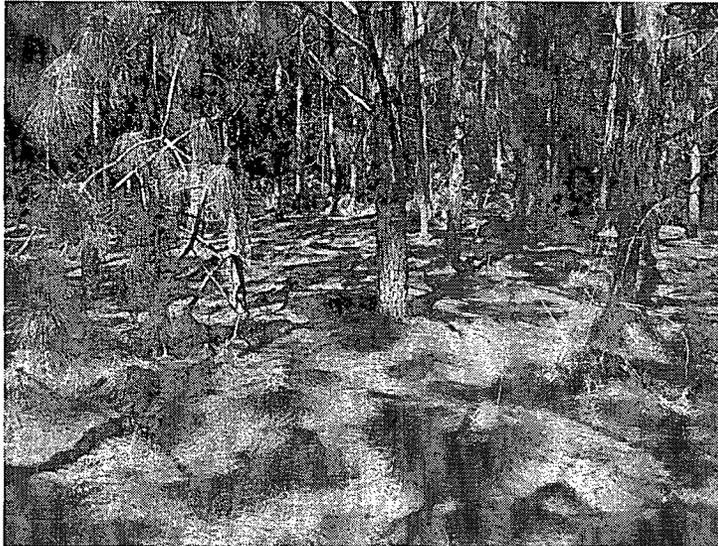
Historical Mesic Flatwoods

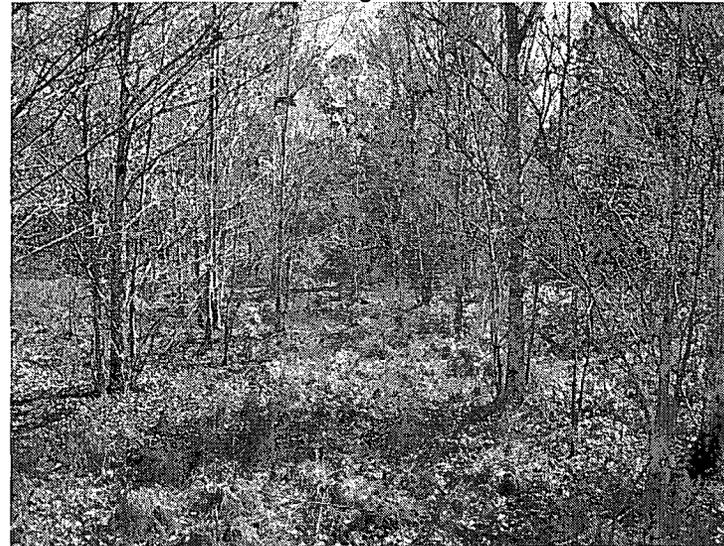
Overgrown Wet Flatwoods

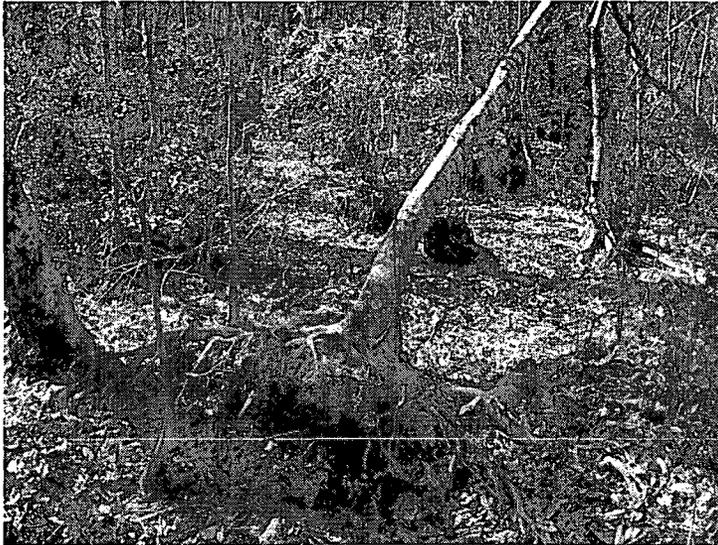
Soil Oxidation

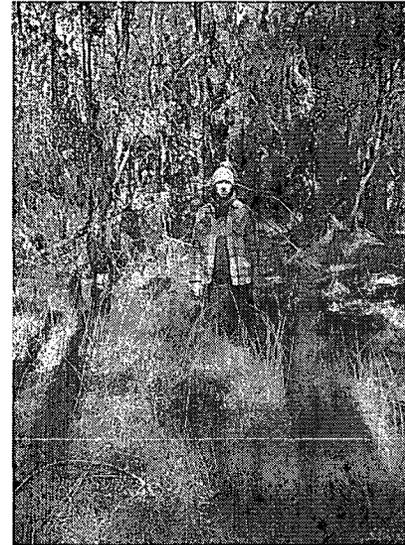
Thick Pine Duff in Basin Swamp

This forested community comprises the majority of the forested wetlands targeted for restoration/enhancement. This community designation encompasses all historic basin swamp limits as well as historic wet flatwoods that have evolved basin swamp characteristics due to fire exclusion. The closed canopy is dominated by hardwood species including red maple (*Acer rubrum*), laurel oak (*Quercus laurifolia*), sweetgum (*Liquidambar styraciflua*), swamp bay (*Persea palustris*), sweetbay (*Magnolia virginiana*), loblolly-bay (*Gordonia lasianthus*) and swamp tupelo (*Nyssa sylvatica* var. *biflora*). Bald cypress ranges from common to absent within the canopy and understory. Portions of this community contain both slash pine (*Pinus elliottii*) and longleaf pine (*Pinus palustris*) at low to high densities. Pines encroachment is present primarily within areas of higher elevations with a short hydroperiod. Slash pine encroachment is less common overall, most prevalent at lower elevations and appears to be occurring naturally. Longleaf is present primarily landward of the lands occupied by slash pine occurring primarily within ecotones. High density pine encroachment areas commonly contain a 1-2.5 feet thick duff layer from needle cast.

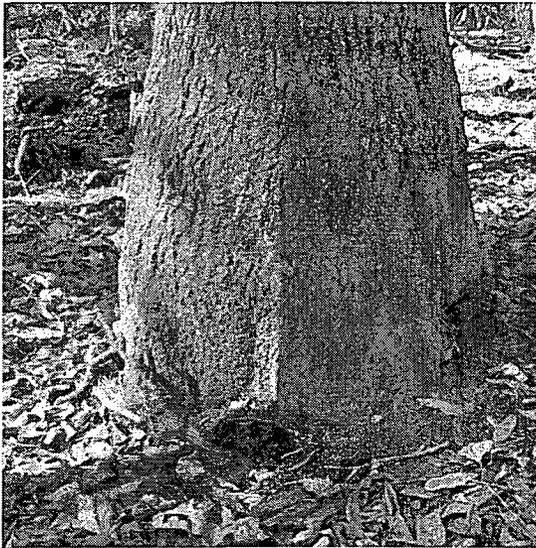
Water Stain Line Upstream of Fill Road

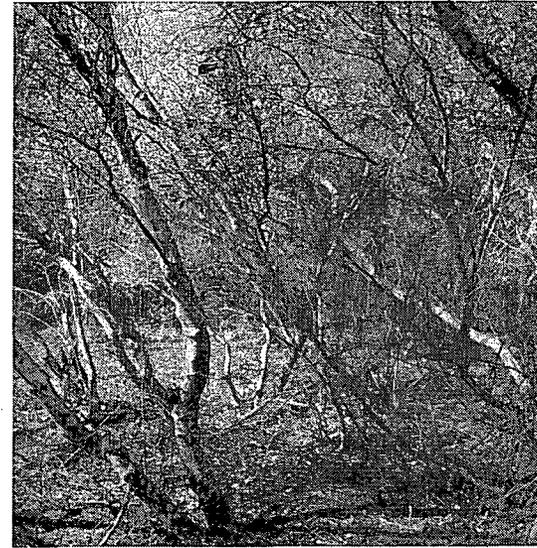
Wetland Shrub

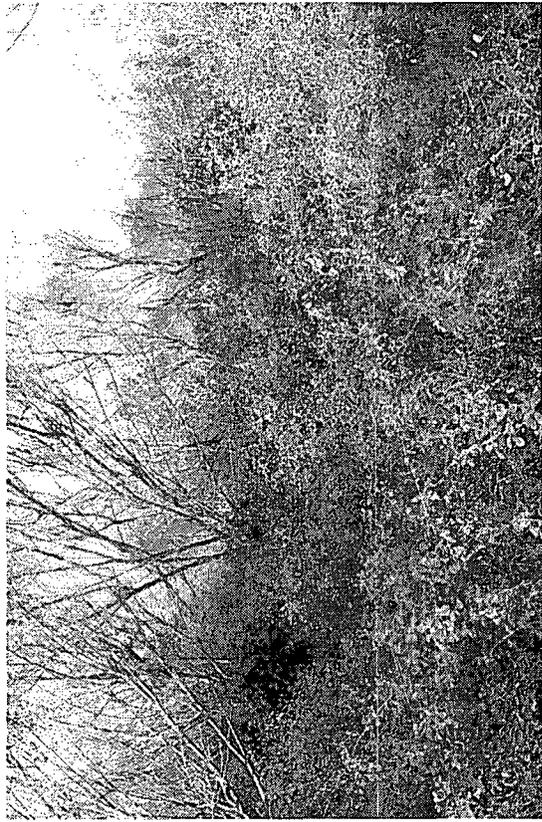
Five Mile Creek upland area overgrown with blackberry and groundsel bush.

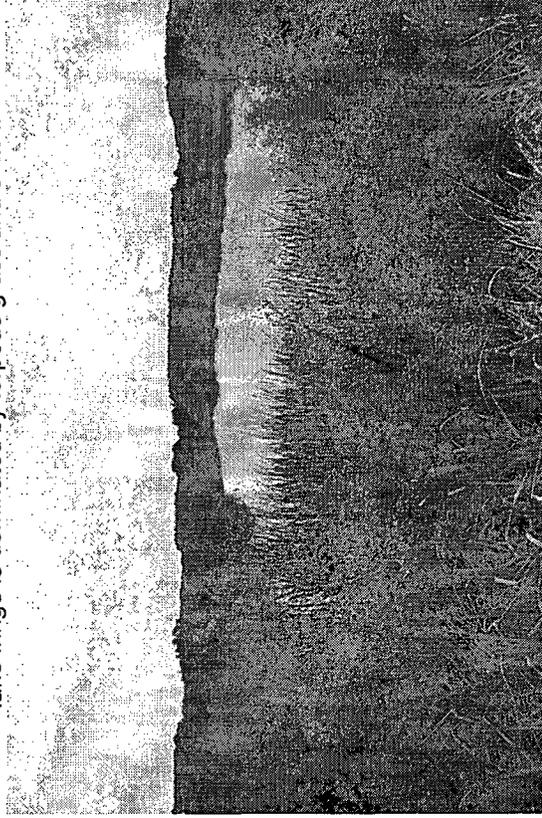
One of the man-made lakes. The photo shows the overgrown condition of the uplands and dominance by cattails of the lake fringe.

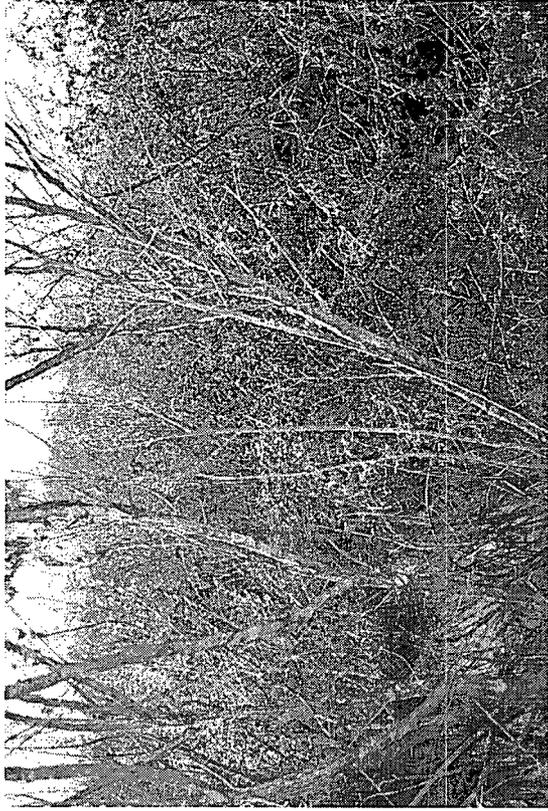
Primrose-willow and groundsel bush dominated area.

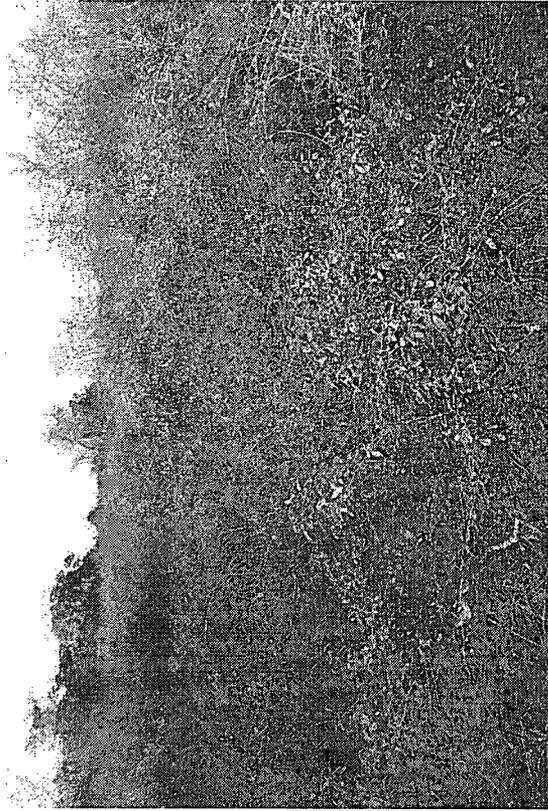
Typical upland area on the Five Mile Creek parcel. The area is heavily overgrown with blackberry and dogfennel.

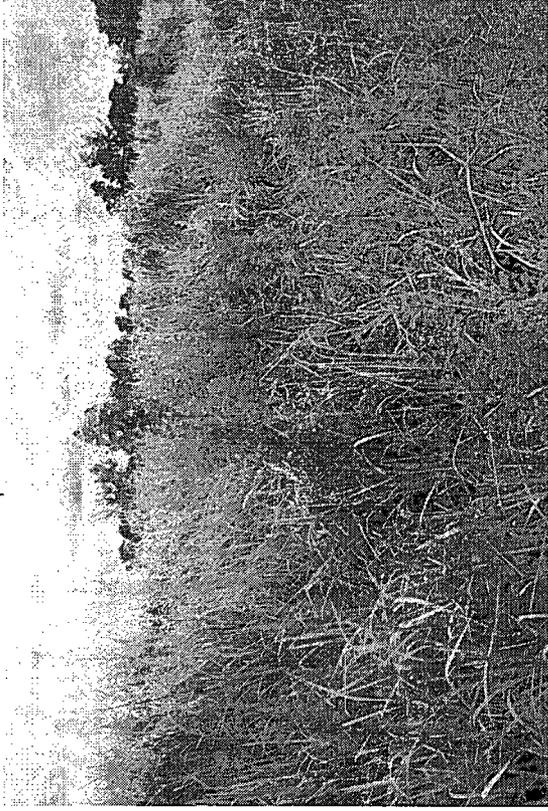
Typical view of one of the lake perimeter berms. The dominant plant is cogon grass; blackberry and bahia grass are also common.

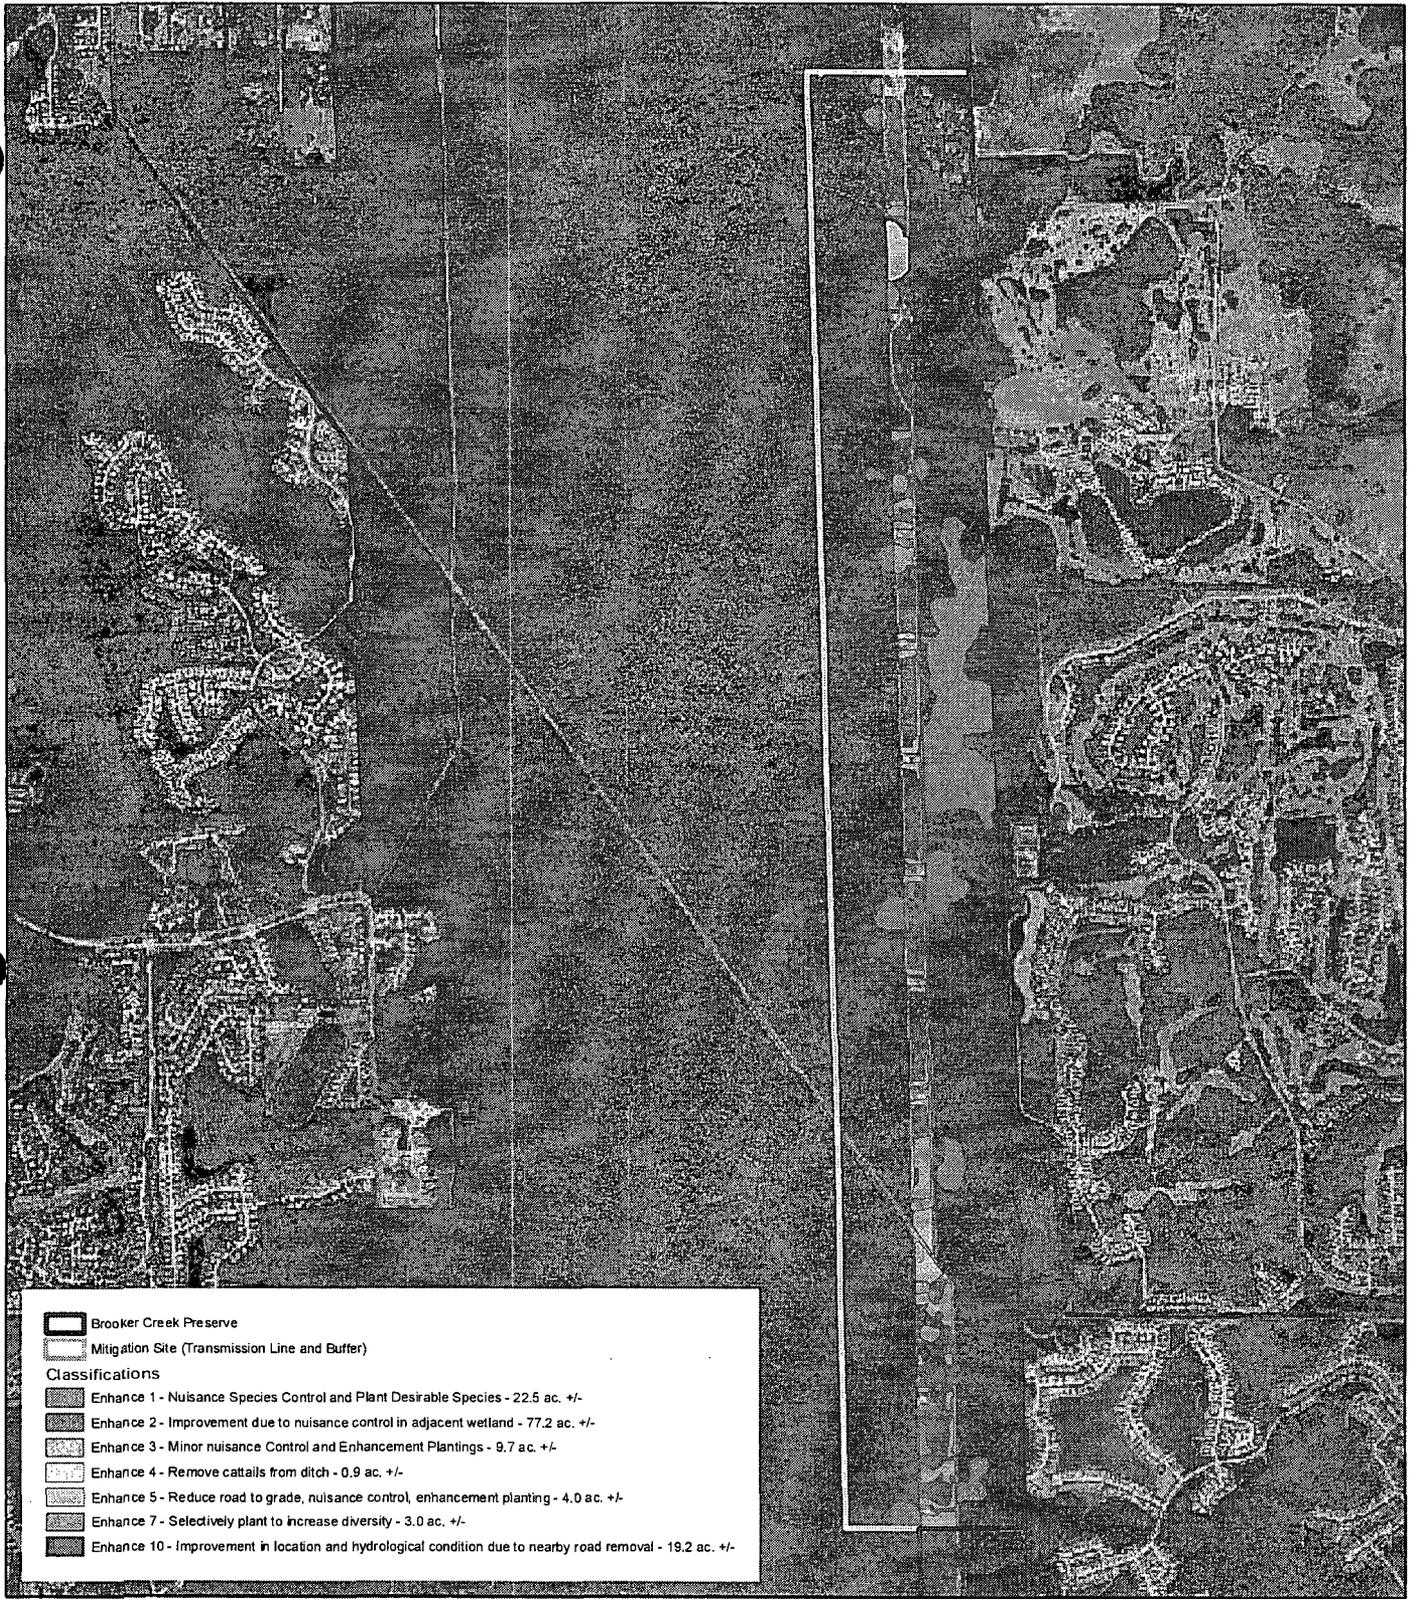
- Brooker Creek Preserve
- Mitigation Site (Transmission Line and Buffer)
- Classifications**
- Enhance 1 - Nuisance Species Control and Plant Desirable Species - 22.5 ac. +/-
- Enhance 2 - Improvement due to nuisance control in adjacent wetland - 77.2 ac. +/-
- Enhance 3 - Minor nuisance Control and Enhancement Plantings - 9.7 ac. +/-
- Enhance 4 - Remove cattails from ditch - 0.9 ac. +/-
- Enhance 5 - Reduce road to grade, nuisance control, enhancement planting - 4.0 ac. +/-
- Enhance 7 - Selectively plant to increase diversity - 3.0 ac. +/-
- Enhance 10 - Improvement in location and hydrological condition due to nearby road removal - 19.2 ac. +/-

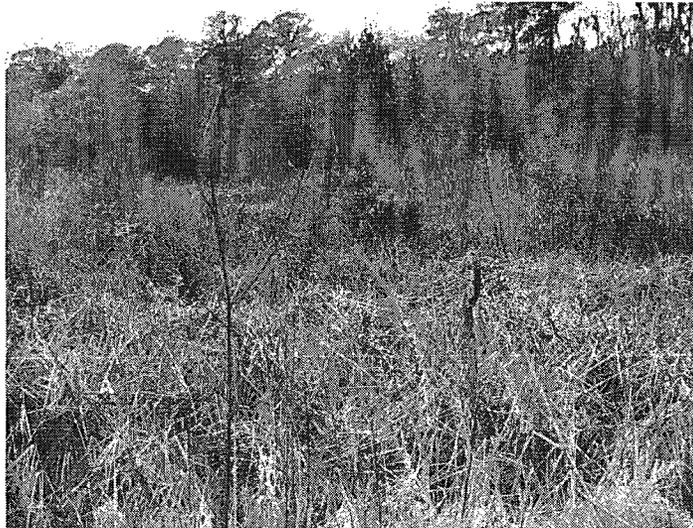
**Enhancement 1.** Typical Enhancement 1 area dominated by cattail (nuisance species) with some wax myrtle. Wetland 45.

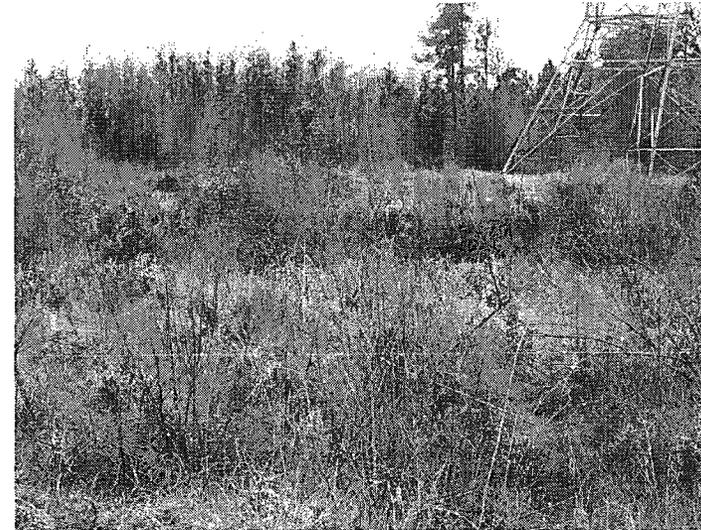
**Enhancement 1.** Typical scraped area (foreground) east of access road looking across residual saw palmetto dominated flatwoods toward a tower fill pad. Wetland 2.

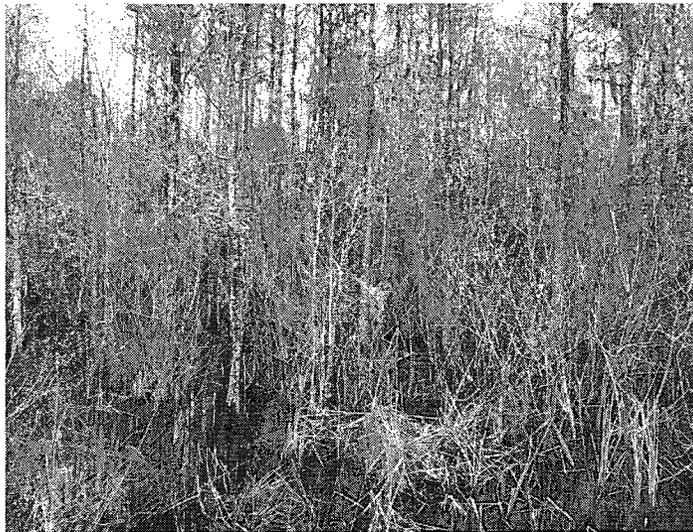
**Enhancement 2.** Basin swamp adjacent to the transmission line and adjacent to and Enhancement 1 area. Note cattail invasion on the edge (foreground; Wetland 5).

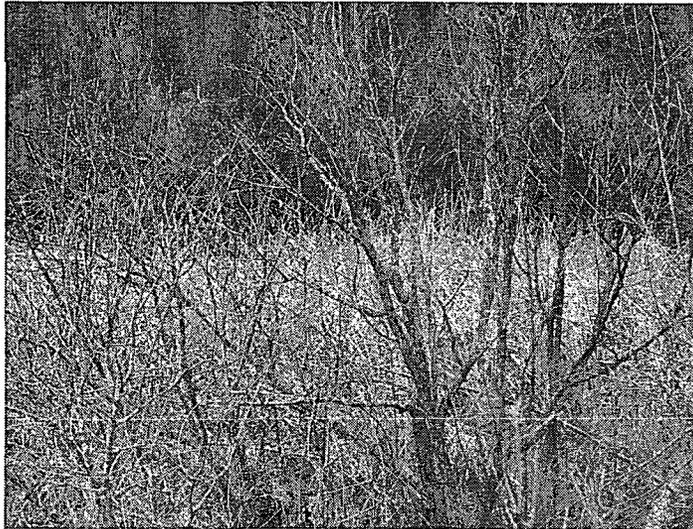
**Enhancement 4.** View across the ditch on the east side of the road. This is one of the wider areas with dense cattail coverage. Mitigation activity will retain the ditch but eliminate the cattails. The photograph with Enhancement 6 shows the ditch at a location beside a wetland where there is no nuisance species cover.

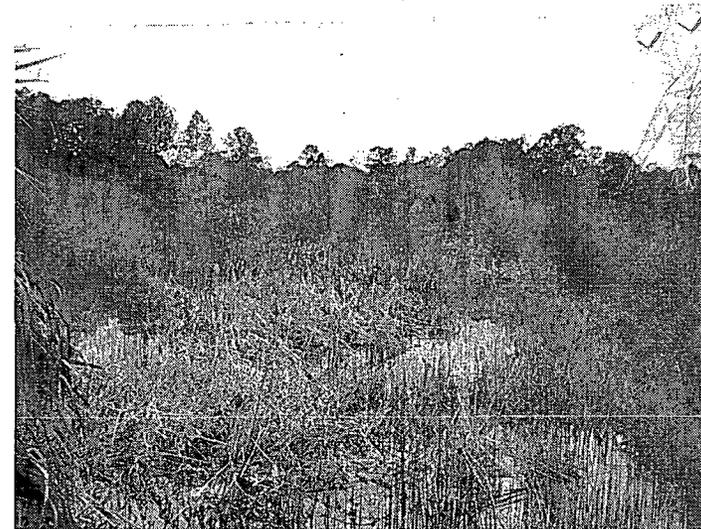
**Enhancement 5.** Area under powerline affected by scraping and hydrological alterations due to the raised access roadway which is where the photographer is standing. Note the patch of cattails in the center. Photograph shows the view to the west (Wetland 58).

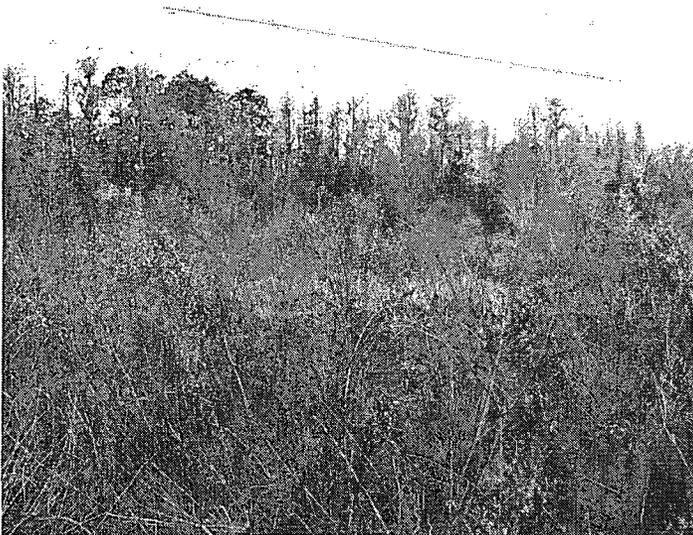
**Enhancement 5.** Area under powerline affected by scraping and hydrological alterations due to the raised access roadway which is where the photographer is standing. Photograph shows the view to the west. Wetland 29.

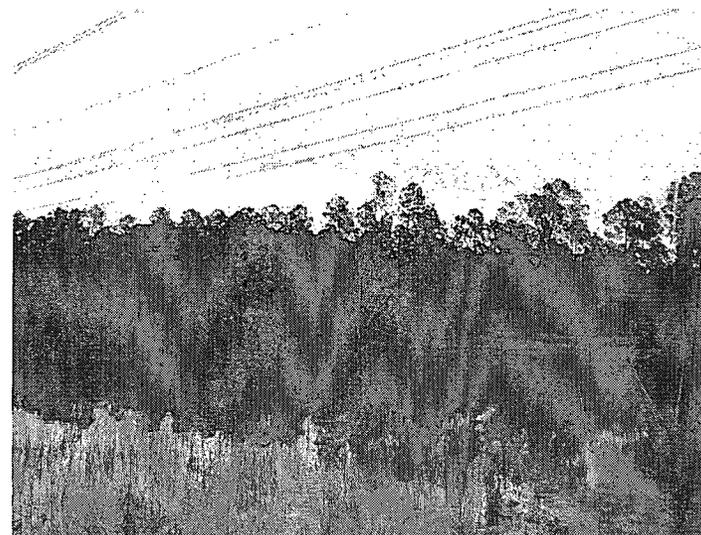
**Enhancement 7.** While lacking in diversity, this wetland is free of nuisance species. Wetland 20.

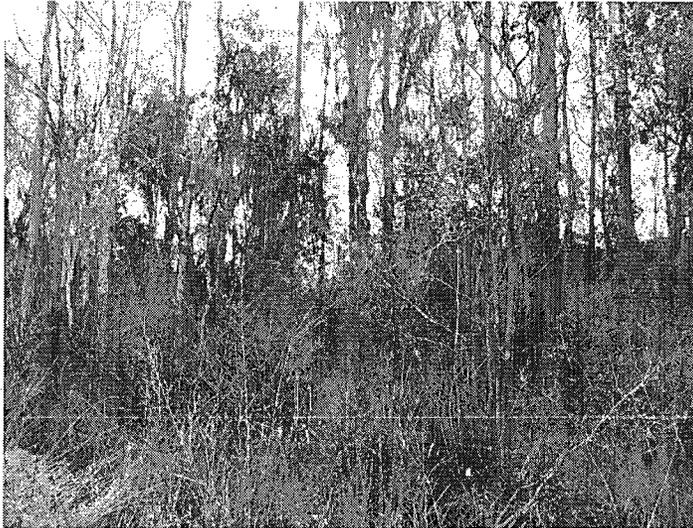
**Enhancement 10.** Area adjacent to roadway that will be enhanced hydrologically by scraping the roadway down to grade to restore natural flows. Wetland 50.
