# Crystal River Unit #3 Containment Investigation and Repair

September 2, 2010

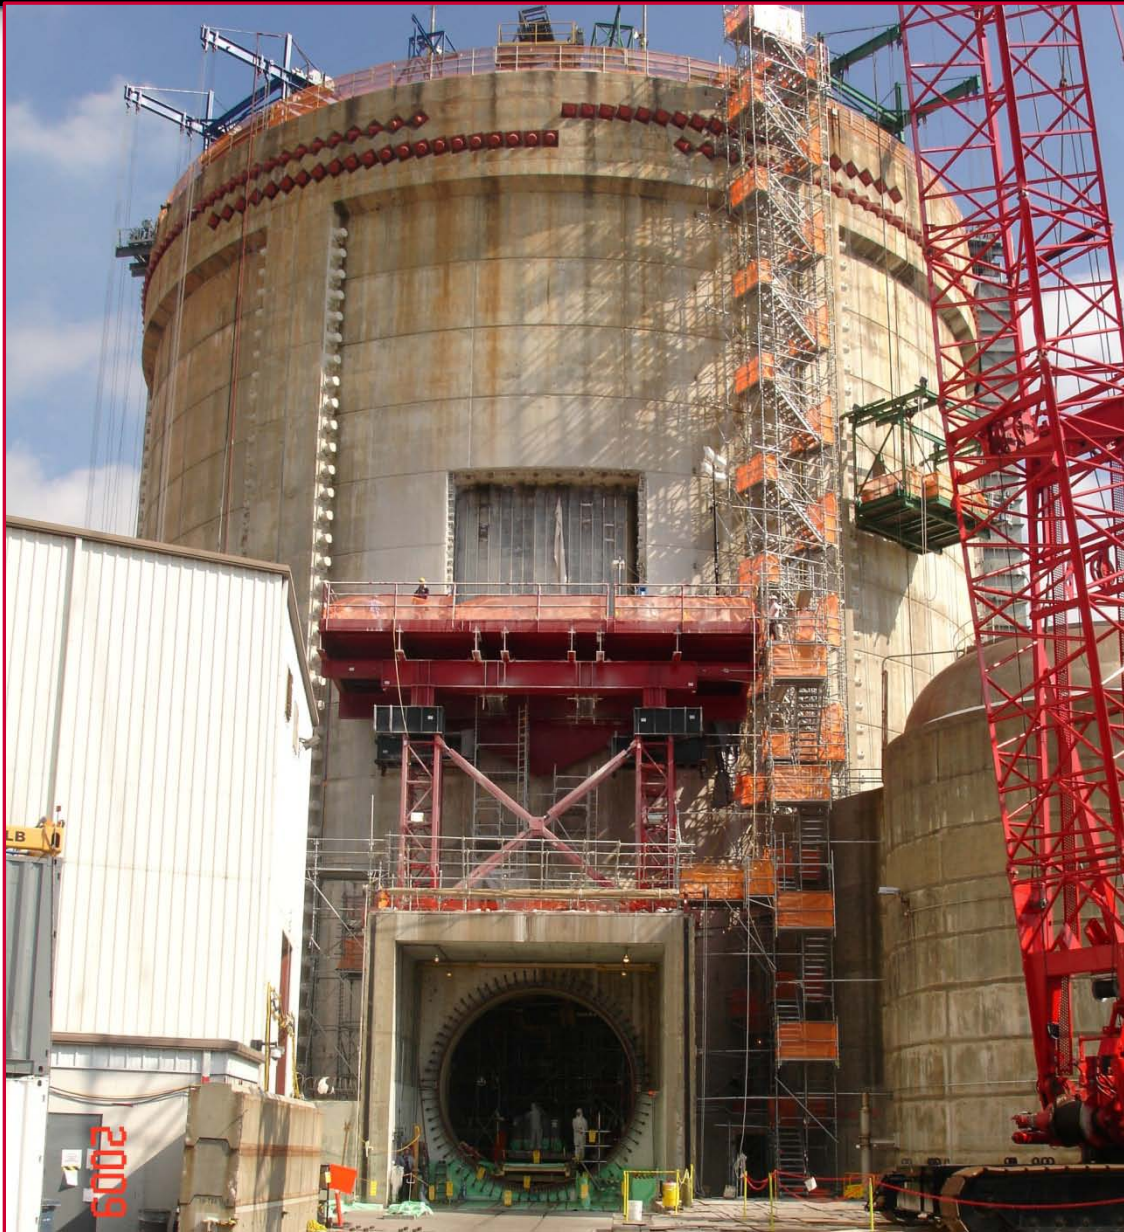
# Steam Generator Replacement Opening

## *Identification of Issue*

### **SGR Opening Dimensions**

@ Liner  
23' 6" x 24' 9"

@ Concrete Opening  
25' 0" x 27' 0"

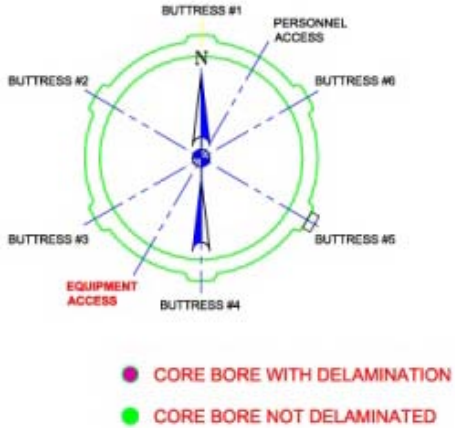
# Core Borings

**Conclusion** – Physical observation of core boring has validated the delamination boundary, as accurately predicted by Impulse Response (IR).
