**DPSPU 83-11-5**

# HISTORY OF WASTE TANK 2

## 1955 THROUGH 1974

**E. I. du Pont de Nemours & Company**  
**Savannah River Plant**

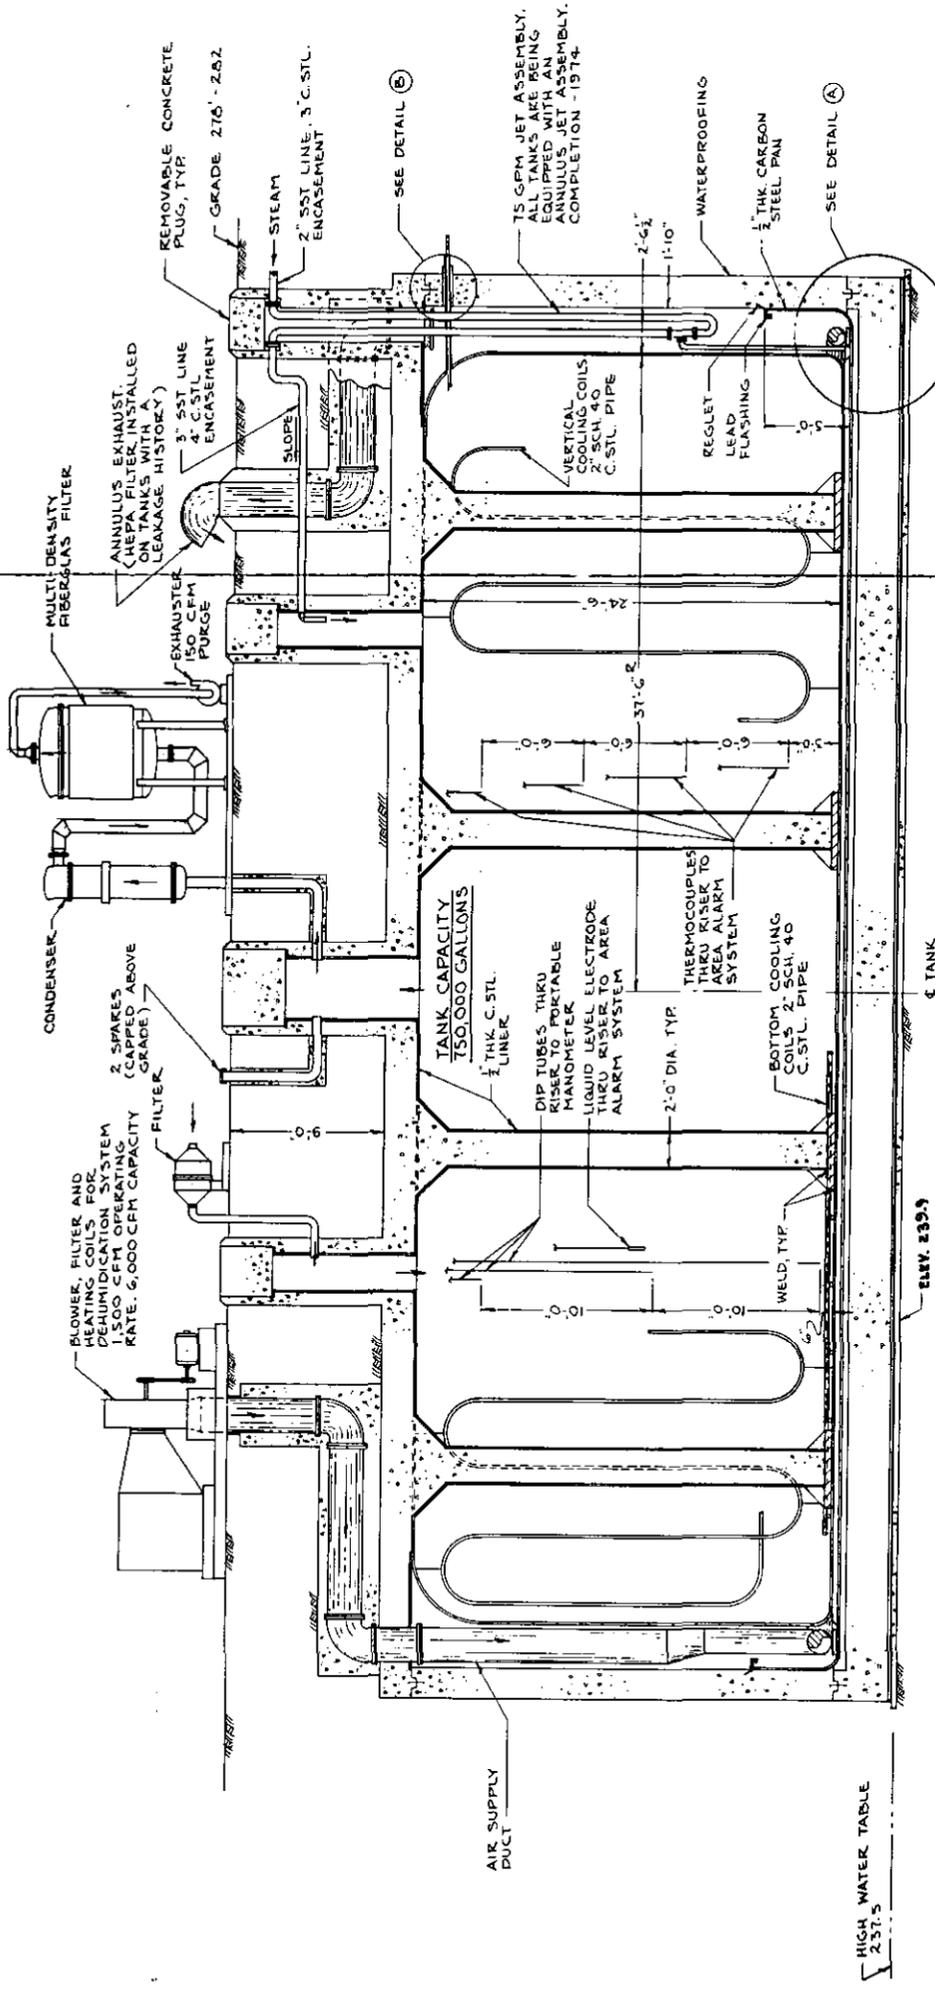
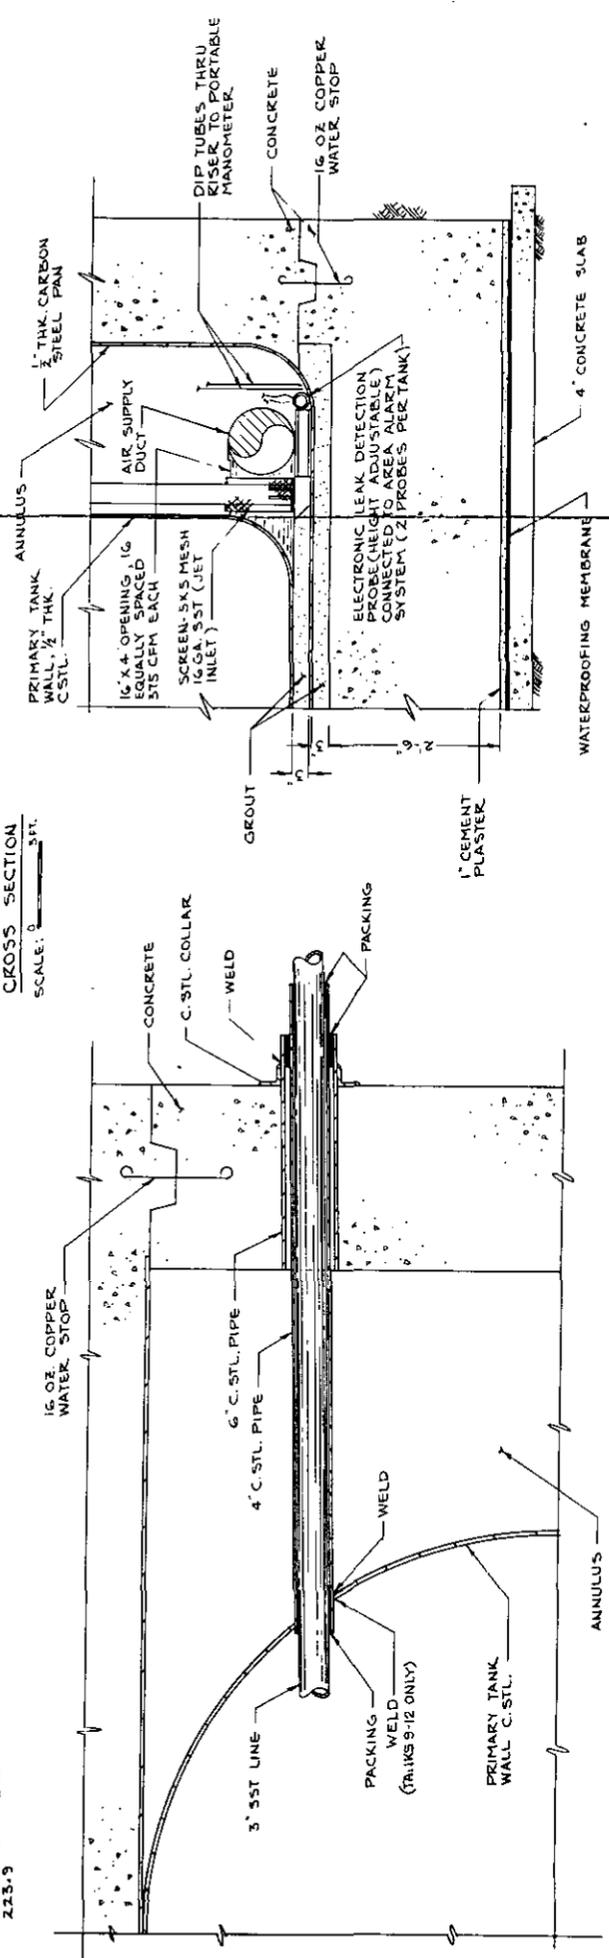
FIGURE 1. WASTE STORAGE TANK 2 12

Tank 2 is a 750,000 gallon, type I tank in F Area used for HW storage (figure 1). It is 75 ft in diameter, 24-1/2-ft high, and has 34 vertical cooling coils. At the bottom, where sludge and most of the fission products concentrate, there are four horizontal cooling coils. The tank is constructed of type ASTM A-285B steel, with nonstress-relieved welds, and is inside a concrete vault with an annular space surrounding the tank. Lining the bottom of the vault is a 5-ft-high steel annulus pan (secondary container) to collect leakage from the tank. Eight risers provide access to the tank interior and four risers to the annulus.

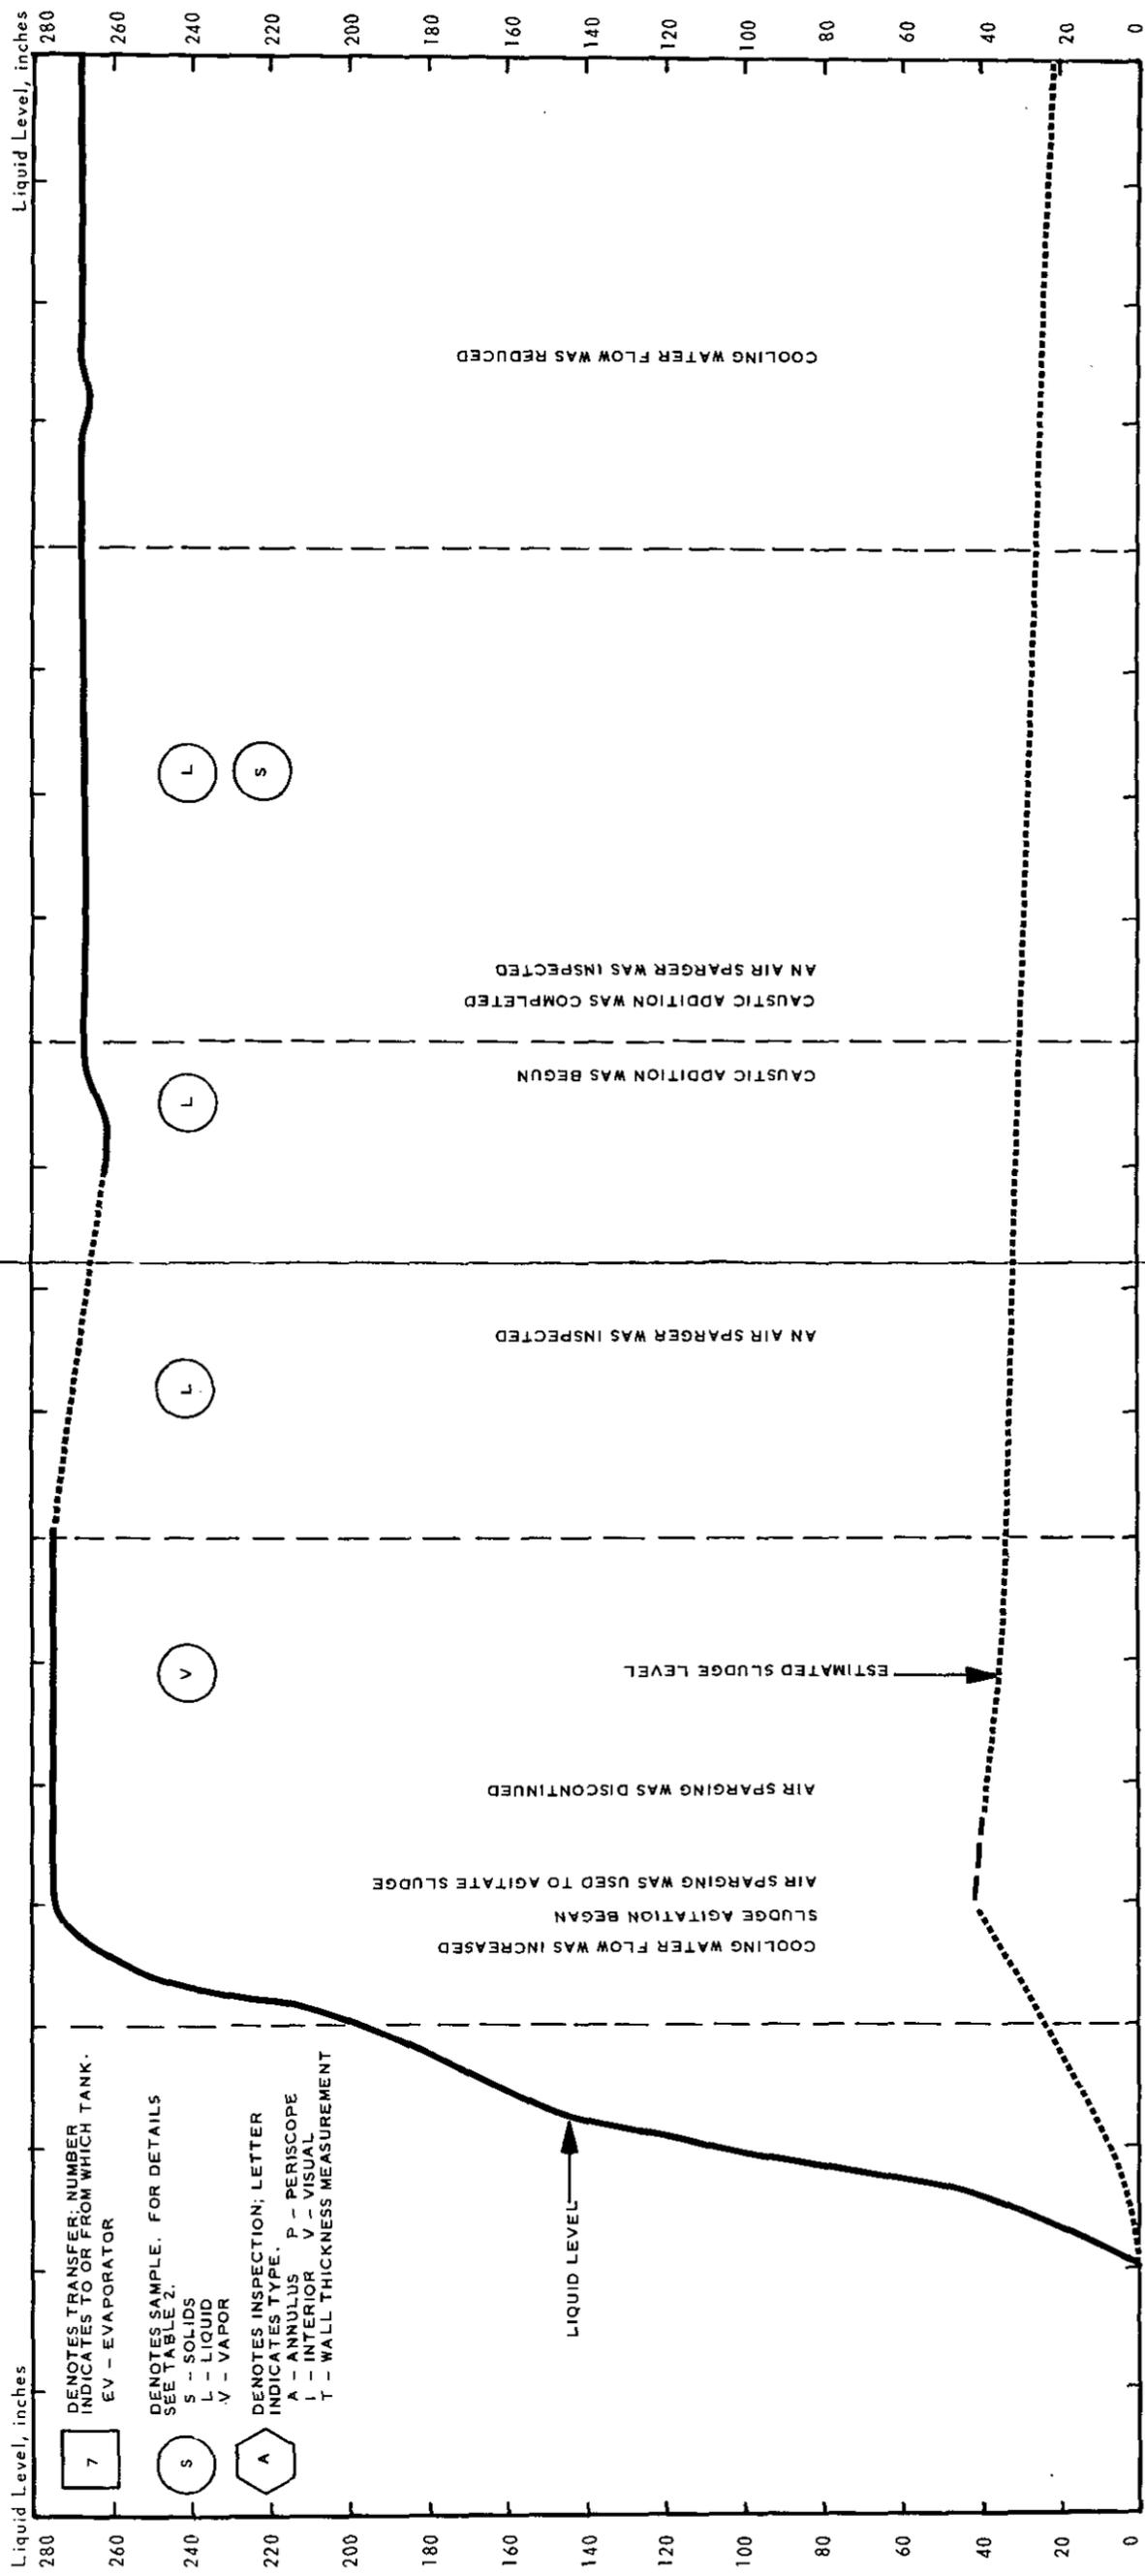
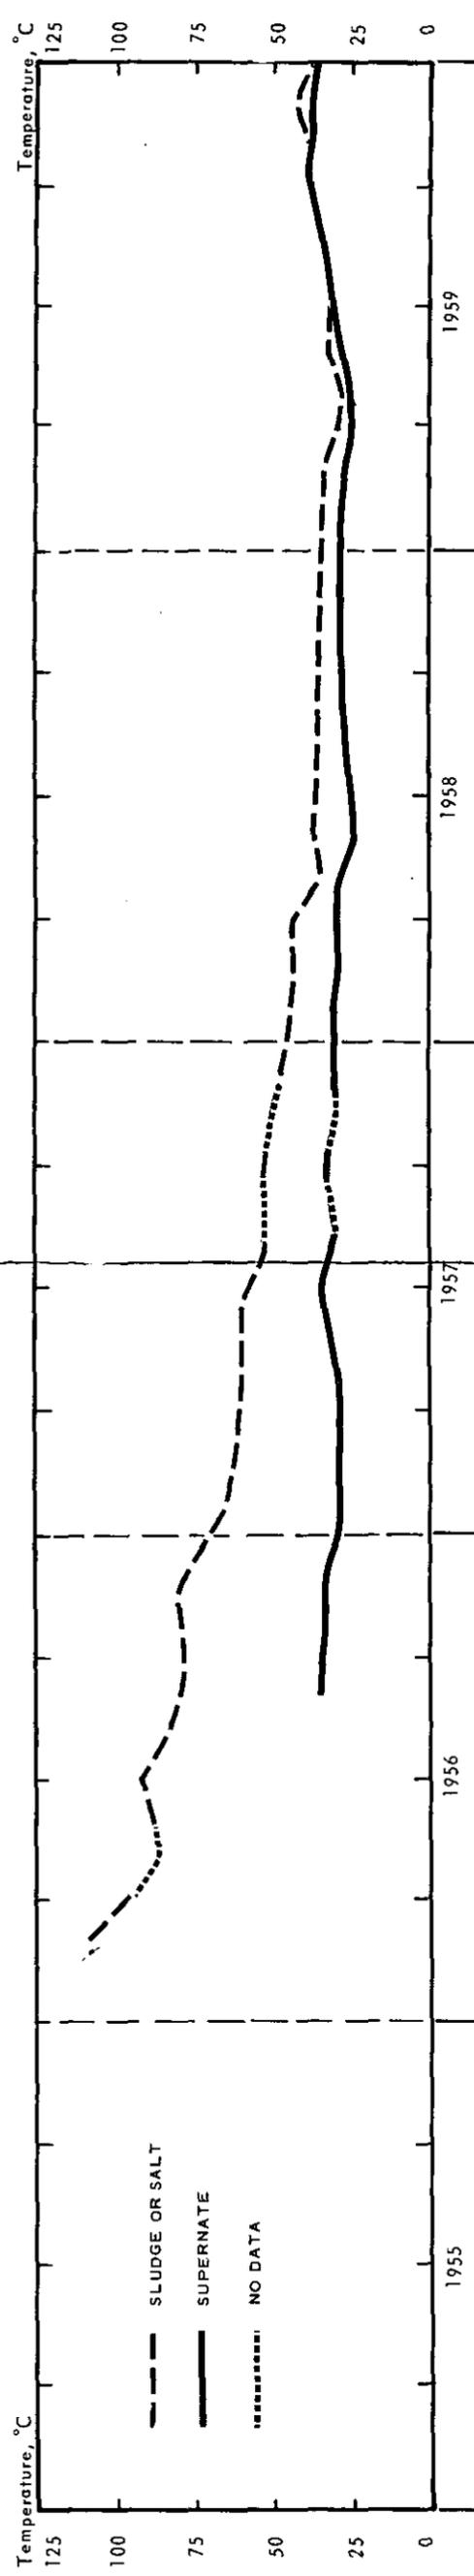
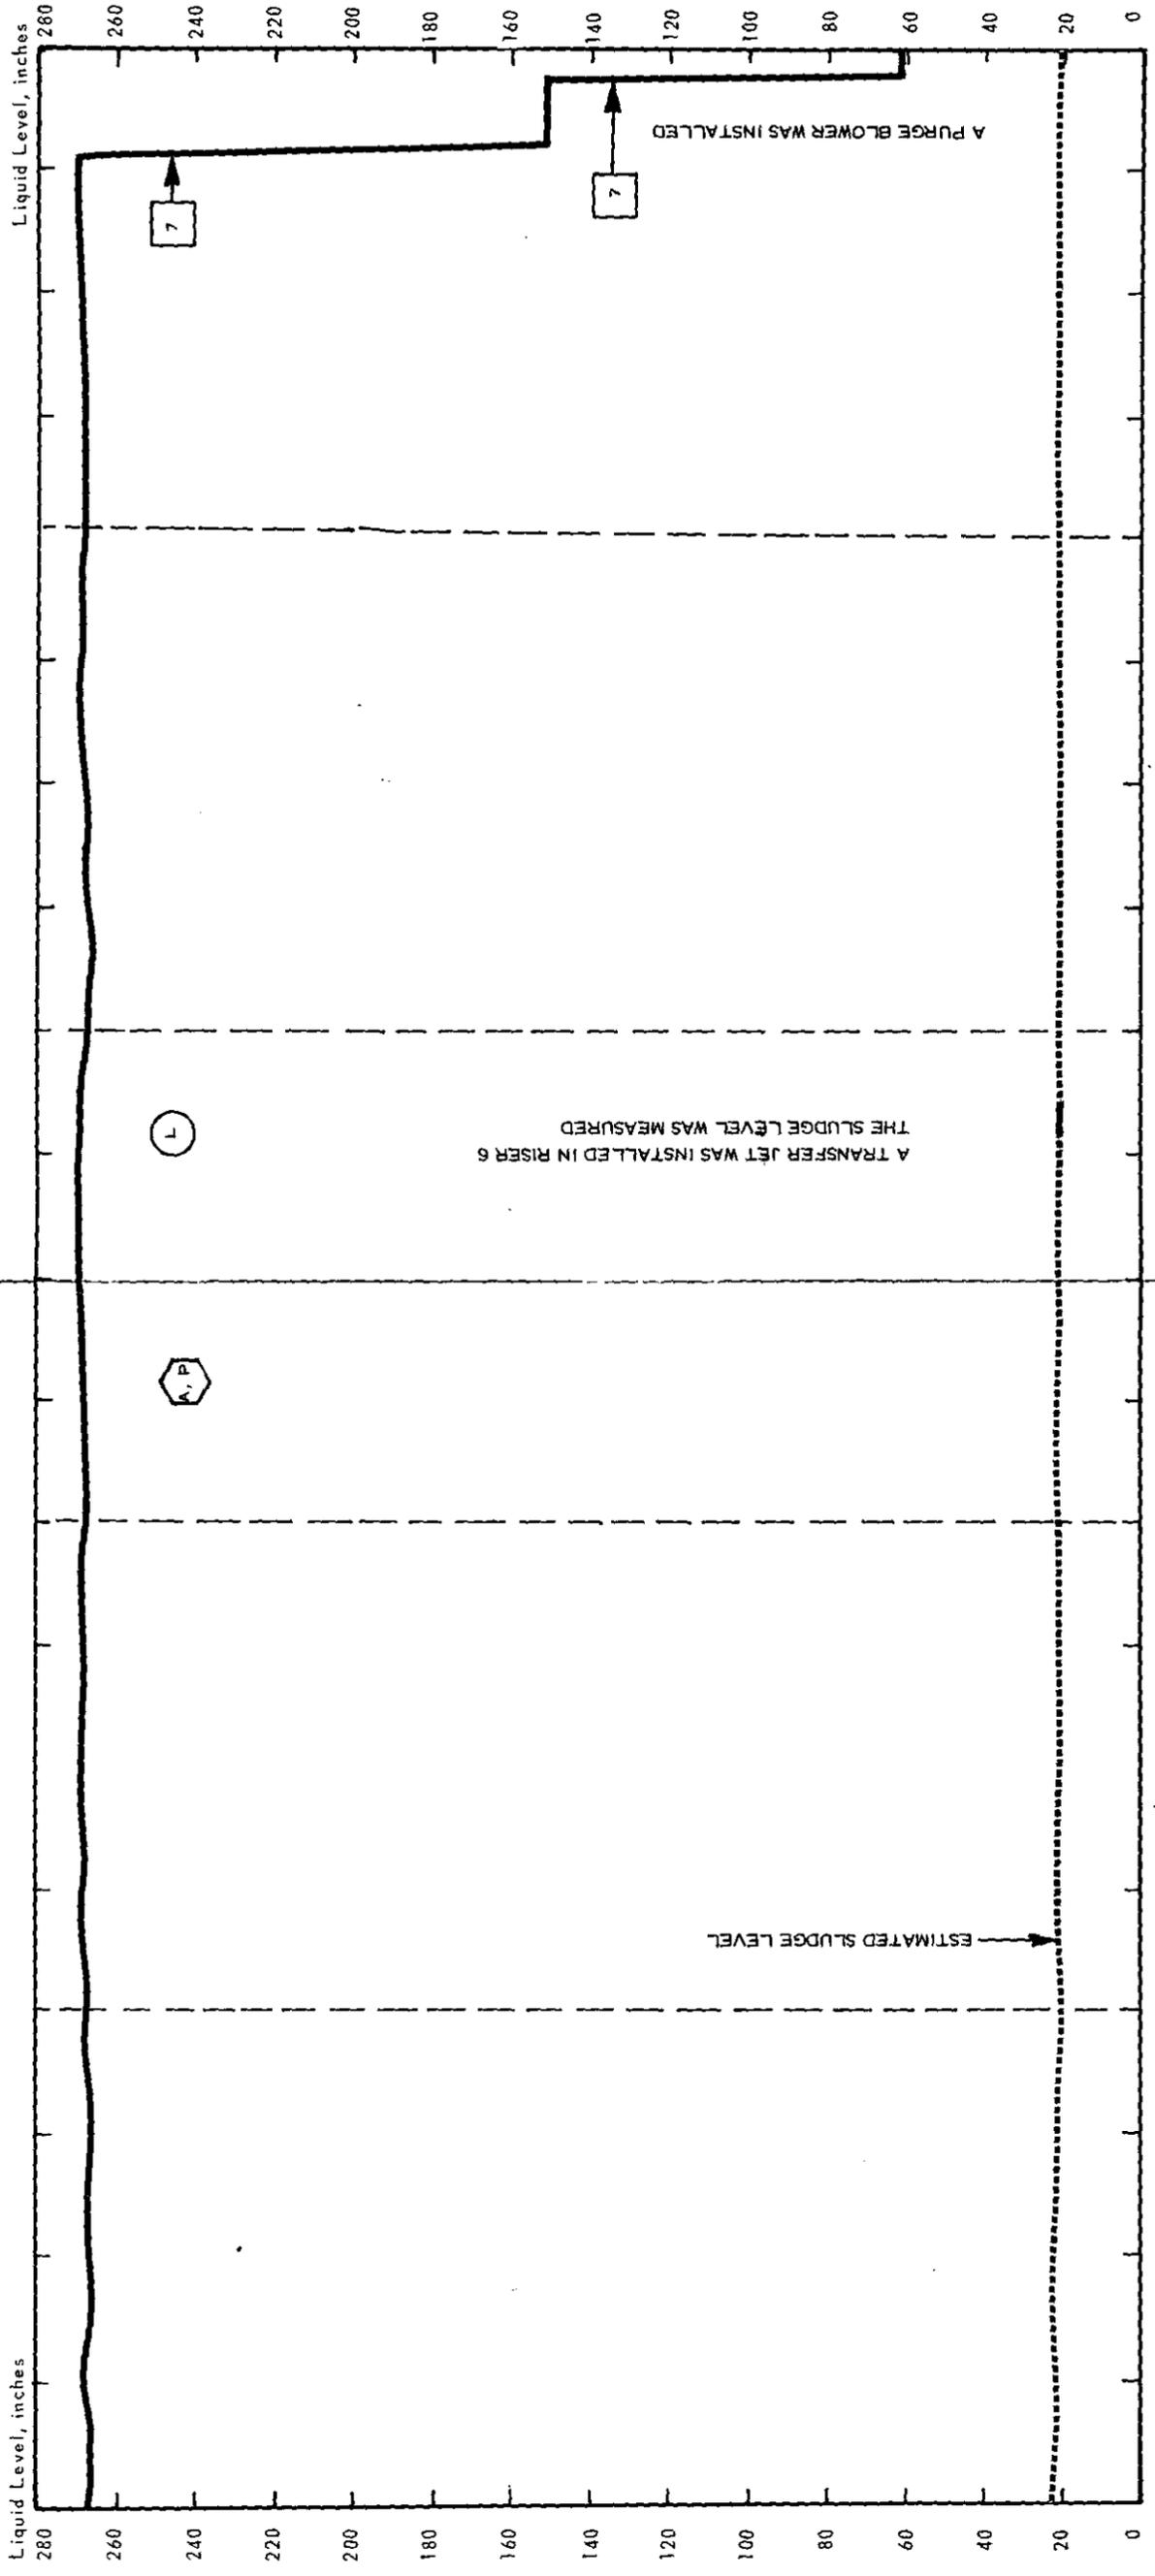
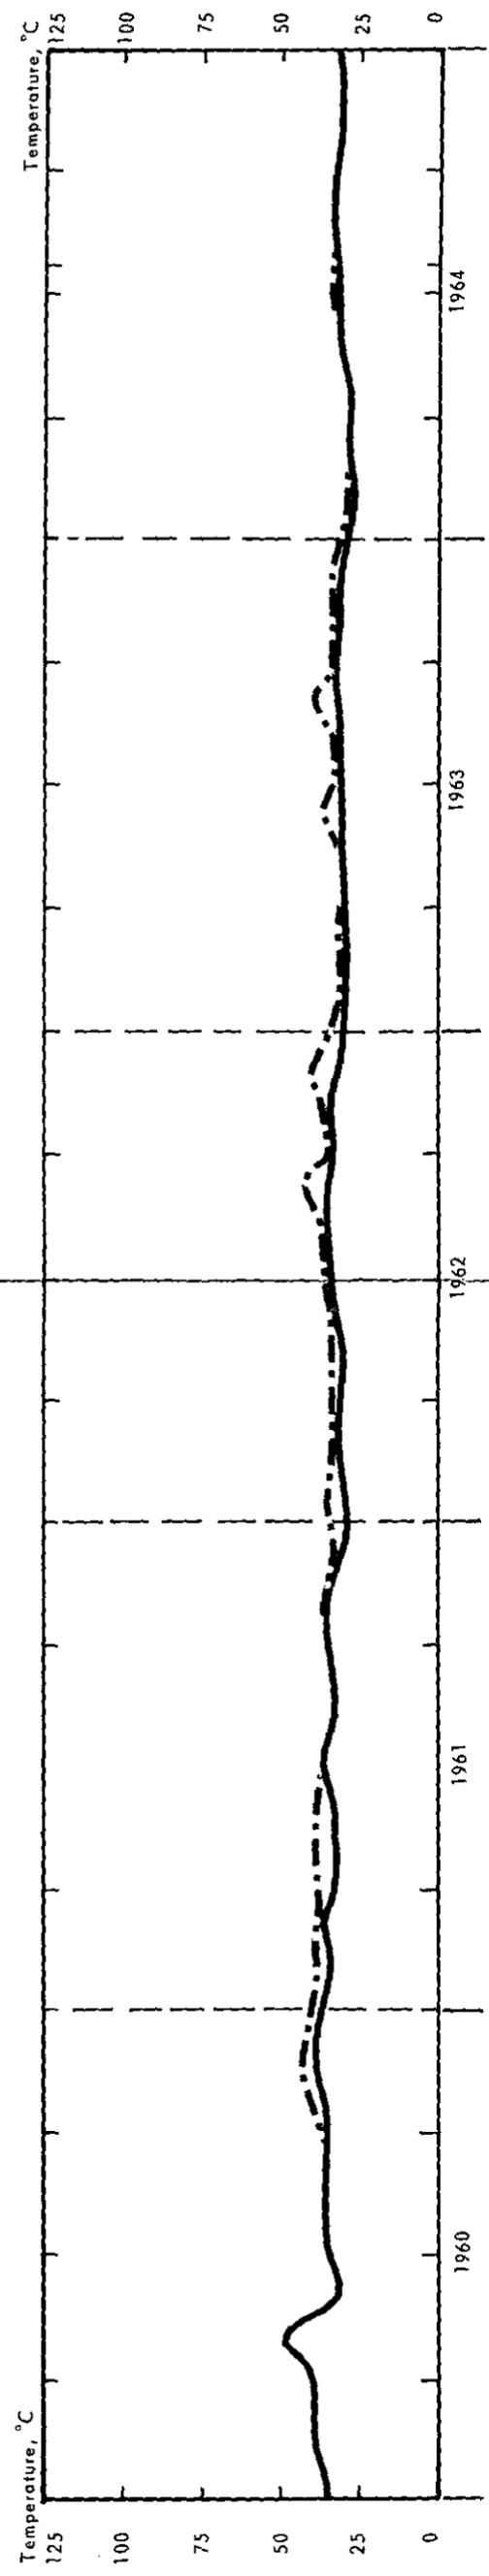
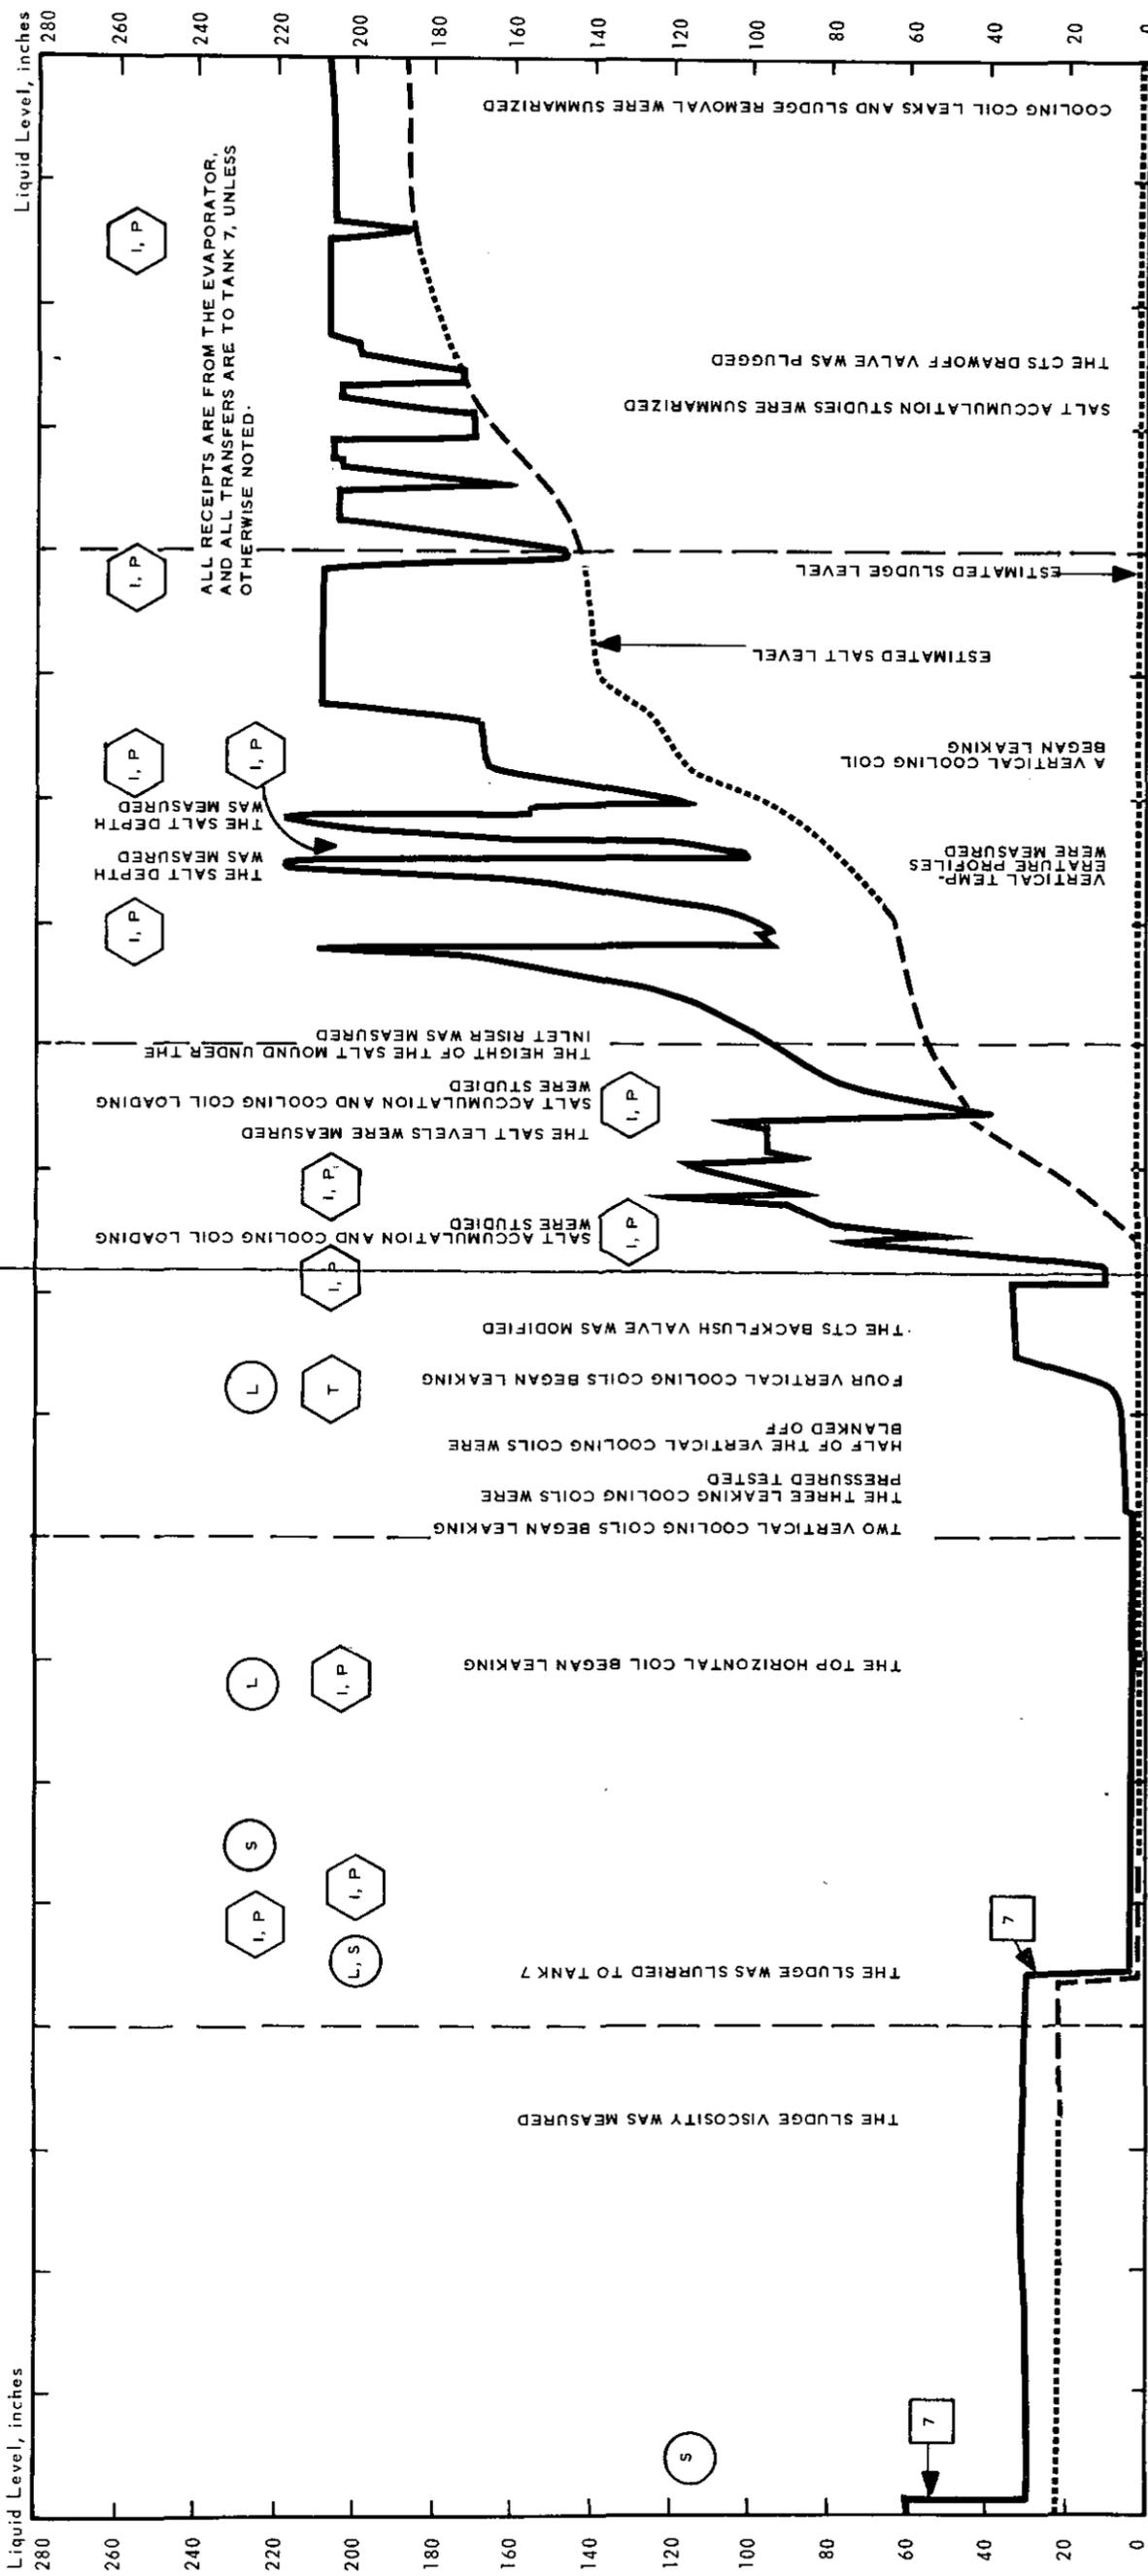
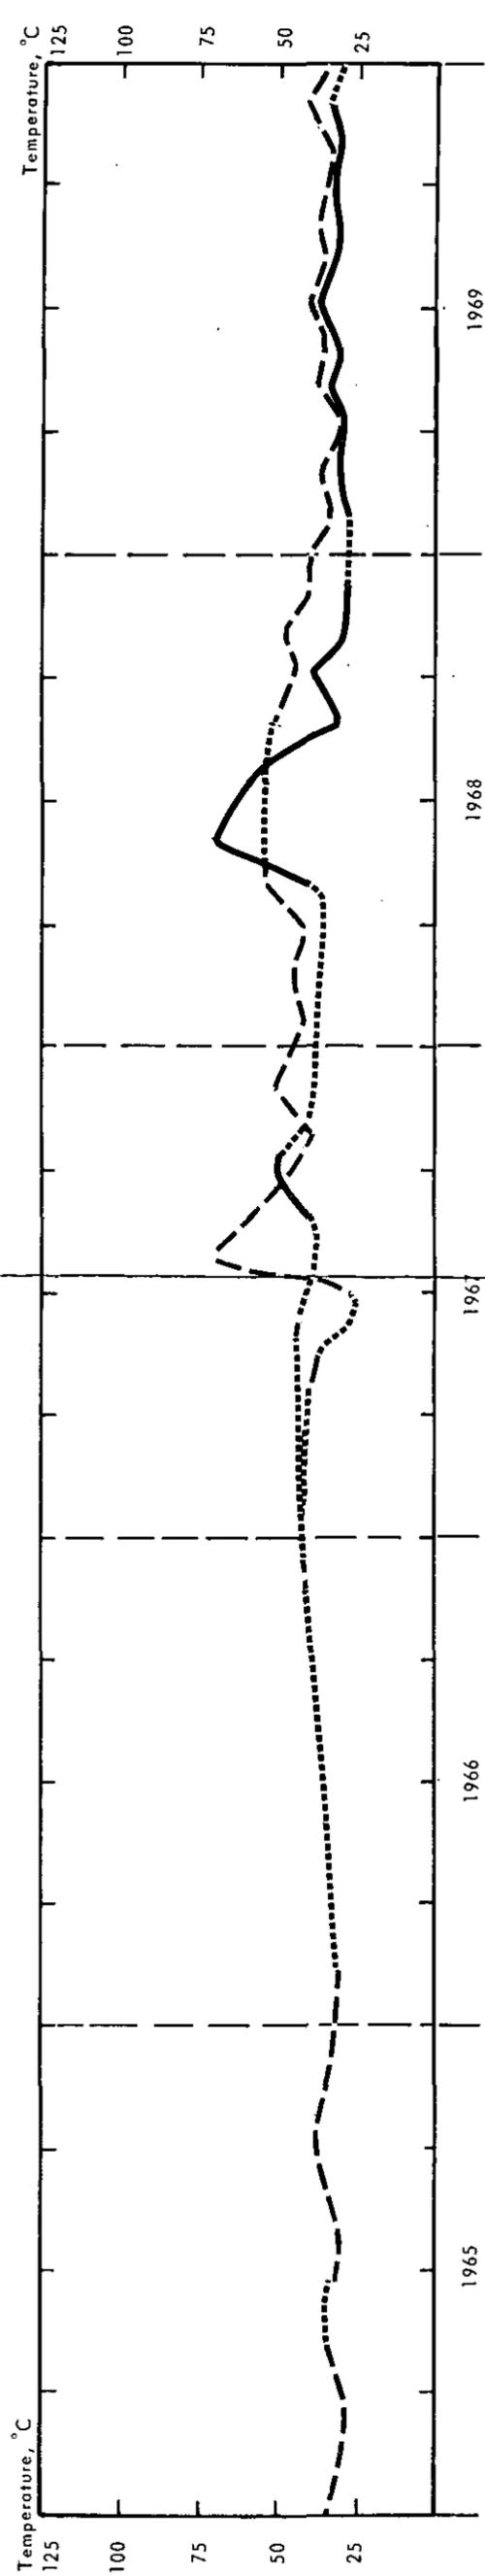
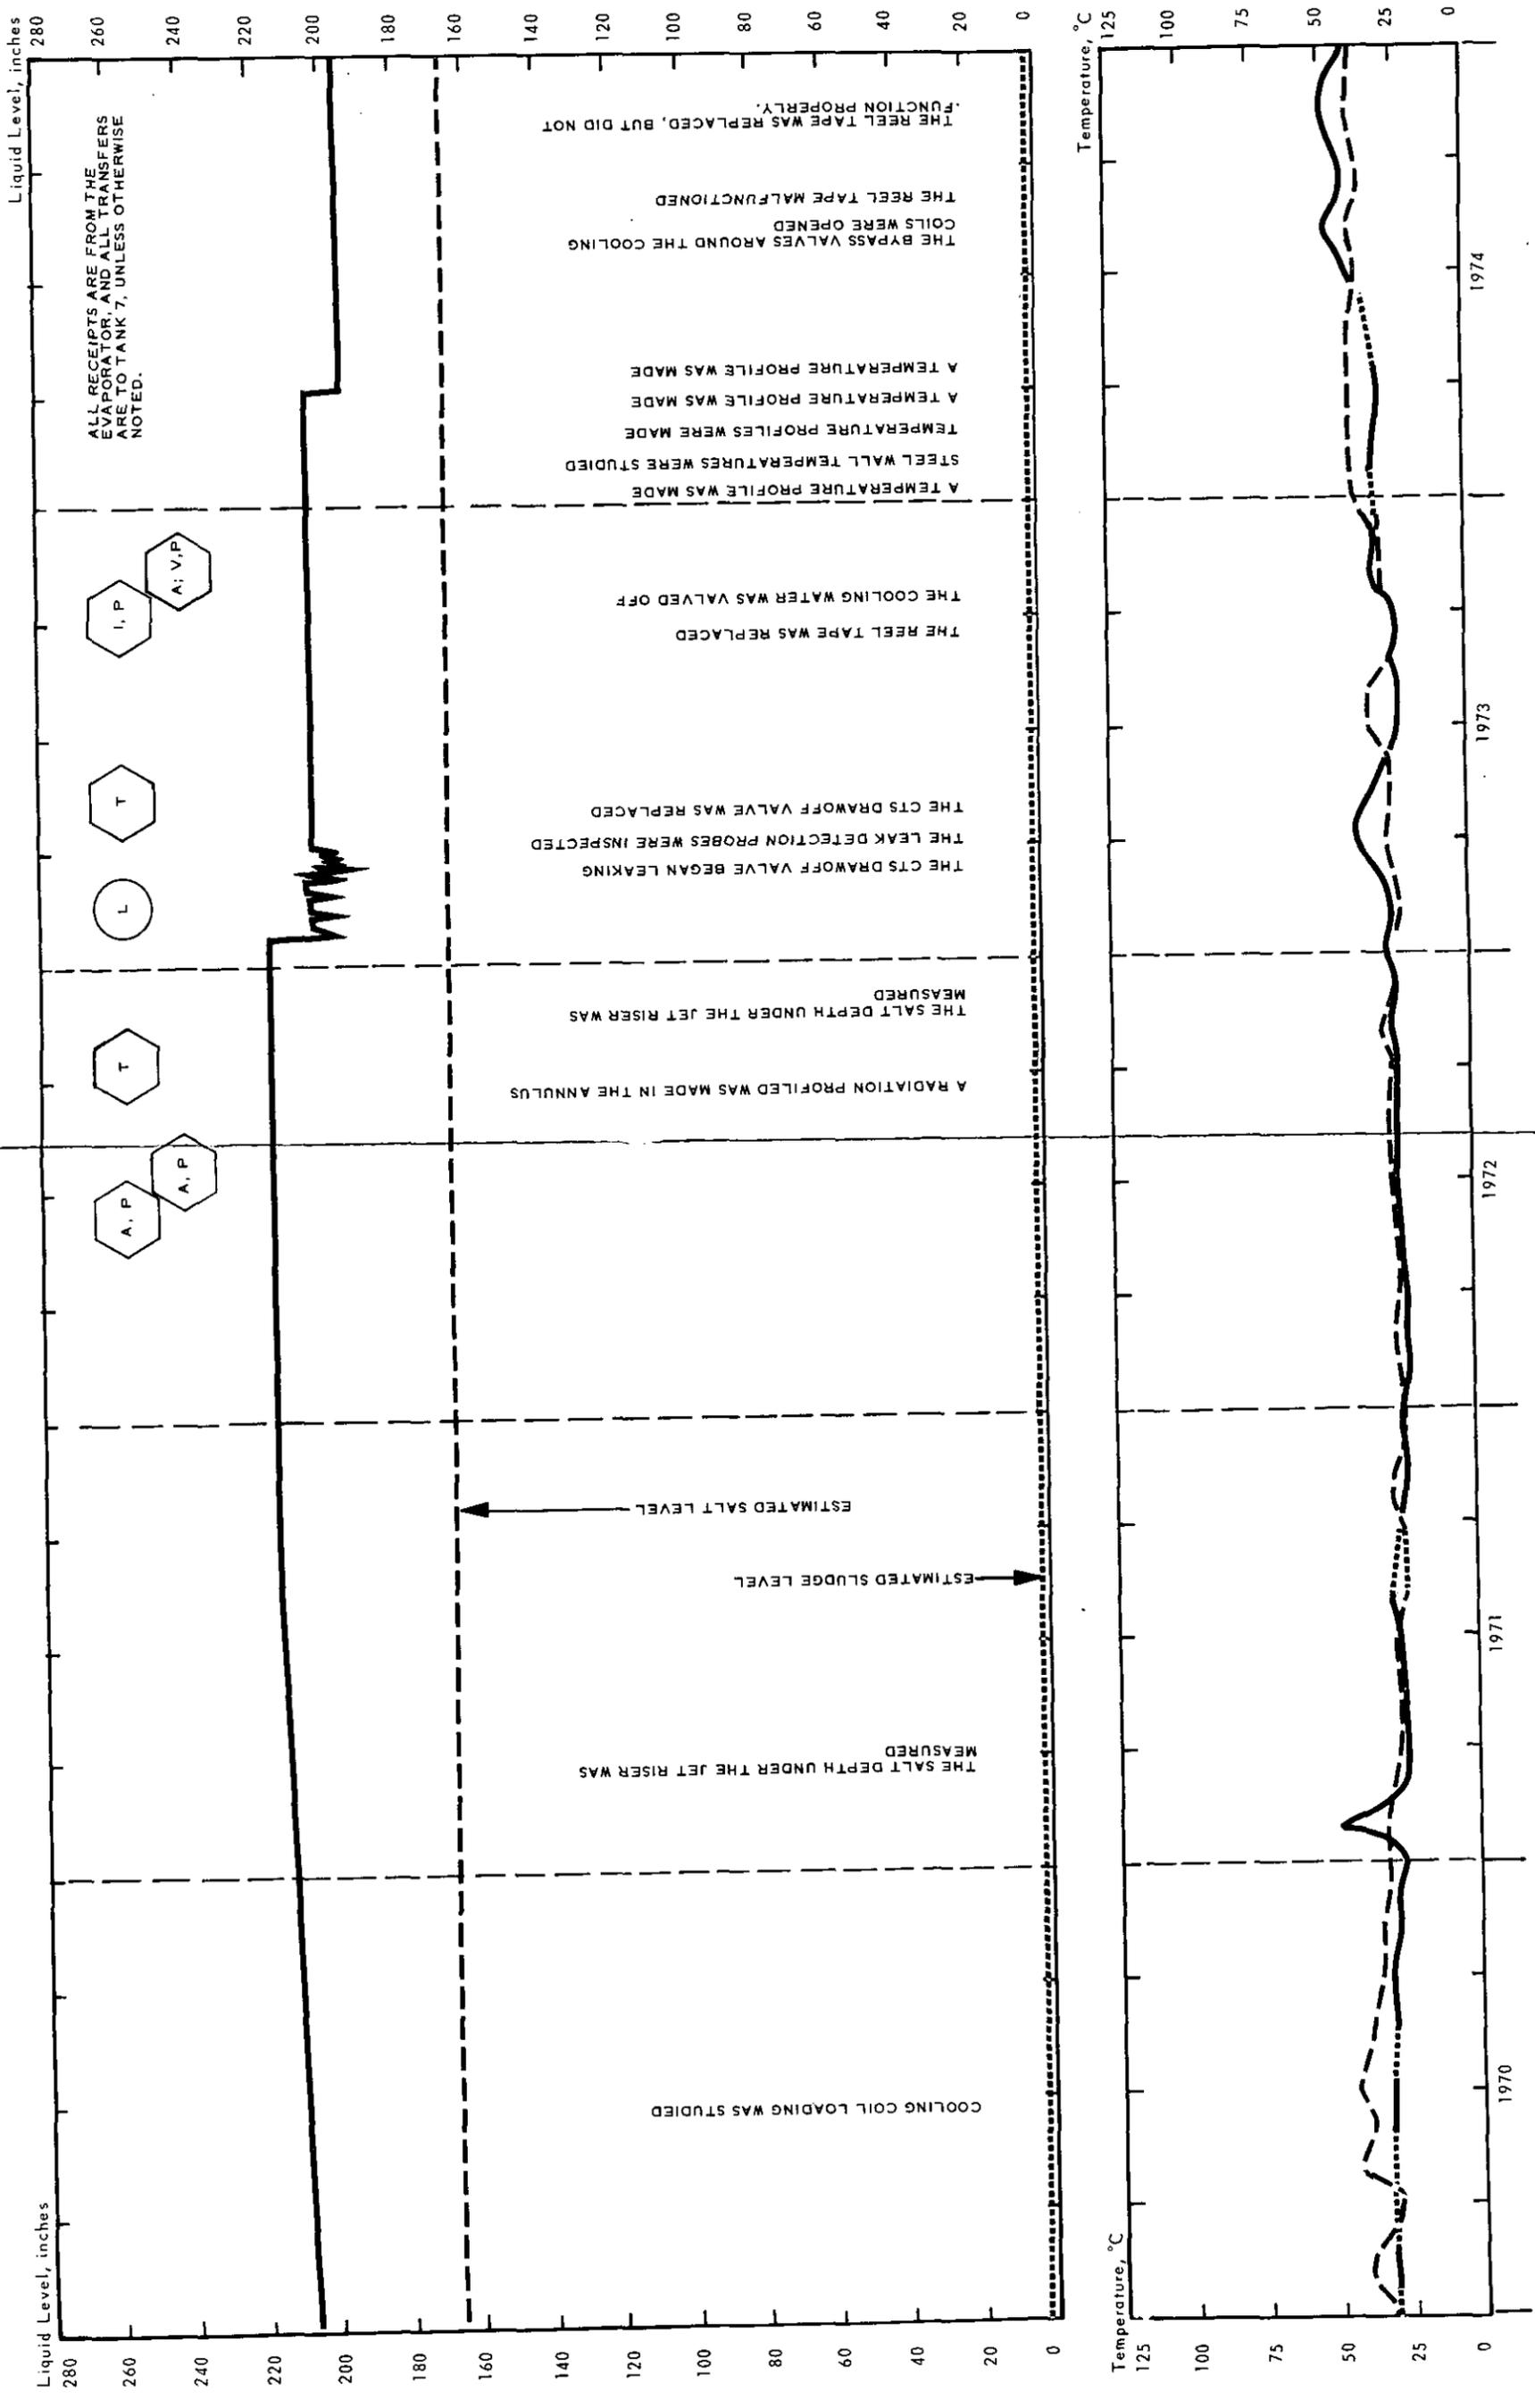
FIGURE 2. TANK 2 LIQUID LEVELS AND TEMPERATURES

Events in the history of tank 2 are listed chronologically in figure 2 and discussed briefly in this report. Listing of a date by month and year at any place in this report serves as a reference to the Works Technical Report for that month. This history covers the period from July 1955 through December 1974.

Significant events, including all entries discussed in the chronology, are shown in figure 2 along with the sludge and supernate temperatures.

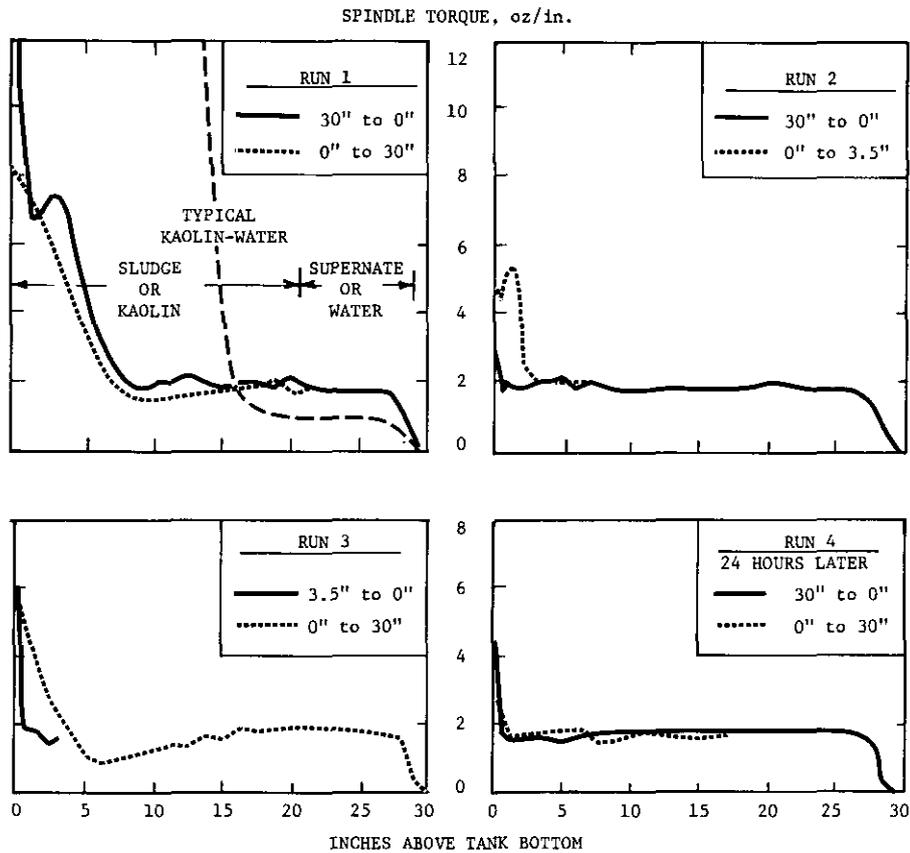
FIGURE 3. VISCOSITY TRAVERSES OF WASTE TANK  
SLUDGE, WASTE TANK 2, RISER 3

[CONDITIONS: TWO-BLADE PADDLE, 3-1/2" dia x 1" high; 100 rpm SPINDLE DRIVE;  
1.35 in./min VERTICAL TRAVEL RATE; NO TIME DELAY BETWEEN RUNS 1, 2, AND 3.]

Oct 1965 The sludge viscosity was measured (figure 3).

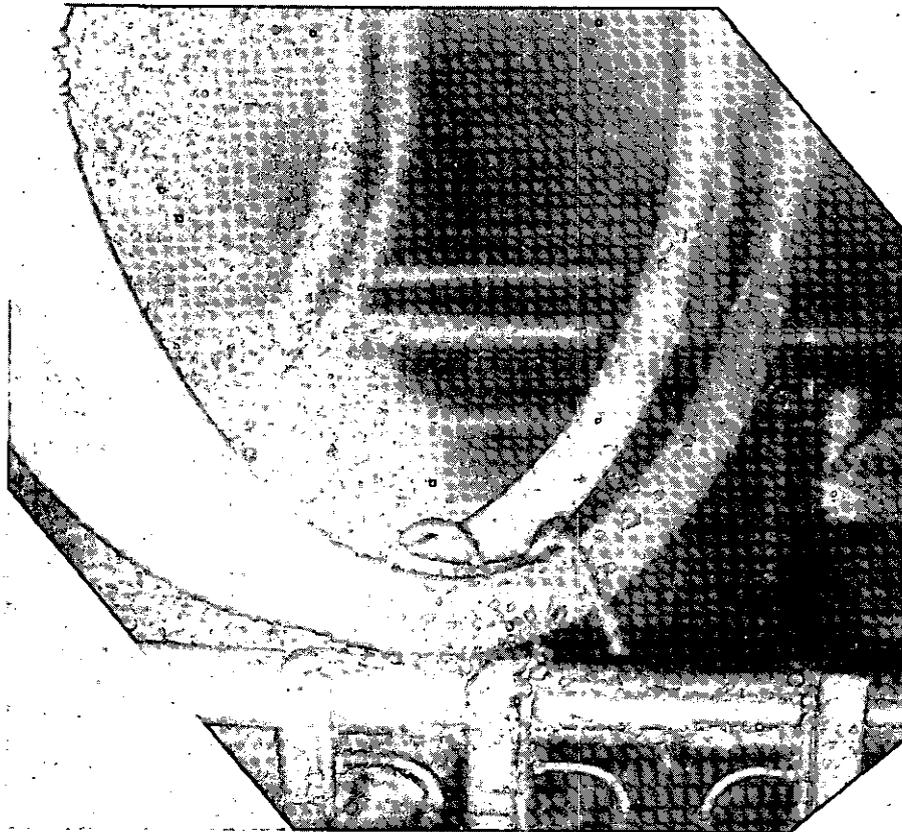
FIGURE 6. PERISCOPIC VIEW OF BOTTOM OF TANK 2. DPSPF 11080-2.

Feb 1966 About 90% of the sludge was slurried, by using high pressure water jets, and transferred to tank 7. 237,000 gallons of water were used to remove 44,000 gallons of sludge. The slurry pumped from the tank was sampled (figures 5 and 6 and table 2).

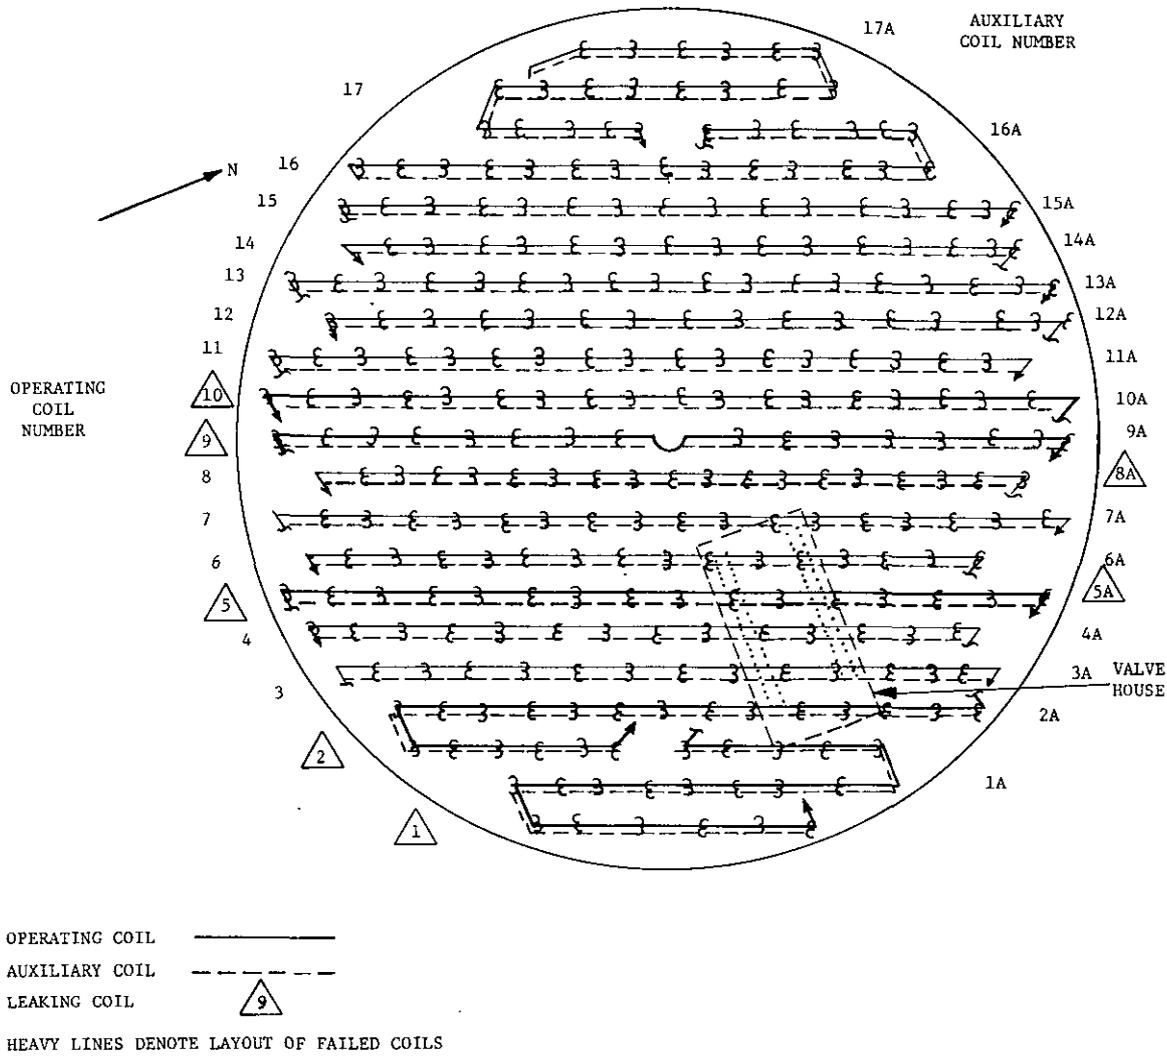
FIGURE 17. TANK 2 VERTICAL COOLING COIL LAYOUT

One horizontal and seven vertical cooling coils in tank 2 have leaked. The coil failures occurred between September 1966 and August 1968, following the February 1966 sludge removal operations. Events related to the coil failures are listed here and are shown in figure 2. The layouts of the failed vertical cooling coils are shown in figure 17.
