**DPSPU 83-11-5**

# HISTORY OF WASTE TANK 2

## 1955 THROUGH 1974

**E. I. du Pont de Nemours & Company**  
**Savannah River Plant**

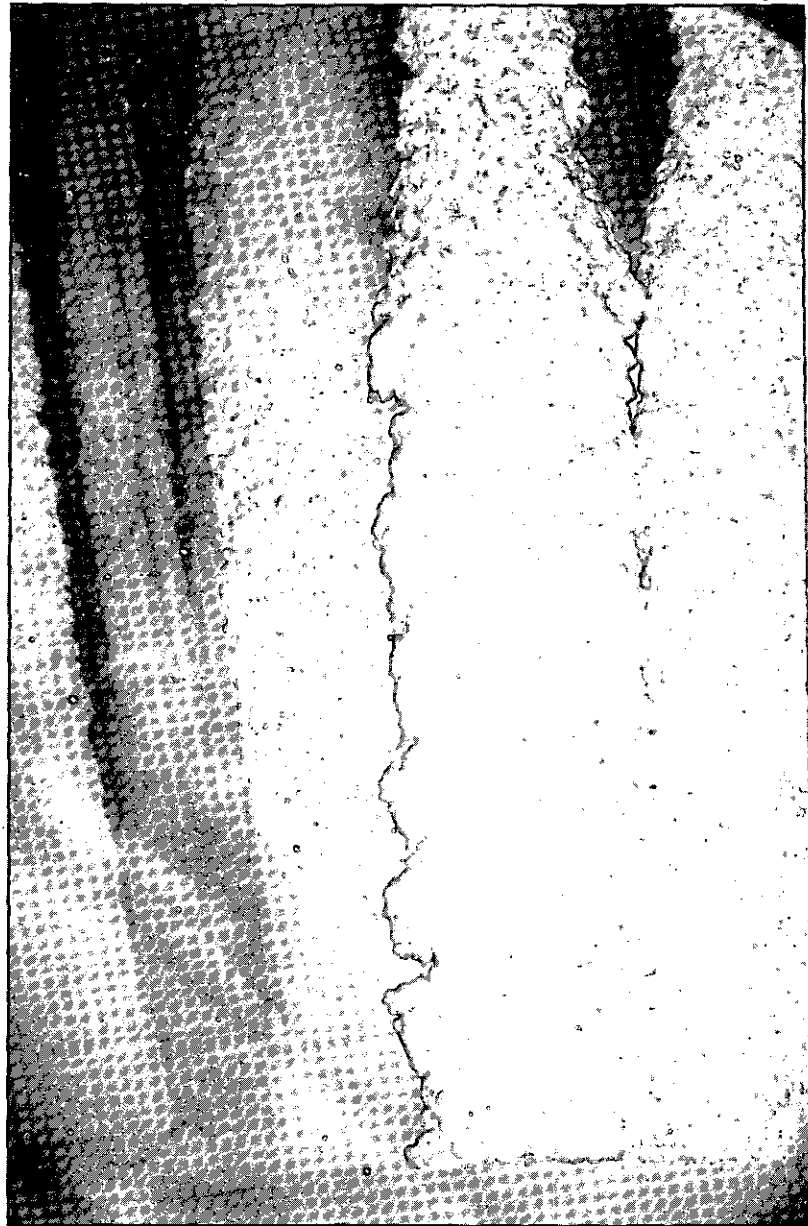
FIGURE 9. WASTE CRYSTALS DEPOSITED ON COOLING COIL, TANK 2-F.  
Coil in foreground was about 3 feet from periscope objective, and is slightly out of focus. Orientation N 80°E, March 15. DPSPF 12549-5.

Mar 1968      About 413,000 gallons of supernate was transferred to tank 7 in two transfers.  
                  The tank interior was periscopically photographed and inspected beneath riser 5. The salt volume was estimated (figures 7, 8, 9, and 15 and table 6).
