Tank 18 Volume Estimation Following Mantis™ Cleaning Operations

The purpose of this report is to document the estimated volume of material left in Waste Tank 18 after Mantis™ Cleaning Operations. Characterization of the remaining material will be discussed in a later report after sample analysis.

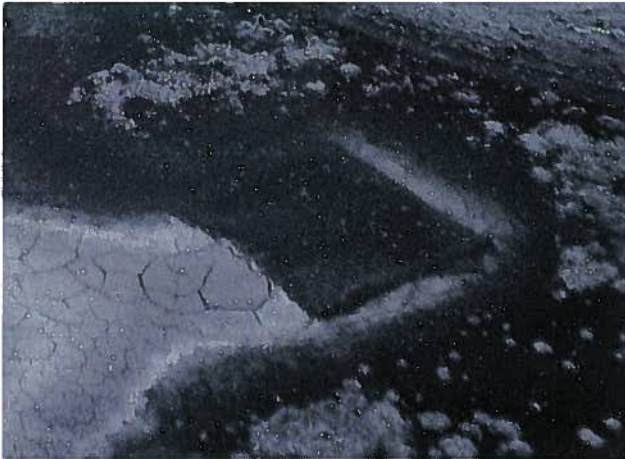
1/8 Inch

Depth (Inches)	Criteria
1/8	Dusting of Solids evident with some clean steel floor visible.
1/4	Sides of lifting plate visible. Solids are mostly well below the top of lifting plate.
1/2	The shape of the lifting plate is clearly visible but the material appears to be the same depth as the top of the lifting plate.
3/4	Shape of lifting plate can be discerned through solids.

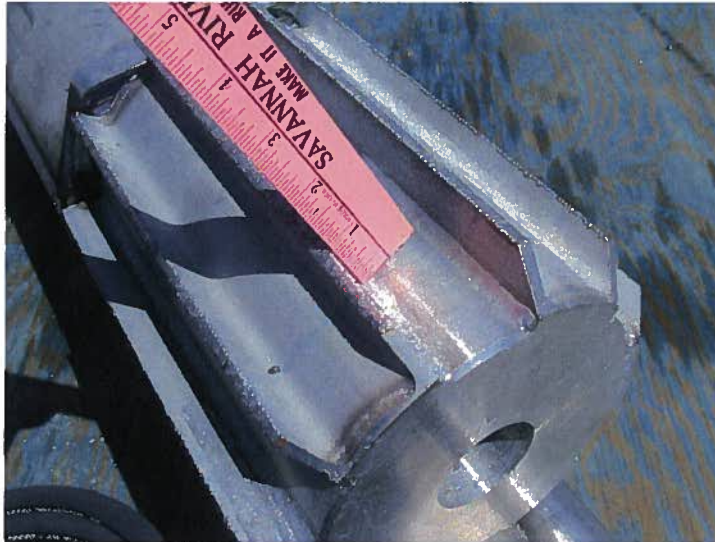
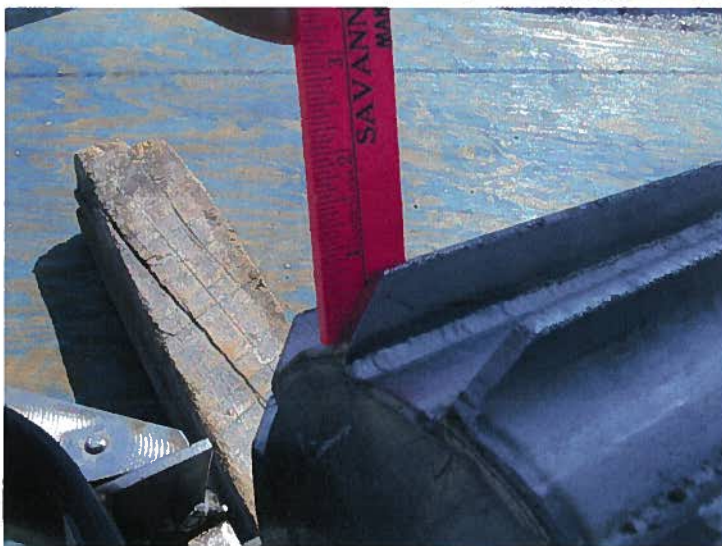
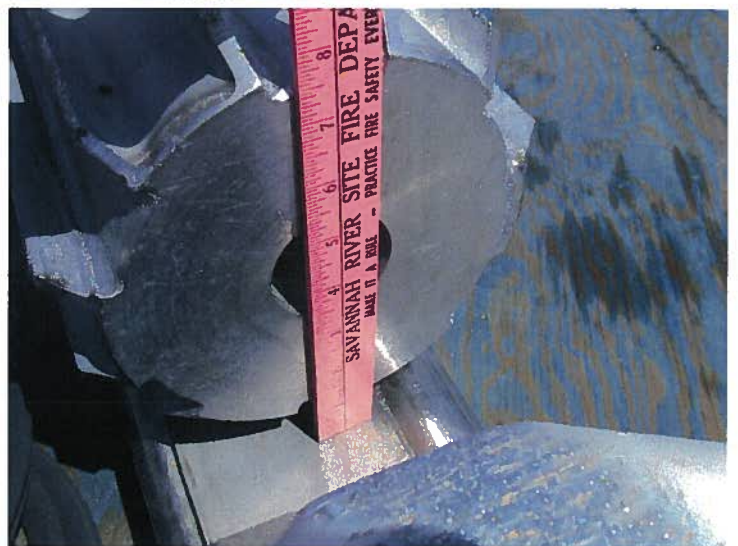
Attachment E
Reference Pictures For Mantis™ Mapping

As the majority of the lifting plates were not visible it was determined additional data would be required to fully map Tank 18 for a volume estimation. It was deemed necessary to restore driving functions to the Tank 18 Mantis™ in order to collect additional material depth measurements using known dimensions of the Mantis™ wheels (Attachment E). In early September 2009, the Mantis™ was used to survey the unmeasured portions of Tank 18. The Mantis™ successfully surveyed the previously indeterminate Central, North Eastern, Eastern and South Eastern regions. For each depth measurement in these regions the Mantis™ was made to dig its' wheels down to bare tank floor to ensure that the measurement was accurate. However, due to a loss in traction caused by material building up inside the Mantis™' wheels and drag weight of hose and tether system the Mantis™ was unable to reach the other regions inside of Tank 18. The travel limitations of the Mantis™ are shown in Attachment F.

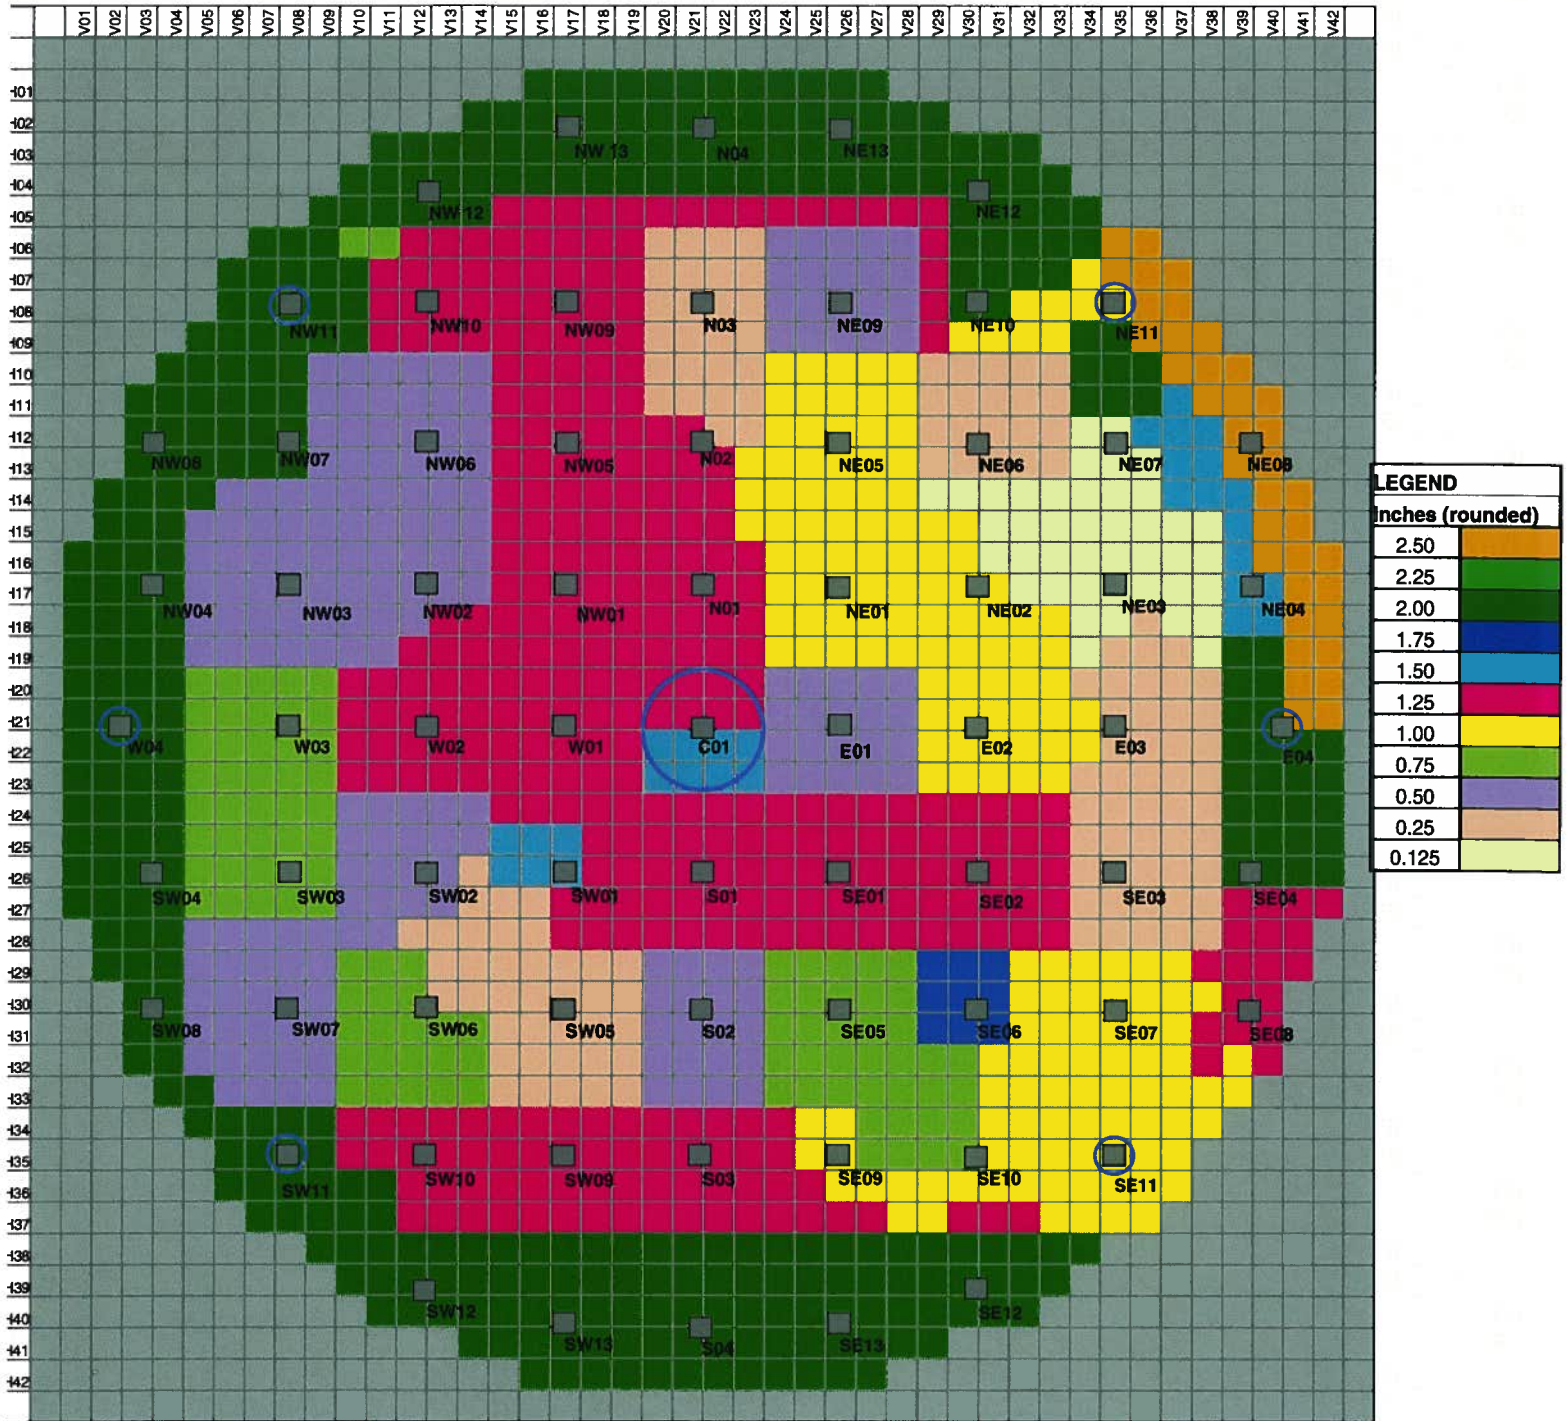
Attachment I Tank 18 Mapping After Mantis™ Operation

The material depths derived from lifting plates in the digital still photos and the regions reached by the Mantis™ during the September survey are listed in Attachment C. The weighted mean averages used for the indeterminate portions of Tank 18 were 1.07 inches for the central plain area and 1.78 inches for the ring along the perimeter. The measured and calculated material depth values were then entered into an Excel sheet (Attachment I). Each cell in the sheet represents a 2 foot by 2 foot section of tank floor. The material volumes for each cell were summed giving a final value of 3900 gallons of material remaining in Tank 18.

The Mantis™ activities have successfully removed the two remaining mounds inside of Tank 18. Using a combination of still pictures and live video of the Mantis™ surveying the Tank and the use of statistical analyses the depth of the remaining material in the tank was estimated to be approximately 4000 gallons.
