U-ESR-F-00042
December 15, 2009
Revision 0

Tank 19 Volume Estimation Following Mantis™ Cleaning Operations

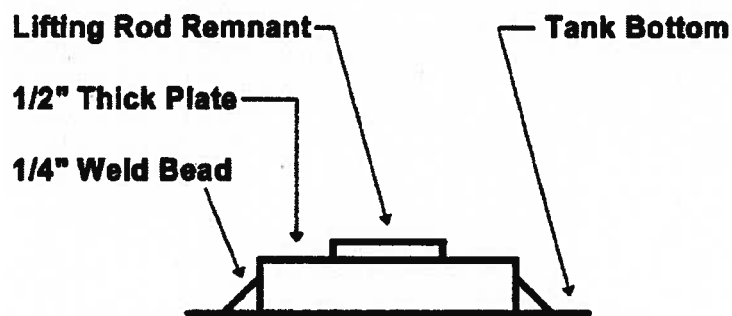
Figure 1: Lifting Plate Elevation View. (Not to Scale)

The floor of a Type IV waste tank has 69 1 foot by 1 foot by 1/2 inch lifting plates arrayed in a grid pattern across the floor (Attachment B). Each plate has a 1/4 inch weld bead affixing it to the floor and the remnant of the lifting rod attached to the top of the plate during tank construction. (Figure 1). These lifting plates were used as landmarks for material mapping.

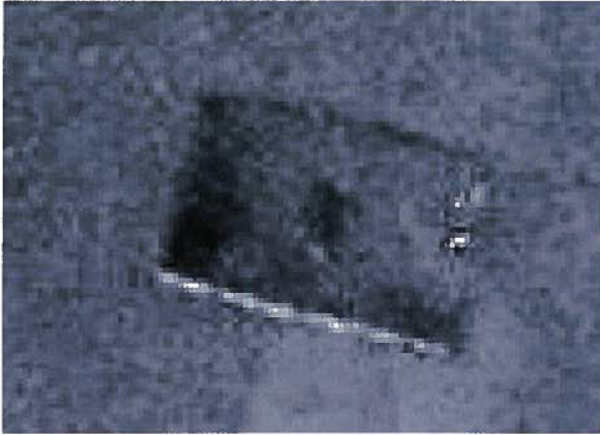
1/8 Inch

Depth (Inches)	Criteria
1/8	Dusting of Solids evident with some clean steel floor visible.
1/4	Sides of lifting plate visible. Solids are mostly well below the top of lifting plate.
1/2	The shape of the lifting plate is clearly visible but the material appears to be the same depth as the top of the lifting plate.
3/4	Shape of lifting plate can be discerned through solids.
1	Lifting plate not discerned. No evidence of significant material depth change from regions where lifting plates were discerned.

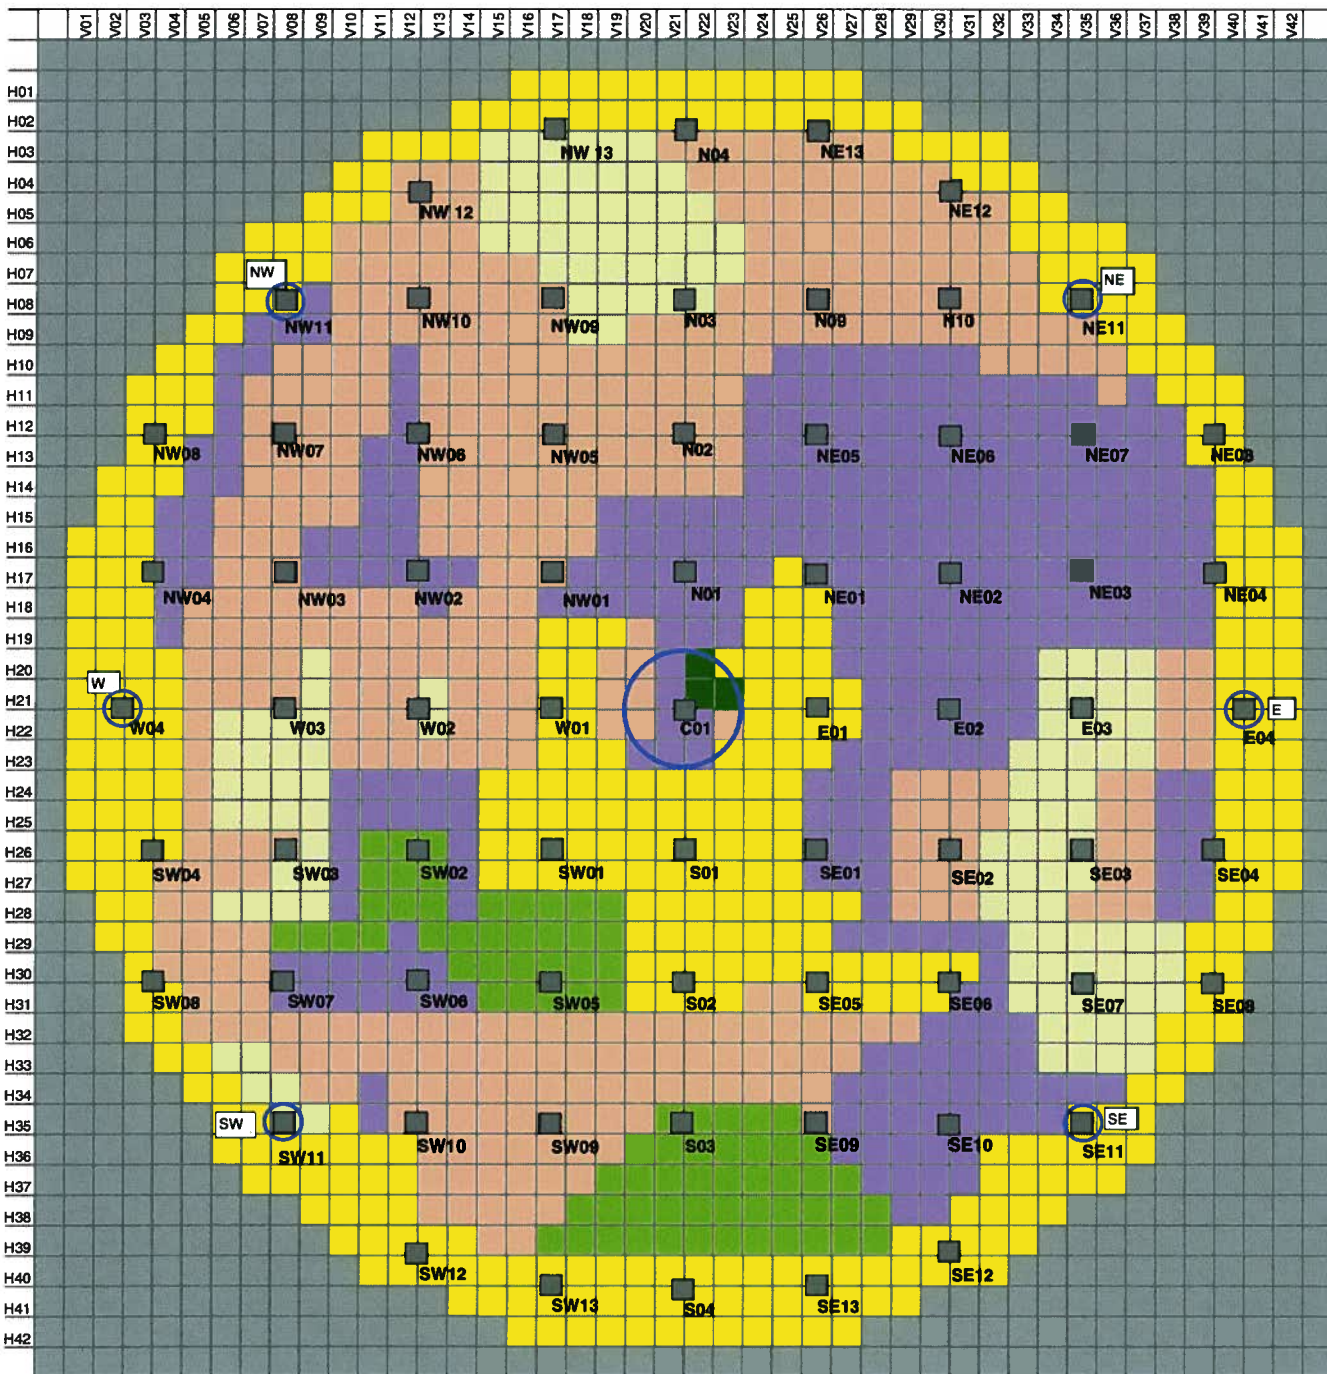
Attachment F Tank 19 Mapping After Mantis™ Operation

The material depths derived from lifting plates in the digital still photos are listed in Attachment C. The measured and estimated material depth values were then entered into an Excel sheet (Attachment F). Each cell in the sheet represents a 2 foot by 2 foot section of tank floor. Material mapping volumes for each cell were summed giving a final value of 1960 gallons of material remaining in Tank 19.

The Mantis™ activities have successfully removed the remaining waste material mounds inside of Tank 19. Using still digital photographs in combination with known landmarks and conservative estimations the material depth across Tank 19 was determined. The mapping was used to determine that the total volume of material remaining inside of Tank 19 is approximately 2000 gallons.
