<p>Progress Energy Florida</p> <p><b>Levy Nuclear Plant Units 1 and 2</b></p> <p><b>Part 2, Final Safety Analysis Report</b></p>
<p>Diagrams Illustrating the Orientation of A)Fracture Sets in Bedrock Exposures and B)Lineaments in the LNP Site Location</p> <p>Figure 2.5.3-224 Rev 2</p>

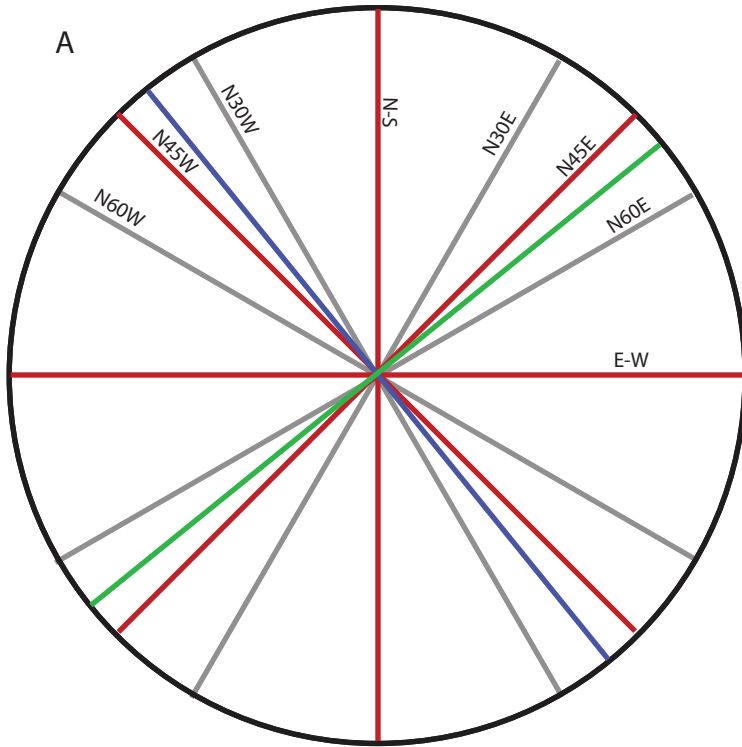
A: Joint orientations observed in Crystal River Unit No. 3 Excavation (no information on frequency or number of observations) (CR3 FSAR, 1973).

- Primary orthogonal joint systems
- Secondary orthogonal joint systems

Gulf Hammock Quarry and Wacasassa River Exposures

- Primary set
- Orthogonal set

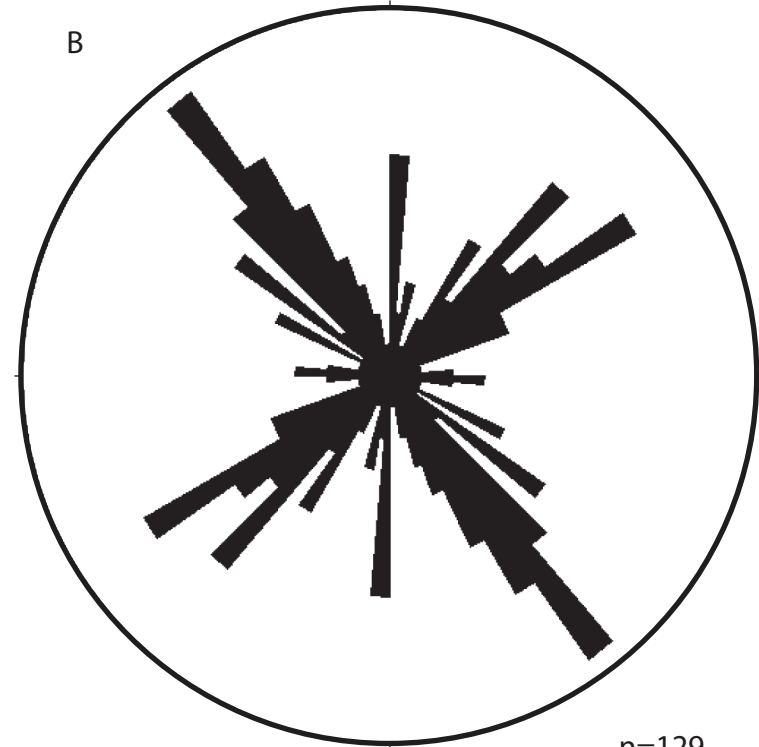
B: Rose diagram showing orientation and frequency of mapped lineaments within the site location (1-km [0.6-mi.] radius)

n=129
