6.3 Thermal Effects of Greasing

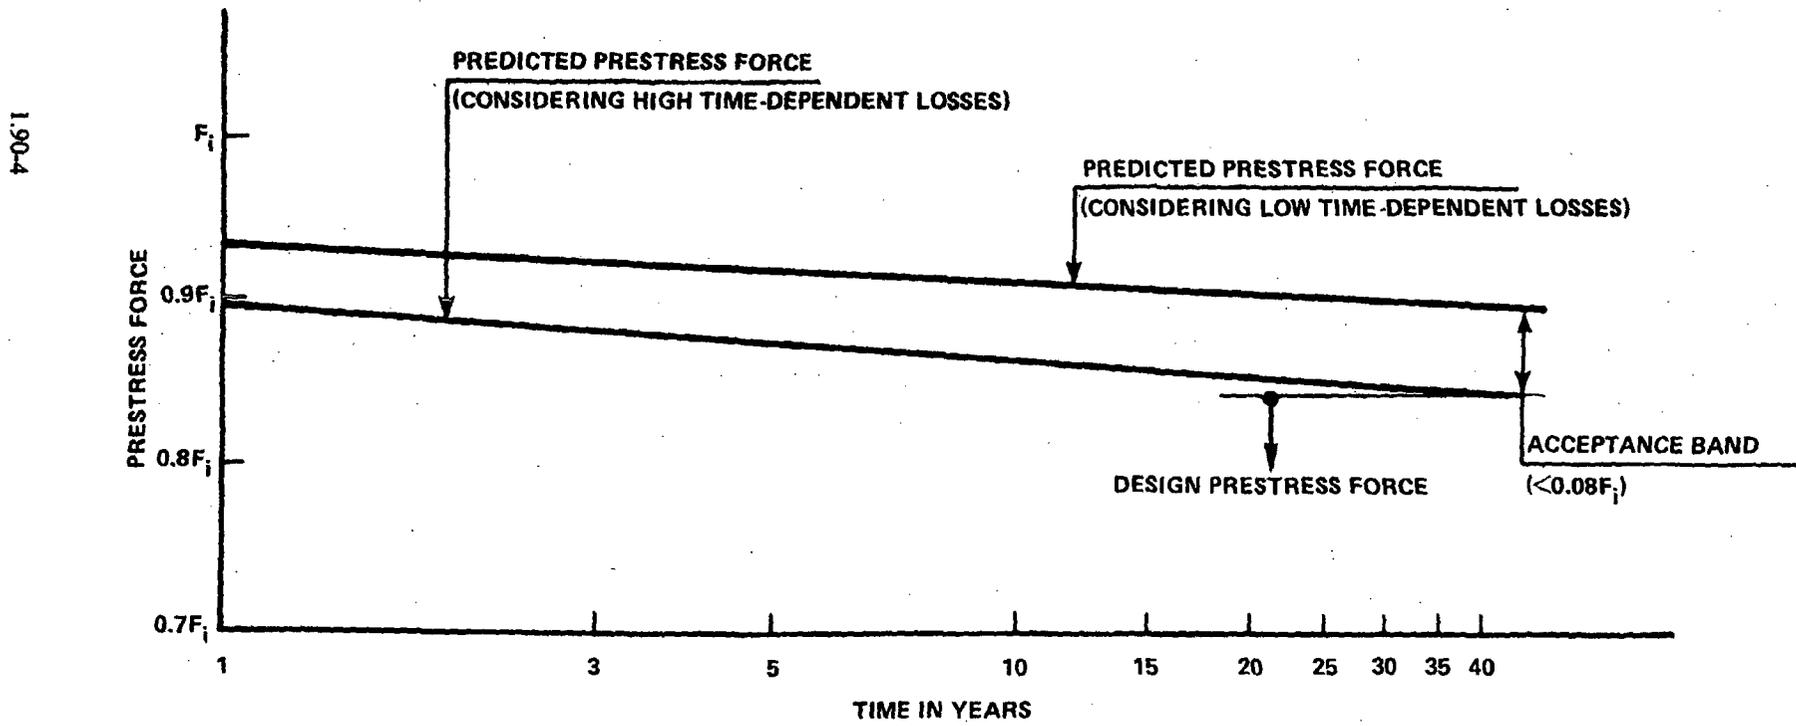
Figure 1. Typical Band of Acceptable Prestress Level

F_i — Initial prestressing force at a section considering the losses due to elastic shortening, anchorage takeup, and friction.

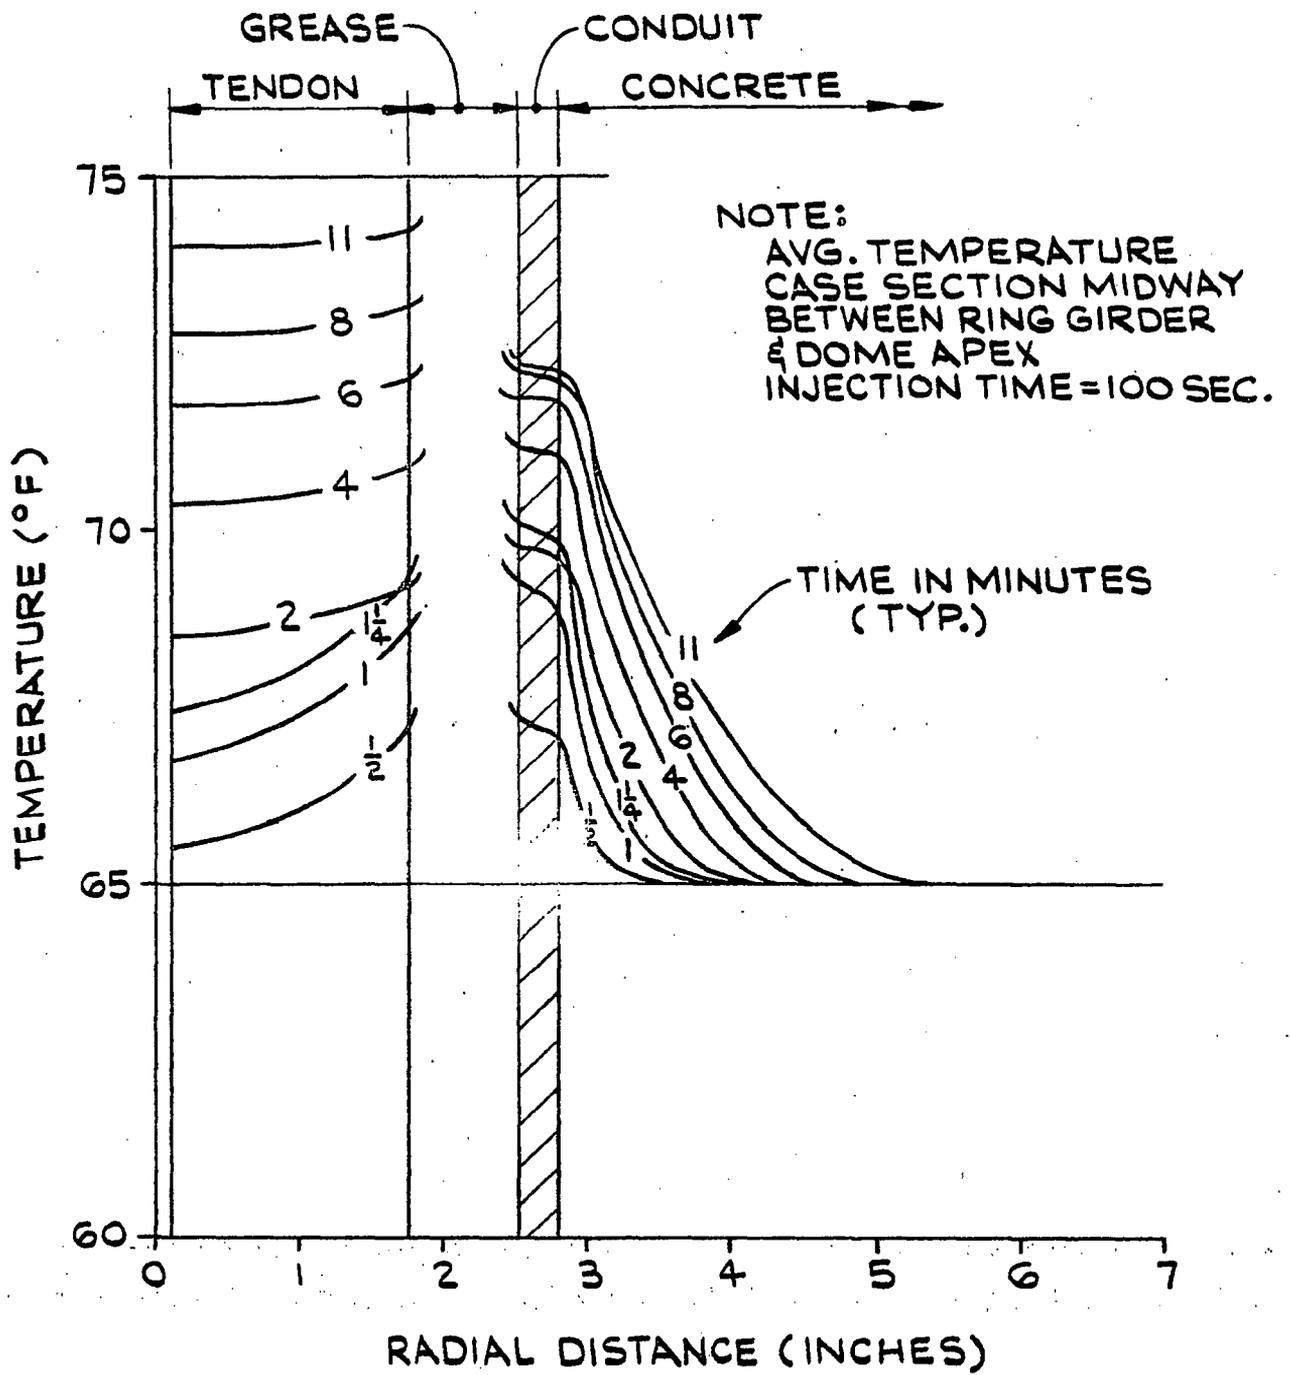
FIGURE 3-23

TEMPERATURE GRADIENTS DUE TO
TENDON GREASING

The grease is injected in the tendon sleeves at a pressure up to 85psi and a temperature around 160oF (FM 6.3 Exhibit 4). The pressure and temperature cause thermal expansion of the duct and of the concrete surrounding the duct. Differences in expansion and/or rate of expansion can induce thermal stresses and possibly cause cracking.

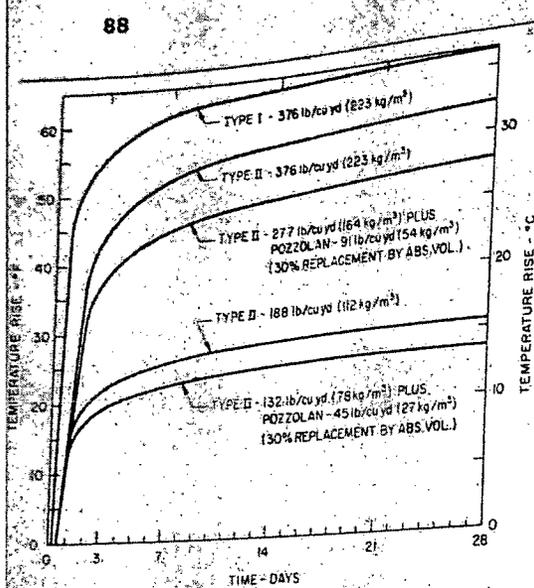
Figure 4-8 Effect of cement and pozzolan contents on temperature rise in concrete. (From R. W. Carlson et al., *J. ACI, Proc.*, Vol. 76, No. 7, 1979.)

The use of a low cement content, an ASTM Type II portland cement instead of Type I, and a partial substitution of the cement by a pozzolan, are effective means by which the adiabatic temperature rise in mass concrete can be significantly reduced.

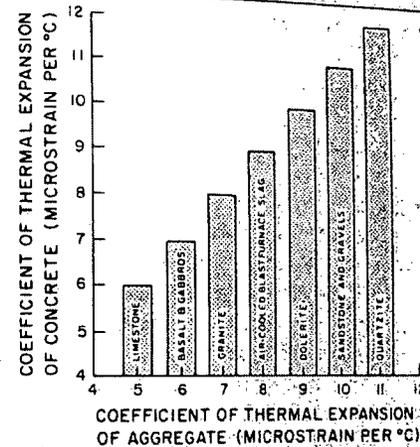
Figure 4-9 Influence of the aggregate type on the coefficient of thermal expansion of concrete.

Since the coefficient of thermal expansion of concrete is directly related to the coefficient of expansion of the aggregate present, in mass concrete the selection of an aggregate with a lower coefficient provides another approach toward lowering the thermal strain.

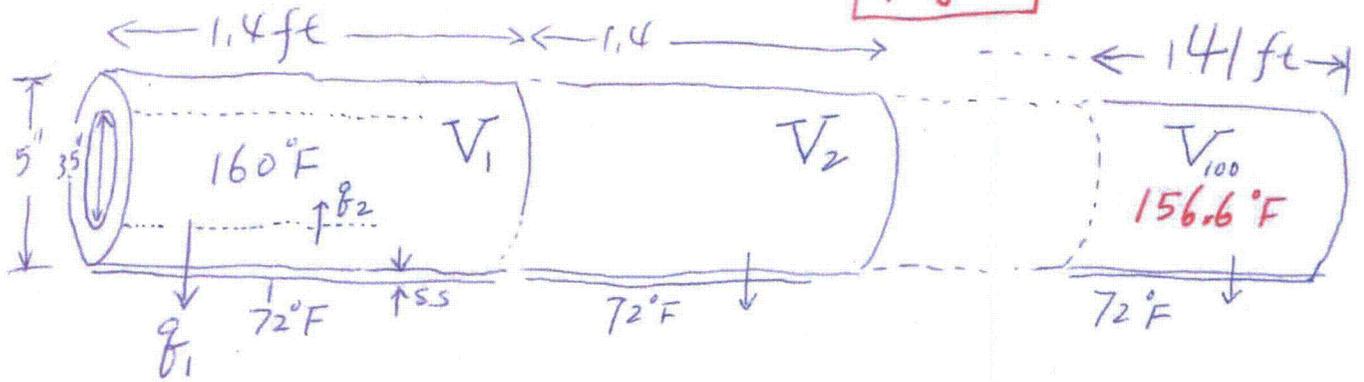
As stated in Figure, it (I assume) took 100 Sec to fill the conduit. For a total length of 141 ft, I assume the flow velocity = $V = 1.41 \text{ ft/s}$

For 1 Second, the grease travels and occupies 1.4 ft worth of volume $V = (1.4) \pi (D_{\text{conduit}}^2 - D_{\text{ten}}^2) = 1.4 \frac{\pi}{144} (5^2 - 3.5^2) = 0.389 \text{ ft}^3$

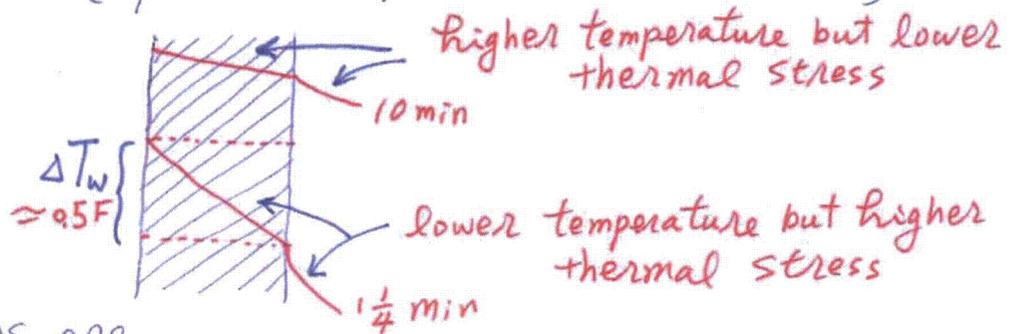
When the slope is near the highest, the temperature drop across the wall (Eye-ball it for the 1 minute curve)

is $\Delta T_w \approx 0.5^\circ\text{F}$,
which is in the ball park of my calculated number, 0.71°F .

My Conclusions are

1. As grease reaches the end of conduit, the grease bulk temperature would drop by roughly 3°F
2. The temperature drop across the conduit wall is less than 1°F , steady state or transient wise.
3. The highest thermal stress should occur close to 2 minutes from the starting of grease injection near entrance.

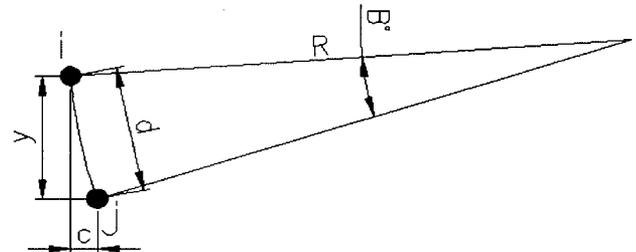
Tendon Profile

Circumferential Offset

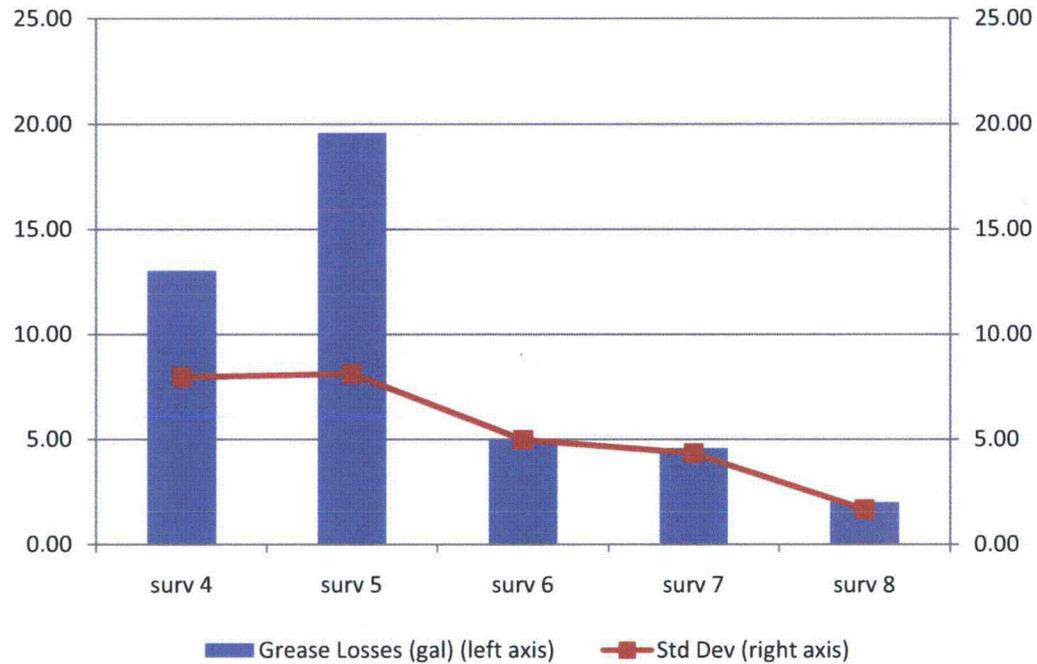
Grease losses from tendon sleeves

Average and standard deviation of grease losses for each surveillance
