# CRYSTAL RIVER UNIT 3 NUCLEAR GENERATING PLANT REACTOR BUILDING DOME DELAMINATION

**FINAL REPORT**

December 10, 1976

This report describes a delaminated condition of the dome of the Reactor Building of Crystal River Unit No. 3, the subsequent structural evaluation of the condition and the repair of the dome.

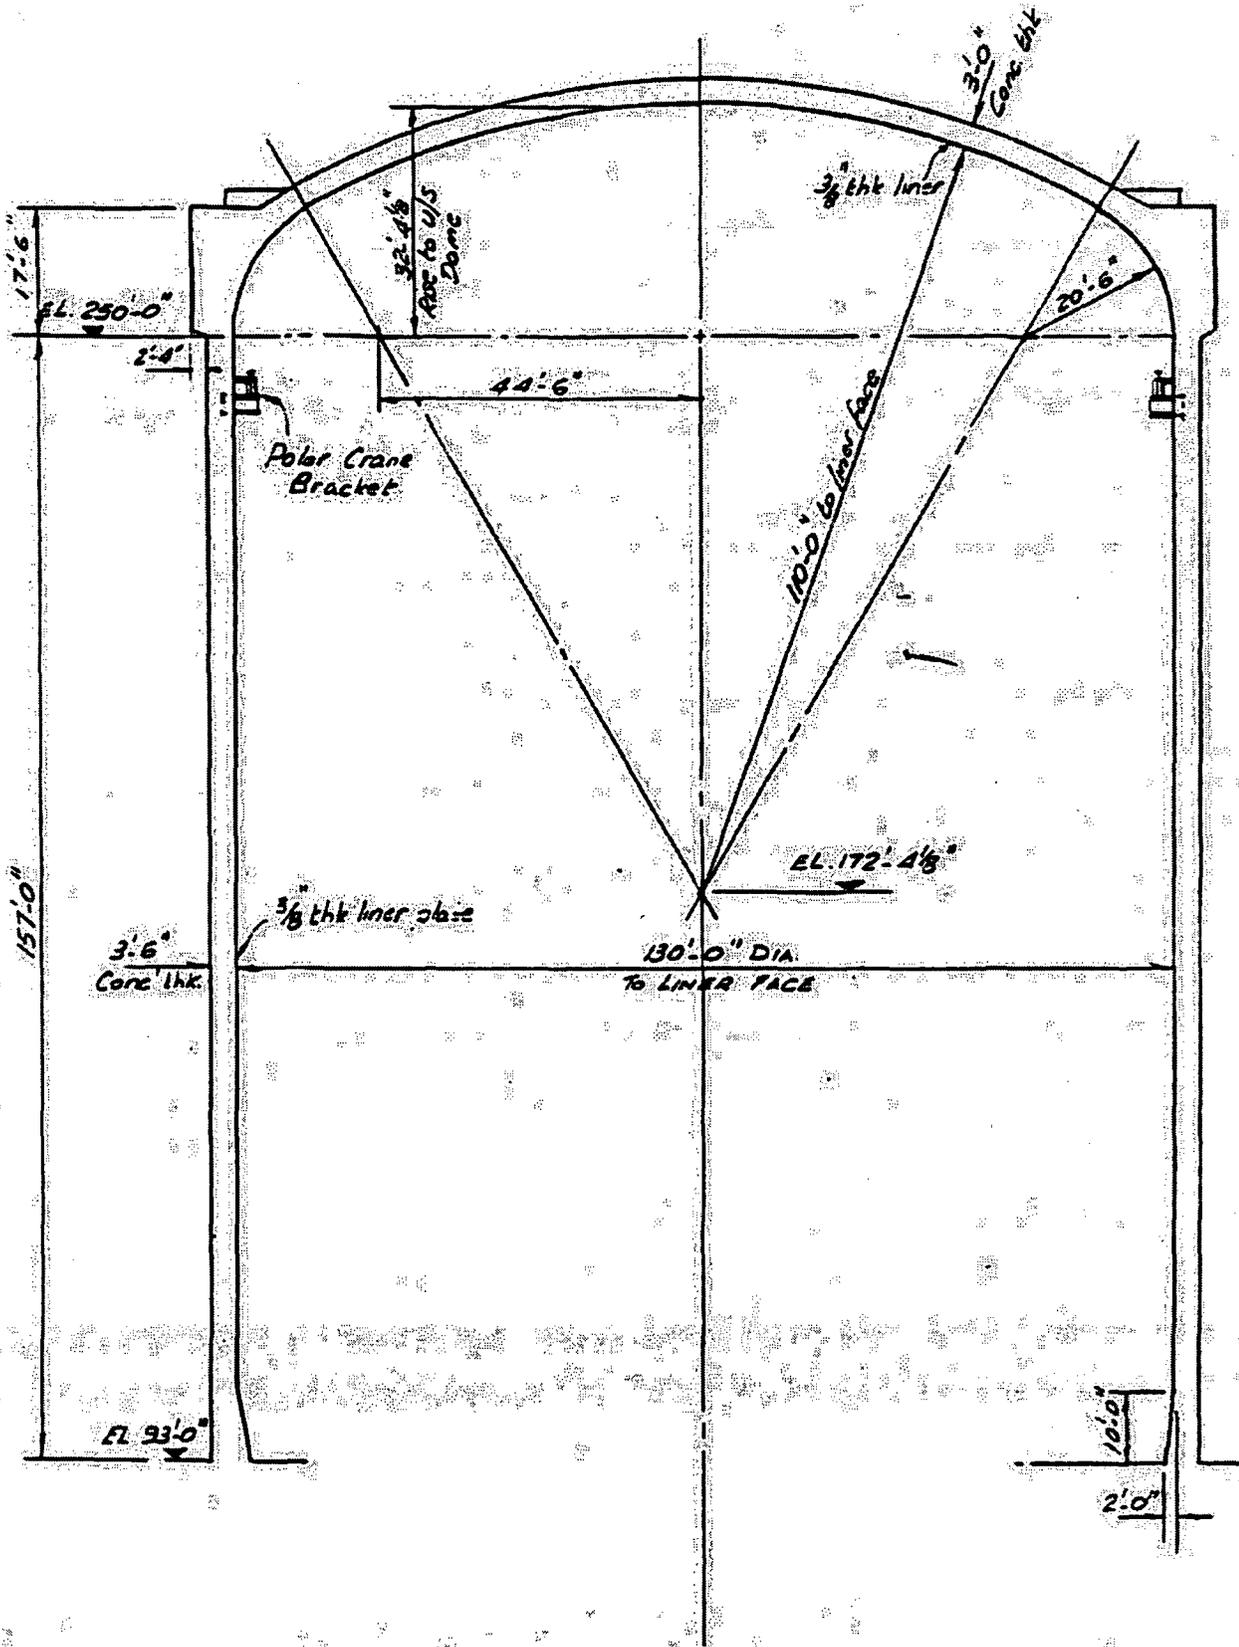
FIGURE 2-1

REACTOR BUILDING DIMENSIONS

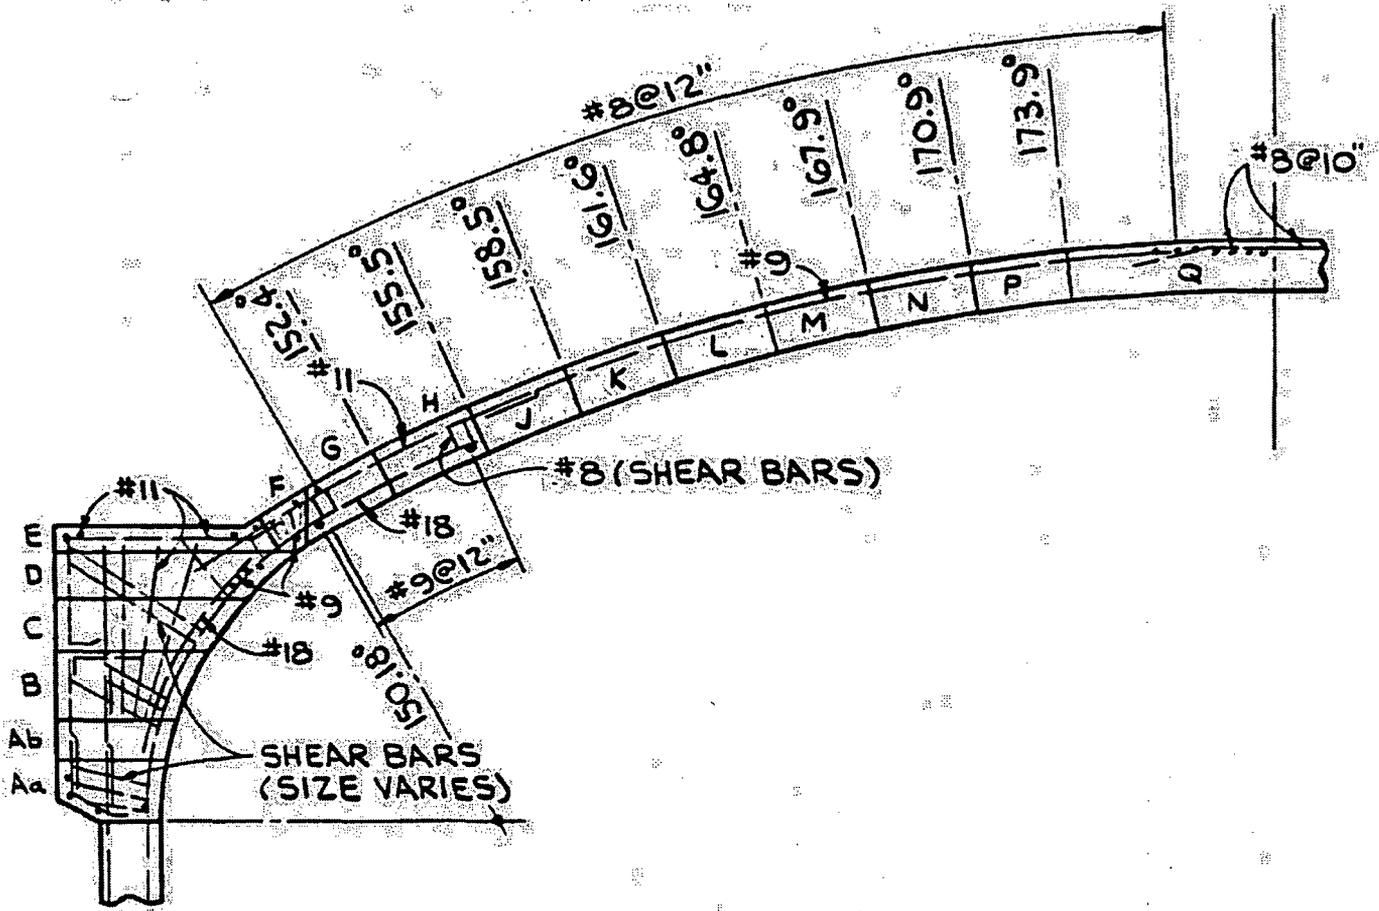
FIGURE 2-2

NON-PRESTRESSED REINFORCEMENT

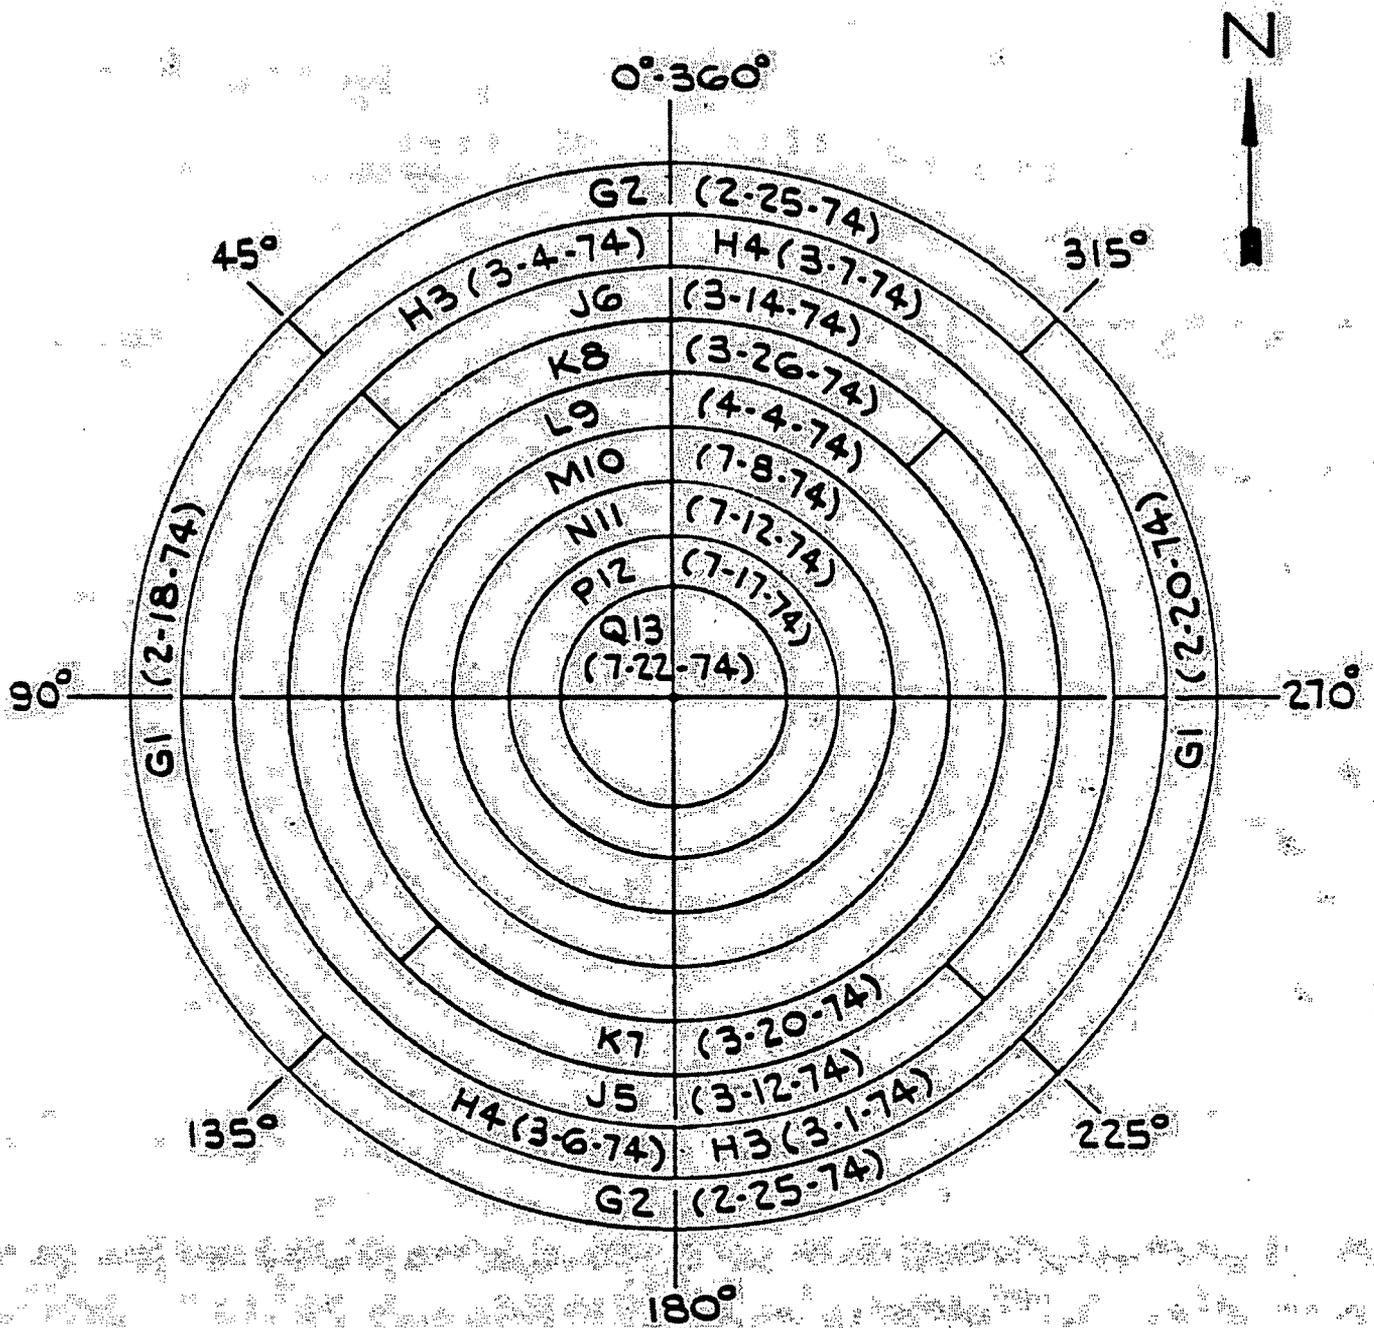
FIGURE 2-3

DOME CONCRETE PLACEMENT - PLAN

Concrete construction joints were located as shown in Figure 2-3 and the concrete placed in the sequence and on the dates indicated in Table 3-5. The field coring investigation program did not indicate unsatisfactory conditions such as honeycombing, voids or cold joints.

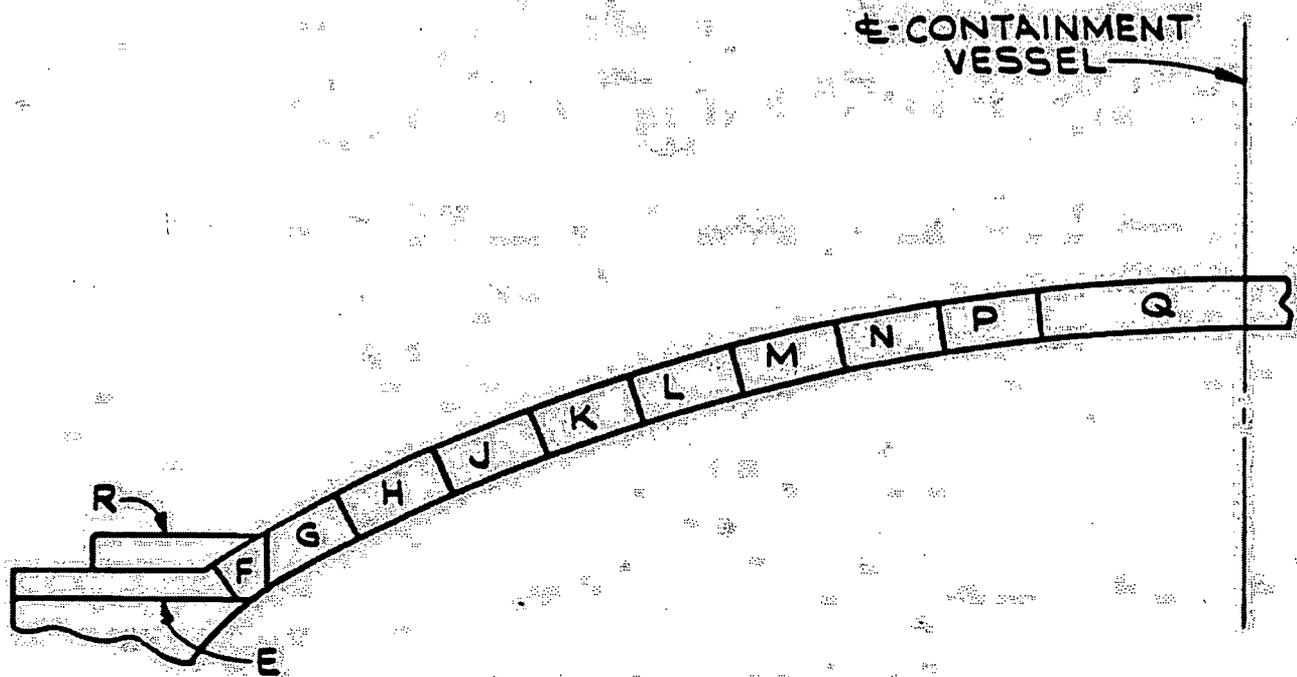
*FIGURE 2-4*

*DOME CONCRETE PLACEMENT - SECTION*

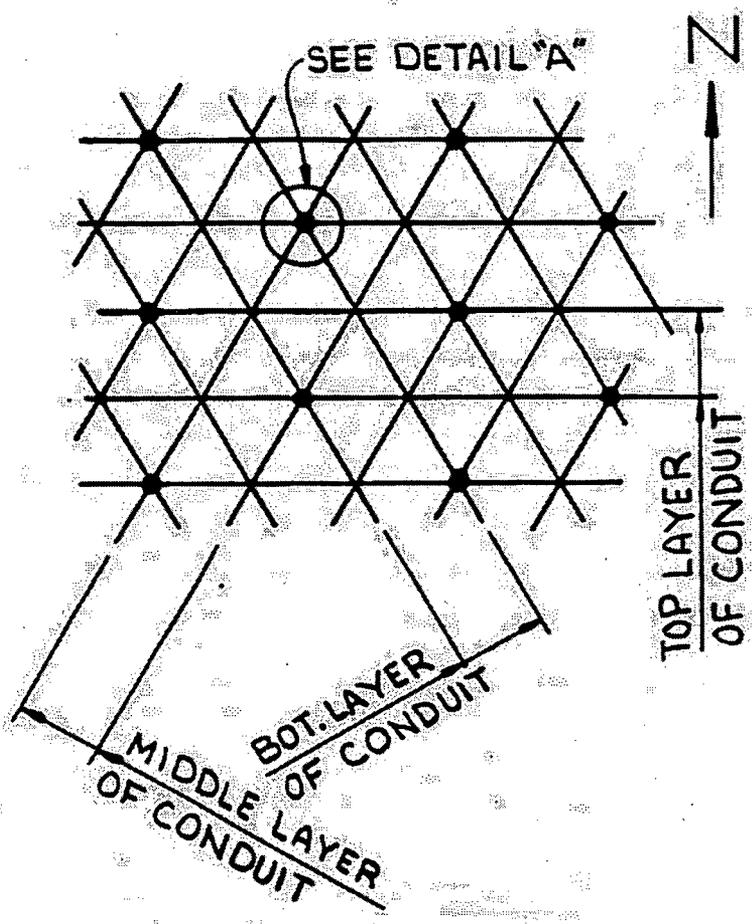
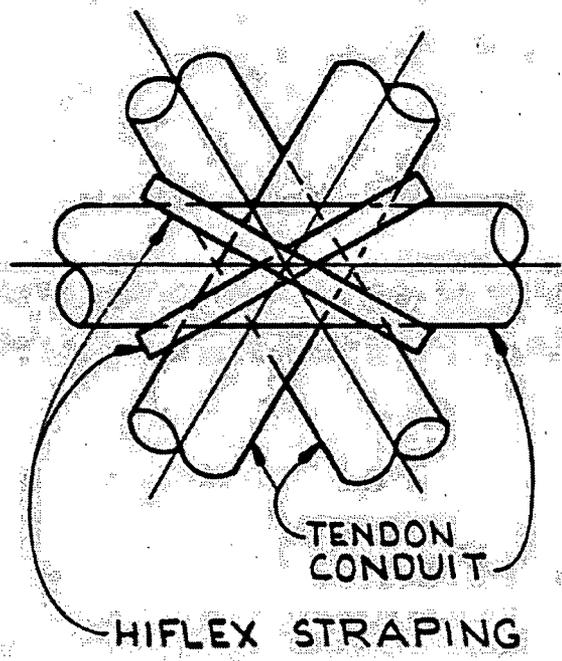
FIGURE 2-5

CONDUIT STRAPPING  
DETAIL

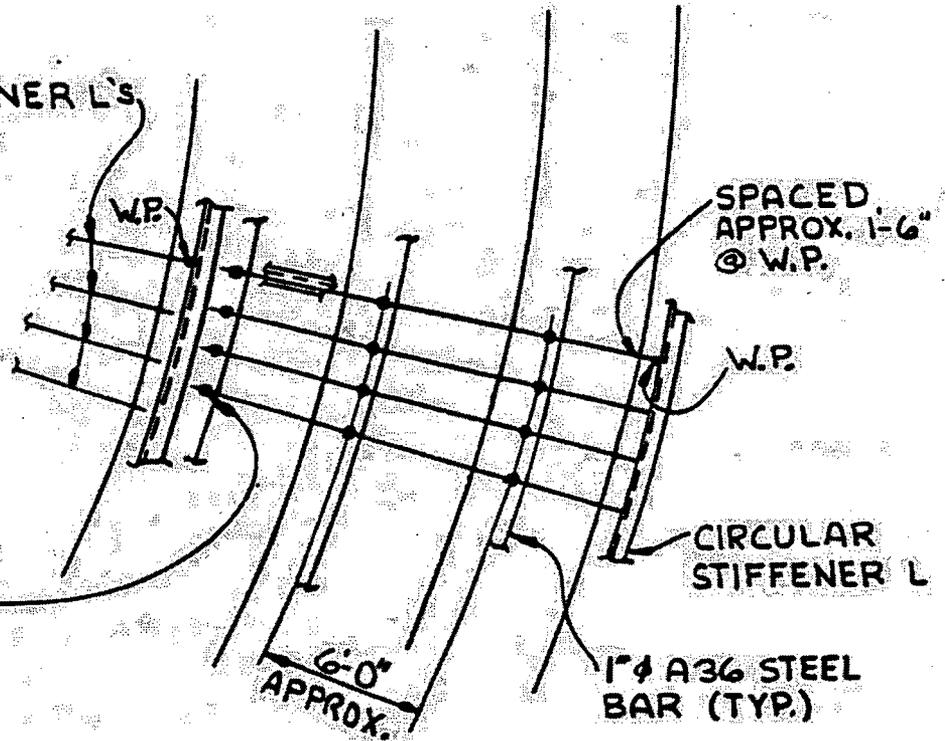
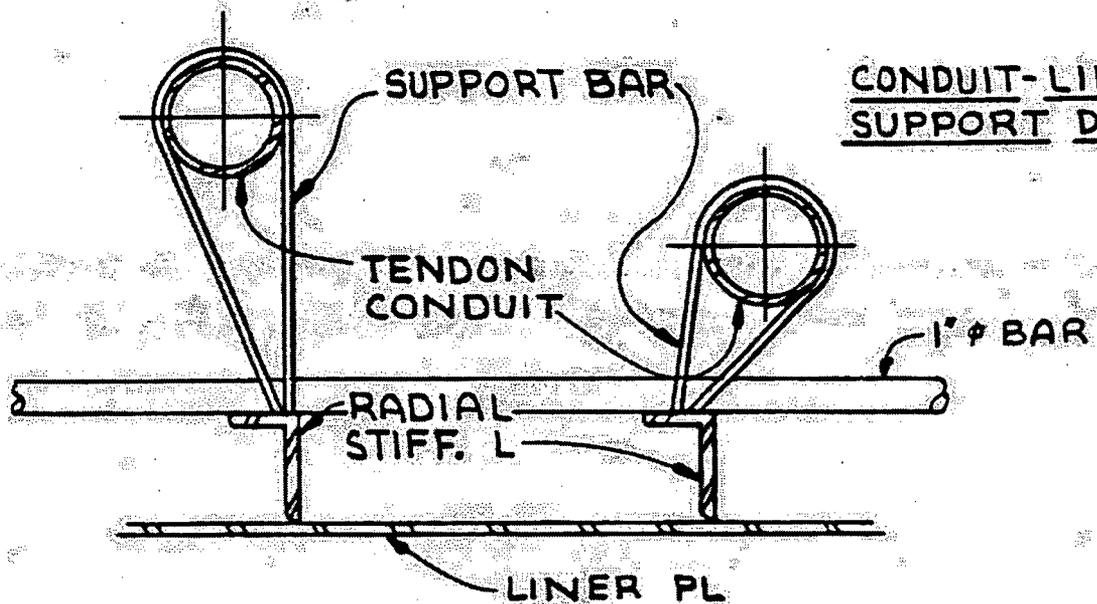
FIGURE 2-6

SUPPORT DETAIL

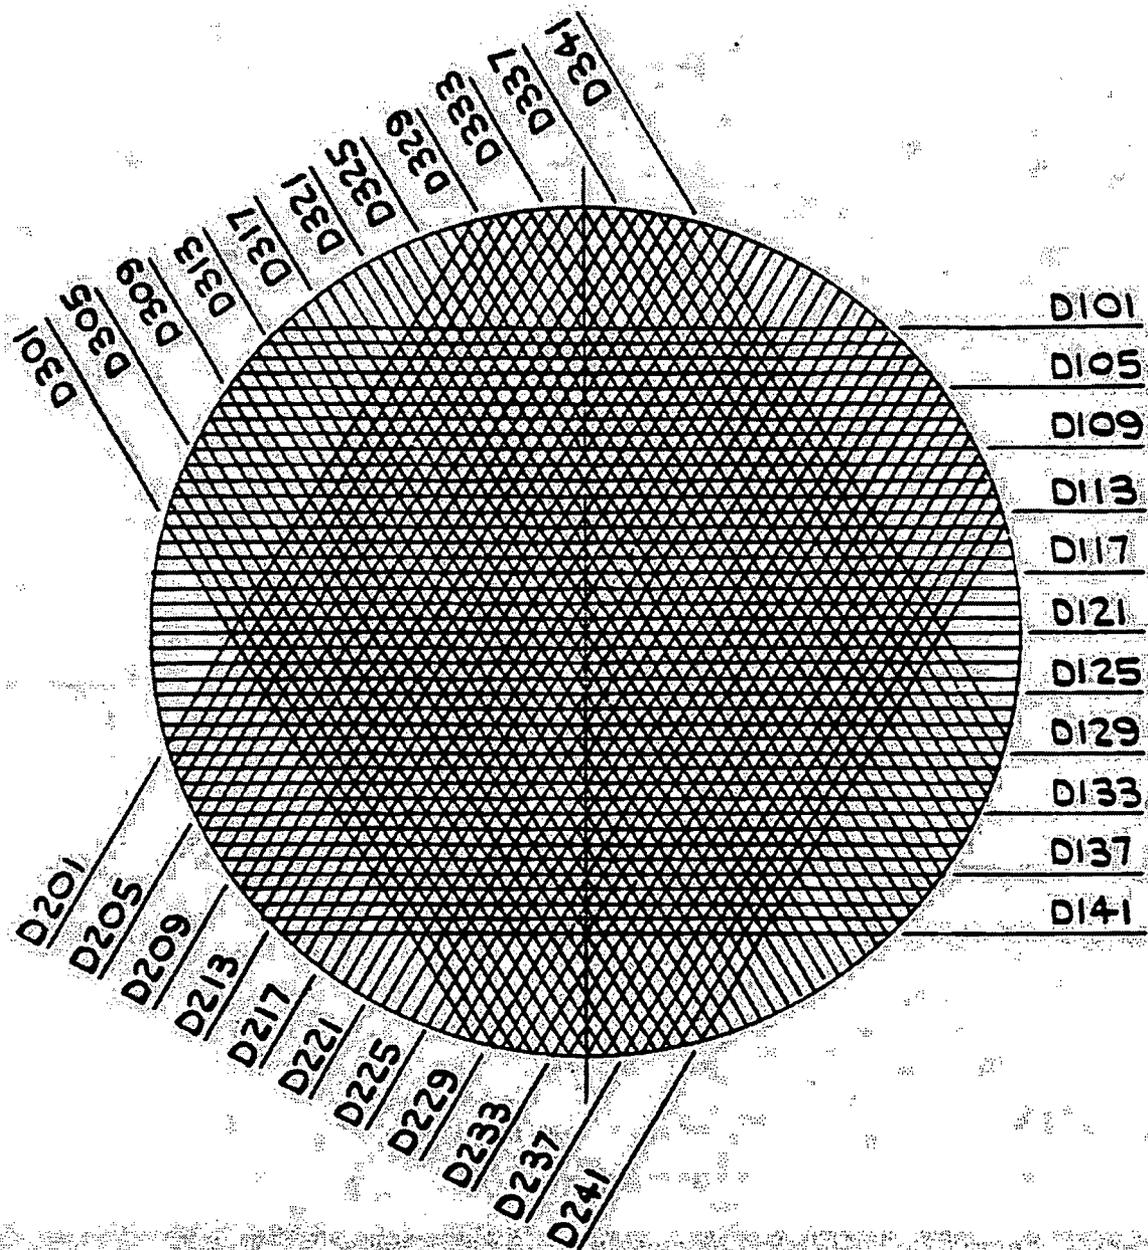
FIGURE 2-7

DOME TENDON LOCATION PLAN

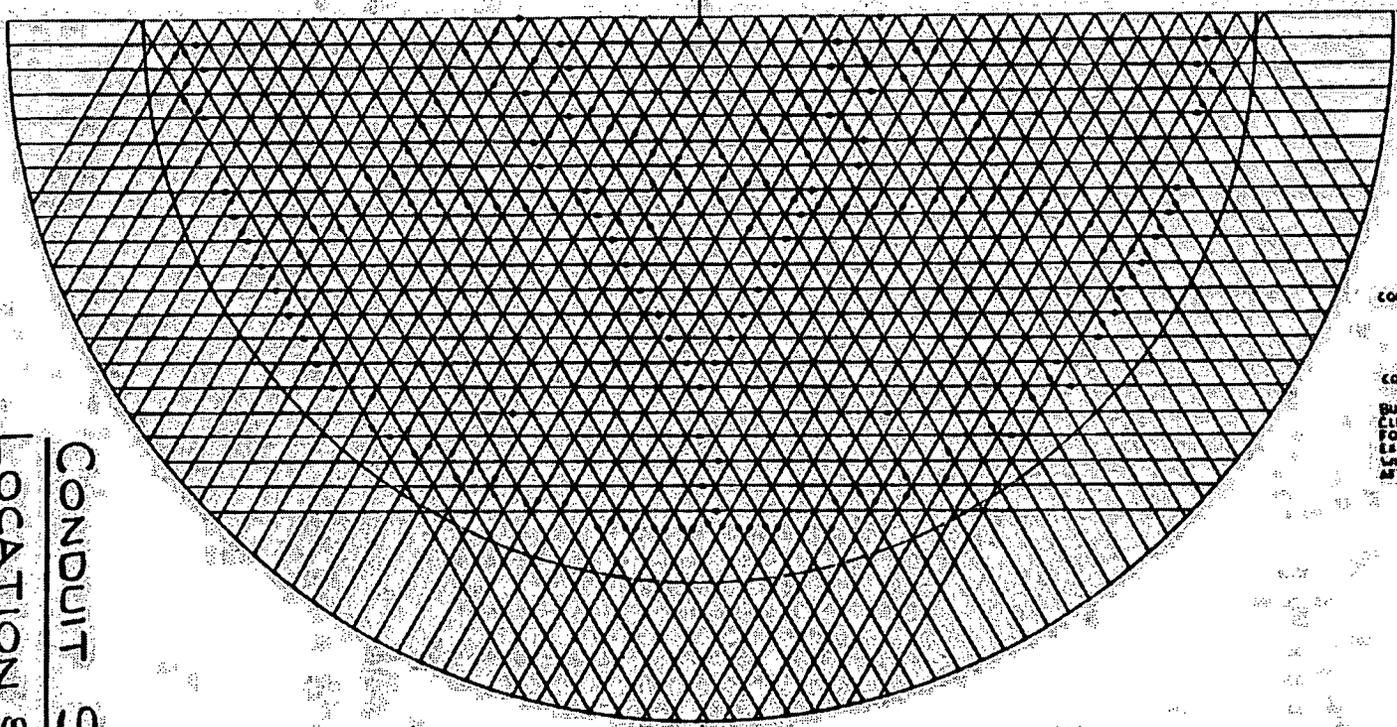
Figure 2-8

BURN OFF GALV. & CLEAN THIS AREA FOR WELD JOINT TO EXTENT OF GUN WITH CARBO KING 11 AFTER WELDING.

CONDUIT SPLICES  
LOCATION & DETAIL

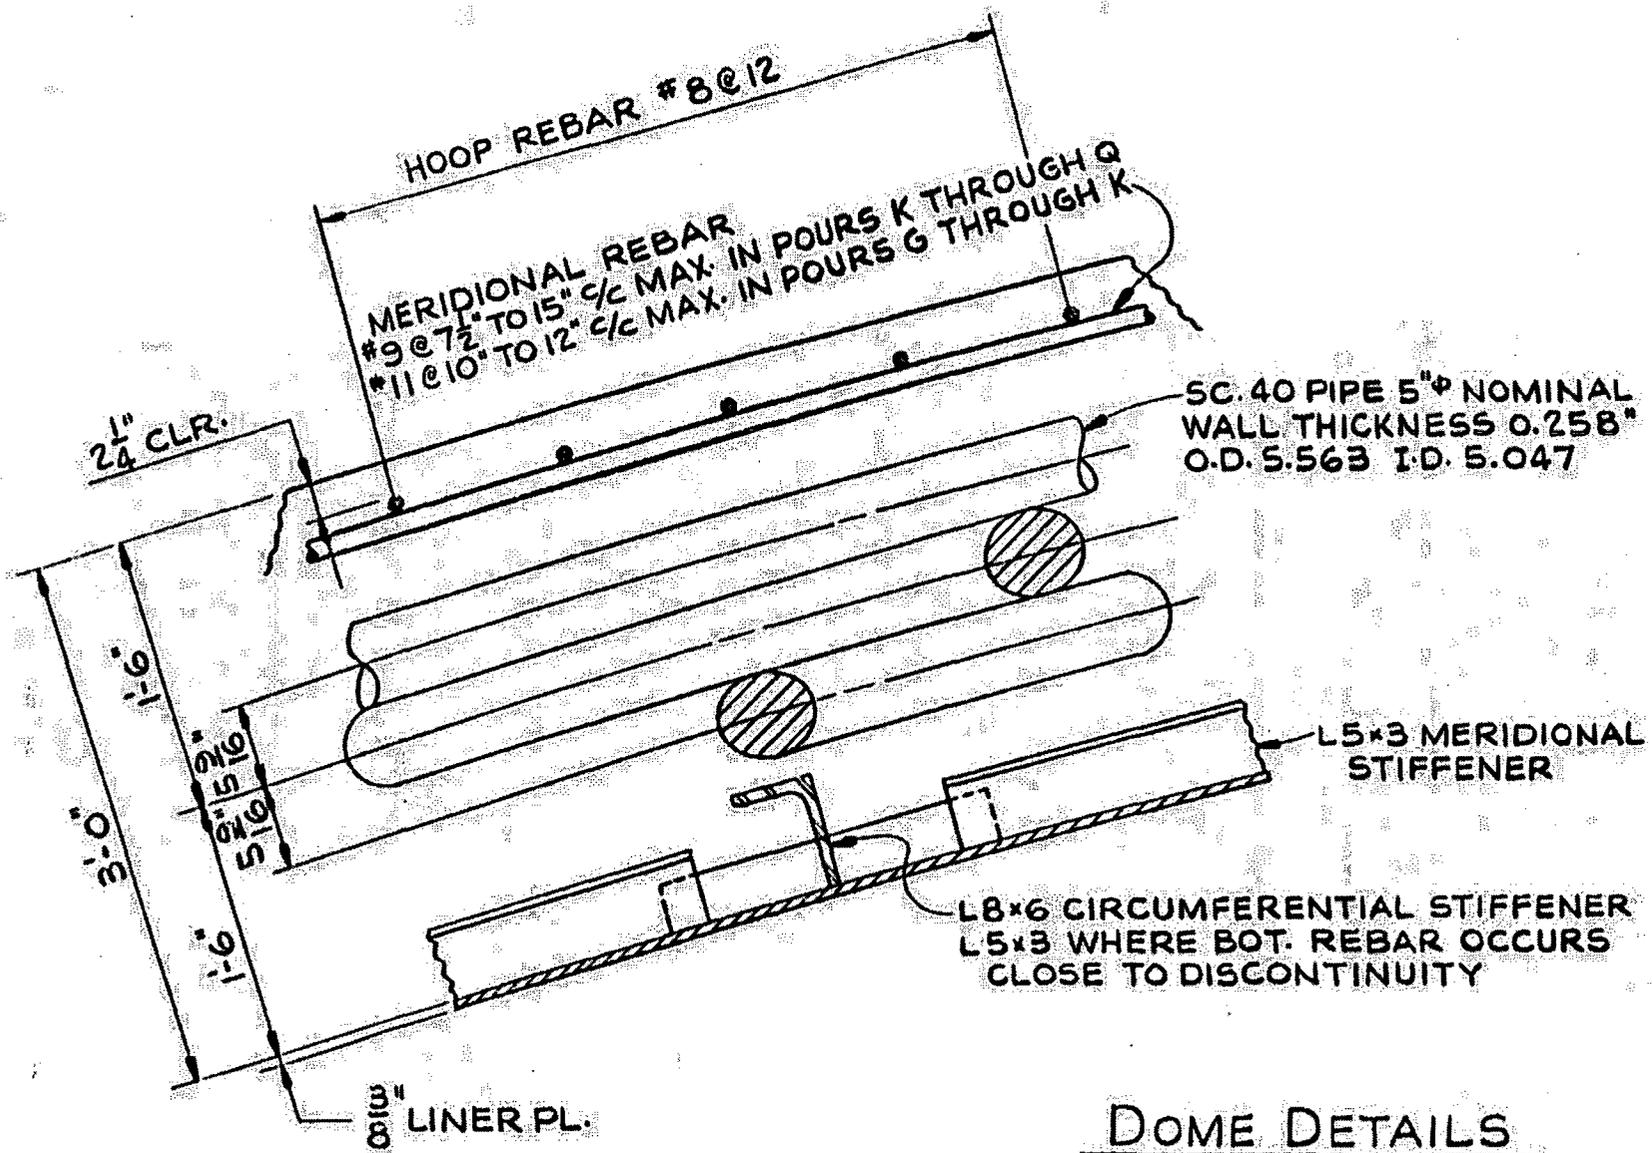
FIGURE 2-9

DOME DETAILS

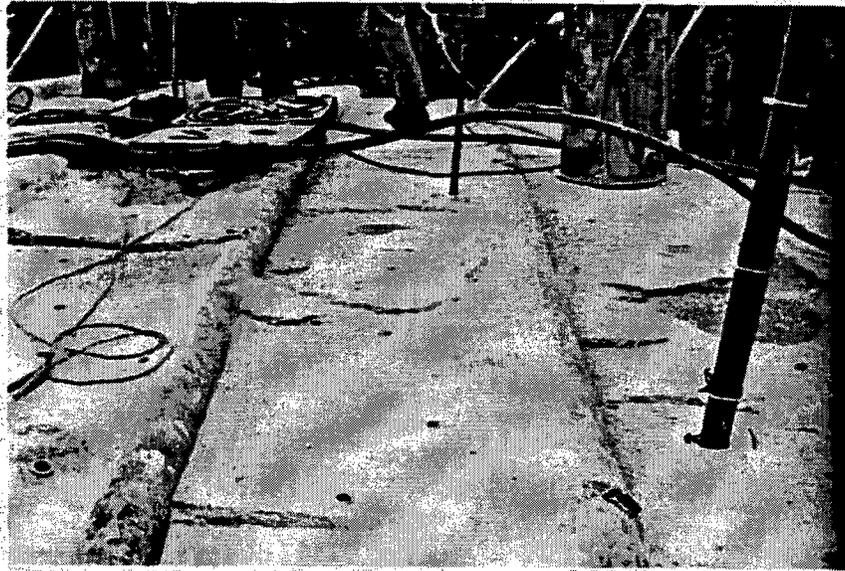
PHOTO NO. 1 - Surface of Concrete Illustrating the Relative Position of Failure Plane and Conduit

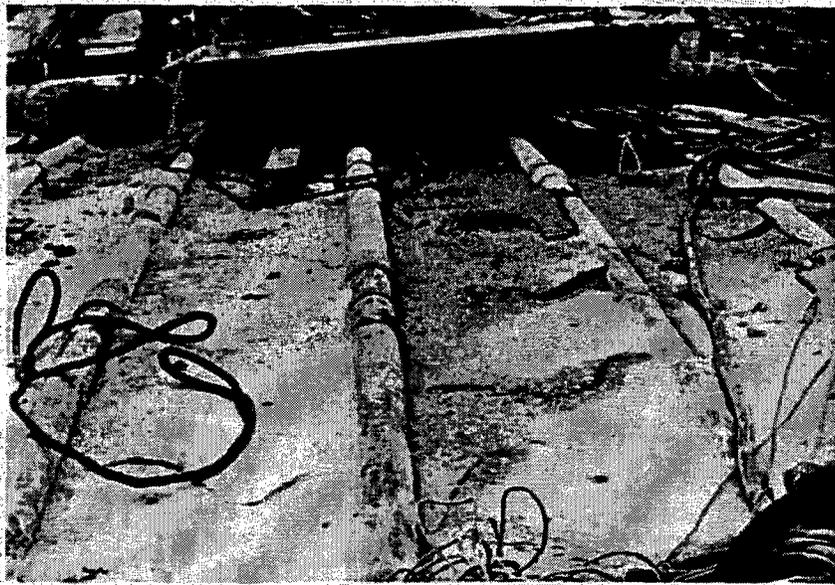
PHOTO NO. 2 - Surface of Concrete Illustrating the Position of Failure Plane and Lens on Surface

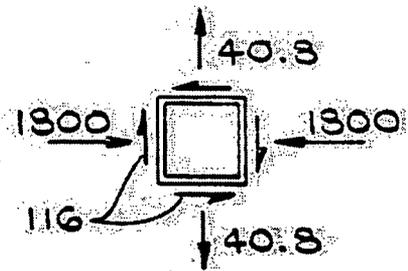
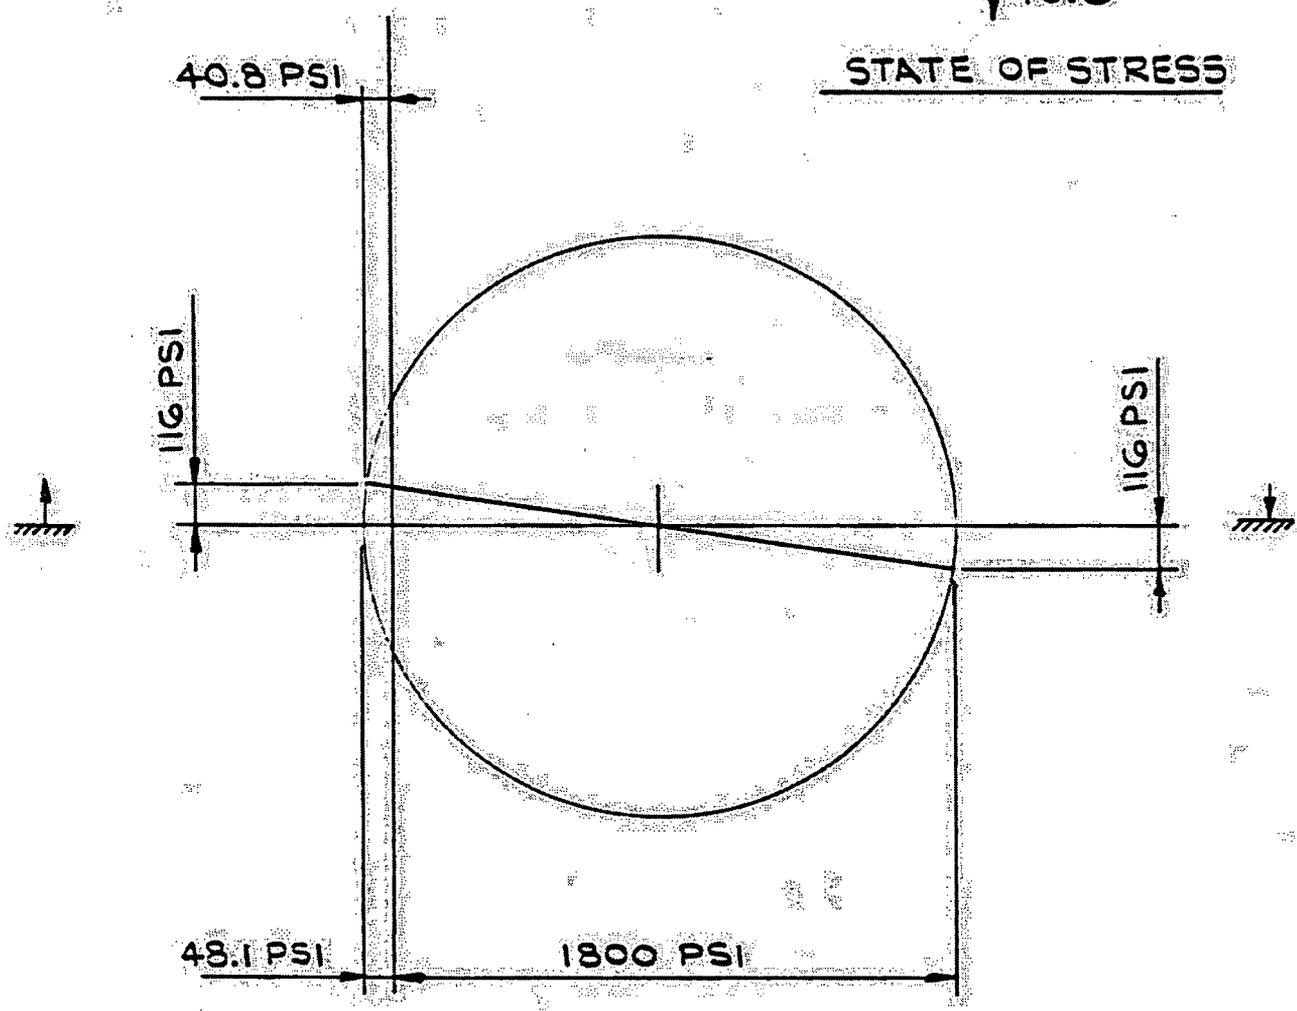
MOHR'S CIRCLE

COMBINED STRESSES

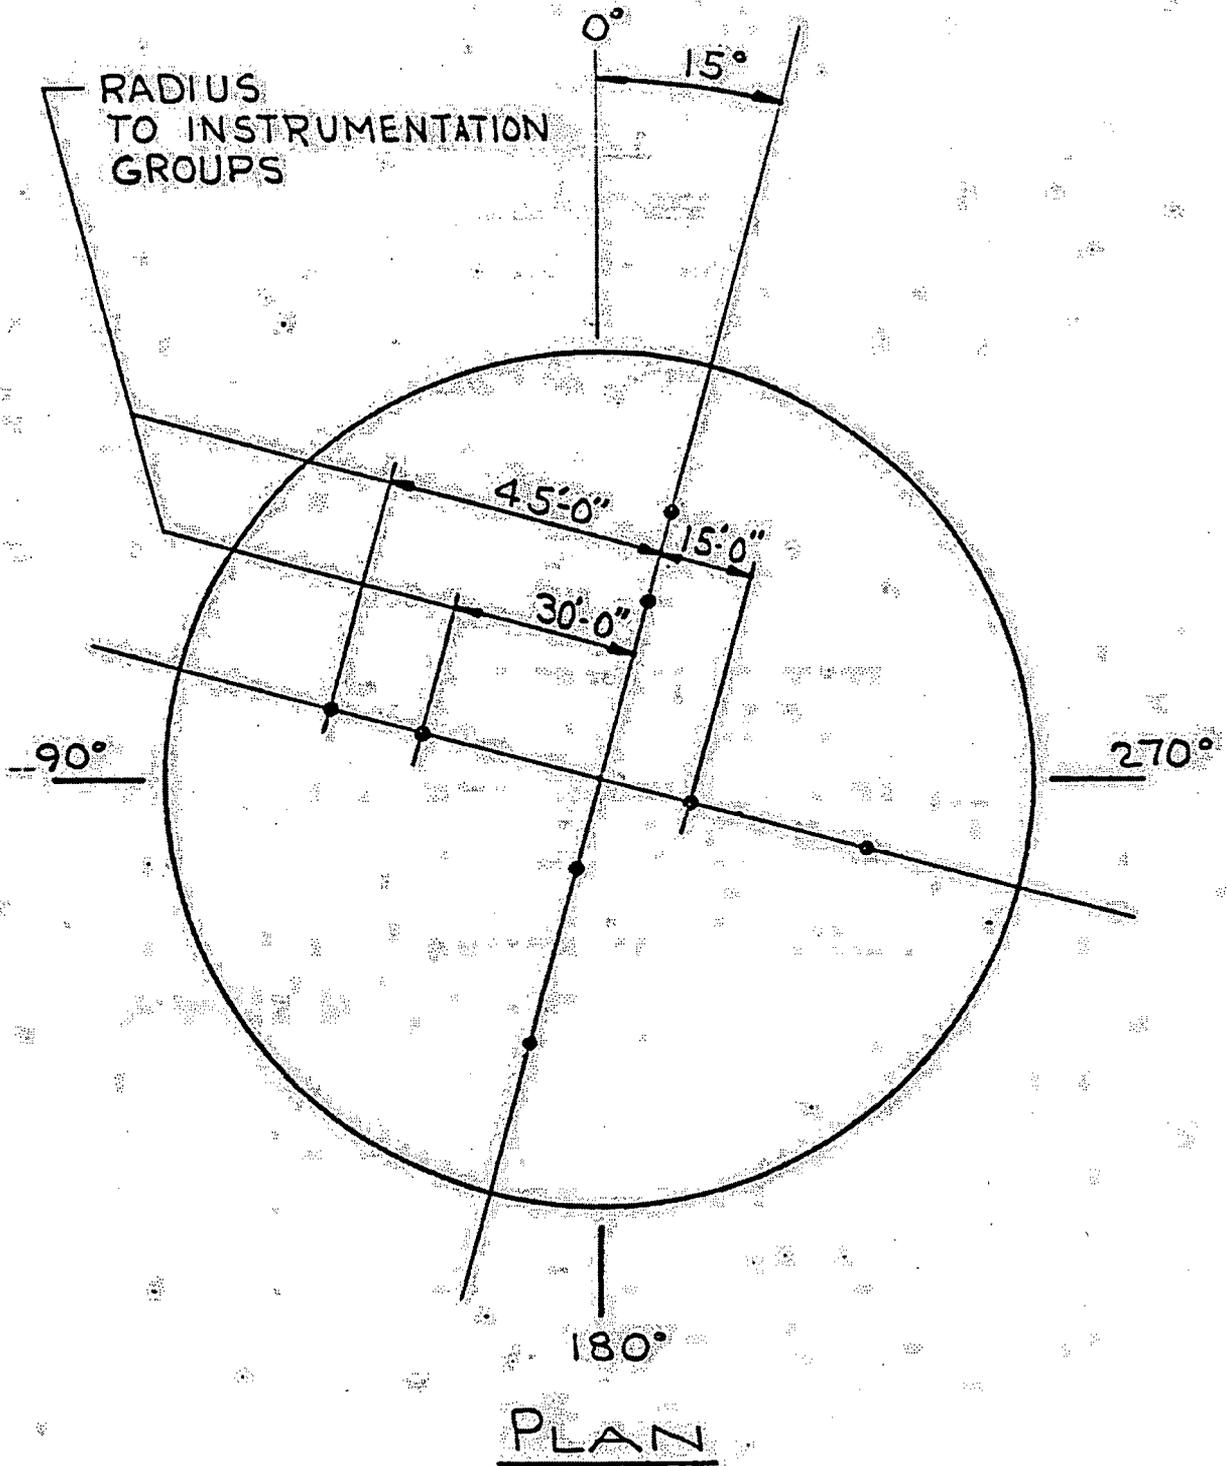
STRAIN INSTRUMENTATION FOR MONITORING STRUCTURAL RESPONSE DURING SIT

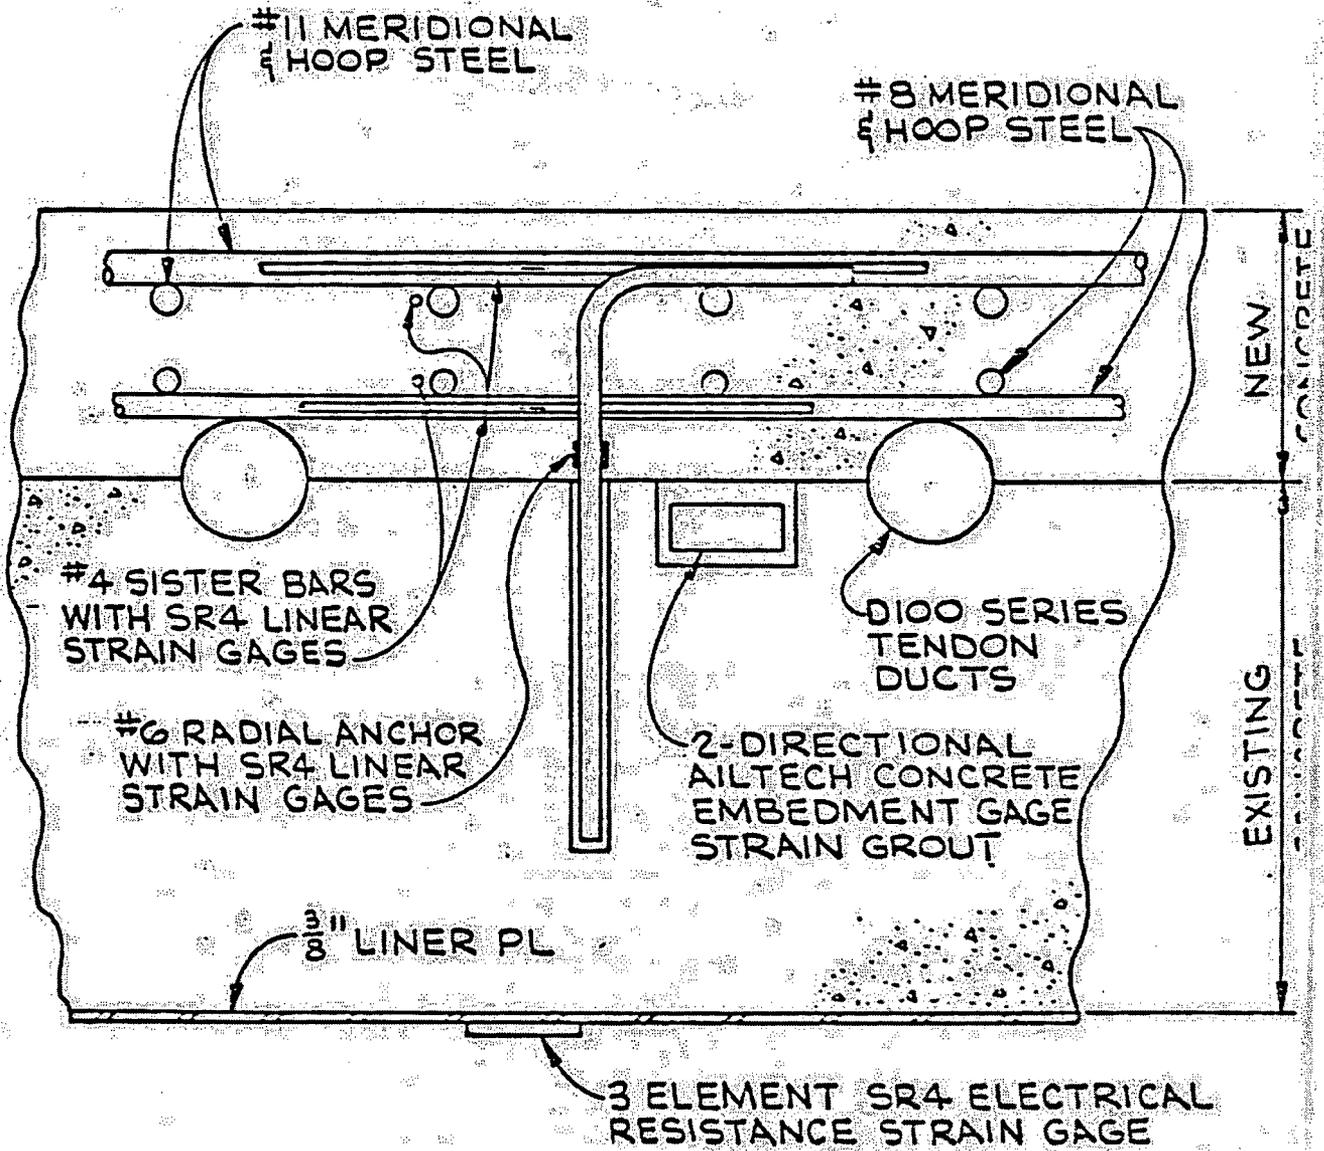
TYPICAL SECTION AT INSTRUMENTATION LOCATION

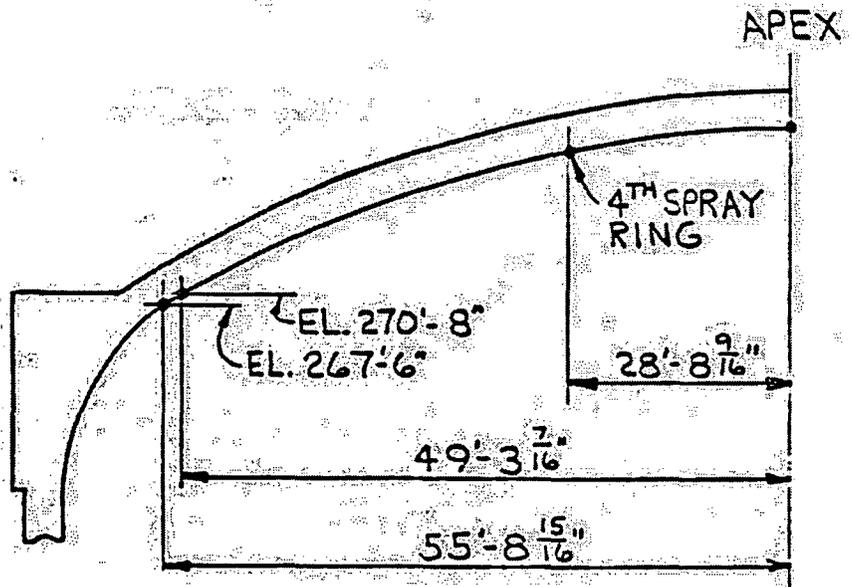
EXTENSOMETERS ON LINER  
FOR DISPLACEMENT MEASUREMENT

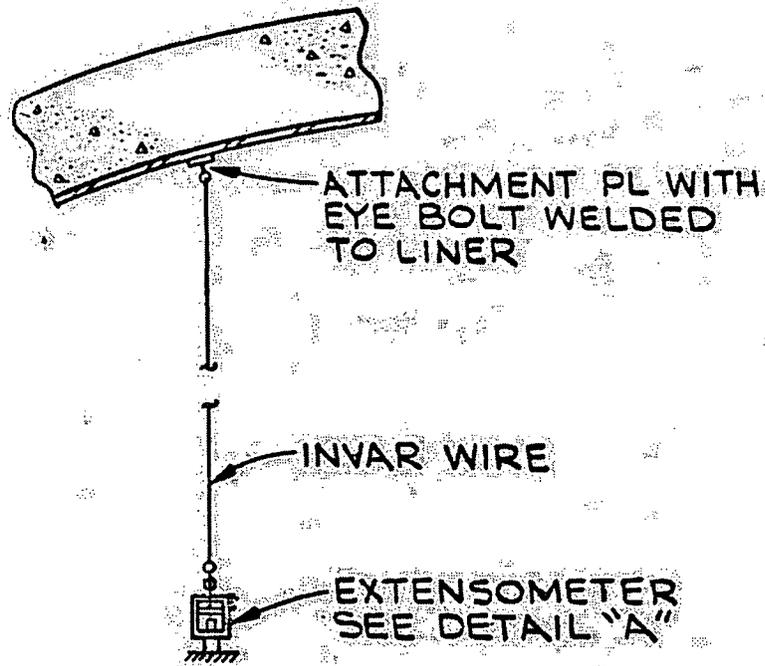
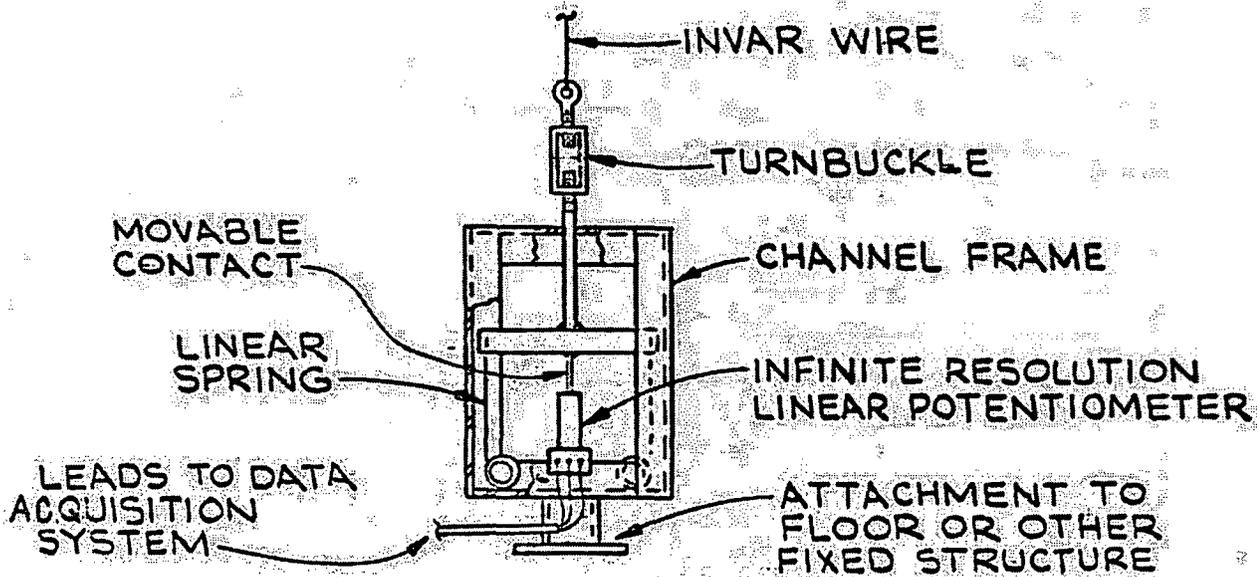
FIGURE I

TYPICAL DETAIL OF  
EXTENSOMETER INSTALLATION

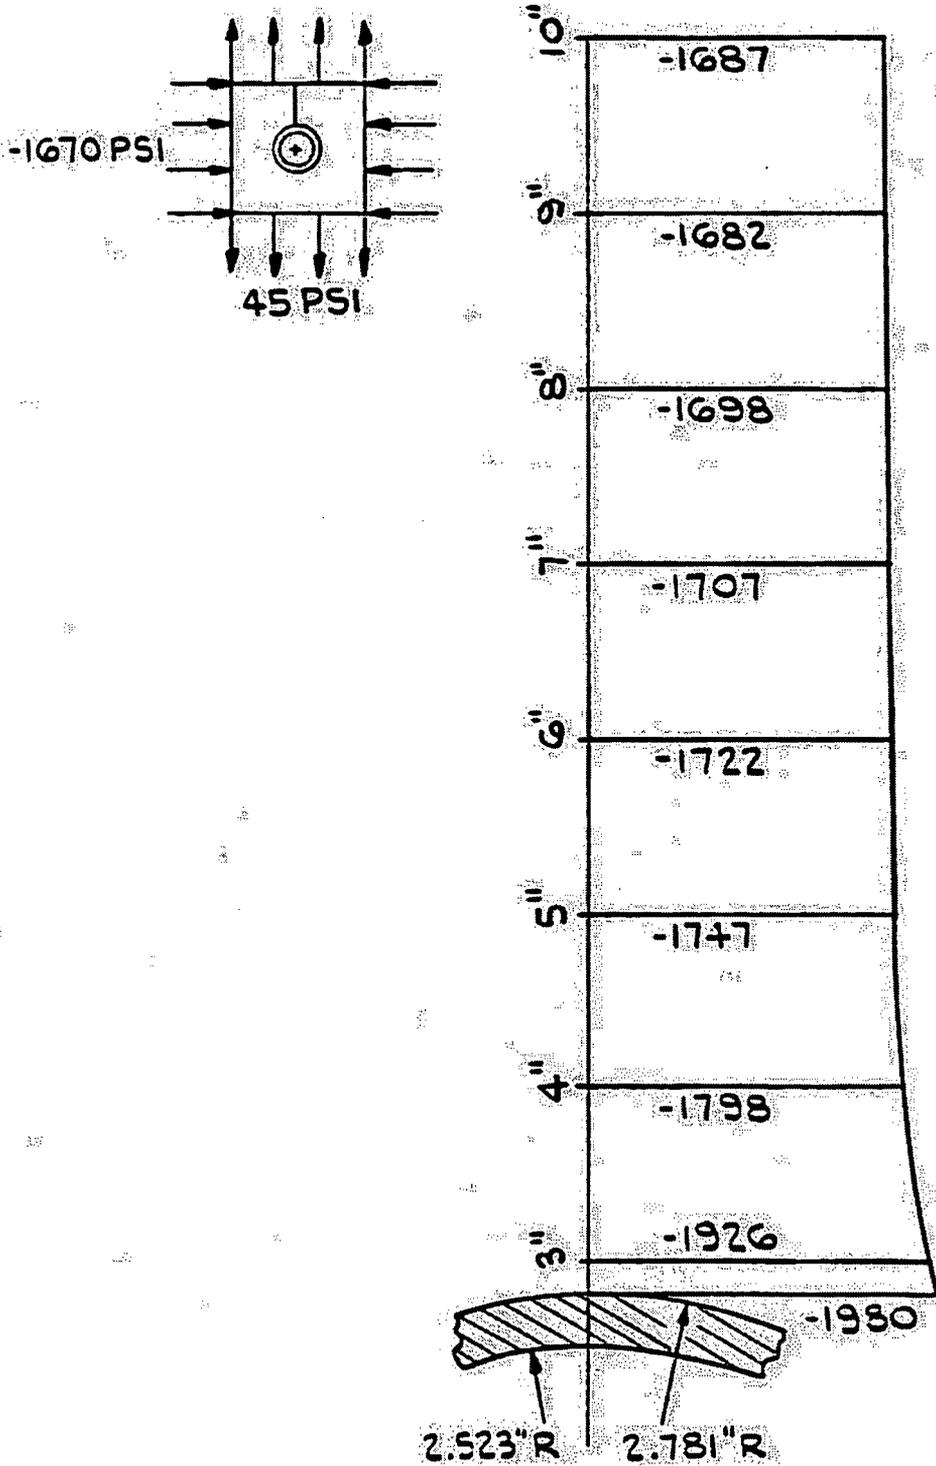
SECTION 4.4

STRESS PROFILE PARALLEL TO MEMBRANE
