From: Lake, Louis
Sent: Tuesday, November 24, 2009 9:25 AM
To: Carrion, Robert
Subject: FW: Refute 3.3 for Review
Attachments: FM 3.3.ppt; PTL Test Cement 04011974.pdf; mill cert 04021974.pdf; all strength table.pdf; 7 and 28 day strength.pdf; all strength graph.pdf; Erlin Hime Petro report 05101976.pdf; Core Bore #5 Final CTL Petrographic Report 059169 C856 (2).pdf

3.3 Inadequate Cement Materials

FOR Florida Power Corporation
PROJECT Crystal River Florida Power Plant Job
BRAND Fla. FROM Silo 19, Tampa, Fla., Sampled by PTL 3/18/74, Received March 22, 1974 10 Samples 340A thru 340J
BIN NO. 19 CONTAINING 20,000 BARRELS SPECIFICATION ASTM C150-72 TYPE II

**Petrographic Examination of Concrete Half
Core from Delaminated Containment Wall,
Crystal River, Florida**

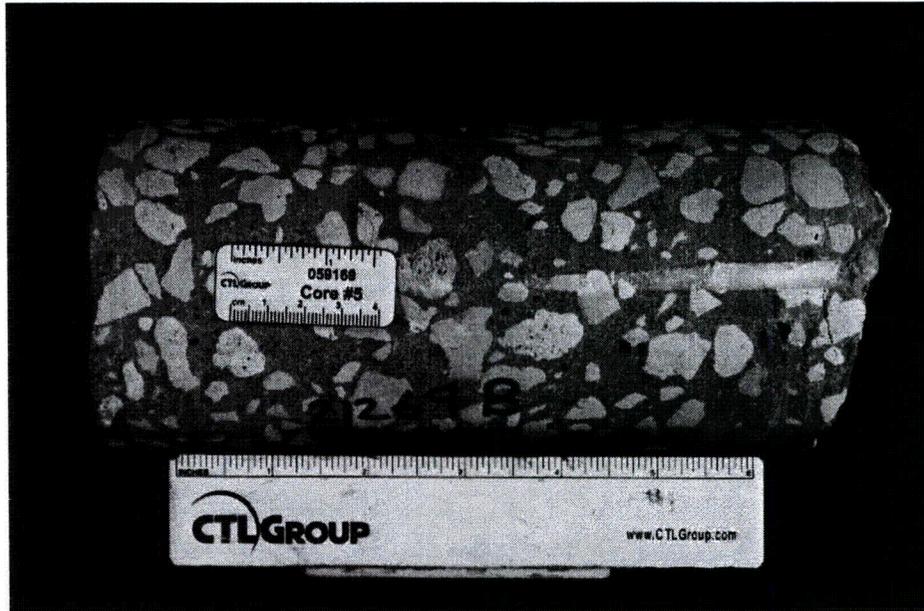
Fig. 1 Side views of Core #5, as received for examination.

1a. Curved surface. Outer end is to the left.

1b. Saw cut surface. Outer end is to the left

One saw cut half concrete core labeled Core #5 (Figs. 1 and 2) was received on October 27, 2009 from Mr. Jerzy Zemajtis, Project Manager, CTLGroup on behalf of Mr. Paul Fagan of Progress Energy, Crystal River, Florida. According to Mr. Zemajtis, the core represents the outer portion of concrete from a containment wall and the core is fractured at its inner surface at a delamination that was found to be present when access was gained to the wall interior. The delamination is approximately at a depth of 200 mm (8.0 in.) where horizontal post tensioning ducts are present.

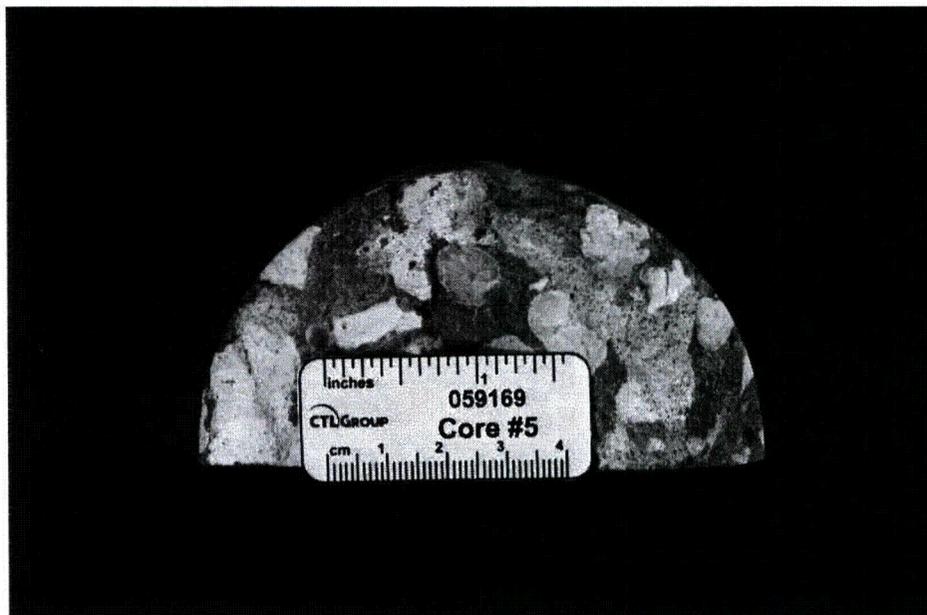
Fig. 2 End views of Core #5, as received for examination.

2a. Inner end.

2b. Outer end.

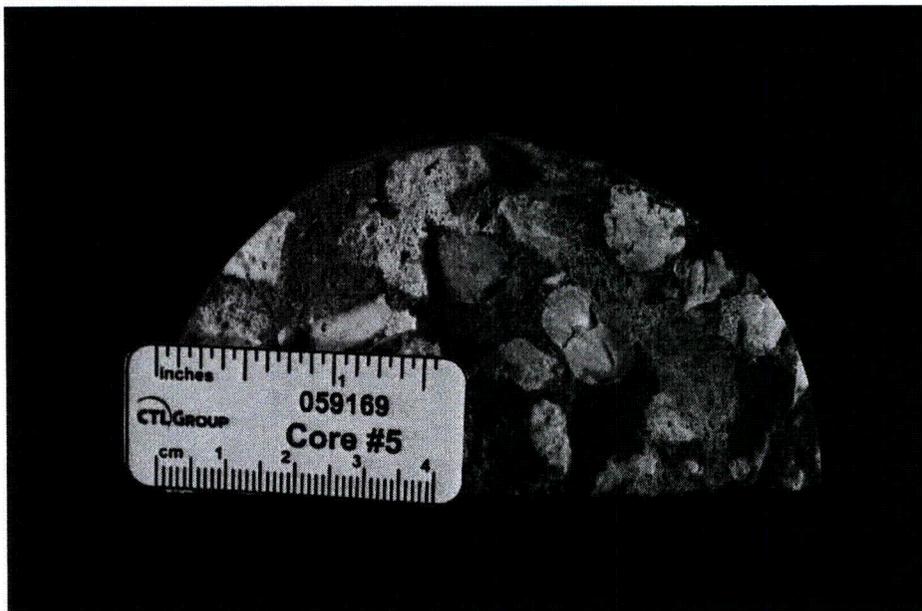
3a. Saw cut side. Outer surface is to the left.

3b. Fractured inner end.

Fig. 3 Views of the portions of Core #5 treated with phenolphthalein, a pH indicator. All the pink regions exhibited denote the limits of where the indicator was applied. No colorless, low pH (carbonated) regions were observed at the fractured end regions.

Carbonation to any significant depth from the fracture surface into the outer concrete is not observed (Fig. 3). Incipient carbonation is exhibited in thin section at the immediate fracture surface (Fig. 6a). However, an older delamination surface that was not exposed to air due to the depth of outer concrete, and other possible wall coverings, may also have such an absence of carbonation.

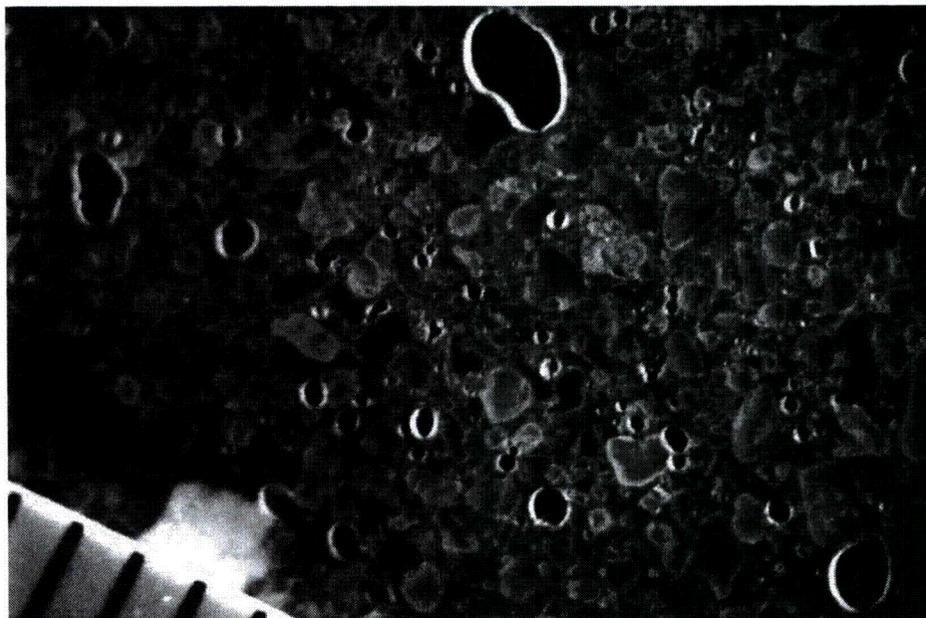
Fig. 5 View of the concrete hardened air-void system of Core #5 illustrating the moderate quantity of both coarse and fine air voids. Scale is millimeter increments.

The concrete represented by Core #5 is well consolidated and free of any cracks or excessive microcracks (Fig. 4). The concrete consists of crushed carbonate rock coarse aggregate and natural sand fine aggregate, well distributed in a portland cement paste. No evidence is exhibited of any deleterious chemical reactions involving the cement paste and / or aggregates. The concrete could be considered marginally air entrained based on an approximate volume of 1 to 2% of small, spherical entrained air voids in the hardened cement paste (Fig. 5).

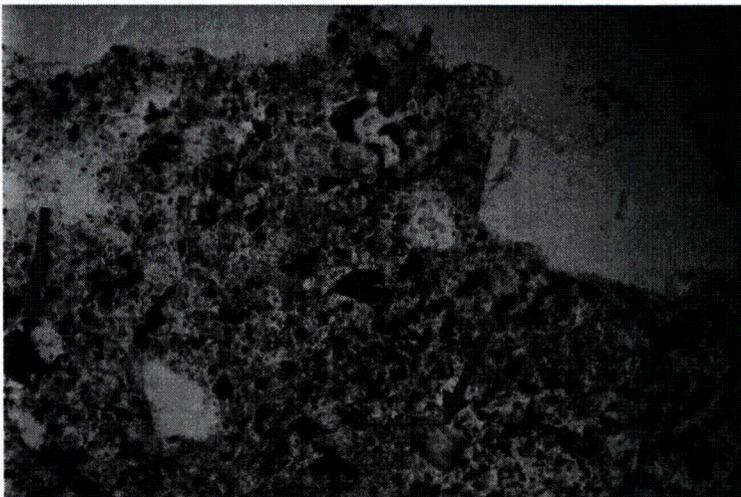
6b. Plane-polarized light view of the paste adjacent to the inner fractured surface (same field of view as 6a.). A low to moderate number of unhydrated and partially hydrated cement particles (arrowed red) are exhibited by the paste. The amount is comparable to that in the body of the core in Fig. 6c. below. Width of view is approximately 0.5 mm.

The cement hydration adjacent to the fracture is well advanced and comparable to that of the body of the core (Figs. 6b and 6c). This suggests that there was no moisture ingress to the fracture surface, over a period of time long enough, to change the general degree of hydration. This is supported by an absence of secondary deposits within air voids adjacent to the fracture surface.
