**Atmospheric Stress Corrosion  
Cracking Susceptibility of Welded and  
Unwelded 304, 304L, and 316L  
Austenitic Stainless Steels  
Commonly Used for Dry Cask  
Storage Containers Exposed to  
Marine Environments**

This report documents information on the susceptibility to atmospheric stress corrosion cracking of welded and unwelded 304, 304L, and 316L austenitic stainless steels commonly used for dry storage containers exposed to marine environments. Standard U-bend specimens were exposed to both salt spray and salt fog conditions at temperatures ranging from 25 to 176 °C [77 to 350 °F] and varying relative humidity. The first test conducted was a salt spray test to scope out material and residual stress effects. This deliberately conservative test resulted in extensive cracking and corrosion as was observed in all the 93 and 176 °C [200 and 350 °F] U-bends in as early as 1 month after exposure. Salt spray tests are non-prototypical since deposition of salt on dry casks is in the form of a dry aerosol; hence, the first test was not suitable for evaluation of stress corrosion cracking susceptibility of austenitic stainless steels in coastal atmospheres. The second test conducted

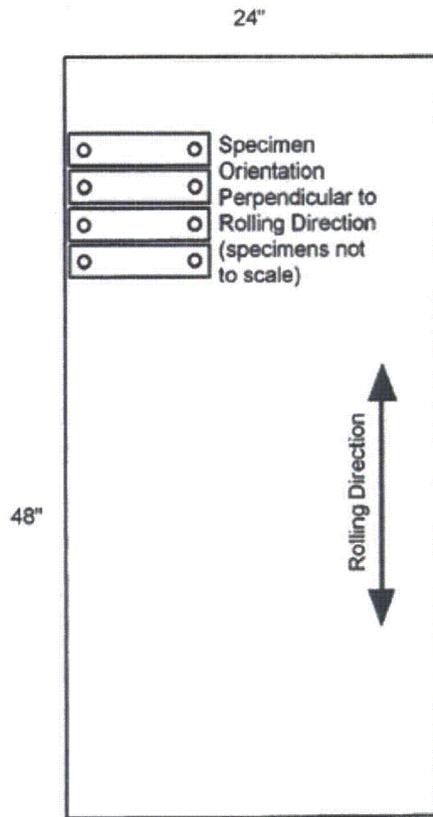
Figure 1 U-Bend Specimen Fabrication With Respect to the Sheet Rolling Direction (Specimen Dimensions not to Scale)

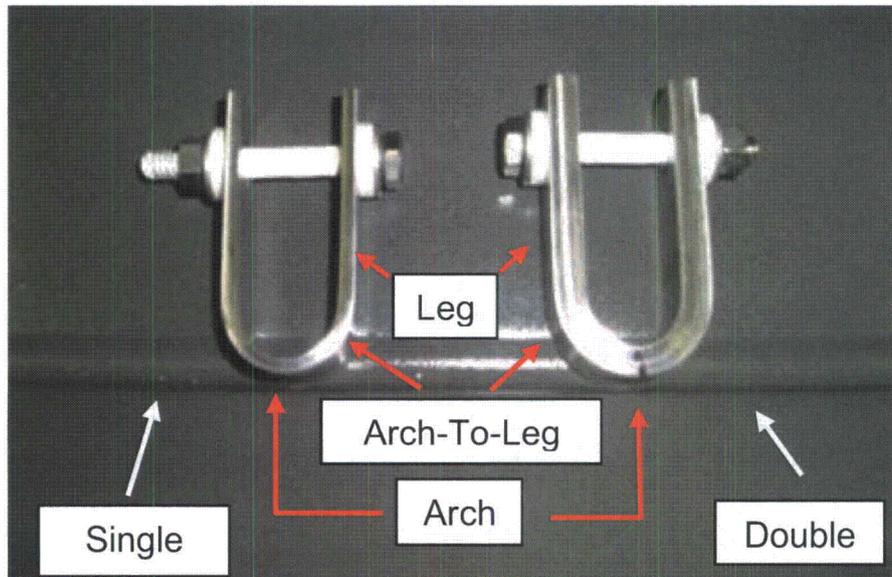
Figure 2 Configuration of the Single and Double U-Bend Specimens

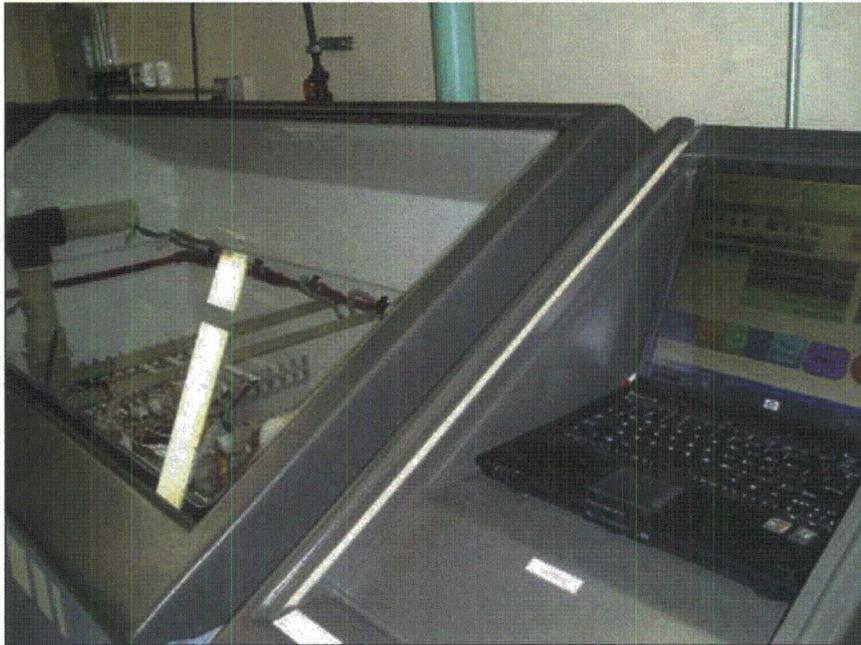
**Figure 3** Picture of the Standardized Auto Technology Environmental Chamber

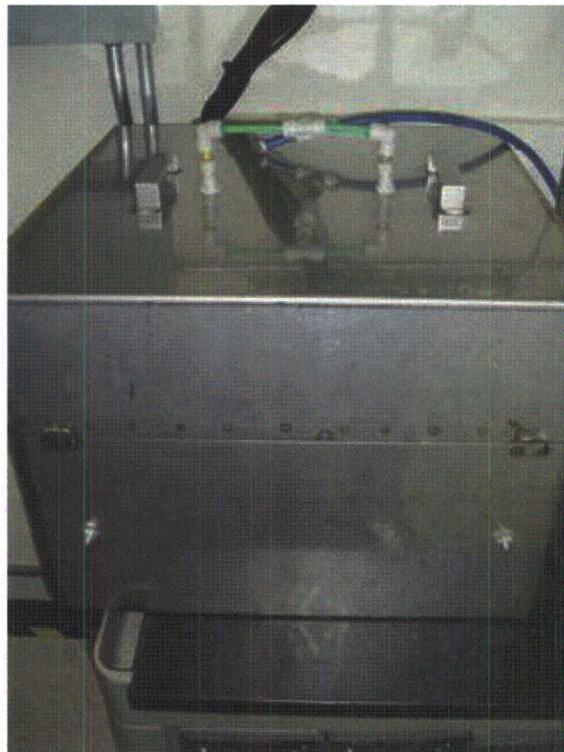
**Figure 4** Picture of the Custom Stainless Steel Environmental Chamber

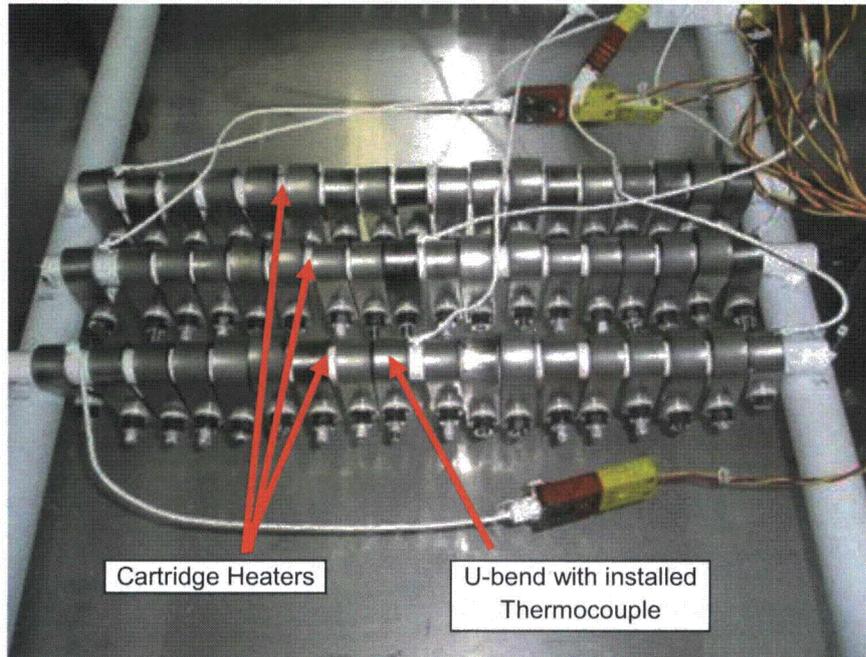
**Figure 5** U-Bend Specimens Placed on Cartridge Heaters in the Custom Environmental Chamber

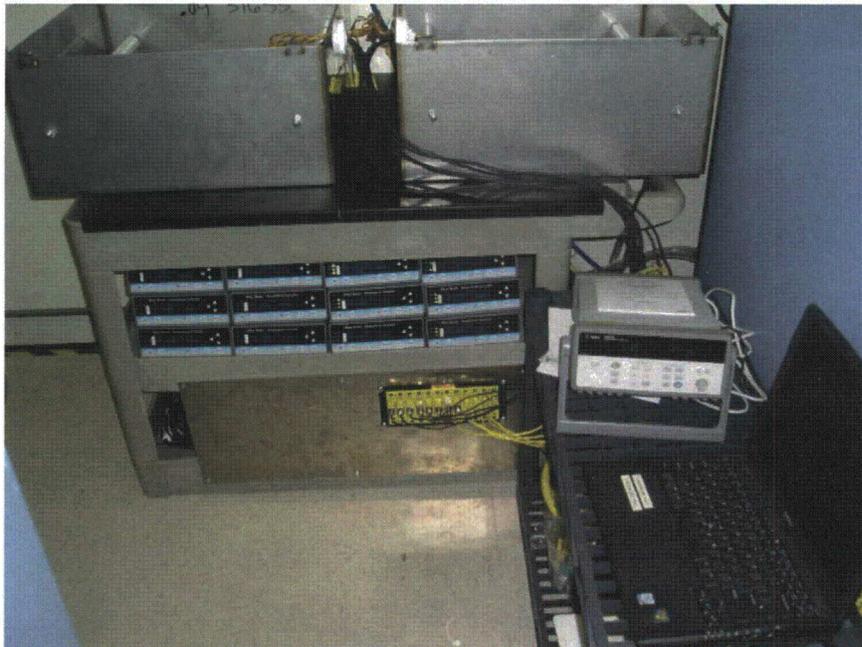
**Figure 6** PID Controllers Used to Set and Control the Temperature of the Cartridge Heaters

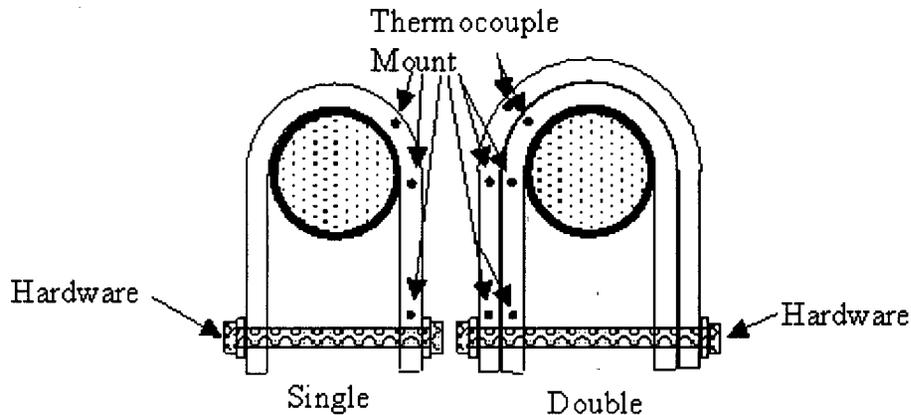
**Figure 7 Schematics of the Locations of Thermocouples Attached to Selected Single and Double U-Bend Specimens for Temperature Profile Determination**

instrumented with thermocouples at the specimen arch, arch-to-leg transition, and the leg regions for temperature profile determination (Figure 7). A total of three and six thermocouples were installed in single and double U-bend specimens, respectively.

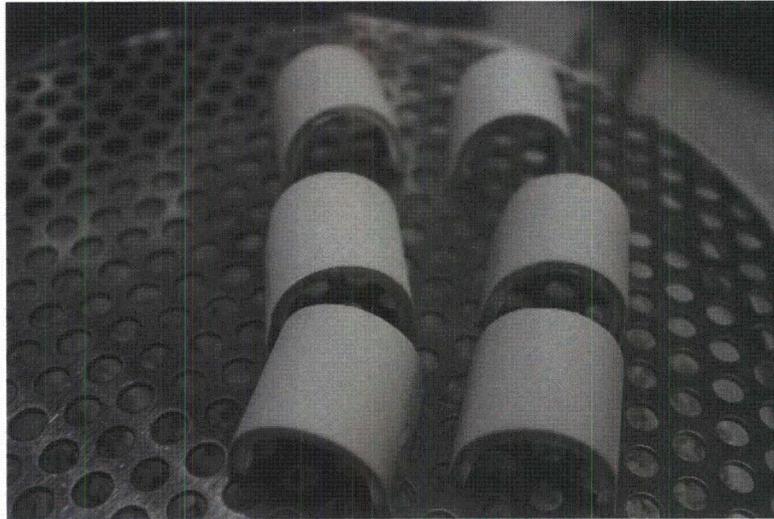
**Figure 8 Typical Appearance of the Half U-Bend Samples Used for Salt Deposition Measurements After 2 Weeks of Exposure**

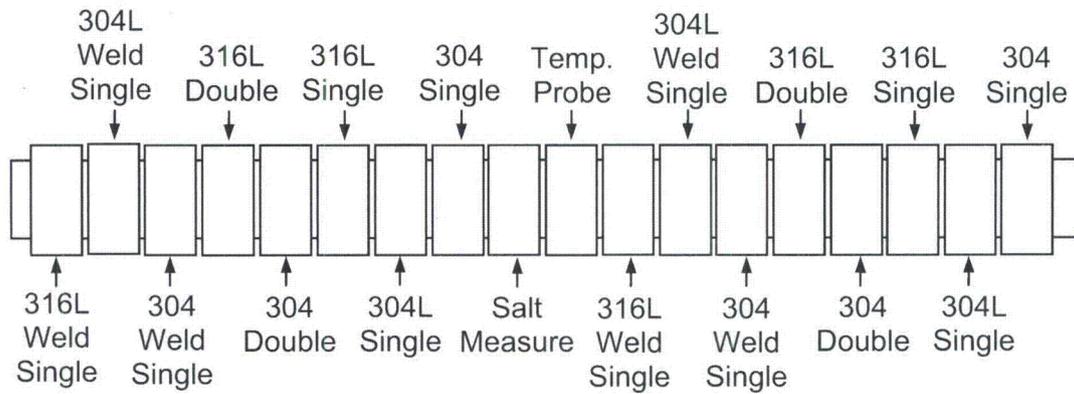
**Figure 9 Schematic of the U-Bend Specimen Arrangement on Each Cartridge Heater**

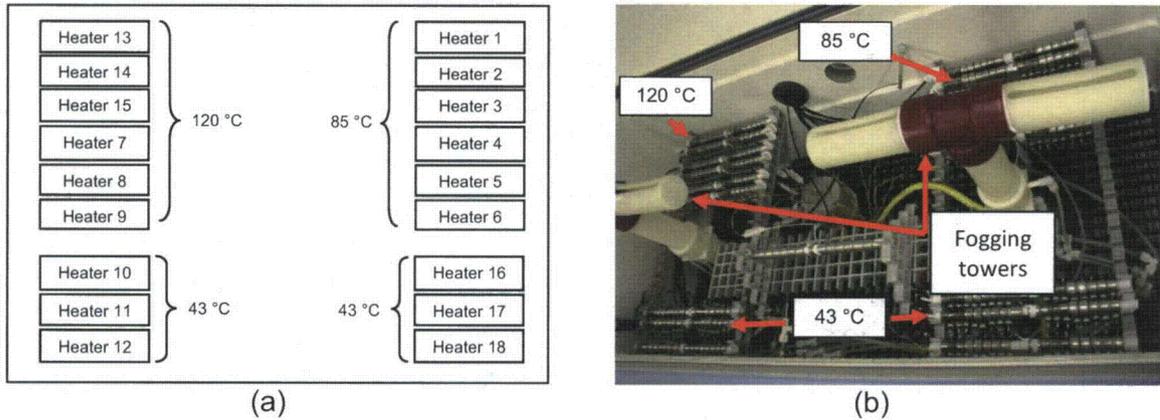
**Figure 10** (a) Schematic of the Cartridge Heater Layout and (b) a Picture of the Standardized Atmospheric Chamber

Figure 10 shows a schematic of the layout of the heaters inside the chamber and a representative picture of the experimental setup of the salt fog test. As shown in Figure 11, the inner surface of the specimen arch was positioned facing upward in close contact with the heater perimeter so that salt could accumulate on the outer specimen surface where increased stress concentration was expected.

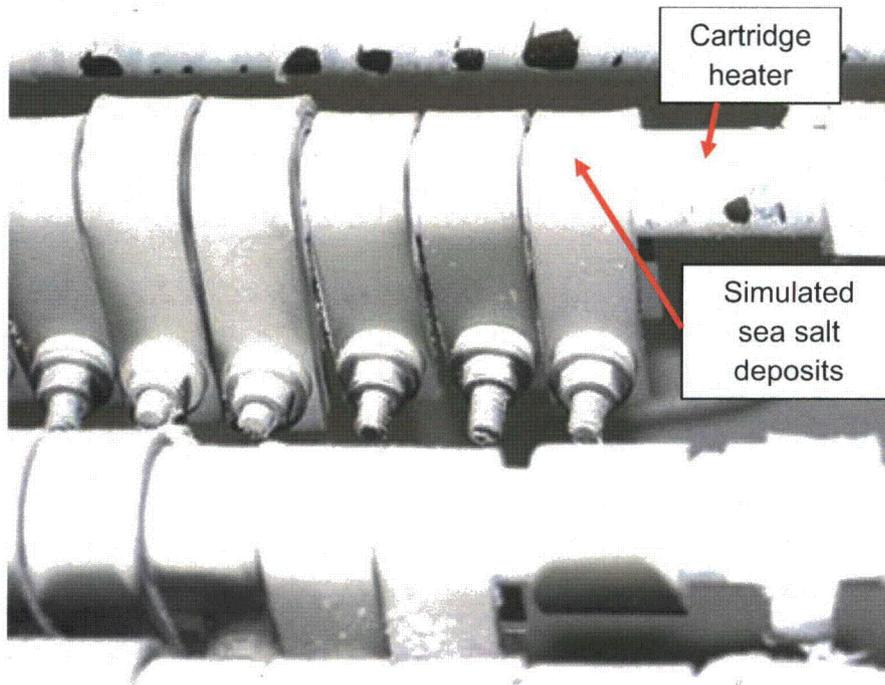
**Figure 11** Typical U-Bend Arrangement Used for the Salt Spray and Salt Fog Tests

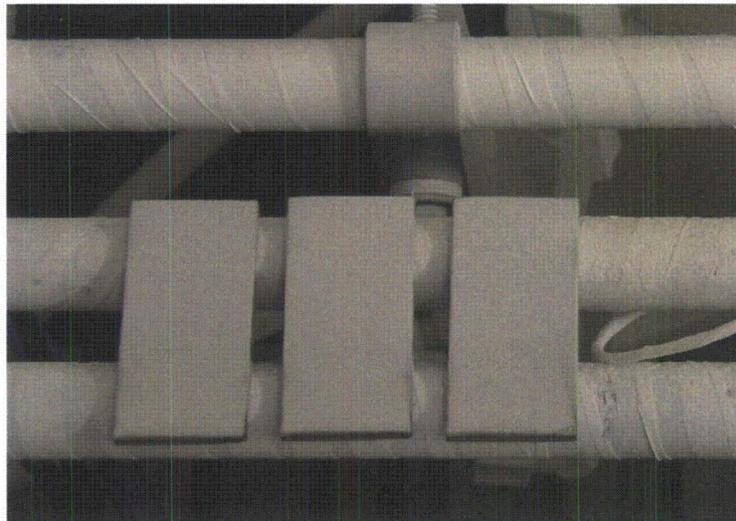
**Figure 12** Photograph of the Flat Specimens Exposed to 85 °C [185 °F] Used for the Salt Deposition Rate Determination. The Specimens Appeared to be Completely White Because of the Deposited Salt

In order to determine the salt deposition rates before the salt fog test, a 6-week test was initially examined using 304 stainless steel flat specimens of the same dimensions as the half U-bend samples. The flat specimens were placed inside the chamber and heated to 43, 85, and 120 °C [109, 185, and 248 °F]. The chamber temperature and relative humidity were set to 35 °C [95 °F] and 25 percent, respectively, which corresponded to an absolute humidity of 10 g/m<sup>3</sup> [3.61 10<sup>-7</sup> lb/in<sup>3</sup>]. Each salt fog cycle was 5 min long carried out every 20 min for a total of 3 cycles/hr. A picture of the 85 °C [185 °F] specimens during testing is shown in Figure 12.

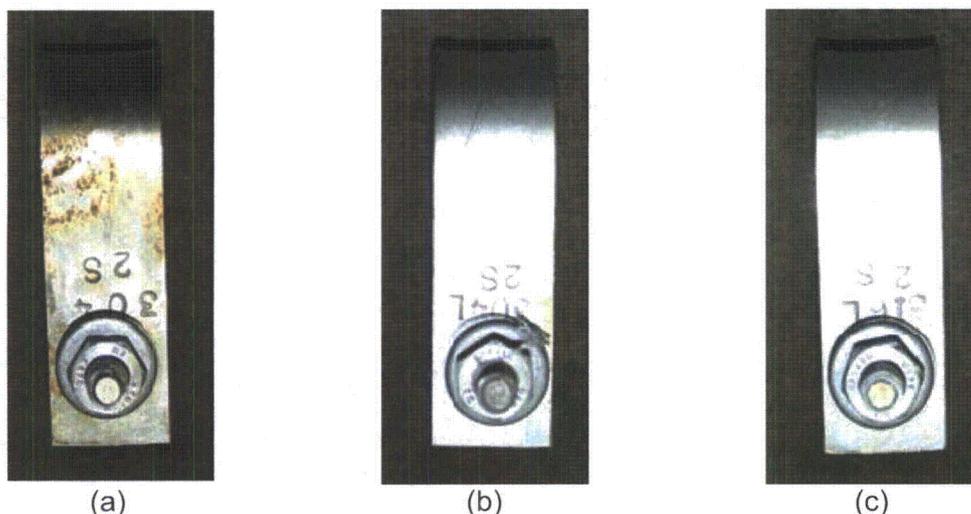
**Figure 13 Typical Surface Appearance of the Single U-Bend Specimens: (a) 304, (b) 304L, and (c) 316L Held at 25 °C [77 °F] for a 1-Month Exposure**

Optical examination of the single and double U-bend specimens that were held at 25 °C [77 °F] showed minor corrosion distress for the 304 stainless steel, but no signs of cracking for all the alloys for both 1-month and 2-month exposure periods. This observation was consistent with the specimen temperature being lower than the expected critical temperature for SCC development.

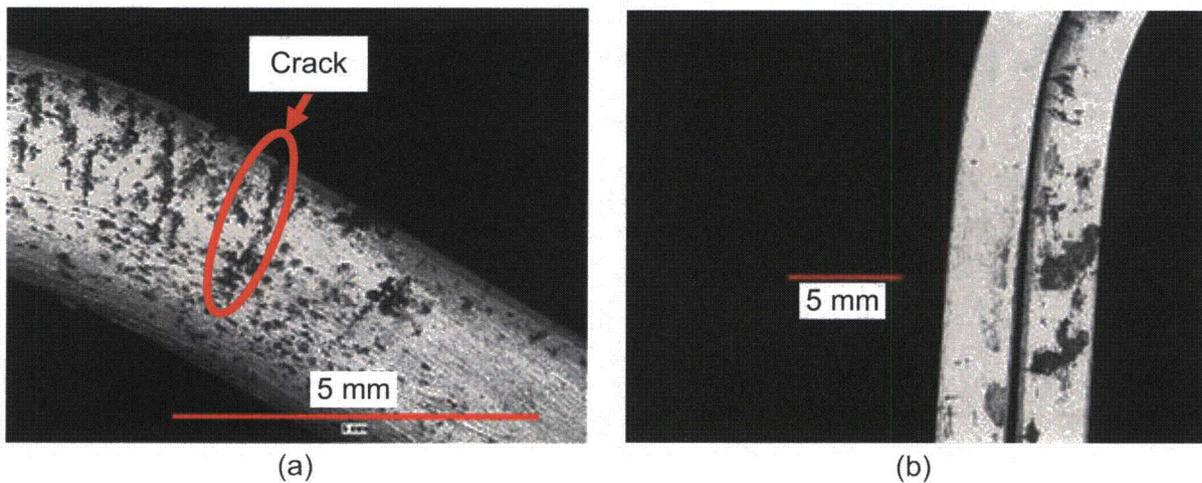
**Figure 14** Typical SCC Behavior of the 304 Stainless Steel (a) Single and (b) Double U-Bend Specimens Exposed for 1 Month at a Temperature of 93 °C [200 °F]

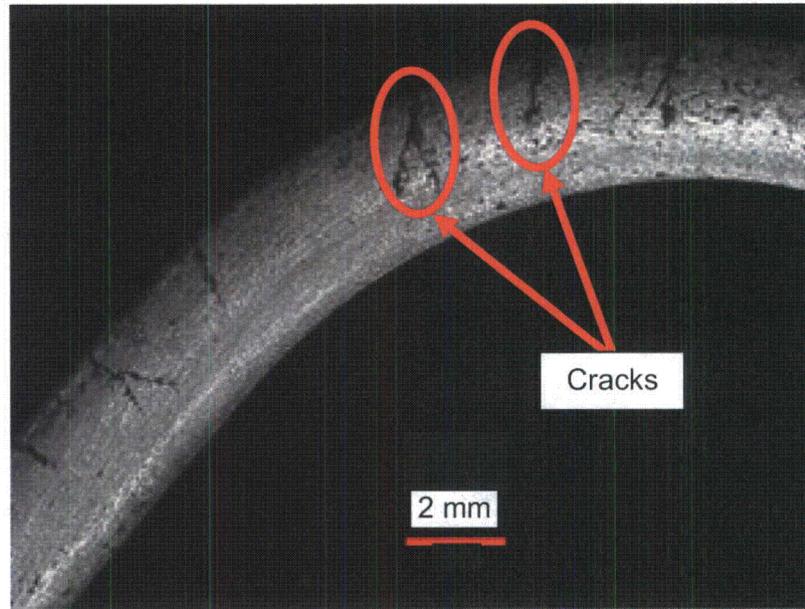
**Figure 15** Typical SCC Behavior of a 304L Stainless Steel Single U-Bend Specimen Exposed for 1 Month at a Temperature of 93 °C [200 °F]

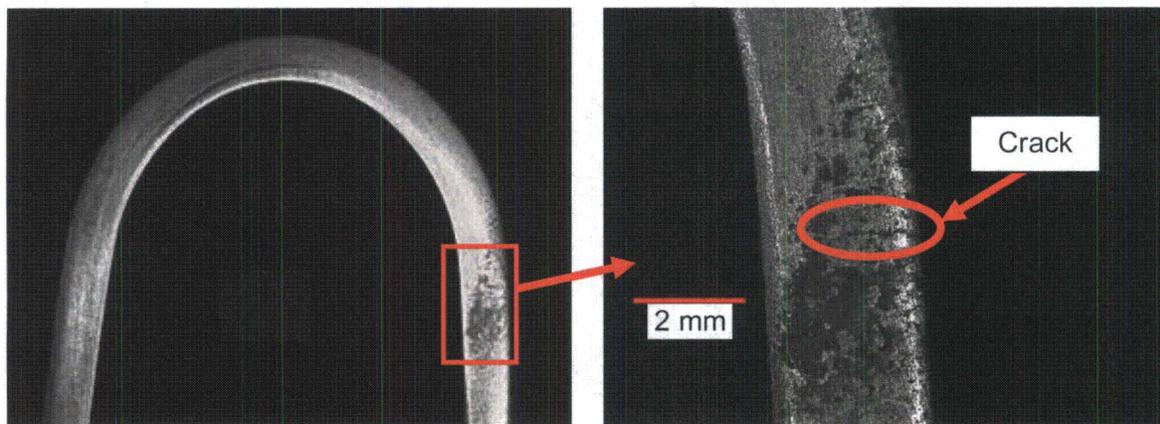
**Figure 16** Typical SCC Behavior of a 316L Stainless Steel Single U-Bend Specimen Exposed for 1 Month at a Temperature of 93 °C [200 °F]

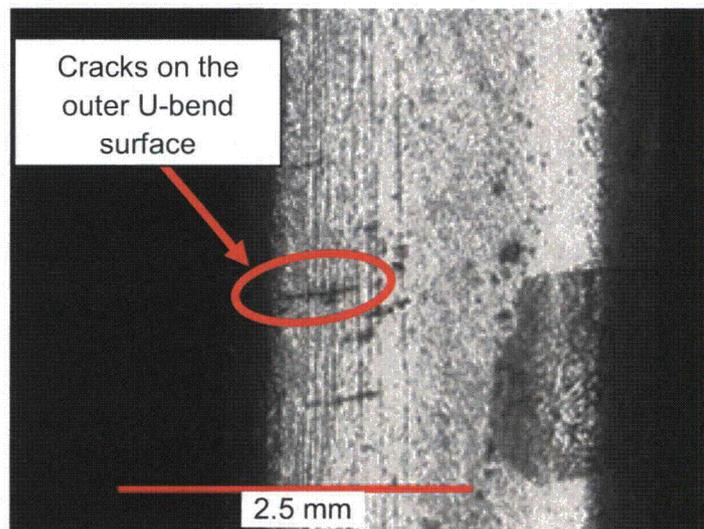
**Figure 17** Typical SCC Behavior of a 304 Stainless Steel Single U-Bend Specimen Exposed for 1 Month at a Temperature of 176 °C [350 °F]

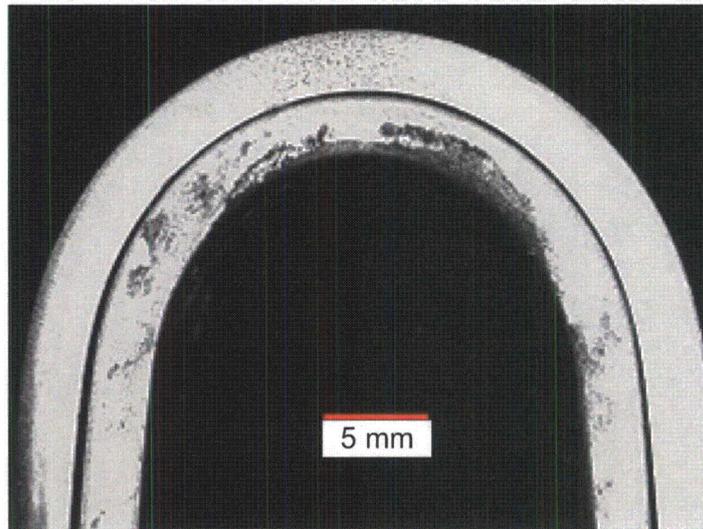
**Figure 18** Typical SCC Behavior of a 304 Stainless Steel Double U-Bend Specimen Exposed for 1 Month at a Temperature of 176 °C [350 °F]

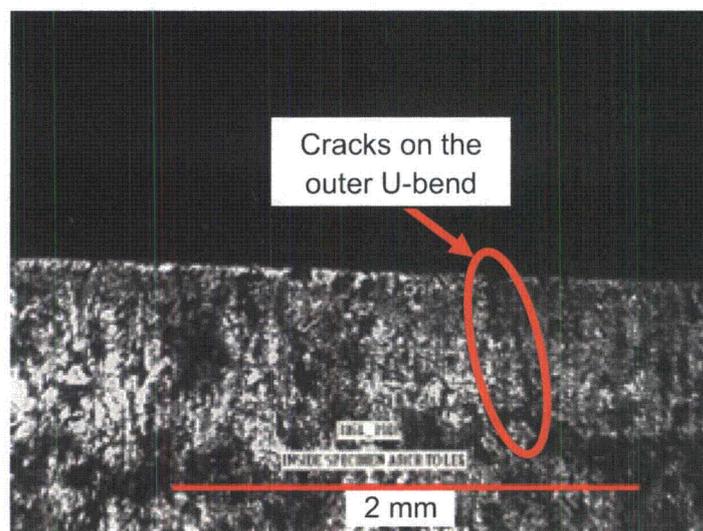
**Figure 19** Typical SCC Behavior of the Inner 316L Stainless Steel Double U-Bend Specimen Exposed for 1 Month at a Temperature of 176 °C [350 °F]

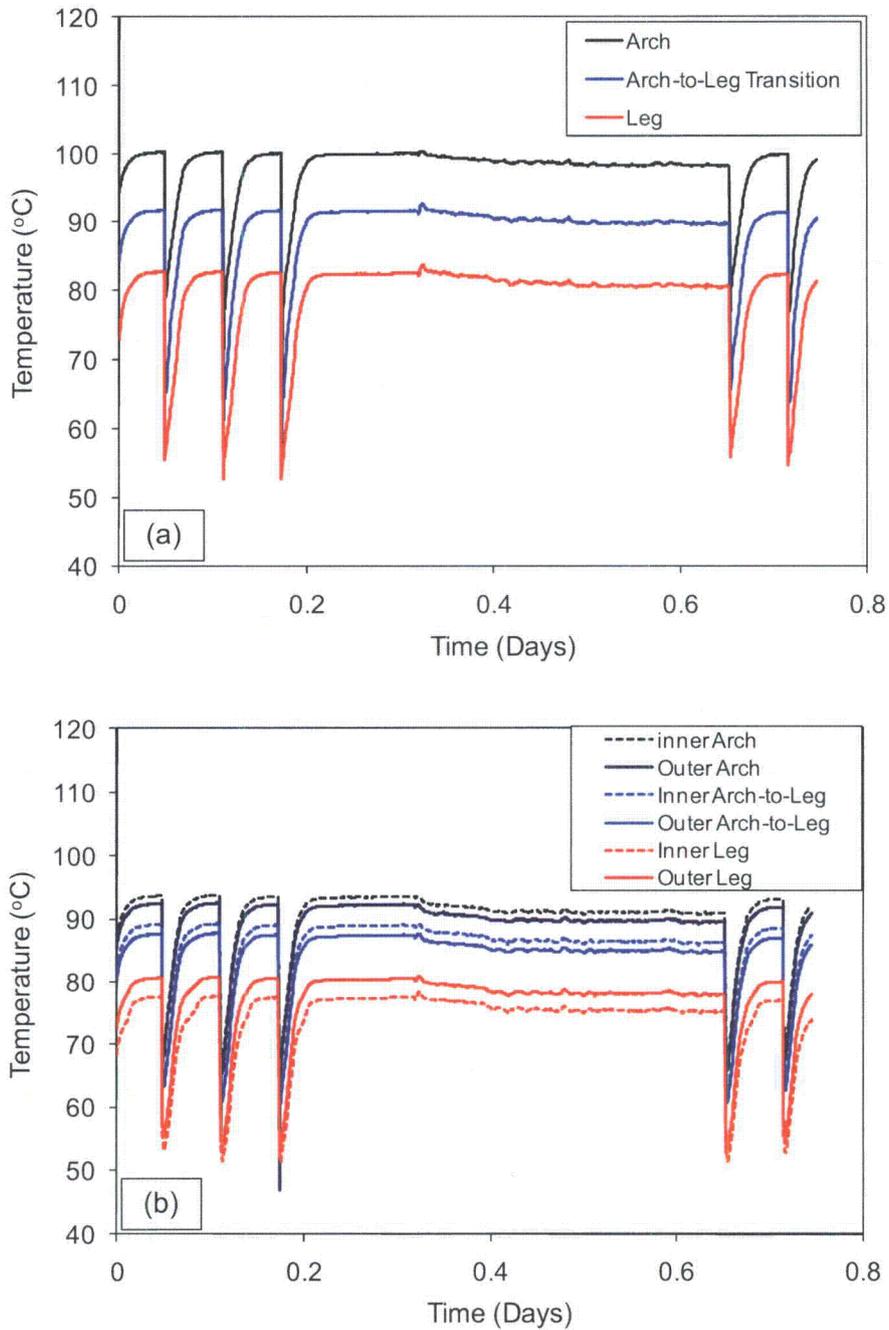
**Figure 20** Temperature Profile for a) Single and b) Double U-Bend Specimens at 93 °C [200 °F] Subjected to the Salt Spray Test

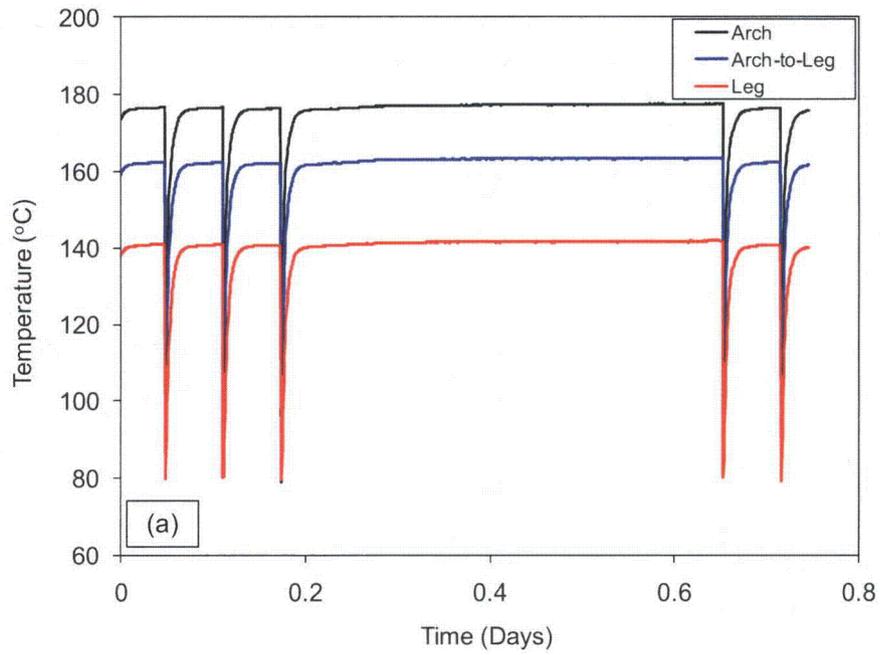
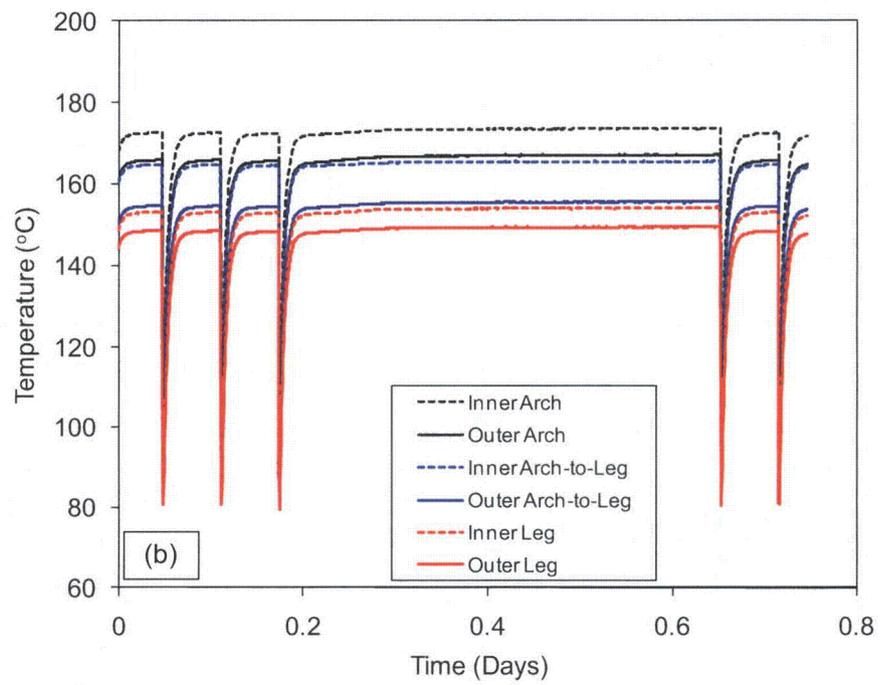
**Figure 21** Temperature Profile for a) Single and b) Double U-Bend Specimens at 176 °C [350 °F] Subjected to the Salt Spray Test

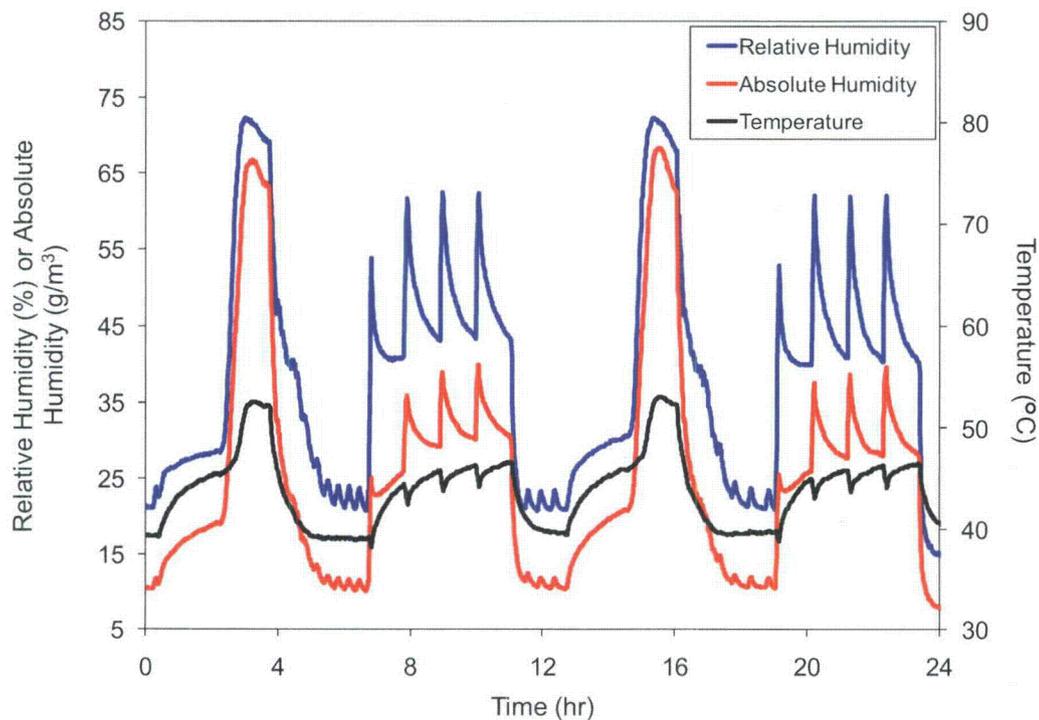
**Figure 22 Chamber Temperature, Relative Humidity, and Absolute Humidity Trends as a Function of Time for Two Consecutive Full Cycles Recorded During the Salt Fog Test**

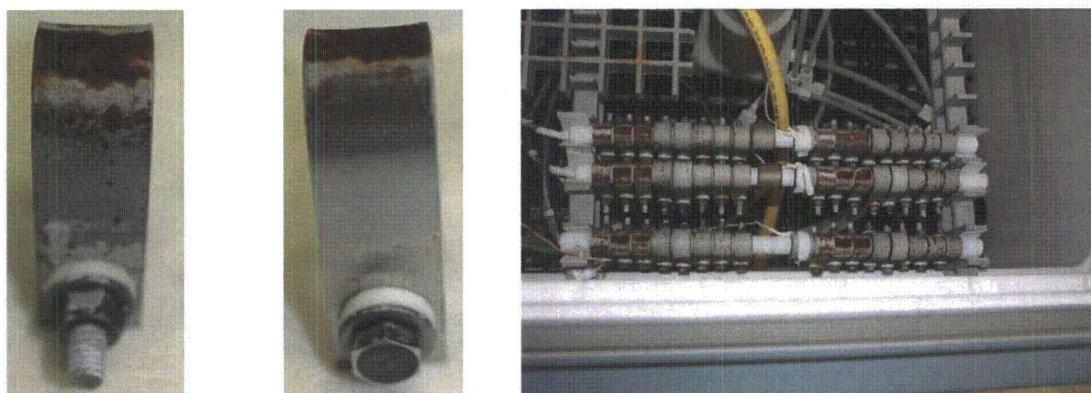
**Figure 23** Pictures of Selected  $43\ \text{°C}$  [ $109\ \text{°F}$ ] 304 and 304L Weld U-Bend Specimens and an Overall Photograph of all the  $43\ \text{°C}$  [ $109\ \text{°F}$ ] Specimens Mounted on the Heaters 16, 17, and 18 in the Environmental Chamber After 4 Weeks of Exposure. The Specimen Arrangement in Each Heater is Shown in Figure 9

general corrosion at the apex curvature of the bend, particularly within the weld and heat-affected zone in the welded specimens. The 316L single and double weld and unwelded U-bend specimens showed less corrosion deposits than the 304 and 304L specimens did, but pitting corrosion was noted at the heat-affected zone and none at the weld area. For all the single U-bend specimens, the presence of isolated small pits (and edge corrosion for the 304 and 304L specimens) were more noticeable at the bent apex curvature area. For all the double U-bend specimens, corrosion was more prominent in the outer specimen compared to the inner specimen, which showed only corrosion at the edges. After exposure, most of the corrosion products and deposited salt were removed during cleaning. After cleaning, optical examination at 100X magnification showed the presence of small and tight cracks ( $<3\ \mu\text{m}$  wide) in one unwelded 304 and 304L single and double U-bend specimens. On the contrary, optical examination of all the 316L U-bends showed no apparent cracks. Pictures of the typical surface appearance of the  $43\ \text{°C}$  [ $109\ \text{°F}$ ] U-bend specimens inside the atmospheric chamber after 4 weeks of exposure are shown in Figure 23.

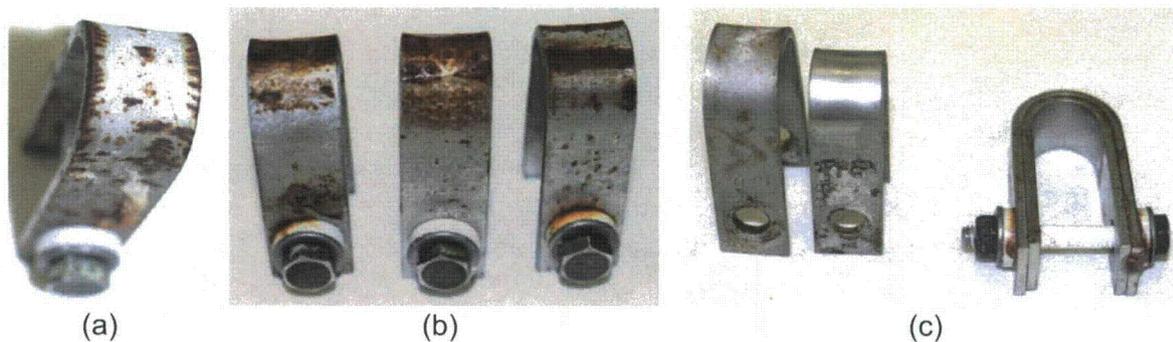
**Figure 24 Pictures of (a) a 43 °C [109 °F] 304L U-Bend Specimen Showing Corrosion Product and Striation Marks on the Surface, (b) Corrosion Distress of the 304 Weld U-Bend Specimens, and (c) a 304 Double U-Bend Specimen After 16 Weeks of Exposure**

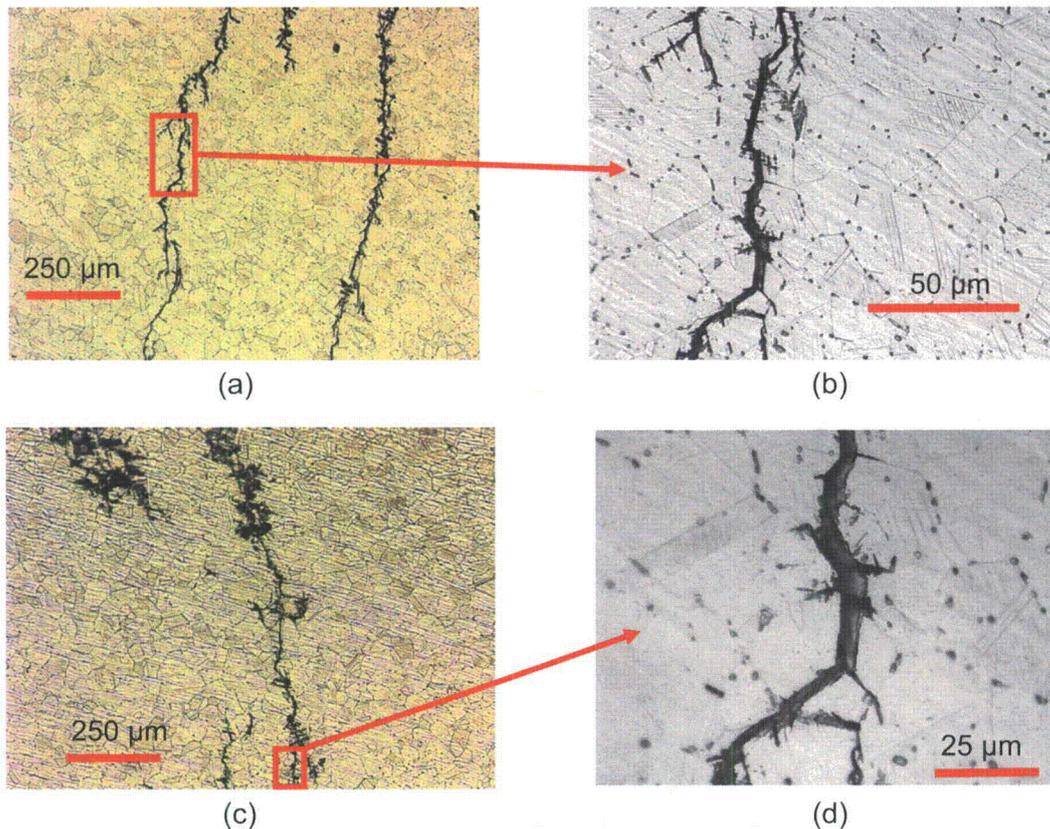
**Figure 25 Pictures of SCC Observed Near the Outer Surface at the Specimen Arch: (a and b) a 304 Single U-Bend Specimen and (c and d) a 304L Single U-Bend Specimen. Both Samples Were Exposed to 43 °C [109 °F] for 16 Weeks of Exposure**

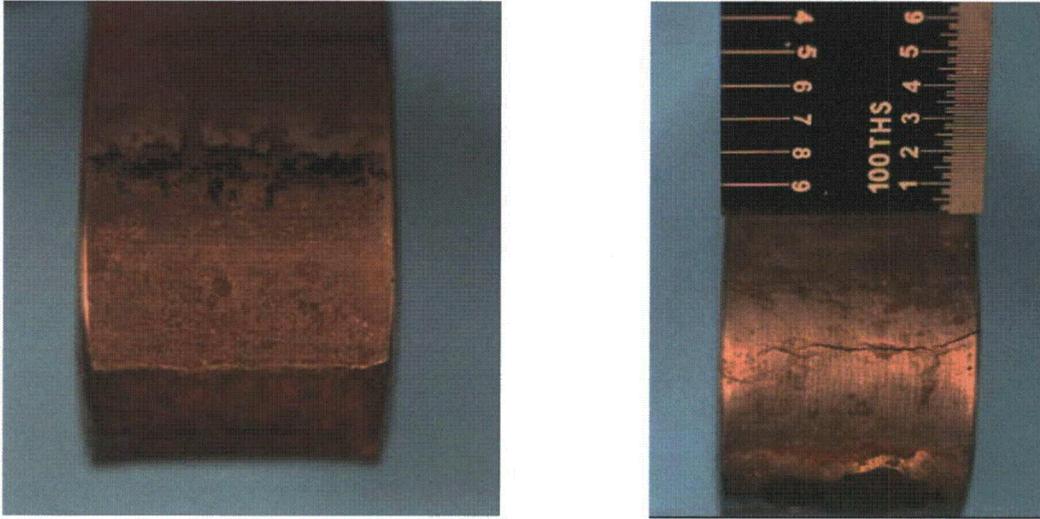
**Figure 26** Pictures of a Cleaned 304 Stainless Steel U-Bend Specimen Exposed for 32 Weeks at a Temperature of 43 °C [109 °F]

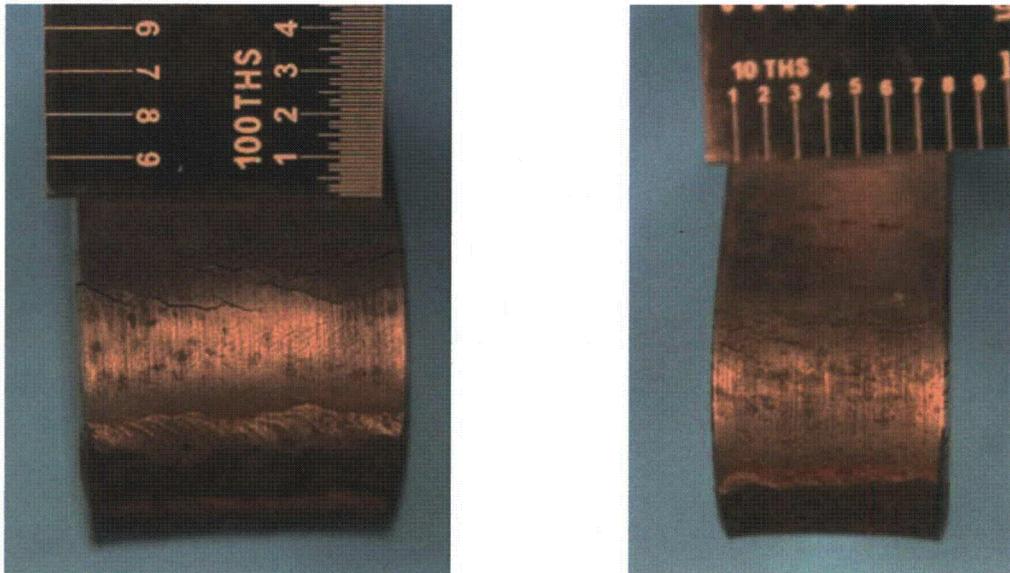
**Figure 27** Pictures of a Cleaned 304L Stainless Steel U-Bend Specimen Exposed for 32 Weeks at a Temperature of 43 °C [109 °F]

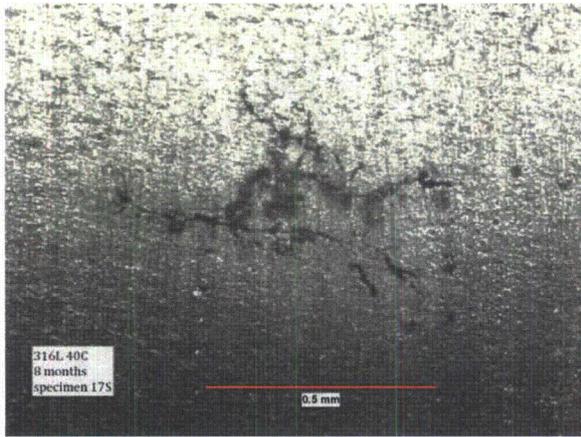
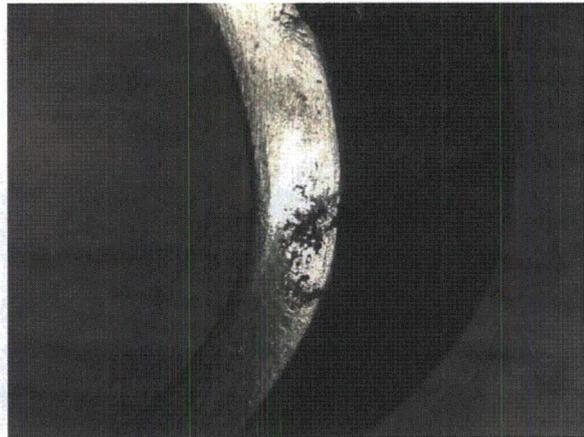
**Figure 28 Stereomicroscopic Images of a 316L Stainless Steel: (a) Single and (b) Welded U-Bend Specimens**

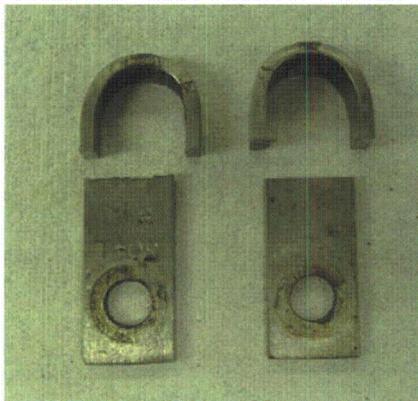
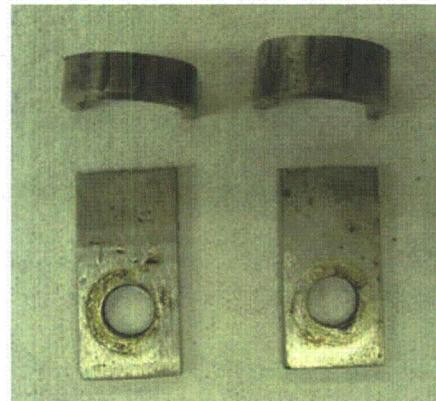
**Figure 29 Pictures of Cut Stainless Steel U-Bend Specimens for Microstructure Evaluation**

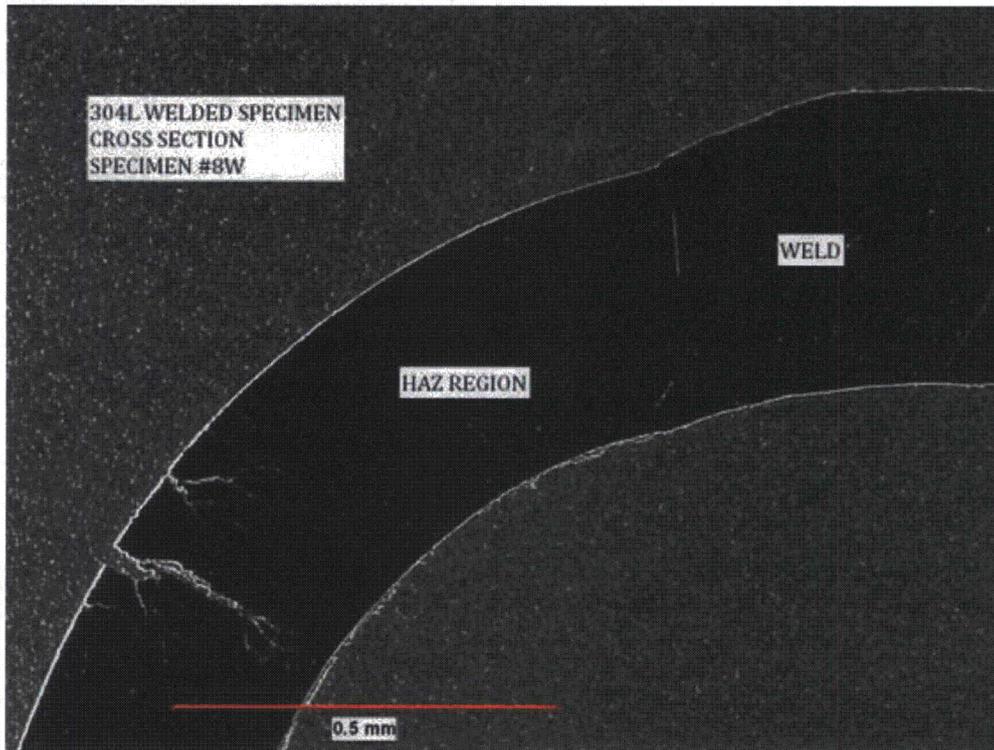
Figure 30 Stereomicroscopic Image of the Cut 304L Weld U-Bend

600-grit surface finish, and optically examined at a 50X magnification or higher. Figures 30 to 33 show that in all cases the cracks propagated from the outside diameter inwards, covering in some cases the entire specimen thickness. The cracking density was noticeably larger than in previous exposure periods suggesting that the environment was aggressive enough to promote (and propagate) the formation of SCC. As mentioned earlier, cracking appears to be a mixed mode of transgranular and intergranular cracking for all cases, having characteristic branching. However, cracks in the 316L specimens appeared to be much narrower compared to the type 304 and 304L cracks.

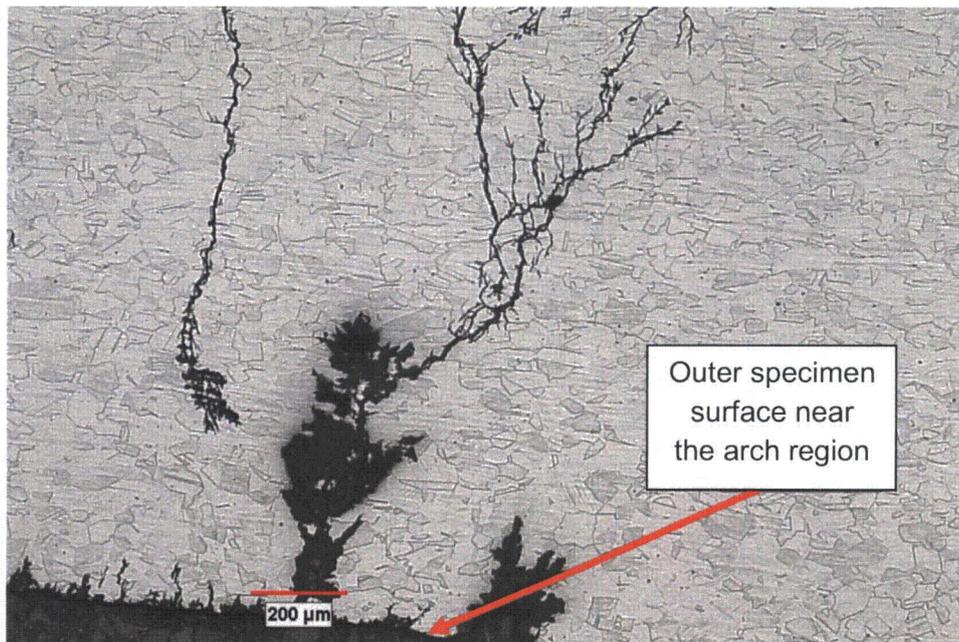
Figure 31 Stereomicroscopic Image of a Cleaned 316L Weld U-Bend Exposed for 32 Weeks at a Temperature of 43 °C [109 °F]

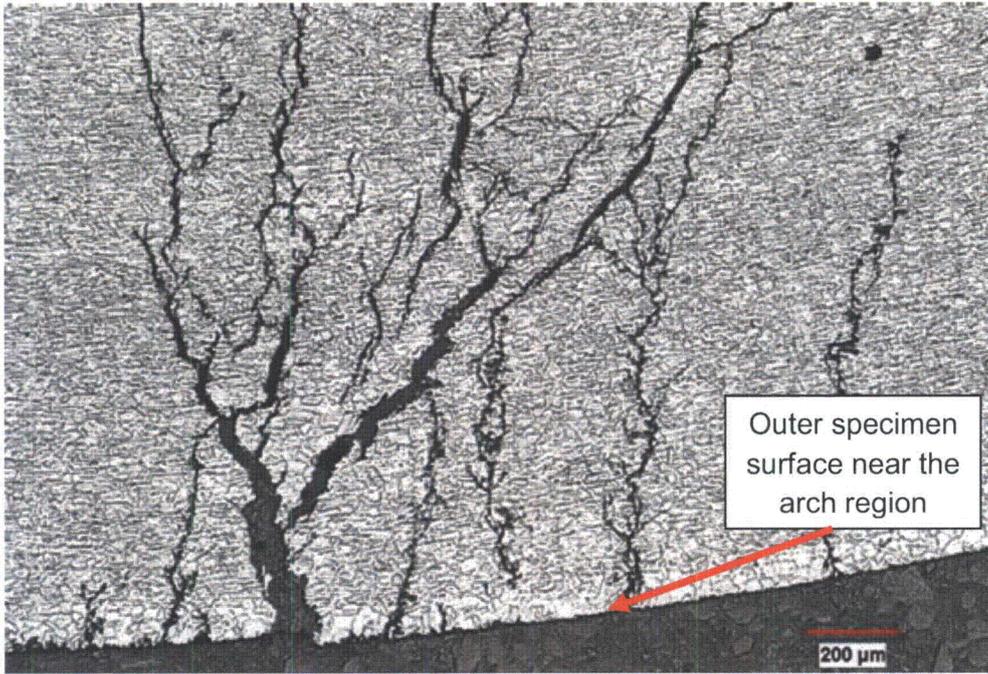
**Figure 32** Stereomicroscopic Image of a Cleaned 304L Weld U-Bend Exposed for 32 Weeks at a Temperature of 43 °C [109 °F]

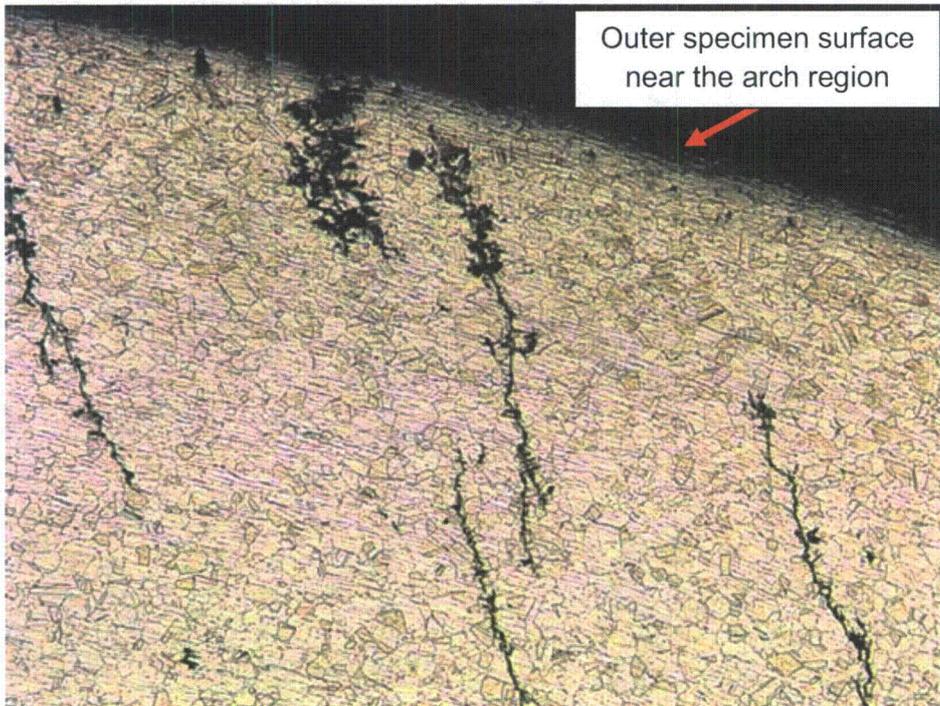
**Figure 33** Stereomicroscopic Image of a Cleaned 304 Unwelded Single U-Bend Exposed for 32 Weeks at a Temperature of 43 °C [109 °F]

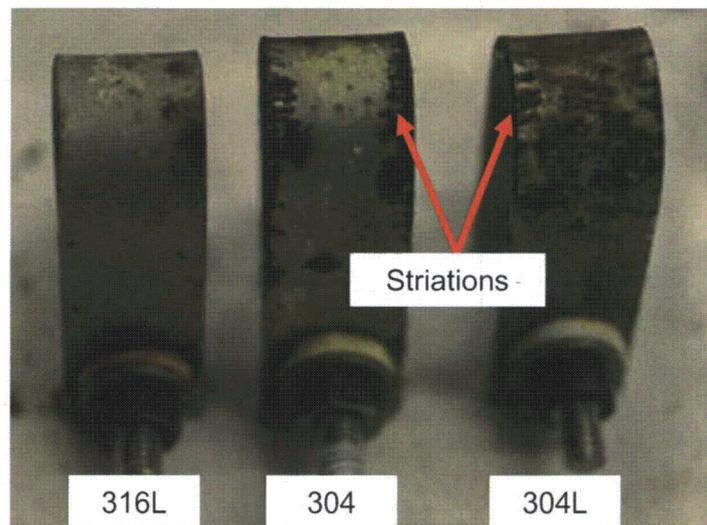
**Figure 34 Typical Surface Appearances of Unwelded Single U-Bend Specimens Exposed for 52 Weeks at 43 °C [109 °F]. Striation Marks on the Outer Surface of the 304 and 304L Unwelded Specimens are Indicated**

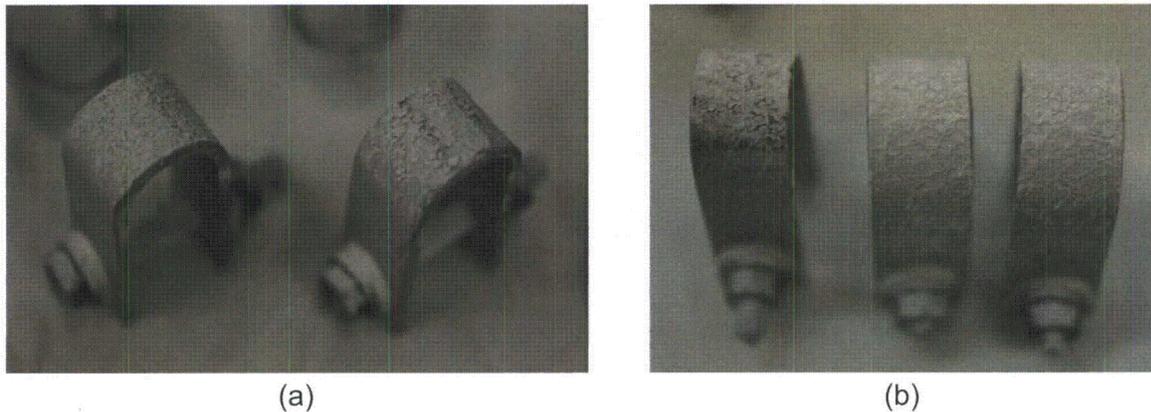
**Figure 35** Pictures of the U-Bend Specimens Exposed to (a) 120 °C [248 °F] and (b) 85 °C [185 °F] for 52 Weeks of Exposure

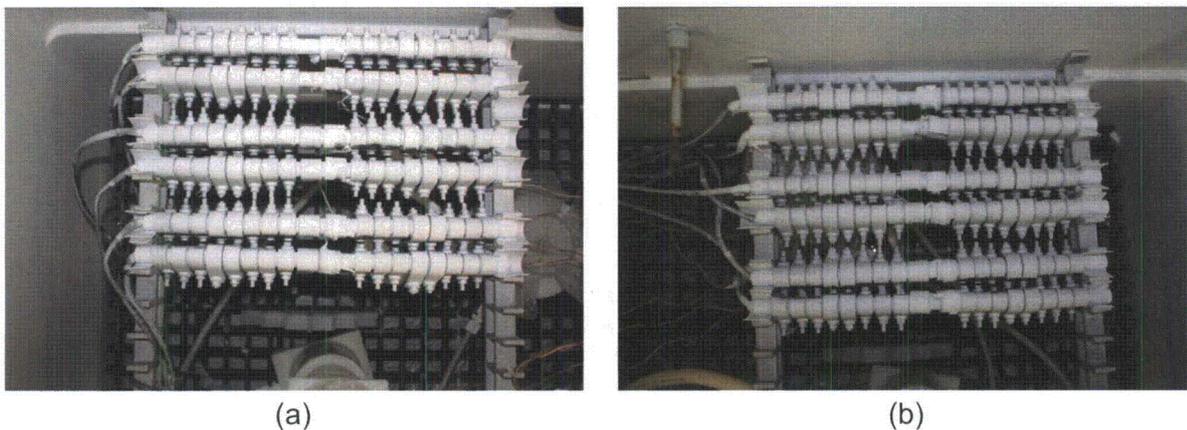
**Figure 36** Pictures of the U-Bend Specimens Exposed to (a) 120 °C [248 °F] and (b) 85 °C [185 °F] for 4 Weeks

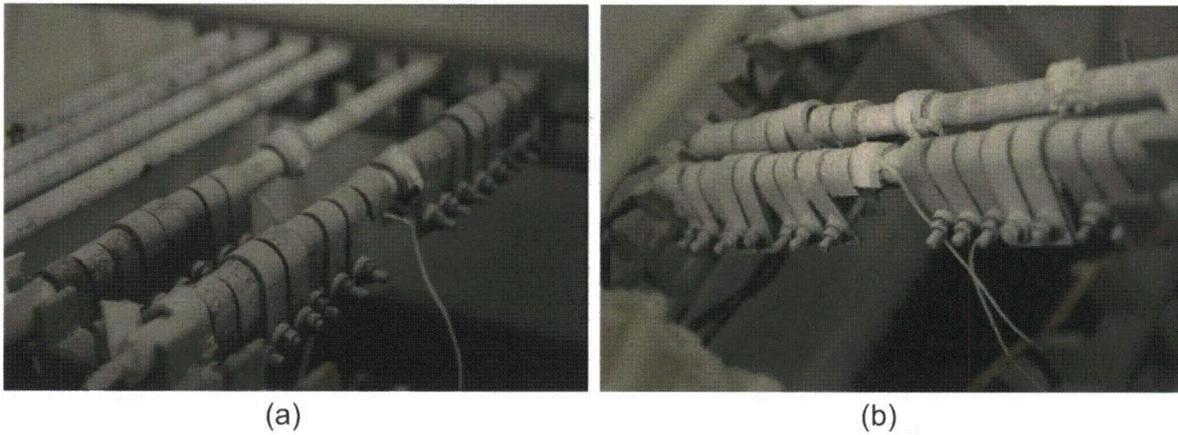
**Figure 37** Pictures of the U-Bend Specimens (a) 120 °C [248 °F] and (b) 85 °C [185 °F] Before Removal from the Environmental Chamber After 52 Weeks
