**Atmospheric Stress Corrosion  
Cracking Susceptibility of Welded and  
Unwelded 304, 304L, and 316L  
Austenitic Stainless Steels  
Commonly Used for Dry Cask  
Storage Containers Exposed to  
Marine Environments**

This report documents information on the susceptibility to atmospheric stress corrosion cracking of welded and unwelded 304, 304L, and 316L austenitic stainless steels commonly used for dry storage containers exposed to marine environments. Standard U-bend specimens were exposed to both salt spray and salt fog conditions at temperatures ranging from 25 to 176 °C [77 to 350 °F] and varying relative humidity. The first test conducted was a salt spray test to scope out material and residual stress effects. This deliberately conservative test resulted in extensive cracking and corrosion as was observed in all the 93 and 176 °C [200 and 350 °F] U-bends in as early as 1 month after exposure. Salt spray tests are non-prototypical since deposition of salt on dry casks is in the form of a dry aerosol; hence, the first test was not suitable for evaluation of stress corrosion cracking susceptibility of austenitic stainless steels in coastal atmospheres. The second test conducted

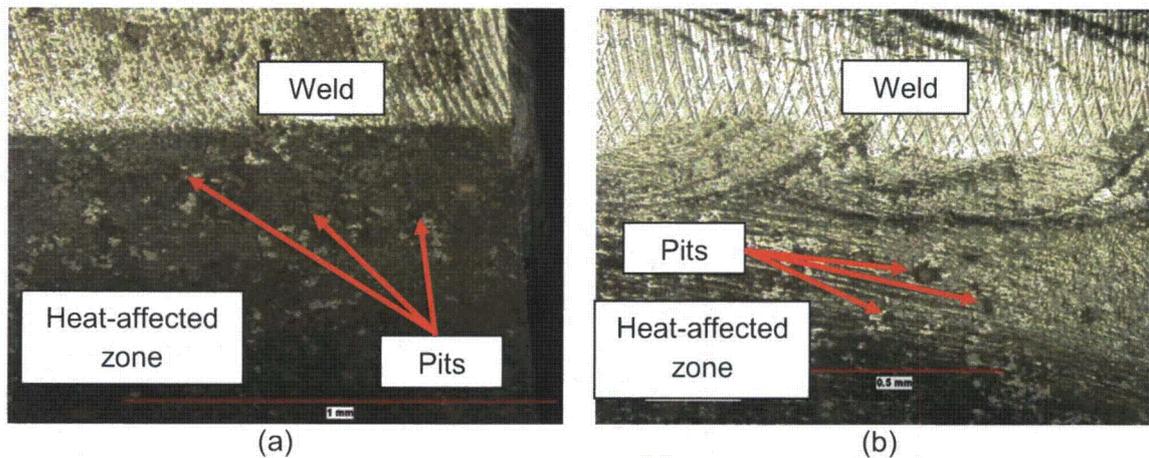
**Figure 38** Optical Examinations of the Weld/Heat-Affected Zone of (a) a 304 U-Bend Specimen and (b) a 316L U-Bend Specimen. Both Specimens Were Exposed to 85 °C [185 °F] for 32 Weeks

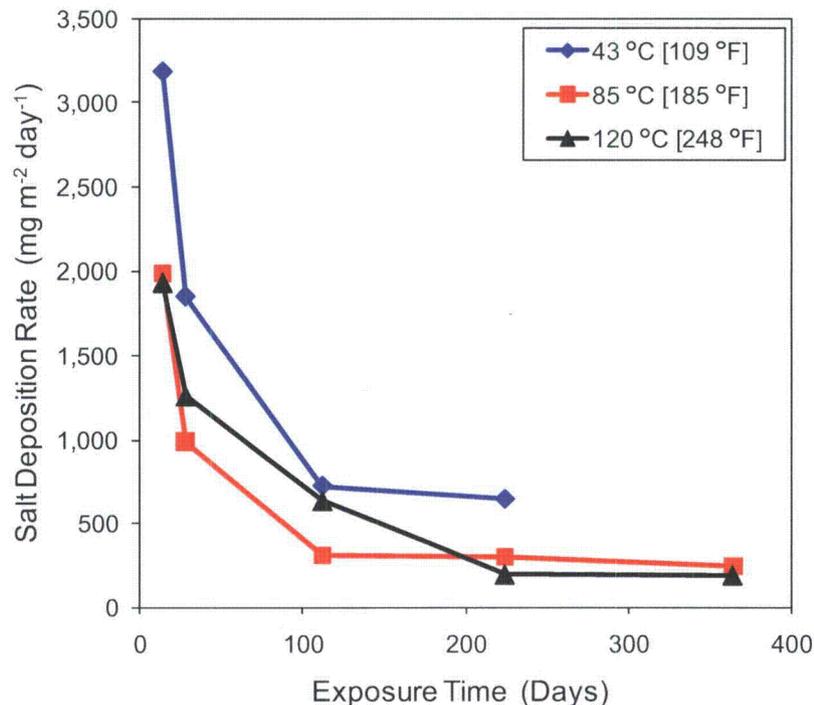
**Figure 39 Salt Deposition Rates as a Function of Time for the Half U-Bend Samples Exposed to the Salt Fog. Due to the Condensation Issue Inside the Chamber, the Salt Deposition Rates for the 120 °C [248 °F] Samples are Inaccurate Between 100 and 365 Days of Exposure**

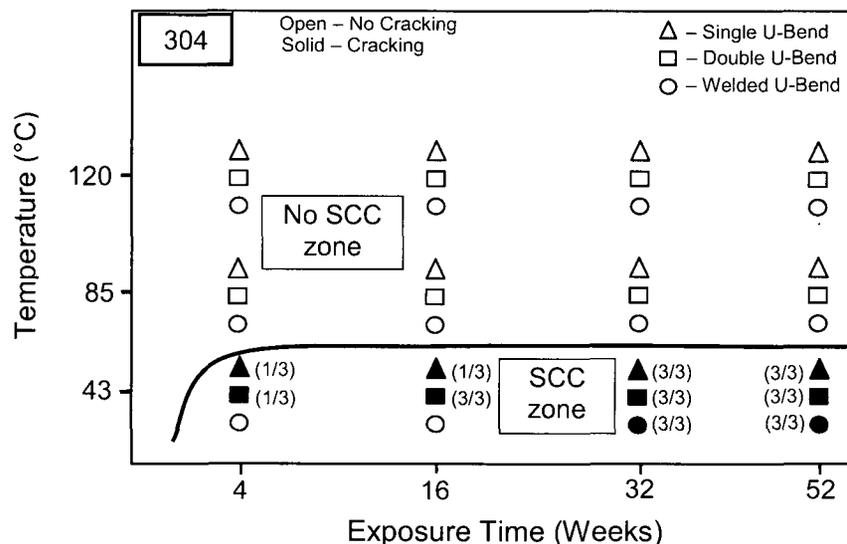
**Figure 40 SCC Susceptibility Map for the Type 304 Stainless Steel (Number in Parenthesis States Number of Specimens Cracked/Total Number of Specimens Tested)**

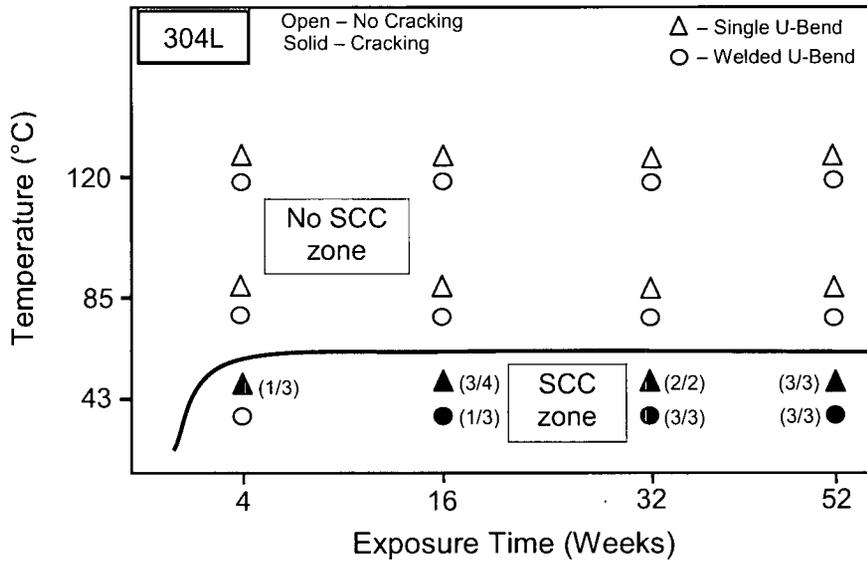
**Figure 41 SCC Susceptibility Map for the Type 304L Stainless Steel (Number in Parenthesis States Number of Specimens Cracked/Total Number of Specimens Tested)**

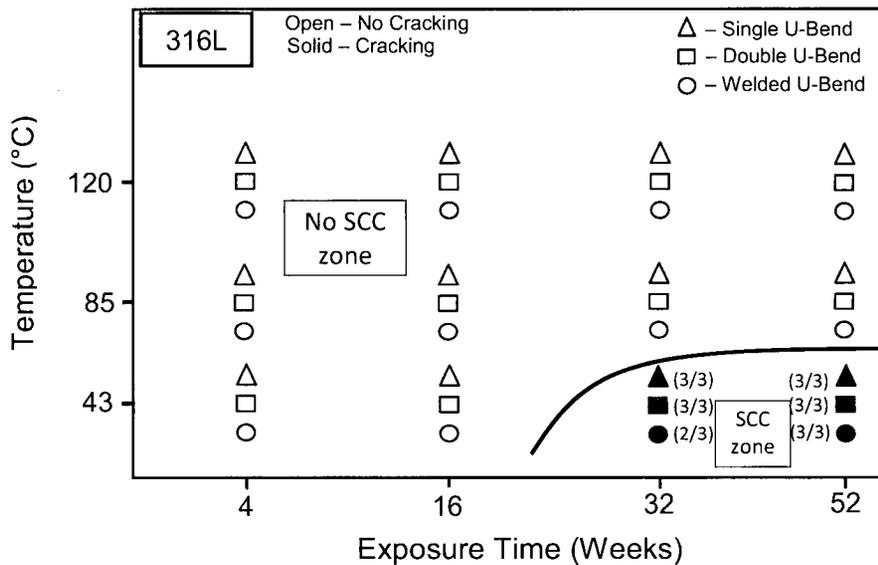
**Figure 42 SCC Susceptibility Map for the Type 316L Stainless Steel (Number in Parenthesis States Number of Specimens Cracked/Total Number of Specimens Tested)**

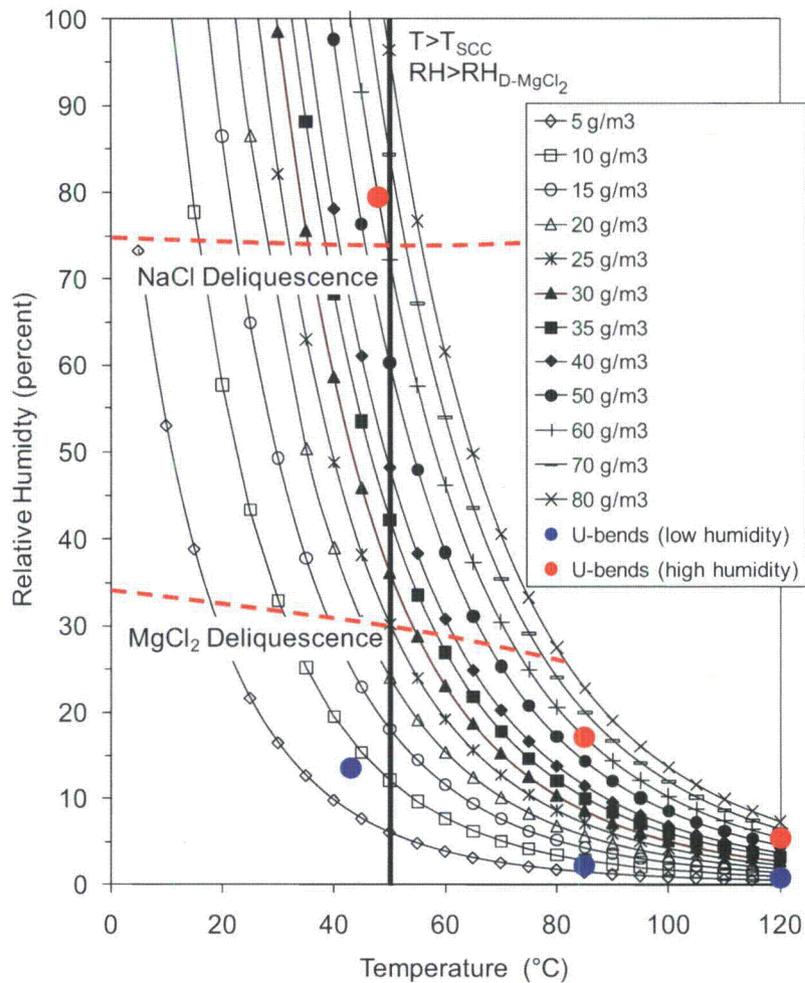
**Figure 43 Evolution of the Relative Humidity as a Function of Temperature Computed for Various Absolute Humidity Values. The Region Between the Red (Maximum Humidity) and Blue (Minimum Humidity) Symbols Indicate the Expected Environmental Conditions Near the U-Bend Surface in the Salt Fog Test**

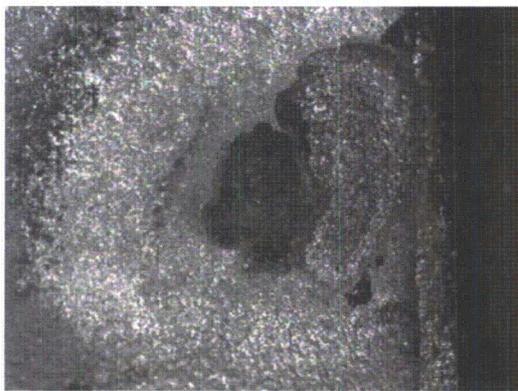
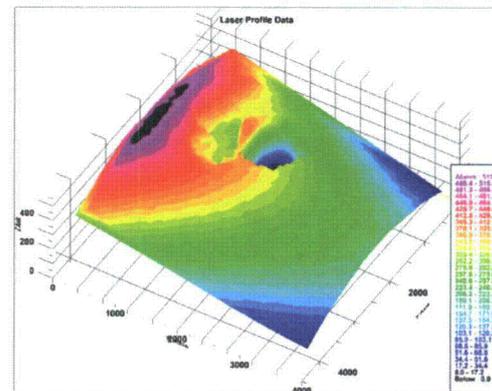
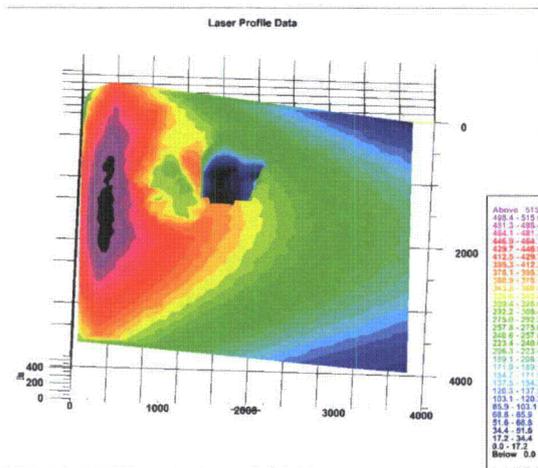
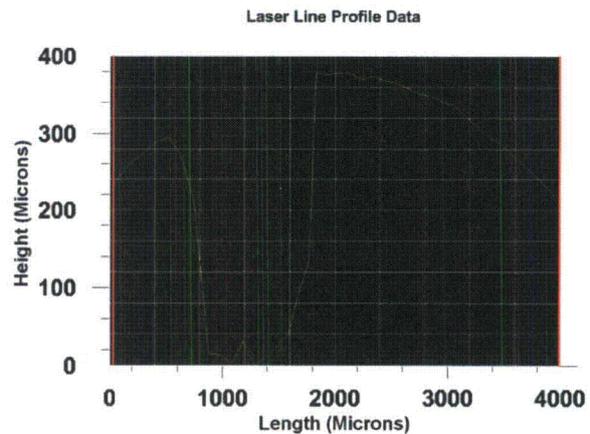
**Figure 45** Laser Profilometer Data Evaluating Depth of Pitting on a 304 Stainless Steel Half U-Bend Sample Exposed to 2-Month at 65 °C [149 °F] and 70 Percent Relative Humidity

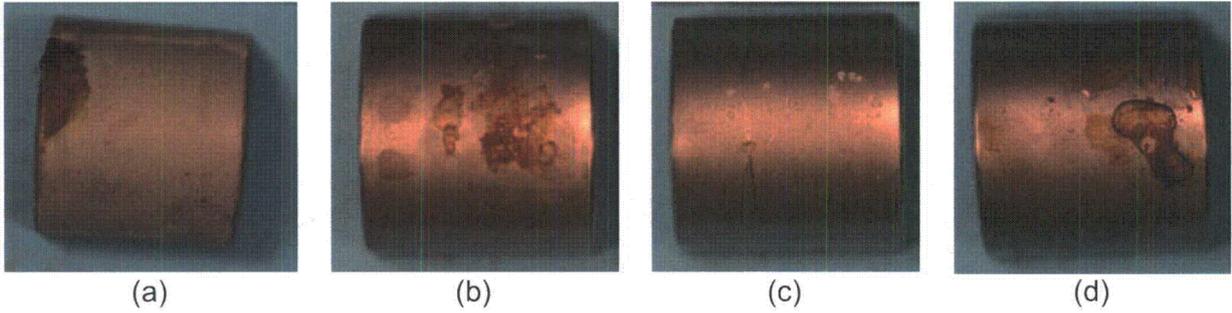
**Figure 46** Typical Surface Appearance (Before Cleaning) of the 304 Stainless Steel Half U-Bends Exposed to 50 °C [122 °F] and 65 Percent Relative Humidity for 2 Months:(a) Initial Salt Deposits on the Surface During the Salt Fog Test, (b) Simulated Sea Salt Droplets, (c) Sodium Chloride Droplets, and (d) Magnesium Chloride Droplets

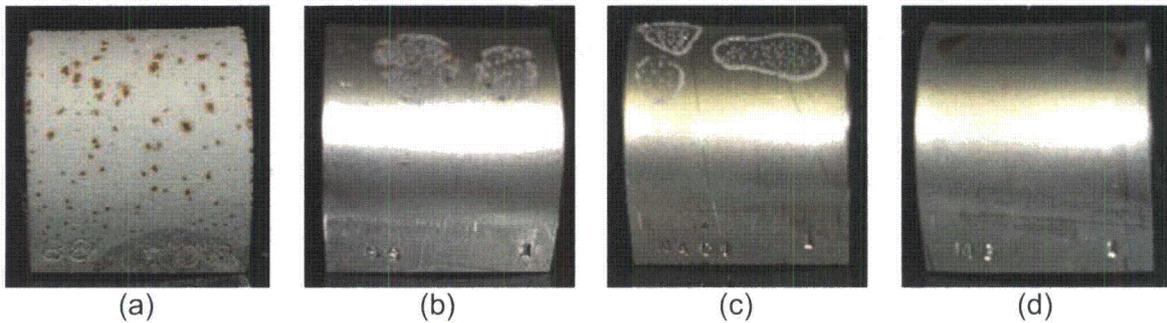
**Figure 47** Typical Surface Appearance (Before Cleaning) of the 304 Stainless Steel Half U-Bends Exposed to 50 °C [122 °F] and 40 Percent Relative Humidity for 2 Months:(a) Initial Salt Deposits on the Surface During the Salt Fog Test, (b) Simulated Sea Salt Droplets, (c) Sodium Chloride Droplets, and (d) Magnesium Chloride Droplets

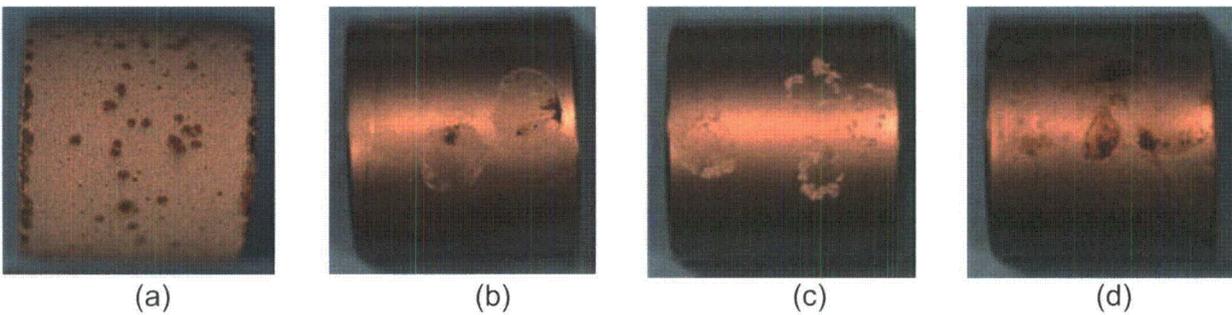
**Figure 48** Typical Surface Appearance (Before Cleaning) of the 304 Stainless Steel Half U-Bends Exposed to 50 °C [122 °F] and 50 Percent Relative Humidity for 2 Months:(a) Initial Salt Deposits on the Surface During the Salt Fog Test, (b) Simulated Sea Salt Droplets, (c) Sodium Chloride Droplets, and (d) Magnesium Chloride Droplets

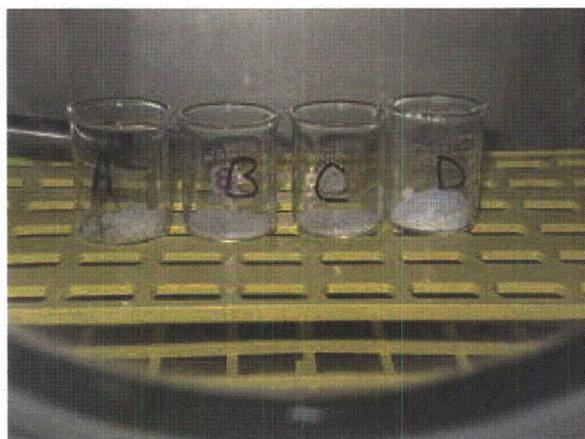
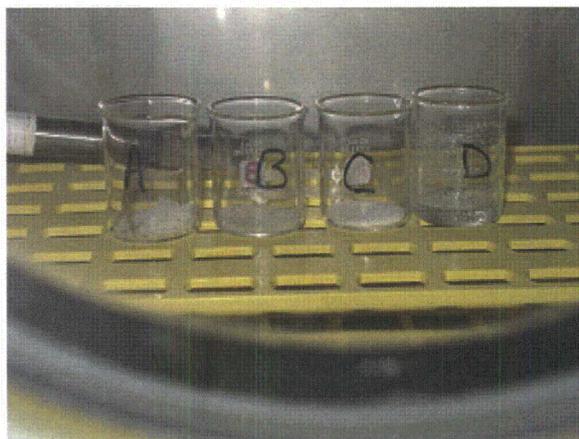
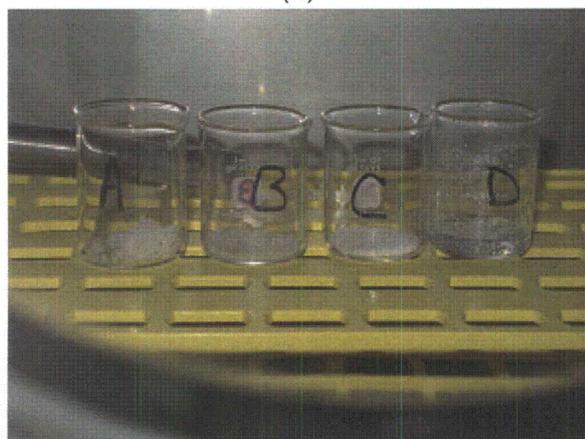
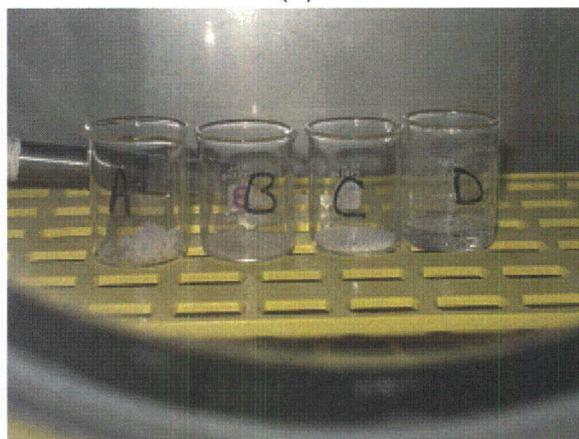
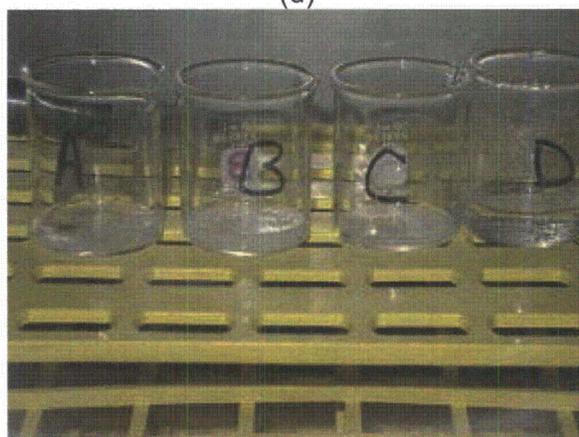
**Figure 49** Deliquescence Experiments Conducted at 50 °C [122 °F] and Relative Humidity of a) 20 Percent, b) 35 Percent, c) 45 Percent, d) 55 Percent, e) 65 Percent, and f) 75 Percent. The Salt Sample Labels are: (A) Corpus Christi Salt, (B) Simulated Sea Salt, (C) Sodium Chloride, and (D) Magnesium Chloride

Simulated sea salt, magnesium chloride, sodium chloride, and a sample of Corpus Christi salt were placed in a humidity chamber at 50 °C [122 °F] (Figure 49). Visual examination revealed that at 20 percent relative humidity, all four salts appeared dry. Once the relative humidity was increased to 35 percent, the magnesium chloride salt deliquesced as expected. On the other hand, the simulated sea salt and Corpus Christi salt appeared to absorb water from the environment, causing a light darkening of the salts. Afterwards, no significant changes took place until the relative humidity reached 75 percent, at which point the simulated sea salt, Corpus Christi salt, and sodium chloride deliquesced.

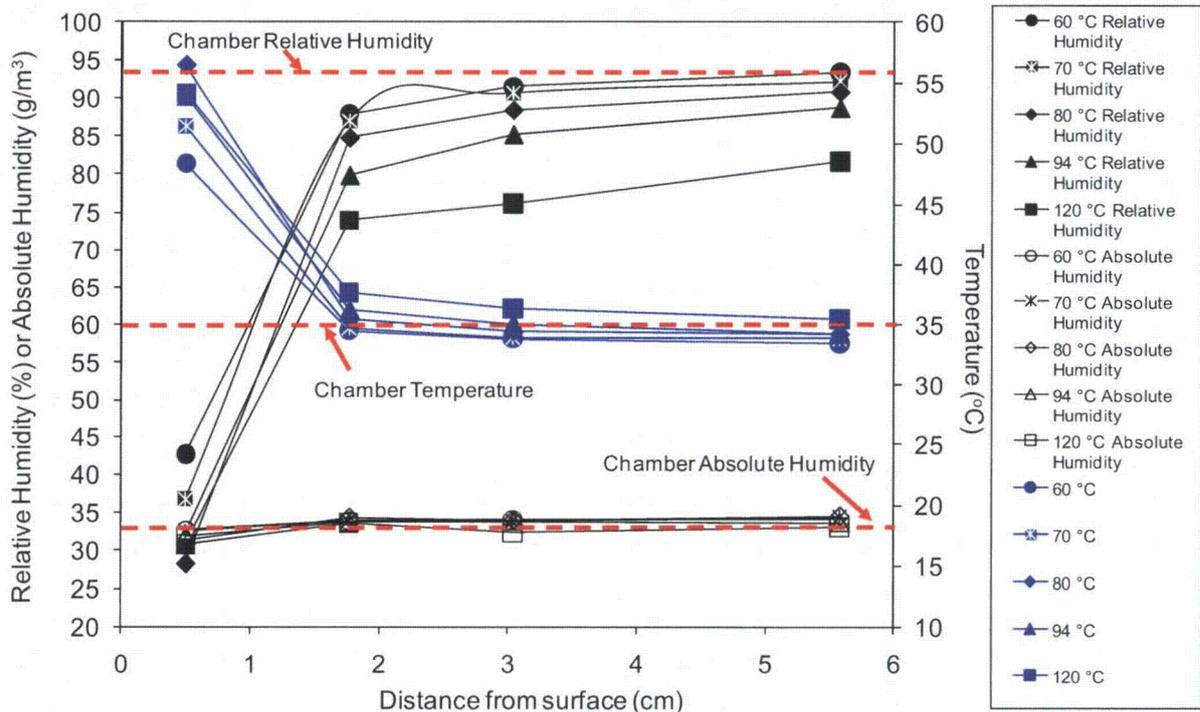
**Figure 50** Temperature, Absolute Humidity, and Relative Humidity Profiles as a Function of Distance from the U-Bend Samples Heated at Different Temperatures
