Asphalt Emulsion Sealing of Uranium Mill Tailings 1980 Annual Report

May 1981

Pacific Northwest Laboratory
Operated for the U.S. Department of Energy
by Battelle Memorial Institute

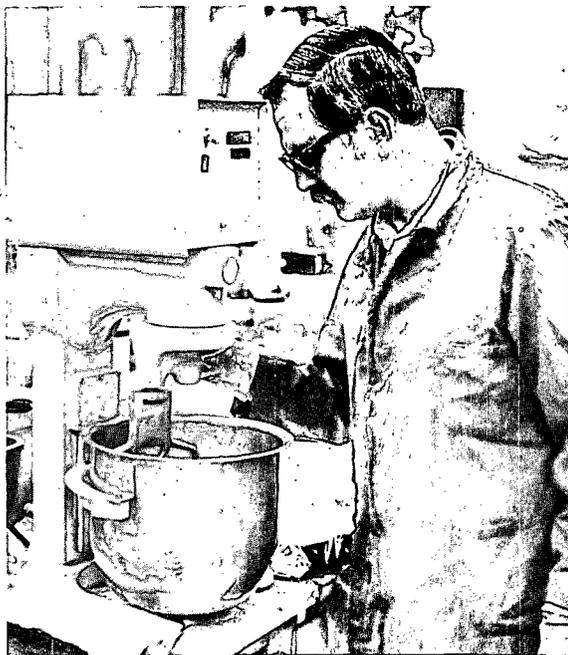
FIGURE 5. Laboratory Mixer Used to Prepare Admix

- 1) The selected seal aggregate was dried and weighed. Water was added to bring aggregate moisture to an optimum moisture content (Hartley et al. 1980) and mixed with aggregate for 2 to 5 min in a laboratory mixer (Soil Test Model C110) (see Figure 5). Asphalt emulsion necessary to obtain the specified residual asphalt was then added and mixed for 30 s at the lowest speed. All ingredients were at ambient temperature unless temperature was a specific variable.

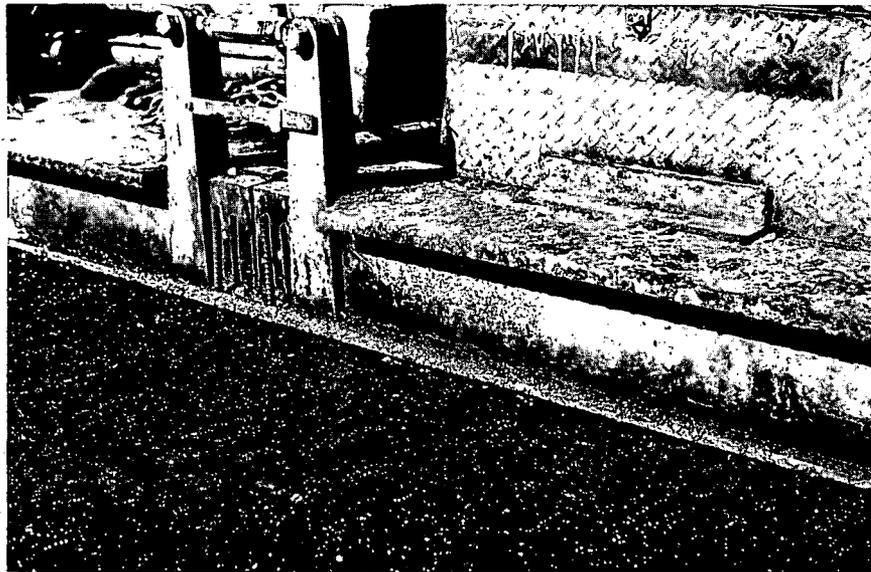
FIGURE 17. Cold-mix Paver Laydown Screed

mixed with the aggregate by the pugmill paddles. The admixture product exits out the back of the machine where augers spread it the width of the laydown screed (Figure 17). The height of this hydraulically controlled screed determines the depth of the admix seal.

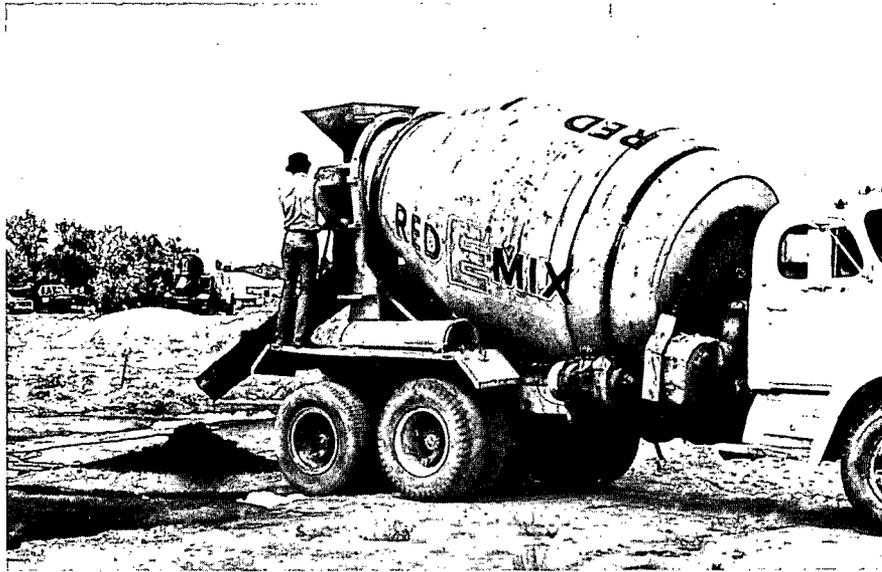
FIGURE 21. Transit Mixer

Use of a transit mix truck capable of mixing and transporting concrete was considered to mix high concentrations of asphalt emulsion and concrete sand. The mixture would be dumped from the transit mixer into a paver for seal application. The transit mixer shown in Figure 21 consists of a truck with a large drum and drum-drive system mounted on the rear. The drum has vanes mounted on the inside which can transport the mixed material to the bottom or top of the drum depending on the direction of drum rotation. The drum is capable of turning during transit or while stationary.

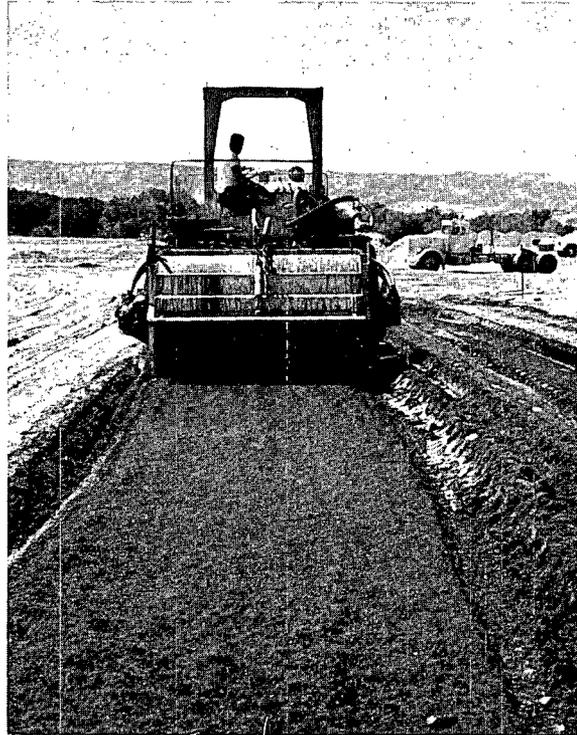
FIGURE 31. Application of 22 wt% Residual Asphalt to Grand Junction Tailings

The first seal application technique involved applying the ~22 residual wt% asphalt all in one pass. First, the soil stabilizer was run through the test area to mix the water and tailings uniformly. The distributor truck was hooked up to the soil stabilizer, and the asphalt emulsion was applied (see

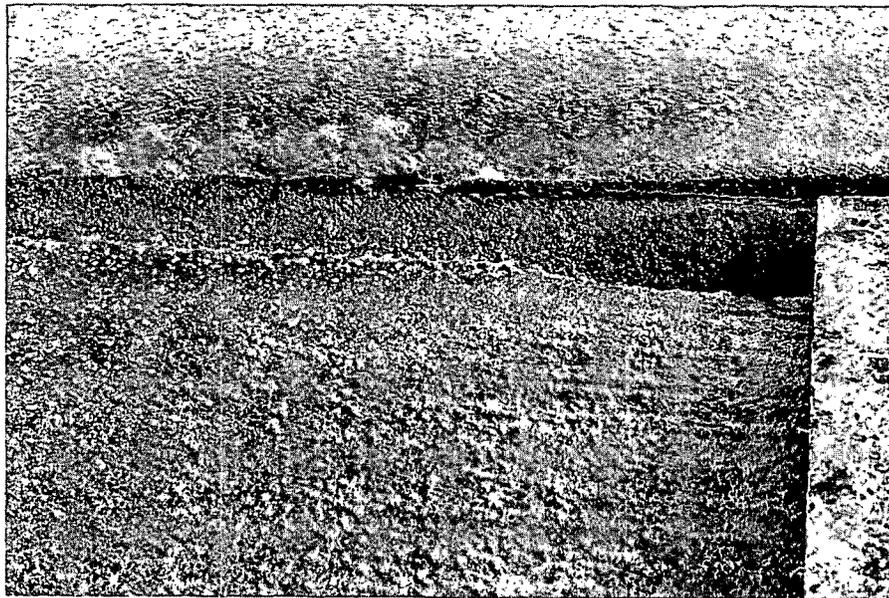
FIGURE 36. Admix Rapidly Seals Over Joint Immediately Behind Slip Form Screed

The +70 to +80 mV CMS-1 asphalt emulsion made up a desirable admix seal. The admix produced in the cold-mix paver pugmill was viscous, somewhat more fluid than molasses. It spread evenly underneath the screed and provided smoothly lapped joints (see Figure 36). The admix set-up approximately 9 m (30 ft) behind the cold-mix paver, slumping from its paved dimensions about 10%; a 3-m wide by 10-cm deep (3-ft by 4-in.) seal laid by the cold-mix paver

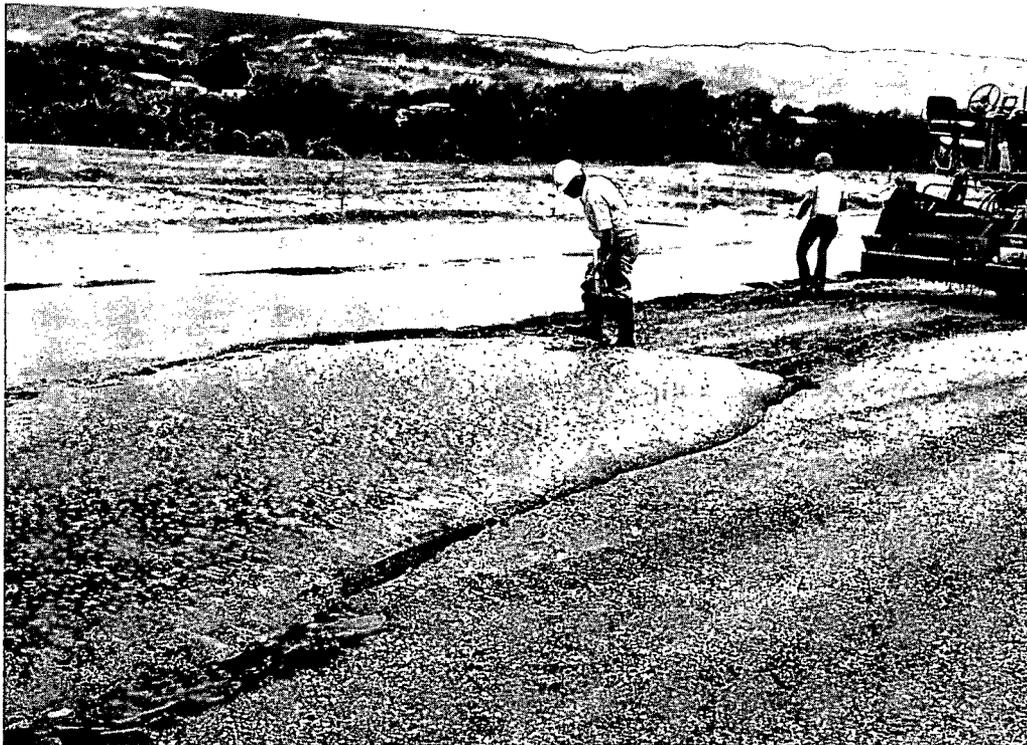
FIGURE 37. Typical Admix Slumping Encountered in Seal Application

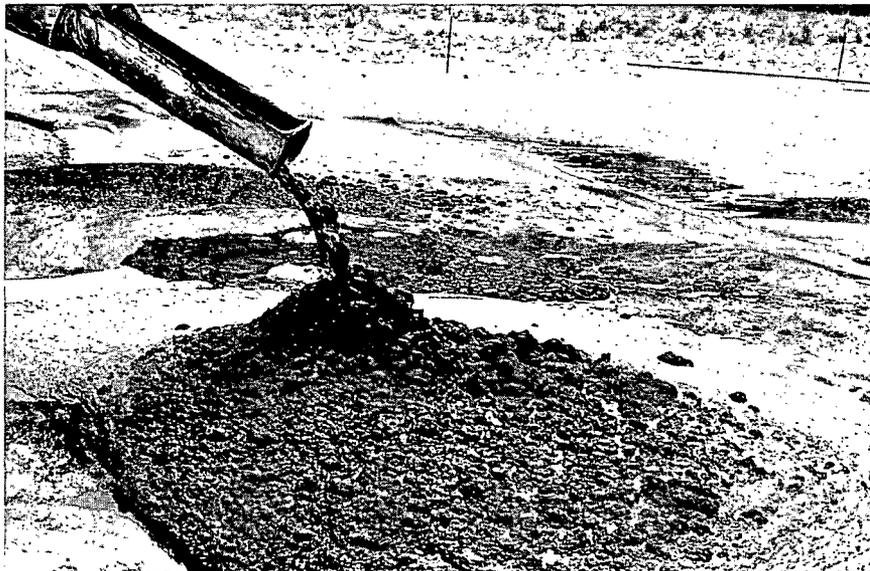
FIGURE 39. Transit Mixer Unloading Admix

In the third test, Armak 4868 emulsion (+18 mV) was used to slow down the setting time which would increase admixture fluidity. Forty-five liters of H₂O, 567 L of Armak 4868 emulsion, and 0.9 t concrete sand were mixed for 10 min. Again during mixing, the admixture appeared as many laboratory 4868 admixtures, but upon reversing the drum direction for offloading, separation occurred which resulted in the water phase dumping followed by large lumps of admixture.
