Asphalt Emulsion Sealing of Uranium Mill Tailings 1980 Annual Report

May 1981

ASPHALT EMULSION SEALING OF
URANIUM MILL TAILINGS
1980 ANNUAL REPORT

Pacific Northwest Laboratory
Richland, Washington 99352

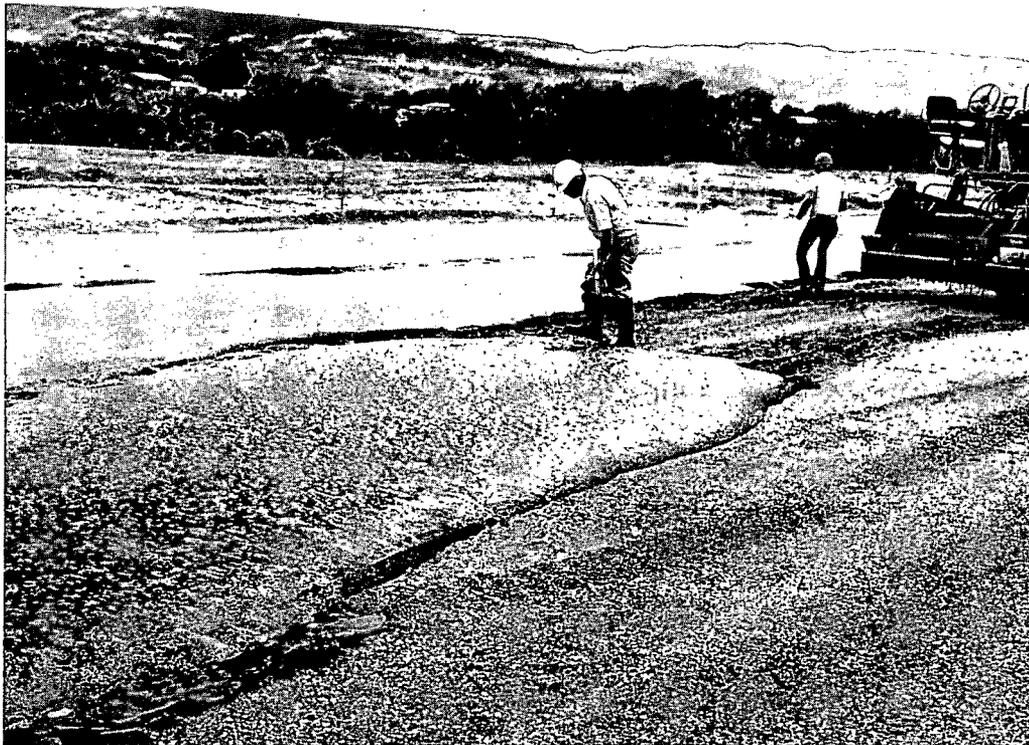
FIGURE 37. Typical Admix Slumping Encountered in Seal Application
