RECONNAISSANCE OF THE DRAPER HEIGHTS LANDSLIDE AND OTHER POSSIBLE EARTH- QUAKE-INDUCED, SHALLOW, DISRUPTED SOIL AND ROCK SLIDES IN DRAPER, UTAH

OPEN-FILE REPORT 519
UTAH GEOLOGICAL SURVEY
a division of
Utah Department of Natural Resources
2008

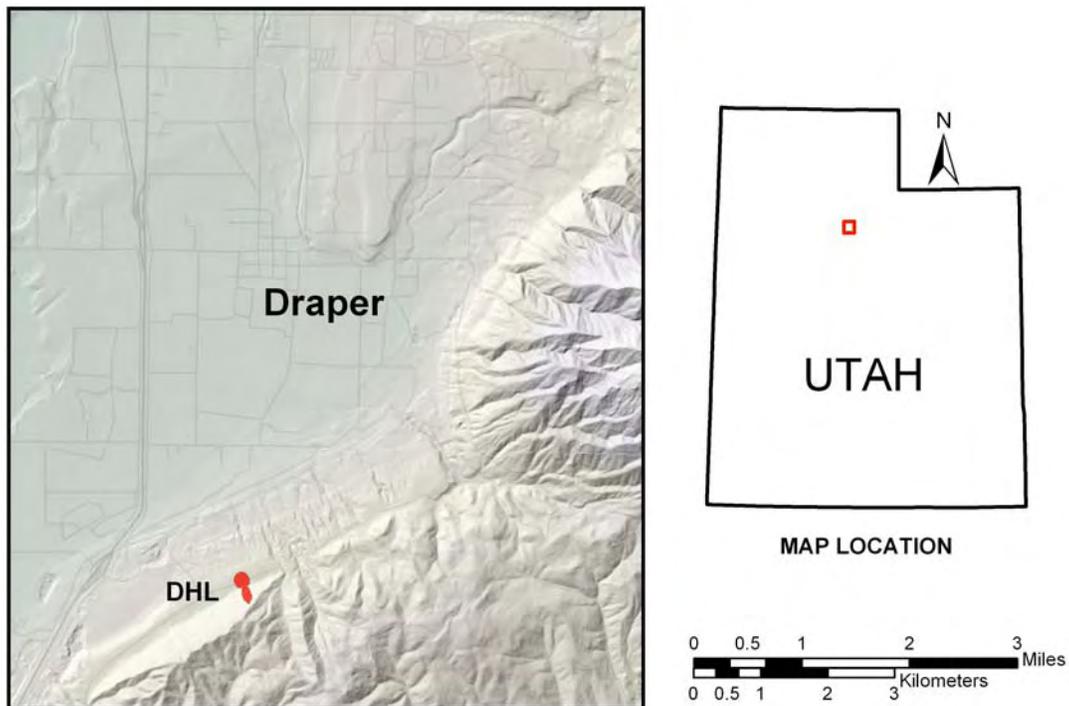
Figure 1. Location of the Draper Heights landslide (DHL) and Steep Mountain.

Steep Mountain (figures 1 and 2) is an area previously recognized as having the potential for shallow, earthquake-induced landslides (Keaton and others, 1987), but to date, prehistoric earthquake-induced landslides have not been identified in the area. The one mapped landslide (Van Horn, 1975; Biek, 2005b) in the northwest slope of the mountain, referred to herein as the Draper Heights landslide (figure 1), is a shallow, disrupted soil slide and thus, the type most likely to be caused by an earthquake.

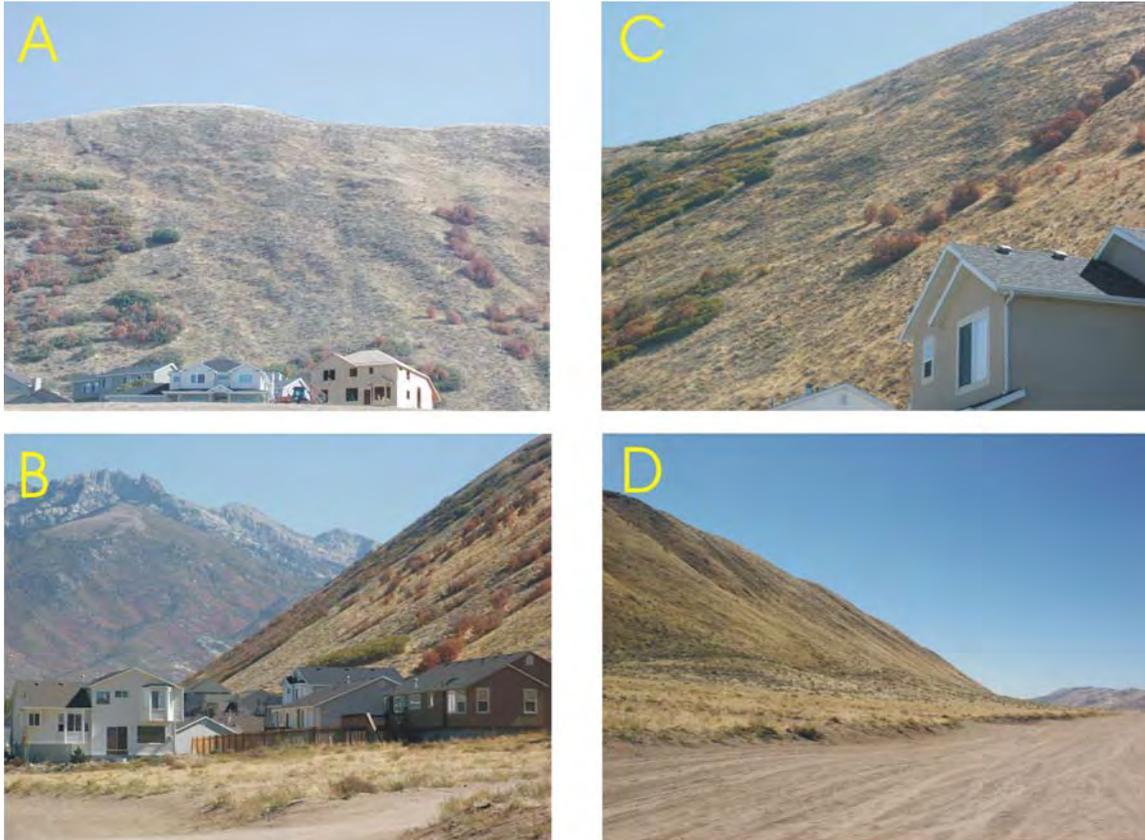
Figure 2. Residential development along the base of Steep Mountain. Keaton and others (1987) mapped a high earthquake-induced landslide potential in the northwest slope prior to any development at the base of the mountain. (A) View of houses at the base of the northwest-facing slope in an area characterized by hummocks, and wavy ridges and swales. Biek (2005a, 2005b) interpreted the latter as evidence of creep (the extremely slow downslope movement) of variably thick colluvium on the slope. These areas may be near the threshold of failure and also extremely vulnerable to earthquake-induced landsliding. (B) View showing the proximity of houses to the northwest slope of Steep Mountain. Average slope is about 66 percent. (C) Detail showing proximity of houses to an area characterized by hummocks. Setback of houses from base of slope is inadequate to protect them from landsliding of the scale of the Draper Heights landslide. (D) View of the undeveloped western part of the Steep Mountain area showing the land that was (in the developed eastern part of Steep Mountain) available for building setback to reduce the risk from earthquake-induced landsliding.

Steep Mountain is an east-northeast trending ridge that reaches a maximum elevation of about 6180 feet (1884 m) in the southern part of the Salt Lake City metropolitan area. The local relief between a prominent bench underlain by Bonneville shoreline deposits and the ridge crest reaches a maximum of about 1020 feet (311 m) and the average slope is relatively uniform, ranging between about 65 and 67 percent (33° to 34°). Recent residential development has occurred at the base of the eastern part of the mountain (figure 2) despite the vulnerability to landsliding.

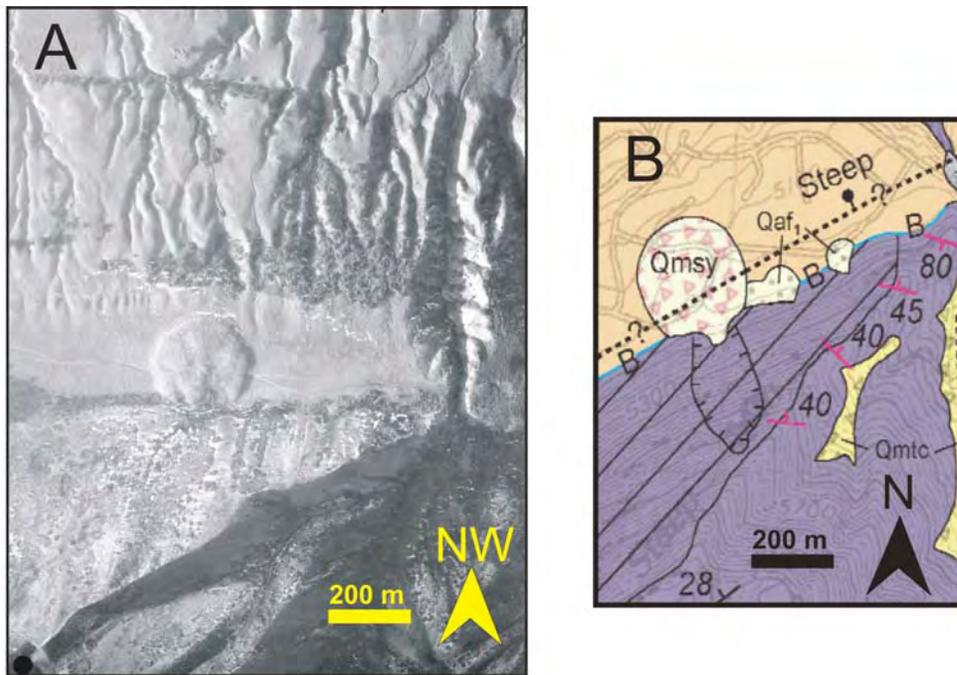
Figure 3. Aerial photograph (A) and geologic map (B) of the Draper Heights landslide (Qmsy). Aerial photograph taken prior to residential development along the base of Steep Mountain. Geologic map from Biek (2005b); showing the Bonneville shoreline (letters "B").

The Draper Heights landslide is a shallow, disrupted, complex debris slide-flow near the east end of Steep Mountain (figure 3). The landslide consists of a nearly circular deposit at the base of the slope that overlies Lake Bonneville highstand shoreline sediments. The deposit is approximately 800 feet (240 m) in diameter and about 20 to 30 feet (6-9 m) thick near the base of the slope. The source area of the debris slide is a zone that locally exceeds 400 feet (120 m) wide and extends about 900 feet (270 m) to the south between the base of the slope and the ridgeline. The local relief upslope of the deposit is about 620 feet (190 m) or about 390 feet (120 m) less than the maximum local relief farther to the west. The average slope directly west of the slide is about 65 percent.

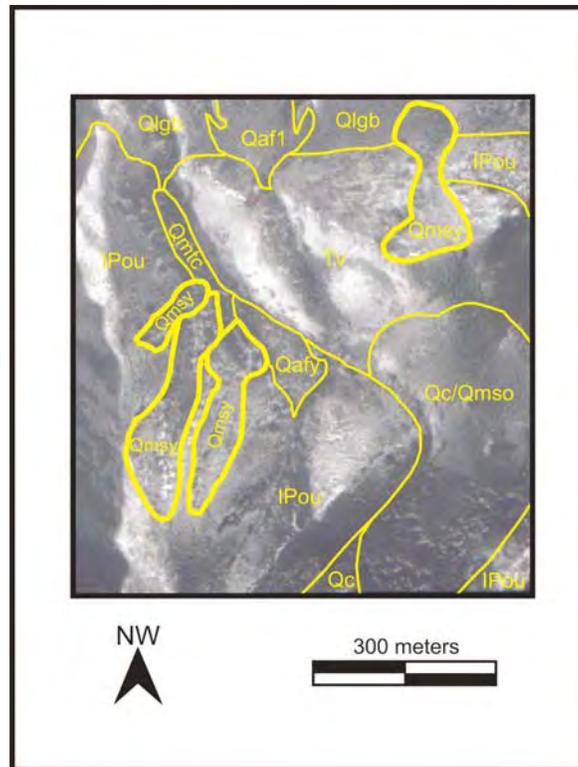
Figure 4. Map showing four possible shallow, disrupted landslides (*Qmsy*) defined by shallow, flat-bottomed scars and cone-shaped deposits. Three of the landslides are in colluvium underlain by Bingham Mine Formation orthoquartzite. The fourth is underlain by both Tertiary volcanic rocks (*Tv*) and Bingham Mine Formation orthoquartzite (*IPou*). Draper Heights landslide is about 0.75 miles (1.2 km) west of these landslides.

Three of the four scars occur in close proximity on slopes underlain by intensely fractured and faulted (as indicated by numerous slickensides) Bingham Mine Formation orthoquartzite (figure 4). The fourth is underlain by both Tertiary volcanic rocks and Bingham Mine Formation orthoquartzite. The scars are characteristically flat-bottomed and differ significantly from nearby V-shaped drainages formed by fluvial erosion that

have alluvial fans at their base. The scars are occupied by short oak trees. The upslope part of each of the scars is characterized by an abrupt, step-like, downslope-facing scarp that suggests a landslide origin. At the base of the easternmost scar, a cone-shaped deposit has a local slope of 25°. None of the deposits below the scars are incised by drainages, in contrast to the incised alluvial fan at the base of the V-shaped drainage directly to the east.

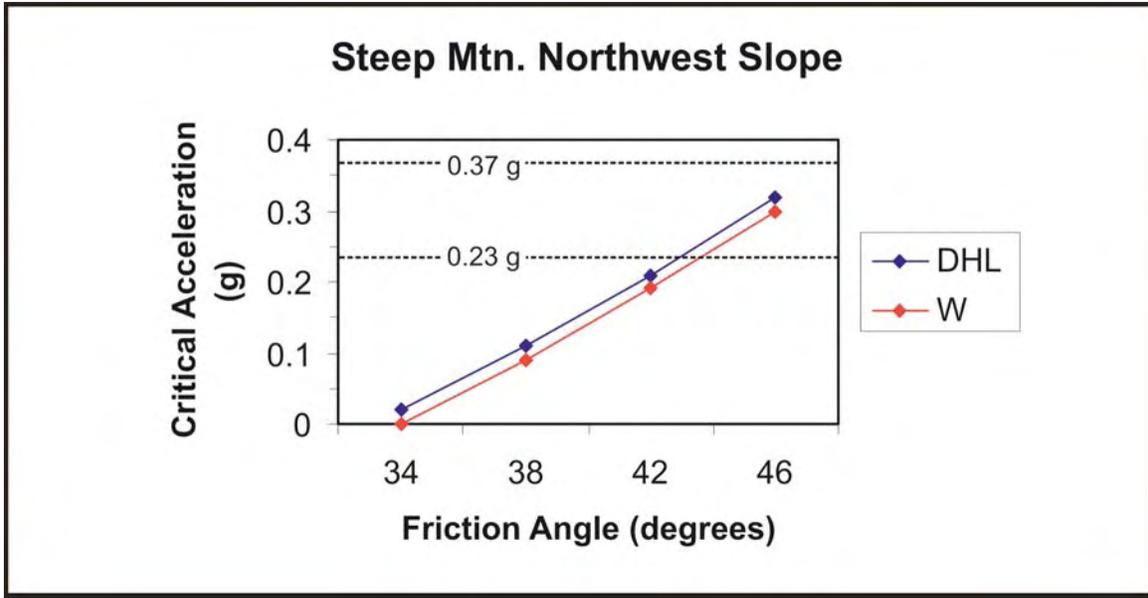
Figure 5. Back-calculated critical accelerations for the northwest slope of Steep Mountain. Range in friction angle is estimated for cohesionless colluvium and intensely fractured Bingham Mine Formation orthoquartzite. Lower bound friction angle (34°) is minimum required for dry slope to remain stable. Most of the back-calculated critical accelerations are below the peak acceleration with a 10 percent probability of exceedance in 50 years (0.23 g) based on site class B conditions (Frankel and others, 1996). All back-calculated critical accelerations are below the peak acceleration with a 5 percent probability of exceedance in 50 years (0.37 g) based on site class B conditions (Frankel and others, 1996). Two profiles used for back-calculations: DHL - profile near Draper Heights landslide and W - profile in steepest part of slope west of slide.

Figure 5 shows that, depending on the actual friction angle of the slope material assuming dry conditions, a potential for earthquake-induced landslides exists for ground motions with less than the 5 percent in 50-year exceedance probability. If the friction angle is 42° or less, then earthquake-induced landslides are possible for ground accelerations less than the 10 percent in 50-year exceedance probability. Thus, the ground motions capable of triggering shallow, disrupted landslides in the northwest slope of Steep Mountain have a return period of less than 1,000 years and likely less than 500 years.
