Crystal River Unit # 3

Containment Delamination

Nikki Gilanshahi
Structural Engineer
NRO/DE/SEB2
1/7/2010

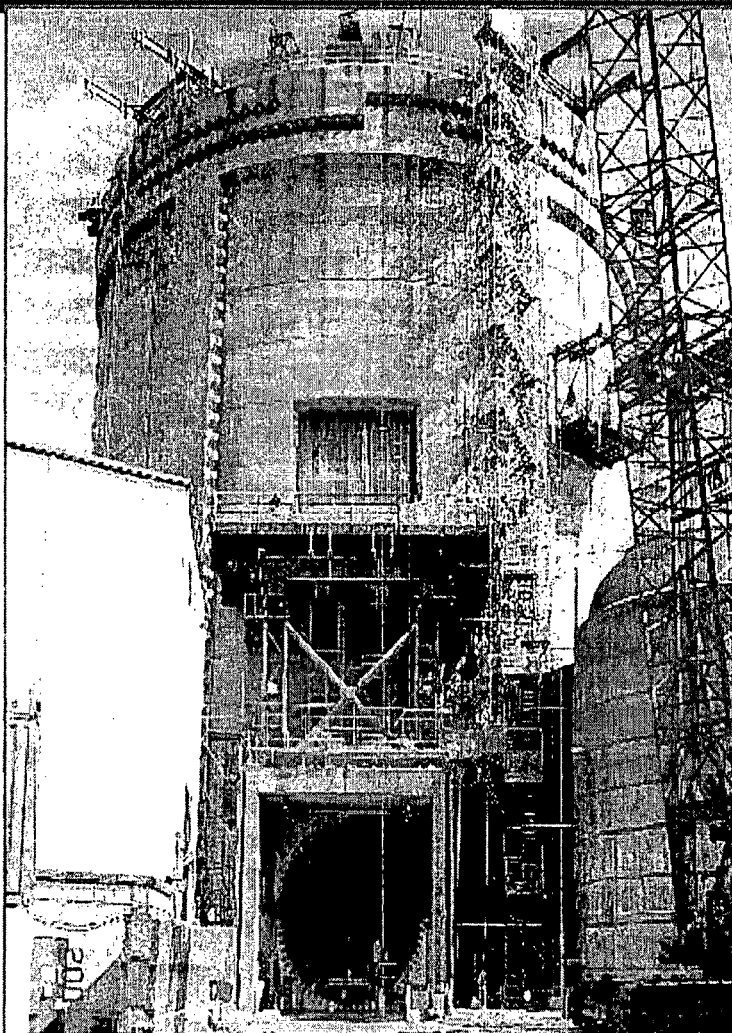
Steam Generator Replacement (SGR) Opening (between Buttresses 3 and 4)

SGR Opening Dimensions

@ Liner

23' 6" x 24' 9"

@ Concrete Opening

25' 0" x 27' 0"

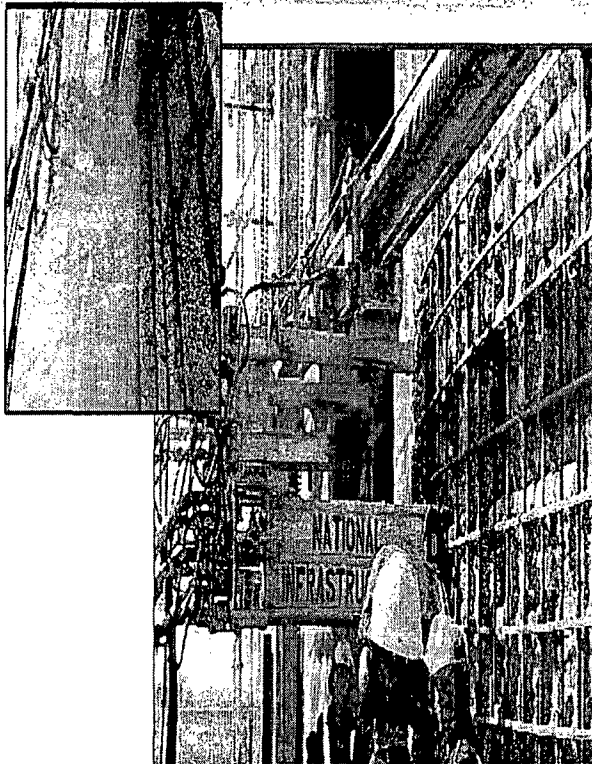
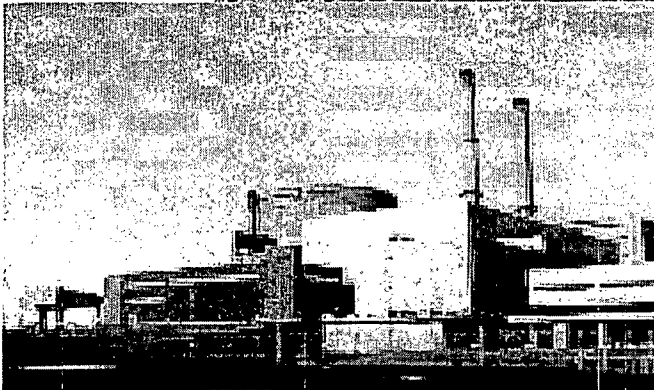
Concrete Removal

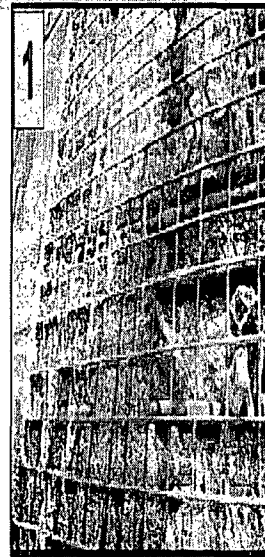
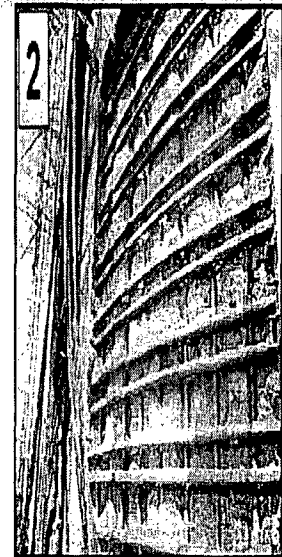
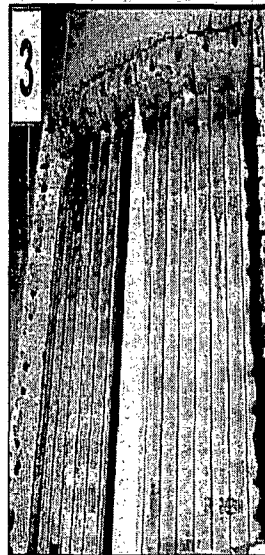
Concrete & Liner Removal Sequence

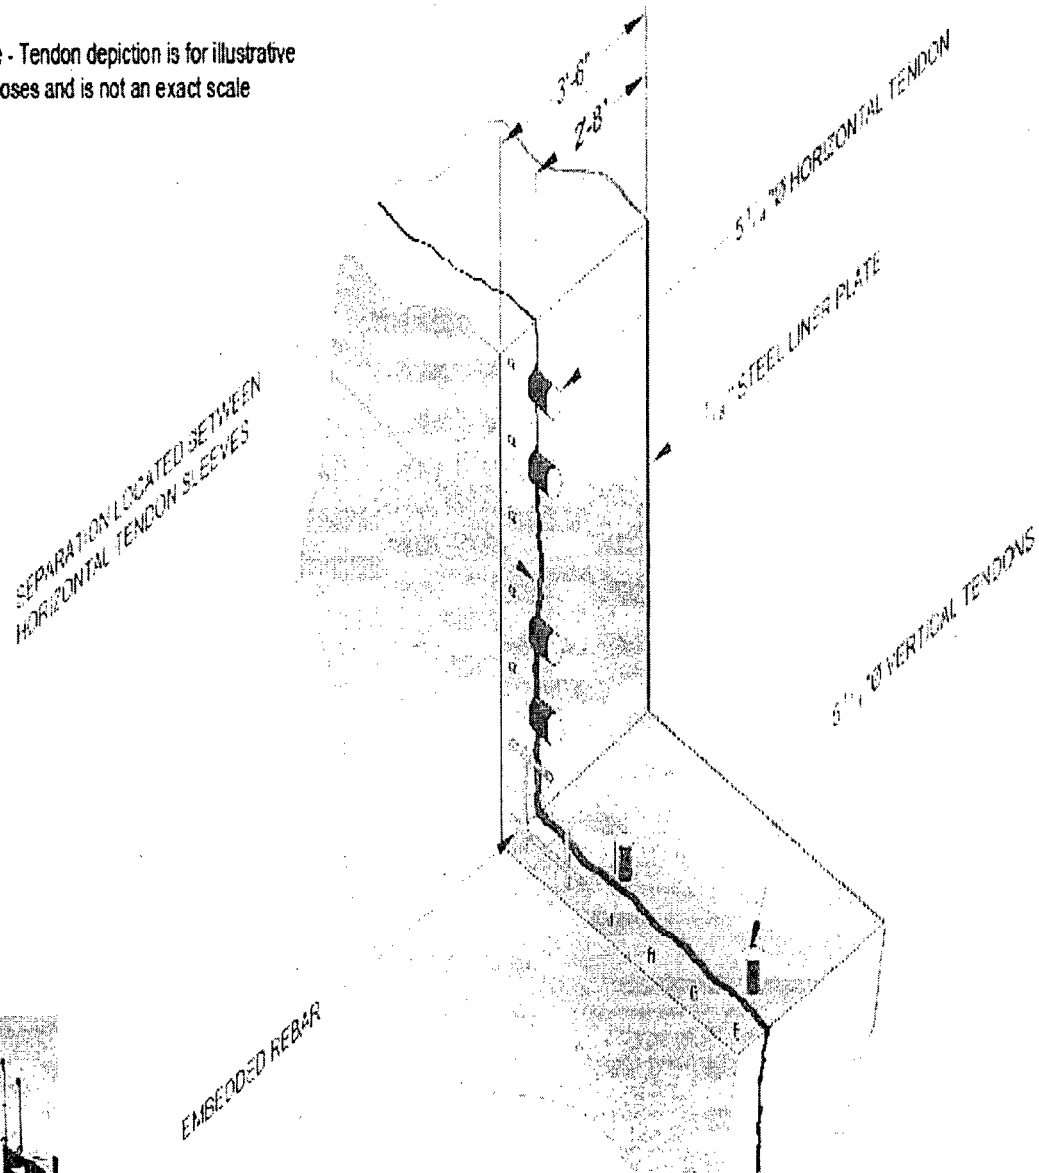
Location of the Delamination

Note - Tendon depiction is for illustrative purposes and is not an exact scale

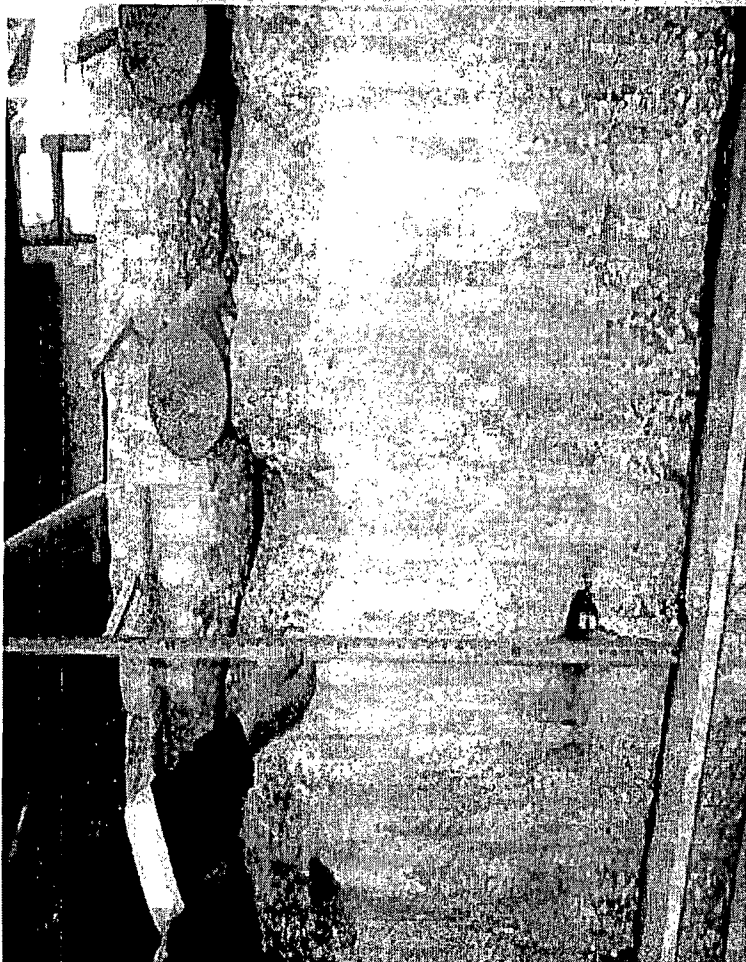
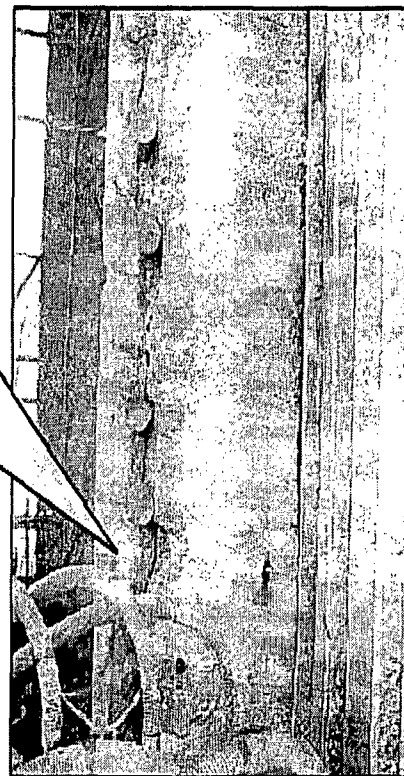
Delamination Close-up

Actual Delamination

Delamination Removal and Replacement.

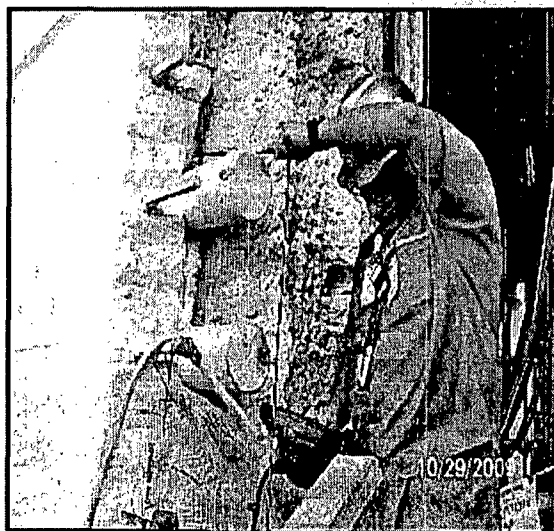
INVESTIGATION APPROACH

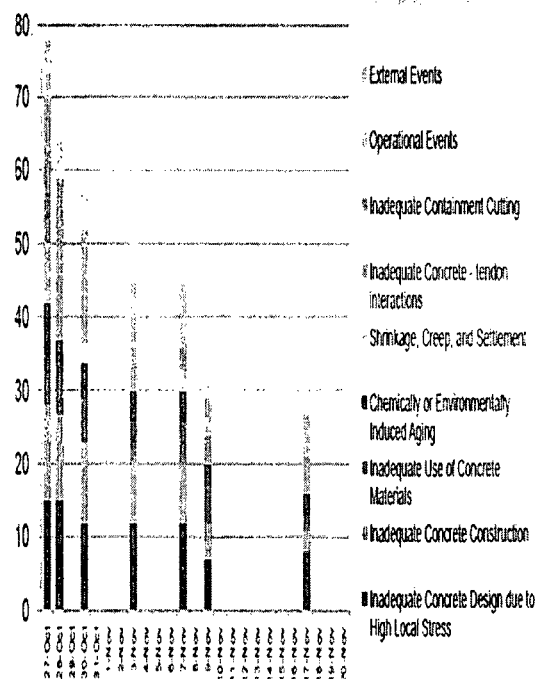
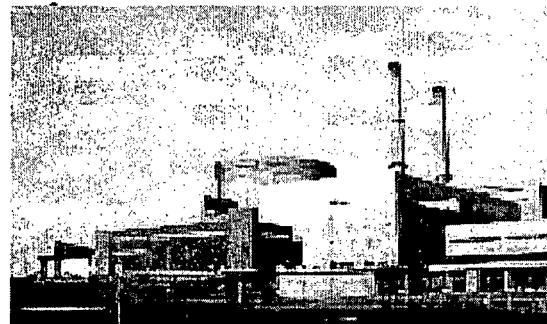
Root Cause Analysis – PII Metrics
Un-refuted Failure Modes as of Nov. 17th 2009

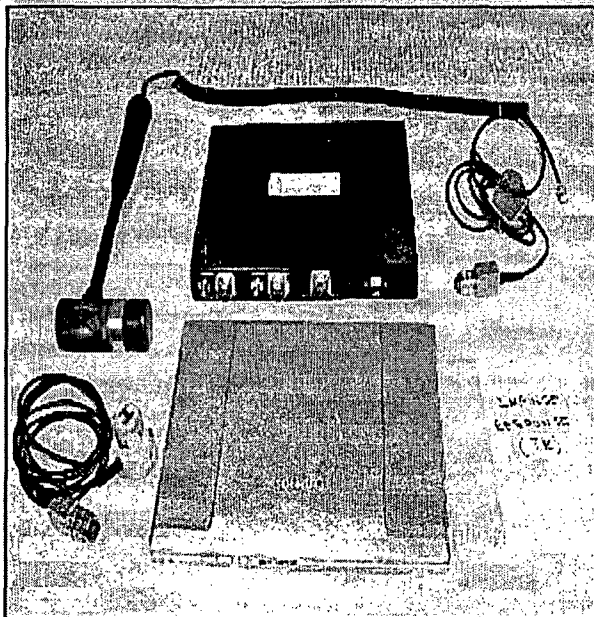
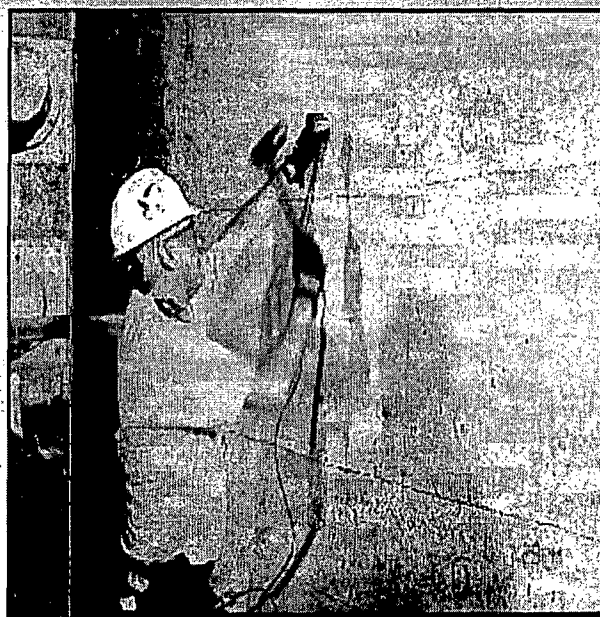
Condition Assessment Techniques *Impulse Response (IR)*

- IR Equipment
Primary test method used in this evaluation

- IR Performed in the Field

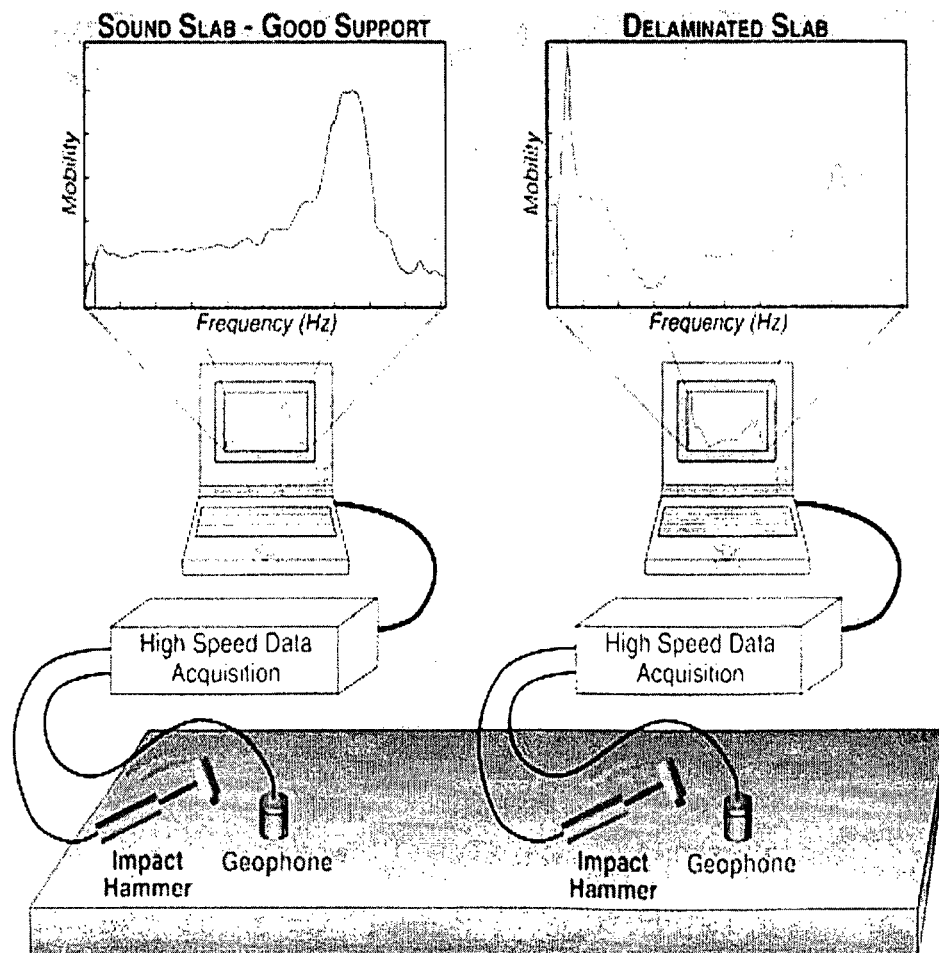
Impulse response (IR) method

- The Impulse Response method can be applied to a variety of situations that require rapid, accurate, and cost-effective nondestructive condition assessment. Which can be used to test relatively rough concrete surfaces; its fast output, Can detect the delamination of concrete & concrete around steel reinforcement, but, it dose not provide the depth of the delamination.

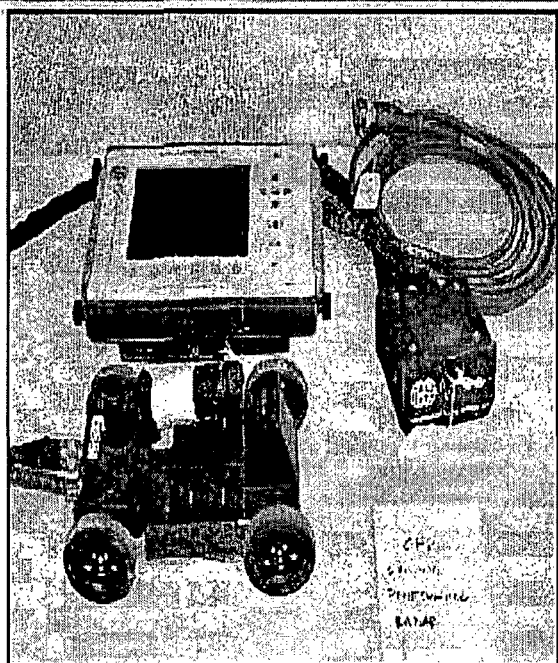
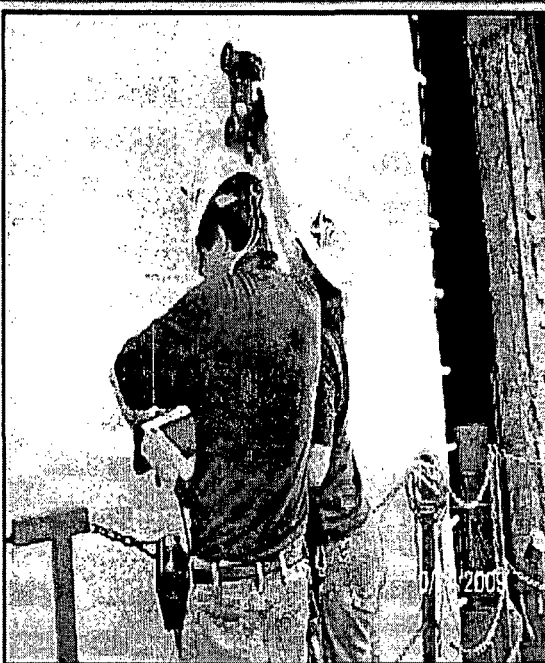
Ground Penetrating Radar (GPR)

Ground Penetrating Radar (GPR) Equipment

- Locates internal features (rebar, tendon conduits, etc.)

GPR Performed in the Field

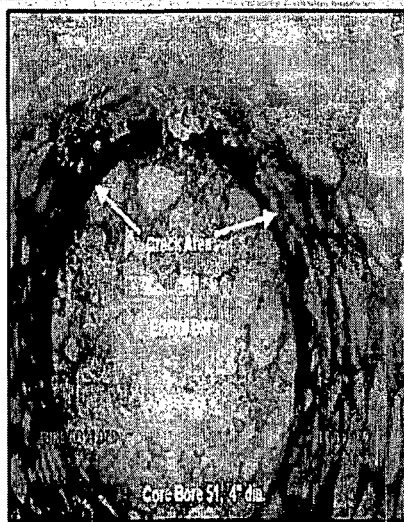
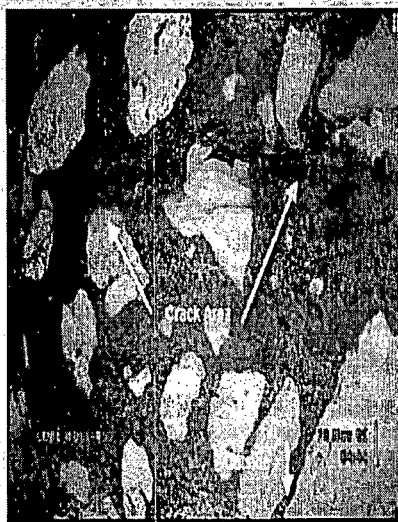
Condition Assessment Techniques Core Bores & Boroscopic Examination

Examination – Inward View

Examination – Side View

Core 51, Gap 1 Depth 5-1/4"

Gap 1 Width Less than 1/8"

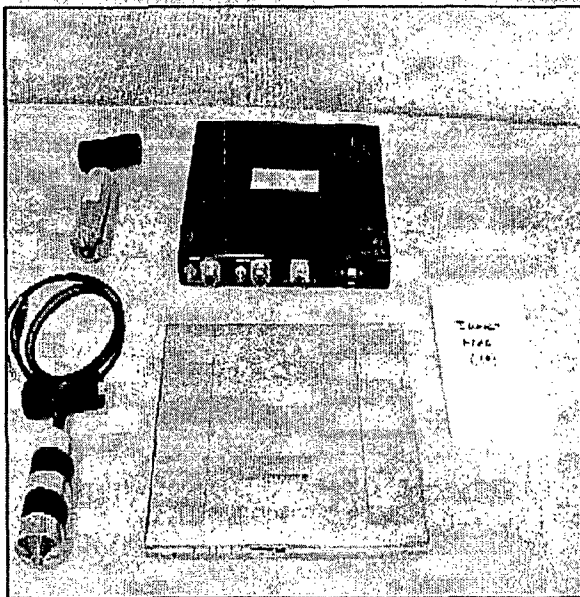
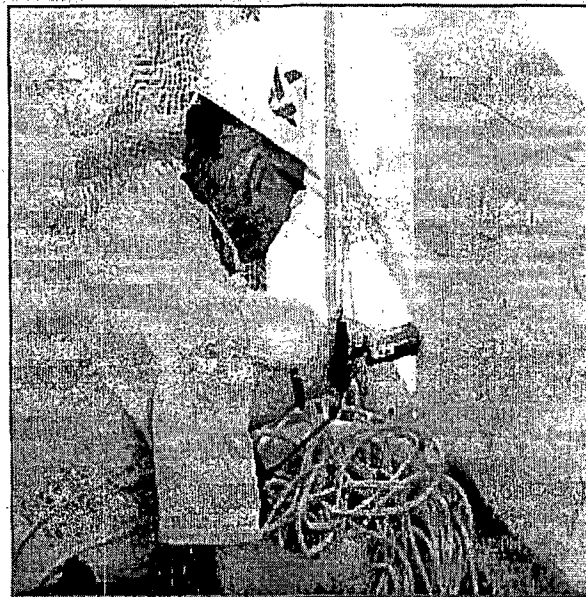
Impact Echo (IE)

- IE Equipment
 - Ability to determine depth of delamination

- IE Performed in the Field

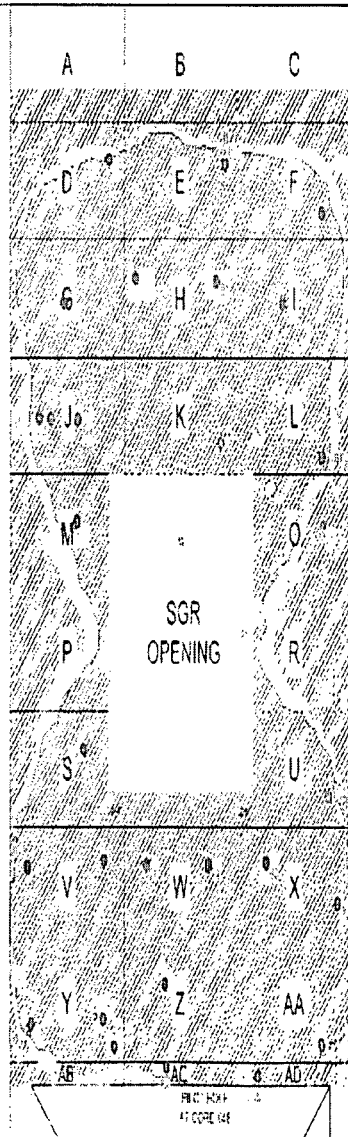
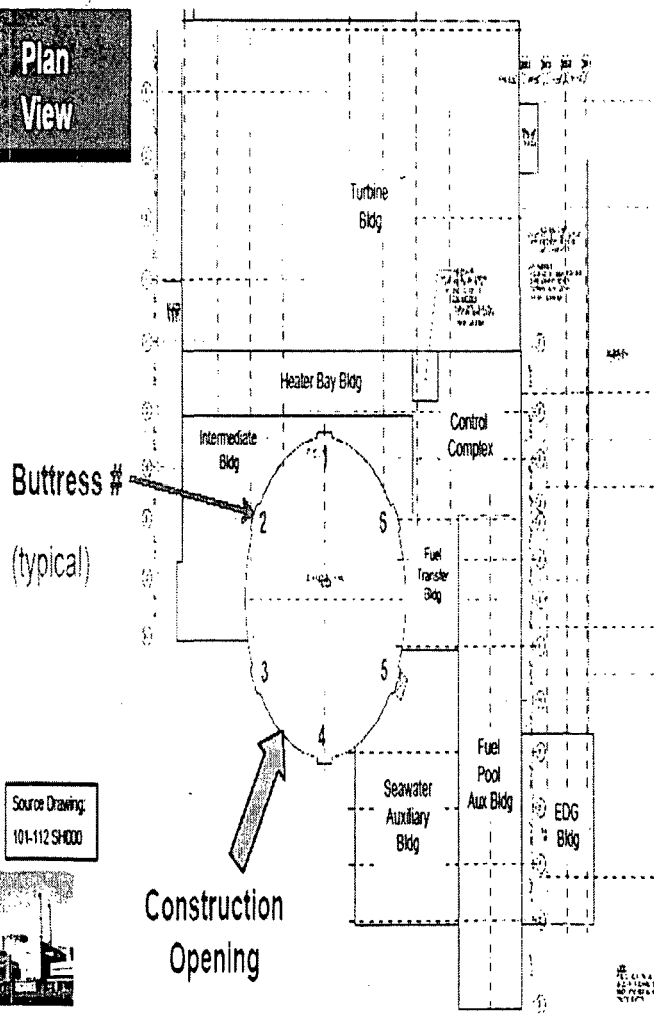
Source Drawing:
101-112 SH000

Delamination has only been observed in core bore holes (s) boroscopic exams in the buttress 3-4 span, as accurately predicated by IR

Red: Core bore with delamination Green :Core bore not delaminated

White: To be Core bored

Core Borings

CONCLUSION - Delamination has only been observed in core bore hole(s) boroscopic exams in the buttress 3-4 span, as accurately predicted by IR

Plan View
