Oconee Information for 10/01/2009 (Modify/Update)

Risk Significant / Emergent Activities:

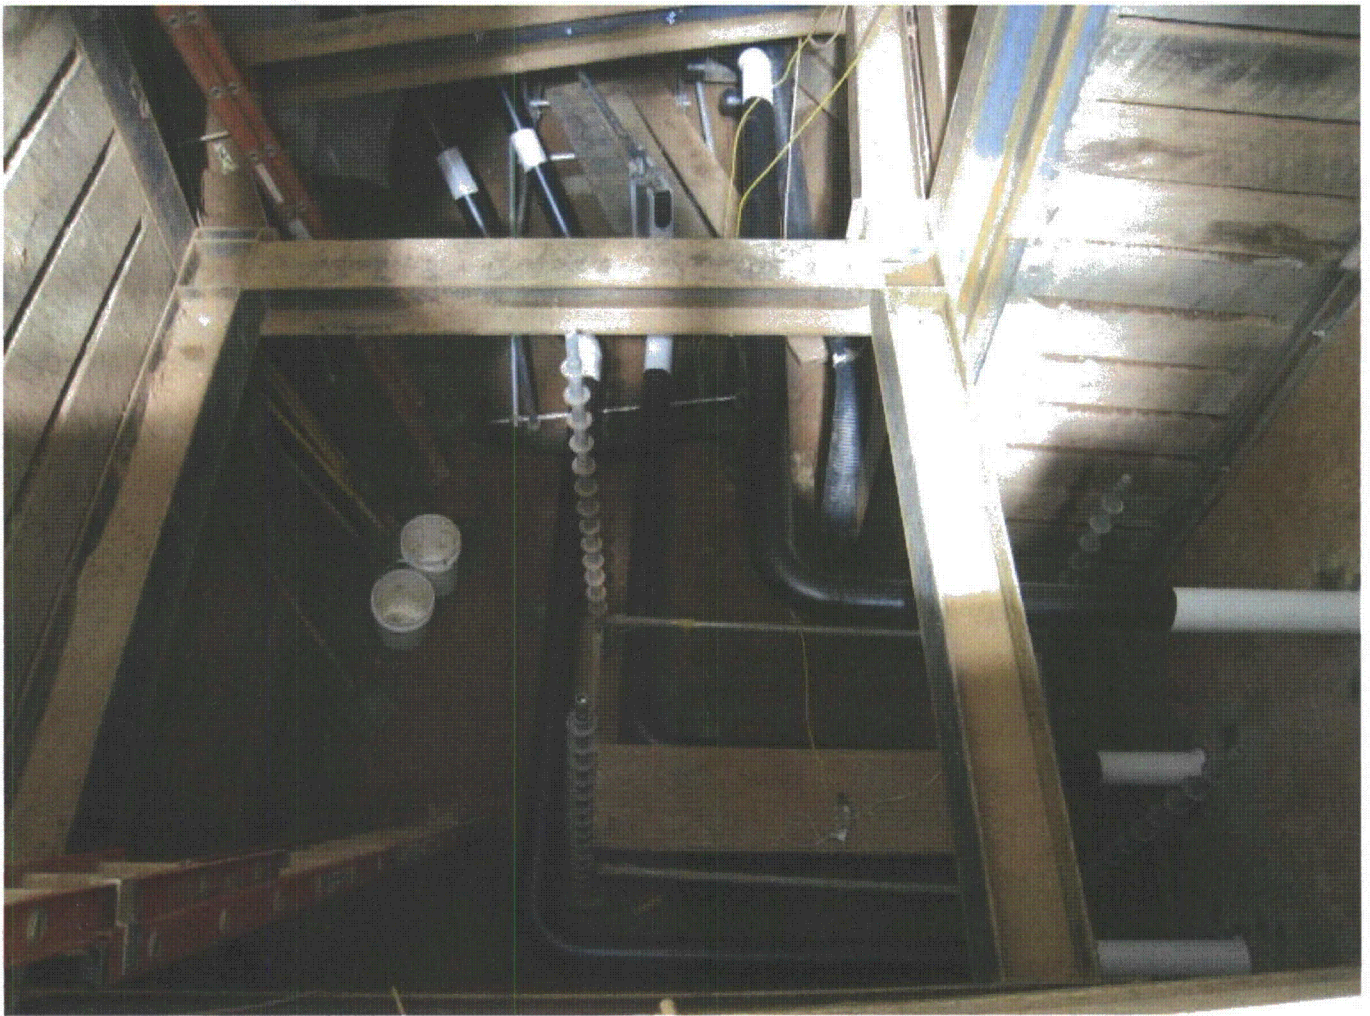
Unit 1 ASW Piping (Other 2 units are similar)

The tie-in work for the SSF ASW system has been completed for all three units (both inside and outside the SSF building). The hydrostatic test of the new piping has been completed successfully on Unit 1 and 2 piping with Unit 3 piping being aligned for testing this morning. Once the test is complete and results deemed acceptable, the asw functional test will commence. Currently all three headers are AVAILABLE and OPERABILILTY will be assessed when the functional test is performed. The old piping has been capped on both ends and will be left in-place. RI's have followed the repair / replacement work activities including the execution of the critical activity plan, protection of other plant equipment as required, application of the external coating on the buried sections of piping and testing of the system following repairs. The photos show the as-left configuration of the ASW piping inside the building (the new line and abandoned old line) as well as the piping that will be buried in its coated state.
