**ADDENDUM 3.4-A**  
**WETLANDS DELINEATION**

# **JURISDICTIONAL WETLANDS DELINEATION FOR THE PROPOSED ROSS ISR PROJECT, OSHOTO, WYOMING**

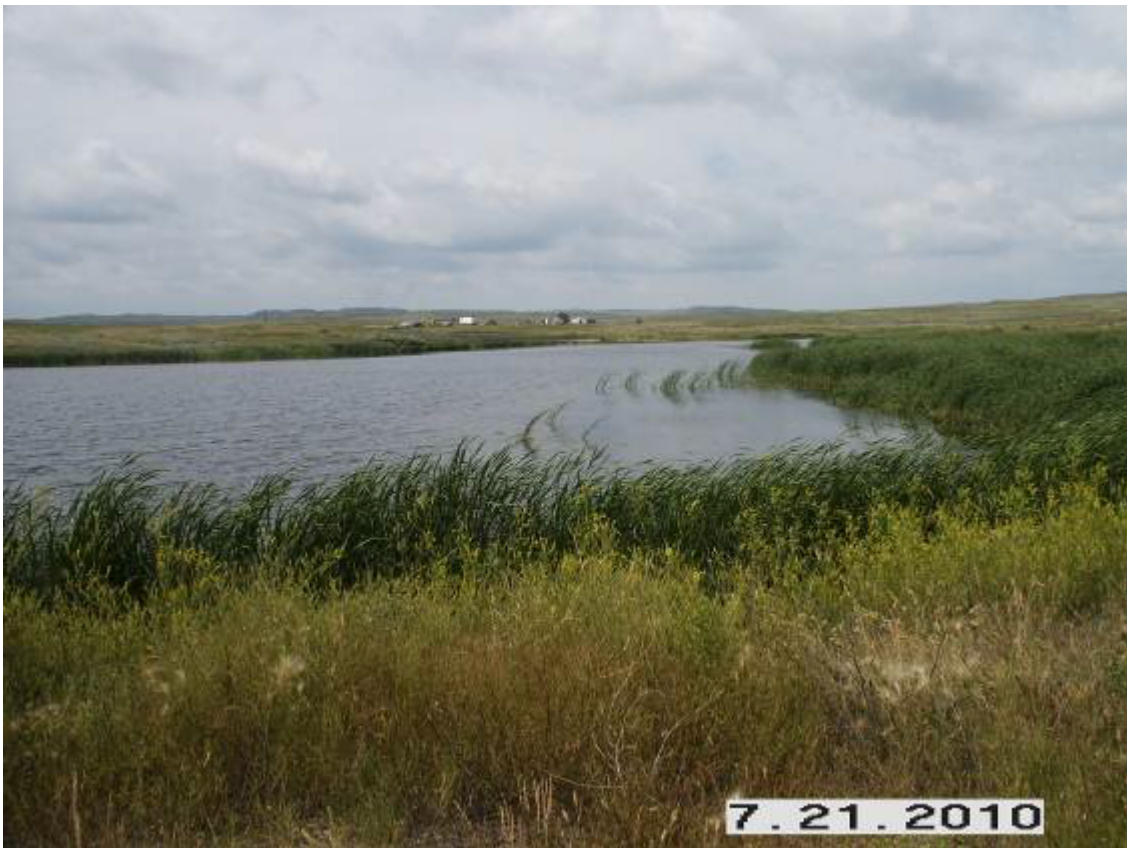
**Photo 04. A2 (Lower Portion) Site R5**

**Site R5** is located at latitude 44.5815° and longitude -104.9503° (Exhibit 1). This site is associated with the main body of the Oshoto Reservoir and is within a Water/Gullied Land soil map unit. *Typha latifolia* and *Scirpus maritimus* dominate the area. *Carex praegracilis*, *C. nebrascensis*, *Eleocharis palustris*, *Potamogeton richardsonii*, *Rumex maritimus*, and *T. angustifolia* were also noted in the area but not within the vegetation

plot. Positive indicators of hydrophytic vegetation, hydric soil, and wetland hydrology were present at the sample point. This area meets all three diagnostic environmental characteristics of a wetland as defined by the COE (COE 2008) and it appears to be a wetland (Appendix A, Sample Point R5 and Appendix B, Photo 04).

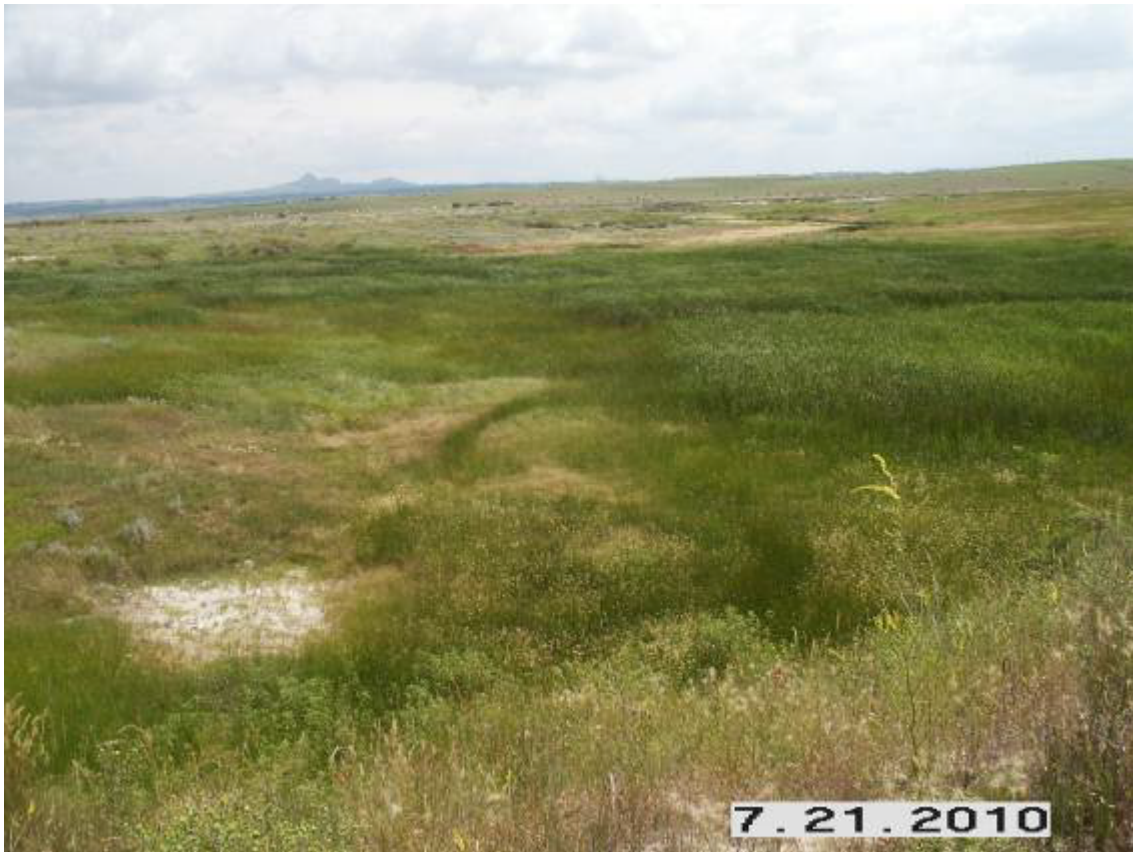
**Photo 07. A4 (Upper Portion) Site R6**

**Site R6** is located at latitude 44.5811° and longitude -104.9495° (Exhibit 1). This site is directly below the Oshoto Reservoir and likely receives seepage from the reservoir and also is receiving some water from a groundwater source and is within a Gullied Land soil map unit. *Typha latifolia*, *T. angustifolia*, and *Carex lanuginosa* dominate the area. Positive indicators of hydrophytic vegetation, hydric soil, and wetland hydrology are associated with the area. This area meets all three diagnostic environmental characteristics of a wetland as defined by the COE (COE 2008) and it appears to be a wetland (Appendix A, Sample Point R6 and Appendix B, Photo 07).

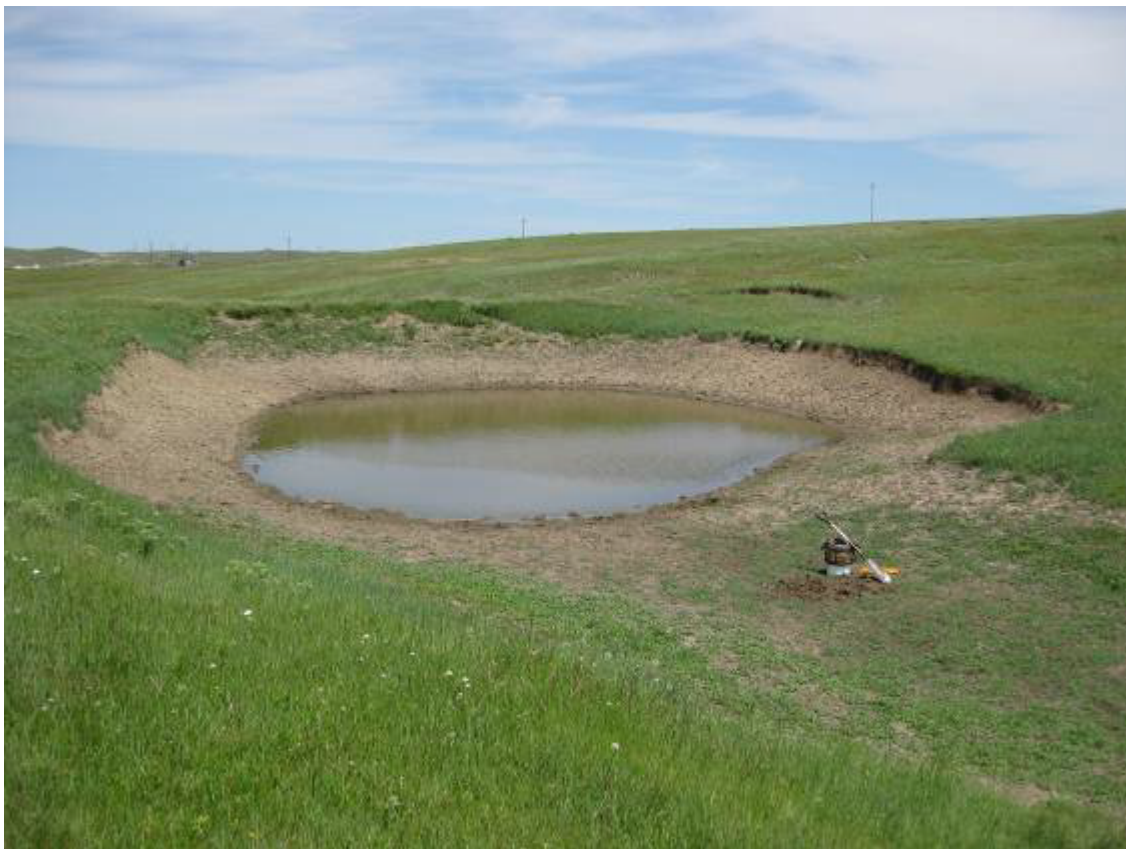
**Photo 12. B2 (Site R1)**

**Site R1** is located at latitude 44.5640° and longitude -104.9522° (Exhibit 1). This site is associated with a small man made stock pond located on an ephemeraally-flowing tributary to the Little Missouri drainage and is within a Fort Collins Loam (6-10% Slope) soil map unit. It appears to be typical of an impoundment situation in that it has a relatively large amount of bare ground (approximately 98 percent) associated with the site. *Equisetum variegatum* dominates the vegetation within the area. Positive indicators of hydrophytic vegetation, hydric soil, and wetland hydrology are associated with the area. This area meets all three diagnostic environmental characteristics of a wetland as defined by the COE (COE 2008) and it appears to be a wetland (Appendix A, Sample Point R1 and Appendix B, Photo 12).

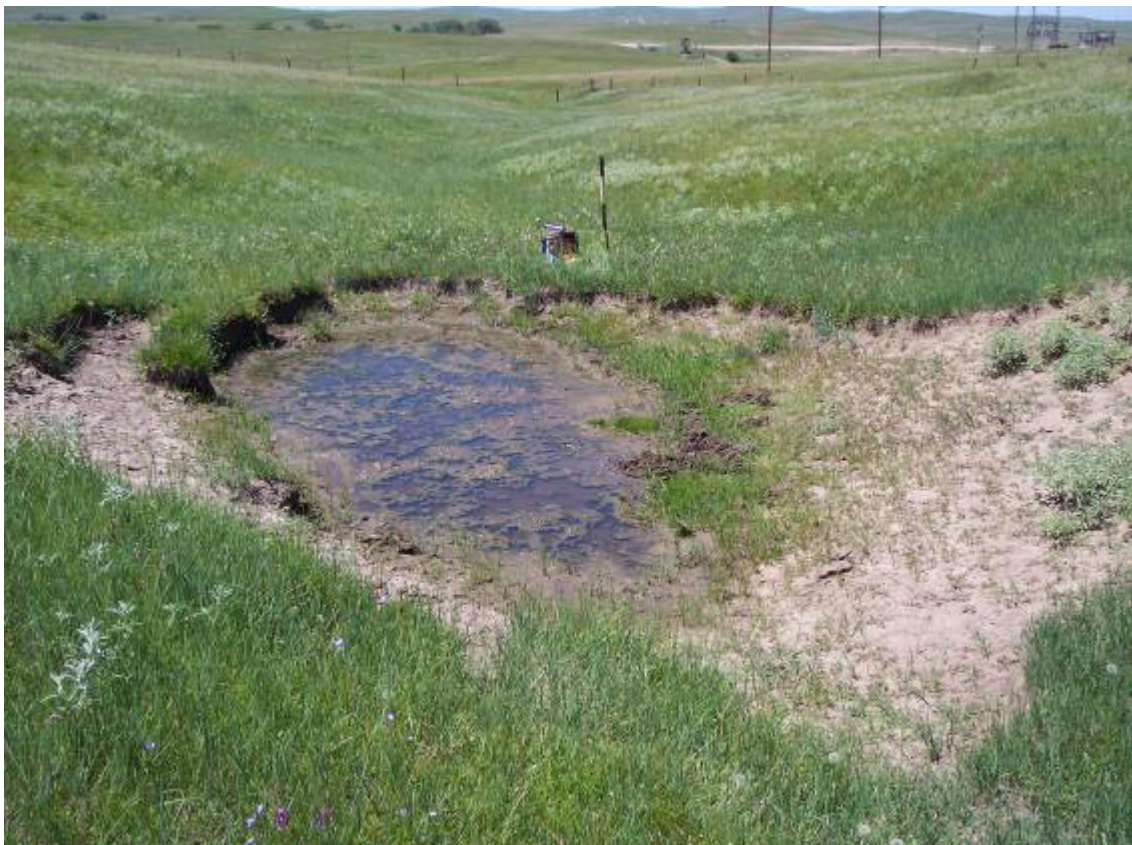
**Photo 16. B6 (Site R2)**

**Site R2** is located at latitude 44.5674° and longitude -104.9520° (Exhibit 1). This site is within a small depression located on an ephemeraally-flowing tributary to the Little Missouri drainage and is within a Fort Collins Loam (6-10% Slope) soil map unit. The

dominant vegetative types include *Marsilea vestita* and *Equisetum Variegatum*. Positive indicators of hydrophytic vegetation, hydric soil, and wetland hydrology are associated with the area. The site may be receiving water from a groundwater source (seep), which helps maintain saturated conditions longer than the site location (higher on the drainage) would indicate. This area meets all three diagnostic environmental characteristics of a wetland as defined by the COE (COE 2008) and it appears to be a wetland (Appendix A, Sample Point R2 and Appendix B, Photo 16).

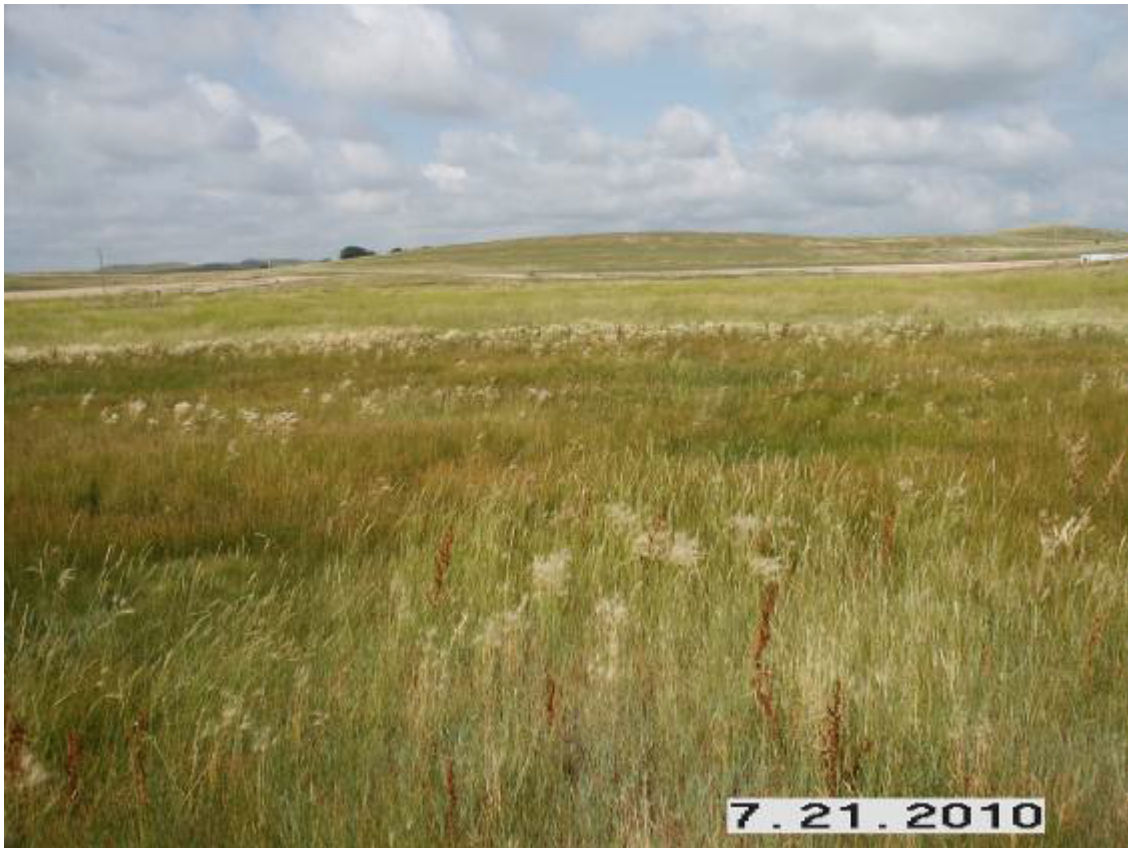
**Photo 23. D2 (Site R3)**

**Site R3** is located at latitude 44.5716° and longitude -104.9601° facility (Exhibit 1). This site is located on an ephemerally-flowing tributary within is an excavated depression that is associated with a decommissioned uranium processing facility and is within an Absted-Bone Complex (0-3% Slope) soil map unit. *Eleocharis palustris* dominates the area. Positive indicators of hydrophytic vegetation, hydric soil, and wetland hydrology are associated with the area. This area meets all three diagnostic environmental characteristics of a wetland as defined by the COE (COE 2008) and it appears to be a wetland (Appendix A, Sample Point R3 and Appendix B, Photo 23).

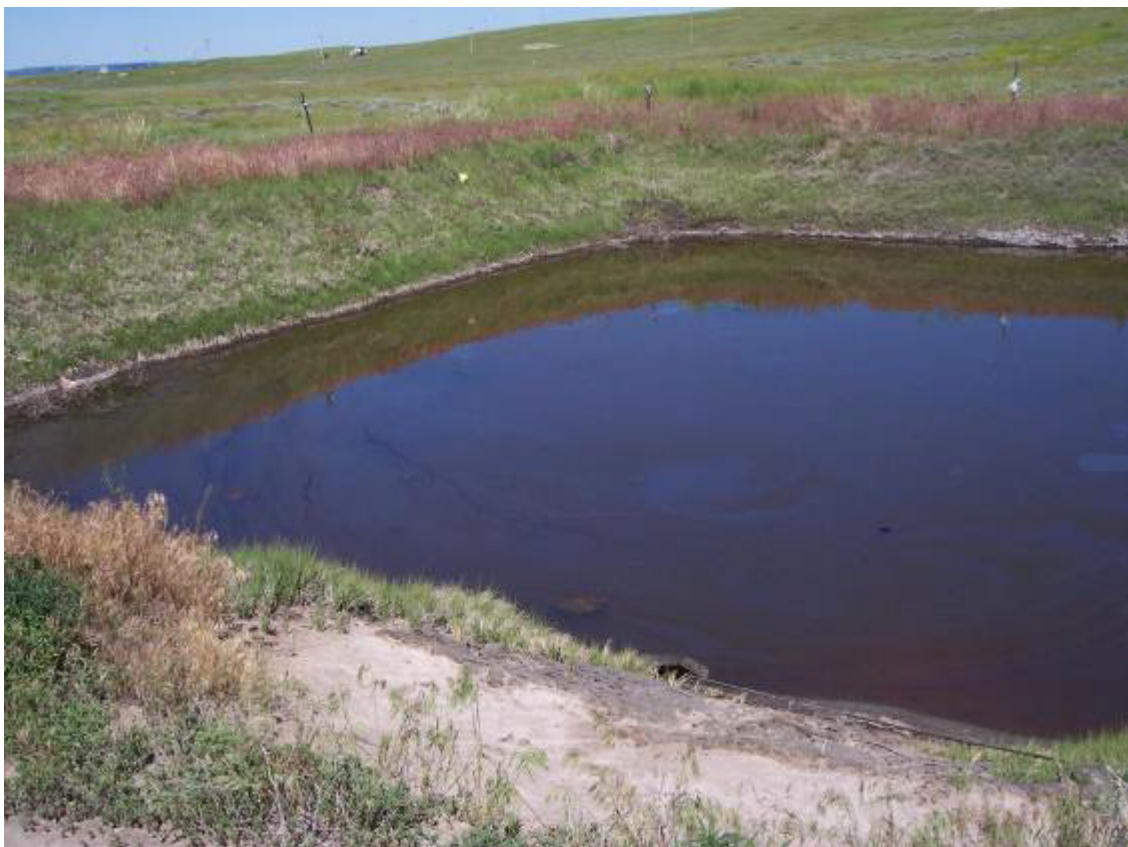
**Photo 24. E1 (Site R8)**

**Site R8** is located at latitude 44.5723° and longitude -104.9601° (Exhibit 1). This site is associated with a man made oil well production pit and is within an Absted-Bone Complex (0-3% Slope) soil map unit. *Agropyron smithii* and *Hordeum jubatum* dominate the area. Although positive indicators of wetland hydrology are associated with the area, it does not meet all three diagnostic environmental characteristics of a wetland as defined by the COE (COE 2008). It does not appear to be a wetland (Appendix A, Sample Point R8 and Appendix B, Photo 24).

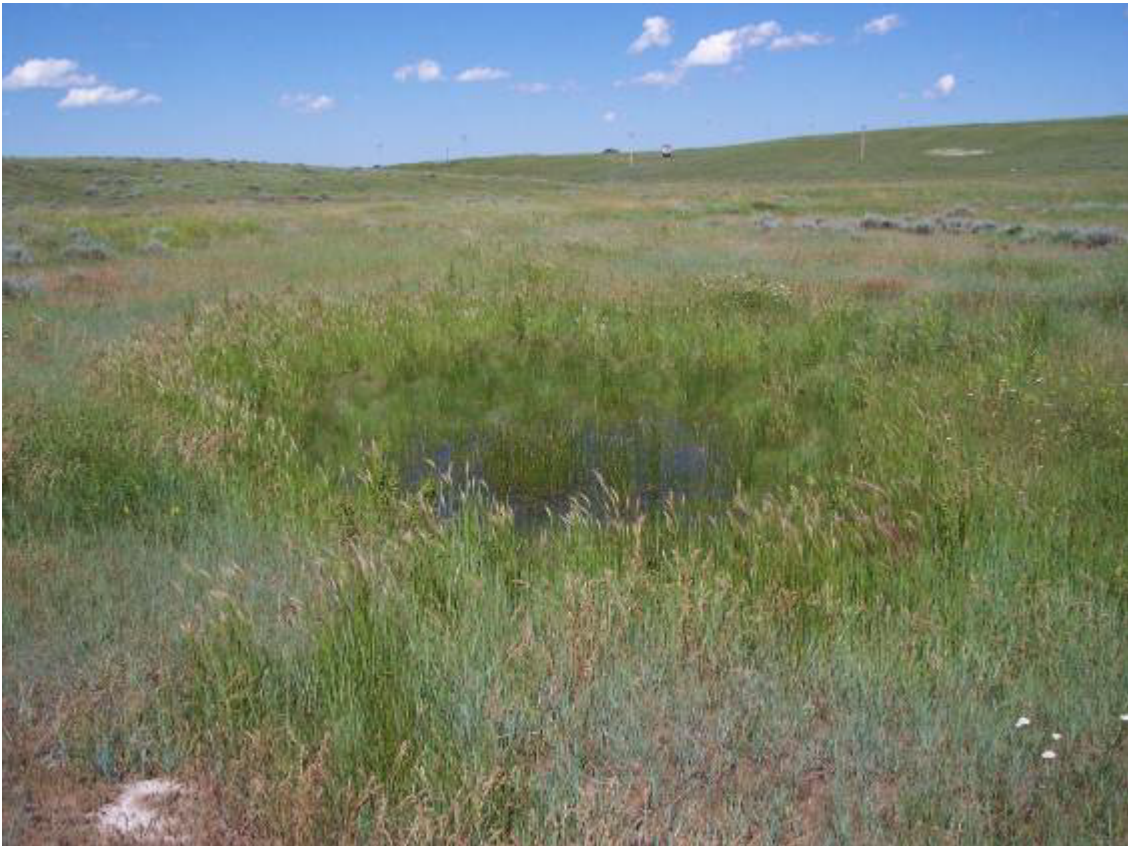
**Photo 25. F1 (Site R4)**

**Site R4** is located at latitude 44.5734° and longitude -104.9599°. This site is within a small depression located on an ephemerally-flowing tributary to the Little Missouri drainage and is within an Absted-Bone Complex (0-3% Slope) soil map unit. *Eleocharis palustris* and *Hordeum jubatum* dominate the area. Positive indicators of hydrophytic vegetation, hydric soil, and wetland hydrology were present at the sample point. The site may be receiving water from a groundwater source. This area meets all three diagnostic environmental characteristics of a wetland as defined by the COE (COE 2008) and it appears to be a wetland (Appendix A, Sample Point R4 and Appendix B, Photo 25).

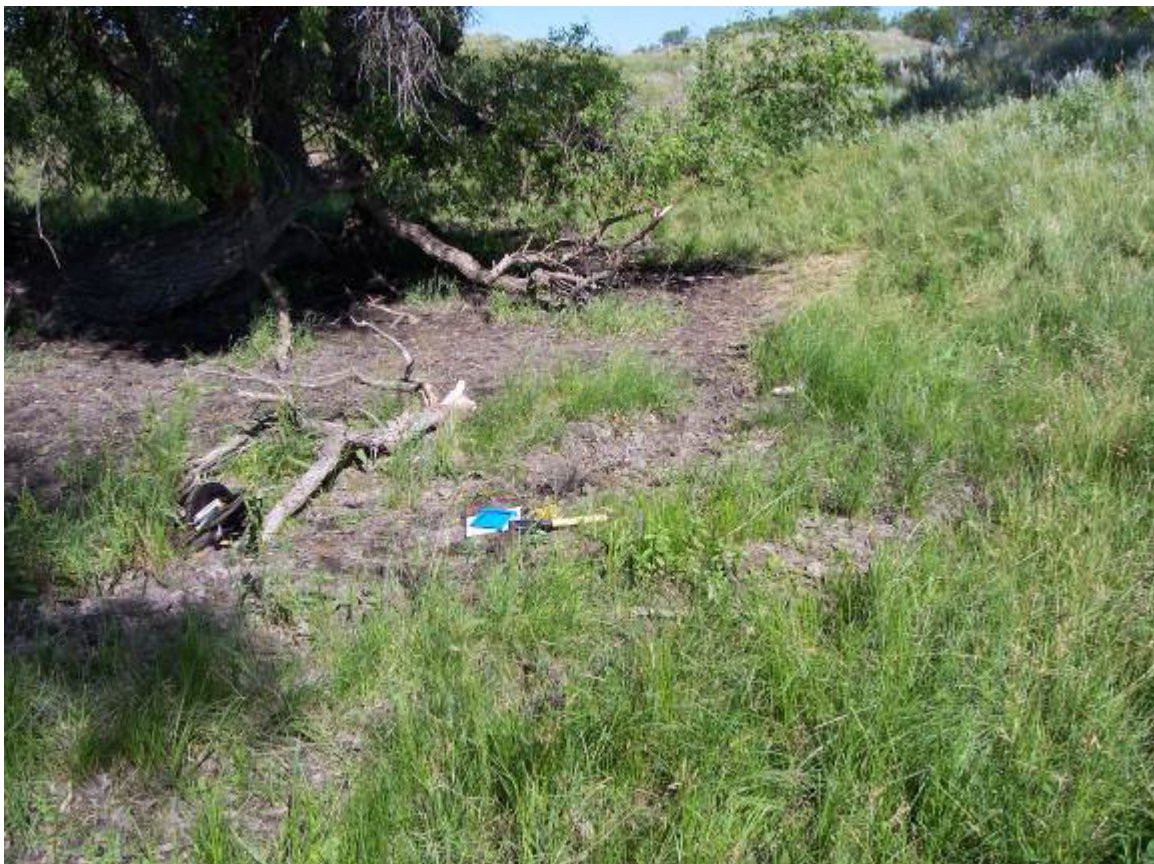
**Photo 39. G2 Lower Portion (Site R7)**

**Site R7** is located at latitude 44.5675° and longitude -104.9640° (Exhibit 1). This site is within a depression above a road fill that has restricted flow down the drainage and is within a Bidman-Bone Loams (2-6% Slope) soil map unit. *Sporobolus airoides* and *Hordeum jubatum* dominate the area. *Carex praegracilis*, *C. nebrascensis*, *Sagittaria cuneata*, *Potamogeton nodosus*, and *Phleym pretense* were also noted in the area but not within the vegetation plot. Positive indicators of hydrophytic vegetation, hydric soil, and wetland hydrology are associated with the area. This area meets all three diagnostic environmental characteristics of a wetland as defined by the COE (COE 2008) and it appears to be a wetland (Appendix A, Sample Point R7 and Appendix B, Photo 39).

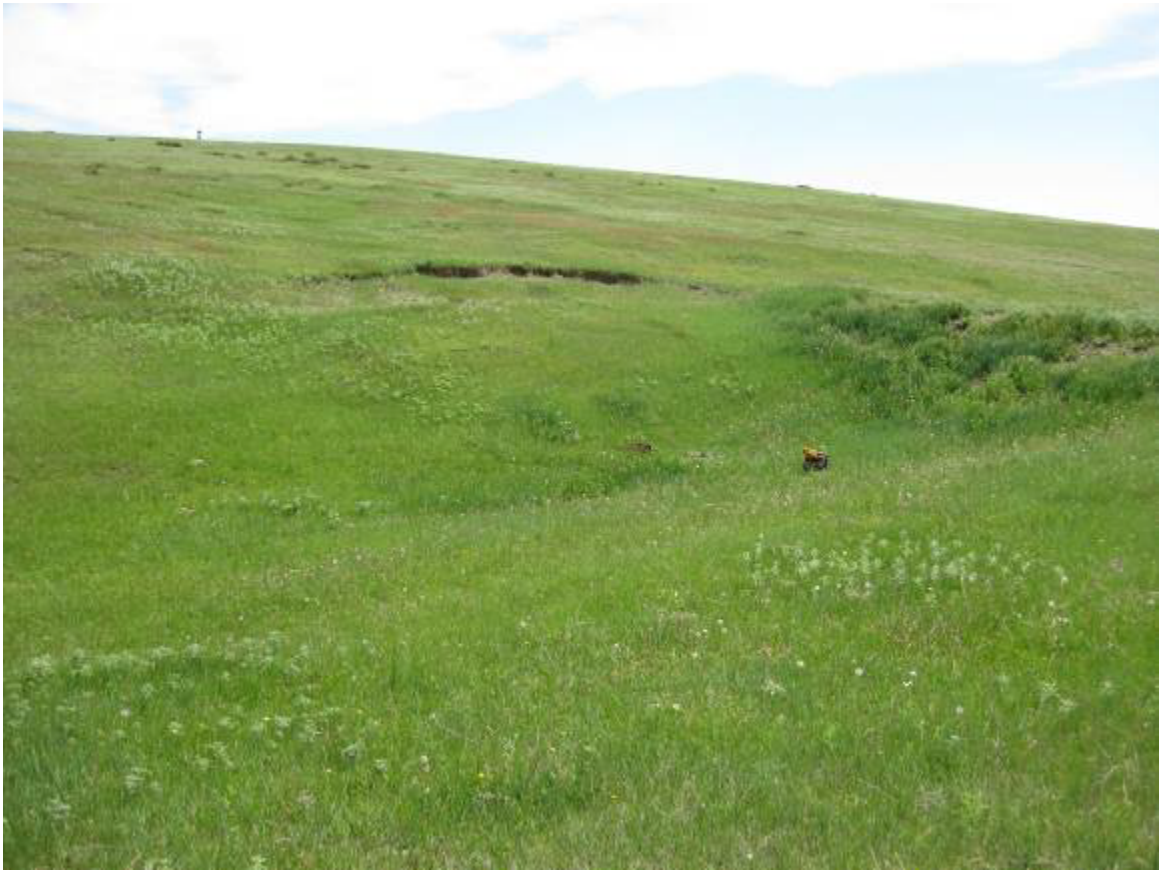
**Photo 64. Site R9**

**Site R9** is located at latitude 44.5642° and longitude -104.9522° (Exhibit 1). This site is directly below a small stock pond (Site r1) and is within a Fort Collins Loam (6-10% Slope) soil map unit. *Agropyron smithii* and *Poa pratensis* dominate the area. Positive indicators of hydrophytic vegetation, hydric soil, or wetland hydrology are not associated with the area. This area does not meet any of the three diagnostic environmental characteristics of a wetland as defined by the COE (COE 2008) and it does not appear to be a wetland (Appendix A, Sample Point R9 and Appendix B, Photo 64). This site was evaluated since it represented an area that had the potential to be a wetland (possibly receiving seepage from the stock pond) but did not exhibit classic wetland characteristics.
