“Fort Calhoun RPV Outlet Nozzle Eddy Current Data Normalization”

Report No: 1305120-Rpt.1

2009 Weld Inspection Data

WesDyne International
Reactor Vessel Nozzle Weld Results Summary

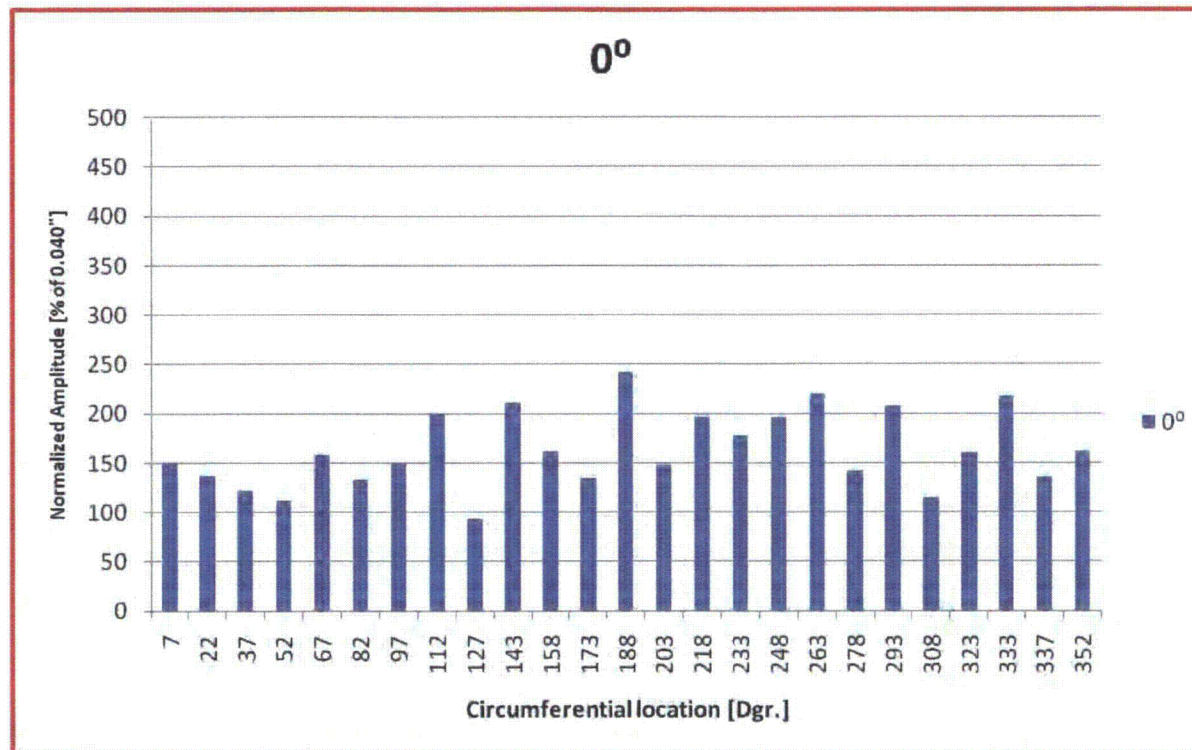
Fig. 1 - Normalized Local Permeability Measurements along DMBW in Outlet Nozzle at 0° Location on Fort Calhoun RPV

For each nozzle a total of 25 individual measurements were taken along even segments along each weld's full circumference. These absolute measurements are presented in Attachment A, for outlet nozzle at 0° orientation (nozzle A), and in Attachment B, for outlet nozzle at 180° orientation (nozzle B). Two graphs with local permeability measurements for two nozzles are shown on Figures 1 and 4.

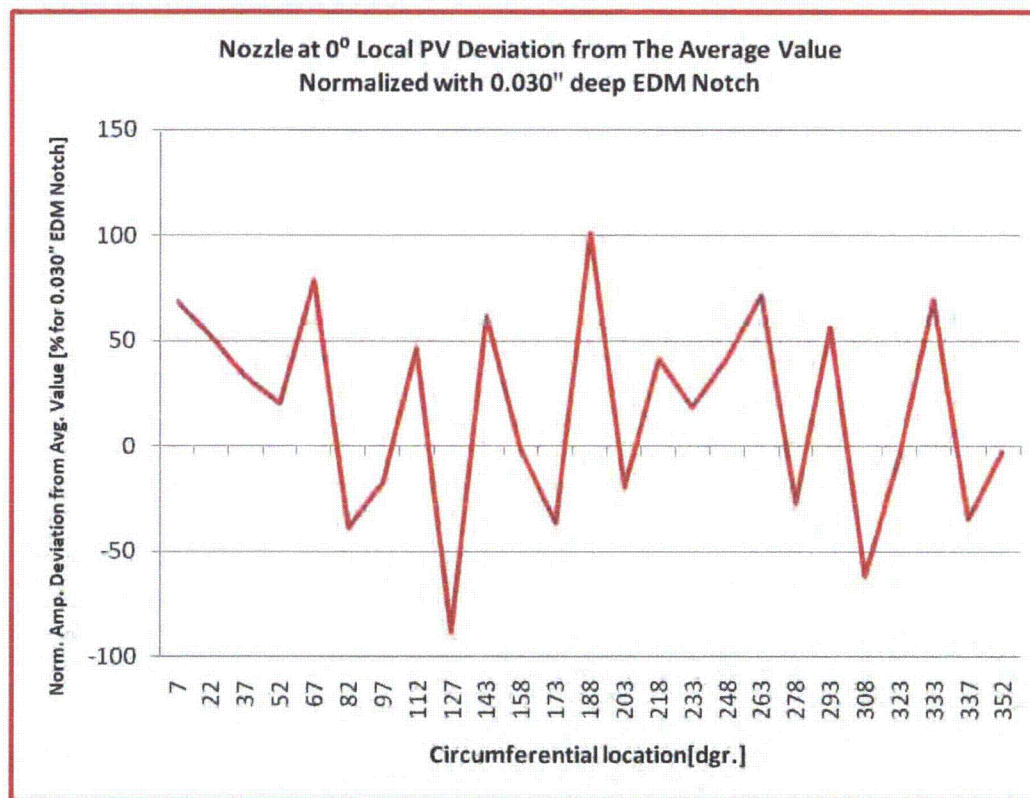
Fig. 2 - Normalized (0.030" notch) Local Permeability Deviation from Average value along DMBW

RPV Outlet Nozzle at 0° Location

Local permeability variations from calculated average value along DMBW-s have confirmed low level of deviations, lower than 150% of normalized amplitude with 0.030" deep EDM notch. Based on earlier experience with CEDM seal housings these level of deviations were associated with structure not affected with degradation mechanism. Very low level of permeability variation and consistency of similar properties along adjacent structure confirms that both DMBW-s on two outlet nozzle contain stable and homogenous structure characteristic for isotropic material structure along inspected surfaces. These results in conjunction with verified structurally sound integrity along DMBW, based on extensive and elaborate combination of NDE performed with qualified UT and similar ECT inspection techniques, provide the basis to characterize these two welds as a structure with minimal property variation and high homogeneity. Such uniform structure with relatively minimal local permeability variations (lower than 150% of normalized amplitudes) were known with earlier experience on CEDM seal housings as a surfaces with minimal susceptibility to the known degradation mechanisms on wetted surfaces.

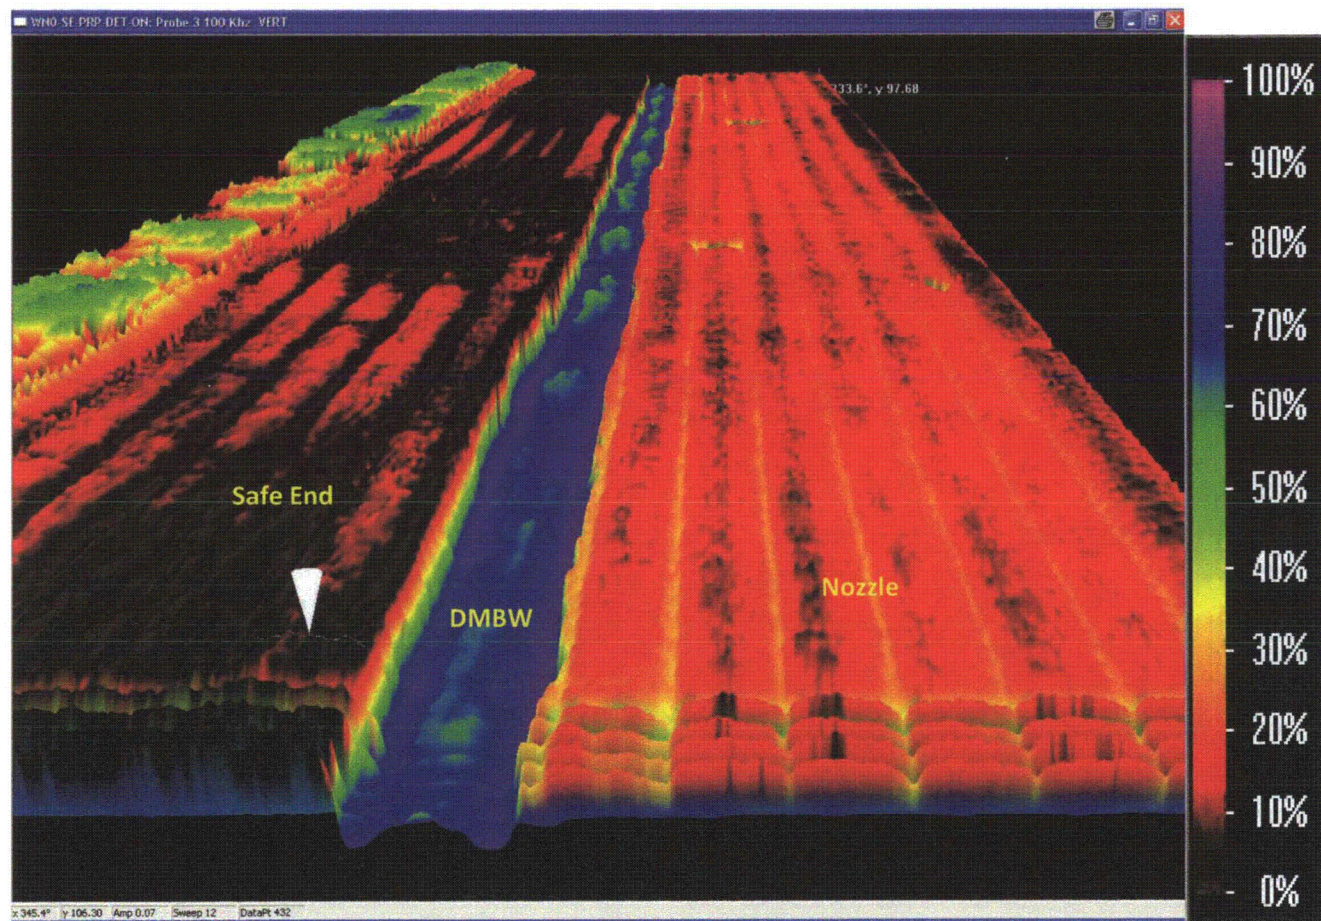
Fig. 3 - Eddy Current Data with Pancake Coil along DMWB in Outlet Nozzle at 0° Location on Fort Calhoun RPV

Results of local permeability variation along two outlet nozzles DMBW on RPV at Fort Calhoun have shown low level of deviation from normalized average value. This low level of permeability variation confirms material isotropic property along the DMBW. In addition to numerical measurements summarized in graphs on Figures 2 and 5, these properties are also visible on 3-D, C-scan presentation with vertical signal amplitude components displayed with color palette image. The presented color palette is associated with the maximum values of detected permeability (dark brown-red colors) along Stainless Steel (S/S) cladding on safe end, and minimum values (blue-green color) along DMBW surface. Slightly lower than maximum level permeability values are detected on S/S cladding on nozzle side (red-yellow colors). These 3-D, C-scans for both outlet nozzles are shown on Figures 3 and 6. From these 3-D, C-scans we can conclude on repeatable and homogenous material properties along DMBW and adjacent surfaces. Some local repair patches locations were detected along S/S cladding on nozzle sides. Based on manufacturing inspection report it appears that these areas were repaired with local grinding to remove shallow surface indications. These areas have shown lowered level of local permeability changes along S/S cladding surfaces in comparison with the as welded surface on the same material. These patches are visible in individual scan measurements in the enclosed attachments (yellow-green patches on red-orange surfaces and blue-green patches on yellow red surfaces along S/S cladding on nozzle sides).

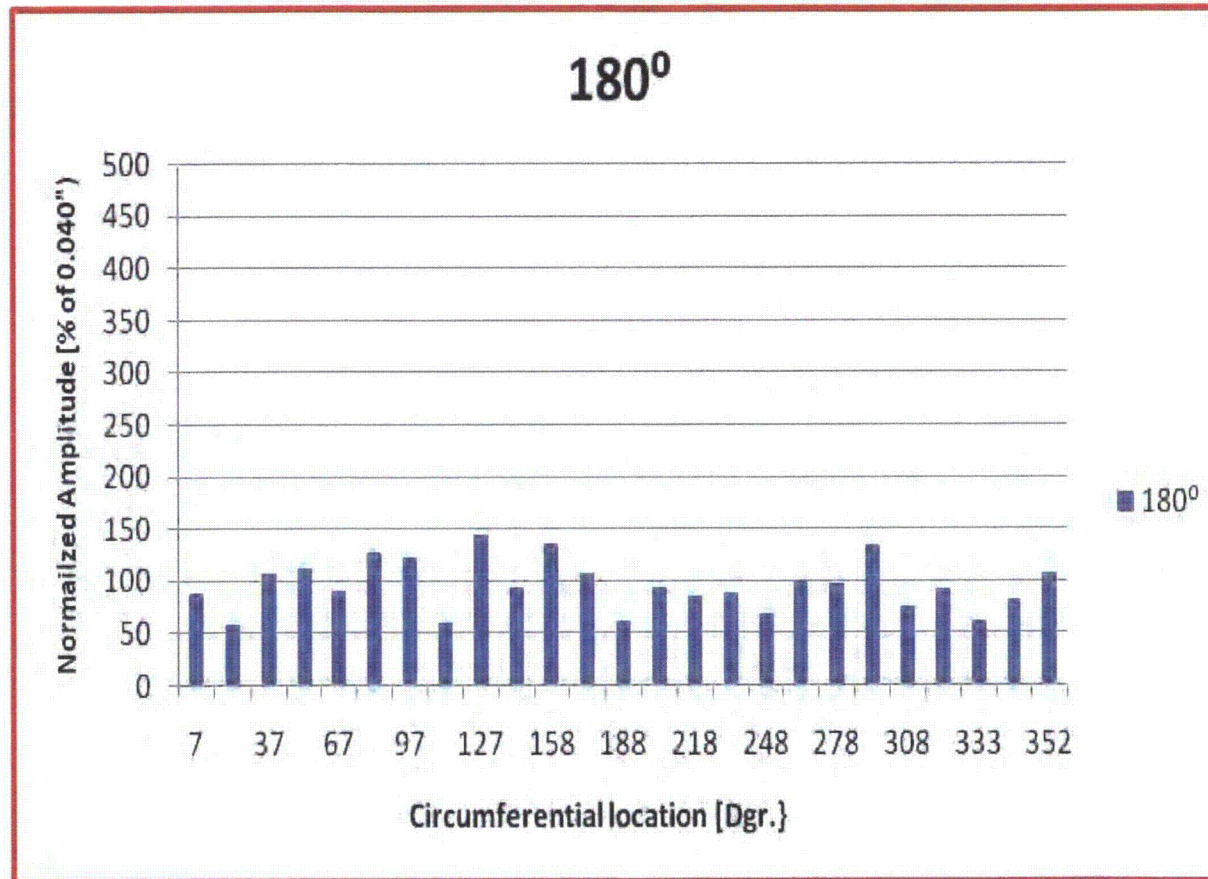
Fig. 4 - Normalized Local Permeability Measurements along DMBW in Outlet Nozzle at 180° Location on Fort Calhoun RPV

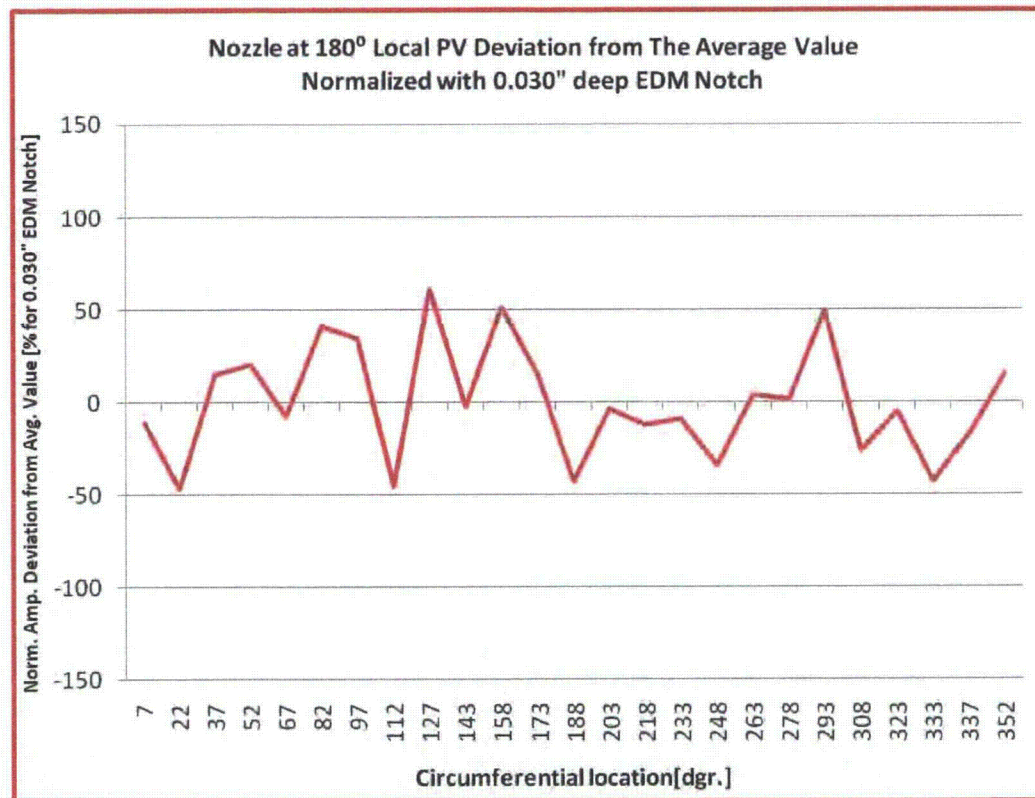
Fig. 5 - Normalized (0.030" notch) Local Permeability Deviation from Average value along DMBW

RPV Outlet Nozzle at 180° Location

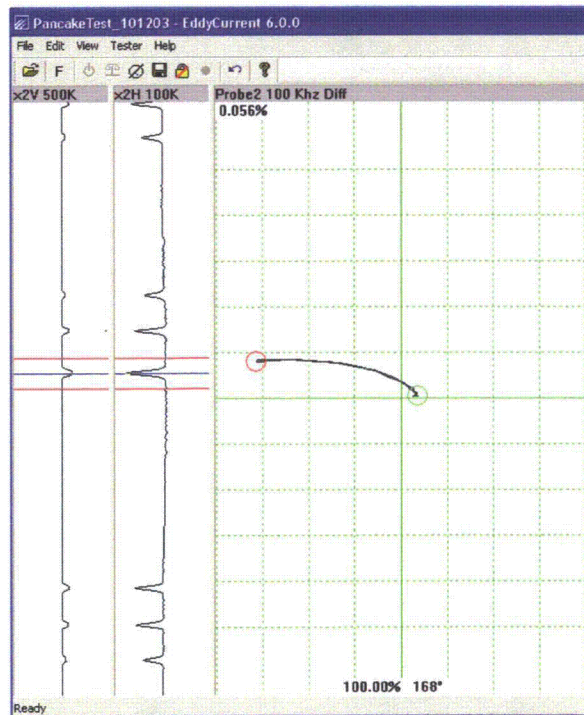
Fig. 8 - Response from 0.040" deep notch measures 100%

To calculate the value for correction factor special test block made from inconel alloy 600 was procured containing EDM notches with 0.030" and 0.040" nominal depth. Characteristic signal responses from these two notches are shown on Figures 8 and 9.

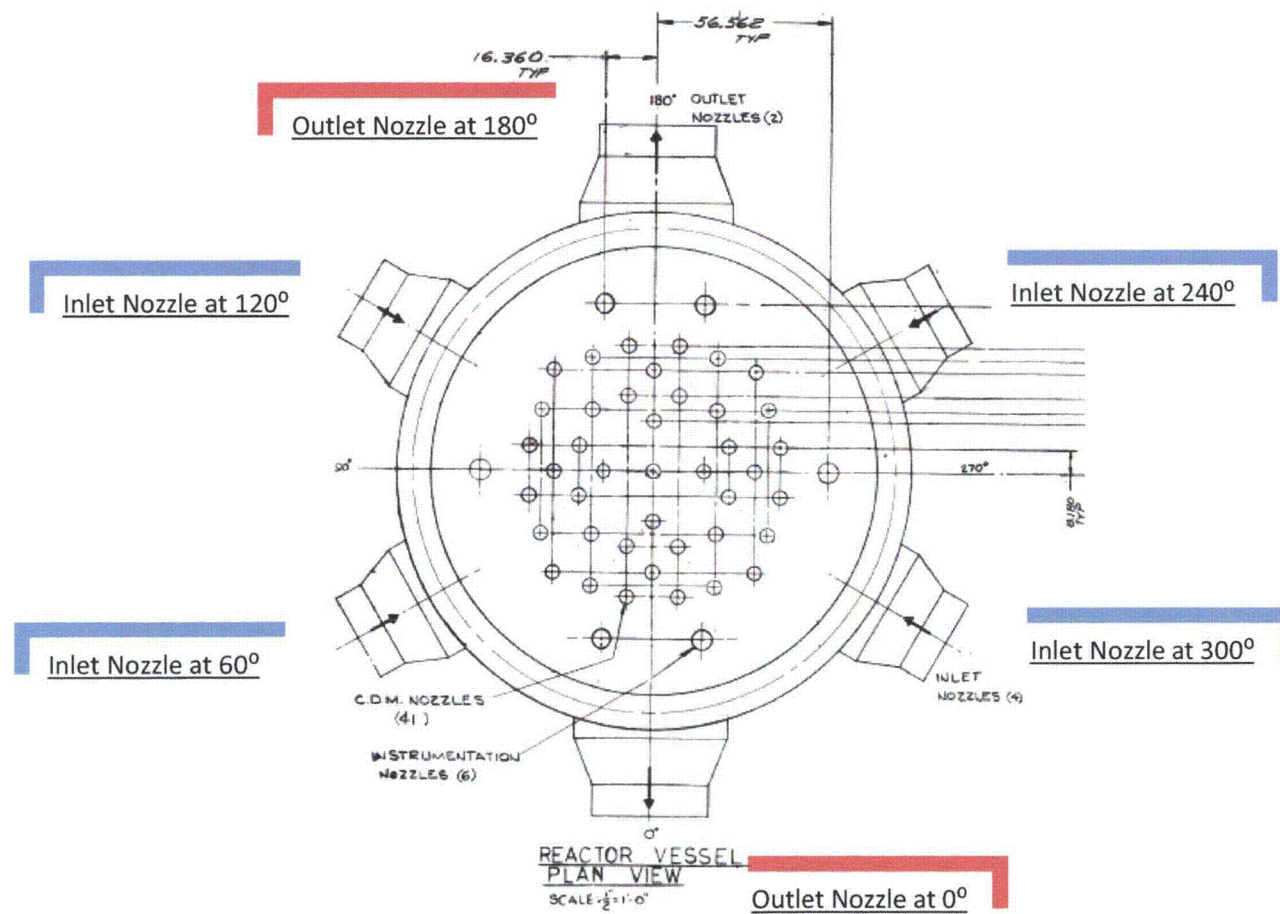
Fig. 10 - Fort Calhoun RPV Nozzles Configuration

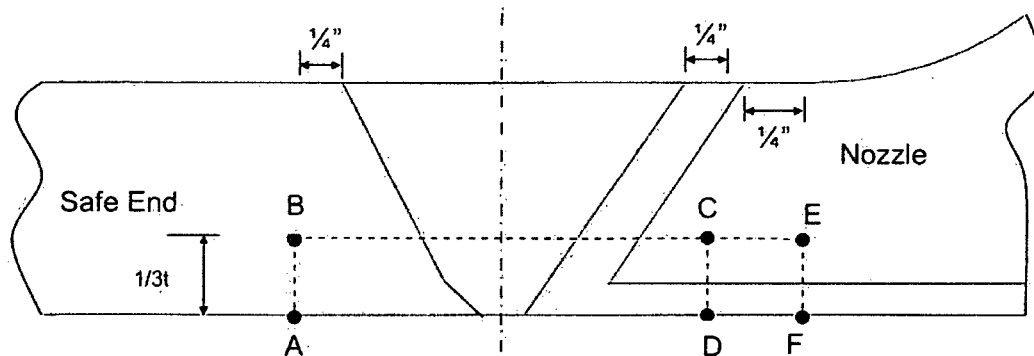
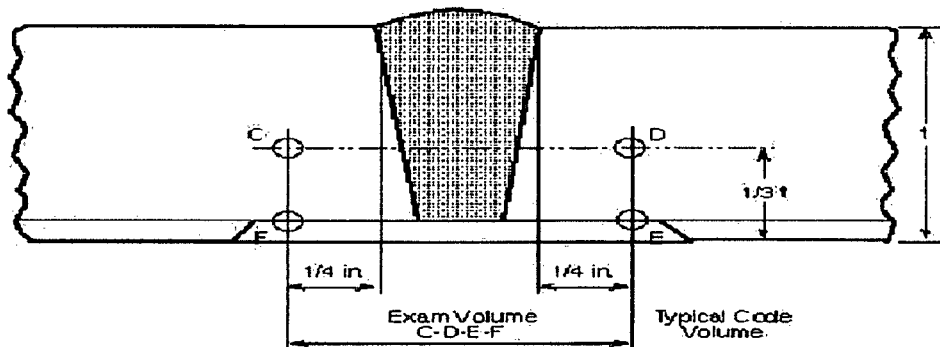
Figure 3 - Examination Volume

**ASME Section XI Examination Volume for Dissimilar Metal Welds A-B-C-D
Additional Procedure Examination Volume Coverage A-B-E-F**

ASME Section XI Examination Volume for Austenitic Piping Welds C-D-E-F
