## **Effects of the MacArthur Maze Fire and Roadway Collapse on a Spent Nuclear Fuel Transportation Package - 11392**

Christopher S. Bajwa\*, Earl P. Easton\*, Harold Adkins\*\*, Judith Cuta\*\*,  
Nicholas Klymyshyn\*\*, and Sarah Suffield\*\*

\*U.S. Nuclear Regulatory Commission, Washington, DC 20005

\*\*Pacific Northwest National Laboratory, Richland, Washington 99352

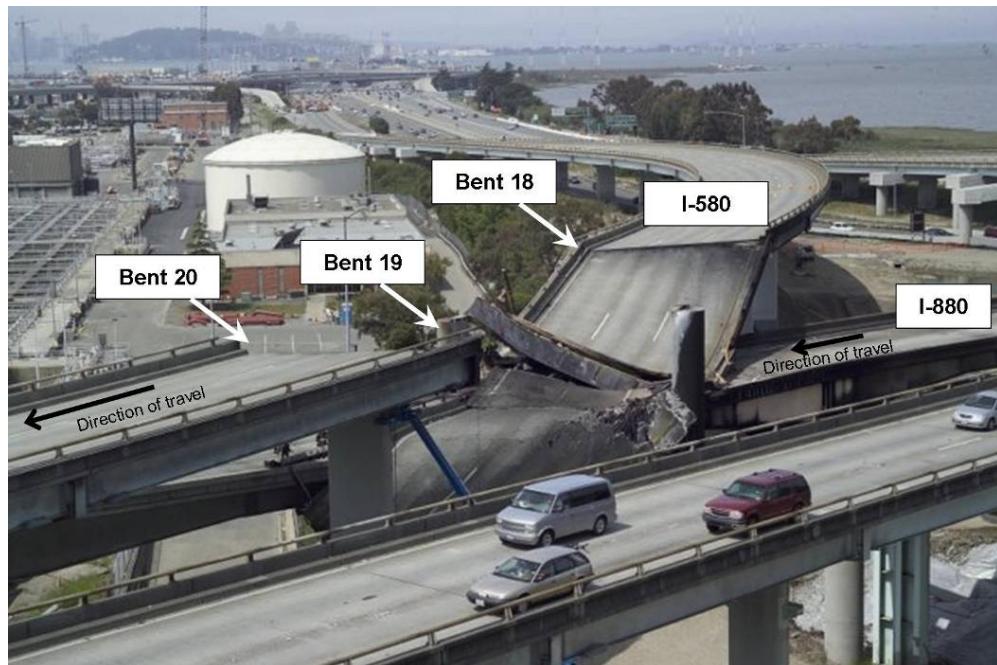
Fig. 2. Post-fire aerial view of the collapsed section of I-580 looking west. Picture from Caltrans  
<http://www.dot.ca.gov/dist4/photography/images/070429.html>.

first overhead span, is shown in Figure 1. A photograph of the scene after the fire was extinguished (from later that day) is shown in Figure 2<sup>1</sup> [2].

<sup>1</sup> The transverse support locations for the elevated roadway are referred to as "Bents" in Figures 1 and 2.

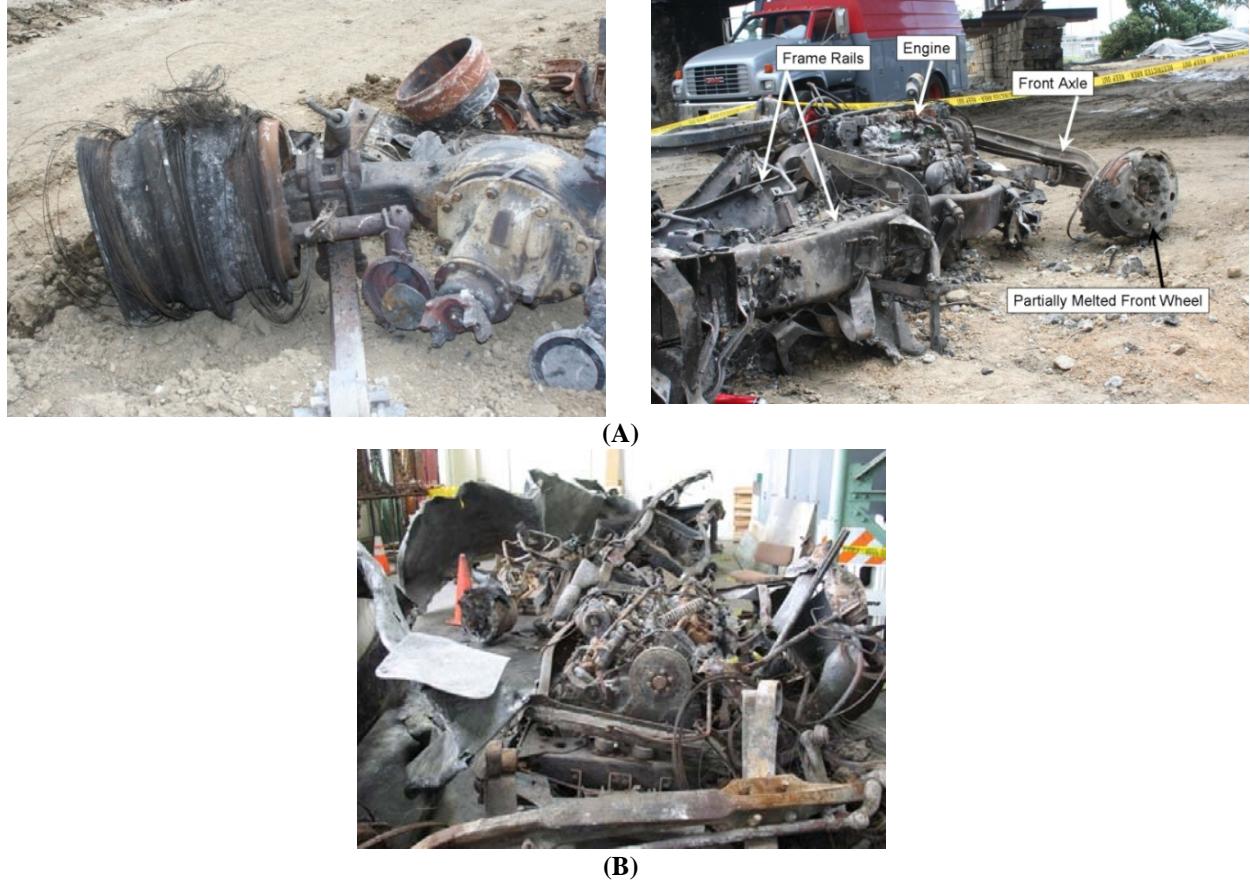
**Fig. 4. Photographs of the tanker truck remains at the accident site (A) and at the Caltrans storage facility (B).**

In March, 2008, staff from SwRI® and NRC inspected the tanker truck involved in the accident and collected selected samples for analysis. A variety of materials were collected including glass, aluminum alloys, steel, copper, brass, and stainless steel. Descriptions of the samples are shown in Table II. Photographs of the truck remains are shown in Figure 4.
