Safety Analysis Report

Advanced Test Reactor Fresh Fuel Shipping Container (ATR FFSC)

Revision 1, April 2008

Docket 71-9330

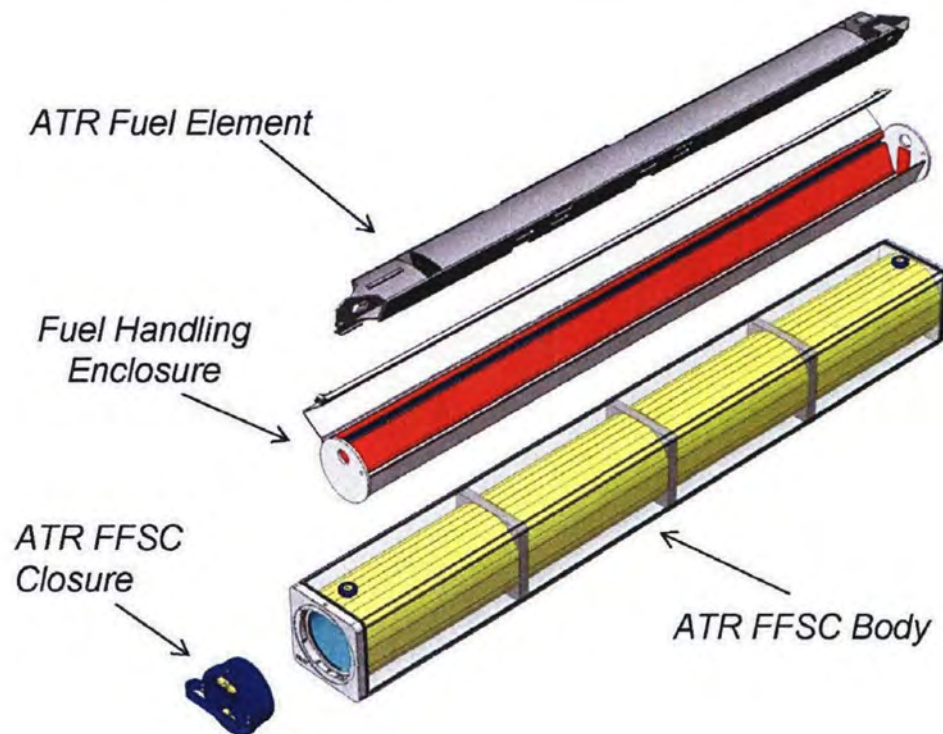
Figure 1.2-1 - Overview of the ATR FFSC (Outer Body Shell Shown Transparent)

The ATR FFSC is a two part packaging consisting of the body and the closure. The body is single weldment that features square tubing as an outer shell and round tubing for the payload cavity. Three 1-inch thick ribs maintain spacing between the inner and outer shells. The components of the packaging are shown in Figures 1.2-2, 1.2-3, and 1.2-4 and are described in more detail in the sections which follow. With the exception of several minor components, all steel used in the ATR FFSC is ASTM Type 304 stainless steel. Components are joined using full-thickness fillet welds (i.e., fillet welds whose leg size is nominally equal to the lesser thickness of the parts joined) and full and partial penetration groove welds.

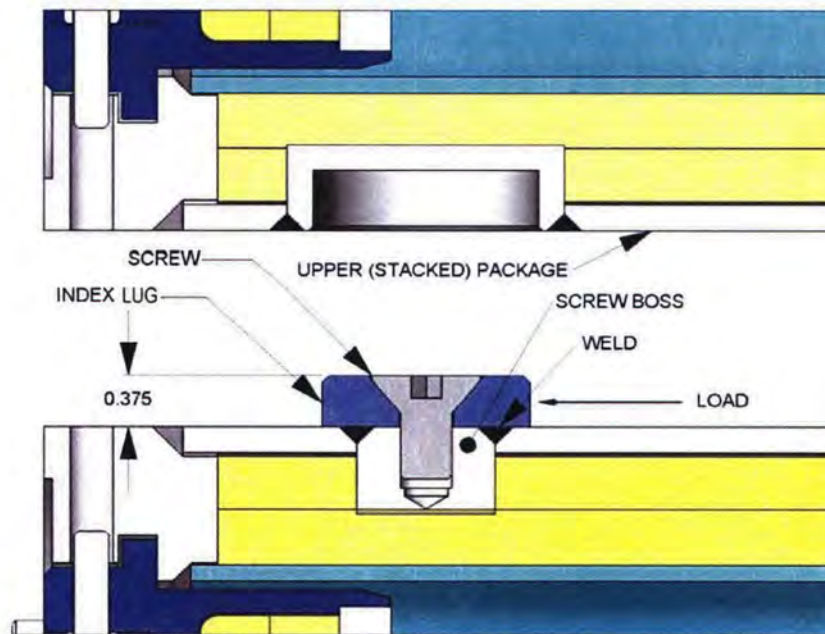
Figure 1.2-5 - Index Lug and Mating Pocket of Stacked Packages

On one face of the package body, two index lugs are secured to the package to facilitate stacking of the packages. The opposite face of the package has pockets into which the index lugs nest. Each index lug is secured to the package by means of a 3/8-16 socket flat head cap screw. Under any load condition, the screw will fail prior to degrading the safety function of the package.

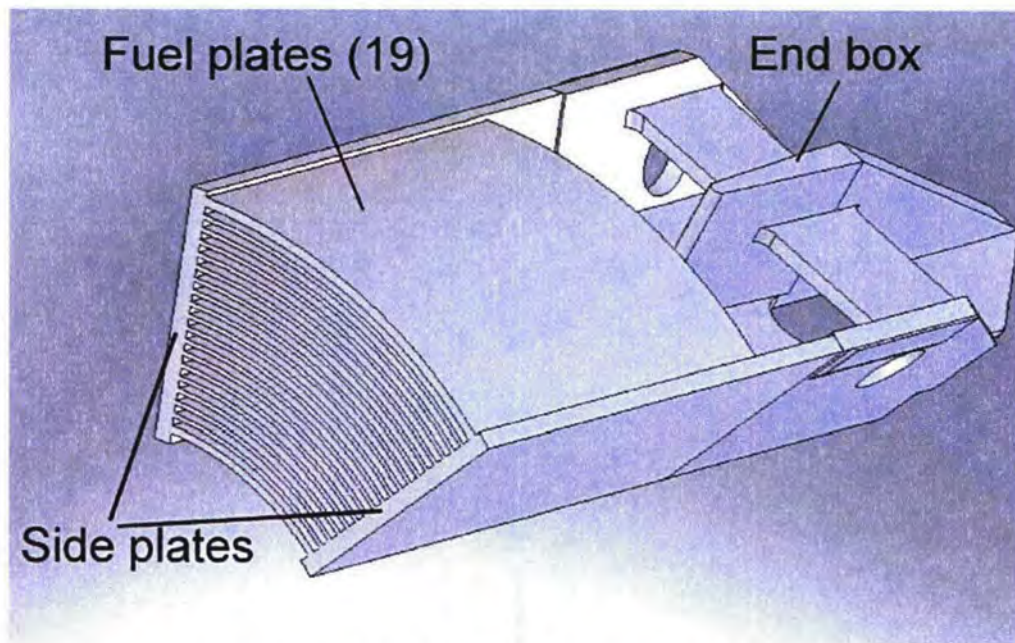
Figure 1.2-6 - ATR Fuel Element – Section View

The ATR fuel elements contain 19 curved fuel plates. A section view of an ATR fuel element is given in Figure 1.2-6. The fuel plates are rolled to shape and swaged into the two fuel element side plates. Fuel plate 1 has the smallest radius, while fuel plate 19 has the largest radius. The fissile material (uranium aluminide) is nominally 0.02-in thick for all 19 plates. Fuel element side plates are fabricated of ASTM B 209, aluminum alloy 6061-T6 or 6061-T651 and are approximately 0.19-in thick. The fuel plates are typically spaced with a 0.08-in gap between plates.

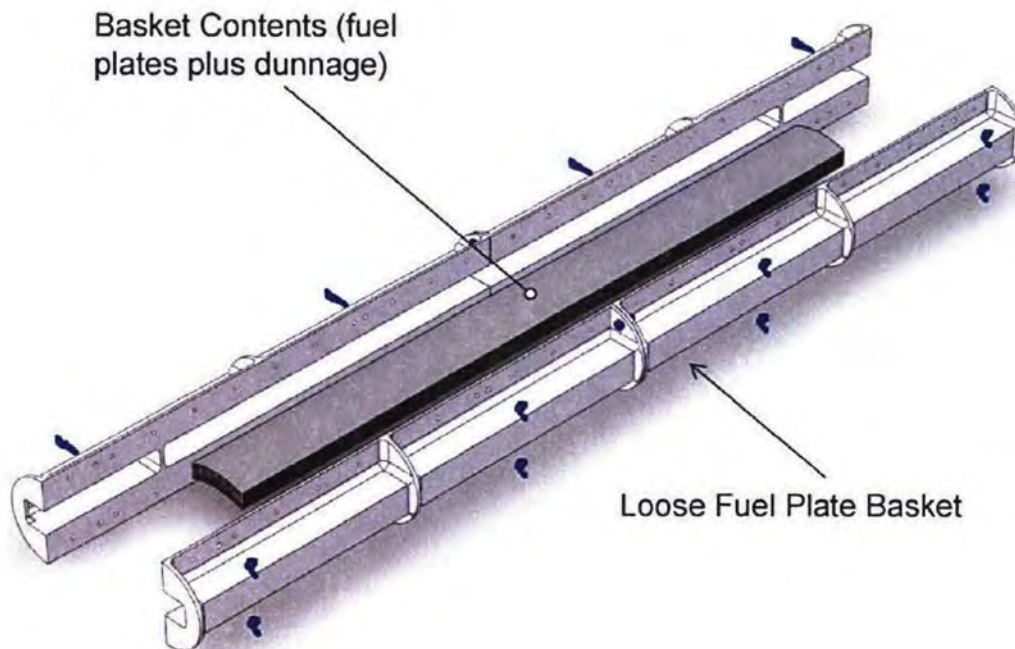
Figure 1.2-7 - Loose Fuel Plate Basket – Exploded View

The maximum weight of the ATR fuel loose plate payload (Figure 1.2-7) is 50 lbs. This weight is made up of the maximum basket contents weight of 20 lbs and the loose fuel plate basket weight of 30 lbs.

The loose plate payload is limited to 600 grams U-235. The plates may either be flat or rolled to the geometry required for assembly into the ATR fuel element. For handling convenience, the loose plate basket will be loaded with either flat or rolled plates. Additionally, the plates may be banded or wire tied in a bundle.

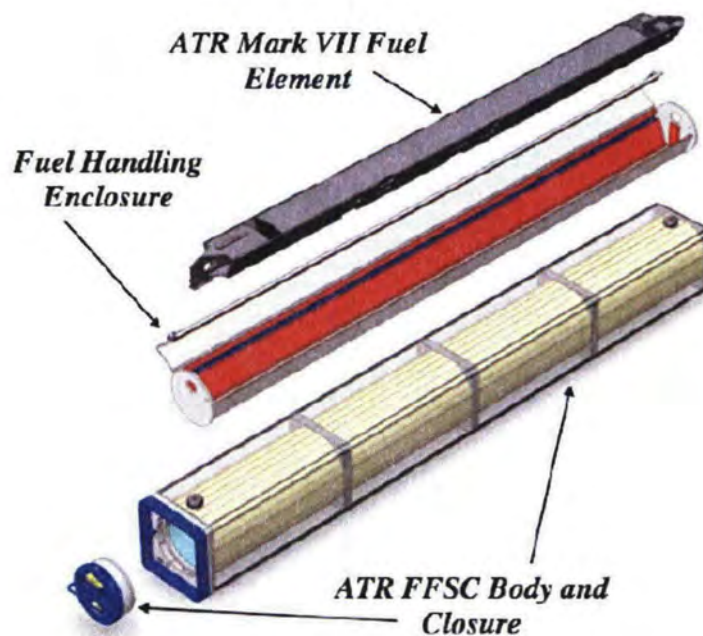
**Figure 2.1-1 – ATR FFSC Package Components (With Fuel Element)**

The maximum gross weight of the ATR FFSC package is 290 lb. The packaging component weights are summarized in Table 2.1-1. The maximum payload weight is 50 lb, for the loose plate payload, and 40 lb for the fuel assembly. Due to symmetry of design, the center of gravity (CG) of the package is located essentially at the geometric center of the package. With either payload, the center of gravity is 35 inches from the face of the closure end and 4 inches from the bottom and sides of the package. The packaging components are illustrated in Figure 2.1-1 and Figure 2.1-2.

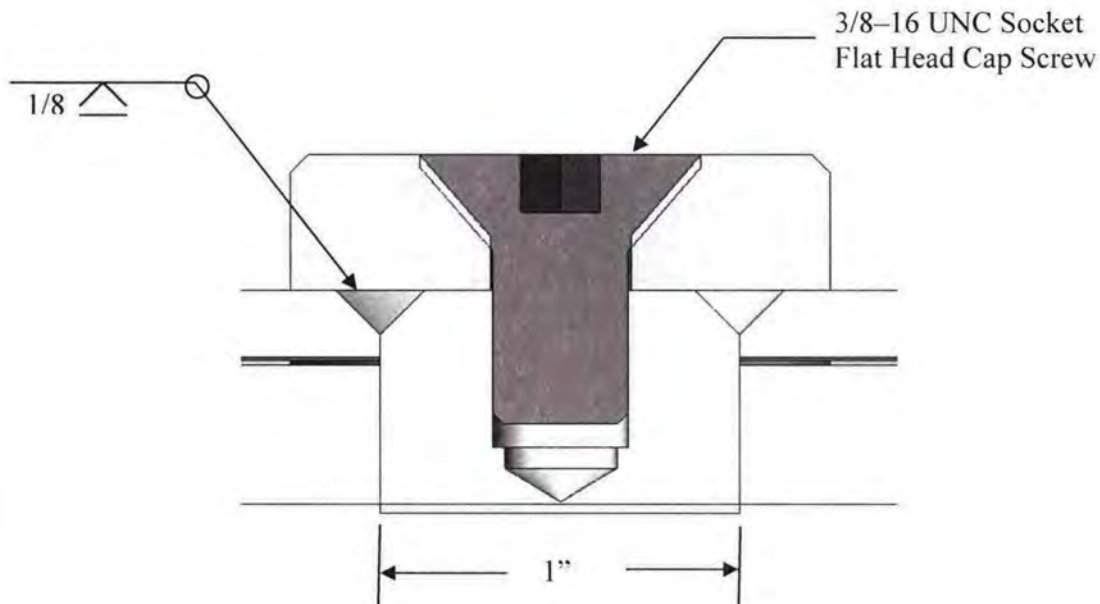
Figure 2.5-2 – Index Lug

The index lugs at each end of the packages are used to align and secure the packages within the array and are subjected to g-loads from neighboring packages. The index lugs are attached to the package by a single flat head, socket cap screw such that horizontal loading causes shearing in the threaded area of the screw as shown in Figure 2.5-2.

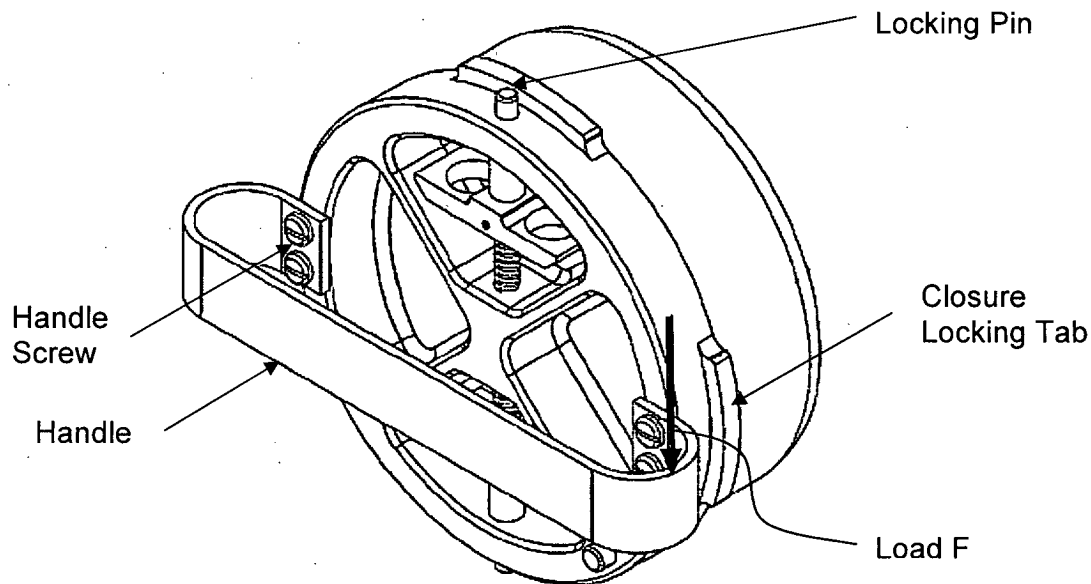
Figure 2.5-3 – Closure Assembly Handle

The closure handle is not considered a structural part of the package but is evaluated here to show that its failure will not impair the ability of the package to meet other requirements. A lifting or tiedown load applied to the closure handle is expected to deform the handle and fail the closure screws causing the handle to become detached from the closure assembly. The closure handle is used only for operator convenience in handling the 10 lb closure assembly by hand. The four small fasteners securing the handle to the closure are designed to fail under light loads

This evaluation conservatively neglects any tension (pulling) on the handle and handle screws since a load in this direction would pull on the closure locking tabs and not the locking pins. A simple comparison between the area of the closure tabs and the area of the handle screws shows that the closure tabs consist of significantly more material and the screws will fail well before any significant loads are applied to the closure tabs.

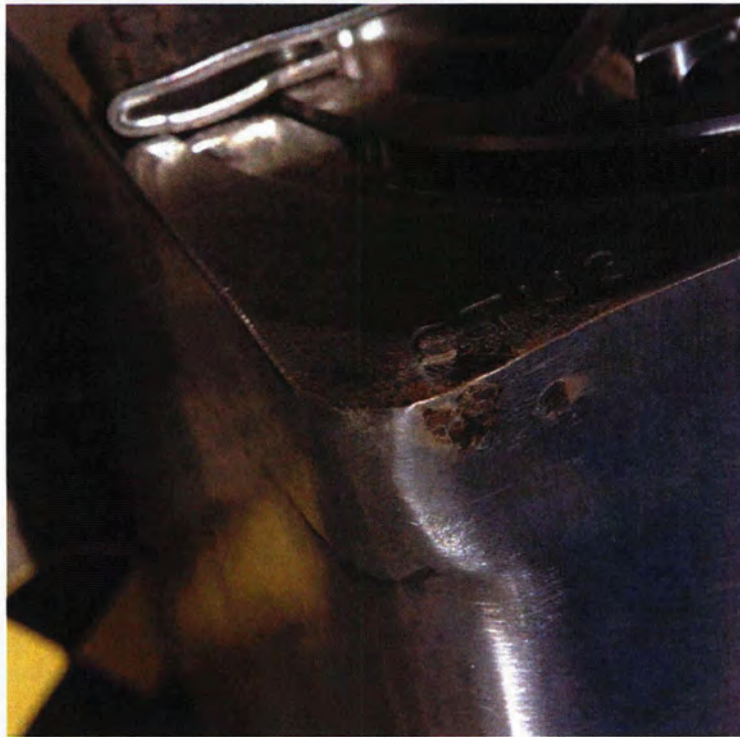
Figure 2.12.1-6 - CN1-1 Impact Damage

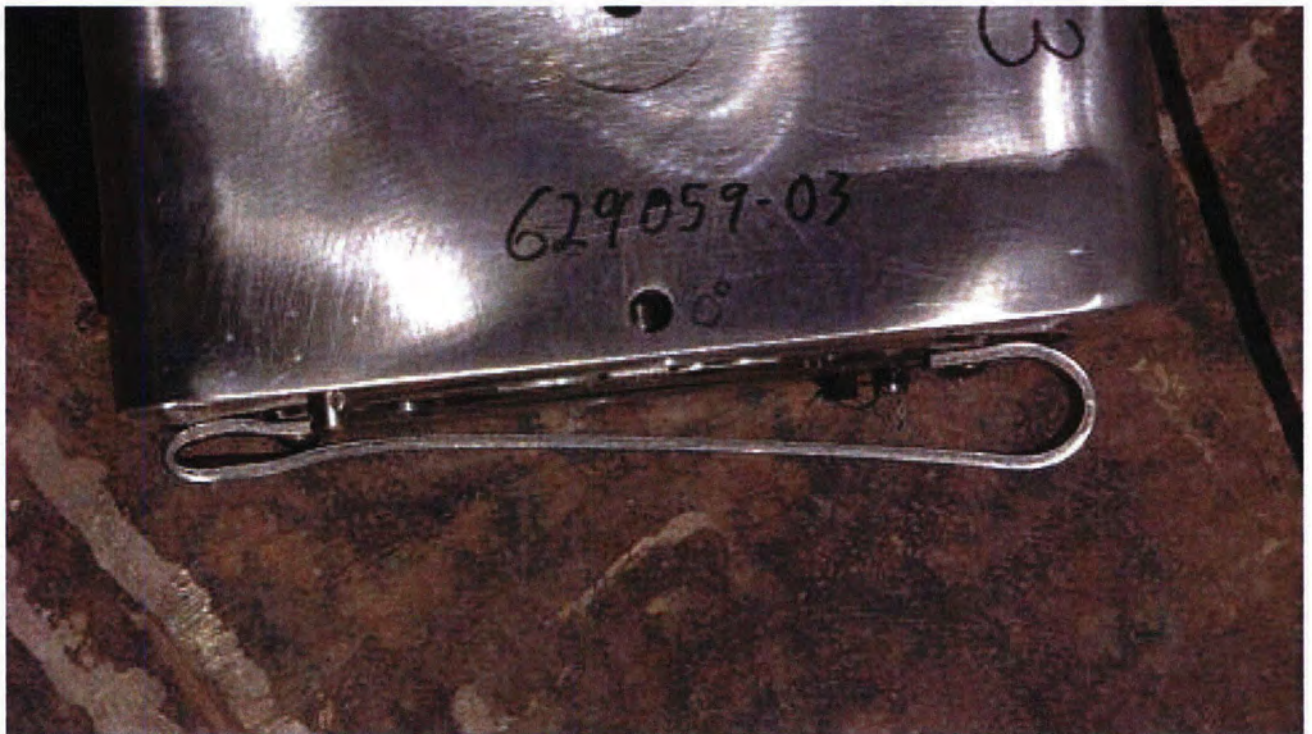
Figure 2.12.1-7 - CN1-1 Impact on Closure Handle

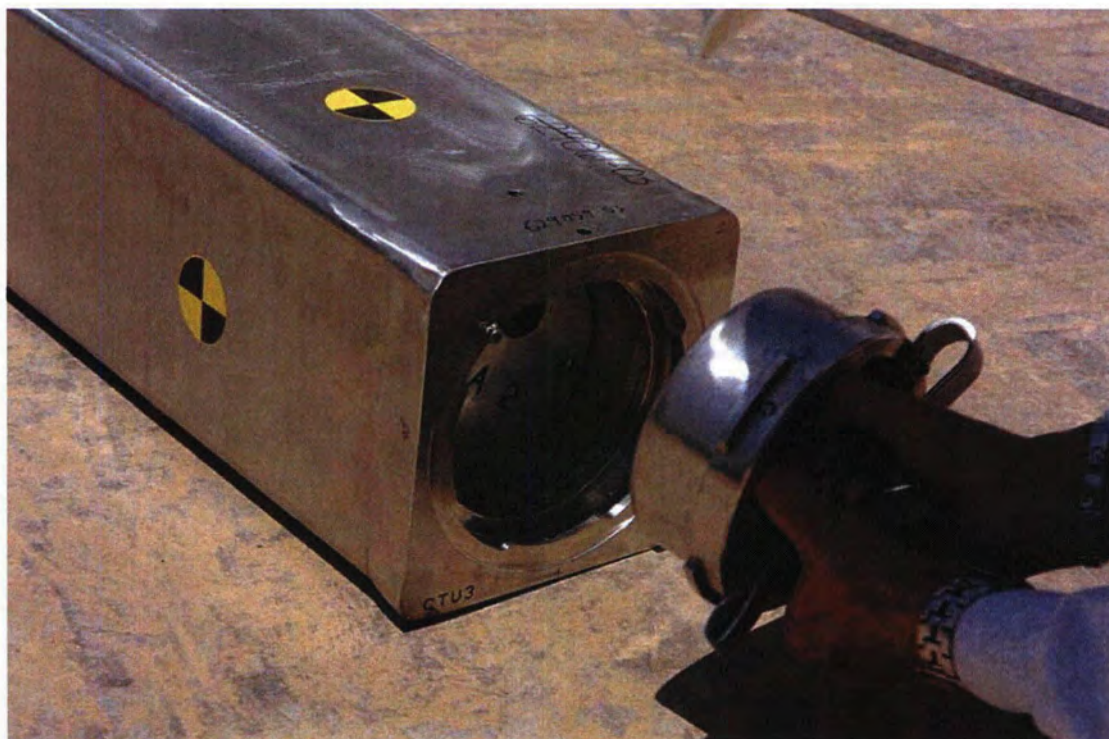
Figure 2.12.1-10 - Opening of CTU Following CD1-1

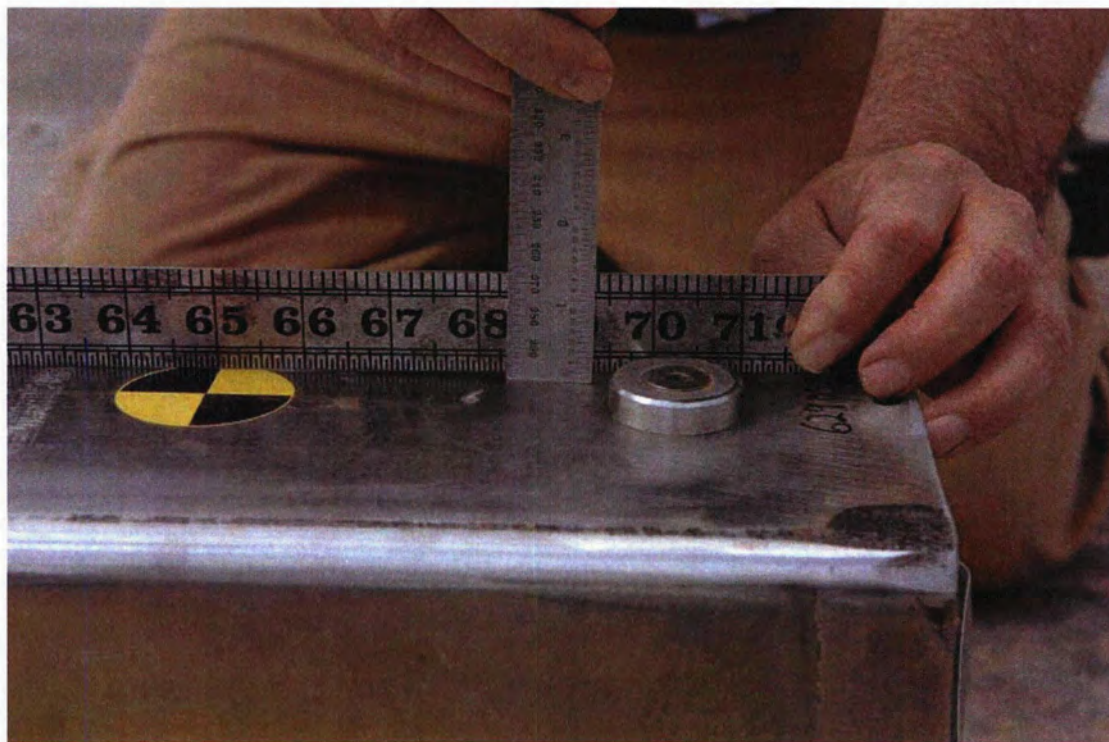
Figure 2.12.1-15 - Index Lug Near Closure End, CD2.A-1

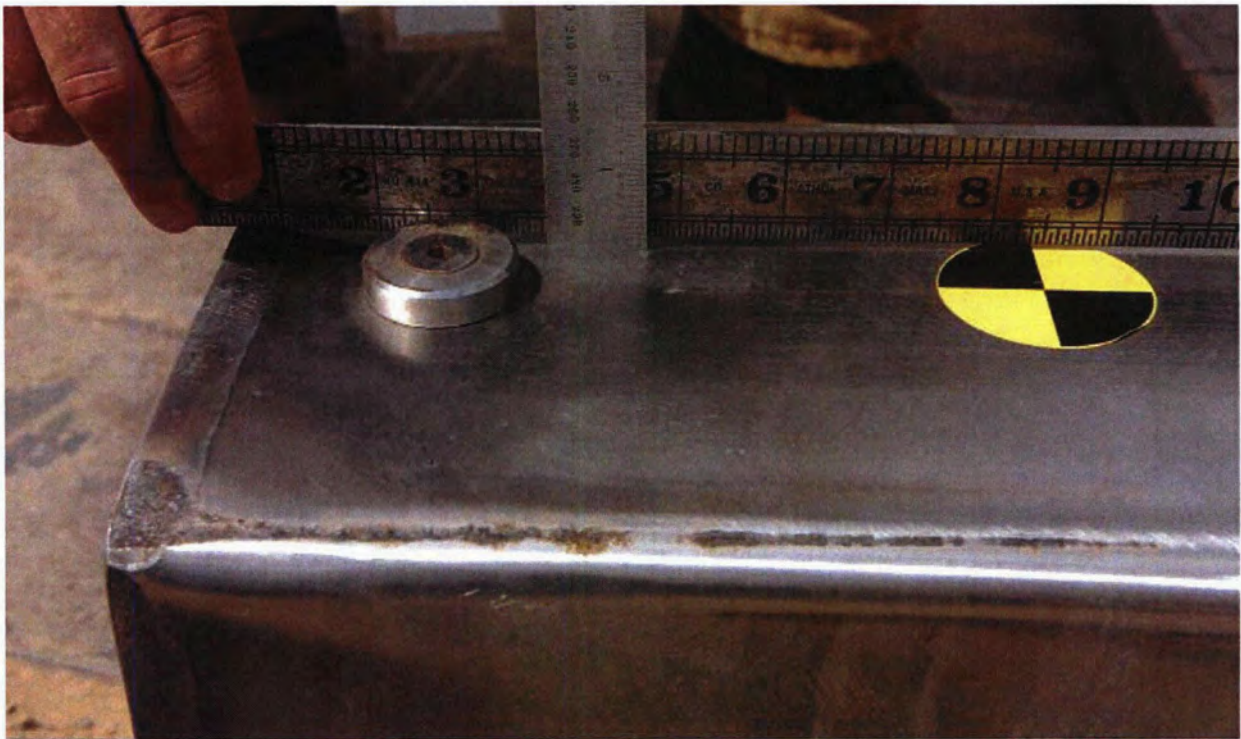
Figure 2.12.1-16 - Index Lug Near Bottom End, CD2.A-1

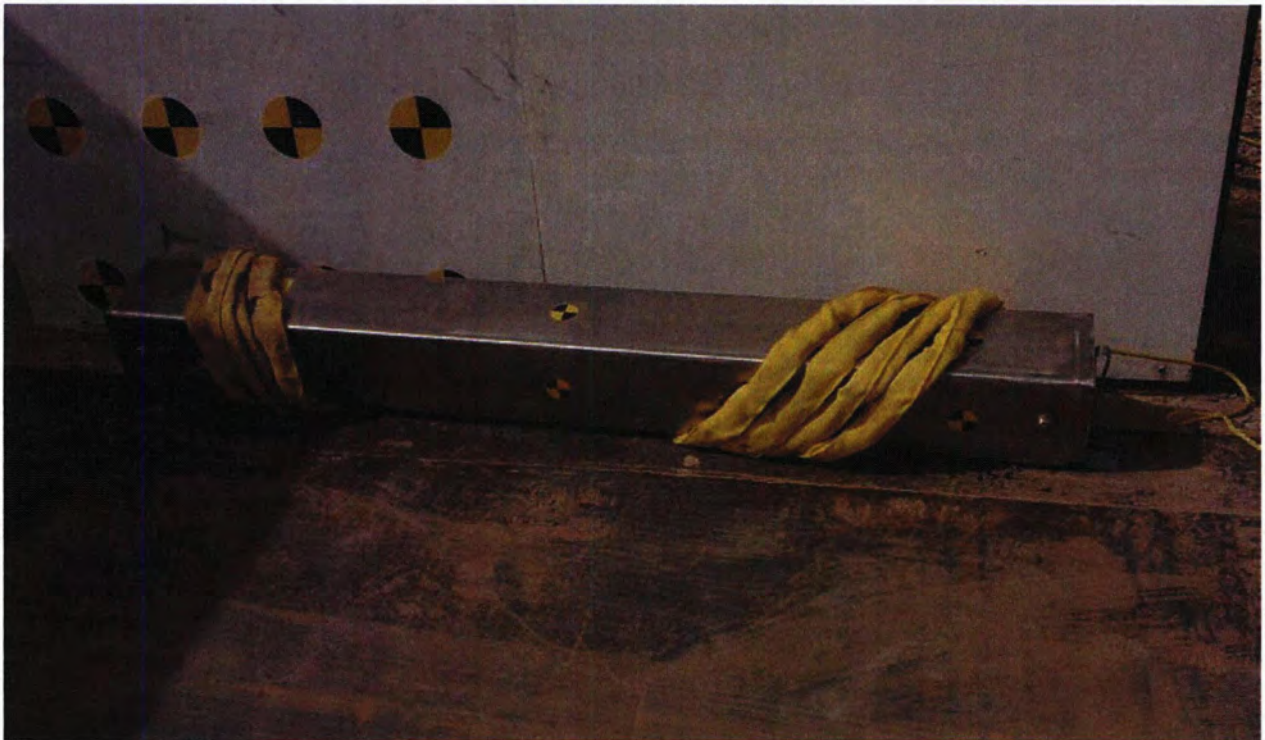
Figure 2.12.1-19 - CTU Position Following CD2.B-1 Drop

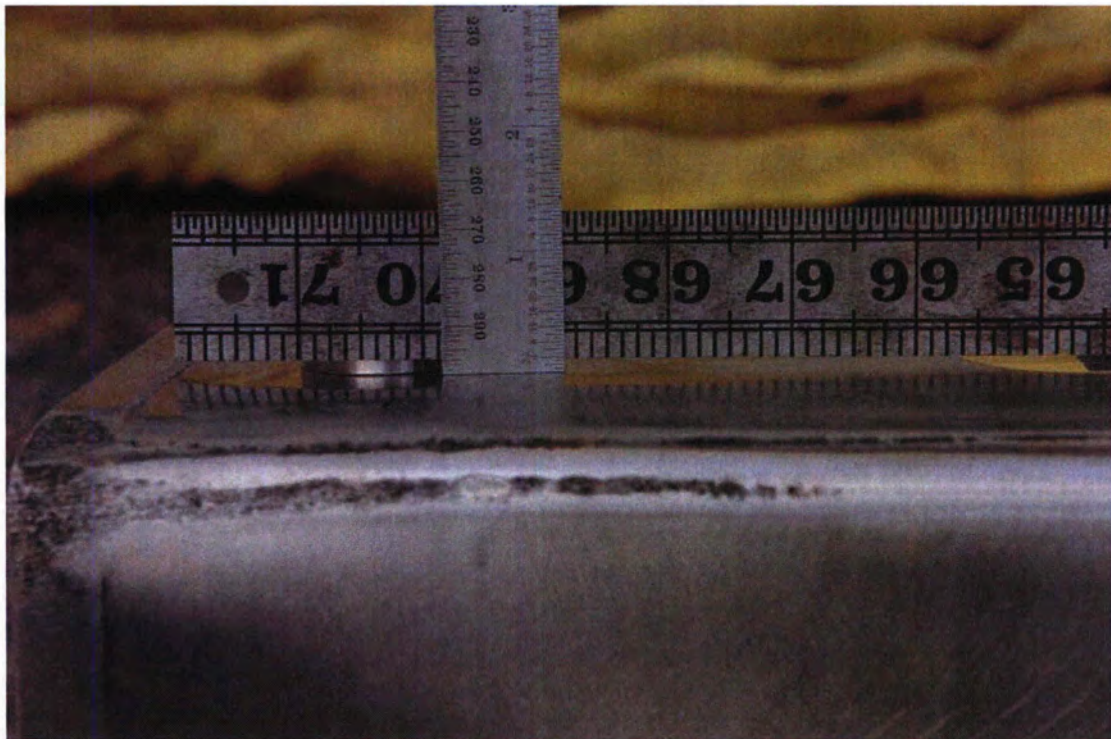
Figure 2.12.1-20 - Index Lug Near Bottom End, CD2.B-1

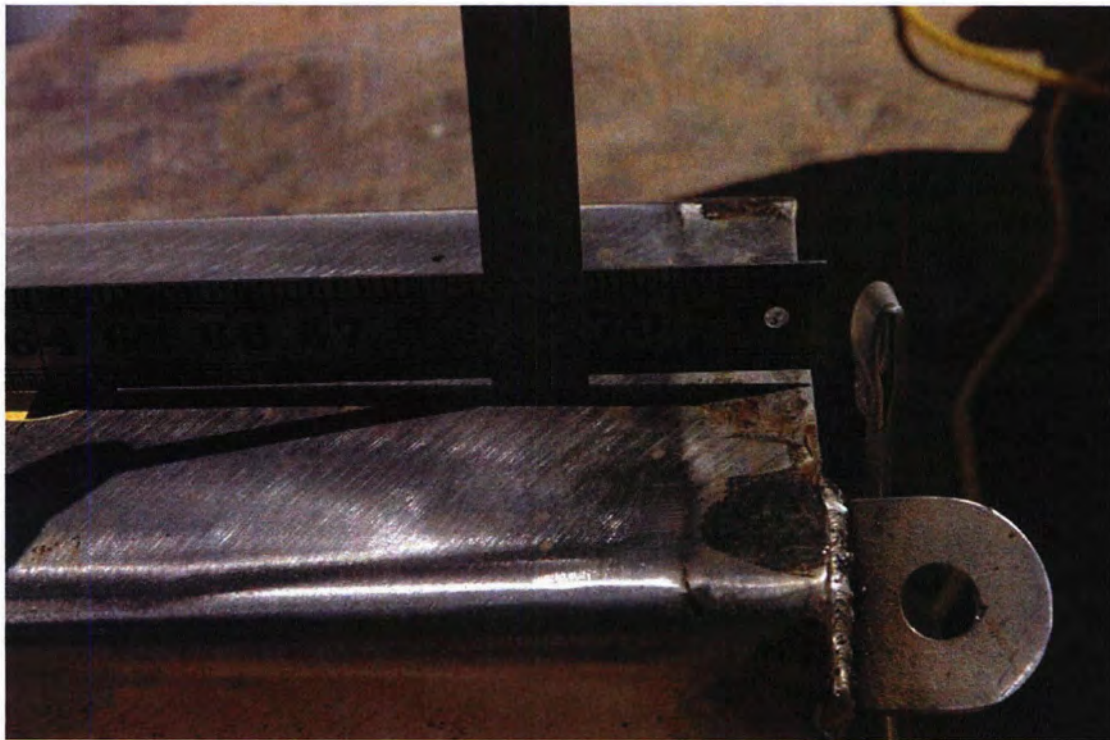
Figure 2.12.1-24 - Deformation Near Closure End Following CD3-1

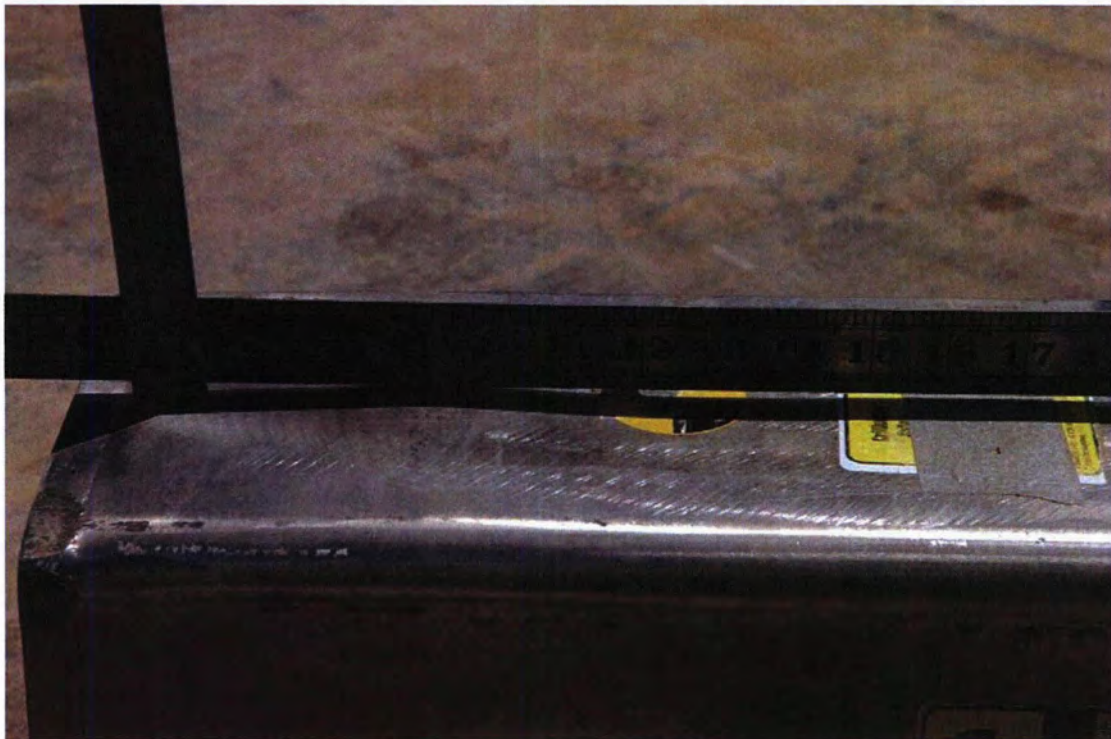
Figure 2.12.1-28 - View of Side Bowing Following CD4-1

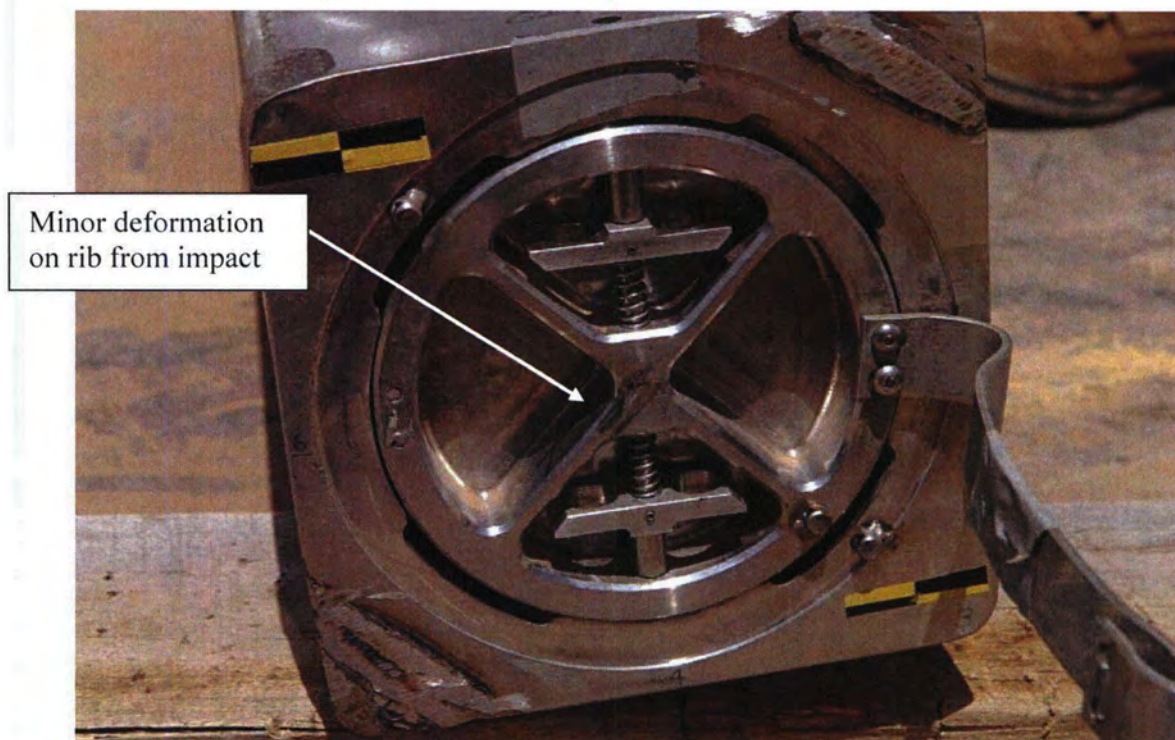
Figure 2.12.1-31 - CTU Following CP3-1 Impact

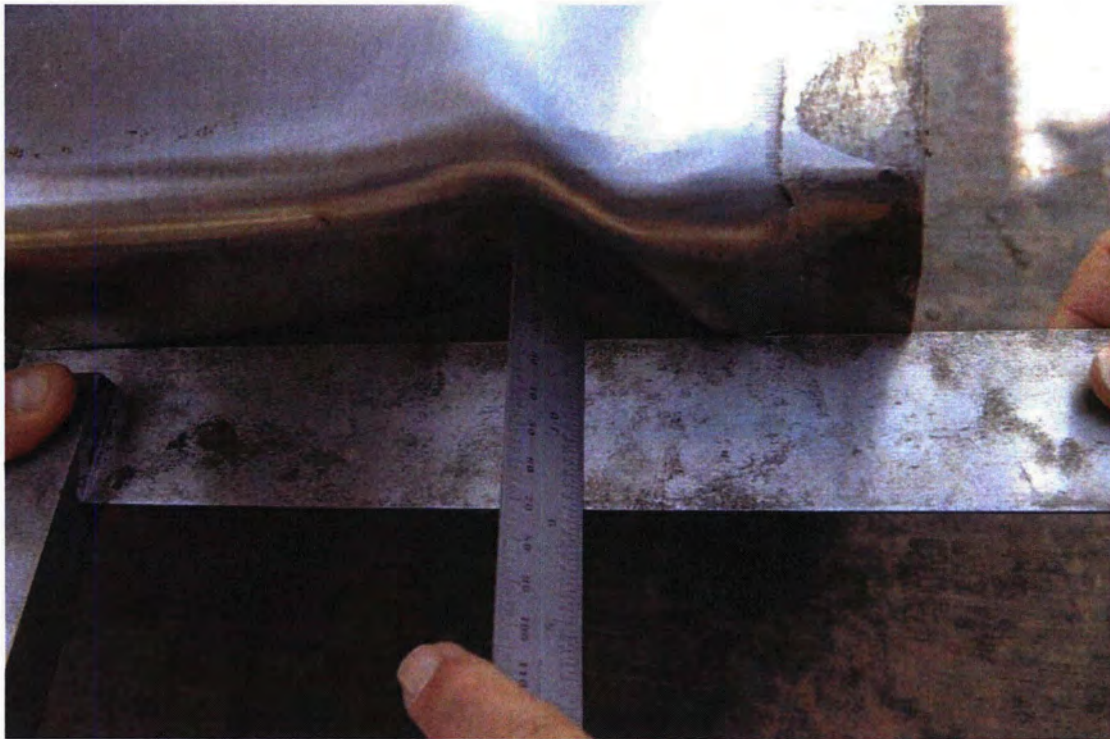
Figure 2.12.1-34 - CD5-1 Impact Damage on Bottom 180° Side

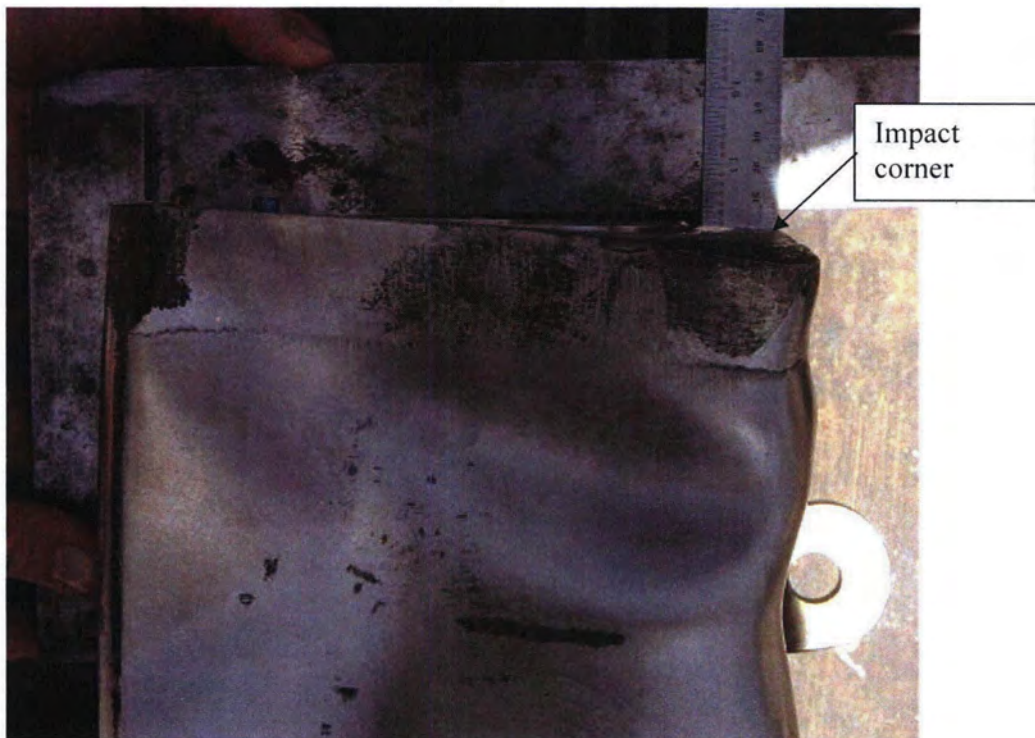
Figure 2.12.1-35 - CD5-1 Impact Damage on Closure End

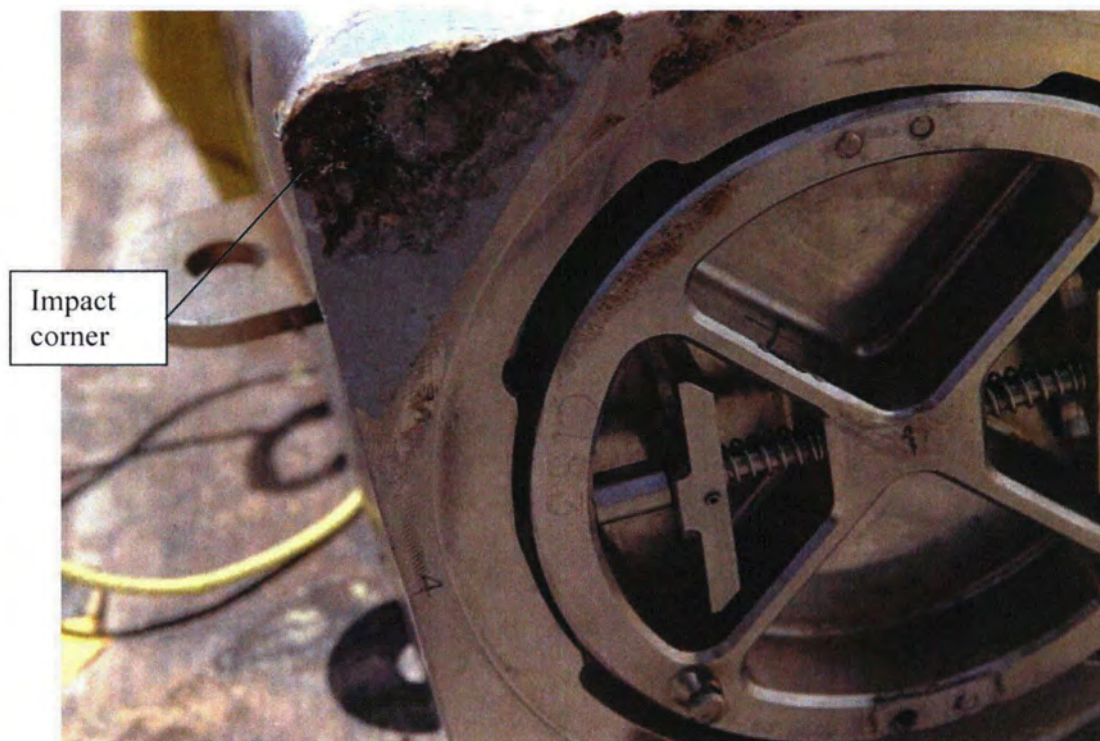
Figure 2.12.1-36 - CD5-1 Impact Damage on Closure Area

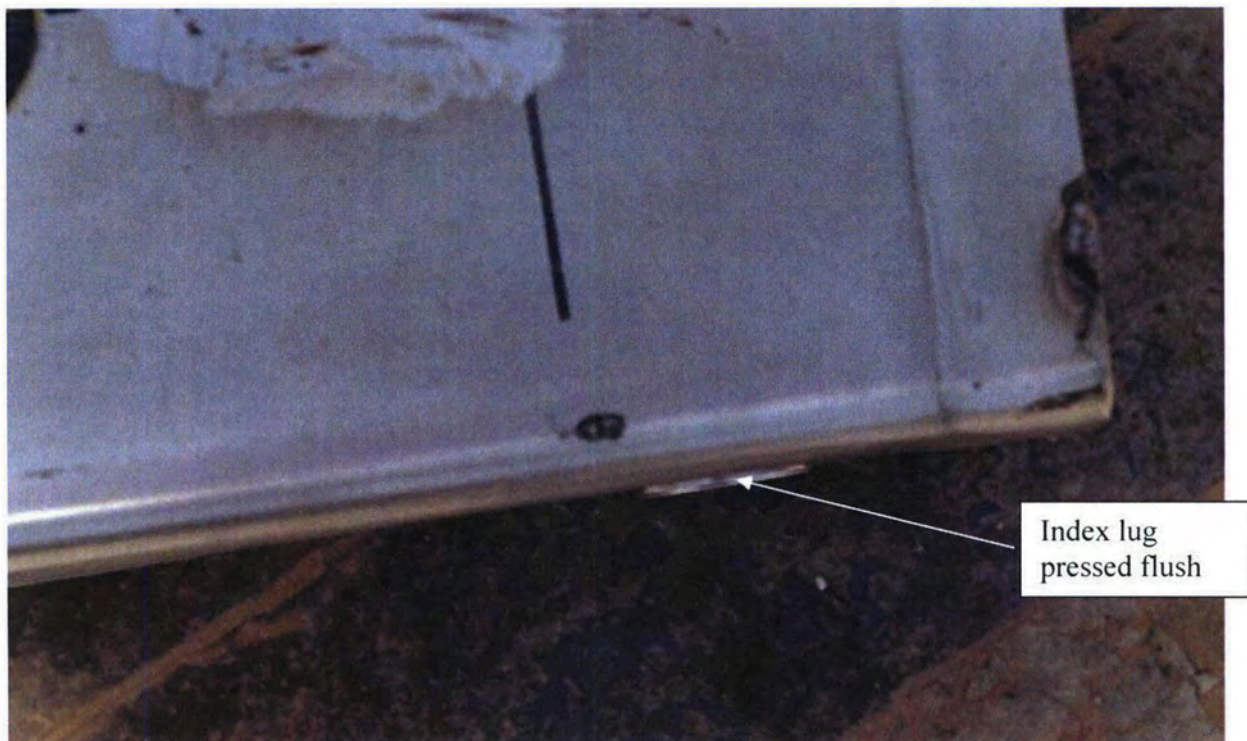
Figure 2.12.1-38 - Side View of CTU Following CD2.C-1 Drop

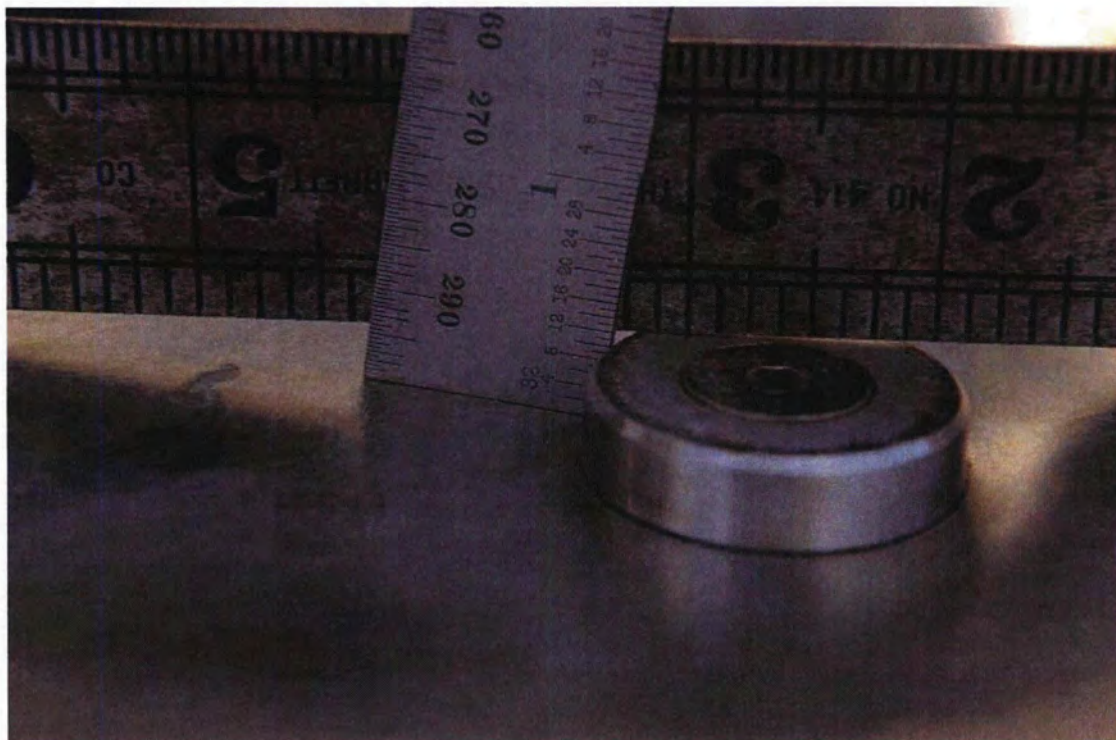
Figure 2.12.1-39 - Index Lug Near Closure End, CD2.C-1

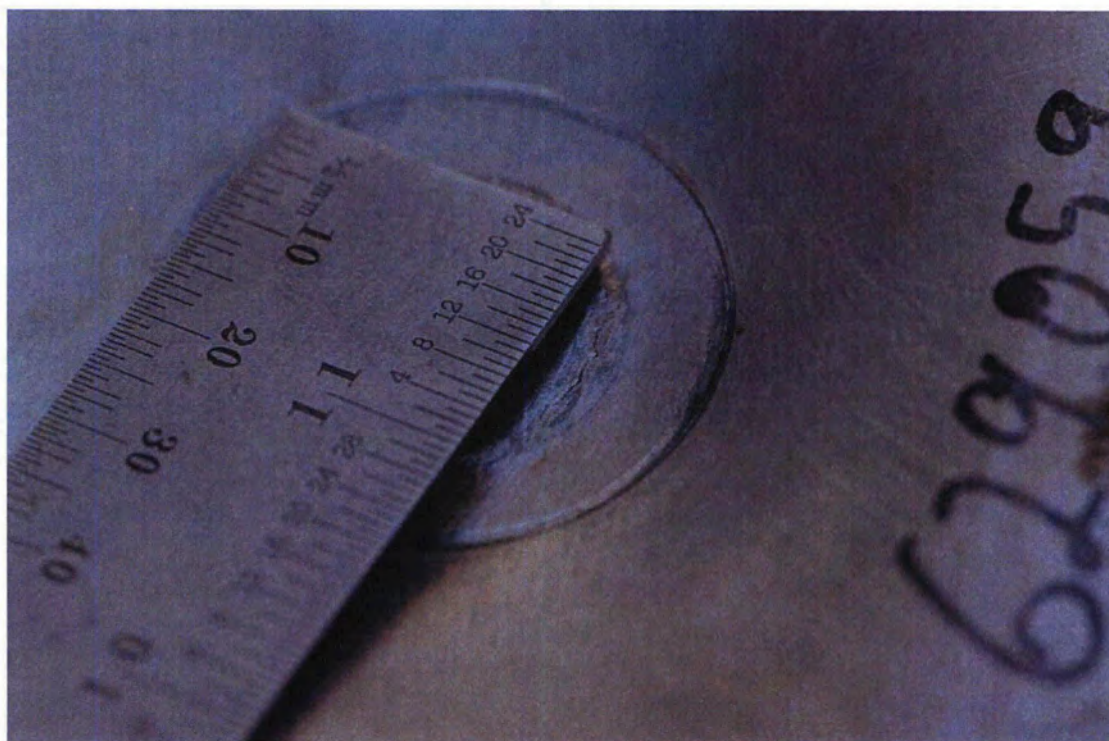
Figure 2.12.1-40 - Cracked Weld Under Index Lug, CD2.C-1

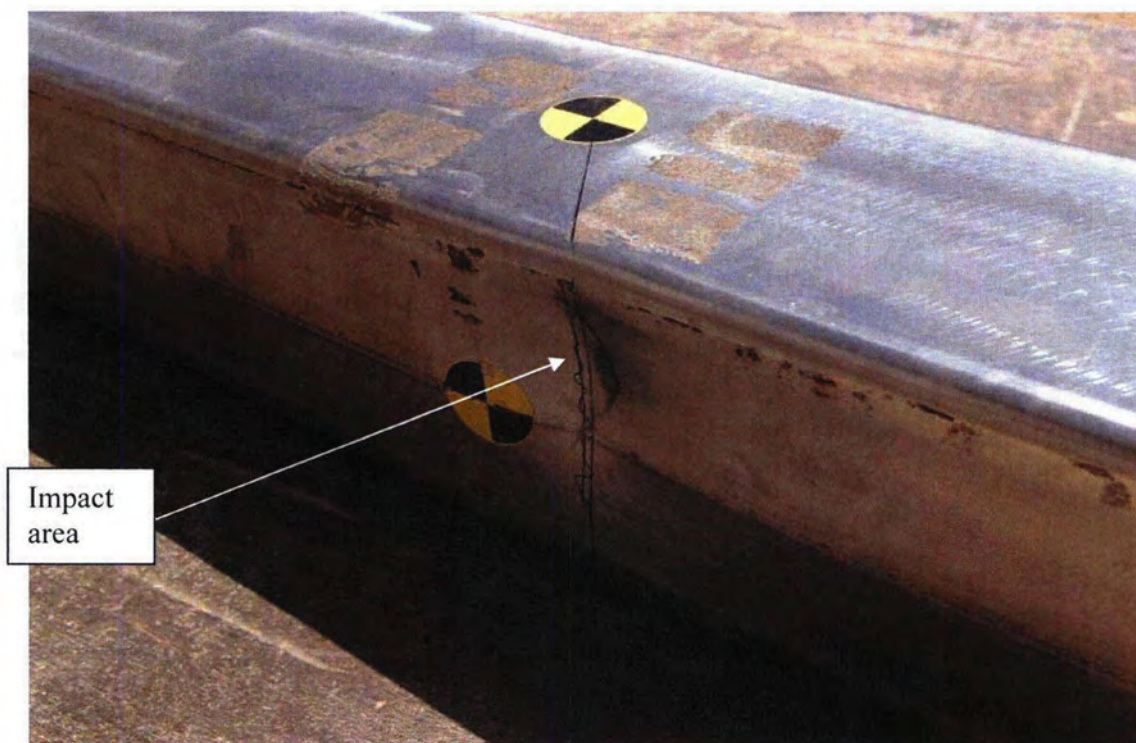
Figure 2.12.1-42 - CTU Following CP2-1 Impact

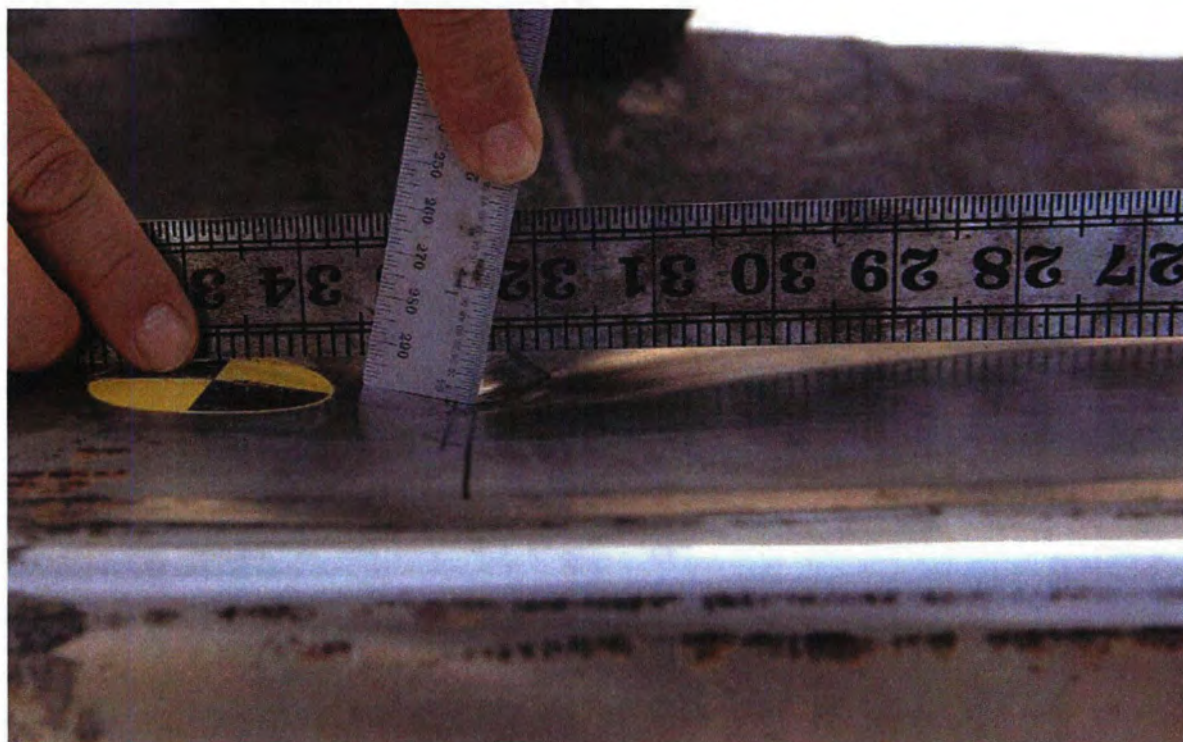
Figure 2.12.1-43 - CP2-1 Impact Damage

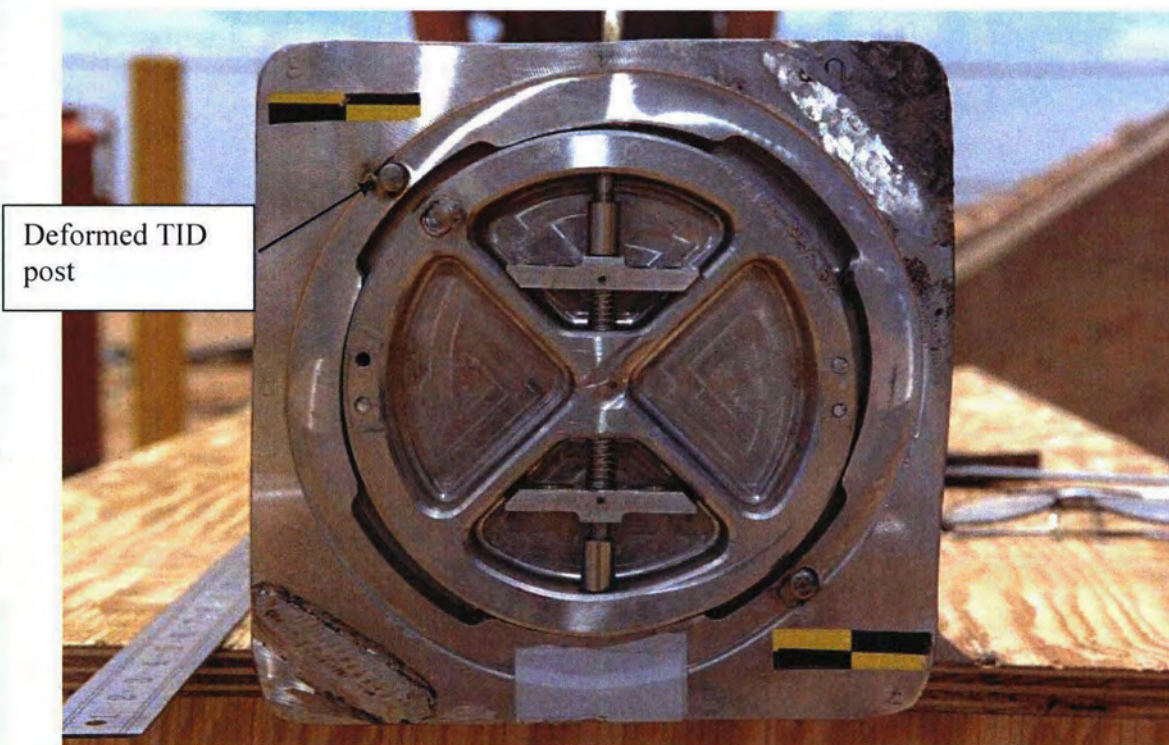
Figure 2.12.1-46 - CP1-1 Impact Damage (Shown Index Lugs Down)

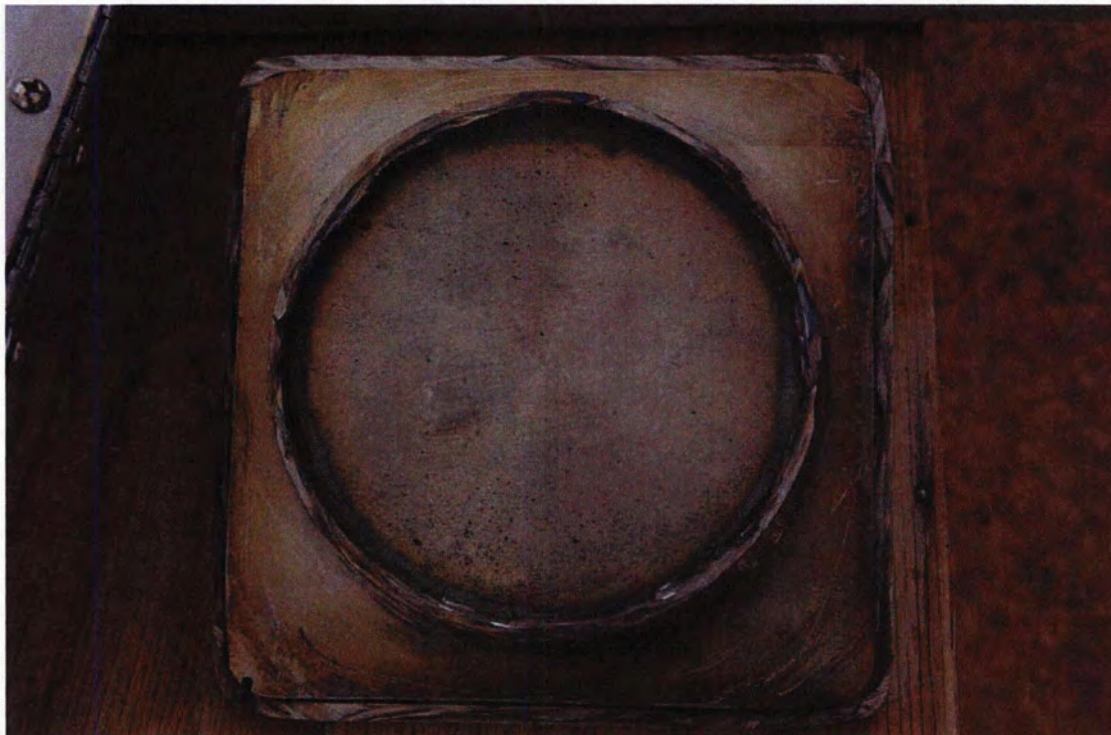
Figure 2.12.1-51 - Bottom End Plate Condition
