Safety Analysis Report

Advanced Test Reactor Fresh Fuel Shipping Container (ATR FFSC)

Revision 1, April 2008

Docket 71-9330

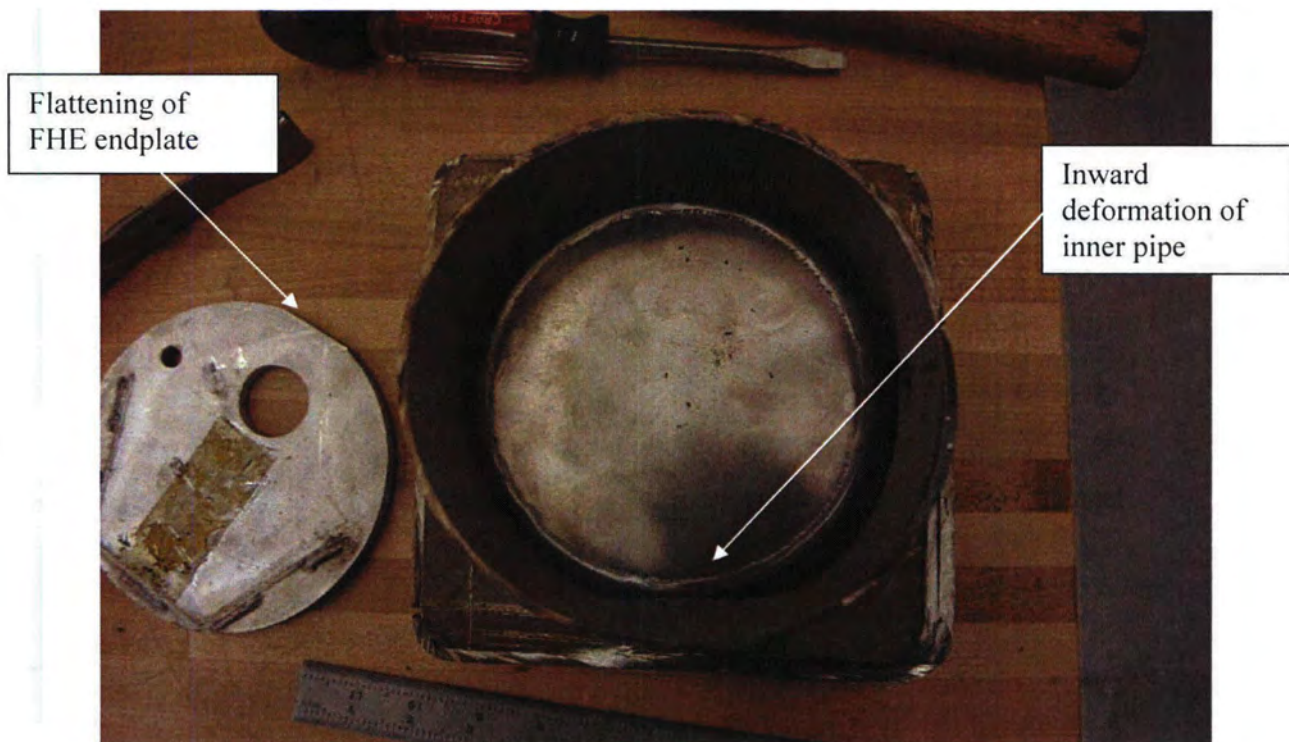
Figure 2.12.1-53 - Inner Tube Deformation at Closure End

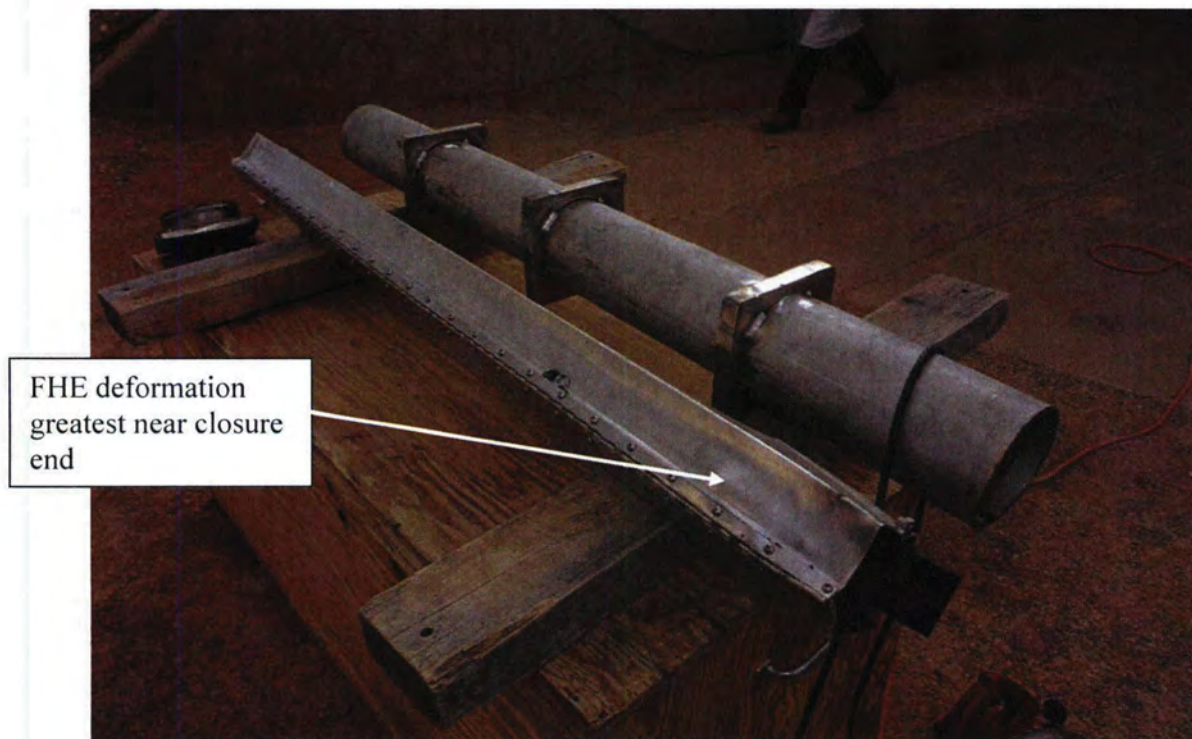
Figure 2.12.1-56 - Fuel Handling Enclosure Deformation

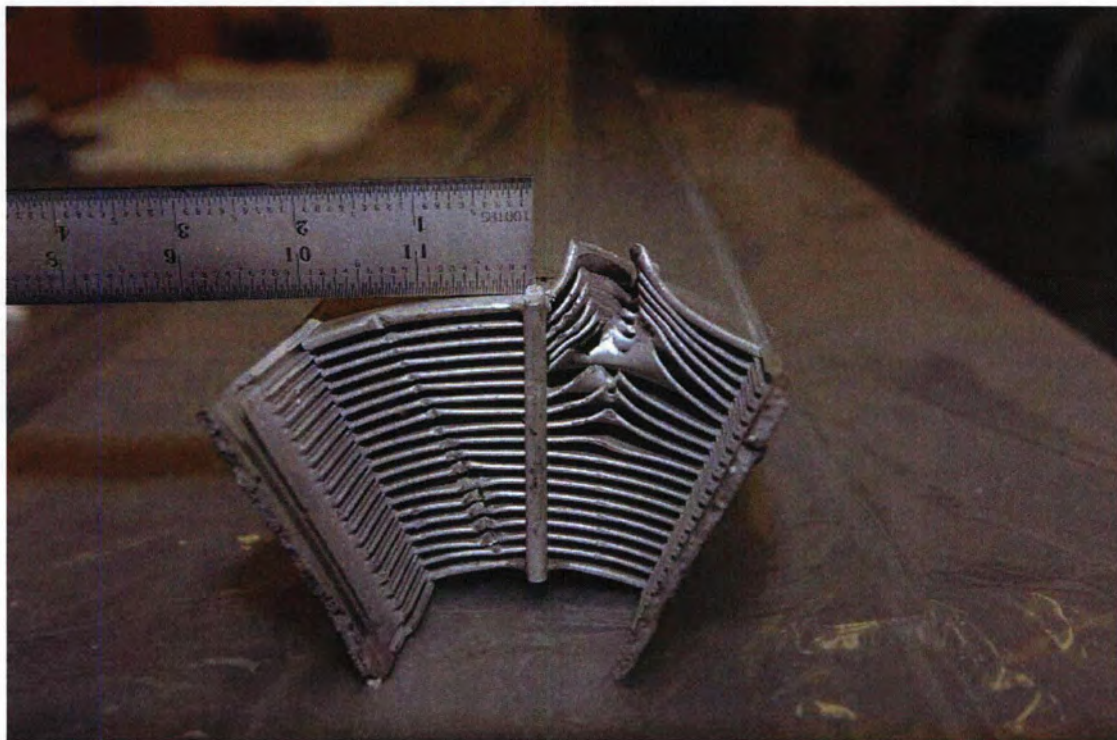
Figure 2.12.1-59 - ATR Fuel Element Damage at Bottom End

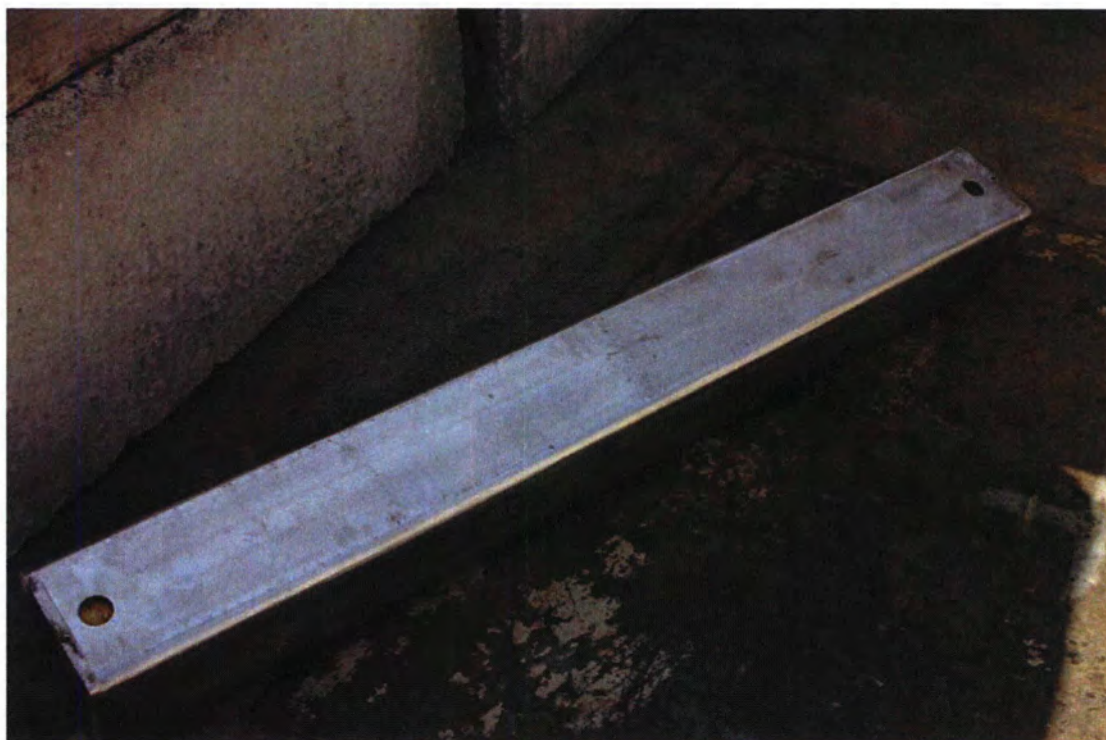
Figure 2.12.2-6 - CTU Following CD1-2 Impact
(impact side facing up)

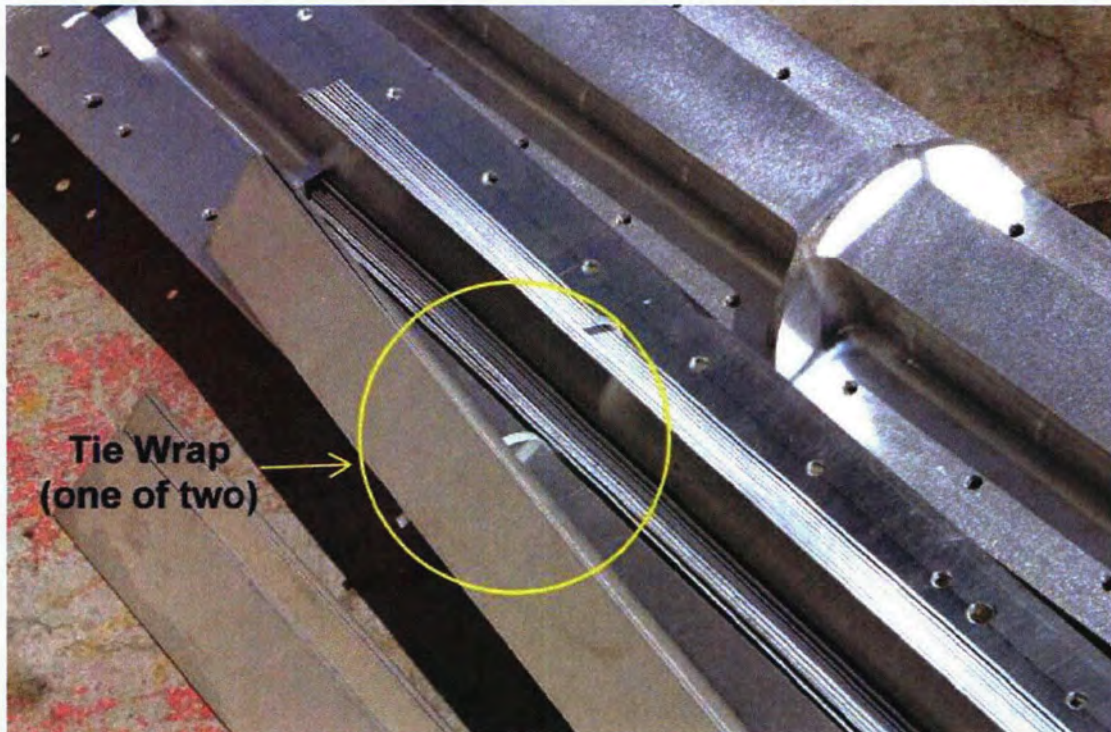
Figure 2.12.2-10 - CD3-2 - Failed tie wraps

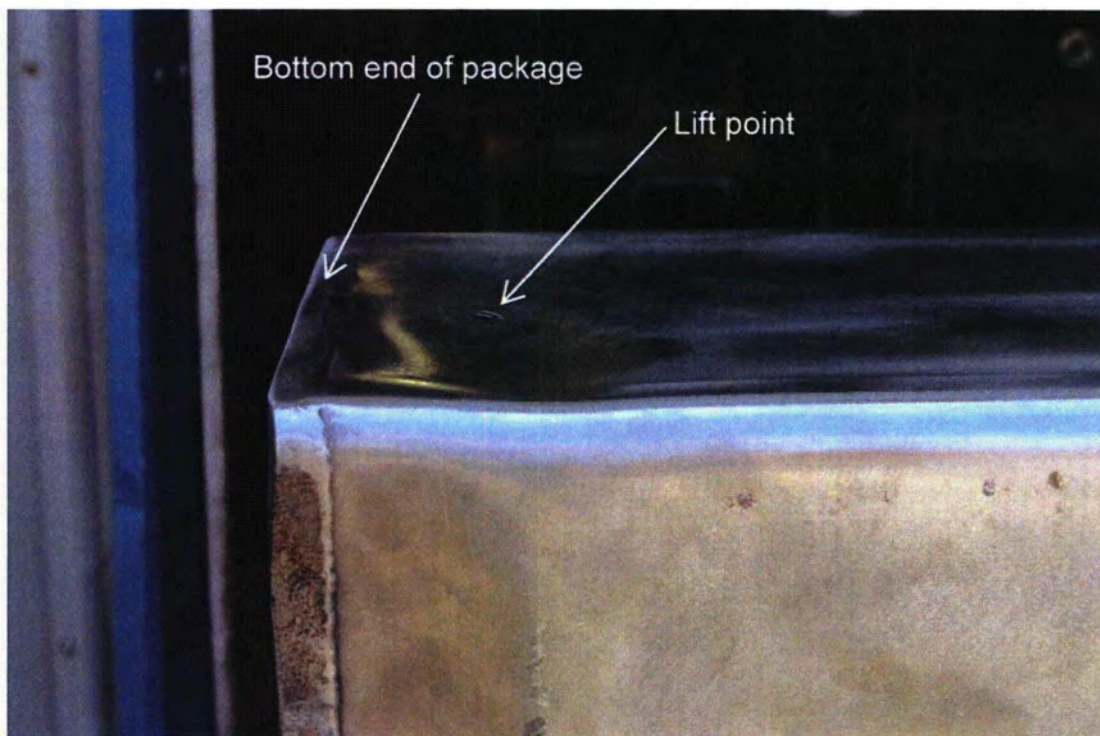
Figure 2.12.2-12 - CD4-2 Impact Damage to Package

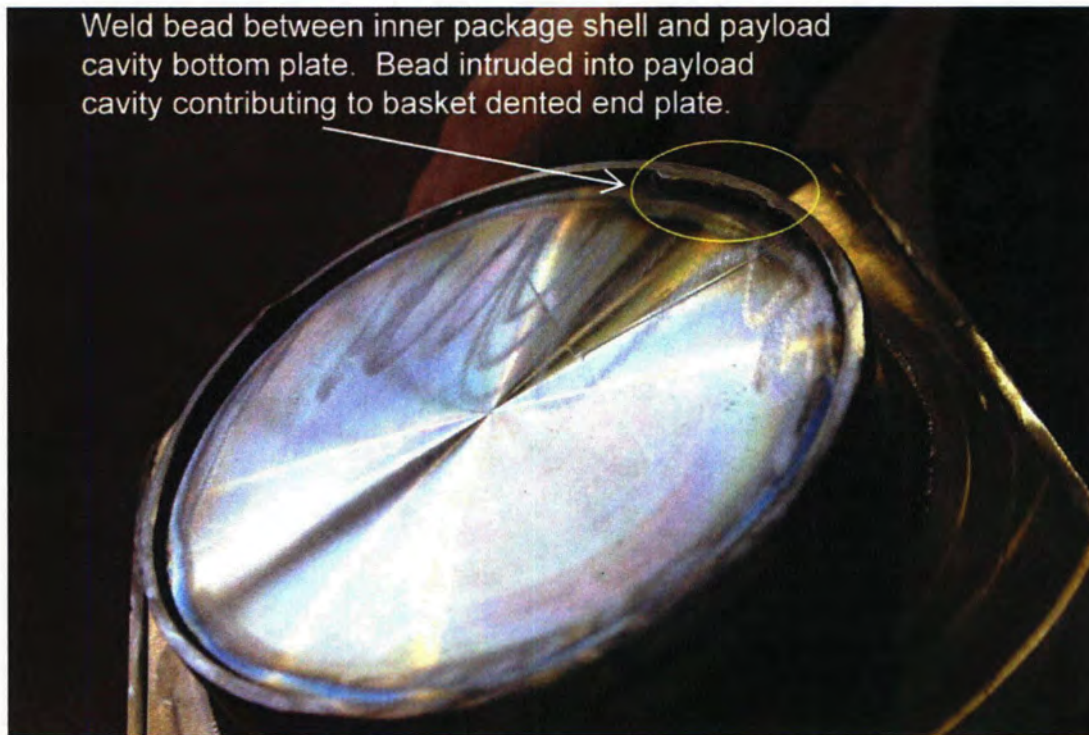
Figure 2.12.2-13 - Weld bead protruding into package payload cavity (inner shell has been removed in this photo)

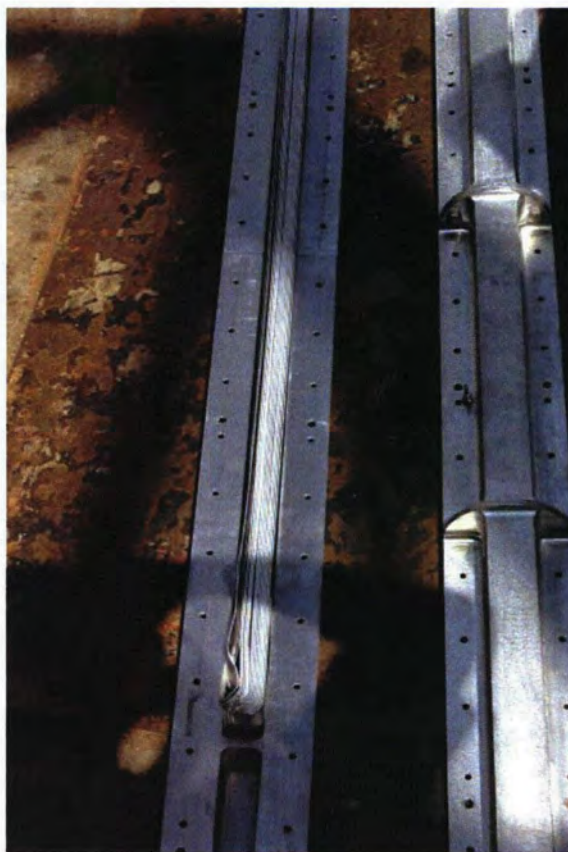
Figure 2.12.2-15 - CD4-2 Impact Damage to Simulated Fuel Plates

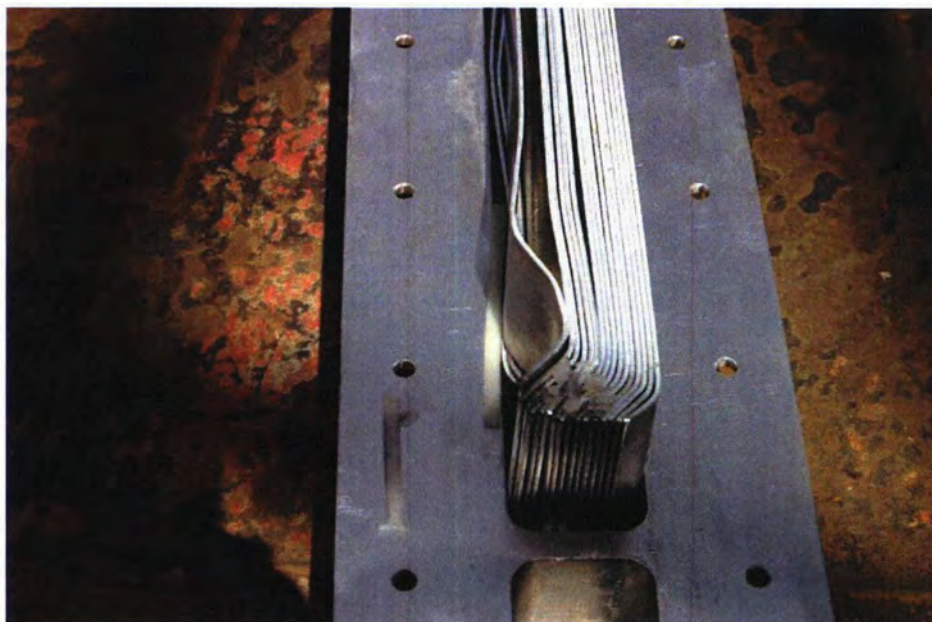
Figure 2.12.2-16 - CD4-2 Impact Damage to Simulated Fuel Plates (close up view)

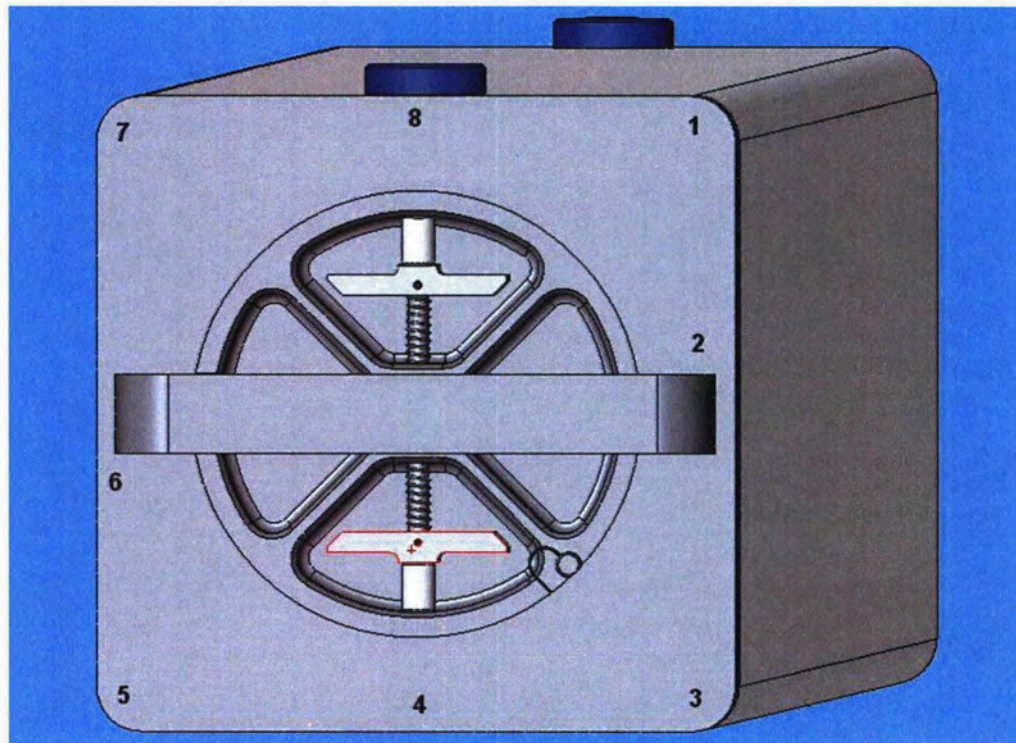
Figure 2.12.2-17 - CTU Measurement Locations

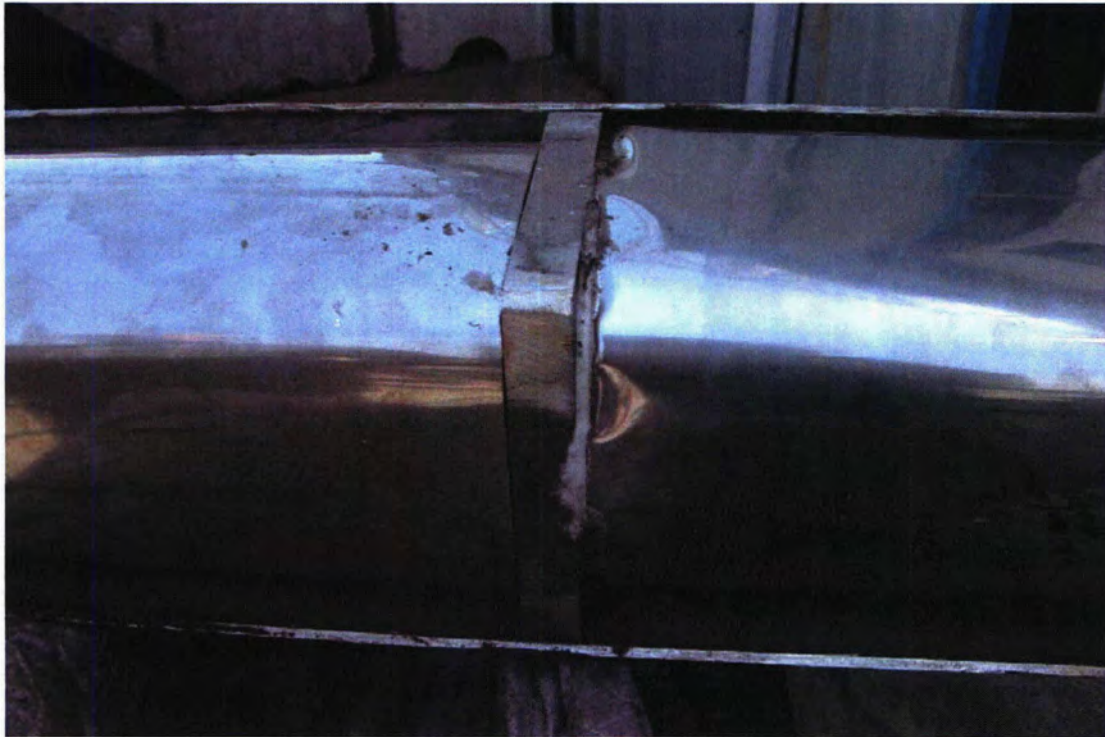
Figure 2.12.2-21 - Thermal Shields at Interface to Stiffening Rib

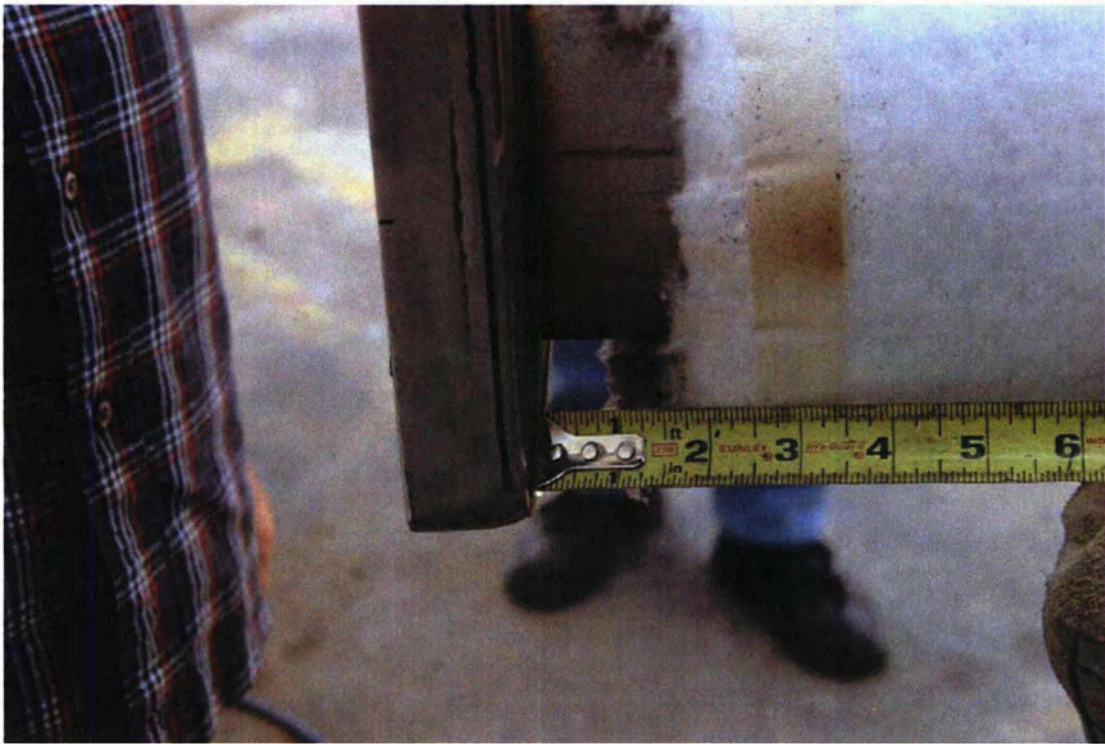
Figure 2.12.2-23 - Insulation Gap at Package Closure End

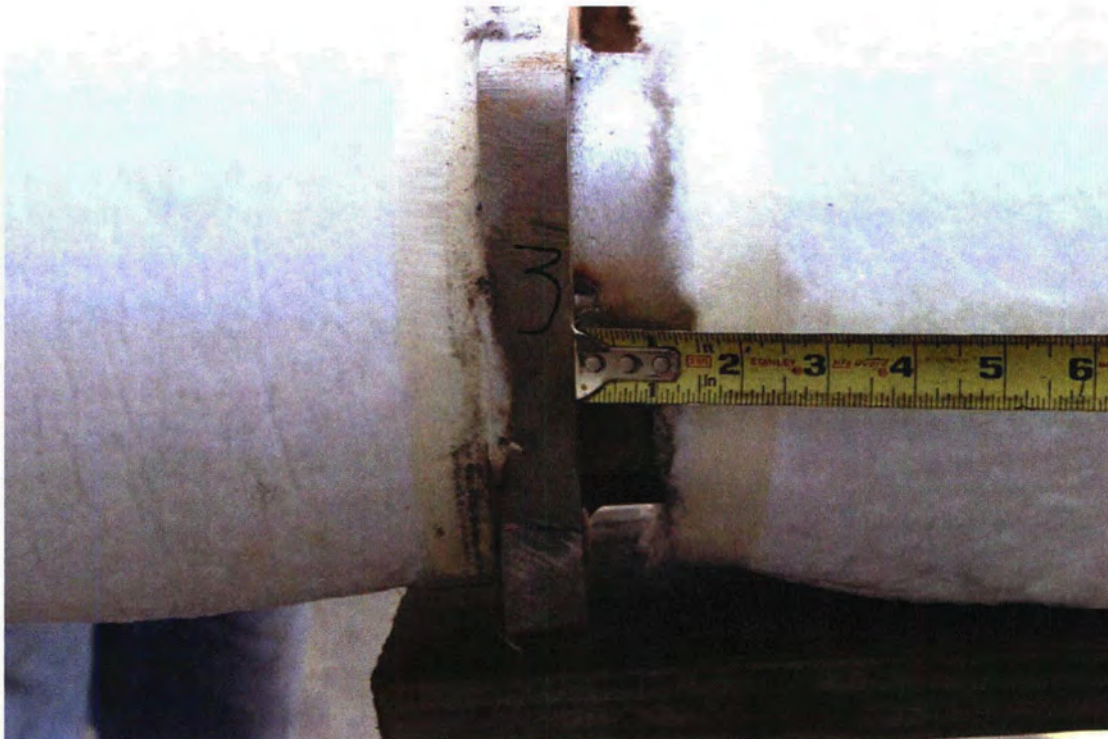
Figure 2.12.2-24 - Insulation Gap at Rib #3

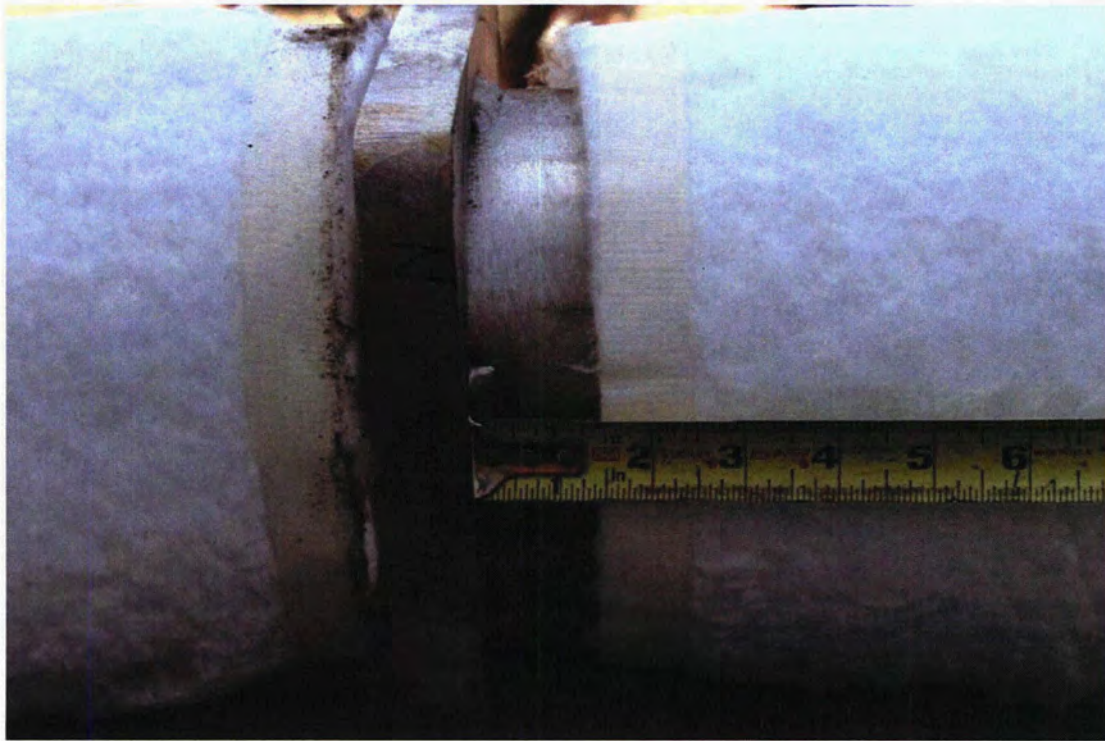
Figure 2.12.2-25 - Insulation Gap at Rib #2

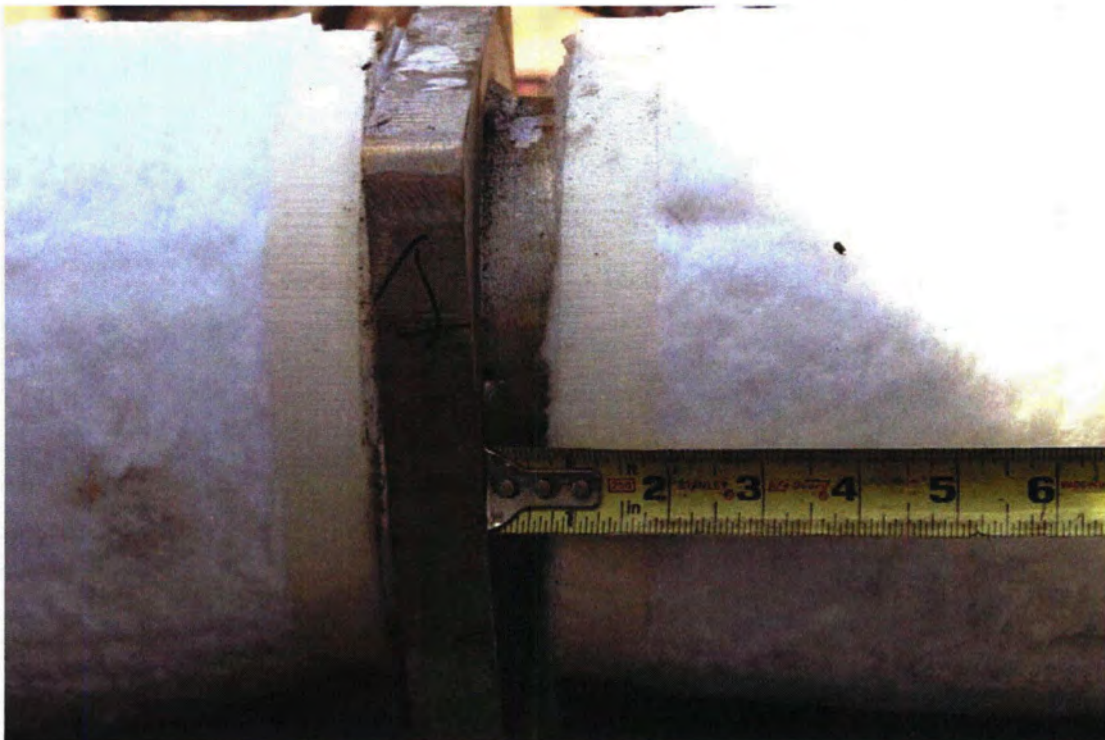
Figure 2.12.2-26 - Insulation Gap at Rib #1 (nearest impact)
