PROGRESS ENERGY FLORIDA  
LEVY NUCLEAR PLANT

#### COMMON ROUTE LISTED SPECIES MAP

**PROJECT TITLE:**  
SPECIFIC PURPOSE SURVEY OF WETLAND JURISDICTIONAL DELINEATION  
AND THREATENED AND ENDANGERED SPECIES

**PROGRESS ENERGY FLORIDA COMMON ROUTE**  
from CR40 South to Citrus Substation  
Levy and Citrus County, Florida

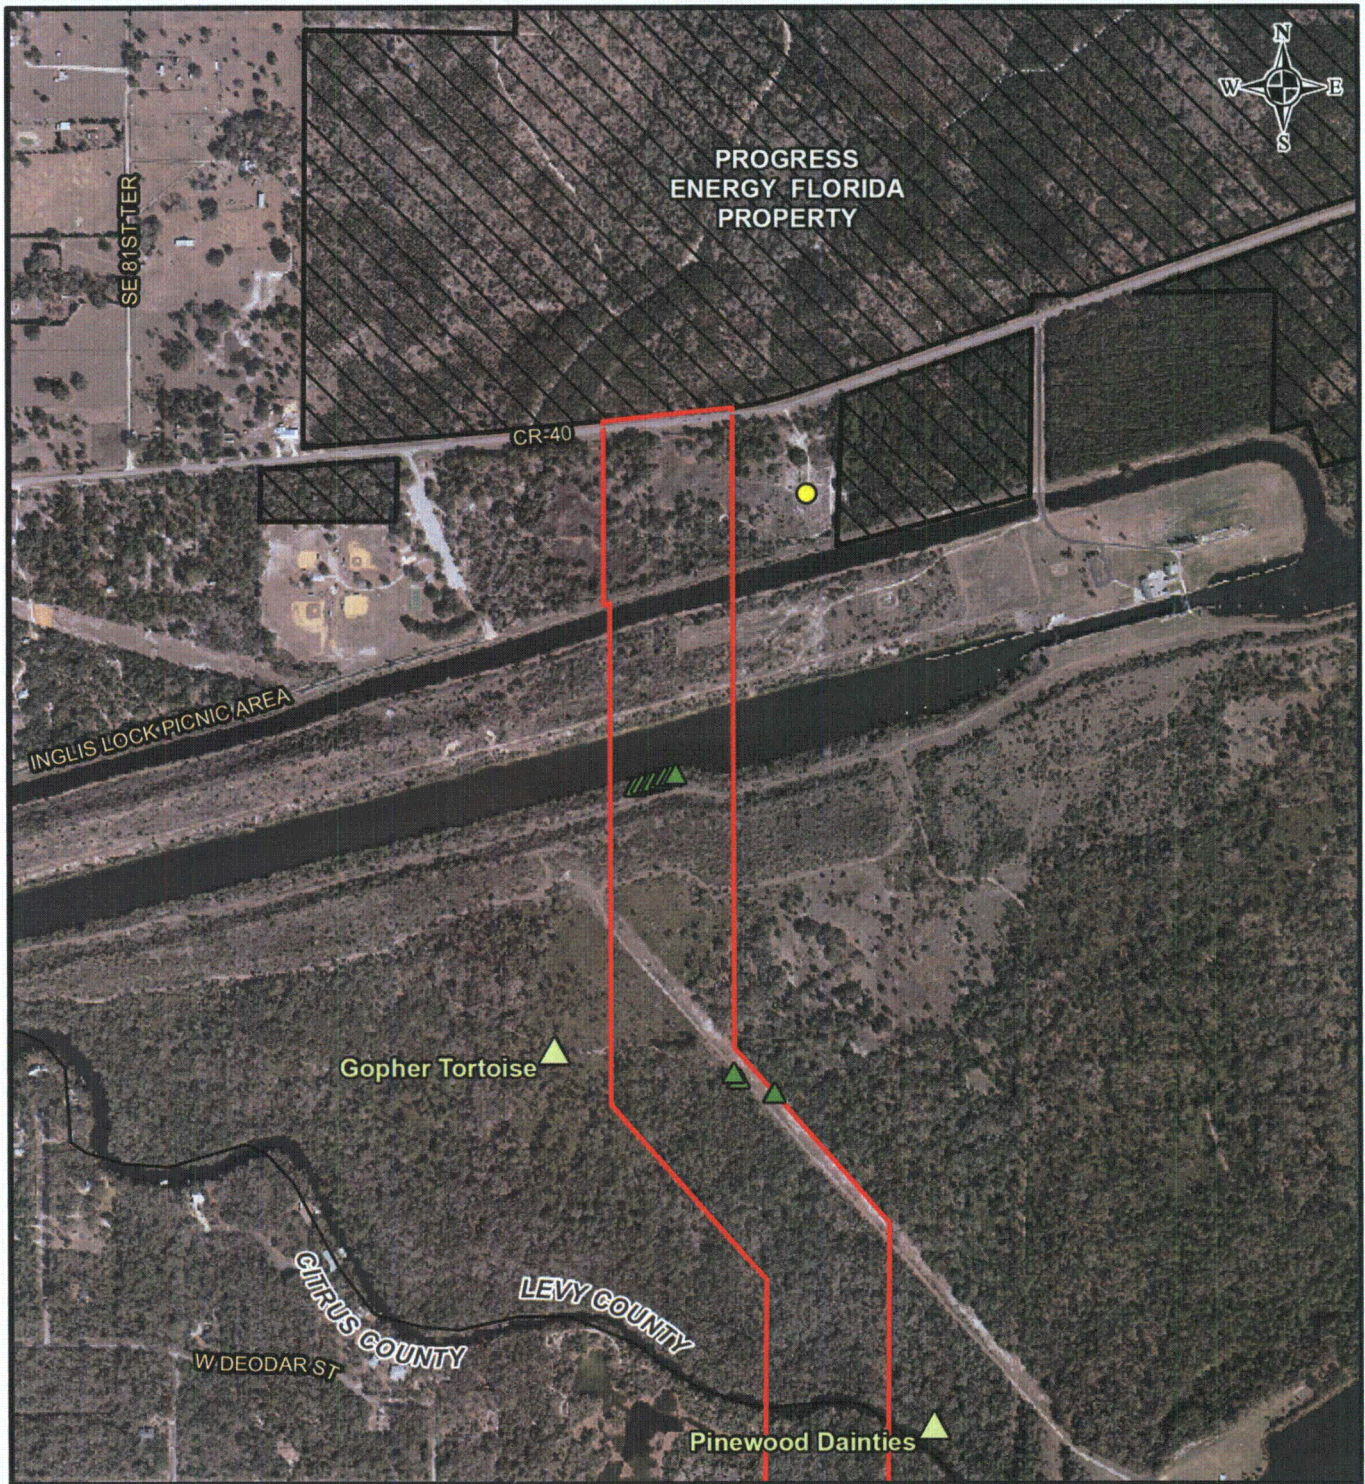
**FIGURE 6**  
**PAGE 1 OF 3**

**NOTE: No portion of the Common Corridor lies within Wood Stork Core Foraging Areas.**

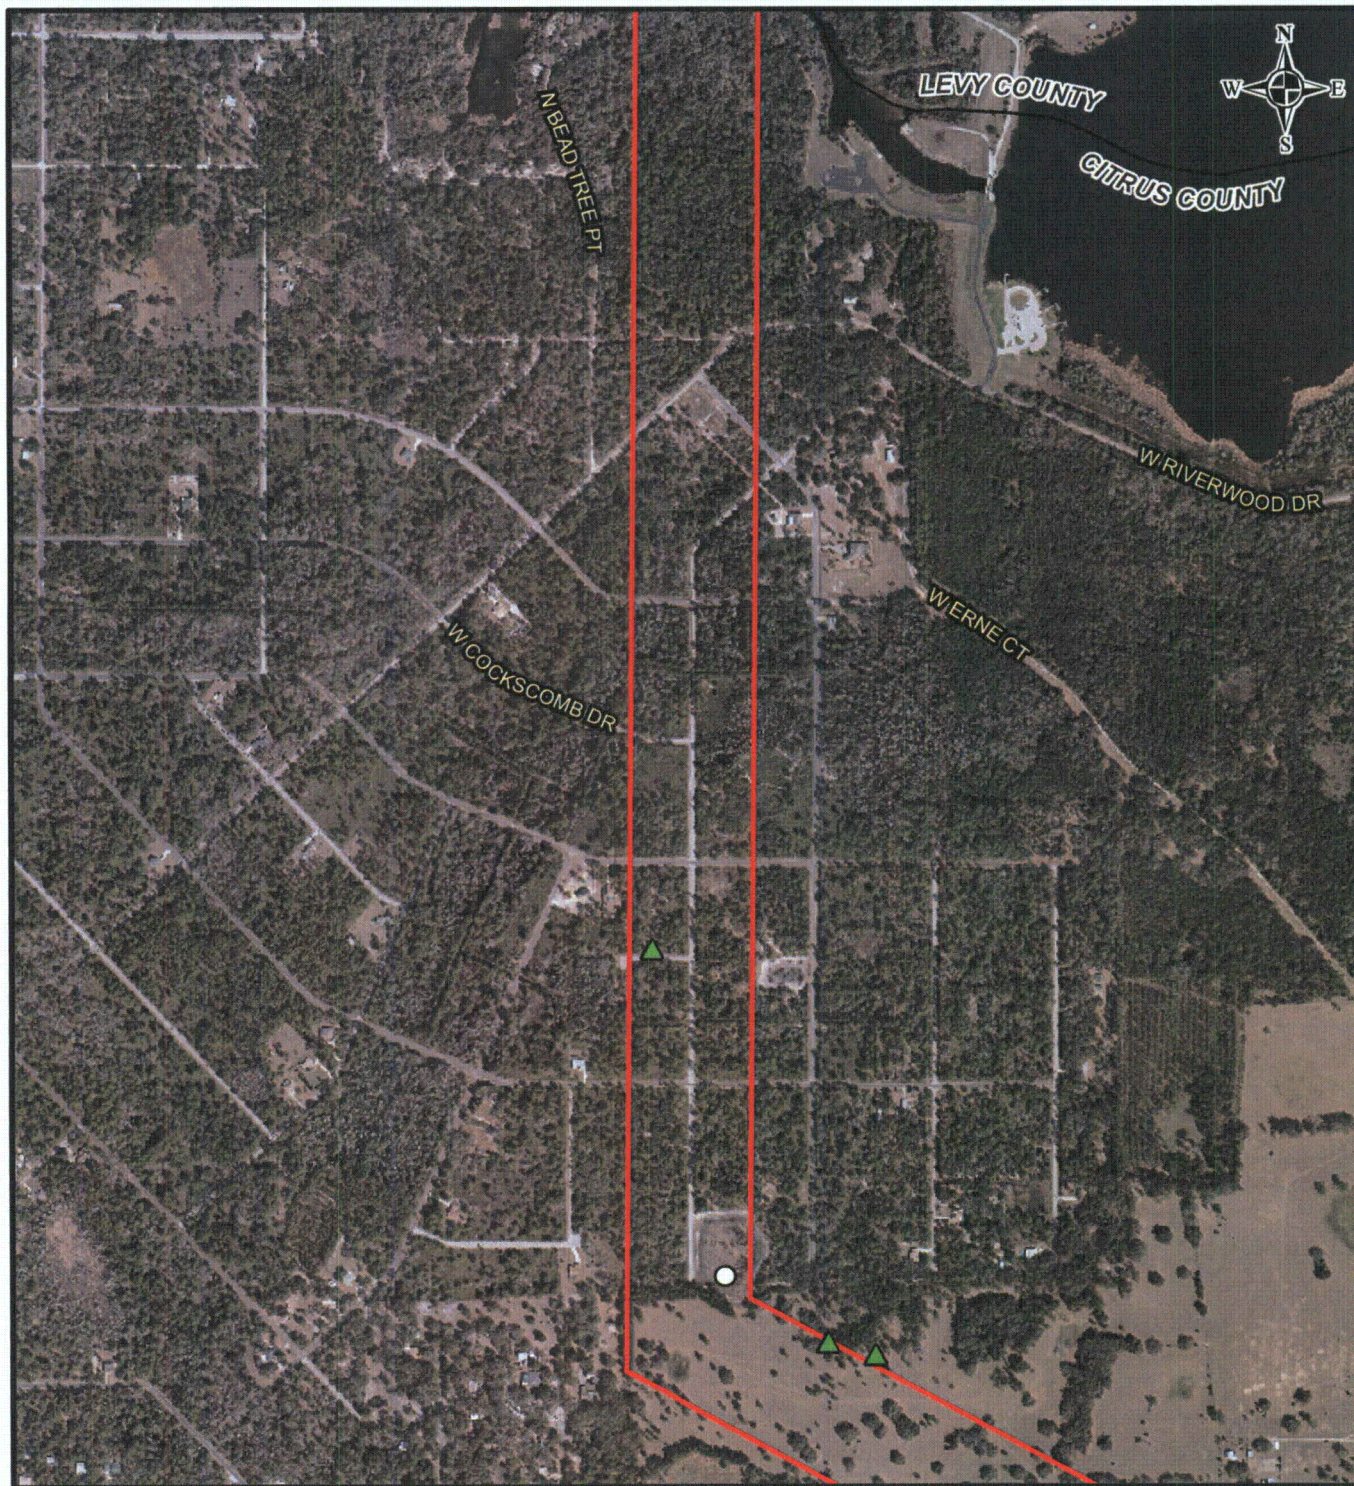
**FIGURE 6**  
**PAGE 2 OF 3**

**NOTE:** No portion of the Common Corridor lies within Wood Stork Core Foraging Areas.

# COMMON ROUTE LISTED SPECIES MAP

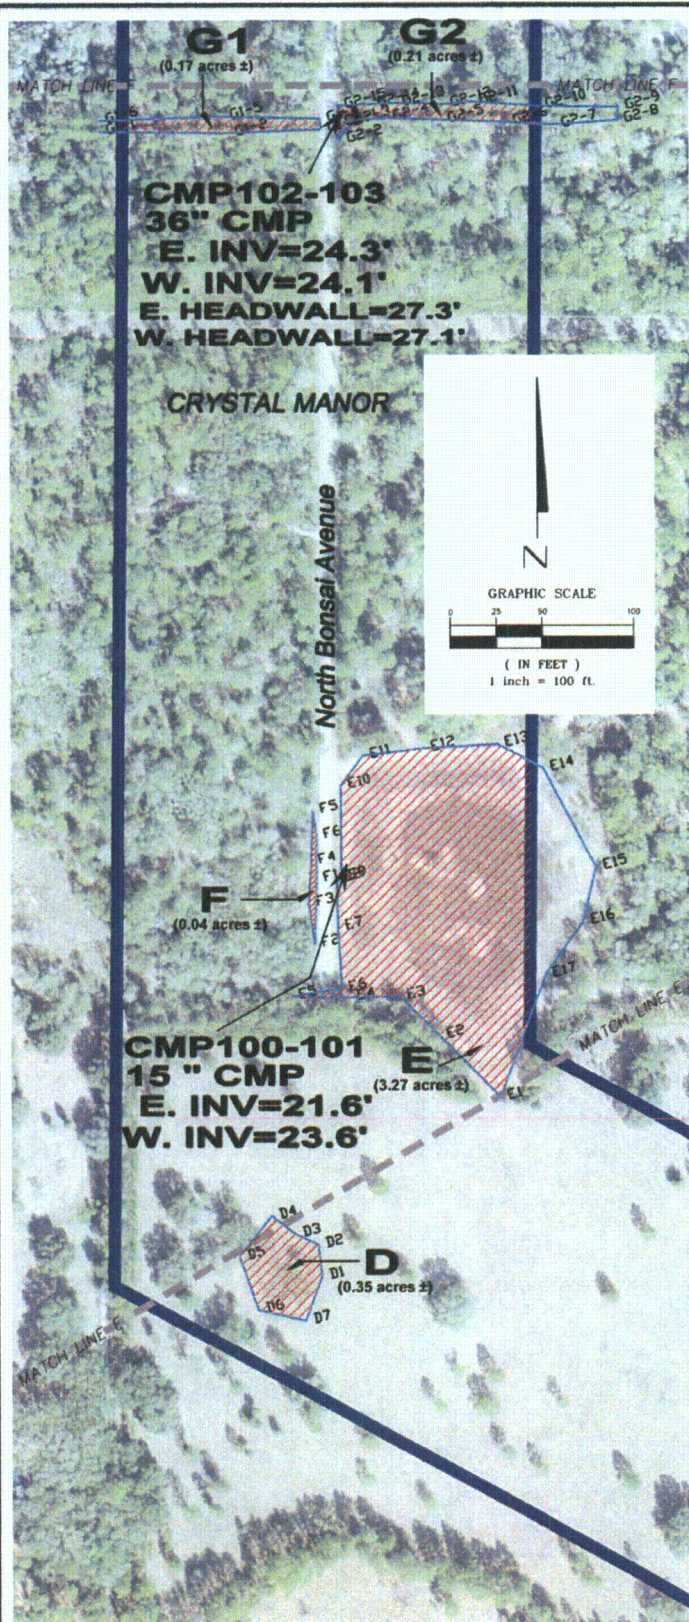
**CMP102-103**  
**36" CMP**  
**E. INV=24.3'**  
**W. INV=24.1'**  
**E. HEADWALL=27.3'**  
**W. HEADWALL=27.1'**
