**DOS K12 CRASH TEST AND EVALUATION OF THE
HESCO C-3315 FLOOD BARRIER**

Contract No.: P2005003
Project/Test No.: 400001-HBL2
Test Date: 12-17-2004

Sponsored by
HESCO Bastion Ltd.

**TEXAS TRANSPORTATION INSTITUTE
THE TEXAS A&M UNIVERSITY SYSTEM
COLLEGE STATION, TEXAS 77843**

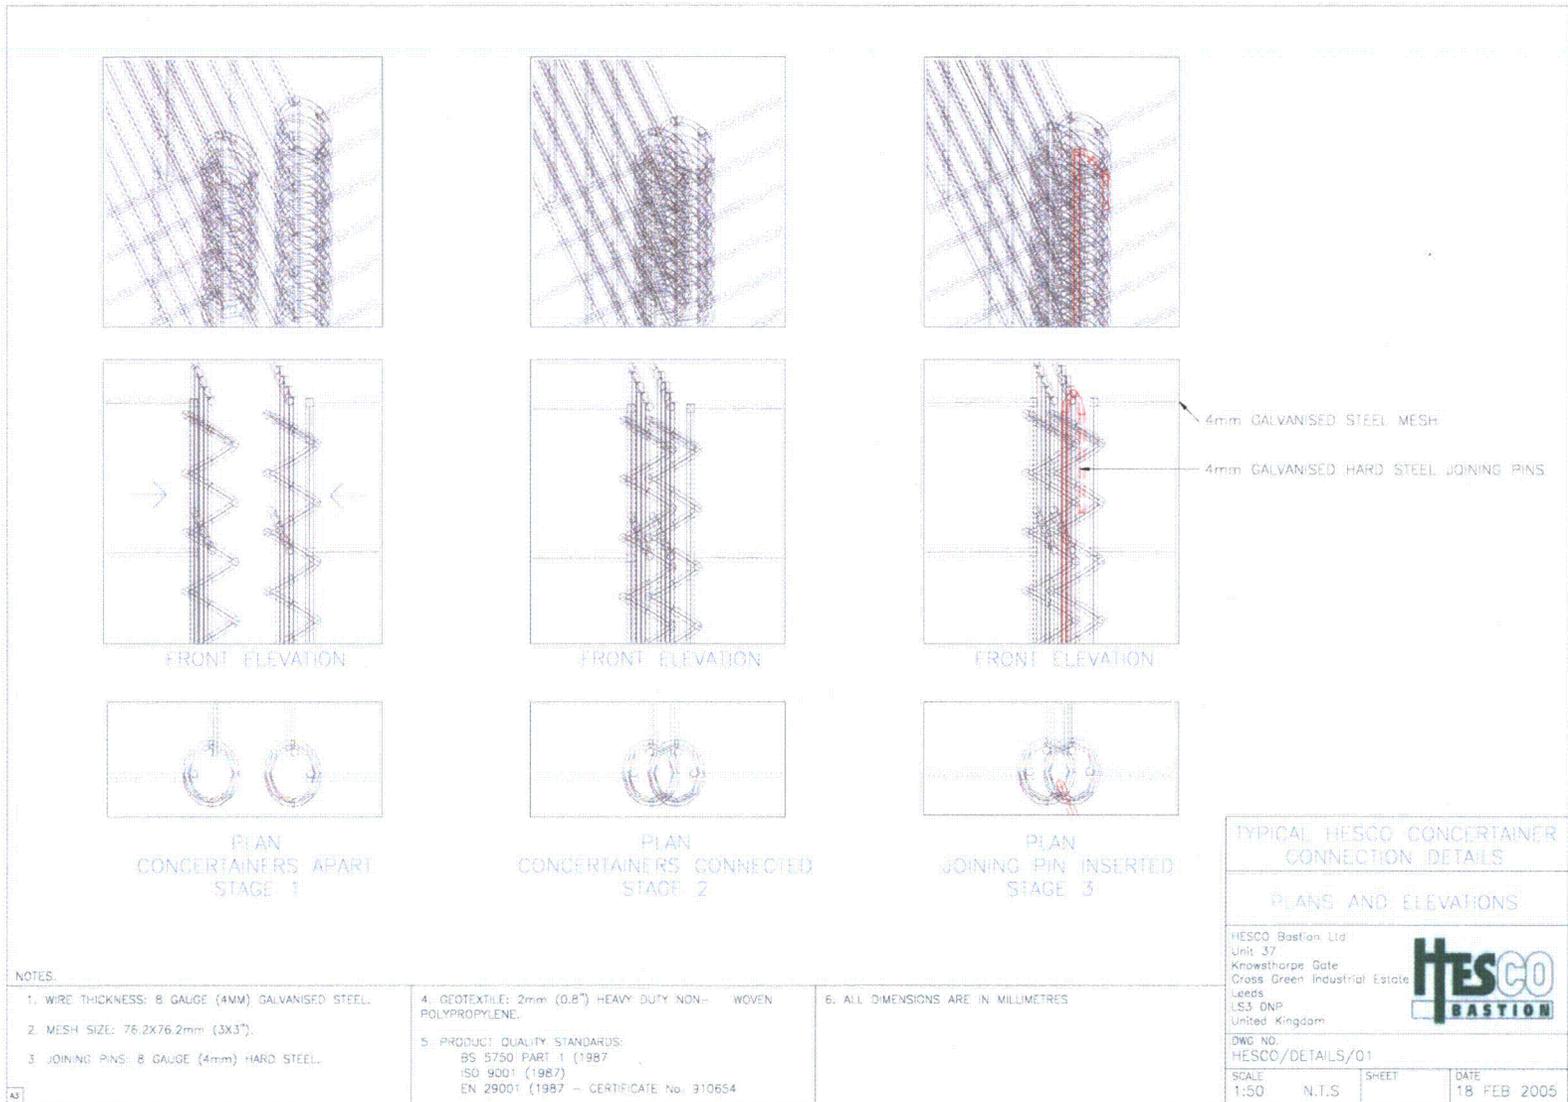
The total installation length of the HESCO Bastion Ltd. C-3315 flood barrier was 9.14 m (30.0 ft). Width at the base was 1.83 m (6.0 ft) and the height of the bottom tier was 0.91 m (3.0 ft). The top tier was identical to the bottom tier. Overall height of the test installation was 1.83 m (6.0 ft).

The HESCO Bastion Ltd. C-3315 flood barriers are constructed with welded wire sheets to form open top cubes that measured 0.91 m (3.0 ft) wide by 0.91 m (3.0 ft) tall. The welded wire was 4mm (0.158 in) diameter and was welded on a 76 mm x 76 mm (3.0 in x 3.0 in) grid. A series of 5 cubes came pre-assembled and lined with 2mm (0.8 in) non-woven polypropylene geotextile fabric. Corners of the HESCO Bastion Ltd. C-3315 flood barriers are formed with coiled 4 mm (0.158 in) wire. The coils are 32 mm (1.25 in) diameter with a coil pitch of 25 mm (1.0 in). Pre-assembled units are joined with adjacent units by overlapping wire coils and placing a 4mm (0.158 in) joining pin in the overlapped section of coils.

The HESCO Bastion Ltd. C-3315 flood barriers were filled with a reddish-tan silty, clayey sand, designated as select fill from the Kelly Burt pit. The density of the fill material was 1900 kg/cubic meter (118.5 lbs/cubic ft) and was manually tamped by HESCO installers. Details of the installation are shown in figures 1 and 2. Photographs of the completed installation are shown in figure 3.

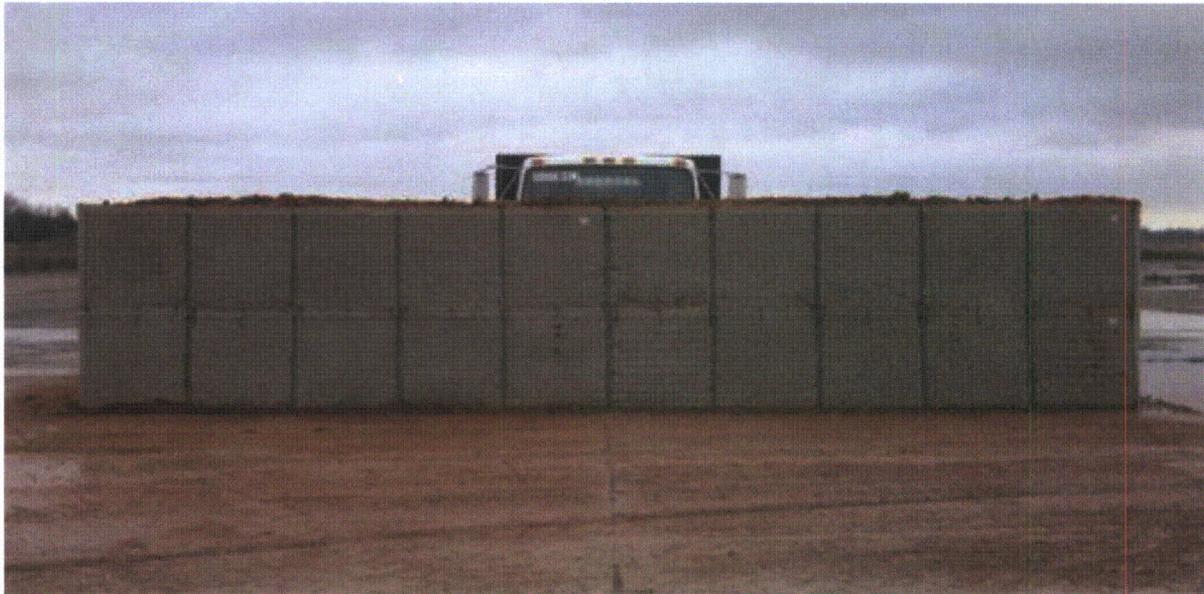
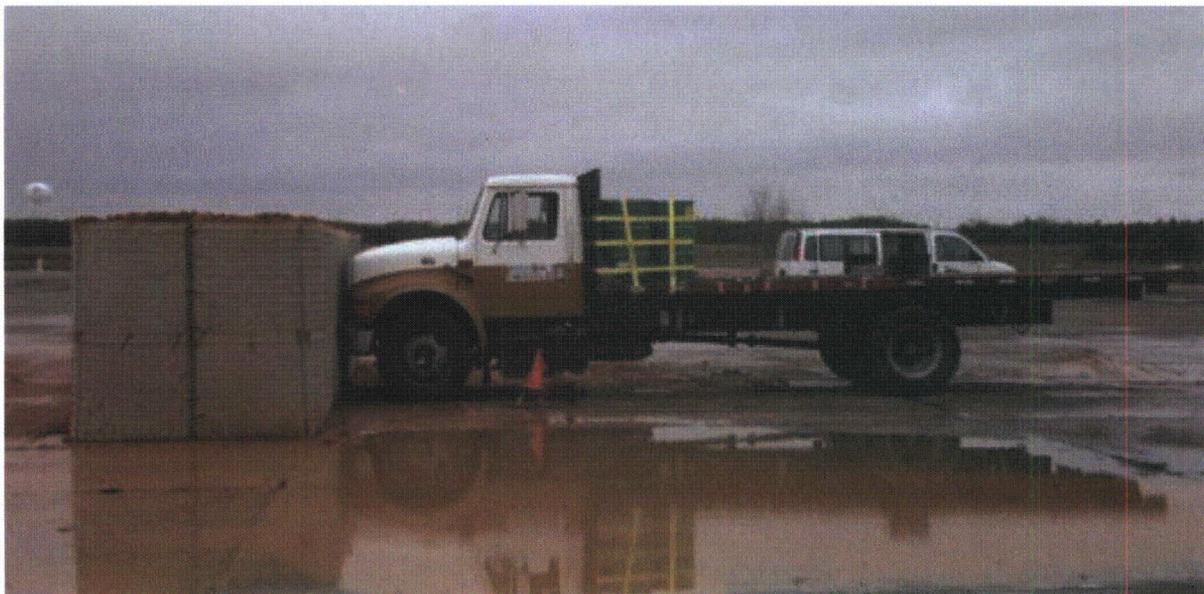
Figure 4. Vehicle/installation geometrics for test 400001-HBL2.

A 1995 International 4700 single-unit flatbed truck, shown in figures 4 and 5, was used for the crash test. Test inertia weight of the vehicle was 6867 kg (15,140 lb). The height to the lower edge of the vehicle front bumper was 514 mm (20.25 inches), and the height to the upper edge of the front bumper was 800 mm (31.5 inches). Figure 11 in appendix B gives additional dimensions and information on the vehicle. The vehicle was directed into the installation using the cable reverse tow and guidance system, and was released to be free-wheeling and unrestrained just prior to impact.

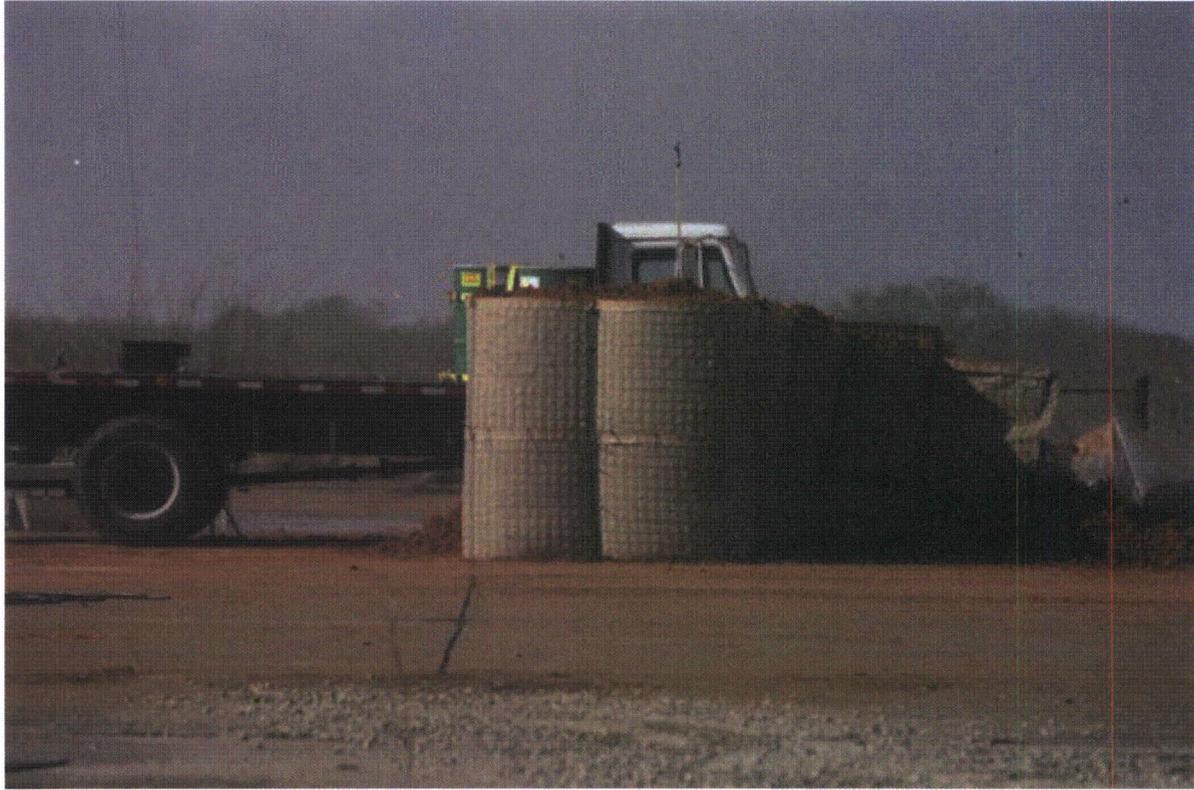
Figure 6. Vehicle trajectory path after test 400001-HBL2.

The wire mesh ruptured and the center rows were damaged. Three rows of box units on each side were intact. The ends of the barrier were pulled inward, 150 mm (5.9 inches) on the right side and 140 mm (5.5 inches) on the left side. Soil was scattered over an area to the inside of the barrier, 12.2 m (40 ft) long and 9.1 m (30 ft) wide. Damage to the installation is shown in figures 6 and 7.

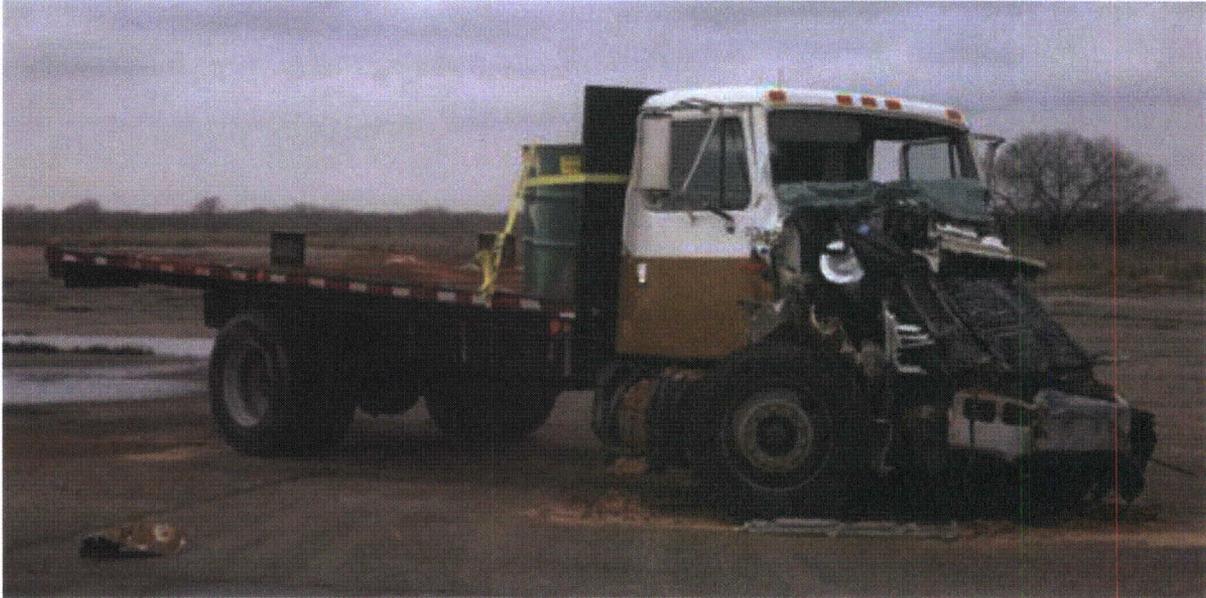
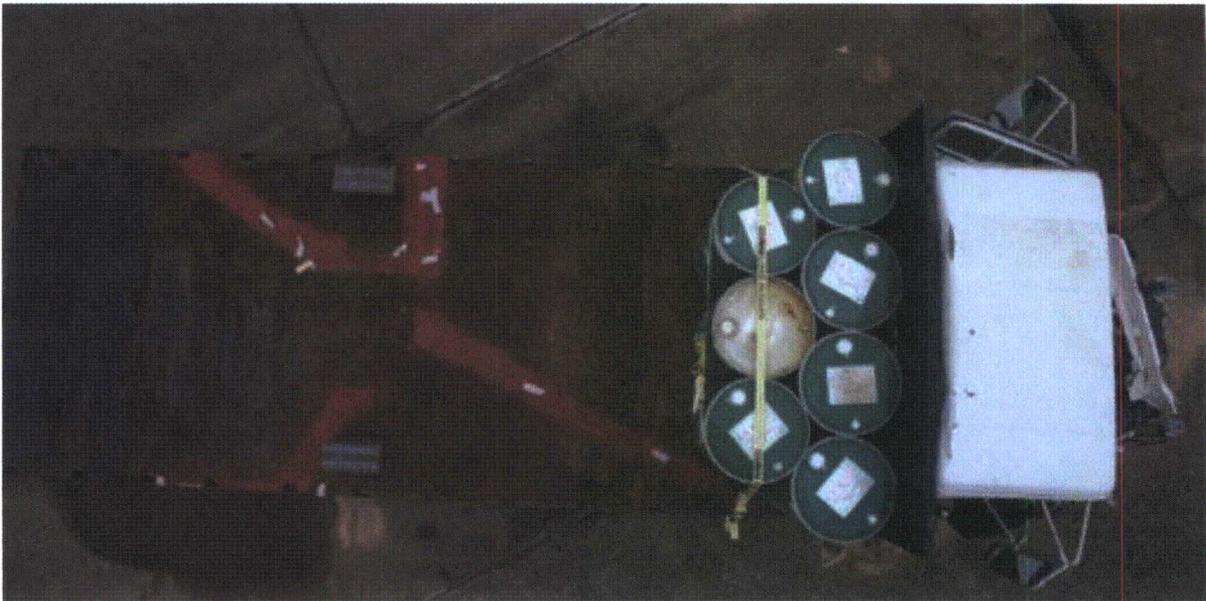
Figure 8. Vehicle after test 400001-HBL2.

Damage to the vehicle is shown in figure 8 and 9. The front of the cargo bed did not penetrate the inside edge of the barrier, and came to rest 0.85 m (2.8 ft) from the inside edge of the barrier.

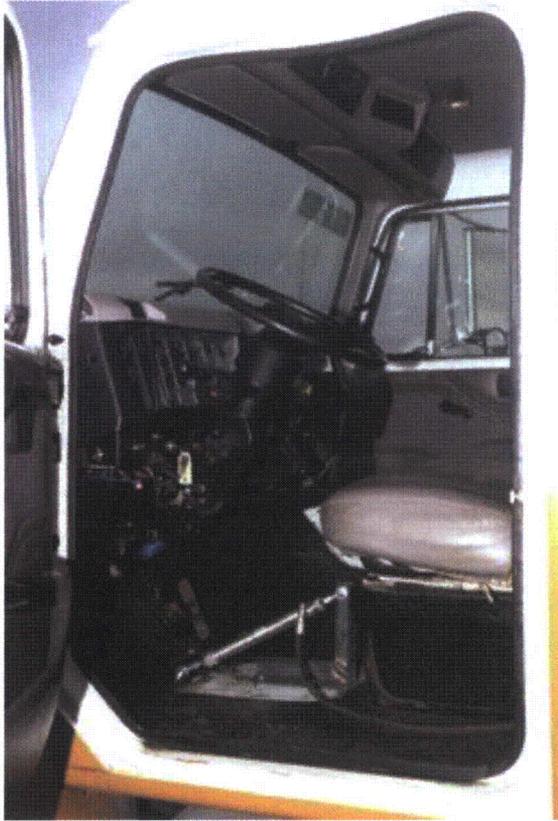
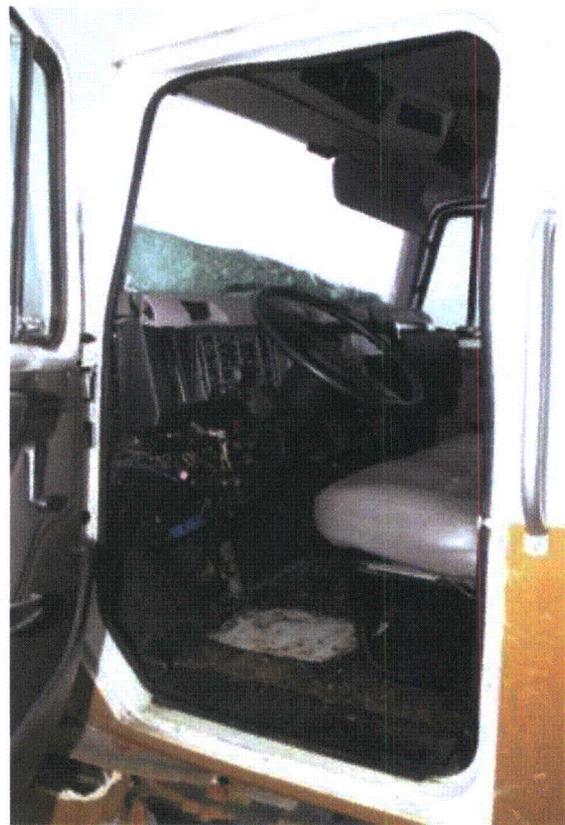
Figure 9. Interior of vehicle for test 400001-HBL2.

Before test

After test

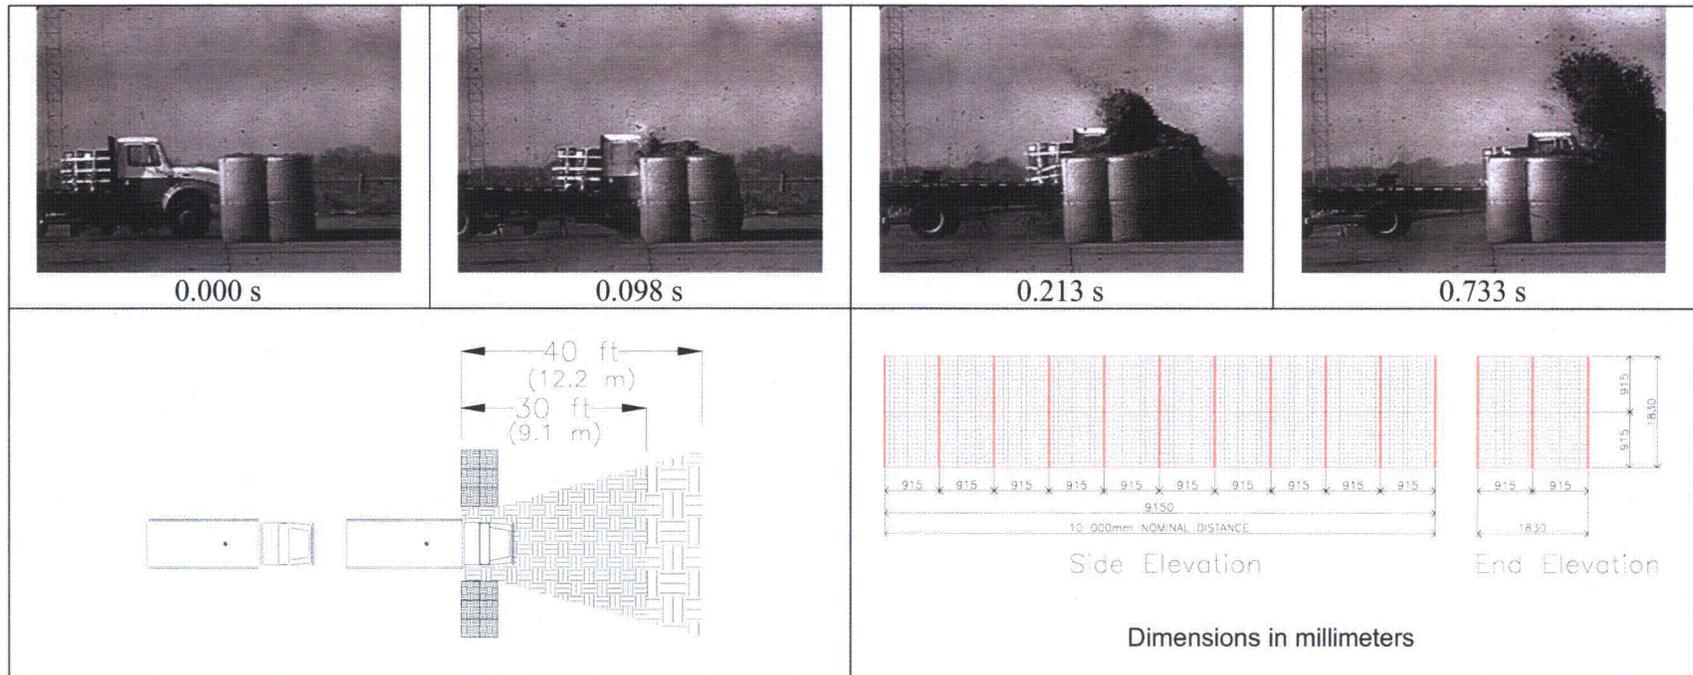
Type..... Anti-Ram Barrier
 Name..... HESCO C-3315 Flood Barrier
 Installation Length (m)..... 4.6
 Material or Key Elements Wire Mesh Box Units with Lining and Filled with Soil

Speed (km/h)..... 81.0
 Angle (deg)..... 90.8

Impact Velocity (m/s)
 Longitudinal..... 11.9
 Lateral 0.4
 Ridedown Accelerations (g's)
 Longitudinal..... -10.6
 Lateral 3.0
 Max. 0.050-s Average (g's)
 Longitudinal..... -14.4
 Lateral -1.5
 Vertical -2.4

Distance Beyond Inside
 Edge of Barrier (m)..... -0.85 (did not reach inside edge of barrier)

Figure 10. Summary of results for test SD-STD-2.01 test K12 on the HESCO C-3315 flood barrier.

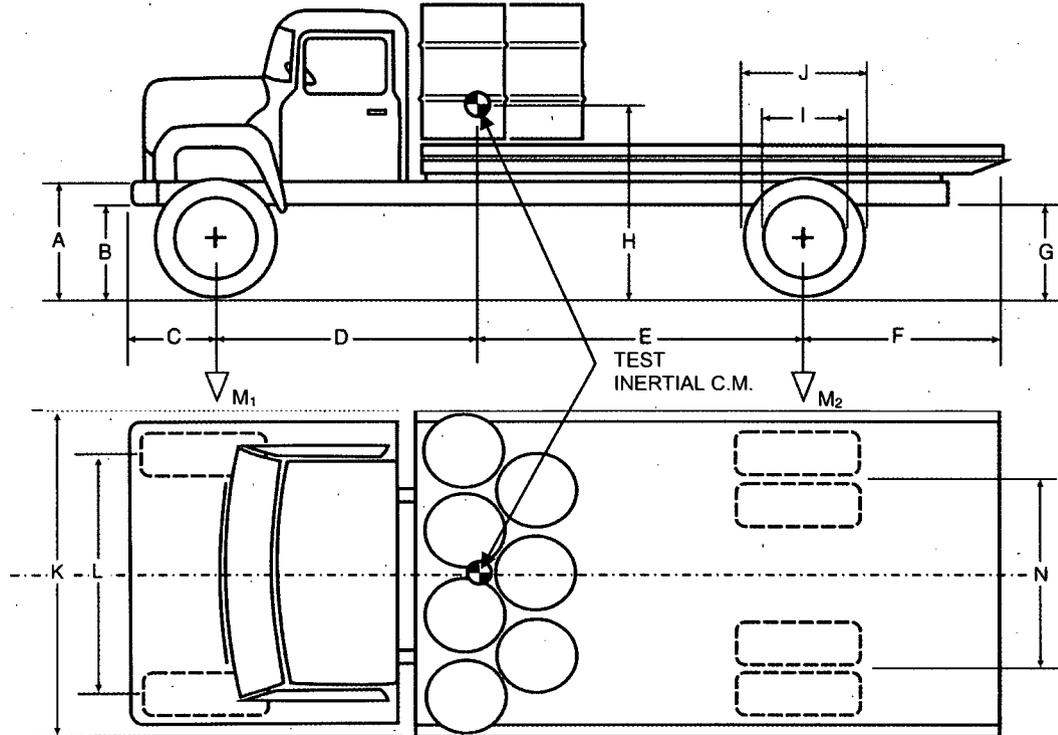
Figure 11. Vehicle properties for test 400001-HBL2.

A 800 B 514 C 775 D 2623 E 2534 F 2794 G 737
 H _____ I 597 J 1003 K 2445 L 2045 N 1854

LF 1696 RF 1678 LR 1783 RR 1710

MASS (kg)	CURB	TEST INERTIAL
M ₁		<u>2889</u>	<u>3375</u>
M ₂		<u>3062</u>	<u>3493</u>
M _{Total}		<u>5951</u>	<u>6868</u>

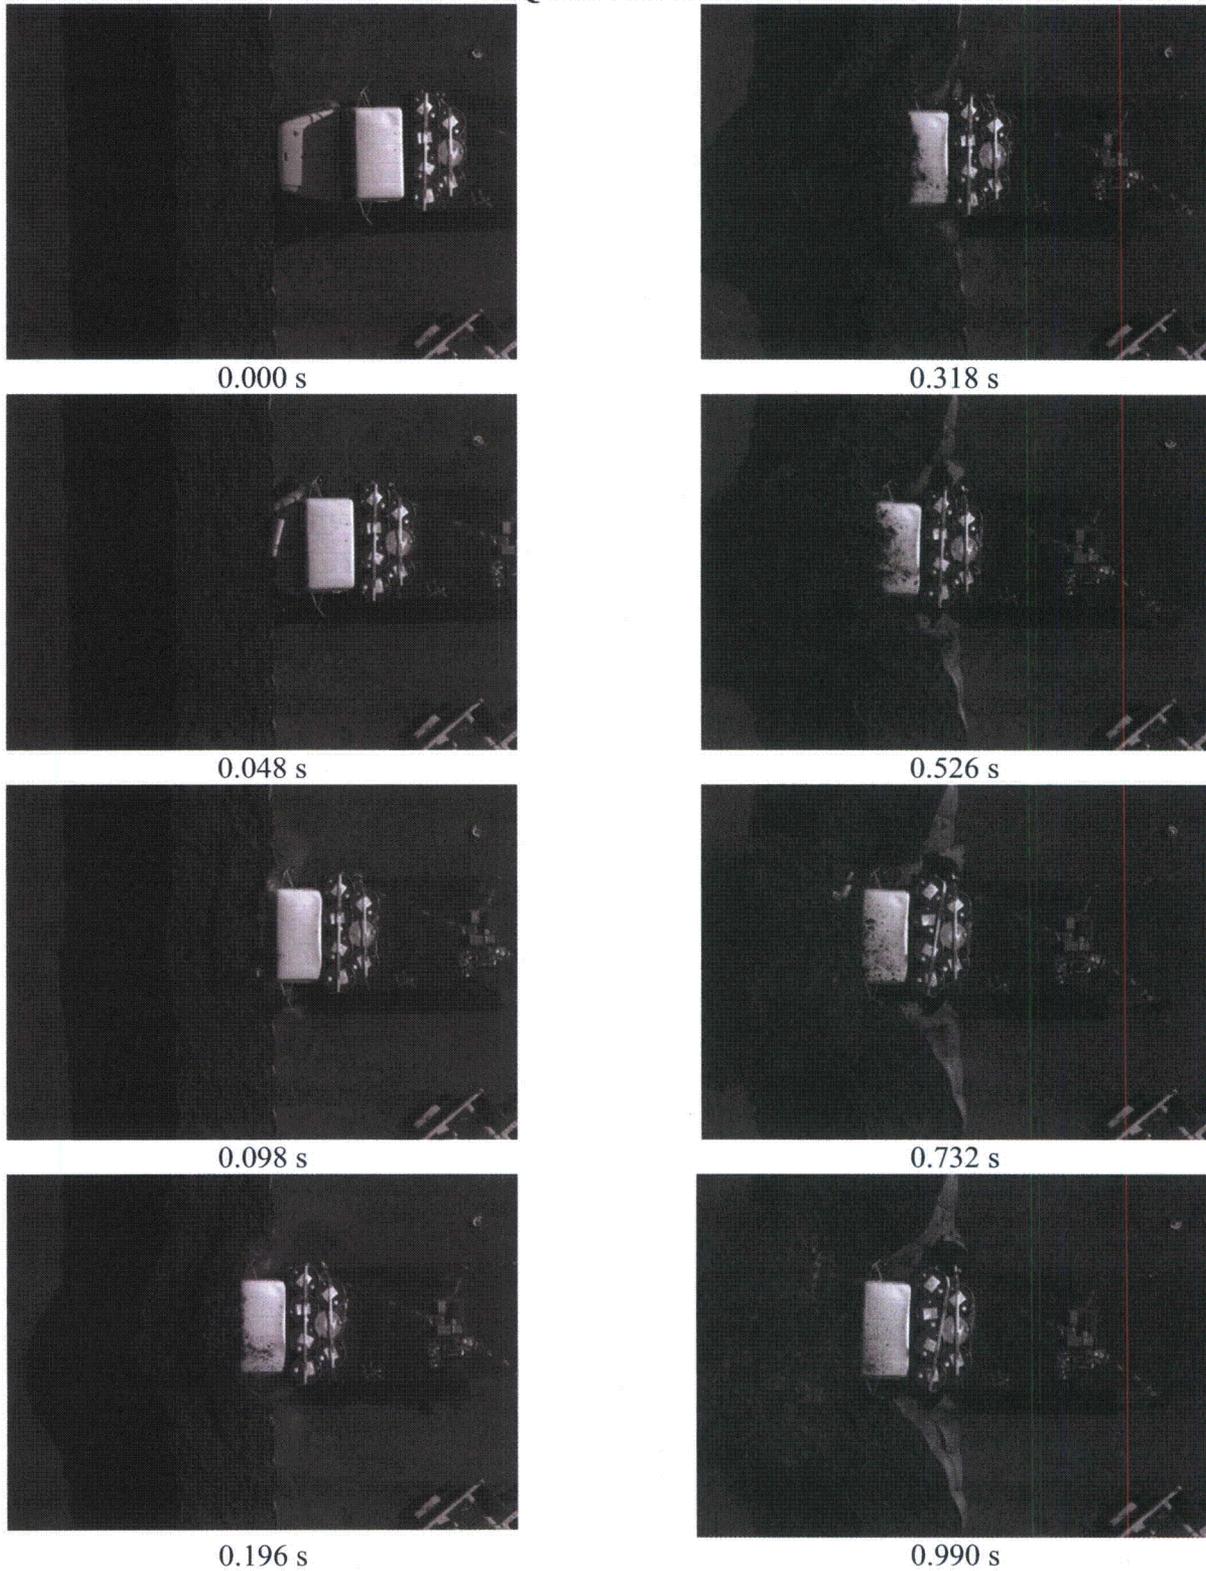
Figure 12. Sequential photographs for test 400001-HBL2 (overhead view).

The 1995 International 4700 single-unit flatbed truck, traveling at a speed of 81.0 km/h (50.3 mi/h), impacted the HESCO Bastion Ltd. C-3315 flood barrier at an impact angle of 90.8 degrees, with the centerline of the vehicle aligned with the centerline of the barrier. Shortly after impact, the hood of the vehicle separated from the vehicle near the cab. At 0.054 s, the head rack of the truck bed contacted the rear of the cab. The inside edge of the bottom row of box units began to move toward the inside of the barrier at 0.060 s, and the top row began to move toward inside of the barrier at 0.078 s. The strap on the front row of the box units separated at 0.560 s. At 0.800 s, the vehicle reached maximum penetration of the front of the truck bed of 1.1 m (3.7 ft) into the barrier (or 0.8 m (2.9 ft) from the impact side of the inside edge of the barrier). The vehicle subsequently backed up slightly and came to rest with the front of the cargo bed 0.85 m (2.8 ft) to the impact side of the inside edge of the barrier. The front of the cargo bed did not reach inside edge of the barrier. Appendix C, figures 12 and 13, show sequential photographs of the test period.

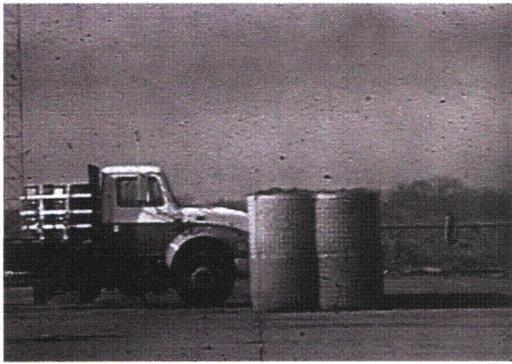
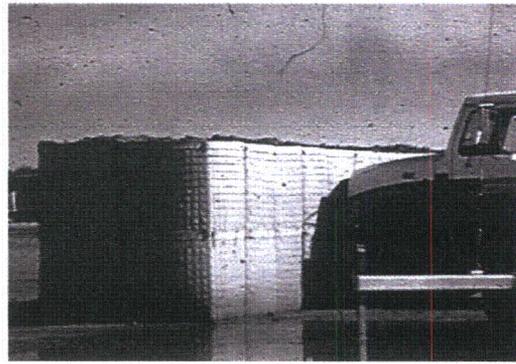
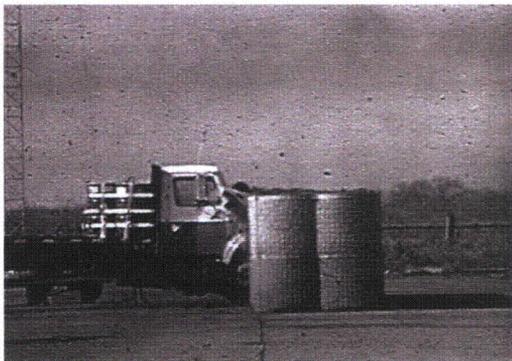
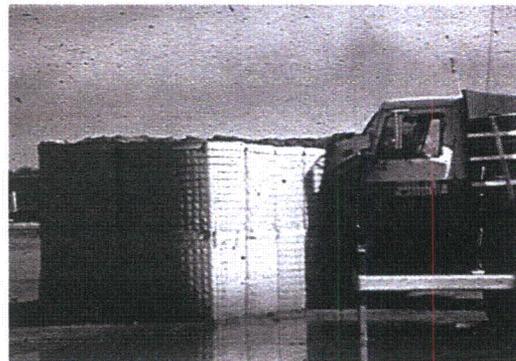
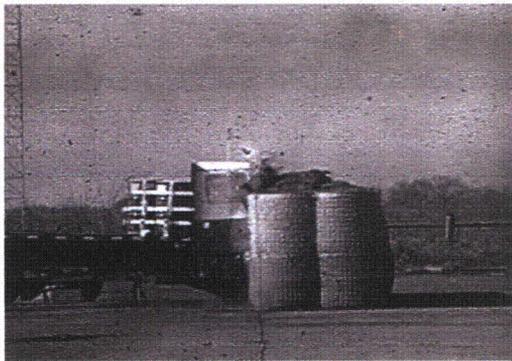
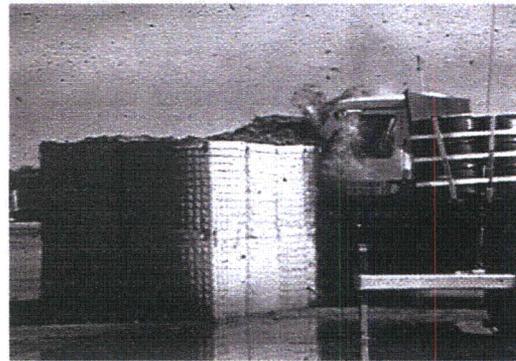
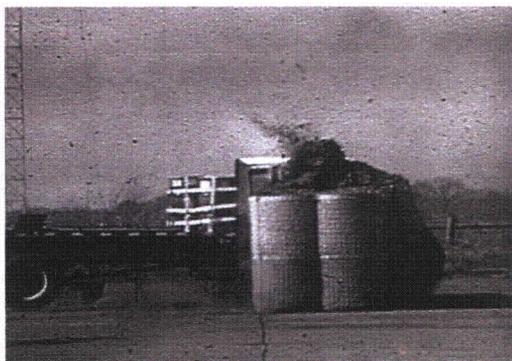
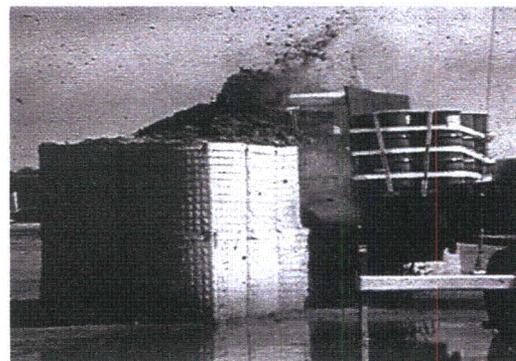
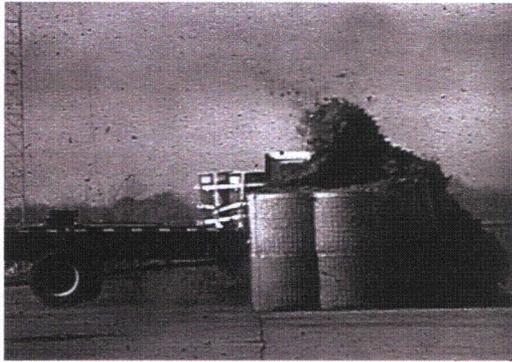
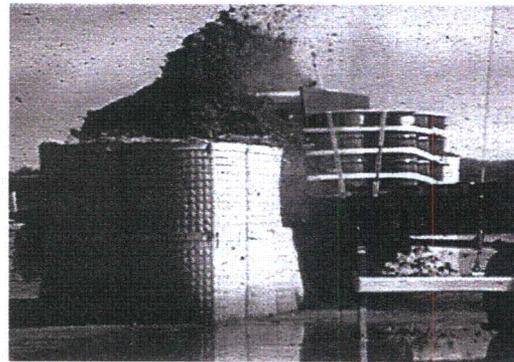
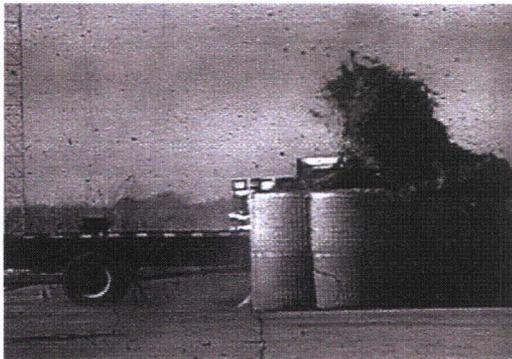
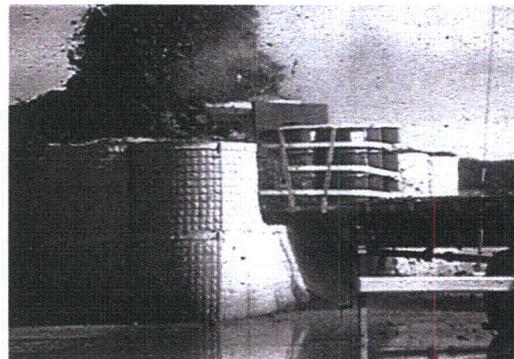
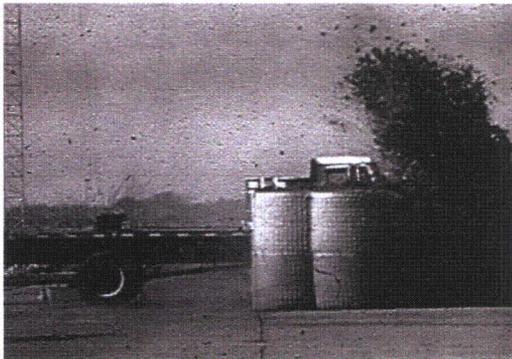
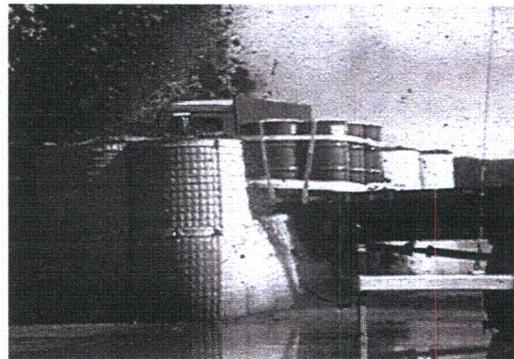
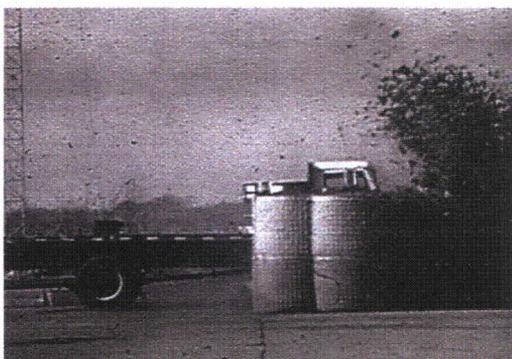
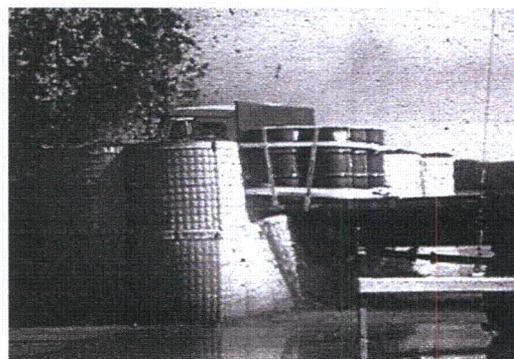
Figure 13. Sequential photographs for test 400001-HBL2 (perpendicular and oblique views).

Figure 13. Sequential photographs for test 400001-HBL2 (perpendicular and oblique views) (continued).

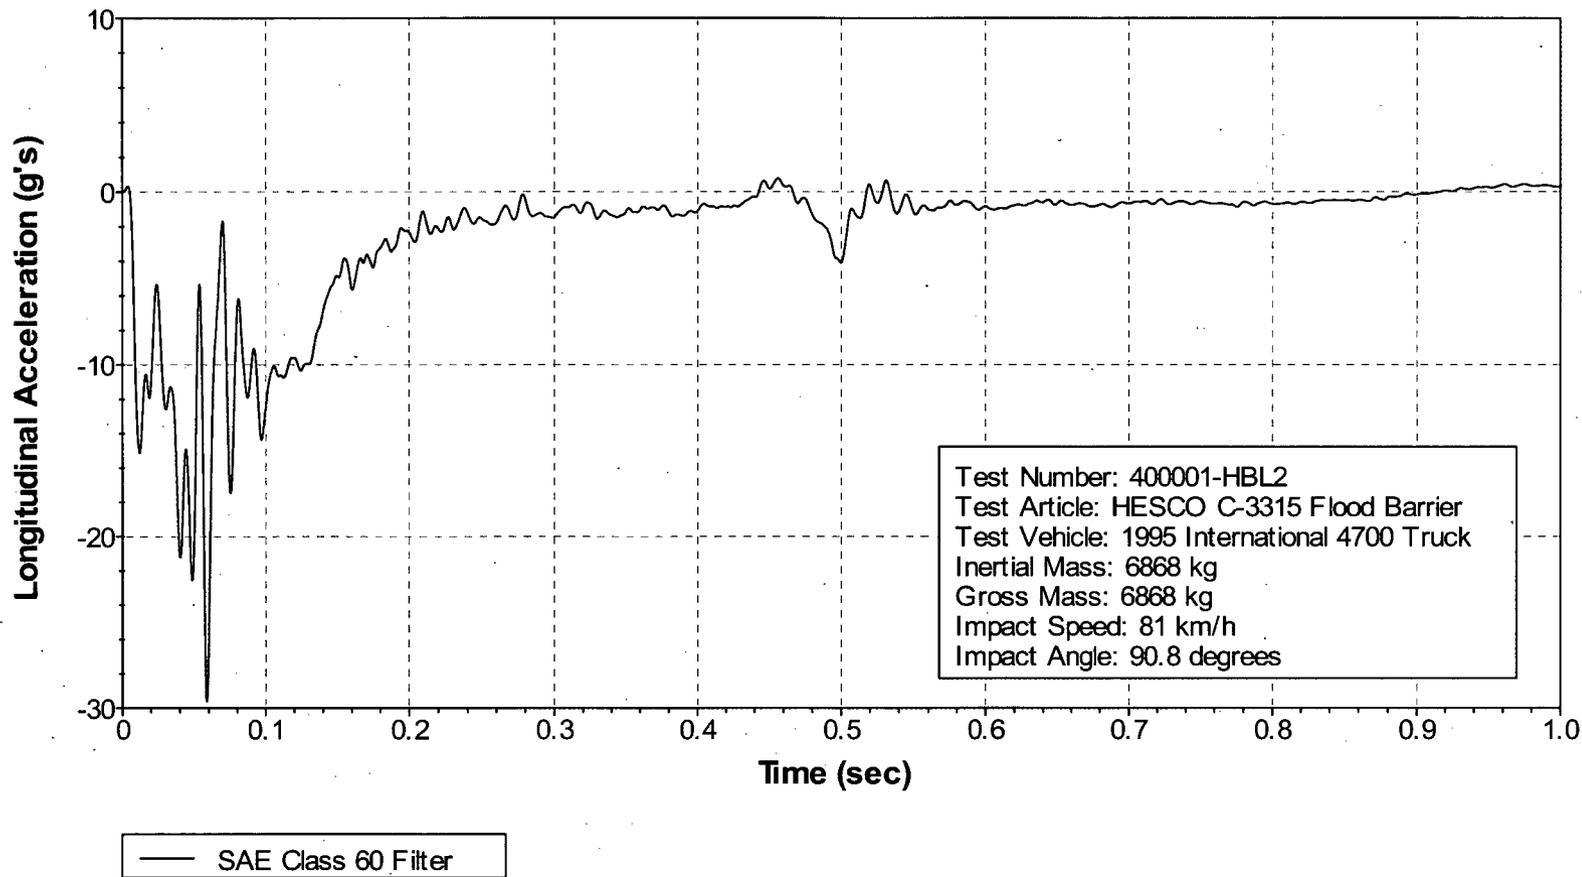
X Acceleration at CG

Figure 14. Vehicle longitudinal accelerometer trace for test 400001-HBL2 (accelerometer located at center of gravity).

Data from the accelerometer, located at the vehicle center of gravity, were digitized for evaluation of occupant risk for informational purposes only. In the longitudinal direction, the occupant impact velocity was 11.9 m/s (39.0 ft/s) at 0.106 s, the highest 0.010-s occupant ridedown acceleration was -10.6 g's from 0.106 to 0.116 s, and the maximum 0.050-s average acceleration was -14.4 g's between 0.011 and 0.061 s. In the lateral direction, the occupant impact velocity was 0.4 m/s (1.3 ft/s) at 0.106 s, the highest 0.010-s occupant ridedown acceleration was 3.0 g's from 0.113 to 0.123 s, and the maximum 0.050-s average was -1.5 g's between 0.024 and 0.074 s. These data and other pertinent information from the test are summarized in figure 10. Vehicle angular displacements and accelerations versus time traces are presented in appendix D, figures 14 through 19.

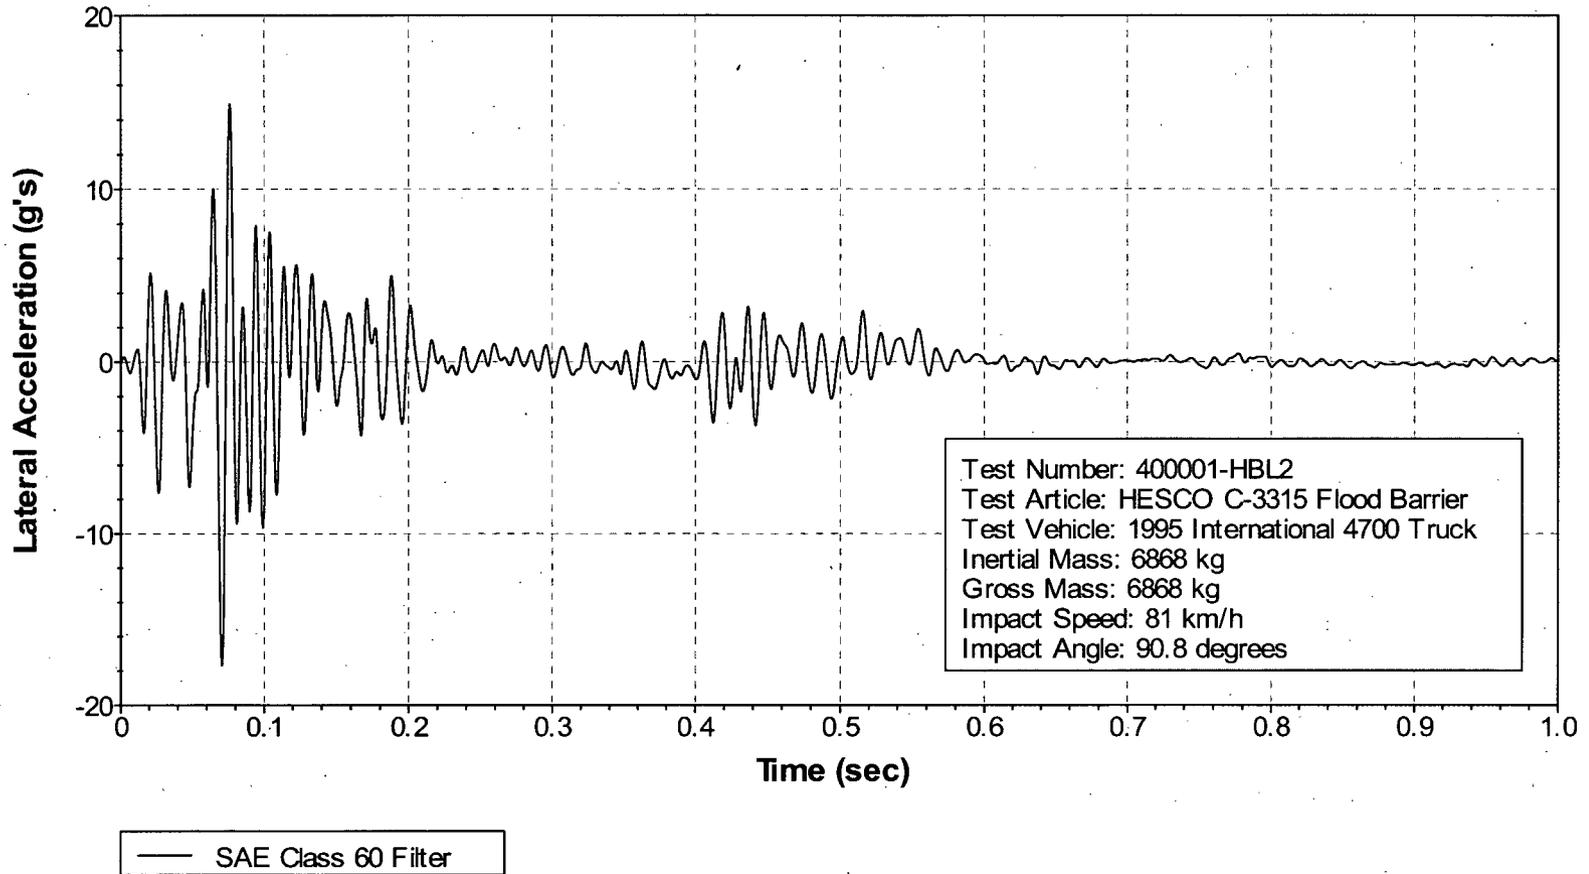
Y Acceleration at CG

Figure 15. Vehicle lateral accelerometer trace for test 400001-HBL2 (accelerometer located at center of gravity).

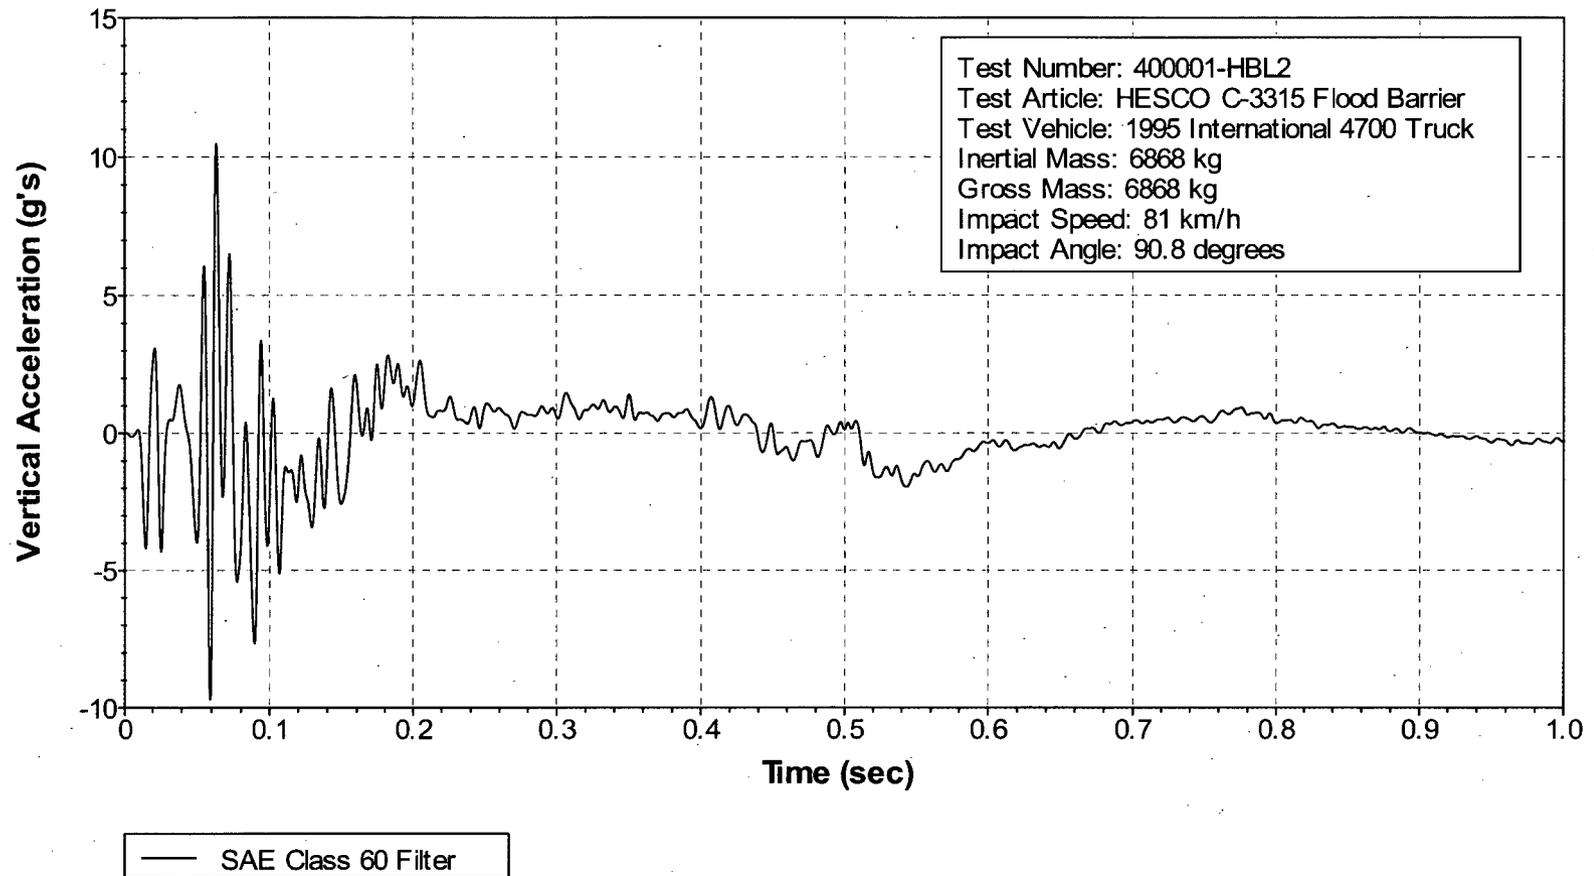
Z Acceleration at CG

Figure 16. Vehicle vertical accelerometer trace for test 400001-HBL2 (accelerometer located at center of gravity).

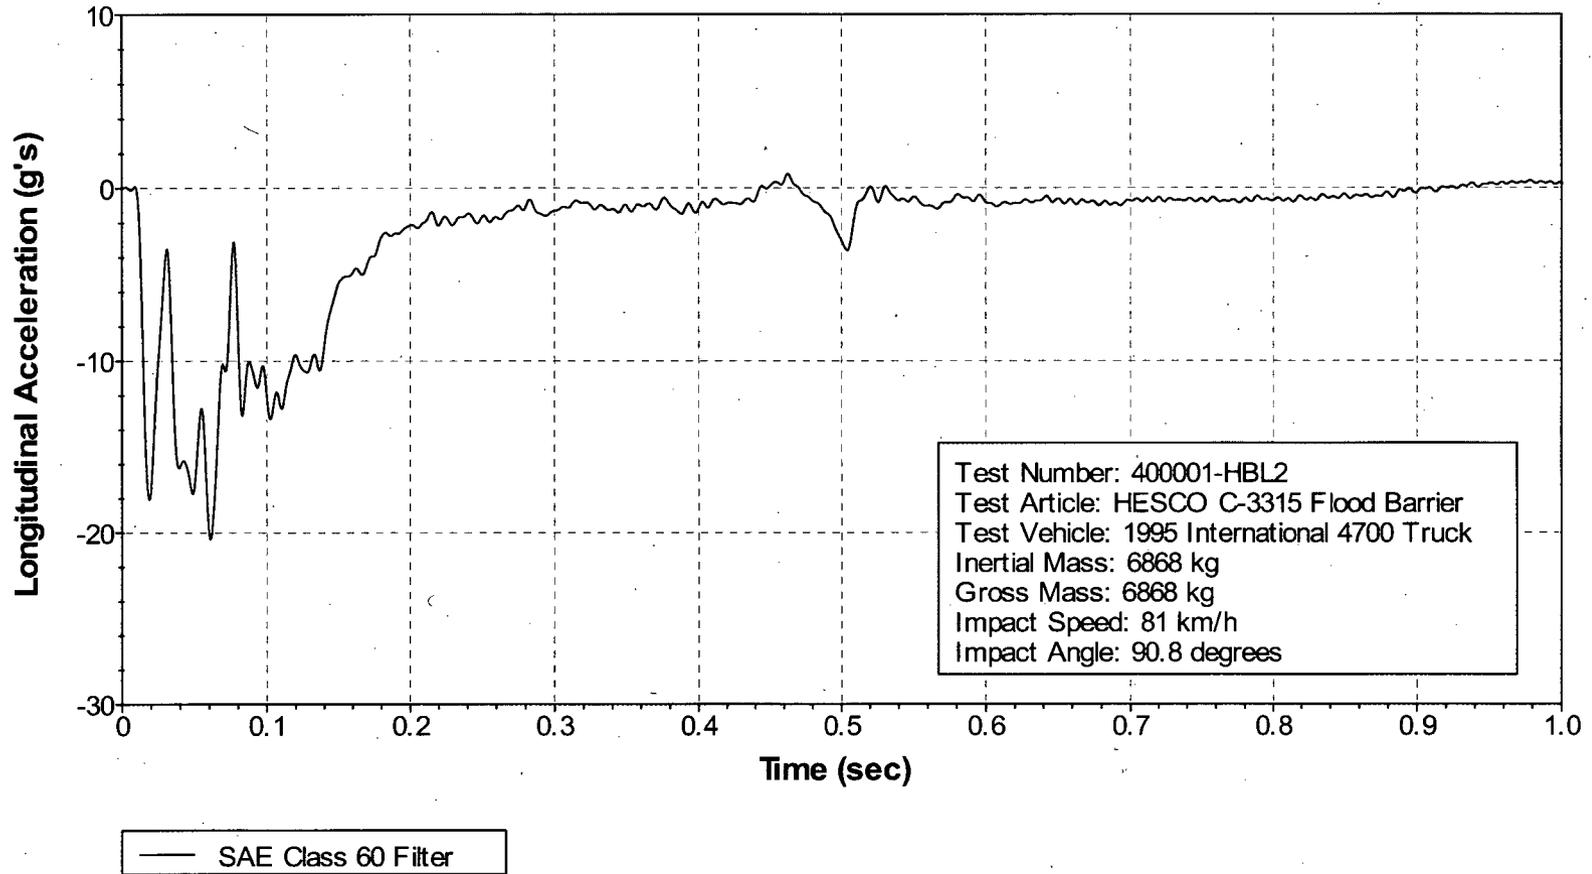
X Acceleration over Rear Axle

Figure 17. Vehicle longitudinal accelerometer trace for test 400001-HBL2 (accelerometer located over rear axle).

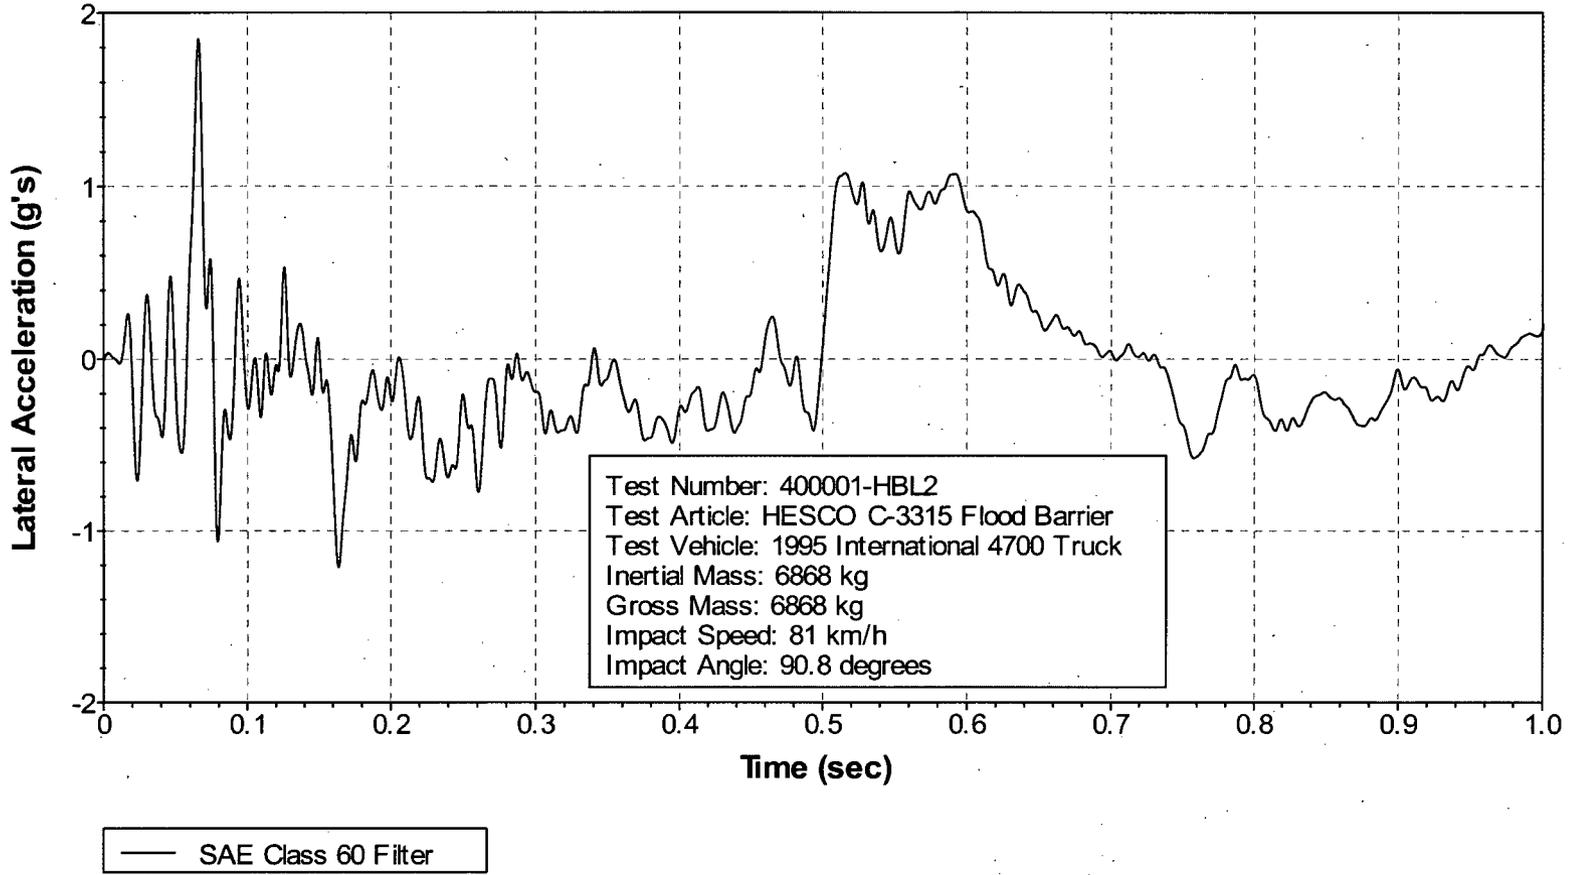
Y Acceleration over Rear Axle

Figure 18. Vehicle lateral accelerometer trace for test 400001-HBL2 (accelerometer located over rear axle).
