**DOS K12 CRASH TEST AND EVALUATION OF THE
HESCO C-3315 FLOOD BARRIER**

Contract No.: P2005003
Project/Test No.: 400001-HBL2
Test Date: 12-17-2004

Sponsored by
HESCO Bastion Ltd.

**TEXAS TRANSPORTATION INSTITUTE
THE TEXAS A&M UNIVERSITY SYSTEM
COLLEGE STATION, TEXAS 77843**

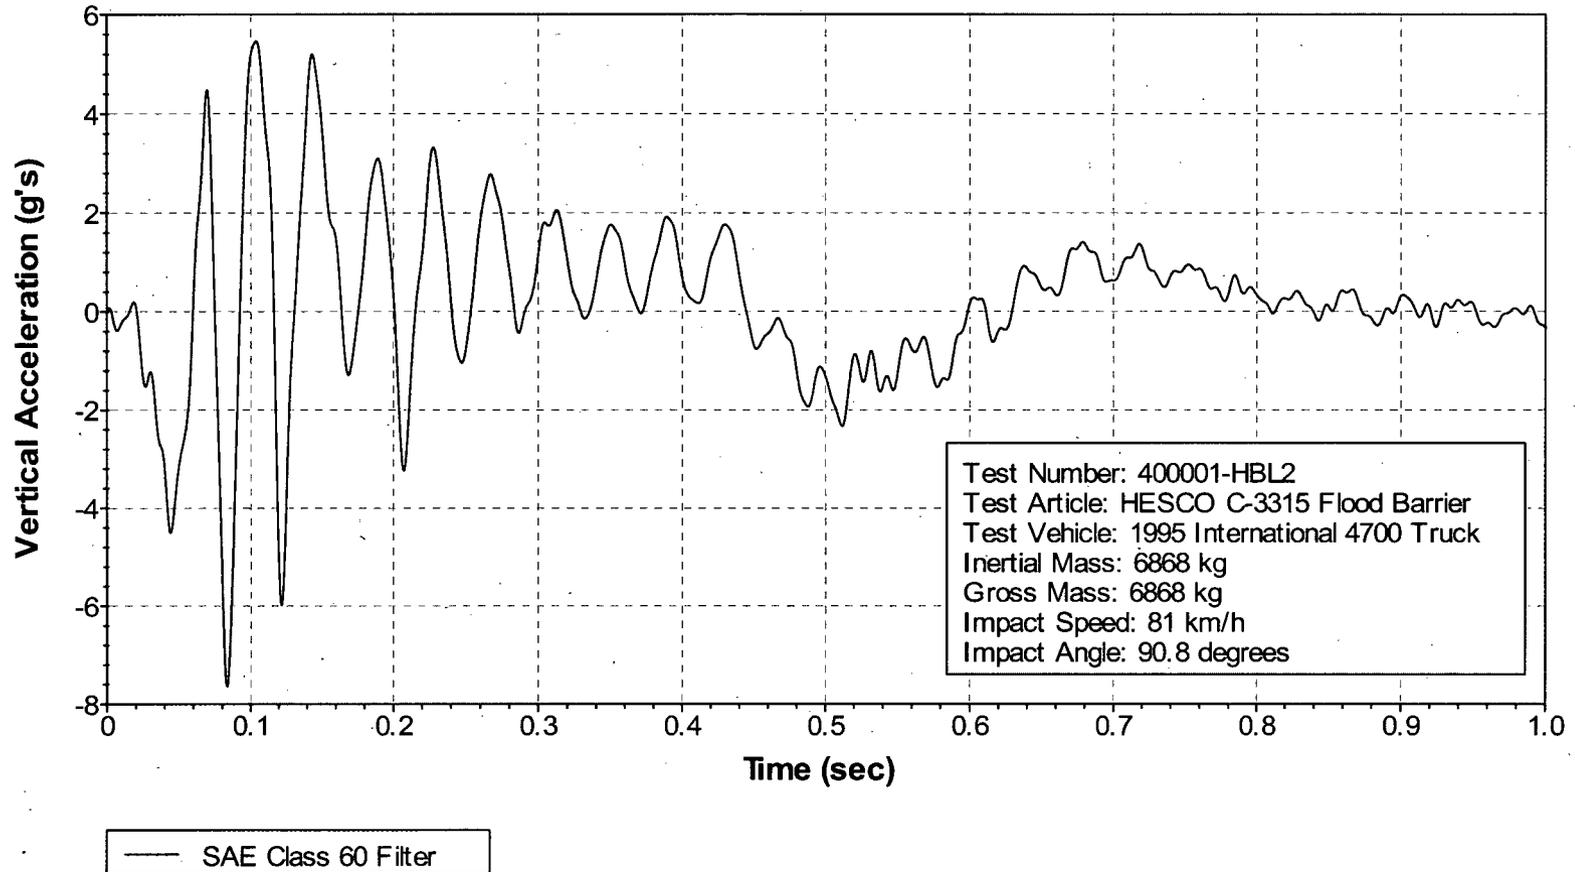
Z Acceleration over Rear Axle

Figure 19. Vehicle vertical accelerometer trace for test 400001-HBL2
(accelerometer located over rear axle).

Data from the accelerometer, located at the vehicle center of gravity, were digitized for evaluation of occupant risk for informational purposes only. In the longitudinal direction, the occupant impact velocity was 11.9 m/s (39.0 ft/s) at 0.106 s, the highest 0.010-s occupant ridedown acceleration was -10.6 g's from 0.106 to 0.116 s, and the maximum 0.050-s average acceleration was -14.4 g's between 0.011 and 0.061 s. In the lateral direction, the occupant impact velocity was 0.4 m/s (1.3 ft/s) at 0.106 s, the highest 0.010-s occupant ridedown acceleration was 3.0 g's from 0.113 to 0.123 s, and the maximum 0.050-s average was -1.5 g's between 0.024 and 0.074 s. These data and other pertinent information from the test are summarized in figure 10. Vehicle angular displacements and accelerations versus time traces are presented in appendix D, figures 14 through 19.
