SUBJECT: TRIP REPORT – APRIL 18 – 19, 2011, GEOLOGY SITE VISIT AND AUDIT  
IN SUPPORT OF THE V.C. SUMMER COMBINED LICENSE APPLICATION

This report summarizes the NRC site visit to the V.C. Summer Nuclear Station (VCSNS) Units 2 and 3 excavations and the surrounding area during the period of April 18, and 19, 2011. An audit plan was developed to support the site visit in accordance with the Office of New Reactors (NRO) Office Instruction NRO-REG-108, "Regulatory Audits." The Audit plan is available in Agencywide Documents Access and Management System (ADAMS) under accession number ML110871115. The purpose of the site visit was to:

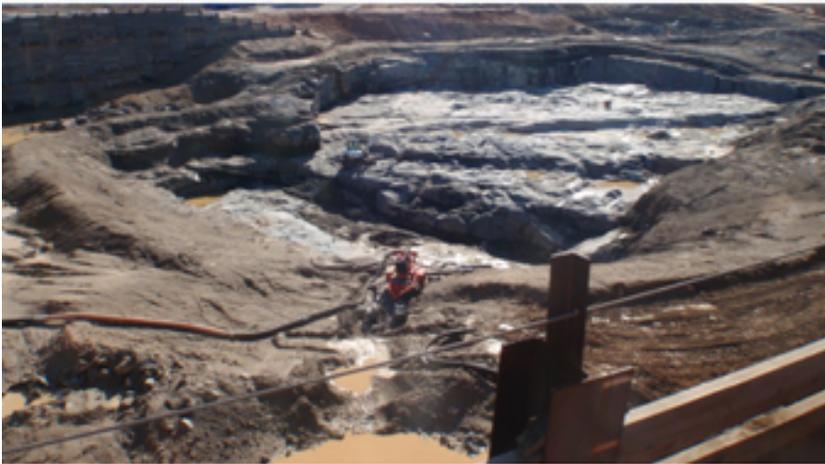
Figure 1 – Unit 2 Excavation View Looking West

Figures 1 through 4 of Enclosure 3 are images provided to the NRC staff by SCE&G prior to the April 18-19, 2011, NRC site visit. Figures 1 through 3 are overview images showing rock units exposed in the Unit 2 excavation in April 2011, looking west, east, and north, respectively. Figure 4 of Enclosure 3 is a close-up image of a probable minor shear zone that was determined by the applicant to be the same shear zone as that which NRC staff identified in Figure 5 of the NRC's August 30, 2010, trip report. Specifically, as removal of rock materials above the foundation grade level progressed, the applicant was able to trace the shear zone vertically downward from the sound rock surface examined during the August 2010 site visit to the foundation grade level examined by the staff during the April 2011 site visit. (The staff observed and confirmed the field relationships used by the applicant to determine that the shear zone extended vertically downward from the higher level to foundation grade level during the April 2011 site visit.) In addition, similar to the observations presented in the August 30, 2010, trip report, based on geologic field relationships related to cross-cutting igneous veins that are not offset by the shear zone, the staff concludes that the minor shear zone shown in Figure 4 of Enclosure 3 does not represent a capable tectonic structure in the foundation bedrock. The applicant also indicated that radiometric age dates would be acquired on undeformed minerals growing in the shear zone that represent deep-seated hydrothermal conditions which are very much older than

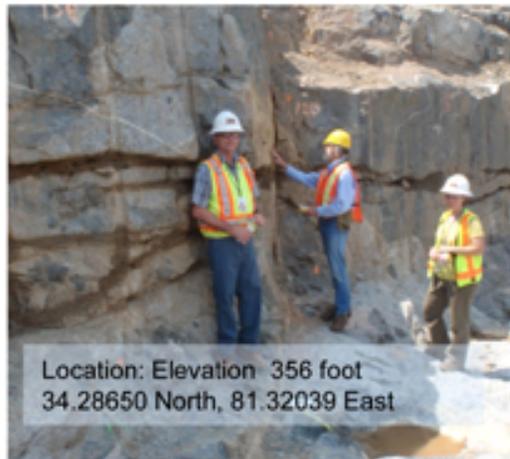
Figure 5 – Three Dimensional Minor Offset Shear

- Figure 5 – Three-dimensional view of the minor shear zone in foundation bedrock, designated as Shear Zone 1 by the applicant, which extends vertically down the Unit 2 excavation wall, passing from the sound rock surface examined during the August 2010 site visit to the foundation grade level surface examined by the staff during the April 2011 site visit.

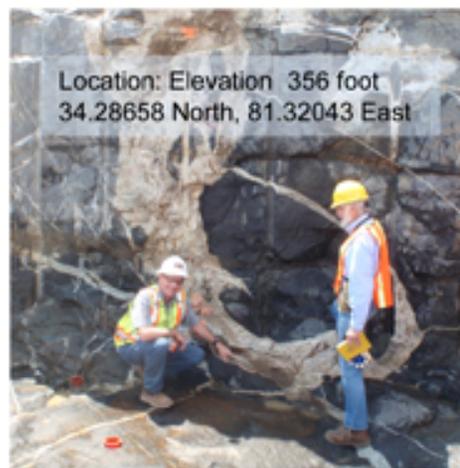
Figure 7 – Complex Intrusive Relationship

- Figure 7 – Complex intrusive relationships between the different igneous intrusions which comprise the foundation bedrock as observed in the vertical wall of the Unit 2 excavation. Three phases of igneous intrusions are shown in this image, all of which are around 307 Ma in age: Intrusive Phase I (dark-colored diorite), Intrusive Phase II (light-colored quartz monzonite), and late-stage, narrow cross-cutting igneous veins.

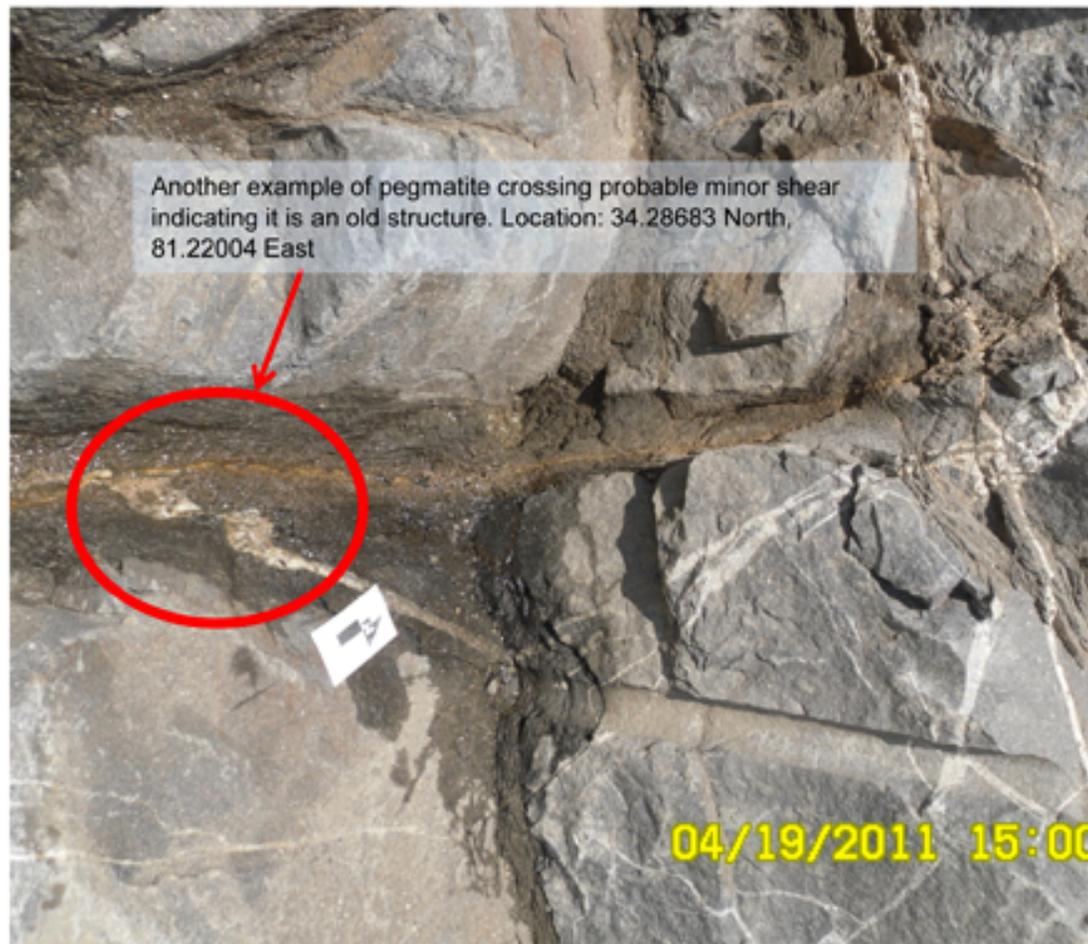
Figure 6 – Another Example of a Probable Minor Shear Zone

- Figure 6 – Another minor shear zone, designated Shear Zone 3 by the applicant, which occurs in foundation bedrock. Although this shear zone has a different orientation than Shear Zone 1, it exhibits similar geologic characteristics. Based on observed field relationships, the staff concludes that this shear zone also does not represent a capable tectonic structure in the foundation bedrock.

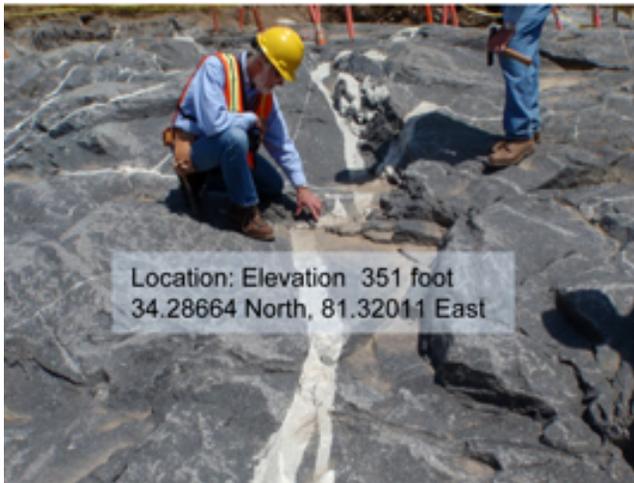
Figure 8 – Igneous Dike Crosscutting Unit 2 Foundation

- Figure 8 – Late-stage igneous vein (a light-colored aplite dike) cross-cutting dark-colored Phase I diorite.
- Figure 9 – Pinch-out of a zone of weathered diorite lying above a light-colored aplite dike, which clearly illustrates that these weathered rock horizons are not laterally continuous layers extending across the site. Borehole data also indicate that weathered horizons are not laterally continuous across the site. Such weathered zones most likely reflect local percolation of ground water, in this case seemingly controlled by the position of the aplite dike.
