PVP2011-58000

Used Nuclear Fuel Transportation Package Seal Performance in Beyond Design Basis Thermal Conditions

Felix Gonzalez, Christopher Bajwa, Robert Einziger, Earl Easton
U.S. Nuclear Regulatory Commission, Washington, DC 20005

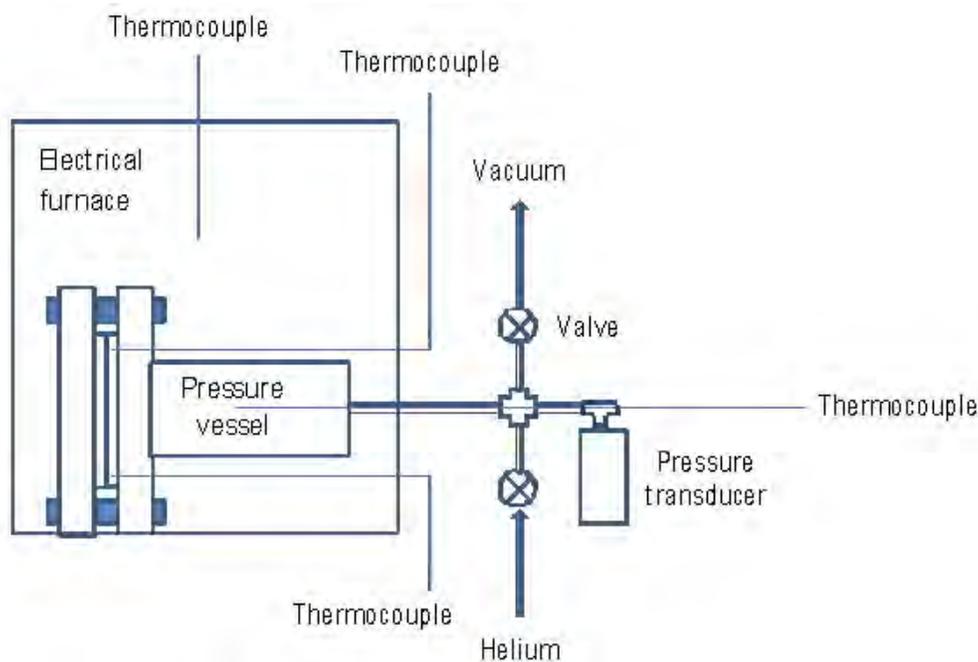
Figure 1: Schematic of experimental apparatus

The test vessels were composed of a cylindrical shell and a flange fabricated from Stainless Steel 304 (SS 304). The flange dimensions were made in conformity with the ASME Standard B16.5-2009, flange class 2500 with a design pressure rating up to 29.2 bar (Table 2-2.1, ASME Standard B16.5-2009) [5]. The vessel cavity had a nominal internal volume of 100 mL. The seal was a metal O-ring made from Inconel 718 and silver with an outer diameter of 6.35 cm (2.5 in) and a cross section of 0.32 cm (0.125 in).

The vessel body and the flange were joined together using four bolts (SS 304 1-1/8 in. 7 TPI), each tightened with a torque of 416 Nm (307 ft·lb) ± 2 N·m using a micrometer torque wrench. A 24 cm long SS tubing with an inside diameter of 0.48 cm (0.189 in) and an outside diameter of 0.953 cm (0.375 in) was inserted into the bottom of the vessel body flush through a straight-hole with a bevel-groove and was all-around fillet welded to the vessel. The exposed end of the tubing was connected to a union cross equipped with two needle valves or bellow valves for filling and evacuating the test vessel and a tee connection for mounting a pressure transducer and a thermocouple to monitor the vessel pressure and temperature. A schematic of the experimental set up is provided in Figure 1. Photographs of the actual experimental setup are provided in Figure 2.

The exposure of the seal to high temperature environment was achieved using a programmable temperature-controlled electrical furnace with an internal capacity of 25.4 cm x 25.4 cm x 40.64 cm (10 in x 10 in x 16 in). Four Type K grounded thermocouples were used to monitor the transient temperature distribution of the test vessel, flange, and oven ambient.

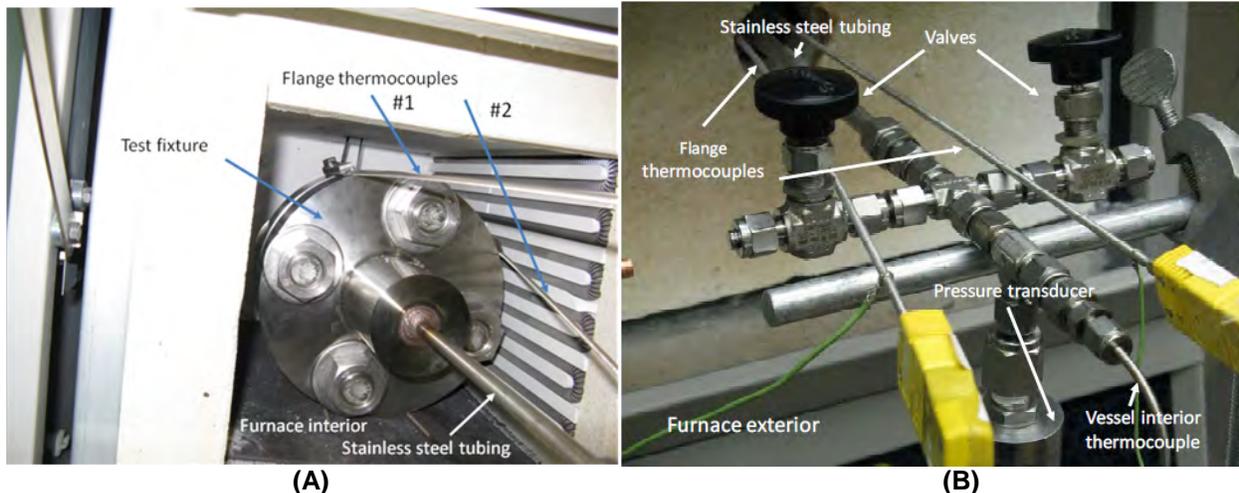
Figure 2: Test vessel inside furnace with flange thermocouples labeled (A); Valve and pressure transducer arrangement external to furnace (B)

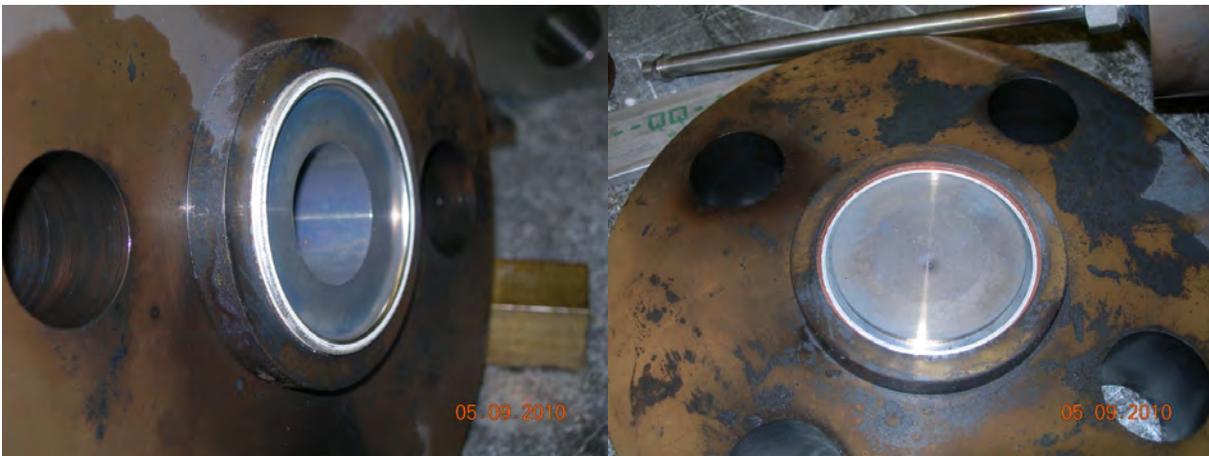
Figure 3: Postmortem photographs showing the O-ring bonded to the tested vessel body (left) and showing silver from the metallic O-ring deposited on the O-ring groove (right)

A postmortem inspection of the tested vessel revealed that the metallic seal was soldered to the flange of the vessel body and a silver-colored coating was imprinted on the surface of the O-ring groove, as shown in Figure 3. The high-temperature exposure also discolored the test fixture.

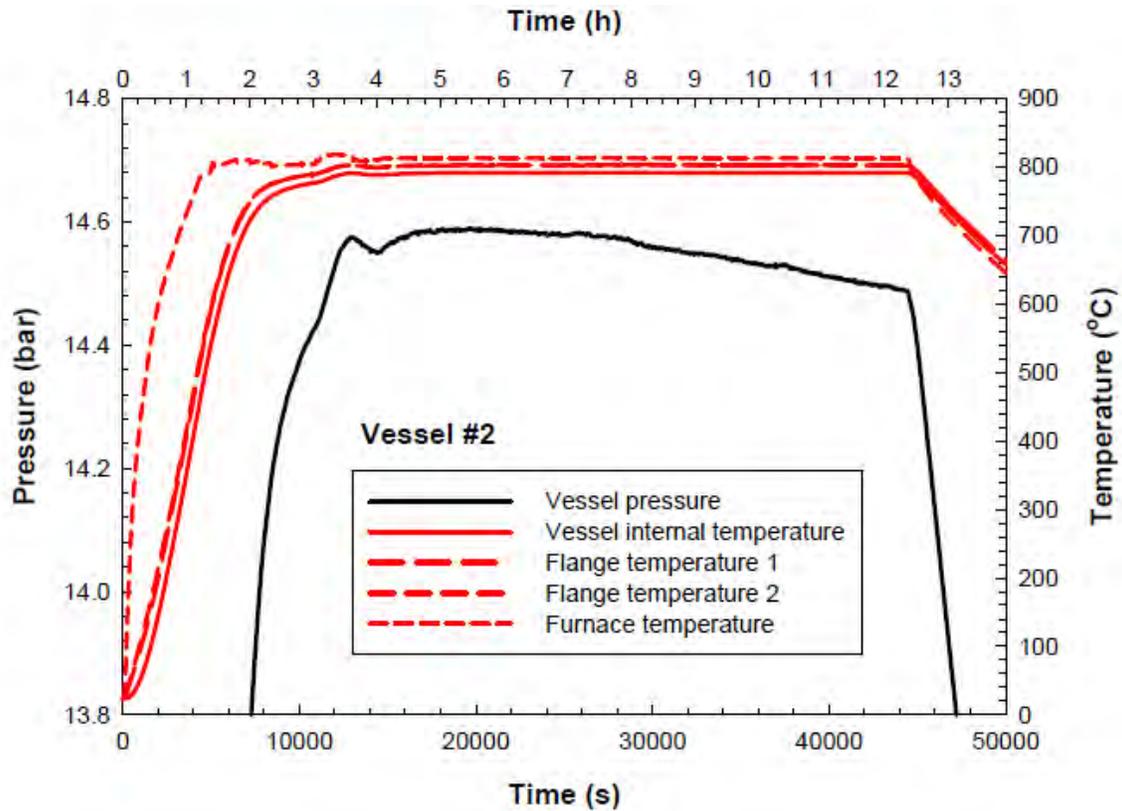
Figure 4: Temporal variations of vessel pressure and temperature in Test #2 [y-axis (pressure) has been magnified to show the small pressure decrease]

Figure 4 shows the temporal variations of the vessel internal pressure and temperature, two flange temperatures and furnace temperature during the heat-up, the constant-temperature heating (isothermal), and the cool-down phases for Test #2.

The entire cool-down phase is not shown in Figure 4 because it normally takes more than several days to naturally cool the test vessel inside the powered-down furnace from 800°C (1472°F) to room temperature.

The scale of the ordinate for pressure in Figure 4 is magnified to show that the pressure starts to decrease shortly after the vessel temperature has reached 800°C (1472°F) and continues to decrease during the rest of the 9 hour constant-temperature heating phase. Although the decrease in pressure, which is within the expanded measurement uncertainty of the pressure transducer, is not significant in this test, the continuous downward trend seems to imply the occurrence of a very small leak.

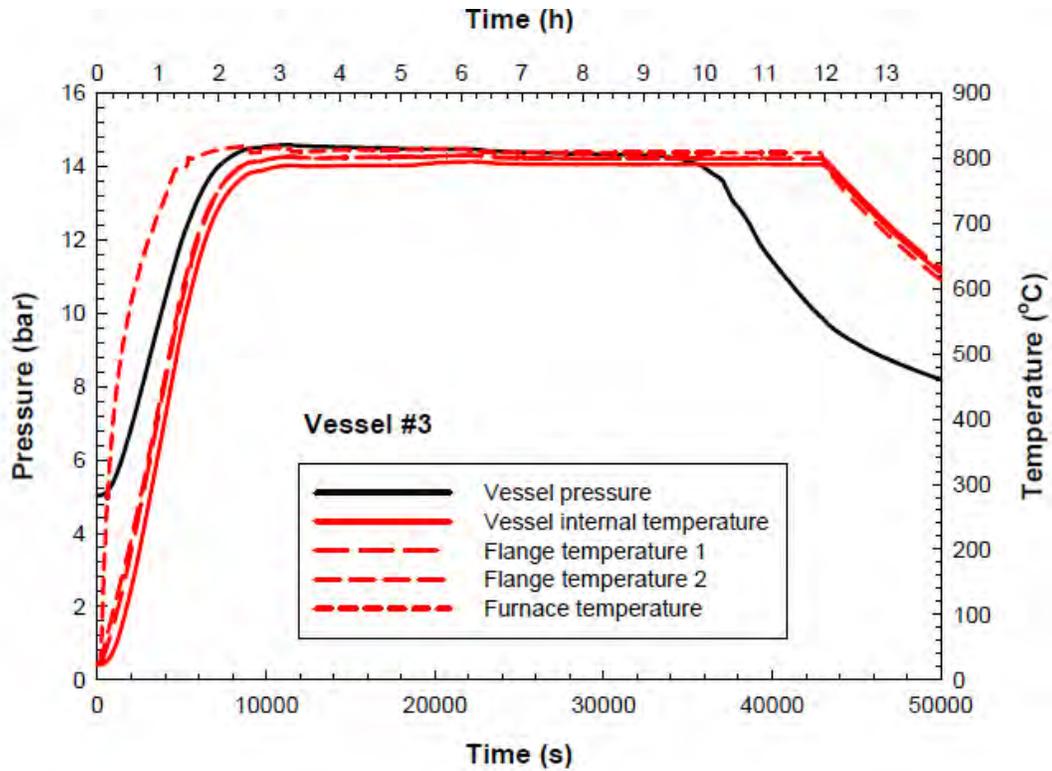
Figure 5: Temporal variations of vessel pressure and temperature in Test #3

Test #3 and #4 are the repeats for Test #2. Figure 5 and Figure 6 are the test results and also show the occurrence of a leak during the 9 hour constant-

temperature heating phase at 800°C (1472°F). In Test #3, the vessel pressure decreases slowly initially and then significantly after about 25,000 seconds (~7 hours) at 800°C (1472°F). Since the leakage rate is directly proportional to the time rate of change of pressure, this two-stage decrease in pressure indicates a slower leak rate at first and then a faster leak rate at the end. In Test #4, the pressure remains relatively constant for about 10,000 seconds (2.8 hours) initially during the 9-hour constant-temperature heating phase, begins to drop significantly for about 15,000 seconds (4.16 hours), and decreases slowly for the remaining duration.

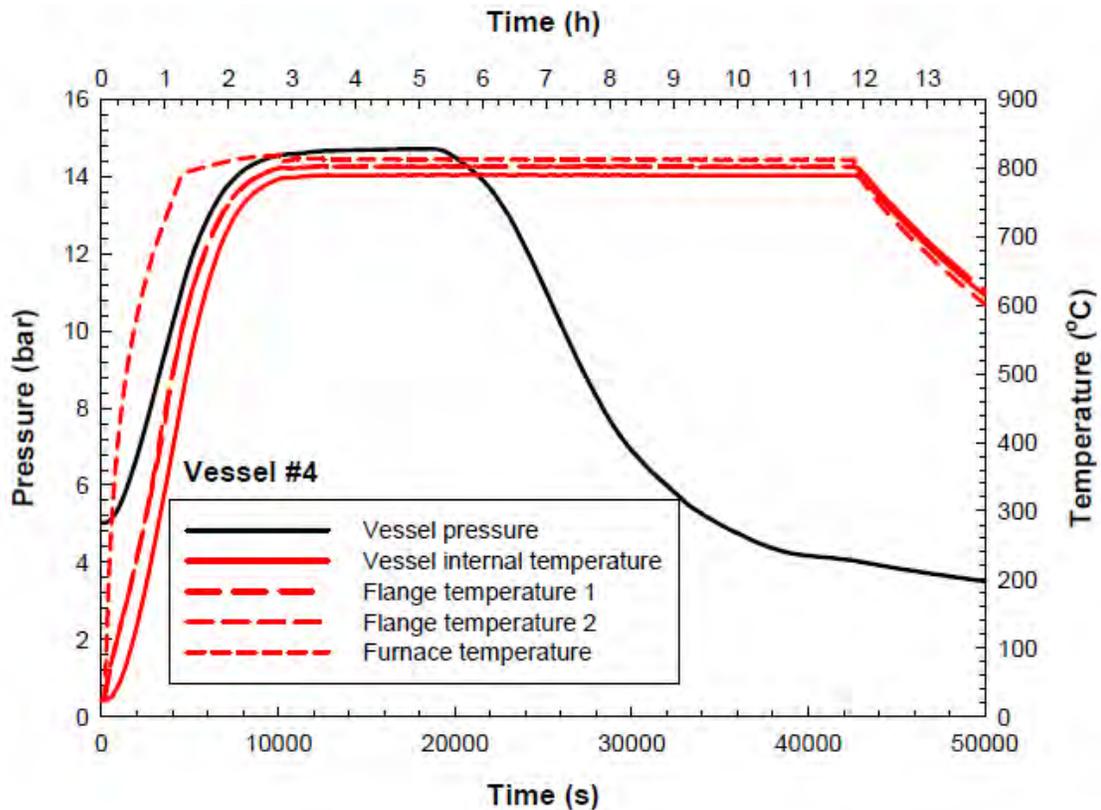
Figure 6: Temporal variations of vessel pressure and temperature in Test #4

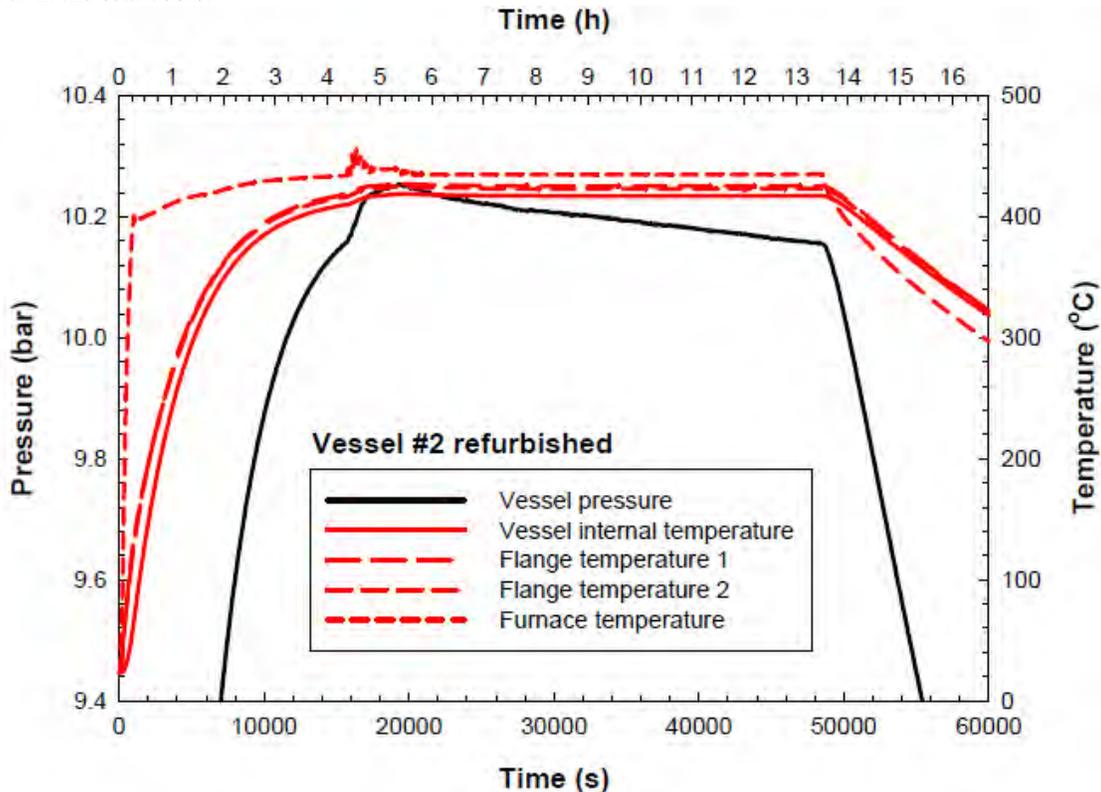
Figure 7: Temporal variations of vessel pressure and temperature in Test #6

The results for Test #6 using the refurbished Vessel #2 are shown in Figure 7. The refurbishment only involved the re-facing of the surfaces of the flanges and the O-ring groove to the specified tolerances. For this test, the vessel pressure started to decrease very slowly during the constant-temperature heating period. The scale of the ordinate pressure is magnified in Figure 7 to elucidate the small pressure drop, which is within the expanded measurement uncertainty of 0.11 bar; however, the continuous decrease in pressure does seem to imply that a very small leak might have occurred during the test.
