# Update of LOCA-Integral and POST-LOCA-Bend Test Results for Fresh ZIRLO Cladding

Y. Yan, T.A. Burtseva, R.O. Meyer, and M.C. Billone  
Argonne National Laboratory

July 21, 2010

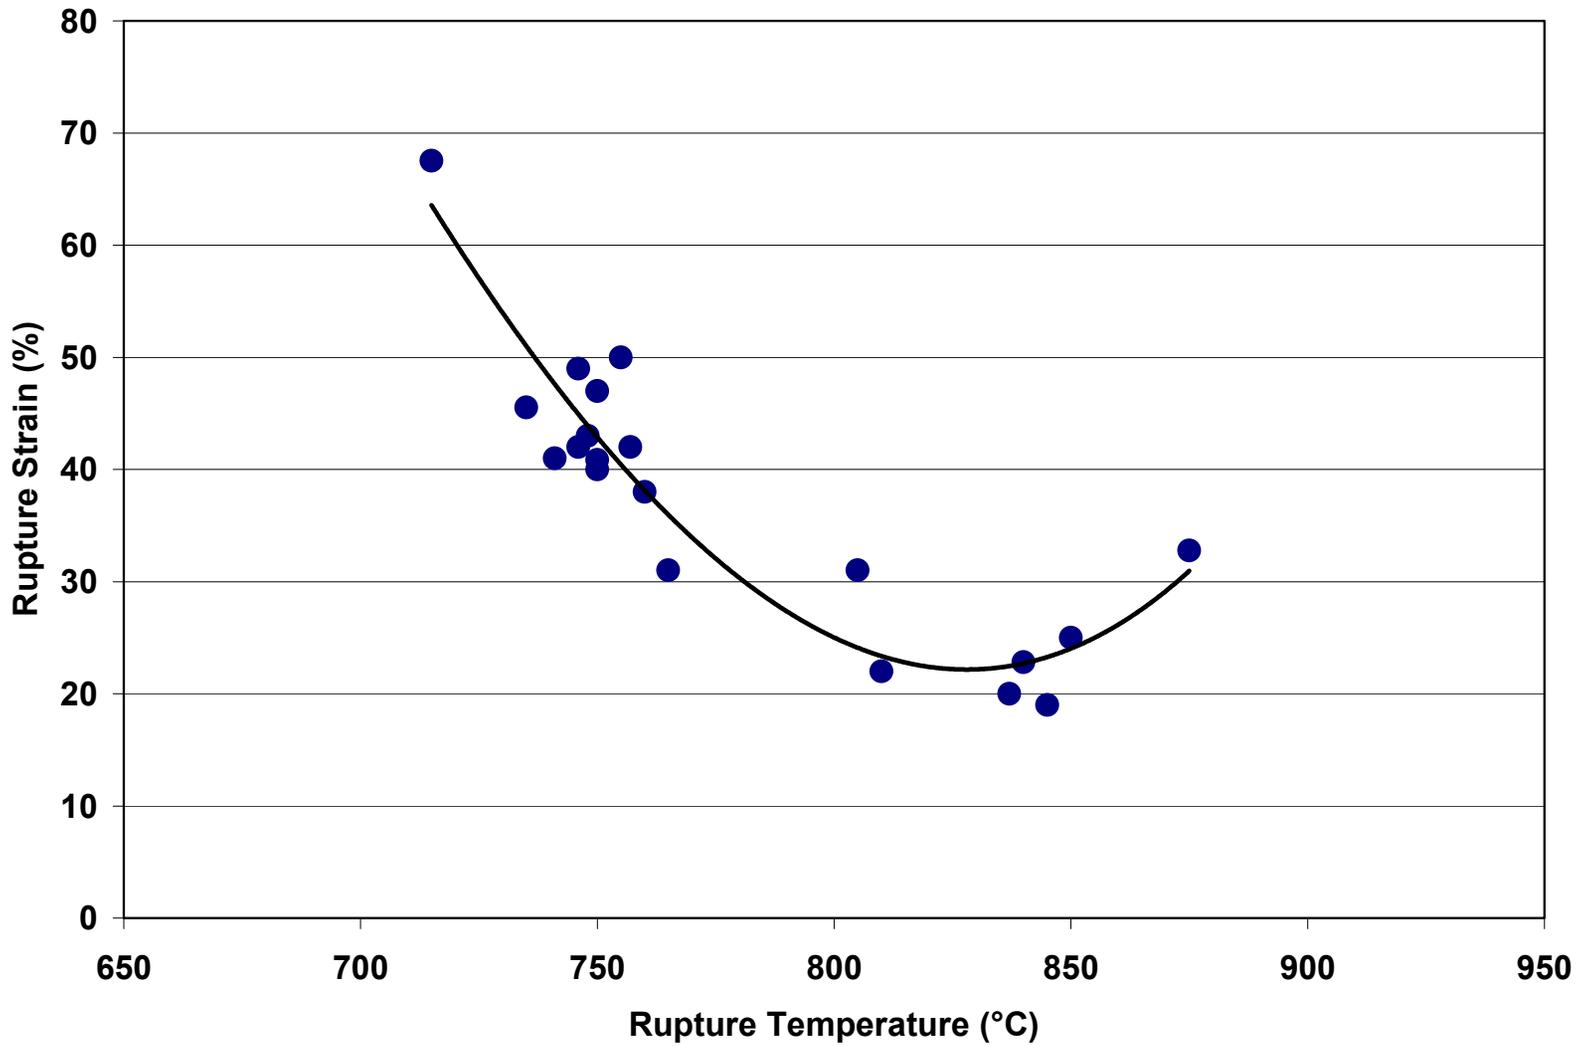
Fig. 1. Rupture strain as a function of rupture temperature for as-fabricated ZIRLO with fill pressures of 400 to 1600 psig at 300°C subjected to a temperature ramp of 5°C/s. Rupture strain is defined as the percent increase in mid-wall circumference following rupture and slow-cooling to room temperature.

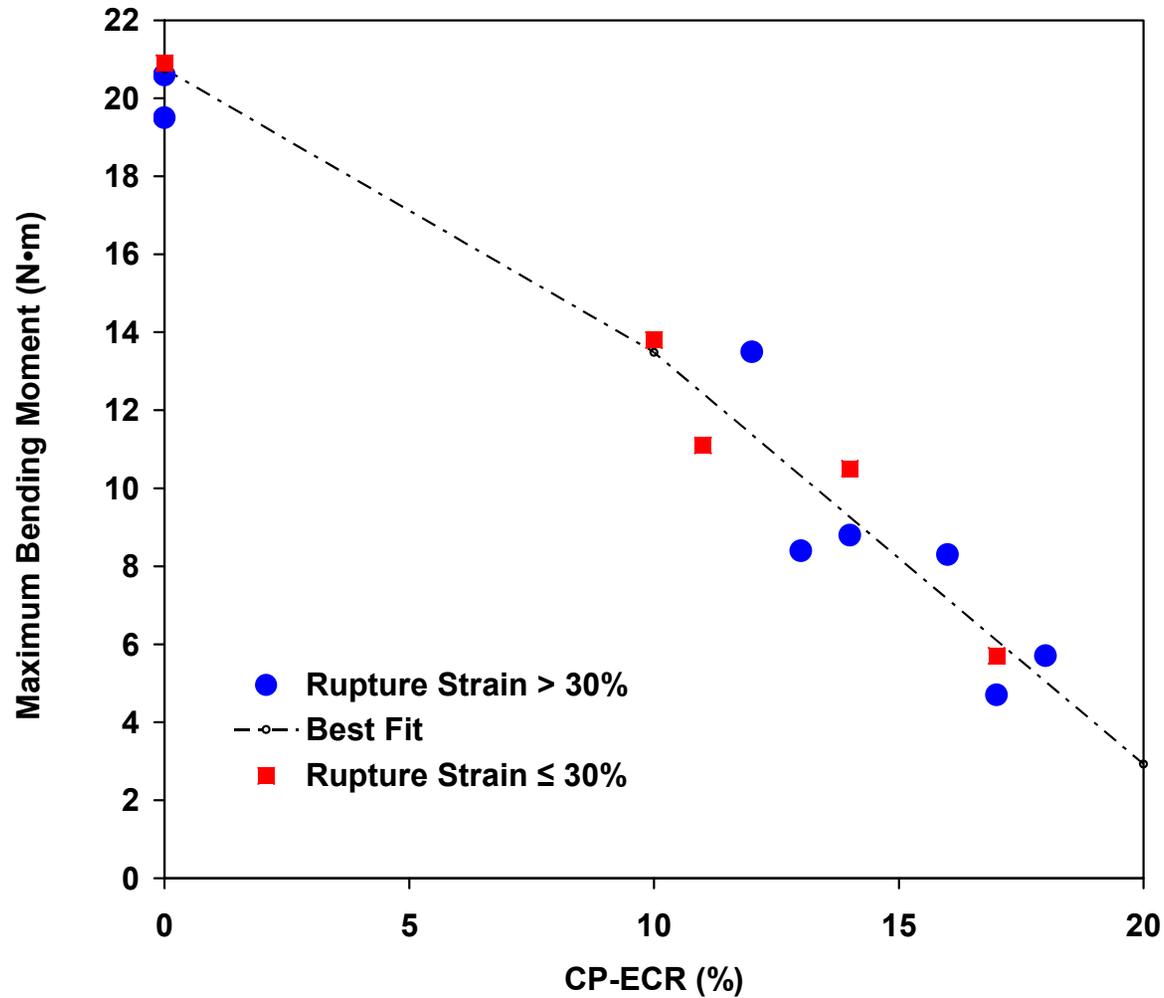
Fig. 2. Maximum bending moment as a function of oxidation level (CP-ECR) for post-LOCA samples subjected to four-point bending with the rupture region in tension for all tests but one. Bend tests were performed at 135°C and 2 or 1 mm/s to 14-mm maximum displacement.

The maximum bending moment decreases with oxidation level expressed as % CP-ECR (see Fig. 2). The decrease is essentially linear from 10% to 18% CP-ECR, with a small non-linearity between 0% and 10% CP-ECR. Within expected data scatter, it appears that the results are independent of rupture strains in the range of 20% to 50%.

Based on the decrease in maximum bending moment (i.e., strength) and maximum energy (i.e., toughness) with increasing oxidation level shown in Figs. 2 and 3, respectively, it is clear that the maximum oxidation level should be limited in the balloon region to increase the probability that fresh fuel rods will maintain their geometry during quench and post-quench in response to loads beyond those associated with thermal stresses in an unconstrained rod. All of the ANL LOCA integral samples (unconstrained) oxidized and quenched at  $\leq 20\%$  CP-ECR survived quench, as expected. As oxidation temperatures above 1200°C would result in enhanced decreases of maximum bending moment and energy with increasing oxidation level, it is also clear that the peak cladding temperature in the balloon region should be limited.

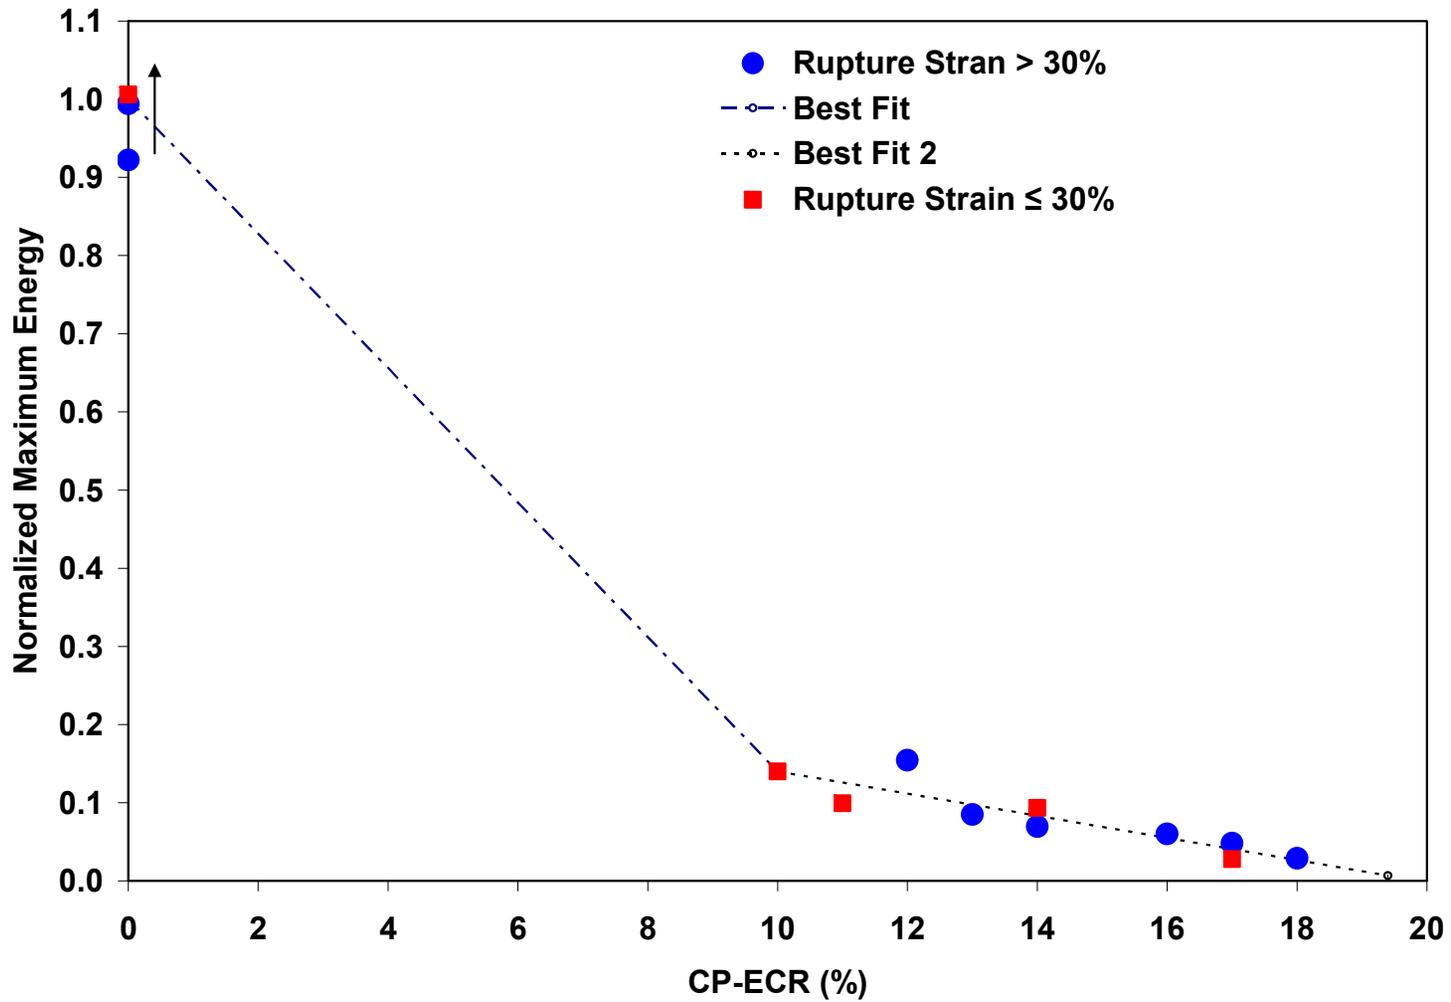
Fig. 3. Normalized maximum energy as a function of oxidation level (CP-ECR) for post-LOCA samples subjected to four-point bending with the rupture region in tension for all tests but one. Bend tests were performed at 135°C and 2 or 1 mm/s to 14-mm maximum displacement.

The maximum energy is dependent on the width (150 mm) of the span exposed to the uniform bending moment. To generalize the results, the maximum energy is normalized to the maximum energy of the highly ductile 0% CP-ECR samples that were subjected to 14-mm displacement at 2 mm/s and 135°C. Figure 3 shows the measured energy normalized to 20.75 J as a function of CP-ECR. The results show a very steep drop between 0% and 10% CP-ECR and a more gradual linear decrease between 10% and 18% CP-ECR. These results also appear to be independent of rupture strain.

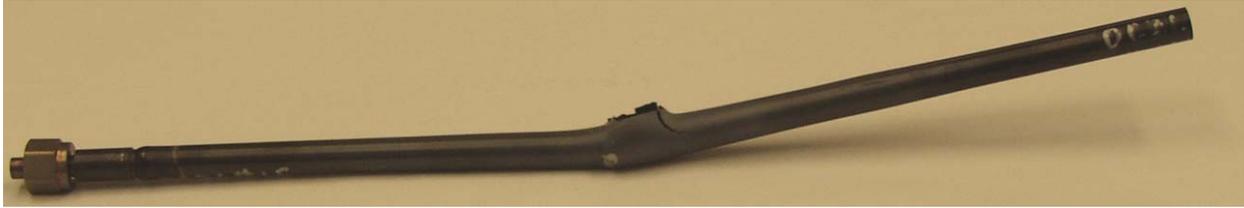
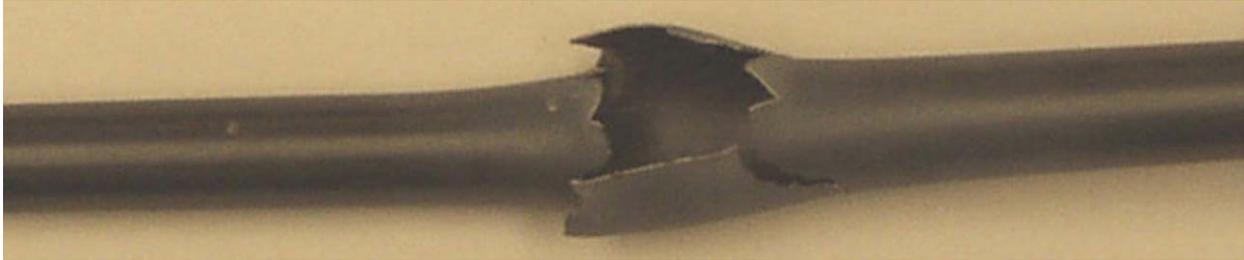
(a) Low magnification side view

(b) Higher magnification rupture view

Fig. 4. Post-bend photographs of OCZL#15 LOCA sample oxidized to 18% CP-ECR and cooled with quench. The sample was bent at 135°C to 14-mm displacement with the rupture region subjected to the maximum axial compressive stress.

Macroscopic plastic flow was observed within the rupture-node cross section in the OCZL#15 sample. This sample was oriented such that the strong, ductile back region was exposed to the maximum tensile bending stress. The brittle rupture tips and surrounding material were under compression. In the absence of a crack growing through a tensile stress field, the sample survived 14-mm displacement without severing and with a plastic displacement of 13 mm (see Fig. 4). Two other tests, which were conducted with the rupture region under tension, survived the test without complete severing of the rupture-node cross-section. The OCZL#17 sample at 13% oxidation level survived 10-mm displacement with 10% of the cross section intact and a plastic displacement of 6.3 mm (see Fig. 5). The OCZL#29 sample at 17% CP-ECR exhibited plastic displacement of about 0.5 mm through the first loading phase of the test (up to  $\approx 3$  mm displacement). The sample was examined after test interruption. The crack extended through about 60% of the cross section (see Figs. 6a and 6b). After reloading, the sample exhibited ductile crack growth through 10 mm of displacement with about 10% of the cross section intact at the end of an additional 8 mm of plastic displacement (see Fig. 6c).

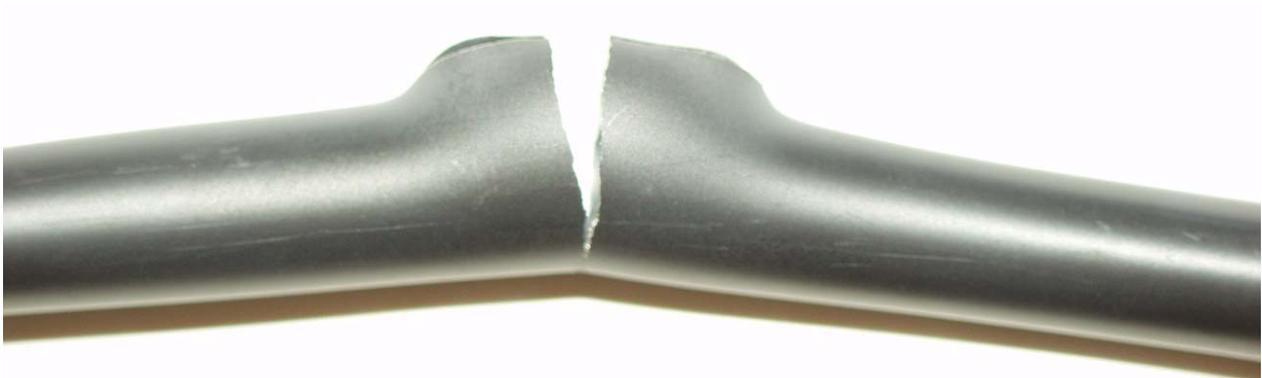
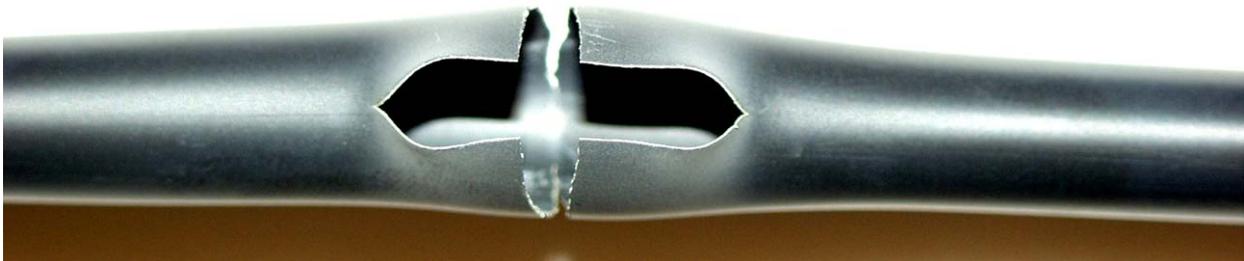
(a) Higher magnification side view

(b) Higher magnification rupture view

Fig. 5. Post-bend photographs of OCZL#17 sample (13% CP-ECR and quenched) after 10-mm displacement at 135°C with the rupture region subjected to maximum tensile stress.

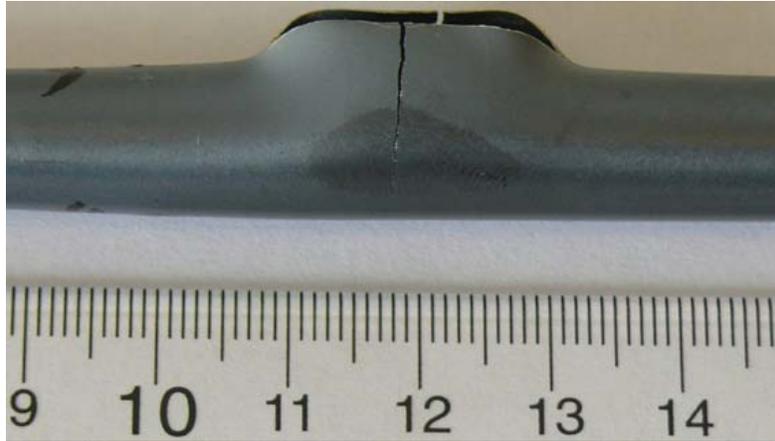
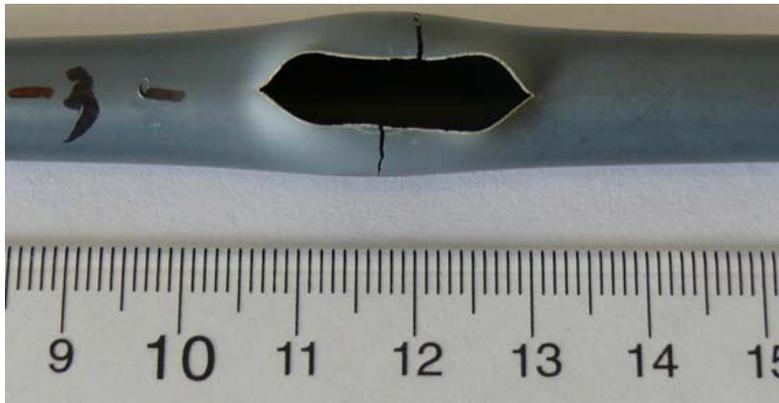
(6a) Higher magnification side view after 1<sup>st</sup> loading

(6b) Higher magnification rupture view after 1<sup>st</sup> loading

(6c) Higher magnification rupture view after 2<sup>nd</sup> loading

Fig. 6. Post-bend photographs of OCZL#29 sample (17% CP-ECR and quench) after 1<sup>st</sup> loading to  $\approx 3$ -mm displacement at 135°C: (a) side view and (b) rupture view; and (c) rupture view after 2<sup>nd</sup> loading to an additional 10-mm displacement at 135°C.

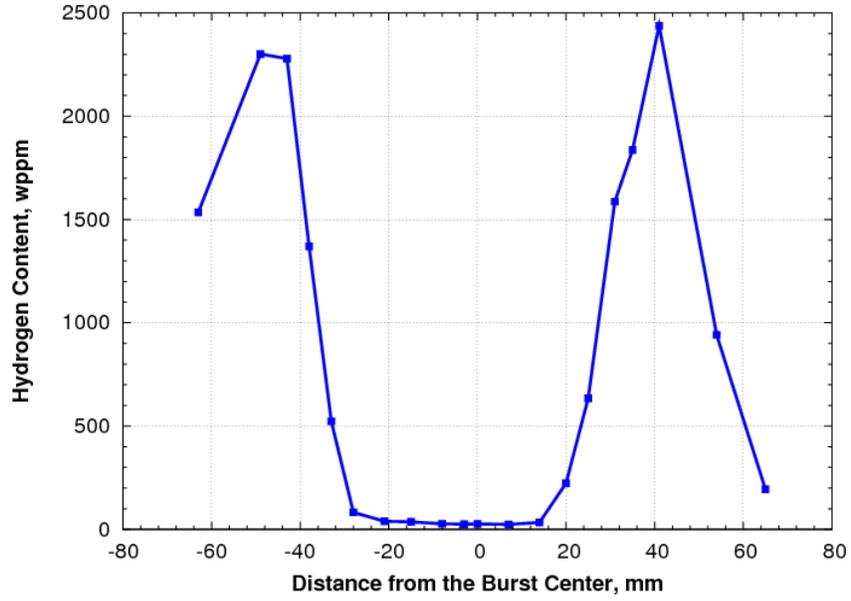
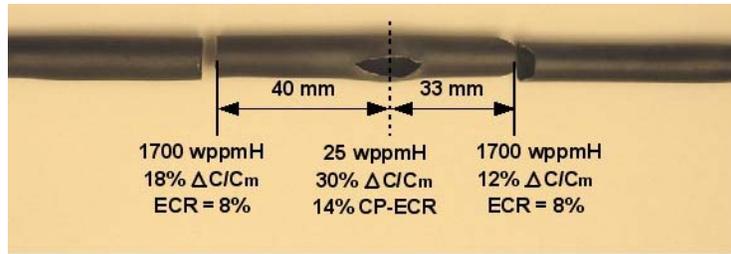
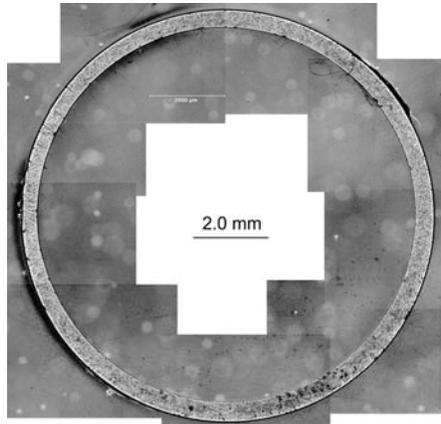
(a) Hydrogen-content profile

(b) Measured values at failure locations

(c) Low-magnification image of severed cross section at -40 mm

Fig. 7. Post-bend characterization of OCZL#12 sample that was subjected to bending at 135°C with the rupture region under maximum compressive stress: (a) hydrogen-content profile; (b) measured values at failure locations; and (c) low-magnification image of severed cross section at 40 mm below rupture mid-span.

Post-bend-test characterization included metallographic imaging at failure locations and measurement of hydrogen-content profiles. Oxygen-content analyses are currently in progress. Figure 7a shows the hydrogen-content profile for the OCZL#12 sample that failed at locations outside the rupture region (40 mm below and 33 mm above the rupture mid-span). These failure locations are between the hydrogen peaks and the longitudinal edges of the rupture. The hydrogen content at the failure locations (1700 wppm), along with the measured circumferential strain and ECR, are shown in Fig. 7b. A low-magnification metallographic image of the severed cross section at -40 mm is shown in Fig. 7c. The outer- and inner-surface oxide layers were measured to be:  $33 \pm 5$   $\mu\text{m}$  and  $10 \pm 3$   $\mu\text{m}$ , respectively, at -40 mm; and  $32 \pm 4$   $\mu\text{m}$  and  $12 \pm 3$   $\mu\text{m}$ , respectively, at +33 mm. The metal layer thicknesses prior to oxidation were calculated to be 0.50 mm at -40 mm and 0.53 mm at +33 mm. Based on the data, it appears that these locations severed simultaneously.

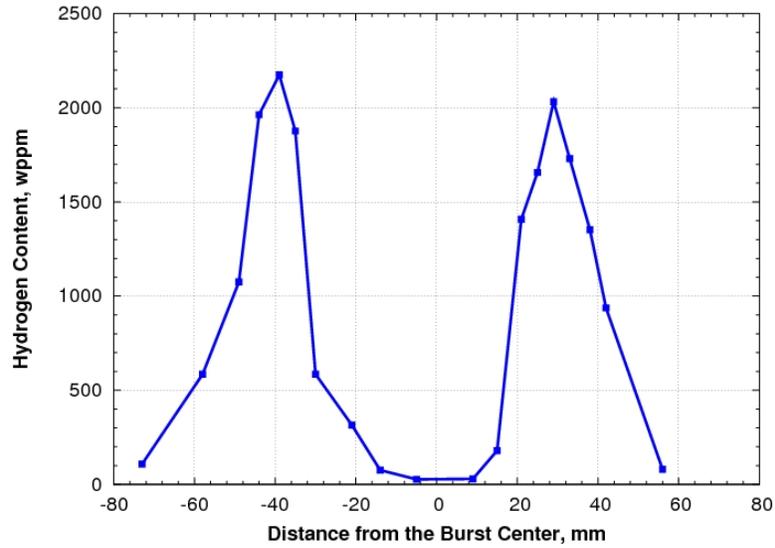
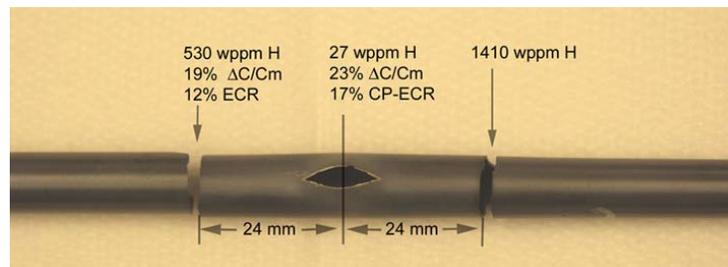
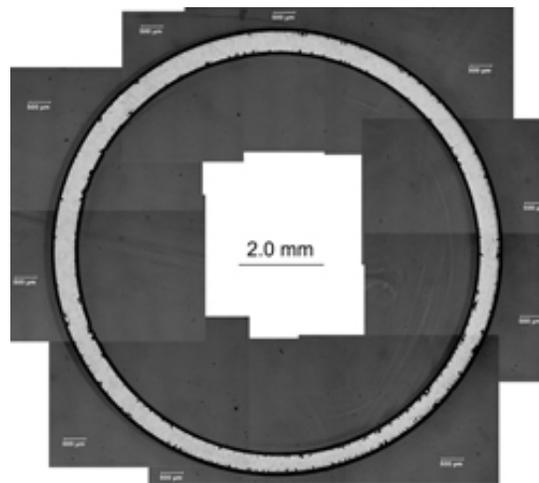
(a) Hydrogen-content profile

b) Measured values at failure locations

(c) Low-magnification image of severed cross section at -24 mm

Fig. 8. Post-bend characterization of OCZL#19 sample that was subjected to bending at 135°C with the rupture region under maximum tensile stress: (a) hydrogen-content profile; (b) measured values at failure locations; and (c) low-magnification image of severed cross section at 24 mm below rupture mid-span.

Similar post-bend characterization was performed for the OCZL#19 sample following oxidation to 17% CP-ECR and quench at 800°C. The sample was subjected to bending with the rupture node under maximum tensile stress. Figure 8a shows the axial profile of hydrogen content. The profile is very similar to the one for the OCZL#12 sample. As shown in Fig. 8b, the sample severed at axial locations 24 mm below and above the rupture mid-span. Neither of these locations coincides with a hydrogen peak. The hydrogen content and measured ECR at the -24 mm location were 530 wppm and 12%, respectively. Based on ring-compression tests, this combination of hydrogen content and oxidation level would lead to brittle failure. The outer- and inner-surface oxide layers were measured to be  $50\pm 6$   $\mu\text{m}$  and  $35\pm 6$   $\mu\text{m}$  and the pre-oxidation metal wall thickness was determined to be 0.51 mm at the -24 mm location.

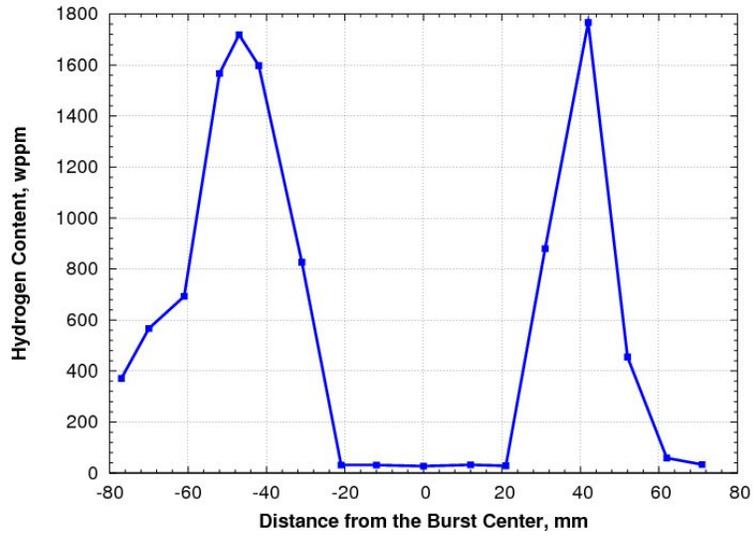
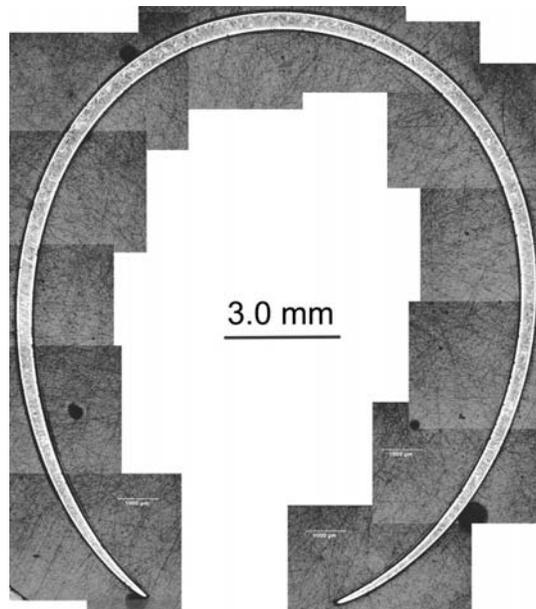
(a) Hydrogen-content profile

(c) Low-magnification image of severed cross section

Fig. 9. Post-bend characterization of the OCZL#18 sample oxidized to 12% CP-ECR, quenched, and subjected to bending at 135°C with the rupture region under maximum tensile stress: (a) hydrogen-content profile; (b) failure location; and (c) low-magnification image of the severed cross section.

The hydrogen-content profile (see Fig. 9a) was also determined for the OCZL#18 sample with 43% rupture strain and 12% CP-ECR. As indicated in Fig. 9b, the sample severed in the cross section containing the rupture node. The low magnification image of the severed cross section is shown in Fig. 9c. There was very good circumferential uniformity in oxide layer thickness ( $29\pm 1$   $\mu\text{m}$ ) based on outer- and inner-surface measurements at 10 locations. Also, the weight gain determined from metallography ( $5.40$   $\text{mg}/\text{cm}^2$ ) was very close to the CP-predicted weight gain ( $5.60$   $\text{mg}/\text{cm}^2$ ) at this location. The average metal wall thickness of the oxidized cladding was 0.35 mm. This converts to a pre-oxidation thickness of 0.39 mm. The measurements are very accurate for each image, but the 10 images represent only about 25% of the cross section. The mid-wall circumference measured from the low-magnification image was 40.0 mm. Assuming conservation of area, the pre-oxidation thickness was calculated to be  $h_f = h_i / (C_{mf} / C_{mi}) = 0.57\text{-mm} / (40.0 / 28.05) = 0.57\text{-mm} / 1.43 = 0.40$  mm. It is encouraging that the two results are very close to each other such that the CP-ECR rounds off to the same integer value of 12% using both approaches.

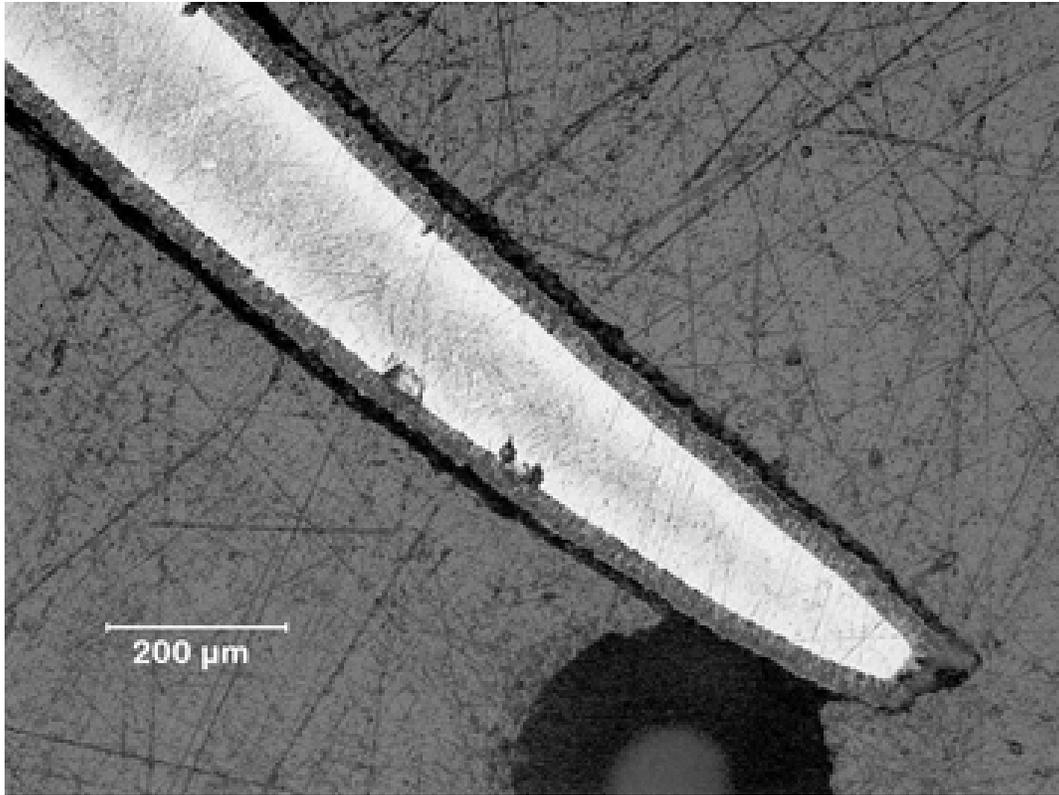
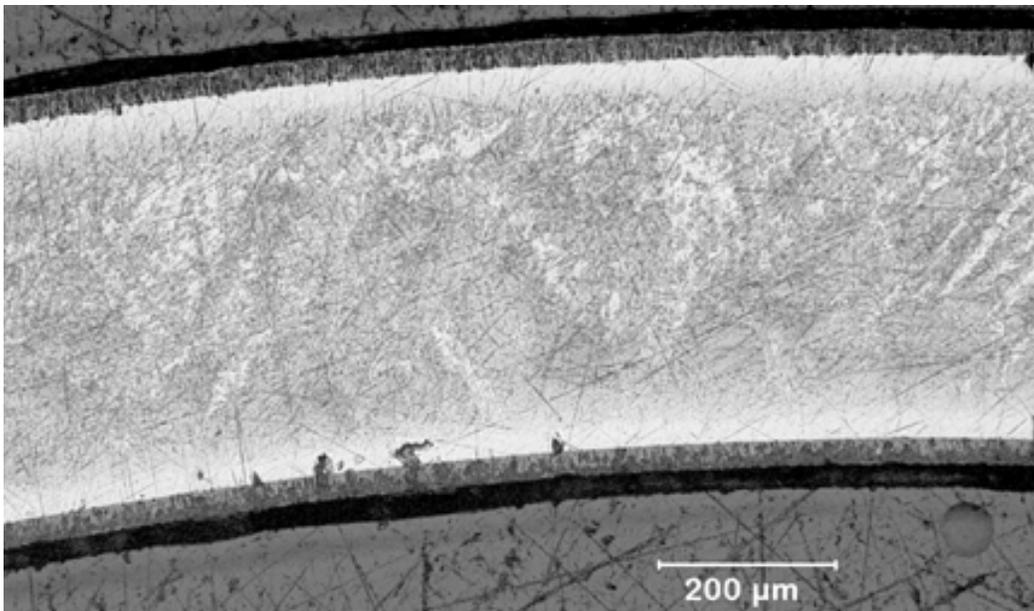
(a) Rupture tip

(b) Back side of rupture node cross section

Fig. 10. Metallographic images for the OCZL#18 severed cross section following oxidation to 12% CP-ECR, quench, and bending at 135°C with the rupture region under maximum tension: (a) rupture tip with 0.14-mm average metal wall; and (b) back side of cross section with 0.44-mm metal wall thickness.

The regions of thinnest (rupture tip) and thickest (back side) cladding metal for the OCZL#18 sample are shown in Figs. 10a and 10b, respectively. It is clear from the metallography that the rupture tips are brittle and that a crack could initiate at these tips and grow into a tensile stress field. However, it is not clear why the crack would not arrest before it reached the back wall of the cladding, which should have a high ductility at <10% CP-ECR. Based on the load-displacement curve (see Fig. 11), it appears that the crack propagated rapidly through the cross section resulting in the severed sample. Although the measured offset displacement is 0.35 mm, it is not at all clear that this offset strain is due to plastic deformation in the mid-span rupture node cross section. It may be due to crack initiation (first small load drop at about 3 mm) and some crack extension (at about 4.2 mm) prior to catastrophic failure. Or it may be due to some slight slippage in the load-train. The observation that the linearized slope remains the same following the first small load drop suggests that the two points exhibiting a slight deviation from linearity do not represent plastic deformation.

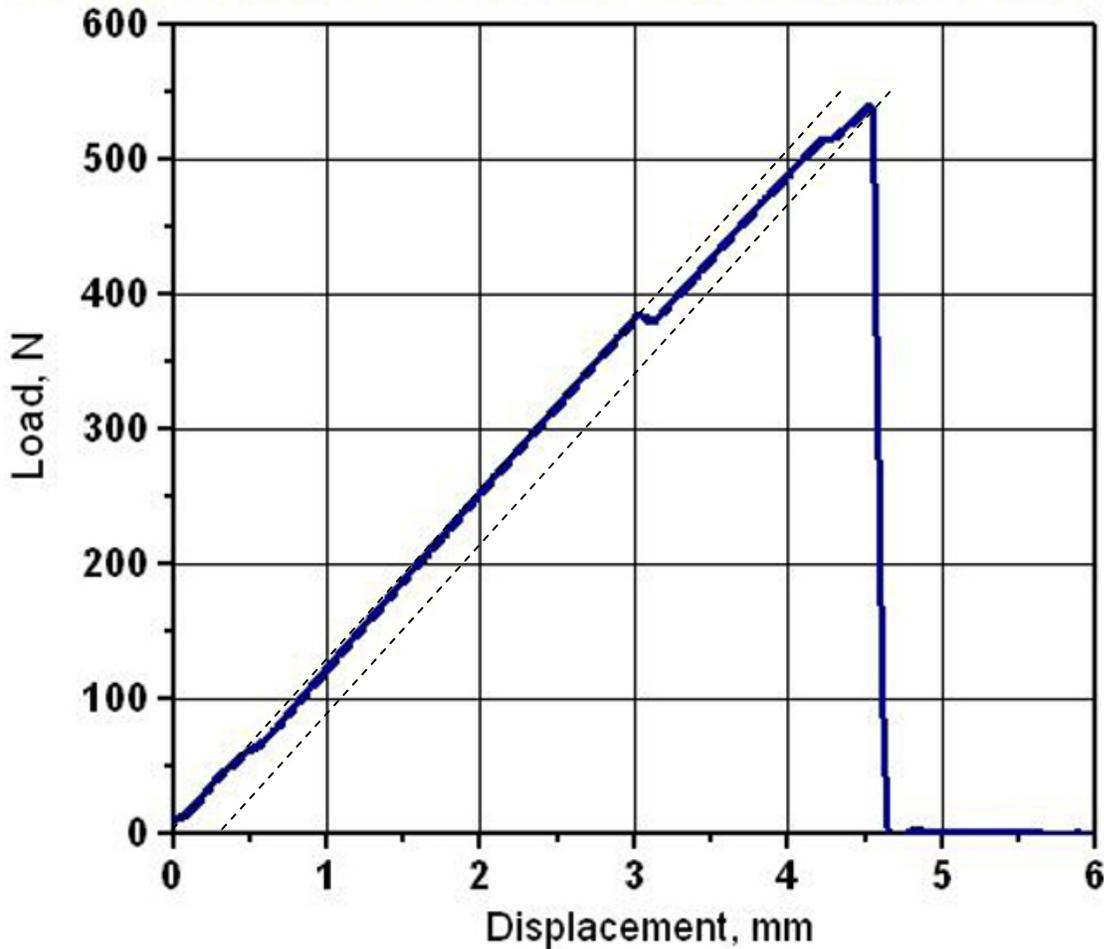
Fig. 11. Load-displacement curve for the OCZL#18 sample (12% CP-ECR and quench) during bend test at 2 mm/s and 135°C with the rupture region under maximum tensile stress.

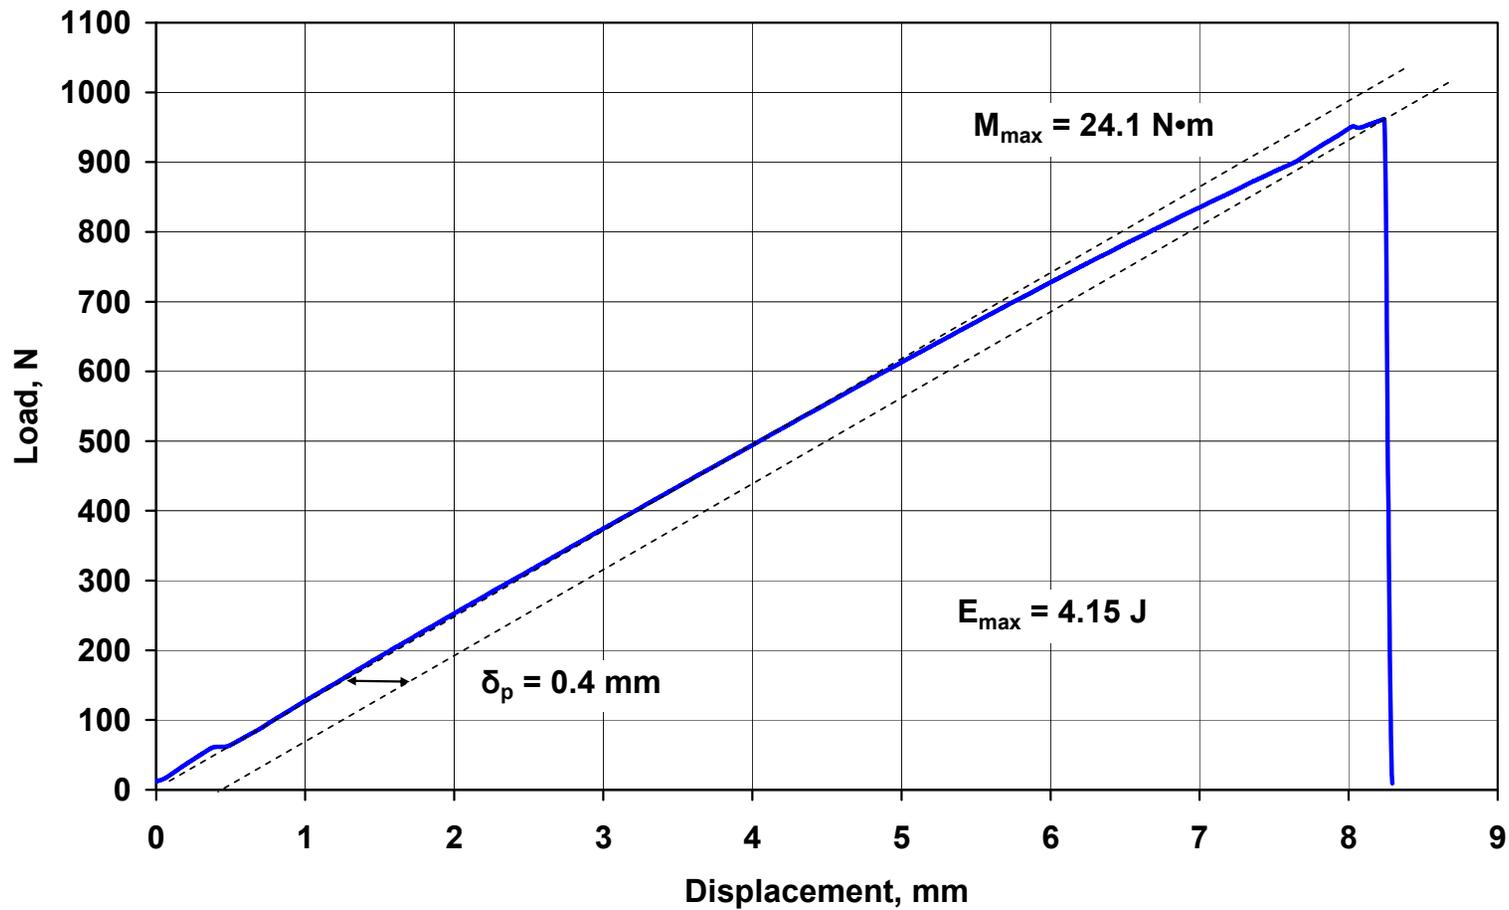
Fig. 12. Load-displacement curve for the OCZL#24 unpressurized LOCA sample oxidized one-sided to 17% CP-ECR, quenched at 800°C and subjected to four-point bending at 135°C and 1 mm/s displacement rate. The sample severed at two locations ( $\pm 38$  mm from the mid-span) following plastic deformation.

Figure 12 shows the load-displacement curve for the one-sided-oxidized, 17% CP-ECR sample subjected to 4-point bending at 135°C and 1 mm/s displacement rate. There is a clear non-linear region of the load-displacement curve prior to rapid crack growth resulting in sample severing at two locations  $\pm 38$  mm from the center of the sample. The gradual non-linearity led to an offset displacement of 0.4 mm, which is indicative of plastic deformation. It should also be noted that the failure bending moment (24.1 N•m) and failure energy (4.15 J) were factors of 4 and 18 higher, respectively, than ballooned, ruptured, and oxidized sample OCZL#19 with 23% rupture strain and 17% CP-ECR.

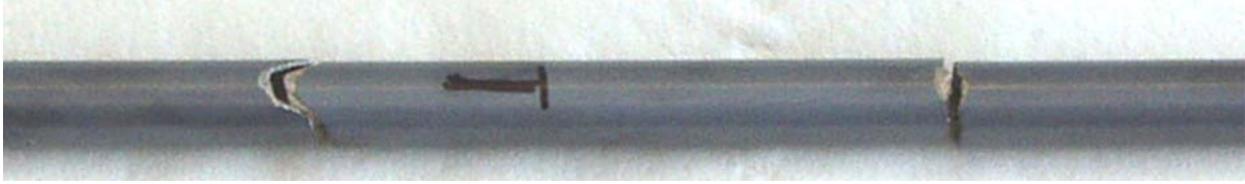
Fig. 13. Failure locations for the non-pressurized, one-sided-oxidized OCZL#24 sample (17% CP-ECR) following bending at 135°C and 1 mm/s. The 76-mm-long segment between the severed cross sections was used to section one metallographic sample and three 8-mm-long rings for RCT.

The remaining 76 mm of material between the two failure locations was sectioned to produce one metallographic sample and three 8-mm-long rings for ring-compression testing. Figure 13 shows the region from which the met and ring samples were sectioned. Given that the sectioned rings had already undergone plastic deformation in the axial direction, the expectation was that these rings would exhibit very low ductility or be brittle. The results of the characterization and ring-compression tests are listed in Table 3. The measured oxide thickness, based on 8 circumferential locations, was  $103 \pm 9$   $\mu\text{m}$ , which is in reasonable agreement with the CP-calculated  $98 \pm 6$   $\mu\text{m}$  based on 4 TC locations. Based on the RCT results in Table 3, the ring with 1.2% permanent strain is classified as ductile ( $\geq 1\%$ ) and the rings with 0.7% and 0.8% permanent strains are classified as brittle. On average, the post-bend material was brittle.

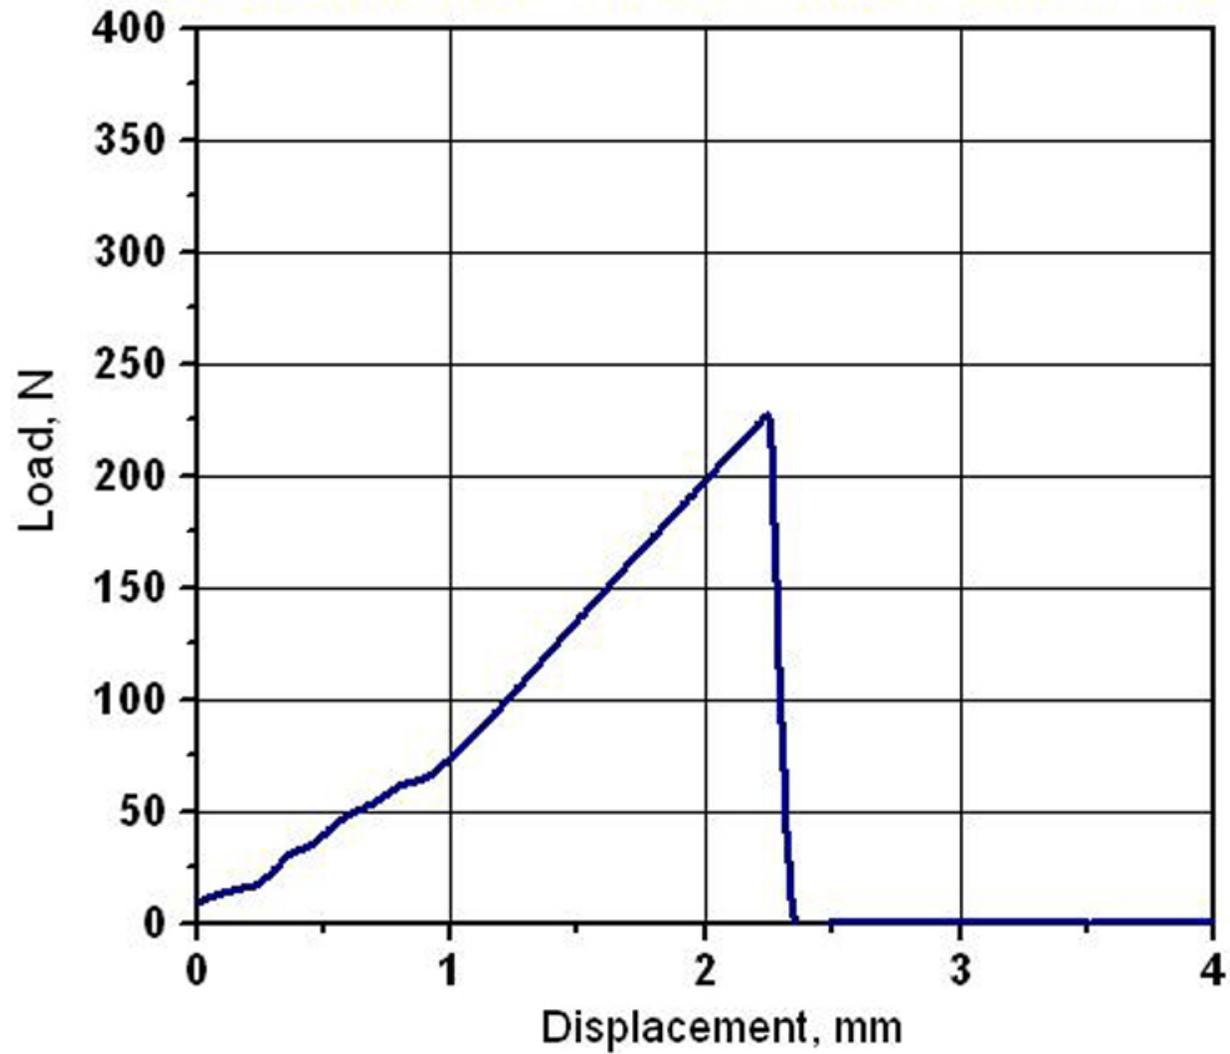
Fig. A.1 Load-displacement curve for post-LOCA sample OCZL#19 (17% CP-ECR) subjected to bending at 135°C and 2 mm/s displacement rate with the rupture tips under maximum tensile stress. Sample severed at two locations ( $\pm 23$  mm from rupture mid-span) in higher hydrogen regions.

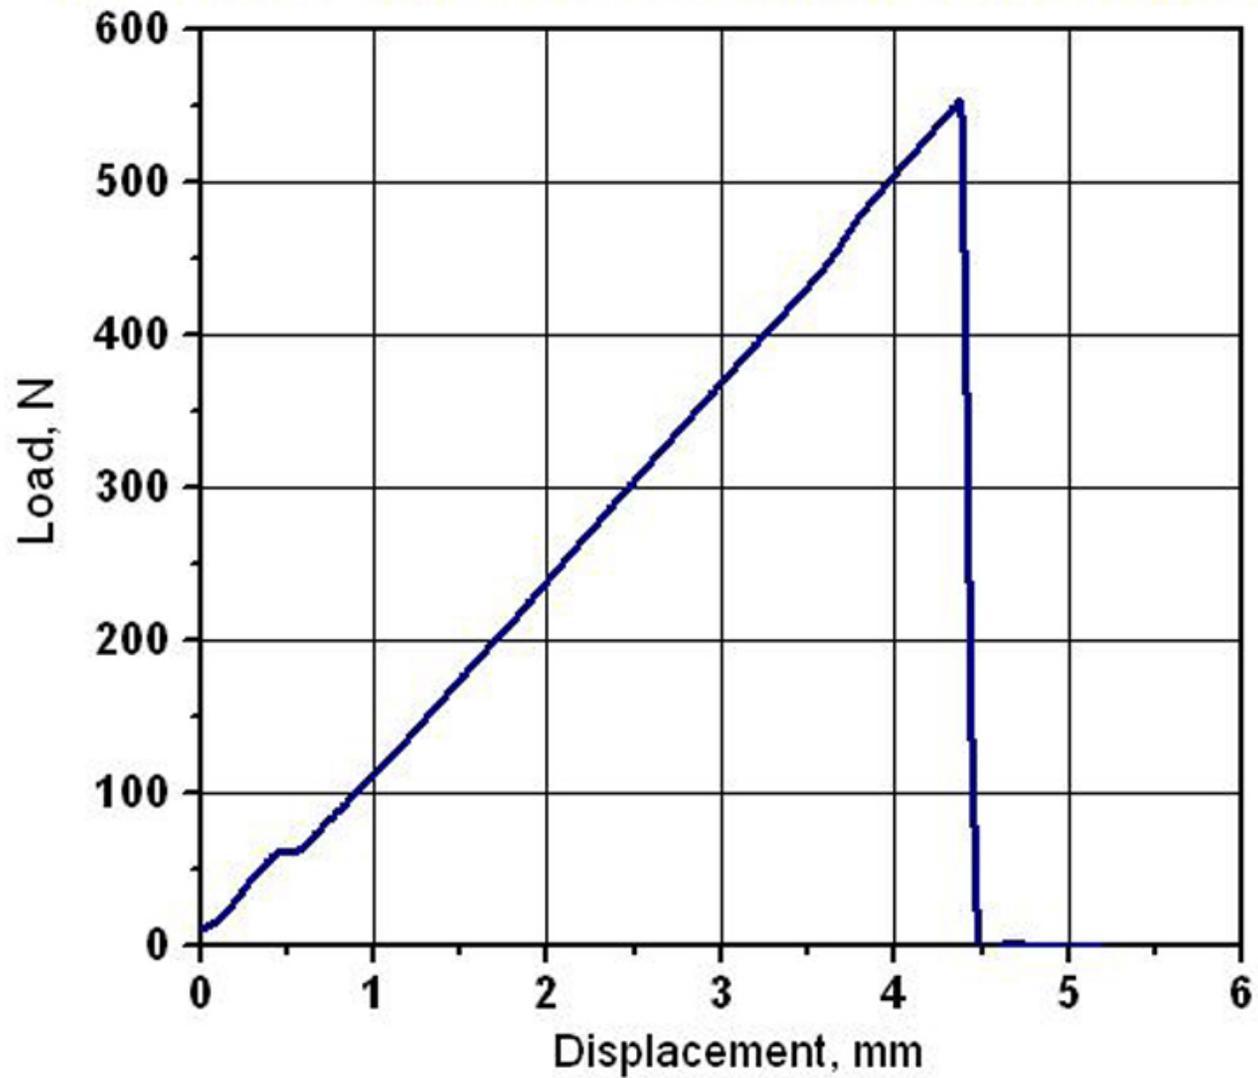
Fig. A.2 Load-displacement curve for post-LOCA sample OCZL#21 (10% CP-ECR) subjected to bending at 135°C and 2 mm/s displacement rate with the rupture tips under maximum tensile stress. Sample severed at two locations (-29 mm and +33 mm from rupture mid-span) in higher hydrogen regions.

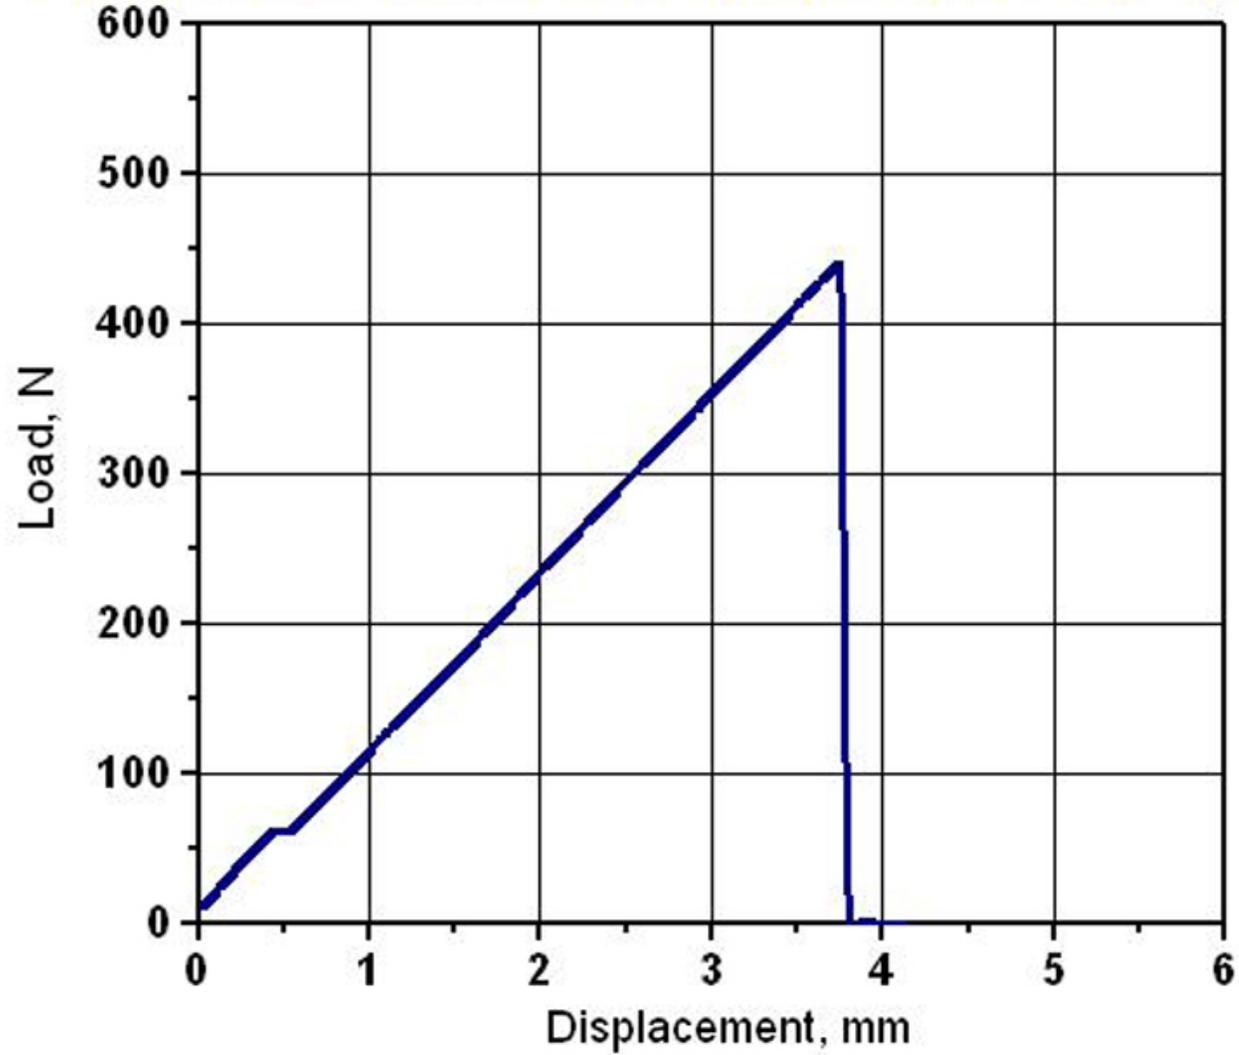
Fig. A.3 Load-displacement curve for post-LOCA sample OCZL#22 (11% CP-ECR) subjected to bending at 135°C and 1 mm/s displacement rate with the rupture tips under maximum tensile stress. Sample severed at two locations (-27 mm and +35 mm from rupture mid-span) in higher hydrogen regions.

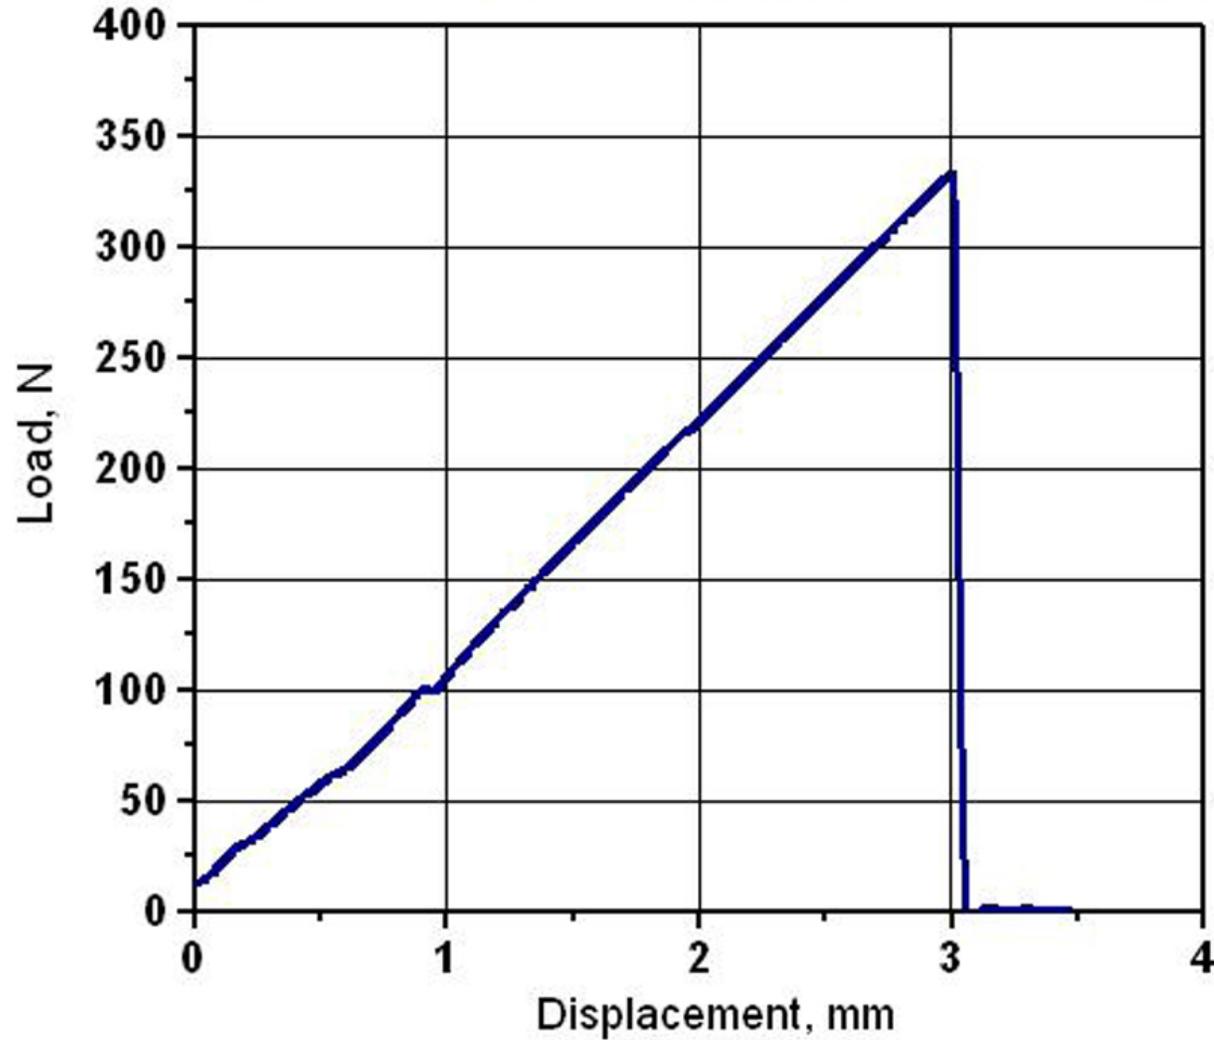
Fig. A.4 Load-displacement curve for post-LOCA sample OCZL#25 (16% CP-ECR) subjected to bending at 135°C and 1 mm/s displacement rate with the rupture tips under maximum tensile stress. Sample severed at two locations ( $\pm 26$  mm from rupture mid-span) in higher hydrogen regions.

The 4-point-bend test is designed to apply a uniform bending moment between the loading points (150-mm span). Such unbiased loading allows the post-LOCA sample to fail at the weakest location. For all tests conducted with the rupture tips under maximum tensile loading, the failures occurred either in the rupture node (high oxidation level, no hydrogen pickup) or at two locations within  $\pm 50$  mm of the rupture mid-span (high hydrogen content, lower oxidation level). Prior to bending the OCZL#25 sample, the data trend indicated that samples with  $<31\%$  rupture strain severed at two locations outside the rupture region, while samples with  $>40\%$  rupture strain severed in the rupture region. However, the OCZL#25 sample (16% CP-ECR) severed at two locations outside the rupture region even though the rupture strain was high (42%) and the rupture width was large (8.7 mm). The OCZL#29 companion sample (17% CP-ECR), with a rupture strain of 49% and a rupture opening of 5.9 mm, cracked through 90% of the cross section containing the rupture opening. Metallography will be performed at the two rupture-node locations to determine why the OCZL#25 rupture-node cross section survived a bending moment of 8.3 N•m without cracking while cracking in the OCZL#29 rupture node initiated at a lower bending moment of (4.7 N•m). Figures A.4 and A.5 in Appendix A show the load-displacement curves for these two bend samples.
