# Update of LOCA-Integral and POST-LOCA-Bend Test Results for Fresh ZIRLO Cladding

Y. Yan, T.A. Burtseva, R.O. Meyer, and M.C. Billone  
Argonne National Laboratory

July 21, 2010

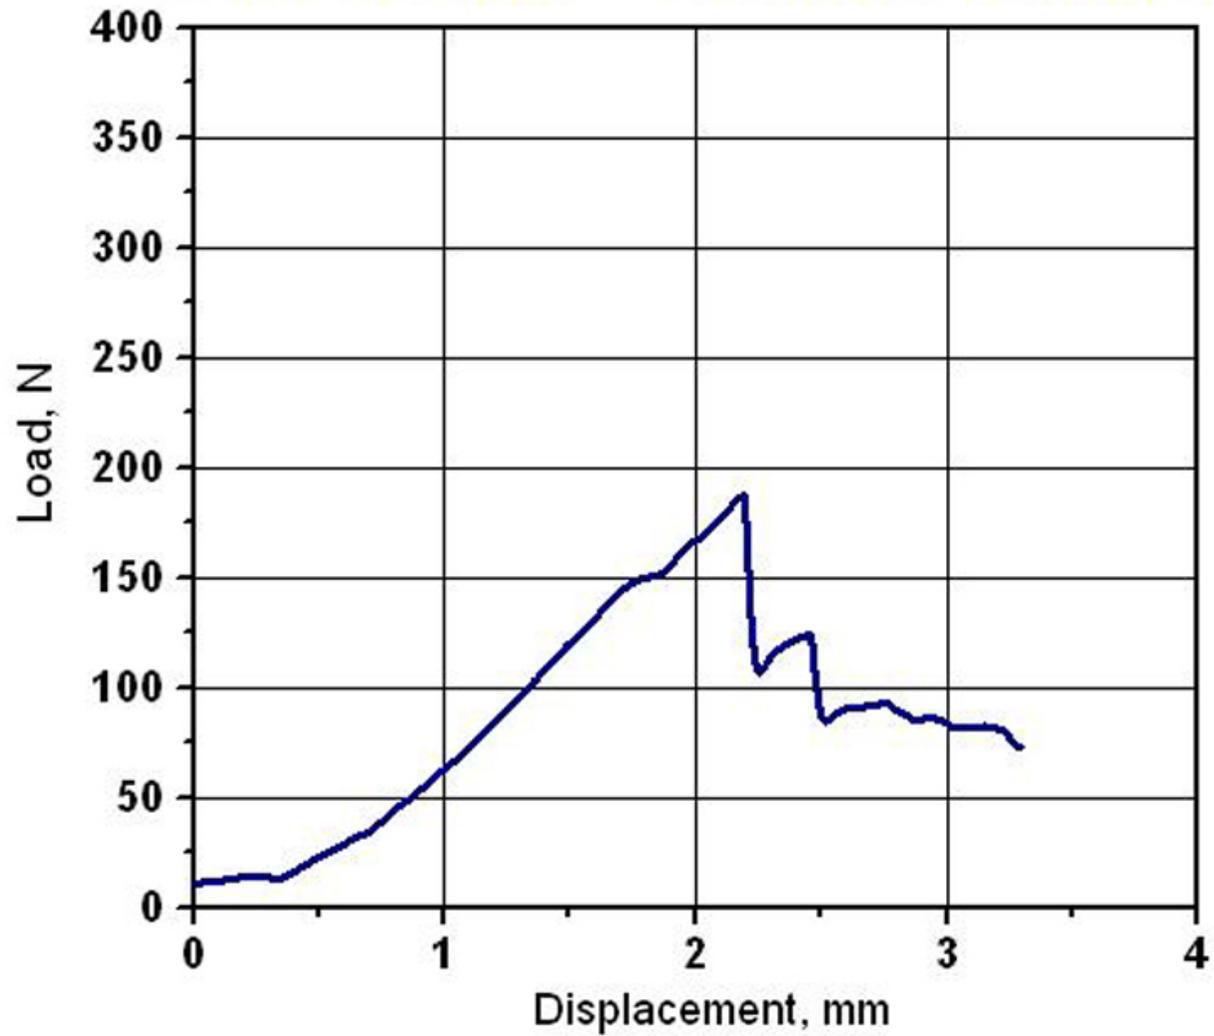
Fig. A.5a Load-displacement curve for post-LOCA sample OCZL#29 (17% CP-ECR) subjected to bending at 135°C and 1 mm/s displacement rate with the rupture tips under maximum tensile stress. Test was interrupted to measure a crack through the rupture node that extended through 60% of the cross section.

The 4-point-bend test is designed to apply a uniform bending moment between the loading points (150-mm span). Such unbiased loading allows the post-LOCA sample to fail at the weakest location. For all tests conducted with the rupture tips under maximum tensile loading, the failures occurred either in the rupture node (high oxidation level, no hydrogen pickup) or at two locations within  $\pm 50$  mm of the rupture mid-span (high hydrogen content, lower oxidation level). Prior to bending the OCZL#25 sample, the data trend indicated that samples with  $<31\%$  rupture strain severed at two locations outside the rupture region, while samples with  $>40\%$  rupture strain severed in the rupture region. However, the OCZL#25 sample (16% CP-ECR) severed at two locations outside the rupture region even though the rupture strain was high (42%) and the rupture width was large (8.7 mm). The OCZL#29 companion sample (17% CP-ECR), with a rupture strain of 49% and a rupture opening of 5.9 mm, cracked through 90% of the cross section containing the rupture opening. Metallography will be performed at the two rupture-node locations to determine why the OCZL#25 rupture-node cross section survived a bending moment of 8.3 N•m without cracking while cracking in the OCZL#29 rupture node initiated at a lower bending moment of (4.7 N•m). Figures A.4 and A.5 in Appendix A show the load-displacement curves for these two bend samples.

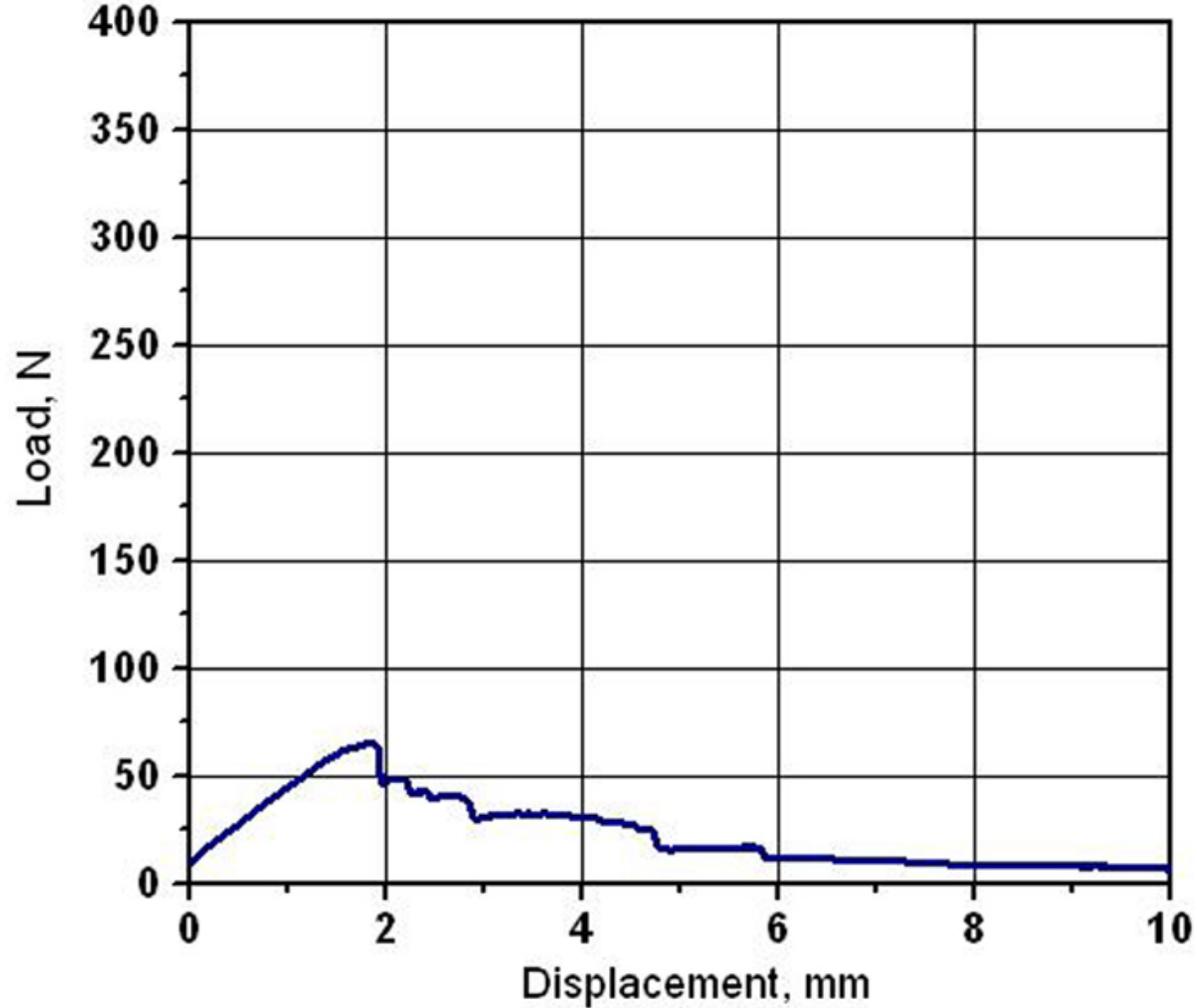
Fig. A.5b Load-displacement curve for post-LOCA sample OCZL#29 (17% CP-ECR) subjected to bending at 135°C and 1 mm/s displacement rate with the rupture tips under maximum tensile stress. Following this reloading of the sample, the crack extended from 60% to 90% of the cross section. However, the sample was intact at the end of the test following significant plastic deformation.
