WETLAND DELINEATION REPORTS:

SITE SEPARATION

Dominion North Anna Power Station
Wetland Delineation for Site Separation Projects

July 2008

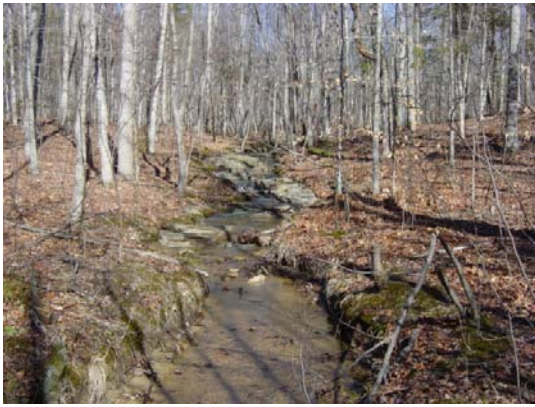
Wetland System A was located in an area selected for a proposed parking lot. This area is classified as a forested wetland and is associated with a small perennial stream that contained braided channels. The channels flowed in a south direction into the waste heat treatment portion of Lake Anna. Wetland System A totaled 26,403 square feet (0.61 acres).

Wetland Area A - Stream and wetland area, northern area. View facing north.

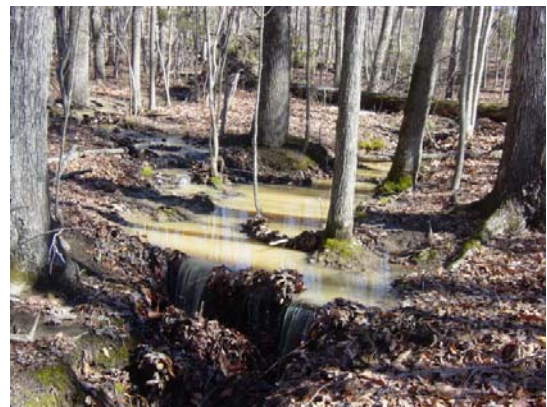
Wetland Area A - Stream and wetland area, southern portion. View facing north.

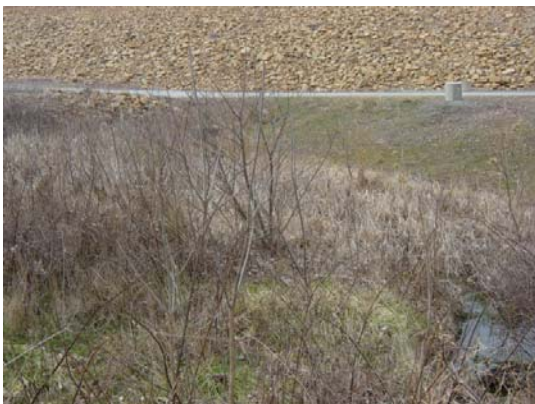
Wetland System B was located within an engineered swale between the emergency water reservoir and a culvert at an existing road. The culvert beneath the roadway was partially blocked by sediment and vegetative debris. The wetland area was located in an area selected for a proposed road widening project and paint shop. Wetland System B totaled 15,534 square feet (0.36 acres).

Wetland Area B – Southern portion of wetland area. View facing northwest.

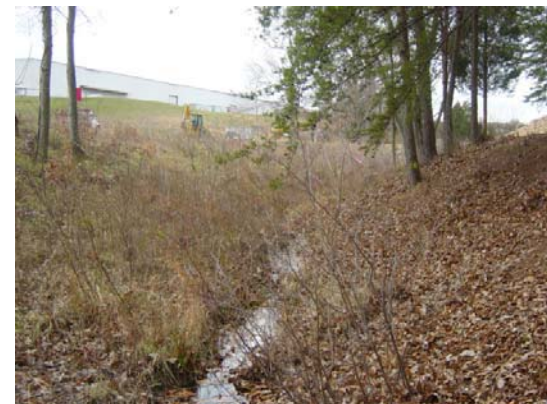
Wetland Area B – Central portion of wetland area. View facing southwest.

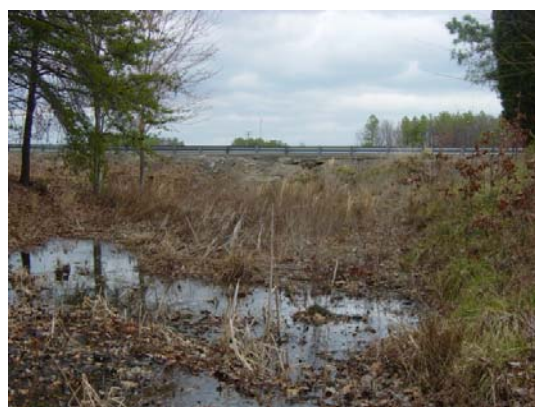
Wetland Area B – Northern portion of wetland area. View facing east.

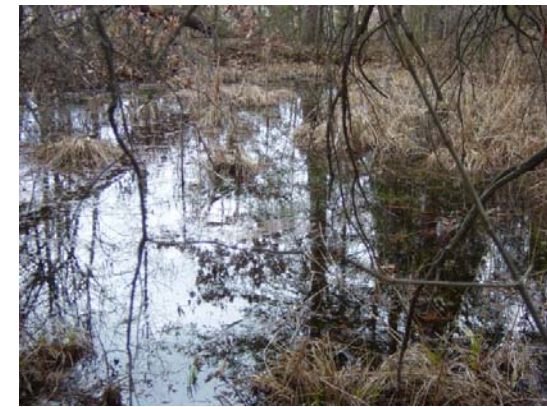
Wetland System C was a small depressed area associated with the same proposed with the same proposed parking lot associated with Wetland System A. This area appears to have been previously scraped by a bulldozer or other piece of equipment presumably during past construction activities. The wetland area was classified as a forested wetland. Wetland System C totaled 2,016 square feet (0.05 acres).

Wetland Area C - Small isolated wetland. View facing east.
