ATTACHMENT E-2

Dominion North Anna Power Station

**Wetland Delineation on Route 700 Parcels Adjacent to
Haley Drive and Kentucky Springs Road**

June 2008

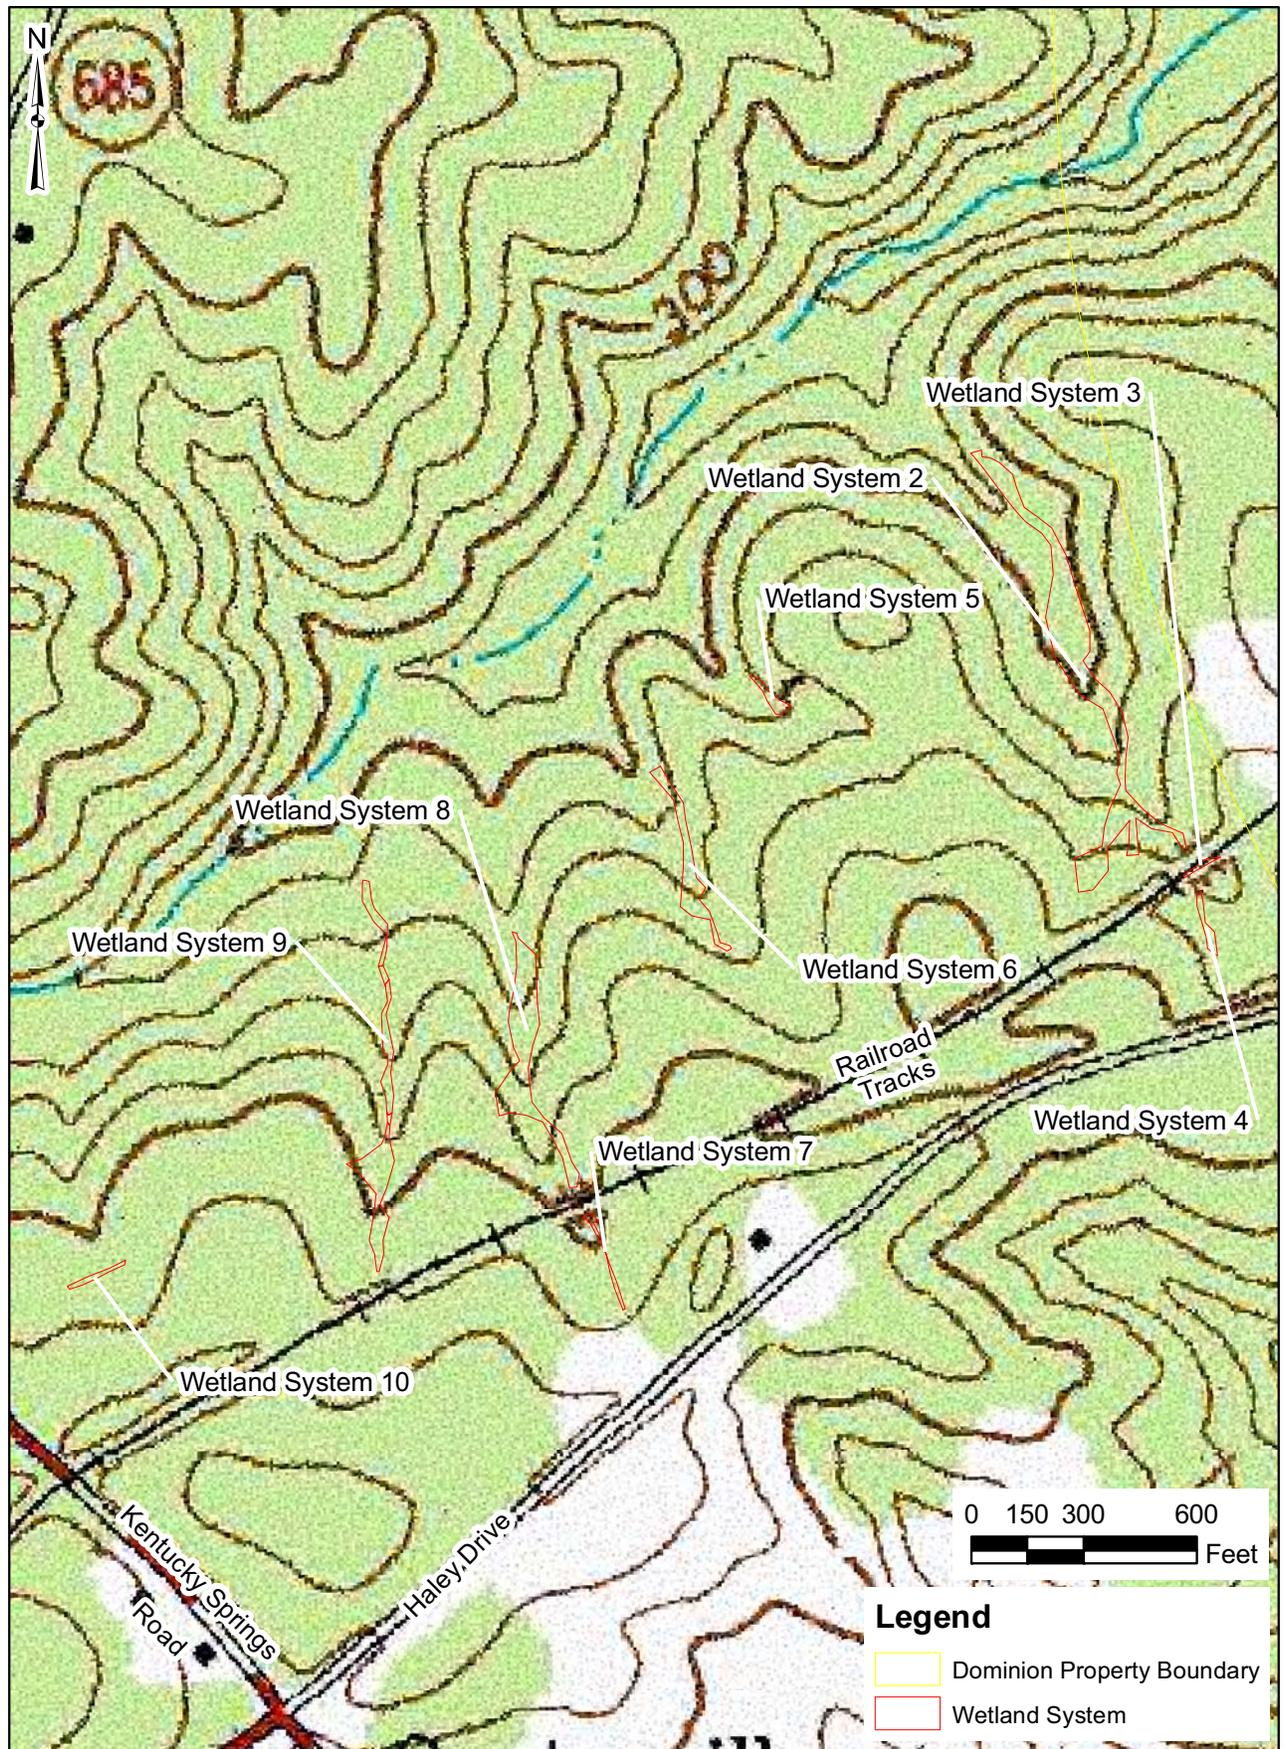
Figure 2. Wetland Areas Delineated.

Based upon a field analysis of the vegetation, soils, and hydrology conducted in accordance with the 1987 Corps of Engineers Wetland Delineation Manual, EA personnel identified and flagged nine potential non-tidal wetland areas within the Route 700 parcels (Figure 2). The majority of the wetland areas were located in valleys with intermittent or perennial streams that generally flowed north toward Harris Creek. The wetland areas observed totaled 156,284 square feet (4.0 acres). Supporting documentation for the wetland delineation findings is included in the appendices of this document.

Three potential wetland areas, Wetlands 2, 4, and 5, were located within an area that had been a deciduous forest prior to being clear-cut during recent timber harvesting operations. Wetland 3 was a small depressed area located between an access road and the railroad tracks. Wetlands 6, 7, 8, and 9 were dominated by deciduous canopy species. Wetland 10 was located in a swale along a gravel roadway. The majority of the wetland areas were located in valleys with intermittent or perennial streams that generally flowed north toward Harris Creek. The wetland areas observed totaled 156,284 square feet (4.0 acres).

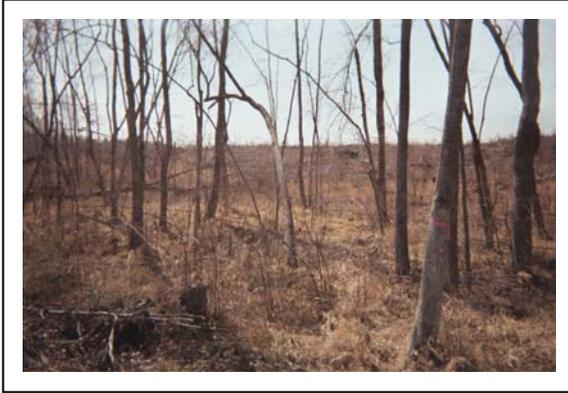
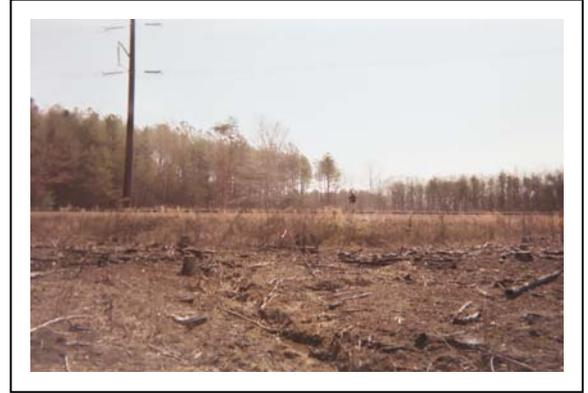
Wetland System 2 was located within an area that had been a deciduous forest prior to being clear-cut during recent timber harvesting operations. The areas clear-cut did not extend into the wetland. The wetland area flagged was associated with a drainage system that flowed north toward Harris Creek. The wetland area began at an access road on the northern portion of the parcel, traveled south and ended at a culvert that went beneath railroad tracks. The Wetland System 2 connected to Wetland System 3 by the culvert. Wetland System 2 totaled 70,480 square feet (1.62 acres).

The wetland area was classified as forested and the dominant vegetation was soft rush (*Juncus effusus*), red maple (*Acer rubrum*), and spicebush (*Lindera benzoin*). Seedbox (*Ludwigia alternifolia*), greenbrier (*Smilax rotundifolia*), sweetbay (*Magnolia*

virginiana), and deertongue grass (*Dichanthelium clandestinum*) were also observed within the wetland area. The soil matrix within the area had a chroma value of 10YR3/3 within the O horizon (0-2 inches), 10YR5/2 within the A horizon (2-5 inches), and 10YR4/1 within the B horizon (5-12 inches). No mottles were observed within the soil sample. The soil was classified as clay with coarse sand. Wetland hydrology indicators included saturation in the upper 12 inches and water was flowing within the stream channel.

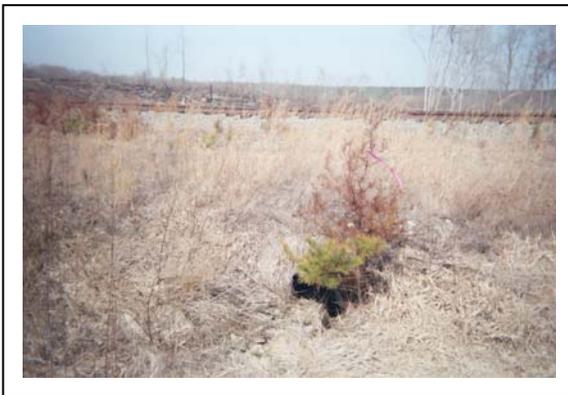
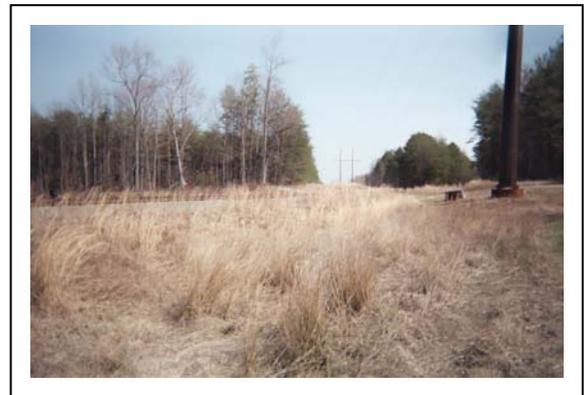
Wetland System 3 was a small depressed area located between an access road and the railroad tracks. Wetland System 3 is connected to Wetland System 2 by a culvert located under the railroad tracks. Wetland System 3 totaled 956 square feet (0.02 acres).

This area was classified as emergent and the dominant vegetation was soft rush and deertongue grass. The soil matrix within the wetland area had a chroma value of 10YR4/3 within the A horizon (0-2 inches) and 10YR7/3 within the B horizon (2-5 inches). The soil sample was only 5 inches from ground surface due to gravel or rock. Mottles were observed within the B horizon and had a chroma value of 7.5YR5/8. The mottles were characterized as few and bright. Hydrophytic vegetation was present; however, hydrology and hydric soil characteristics were not present.

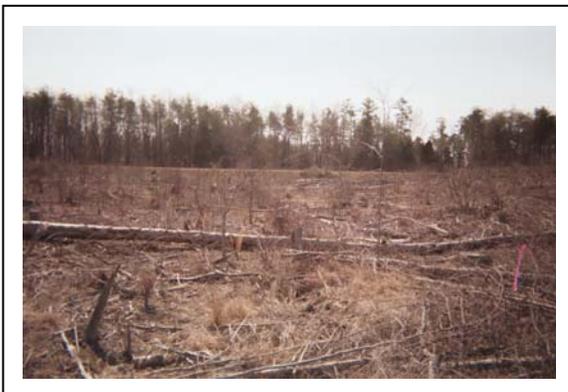
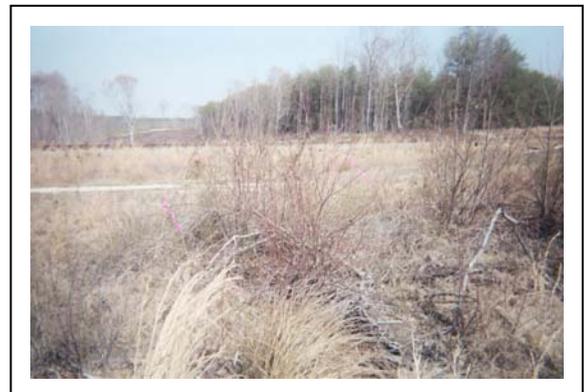
Wetland System 4 was located within an area that had been a deciduous forest prior to being clear-cut during recent timber harvesting operations. The harvesting operations did not extend into the wetland area. The area flagged began at a head-cut and followed a drainage channel north that ended at an access road that paralleled railroad tracks, directly across from Wetland System 3. Wetland System 4 totaled 2,846 square feet (0.07 acres).

The wetland area was classified as forested and the dominant vegetation was soft rush, greenbrier, red maple, and multiflora rose (*Rosa multiflora*). The soil matrix had a chroma value of 10YR2/1 within the A horizon (0-2 inches) and 10YR6/1 within the B horizon (2-12 inches). Mottles were few and bright with a chroma value of 10YR6/8. The soil was classified as clay with coarse sand. The wetland hydrology indicator included saturation in the upper 12 inches.

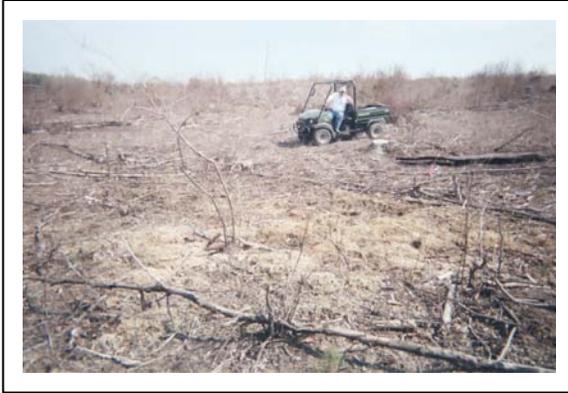
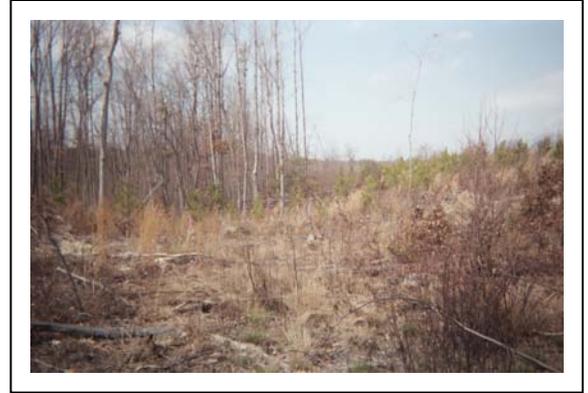
Wetland System 5 was located within an area that had been surrounded by a deciduous forest prior to being clear-cut during recent timber harvesting operations. The areas clear-cut did not extend into the wetland. This area was located at the top of a valley at the parcel boundary and was classified as emergent. The wetland area continued north and followed a stream channel toward Harris Creek, beyond the wetland flagging. Wetland System 5 totaled 2,759 square feet (0.06 acres).

This dominant vegetation was soft rush, and moss (*Sphagnum* sp.). The soil matrix had a chroma value of 10YR4/1 in the O horizon (0-3 inches) and 10YR5/1 in the A horizon (3-12 inches). No mottles were observed within the soil sample. The soil was characterized as a clay silt in the A horizon and a sandy clay in the B horizon. Wetland hydrology indicators included saturation in the upper 12 inches and drainage patterns in the wetland area.

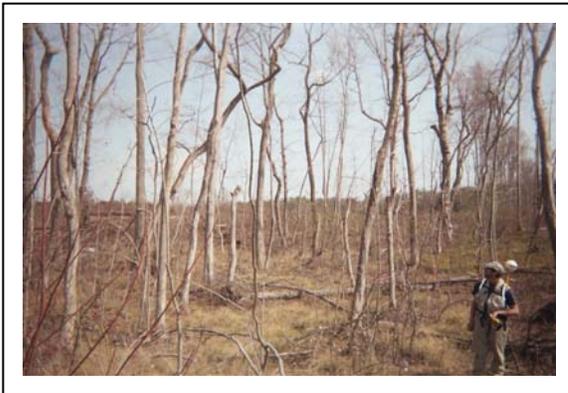
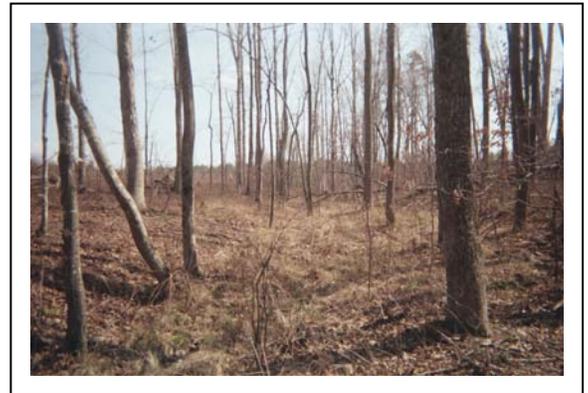
Wetland System 6 was located in an area dominated by deciduous canopy species. The wetland area was between two slopes that have been cut-over, but the harvesting operations did not extend into the wetland area. The area flagged followed a shallow channel (approximately one foot deep and two feet wide) that flowed north toward Harris Creek. Wetland System 6 totaled 14,562 square feet (0.33 acres).

This wetland area was classified as forested and the dominant vegetation was sweetbay, red maple, and moss. Skunk cabbage (*Symplocarpus foetidus*), soft rush, spice bush, and greenbrier were also observed within the wetland area. The soil matrix had a chroma value of 10YR4/2 in the A horizon (0-4 inches) and 10YR5/1 in the B horizon (4-12 inches). No mottles were observed in the soil sample. The soil was characterized as a silty clay with some organic matter in the A horizon and a coarse sand in the B horizon. The soil was saturated at the surface and contained approximately 2 inches of water in the channel.

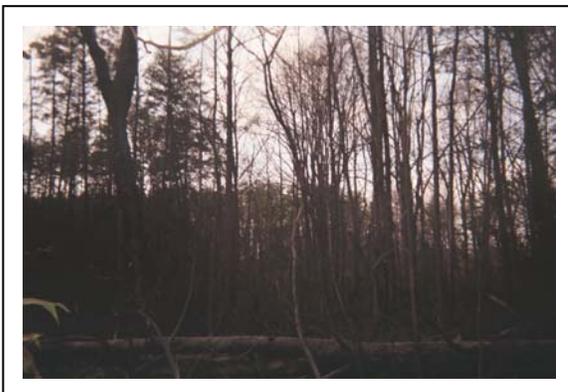
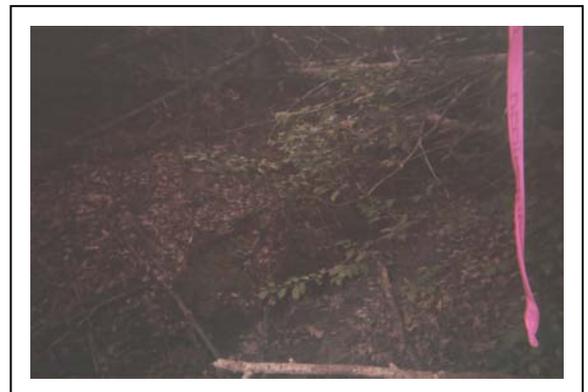
Wetland System 7 was dominated by deciduous canopy species. The area flagged began down-gradient of an excavated pit and followed a channel through the deciduous woods. The area opened to an emergent wetland at an access road that paralleled railroad tracks. A culvert beneath the railroad tracks lead to Wetland System 8. The channel was narrow and incised and no water was observed within the channel. Wetland System 7 totaled 34,539 square feet (0.79 acres).

Wetland System 7 was classified as forested and emergent. The dominant vegetation was sweetbay, greenbrier, and highbush blueberry (*Vaccinium corymbosum*). This area outside of the channel was dominated by red maple, Virginia pine (*Pinus virginiana*), greenbrier, and American holly (*Ilex opaca*). The soil matrix had a chroma of 10YR5/1 in the A horizon (0-6 inches) and 10YR8/1 in the B horizon (6-12 inches). Mottles were observed in the B horizon. The mottles were characterized as many and bright and they had a chroma value of 10YR6/6. The soil texture in both horizons was sandy clay. Pockets of standing water were observed within the channel and the area flagged was saturated in the upper 12 inches.

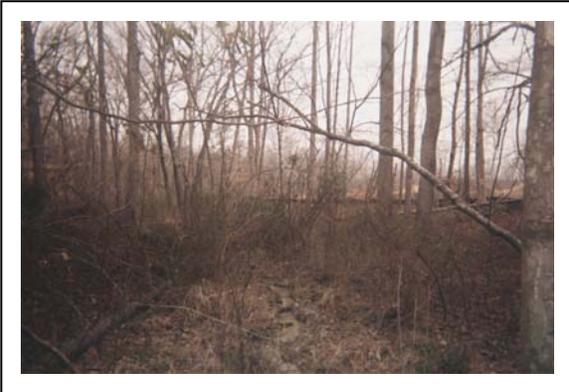
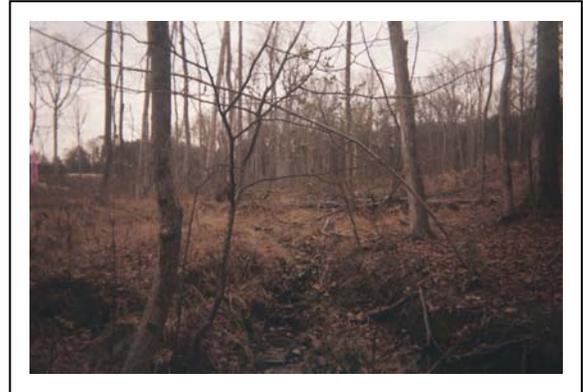
Wetland System 8 was dominated by deciduous canopy species. The deciduous canopy was located along a narrow braided channel. Both sides of the channel were clear cut and the wetland area was adjacent to and between the braided channels. The areas clear-cut did not extend into the wetland. The channel was approximately 1-2 feet wide and was less than one foot deep. Approximately 2 inches of water was flowing in the channel. The area flagged began at a culvert under railroad tracks and traveled north until the end of the property line. The wetland area and stream channel continued beyond the property line. Wetland System 8 totaled 2,300 square feet (0.05 acres).

This wetland area was classified as forested and was dominated by red maple, soft rush, sweetbay, skunk cabbage, and seedbox. The soil matrix had a chroma value of 10YR4/2 in the A horizon (0-5 inches) and 10YR5/1 in the B horizon (5-12 inches). Few and dark mottles were observed within the B horizon that had a chroma value of 10YR4/6. The soil texture of both horizons was characterized as a sandy clay. Wetland hydrology indicators included saturation in the upper 12 inches and observations of drainage pattern within the wetland area.

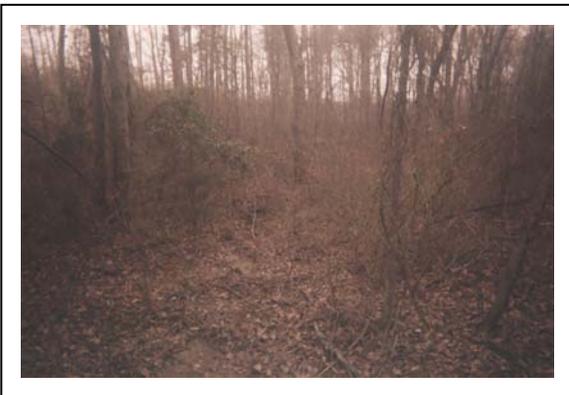
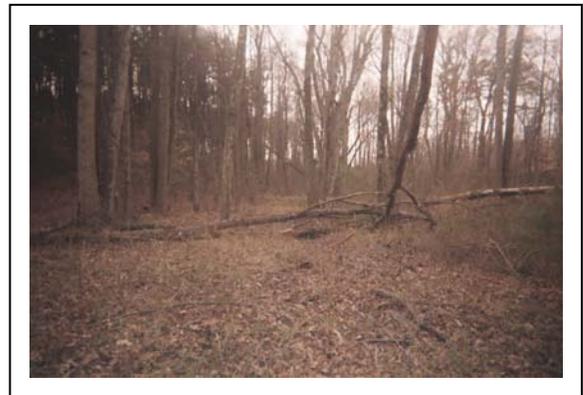
Wetland System 9 began at a culvert located beneath railroad tracks and followed a channel north towards Harris Creek. The delineation of this wetland ended at the parcel boundary. The wetland area and channel continued beyond the parcel boundary. The channel was braided and contained pockets of standing water. No water was observed flowing in the channel. Wetland System 9 totaled 26,010 square feet (0.60 acres).

This wetland area was classified as forested and was dominated by greenbrier, red maple, highbush blueberry, sweetbay, and moss. Within the open area at the end of the parcel boundary, soft rush and woolgrass (*Scirpus cyperinus*) were observed. The soil matrix had a chroma value of 10YR5/3 within the A horizon (0-1 inches) and within the B horizon the chroma values were 10YR6/3 (1-2 inches) and 10YR6/1 (2-12 inches). Few and bright mottles were observed in the B horizon. The chroma value for the first 2 inches was 10YR6/6 and the chroma value for the last 10 inches was 10YR7/8. Within the first 2 inches the soil texture was characterized as a silty sand. The last 10 inches of the soil sample was characterized as a clayey sand. The depth to the saturated soil was approximately 6 inches and water-stained leaves were observed as a secondary wetland hydrology indicator.

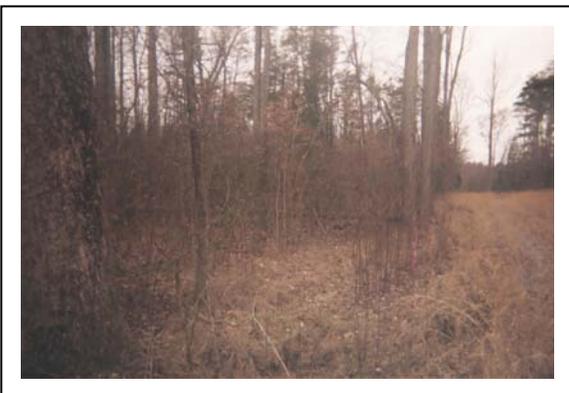
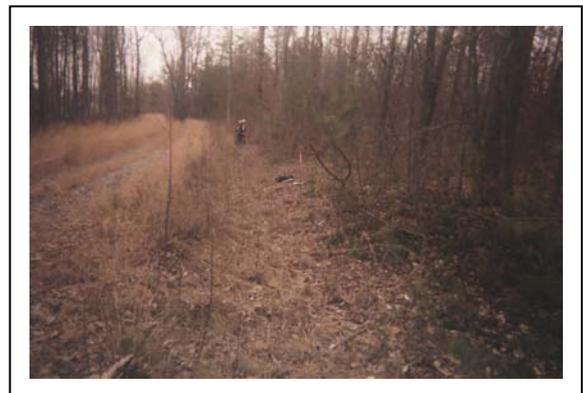
Wetland System 10 was located in a swale along a gravel roadway at the end of the parcel boundary. A culvert was observed beneath a gravel road that leads to a drainage area through the woods north of the area flagged. The drainage area paralleled the gravel roadway. Wetland System 10 totaled 1,831 square feet (0.04 acres).

This wetland area was classified as emergent surrounded by deciduous forest. The dominant species within the wetland area included soft rush, woolgrass, and seedbox. The species observed surrounding the wetland area included red maple, sweetgum (*Liquidambar styraciflua*), sweetbay, ground pine (*Lycopodium obscurum*), and Virginia pine. The soil matrix had a chroma value of 10YR5/2 within the A horizon (0-4 inches) and within the B horizon the chroma values were 10YR4/1 (4-5 inches) and 10YR5/1 (5-12 inches). The A horizon contained many bright and thin mottles with a chroma value of 10YR5/8. The last 8 inches of the B horizon contained occasional and faint mottles with a chroma value of 10YR7/6. The soil texture for the A and B horizons was characterized as a silty clay.
