**CALCULATION RSOFHLHROGCDX00033320090003
"PMF TEMPORARY MODIFICATION ANALYSIS"**

Title PMF Temporary Modification Analysis

Abstract: Hesco Bastion Concertainers will be used to temporarily raise the elevation of the top of the dam while a permanent modification can be implemented. Several configurations of the Concertainers were evaluated including utilizing existing flood walls to support the temporary flood wall. This calculation also documents the applicability of the Concertainer flood wall system to CRH, TEH, and WBH.				
<input checked="" type="checkbox"/> Electronically file and return calculation to Calculation Library.				
<input type="checkbox"/> Electronically file and return calculation _____ Address: _____

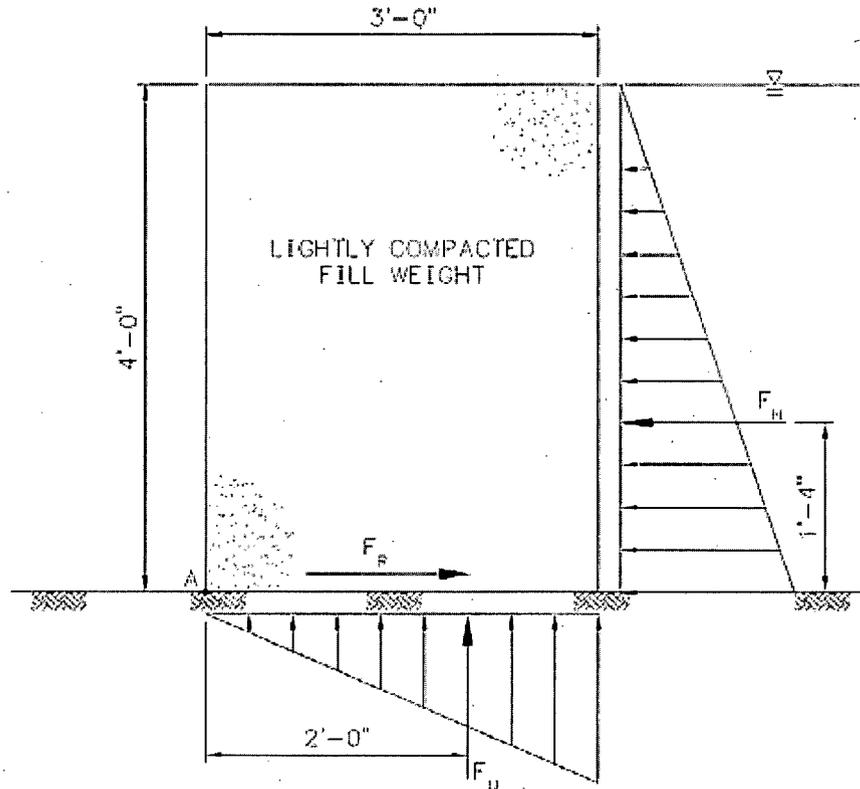
6.1 Single 4-Foot Concertainer Flood Wall

Compute the location of the resultant force under the Concertainer considering the Concertainer installed without any unit tilt loaded with the full hydrostatic and uplift pressures. This analysis assumes that the unit acts as a rigid body.

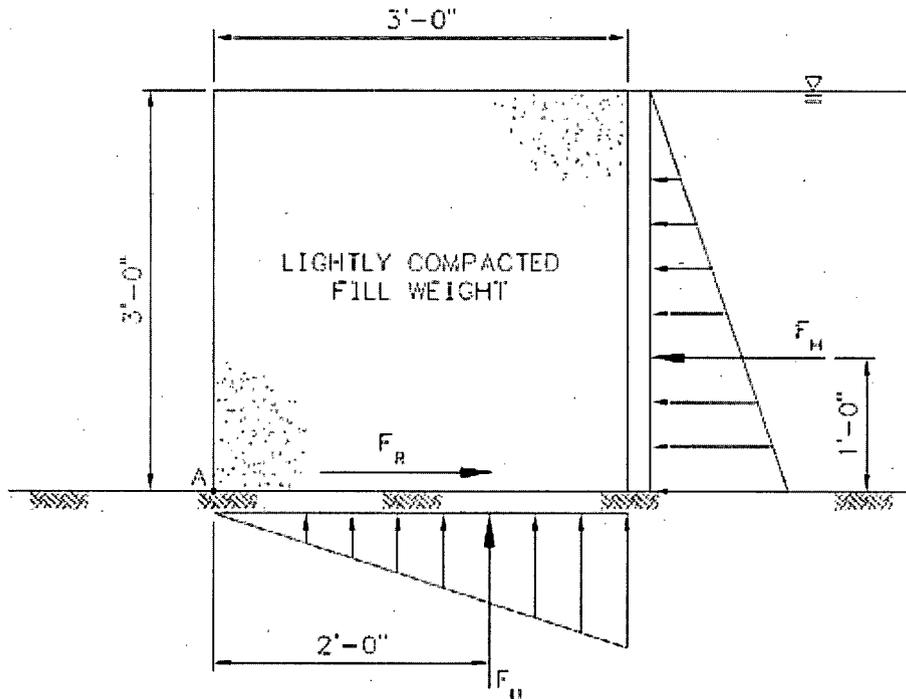
6.2 Single 3-Foot Concertainer Flood Wall

Compute the location of the resultant force under the Concertainers considering the Concertainer installed without any unit tilt loaded with the full hydrostatic and uplift pressures. This analysis assumes that the unit acts as a rigid body.

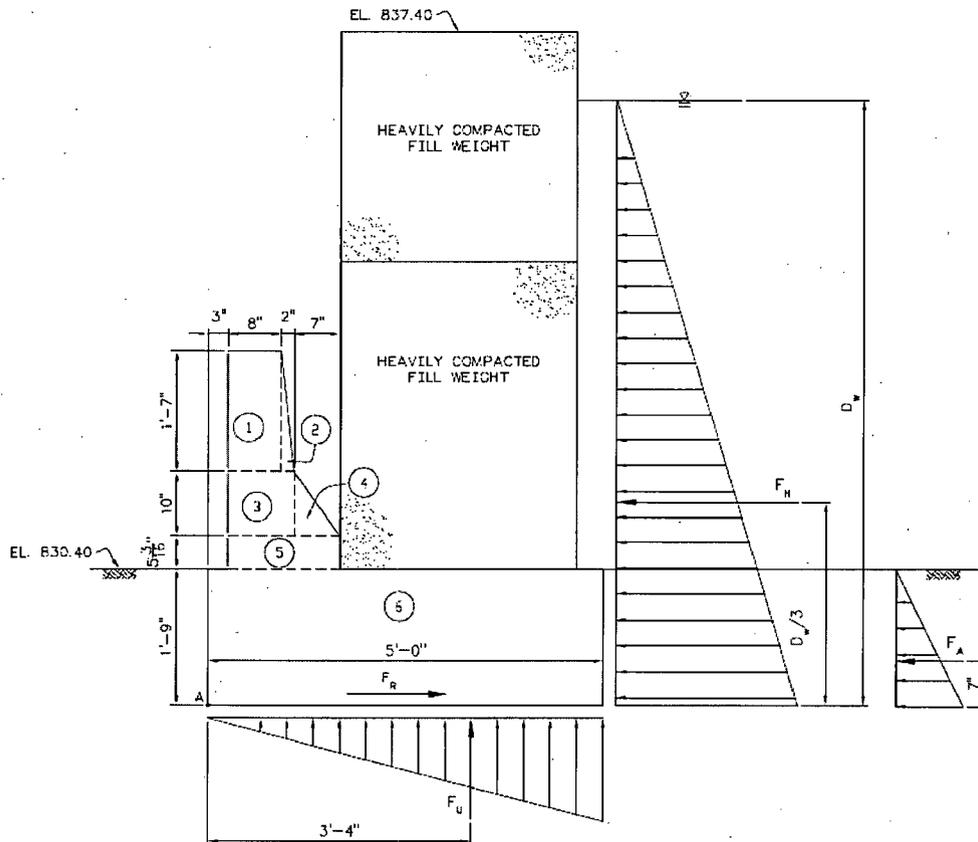
A concrete flood wall was installed along the downstream side of US 321 in the 1990's to raise the elevation of Fort Loudoun Dam to El. 833.25. The temporary modification to Fort Loudoun Dam must raise the elevation above El. 835.00. Therefore, a 4-foot and 3-foot wall will be required to achieve this revised elevation. Hesco Bastion's recommended configuration for a double height flood wall utilizes two Concertainers at the base and one stacked on top. Due to limited space on the shoulder of the road it is desired to utilize the existing concrete flood wall to aid the stability of the double height Concertainer configuration as shown in the figure below and avoid using the second unit on the base level.

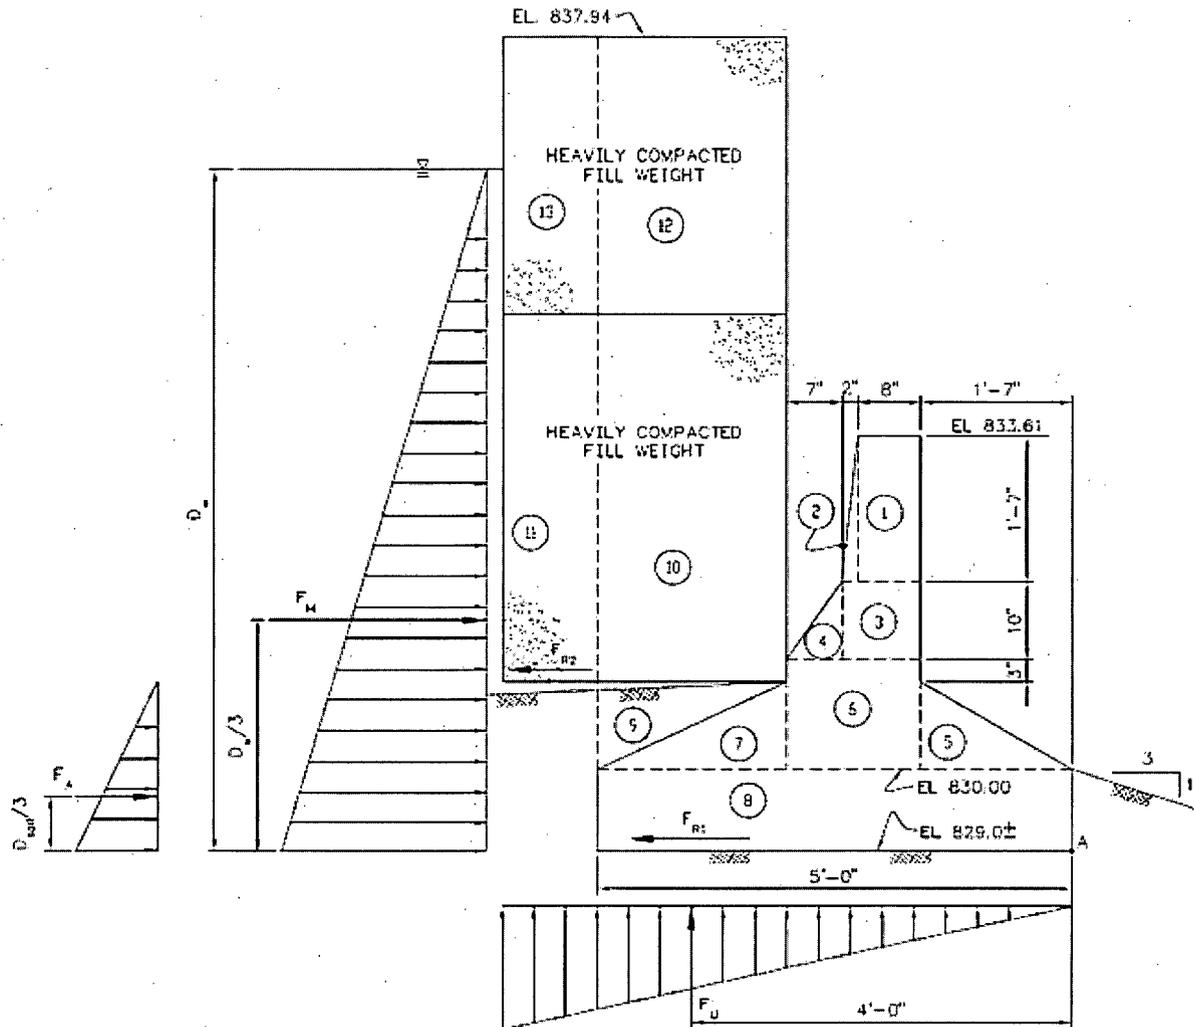
A concrete flood wall was installed along the edge of City Park Drive which runs along the top of the saddle dam in the 1990's to raise the elevation of Fort Loudoun Dam to El. 833.25. As with the flood wall located on the downstream side of US 321, it is desired to utilize the existing concrete flood wall to aid the stability of the double height Concertainer configuration as shown in the figure below and avoid using the second unit on the base level to maintain two lanes of traffic along City Park Drive.

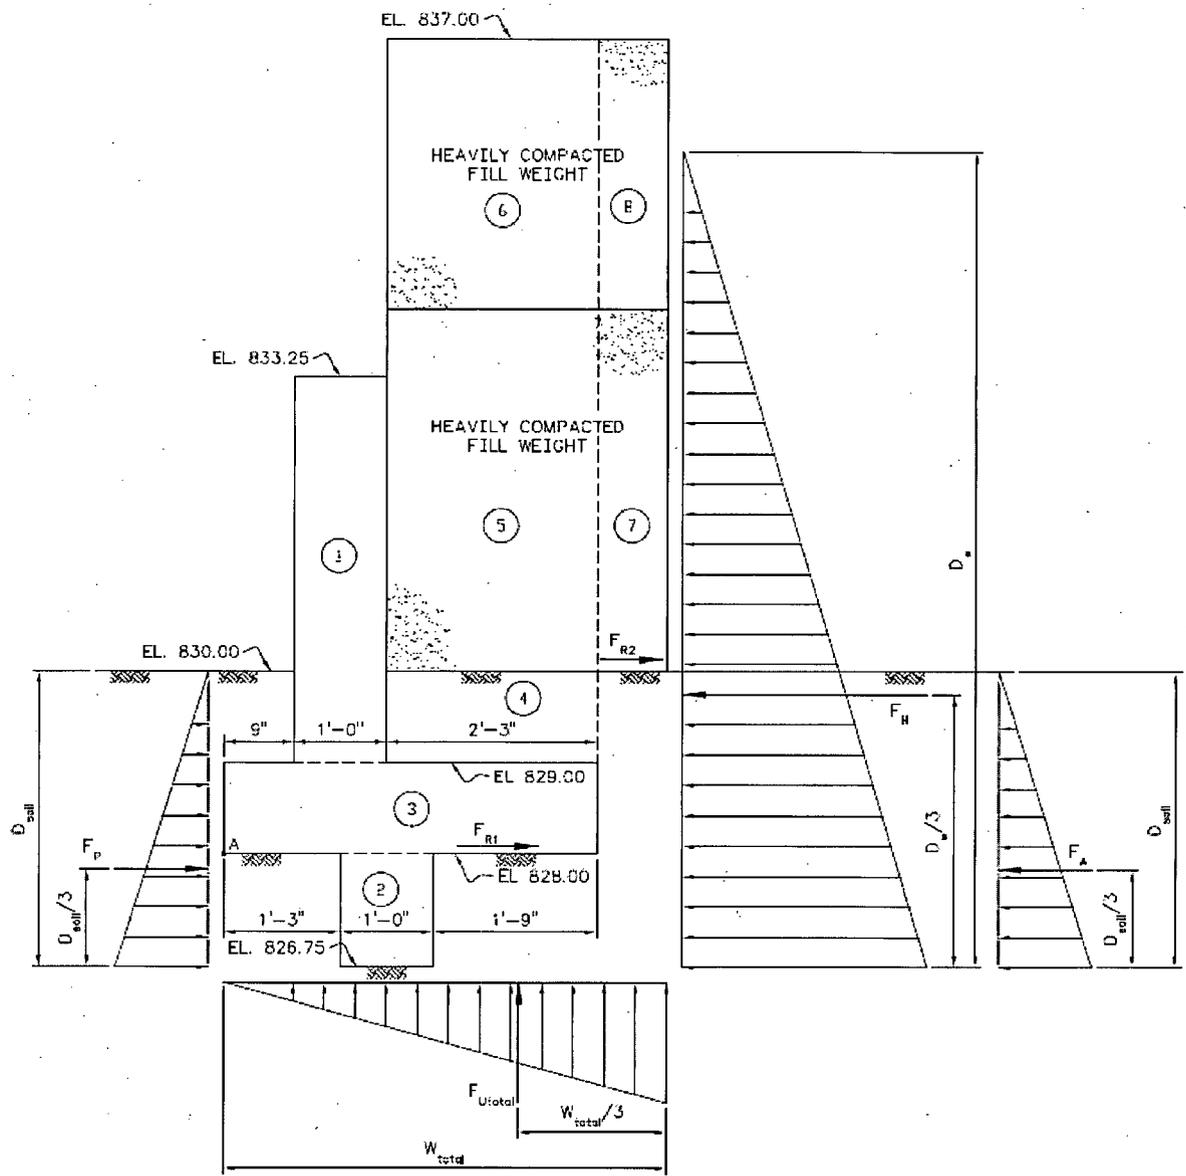
A concrete flood wall was installed along the under the US 321 bridge over the dam in the 1990's to raise the elevation of Fort Loudoun Dam to El. 833.25. As with the flood wall located on the downstream side of US 321 and along City Park Drive, it is desired to utilize the existing concrete flood wall to aid the stability of the double height Concertainer configuration as shown in the figure below and avoid using the second unit on the base level to maintain two lanes of traffic along City Park Drive. The wall configuration is shown in Section A4-A4 on TVA Drawing 23W230-4.

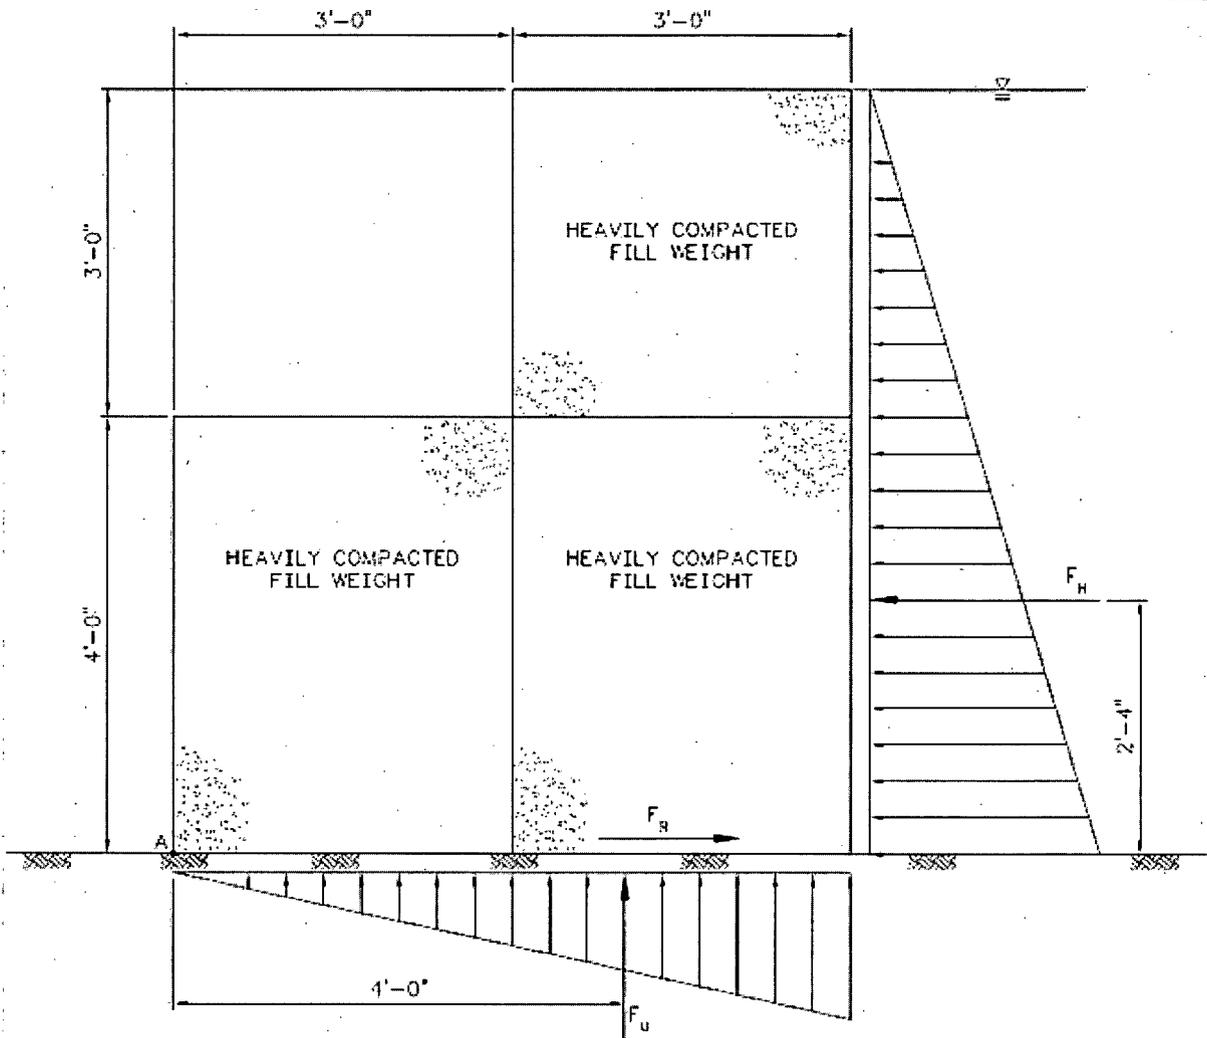
If the pool elevation for Fort Loudoun exceeds the values calculated above for the concrete flood wall configurations, the L-shaped double stacked Concertainer configuration shown below will need to be utilized.

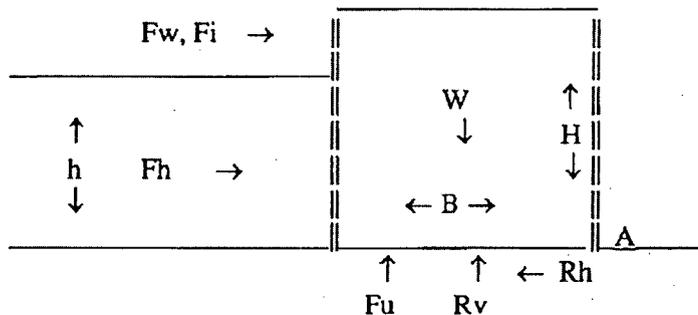
The ability of the structure to resist lateral forces it can be theoretically analyzed based upon the assumption that the structure will respond as a rigid body to hydrodynamic forces. A general load case is shown in Figure 1.

Figure 1. Schematic diagram of forces on a Concertainer® unit.

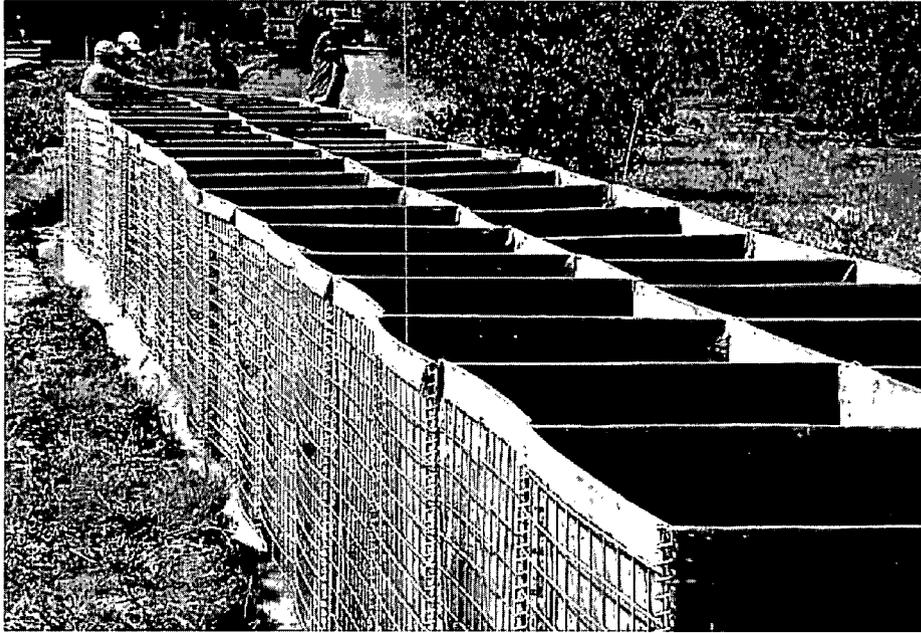
Figure 2-44. Hesco Bastion Concertainer® basket units, assembled and empty

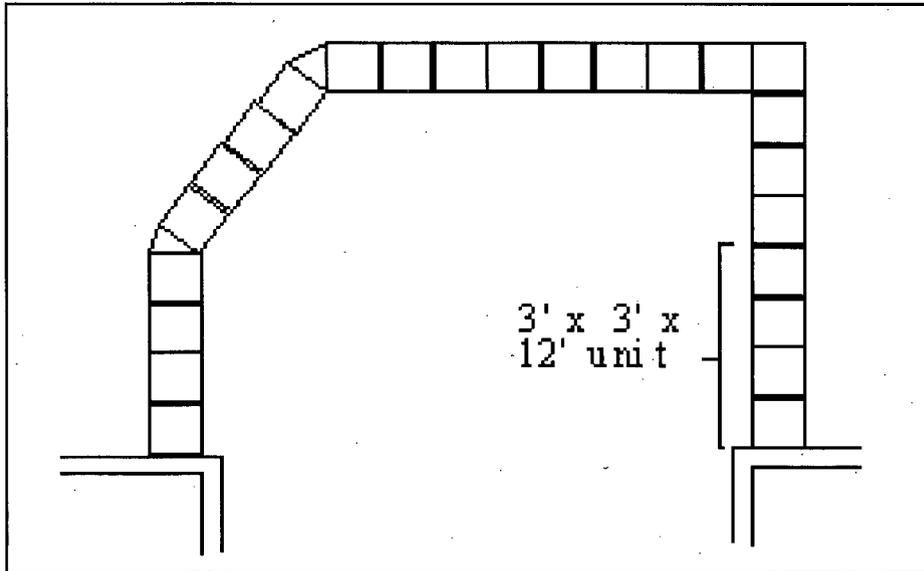
Figure 2-45. Hesco® levee layout

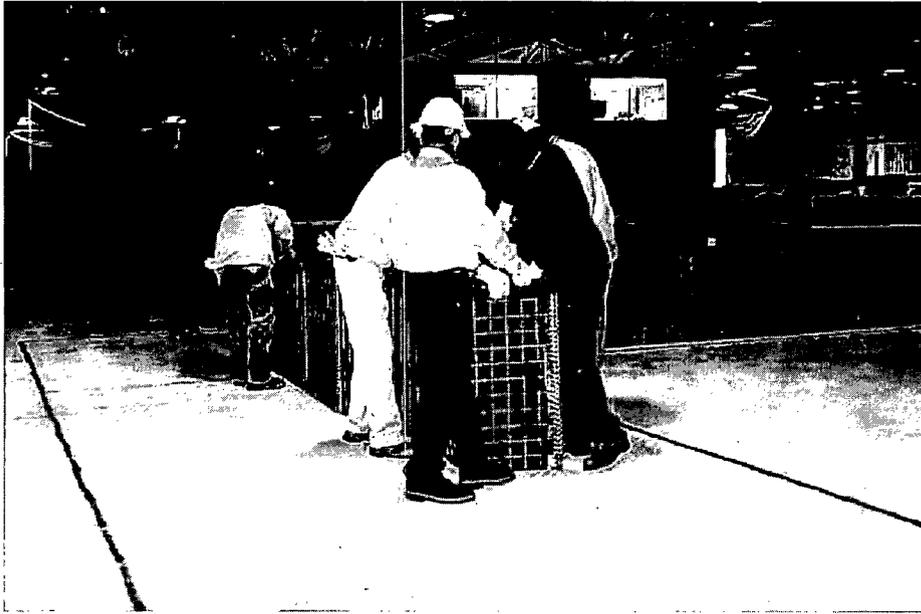
Figure 2-47. Expanding and positioning units

Personnel needed to construct the levee included a Hesco® supervisor and four laborers unfamiliar with the product. A 5-min training session commenced (Figure 2-46), the supervisor handed out gloves to the workers, and they began unloading and expanding the units onto the concrete floor (Figure 2-47).

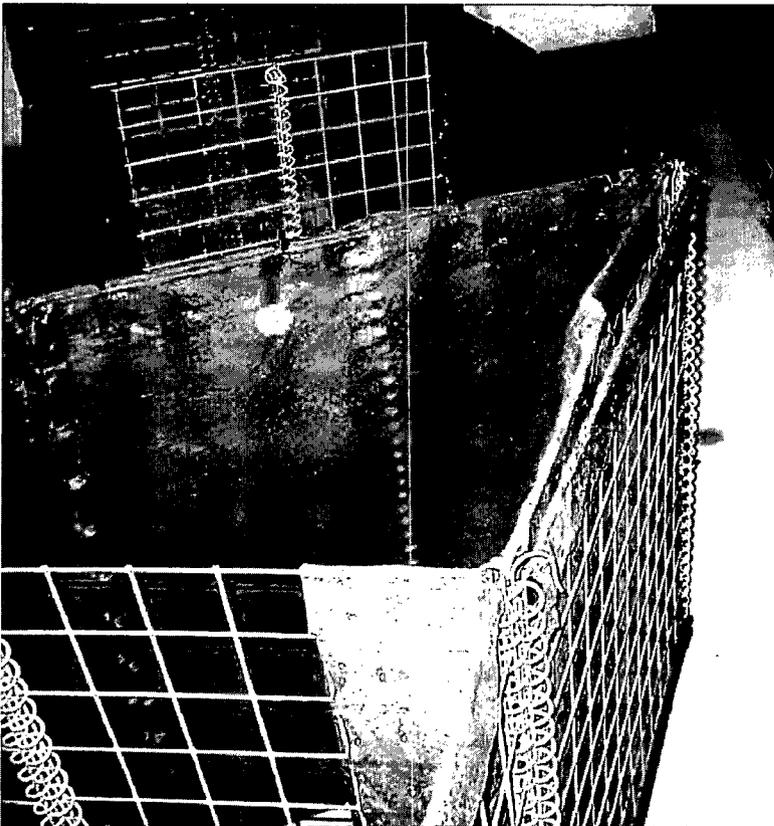
Figure 2-49. Top view of angled unit at intersection of left and center walls

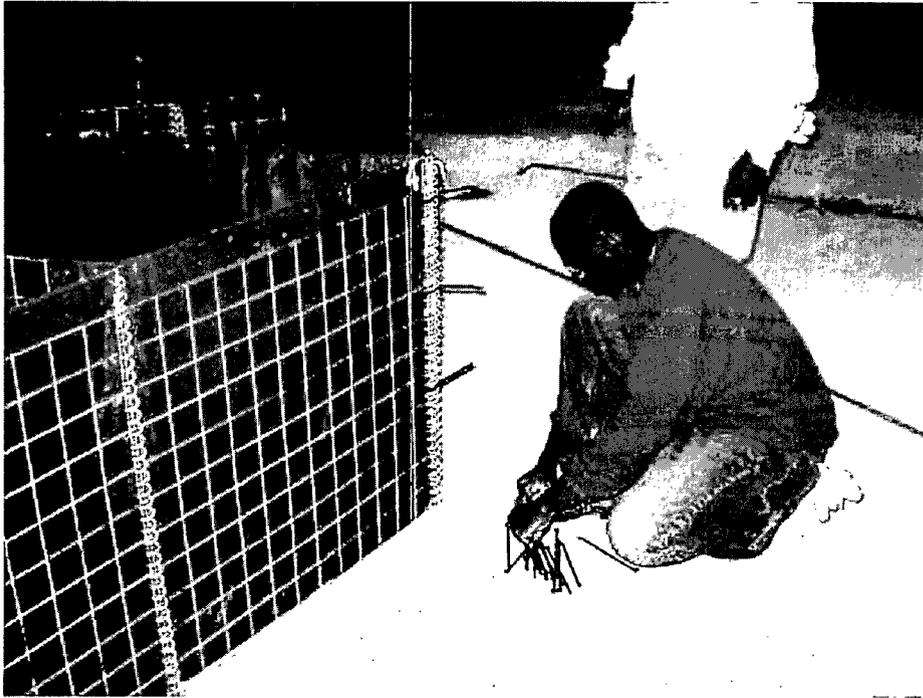
Figure 2-50. Cable ties at joint connections

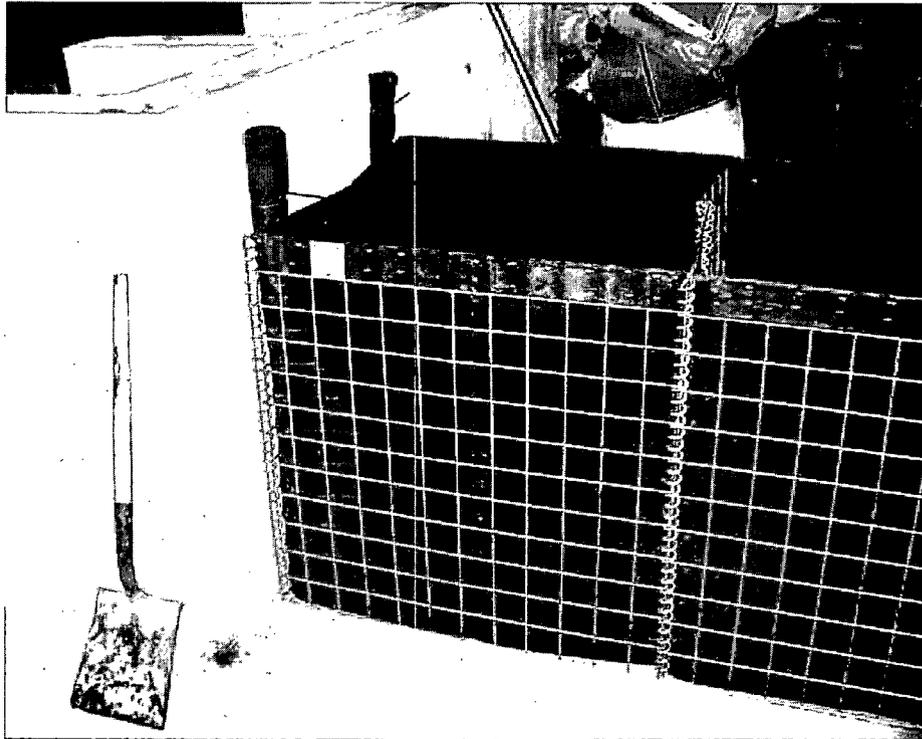
Figure 2-51. Right concrete wall abutment

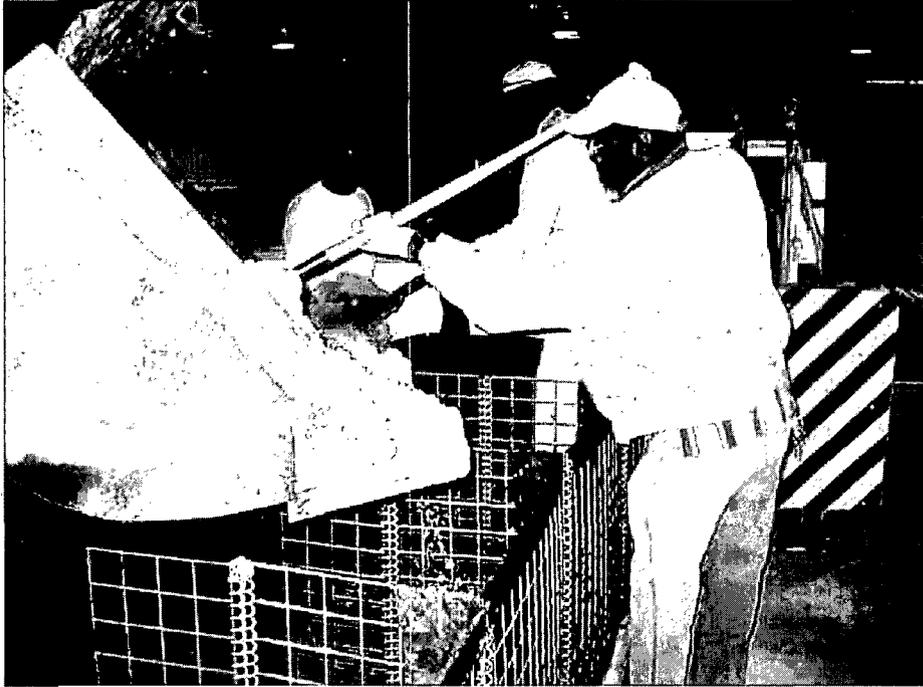
Figure 2-54. Shoveling sand into unit

The next construction phase consisted of filling the units with sand and completing the installation. The bottom flaps were flattened against the concrete floor (Figure 2-52). A front-end loader top-dumped sand into each unit (Figure 2-53). The supervisor and four workers continued securing the units, filling with sand, compacting, and leveling sand within the units with shovels while the sand-fill operation was ongoing, until all units were full and leveled (Figures 2-54 through 2-57). Approximately 24 cu yd of sand was required to fill the units.

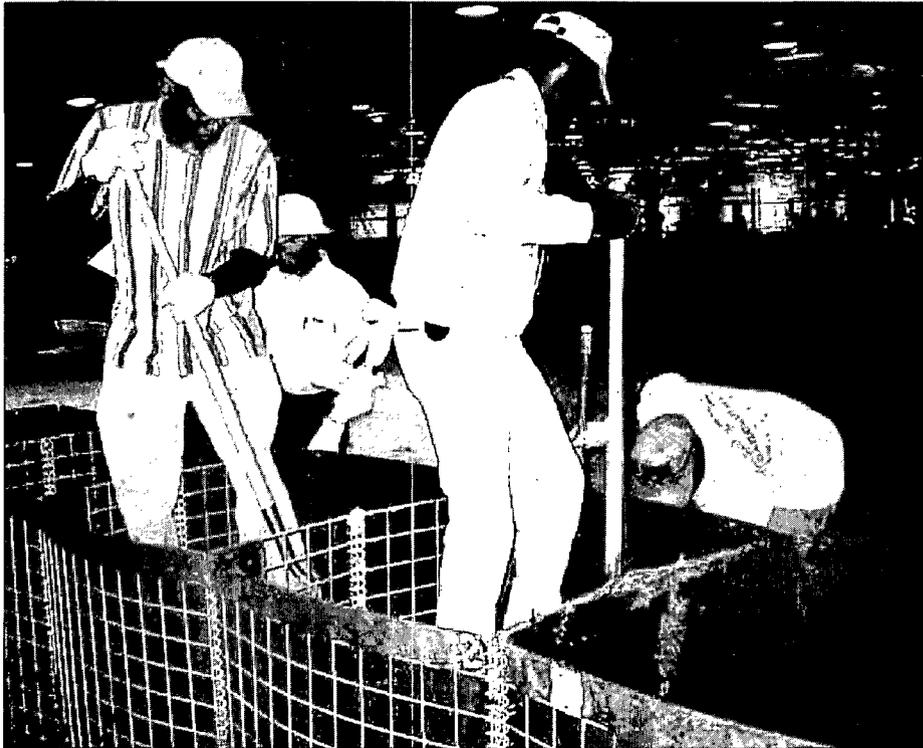
Figure 2-55. Leveling and compacting sand within each unit

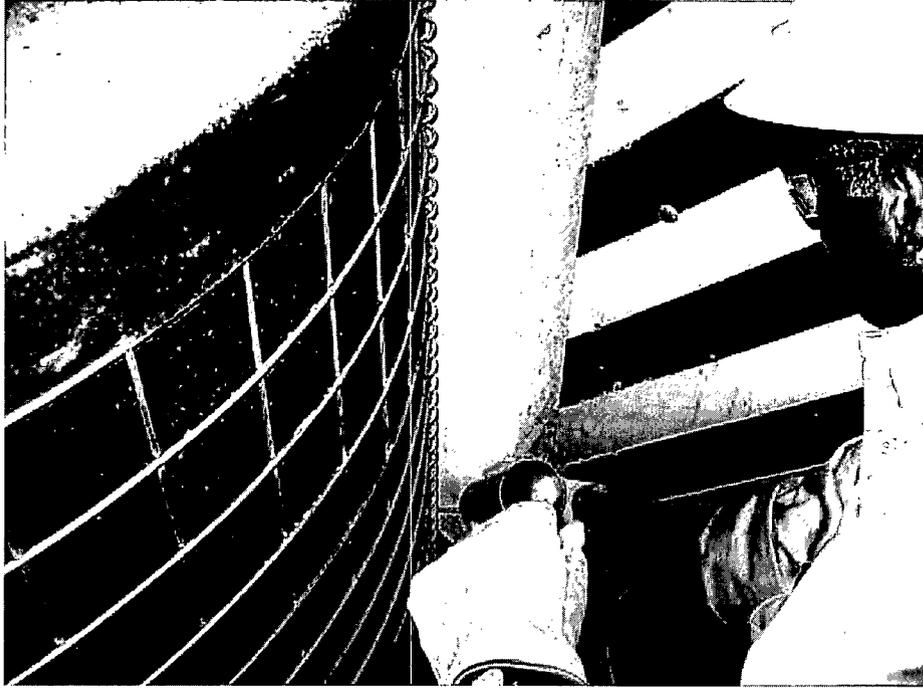
Figure 2-58. Sealing concrete wall abutment with aerosol foam

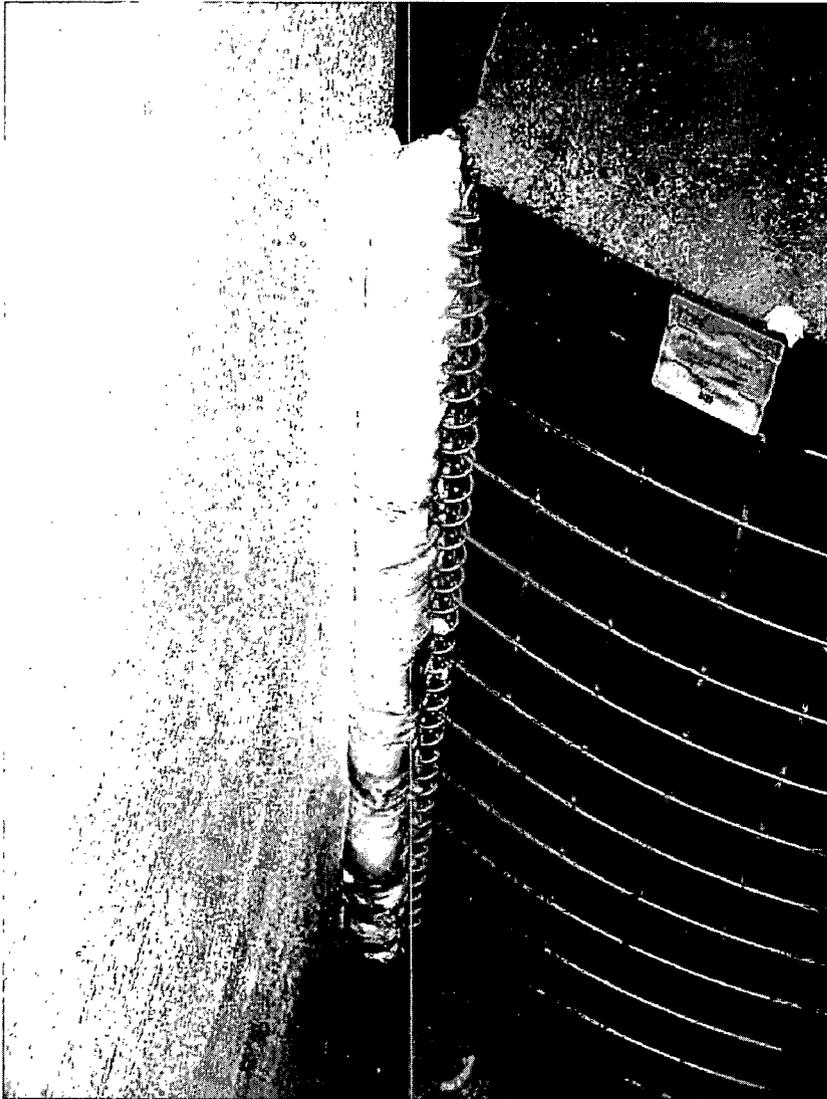
Figure 2-59. Expanded foam at abutment with concrete wall

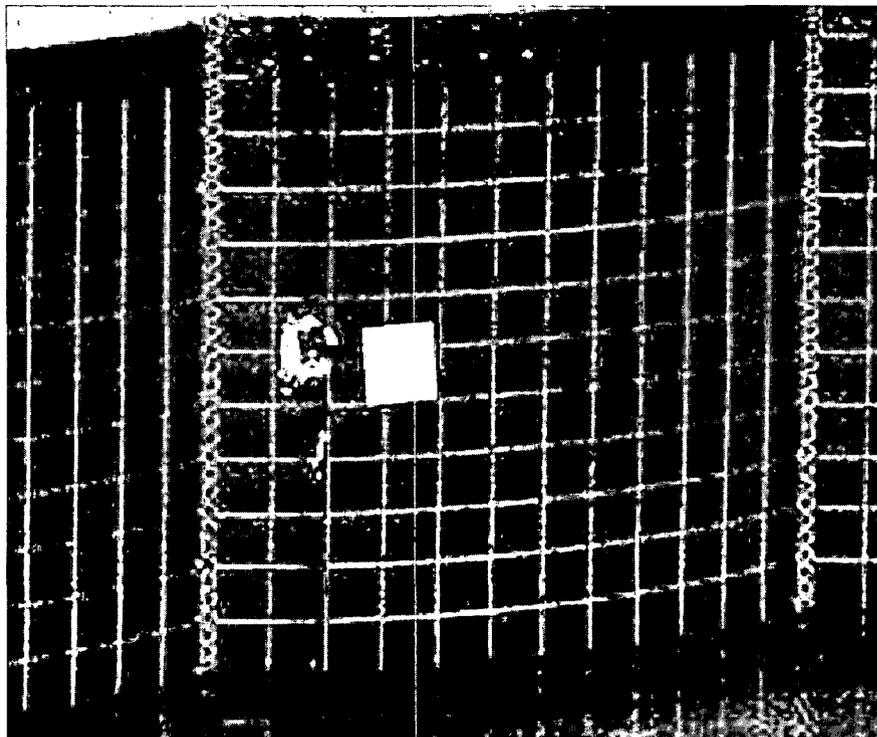
Prior to filling the reservoir to begin the hydrostatic tests, laser targets were positioned in the levee walls and sealed with expandable foam (Figure 2-60). The completed structure was instrumented with the center-wall displacement monitoring system and was readied for static testing (Figure 2-61). The vendor representative agreed in writing that the levee had been constructed properly and was ready for testing.

Figure 2-60. Laser target

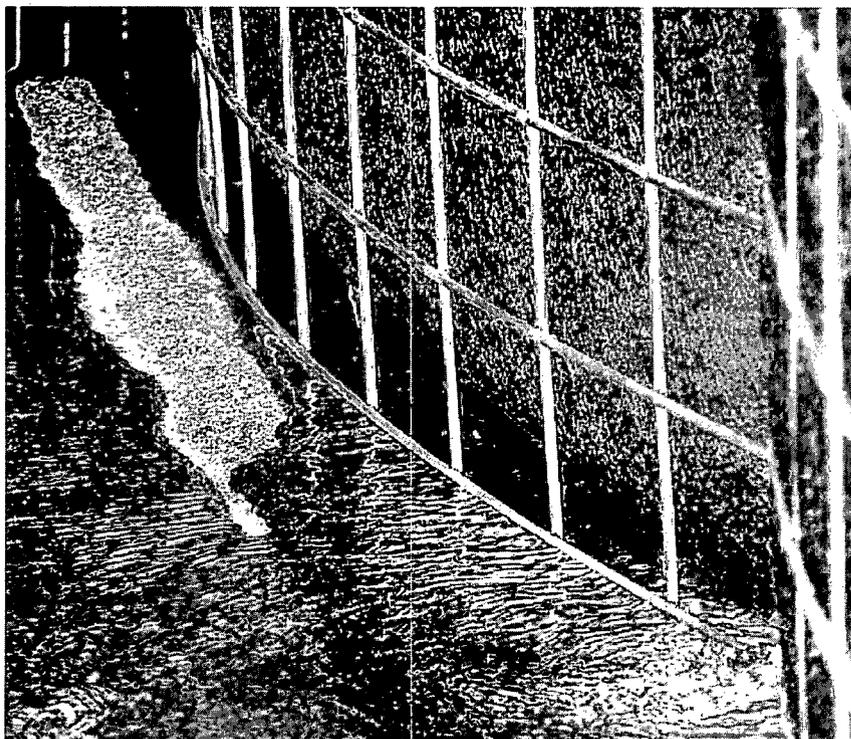
Figure 2-64. Close-up of seepage through vertical joint between units

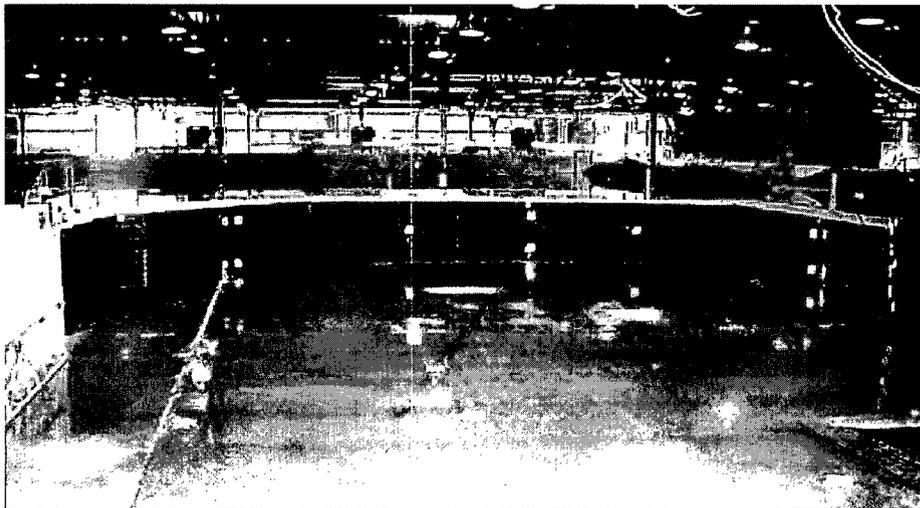
Figure 2-66. View from front

Hydrostatic head test, 2-ft reservoir (66 percent height). The water level in the reservoir on the pool side of the levee was raised to a height of 2 ft (66 percent of levee height). Seepage flow rate ranged from 0.90 to 0.97 gpm/lft (Figure 2-65), and no displacement was observed. Most of the flow was observed coming from the wall corners and the vertical joint between unit ends. Figure 2-66 shows the structure from the front.

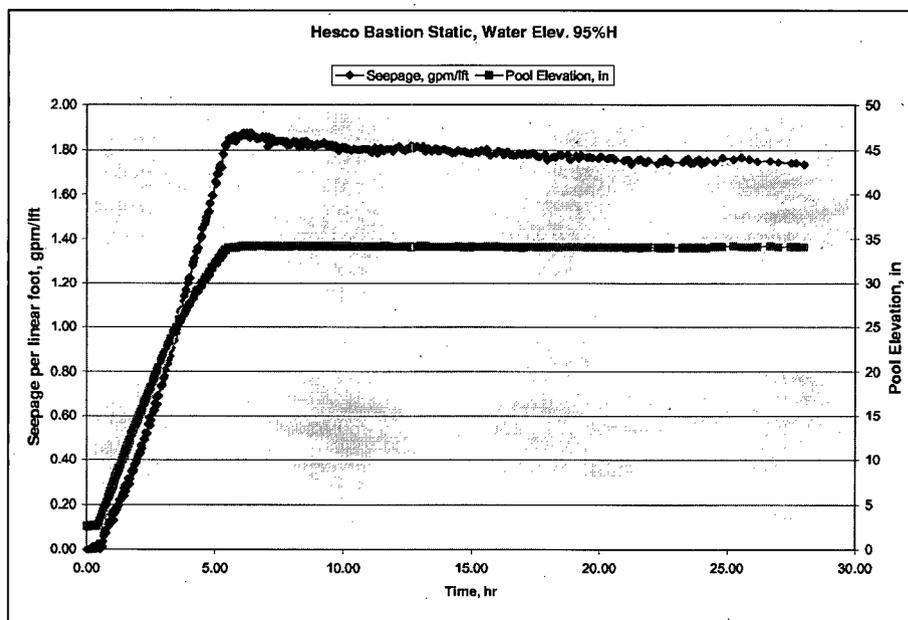
Figure 2-67. Seepage flow rate per linear foot at 95 percent pool elevation

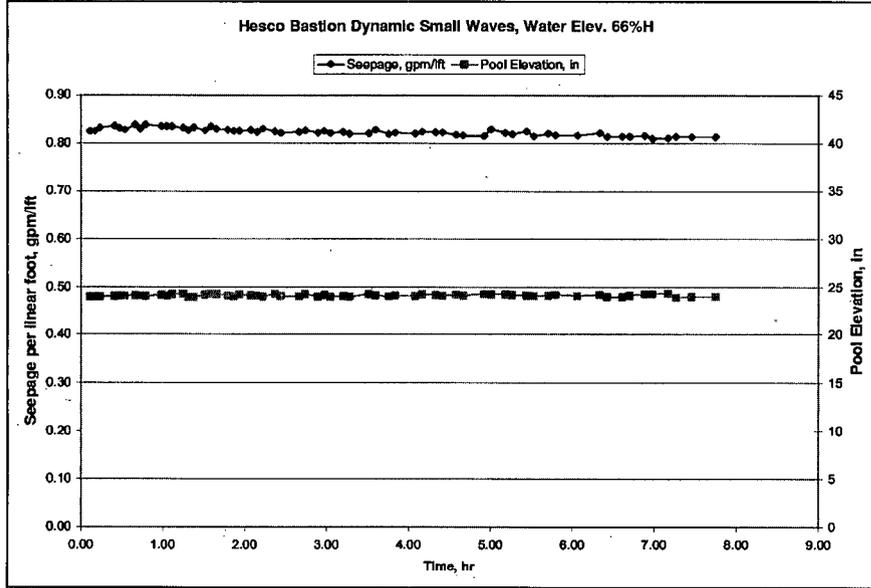
3-in. wave test, reservoir level at 66 percent levee height. The water level in the reservoir of the levee was lowered from the 95 percent level to a height of 24 in. within an interval of about 2 hr. The wave generator was activated and the waves began to impact the levee. Flow rate was observed to range from 0.81 to 0.83 gpm/ft (Figure 2-68), with no displacement. No wave overtopping was observed. Figure 2-69 is a view of the left wall and center wall intersection showing seepage at the wall base.

Figure 2-68. Seepage flow rate per linear foot, small wave at 66 percent pool elevation

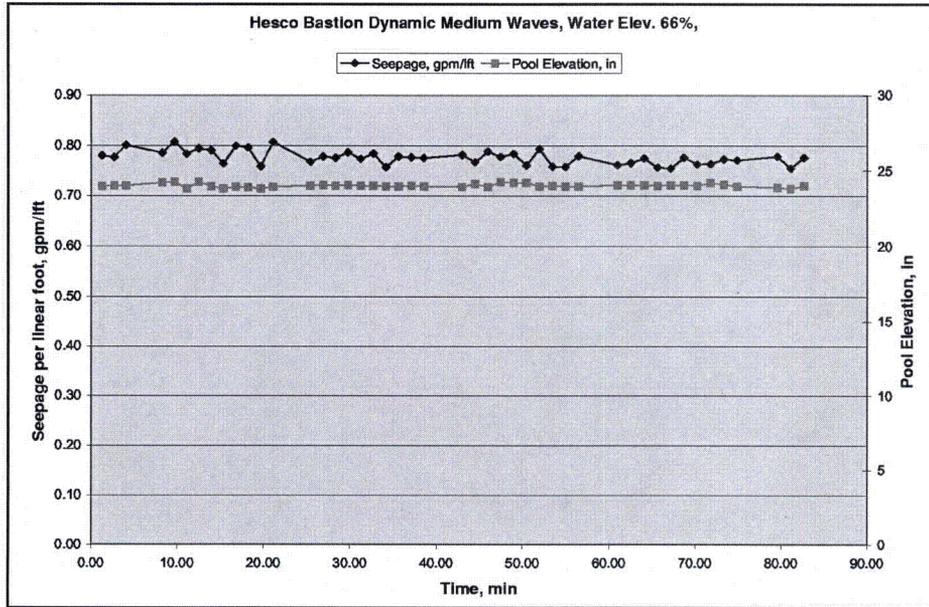
7- to 9-in. wave test, reservoir level at 66 percent levee height. The water level in the reservoir on the pool side of the levee was held at a height of 24 in., the wave generator was activated, and the waves began to impact the levee. Flow rate was observed to subside within a range of 0.77 to 0.78 gpm/ft (Figure 2-70), with no levee displacement. No wave overtopping was observed.

Figure 2-70. Seepage flow rate per linear foot, medium wave at 66 percent pool elevation

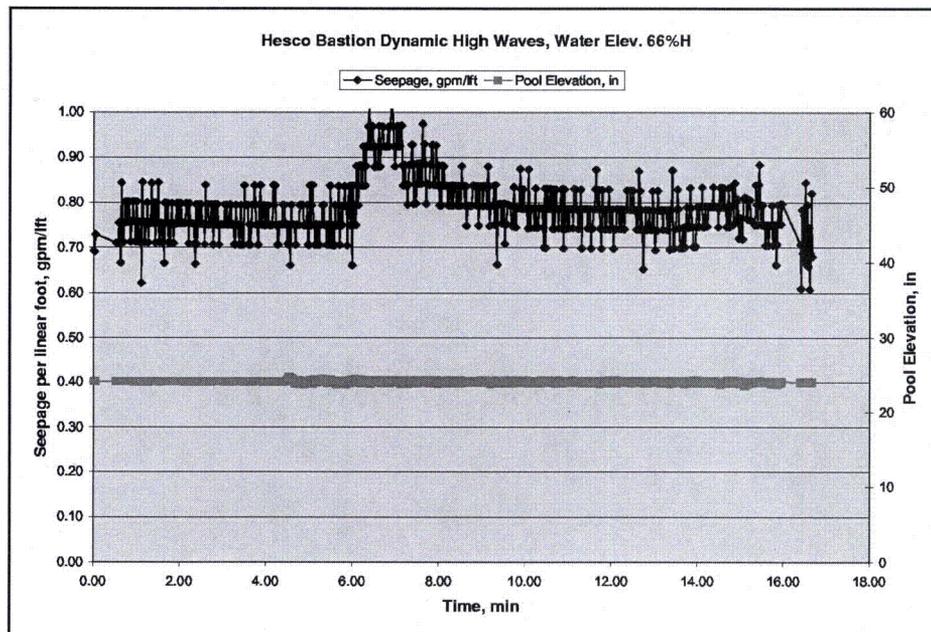
10- to 13-in. wave test, reservoir level at 66 percent levee height. The water level in the reservoir on the pool side of the levee was held at a height of 24 in., the wave generator was activated, and the waves began to impact the levee. Flow rate was observed to range from 0.78 to 0.98 gpm/ft (Figure 2-71), with no displacement. Minor sporadic wave overtopping was observed, primarily along the center wall (Figure 2-72).

Figure 2-71. Seepage flow rate per linear foot, high wave at 66 percent pool elevation

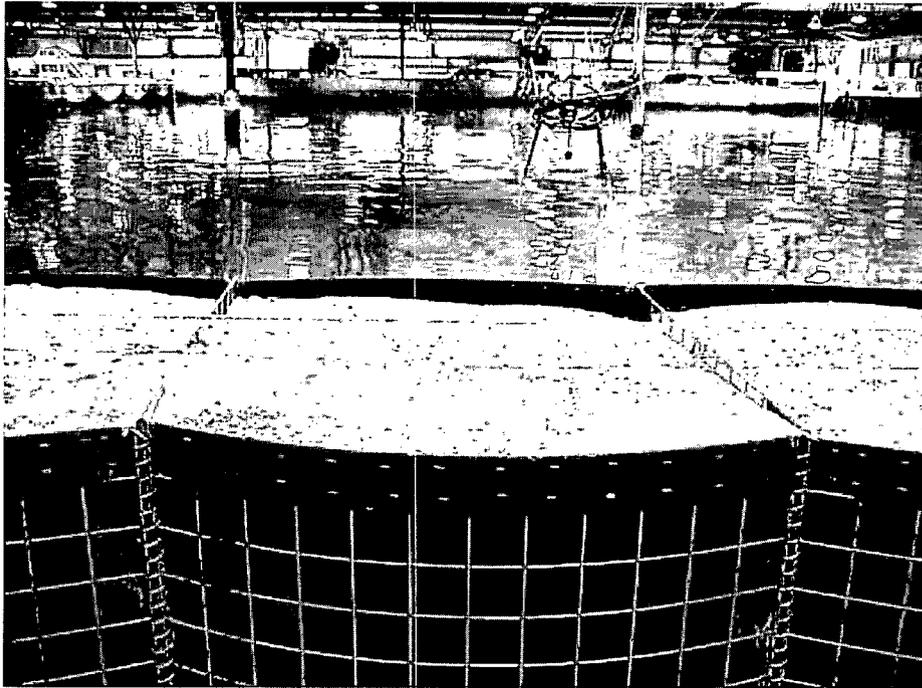
At the conclusion of the test, sand had eroded and settled from the top of the center wall (Figure 2-73), and a solution was devised to prevent further erosion during subsequent testing. As shown in Figures 2-74 and 2-75, a tarp covering was placed on the wall top and secured with cable ties.

Figure 2-73. Sand eroded from top of center wall

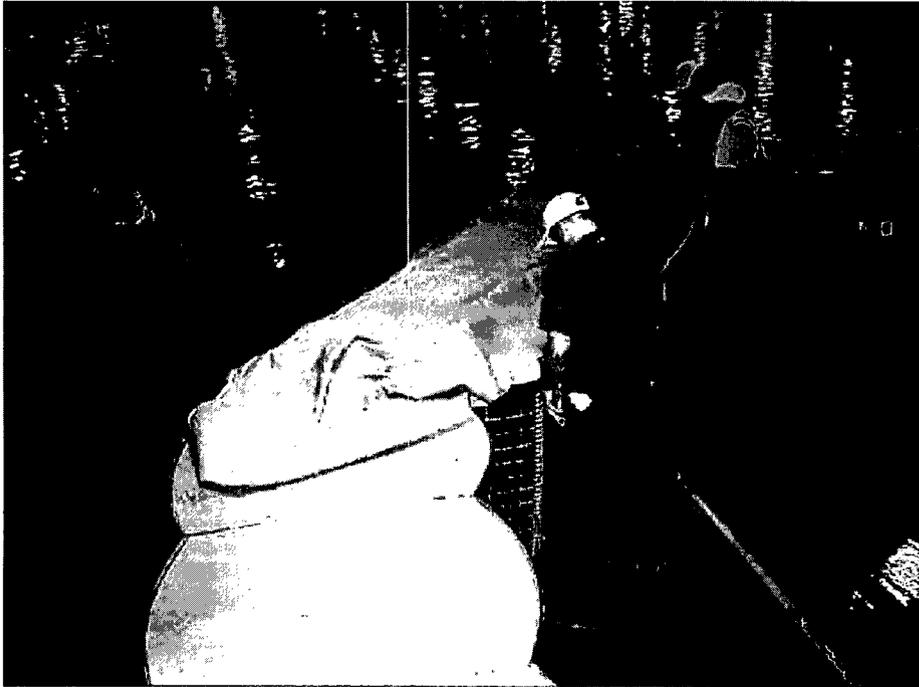
Figure 2-74. Covering top of wall with tarp to prevent further erosion

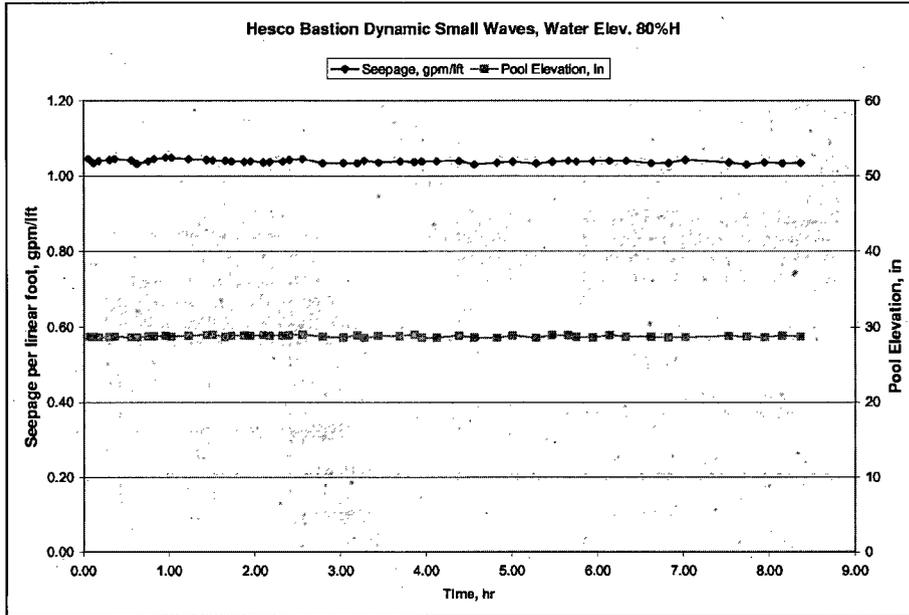
was activated, and the waves began to impact the levee. Flow rate was observed to range from 1.03 to 1.04 gpm/ft (Figure 2-76), with no displacement. No wave overtopping was observed. Figure 2-77 shows seepage under the center wall base.

Figure 2-76. Seepage rate per linear foot, small wave at 80 percent pool elevation

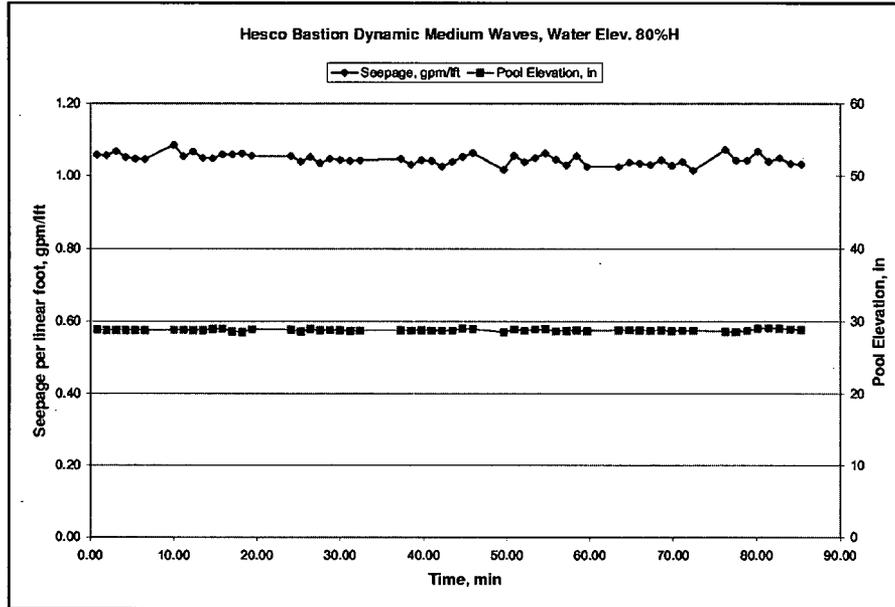
observed to range from 1.03 to 1.07 gpm/ft (Figure 2-78), with no displacement. No wave overtopping was observed. Figure 2-79 shows a view of the structure.

Figure 2-78. Seepage flow rate per linear foot, medium wave at 80 percent pool elevation

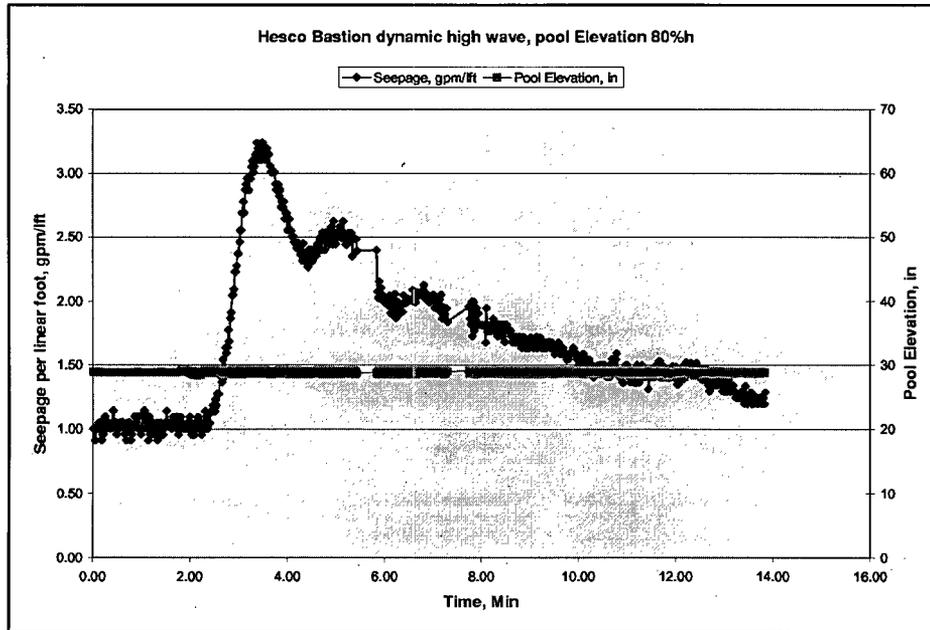
10- to 13-in. wave test, reservoir level at 80 percent levee height. The water level in the reservoir on the pool side of the levee was held at a height of 29 in., the wave generator was activated, and the waves began to impact the levee. Flow rate was observed to range from 1.05 to 3.14 gpm/ft (Figure 2-80), with no displacement. Wave overtopping was observed at each wave front, which contributed to the significant flow rate increase. Figure 2-81 shows wave overtopping.

Figure 2-80. Seepage flow rate per linear foot, high wave at 80 percent pool elevation

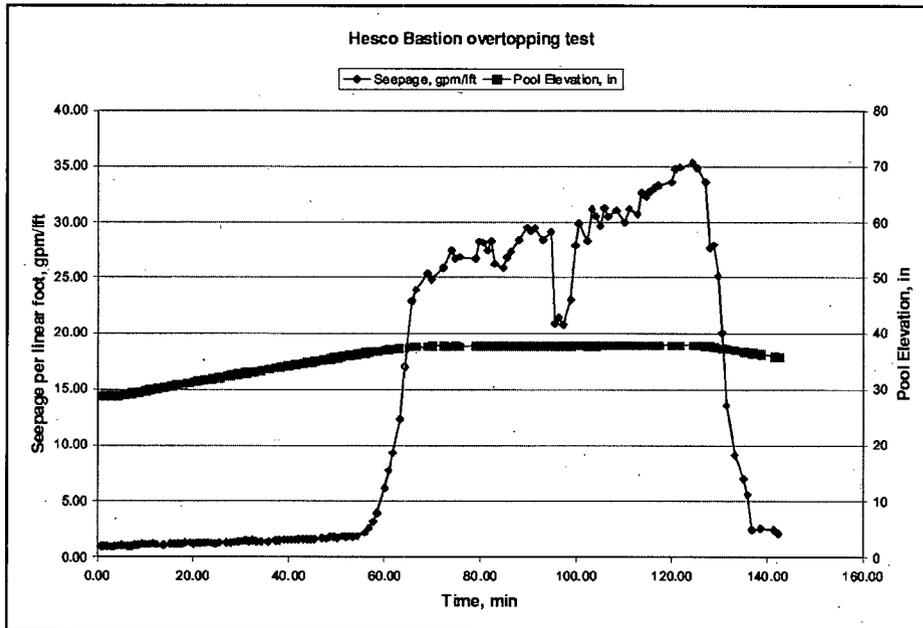
withstood overtopping without failure. Overtopping water combined with seepage water to increase the measured flow rate within a range of 25.2 to 35.0 gpm/ft (1,800 to 2,500 gpm) in the span of 1 hr as shown in Figure 2-82. The overflow was uniform due to the uniform levee height. Figures 2-83 and 2-84, show the overtopped levee.

Figure 2-82. Seepage flow rate per linear foot during overtopping
