**CALCULATION RSOFHLHROGCDX00033320090003
"PMF TEMPORARY MODIFICATION ANALYSIS"**

Title PMF Temporary Modification Analysis

Abstract: Hesco Bastion Concertainers will be used to temporarily raise the elevation of the top of the dam while a permanent modification can be implemented. Several configurations of the Concertainers were evaluated including utilizing existing flood walls to support the temporary flood wall. This calculation also documents the applicability of the Concertainer flood wall system to CRH, TEH, and WBH.				
<input checked="" type="checkbox"/> Electronically file and return calculation to Calculation Library.				
<input type="checkbox"/> Electronically file and return calculation _____ Address: _____

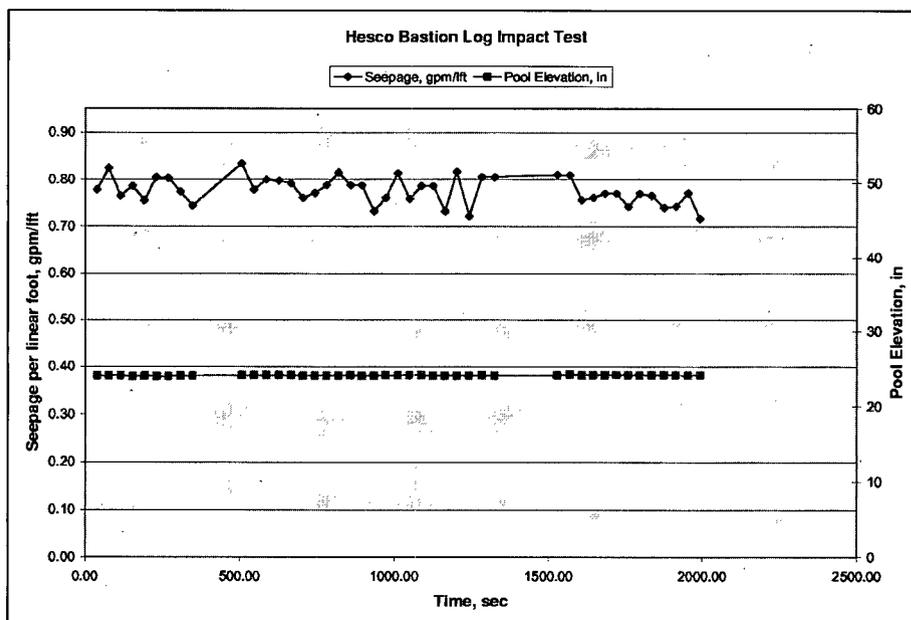
With reservoir level at 24 in., the log impact tests were begun. The 12-in. log impacted the structure and bounced back without causing noticeable damage. The structure displaced slightly and recovered to its original position. The 16-in. log impacted the structure and bounced back also without causing any noticeable damage. The structure displaced slightly and recovered to its original position, but vertical deformations of the sand fill ranging from 4.02 to 0.72 in. were noted. Figure 2-85 shows the minor change in seepage flow rate during impact testing and Figure 2-86 shows the area where the logs hit, viewed from the pool side.

Figure 2-85. Seepage flow rate per linear foot during impact tests

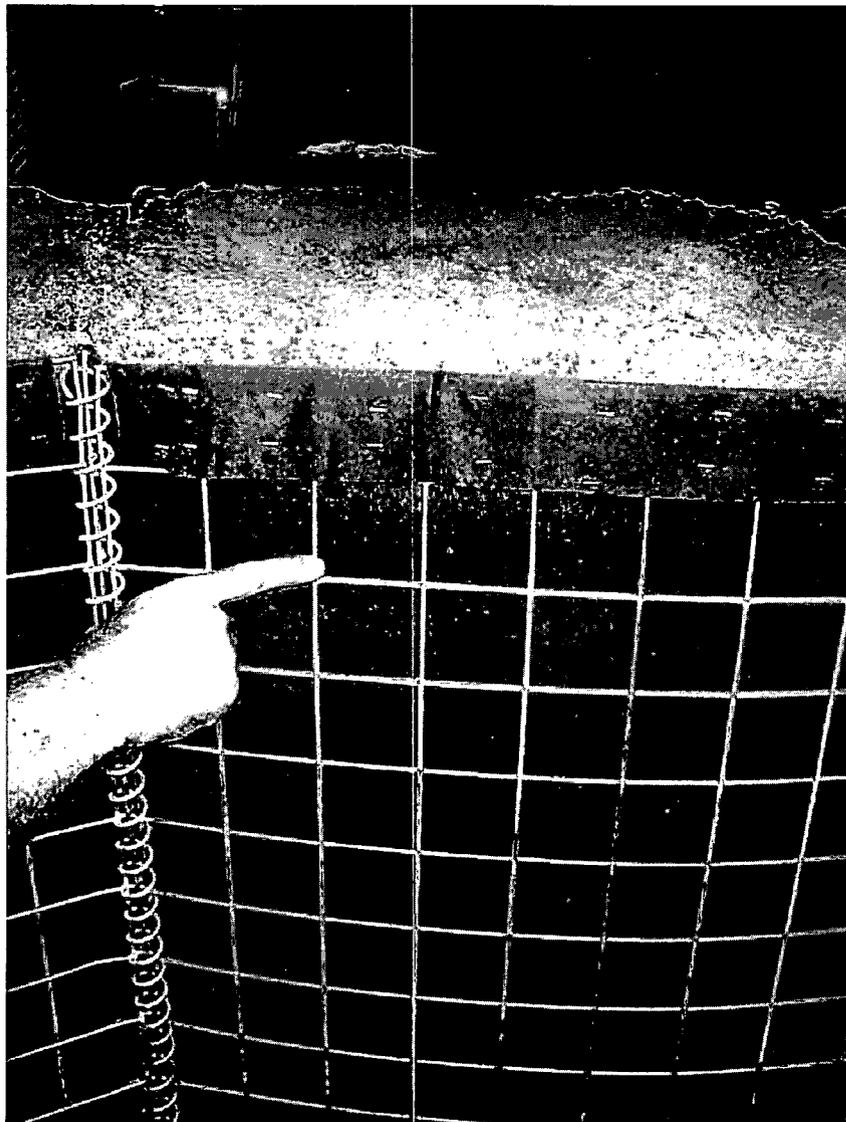
Figure 2-86. Log impact zone on center wall, pool side

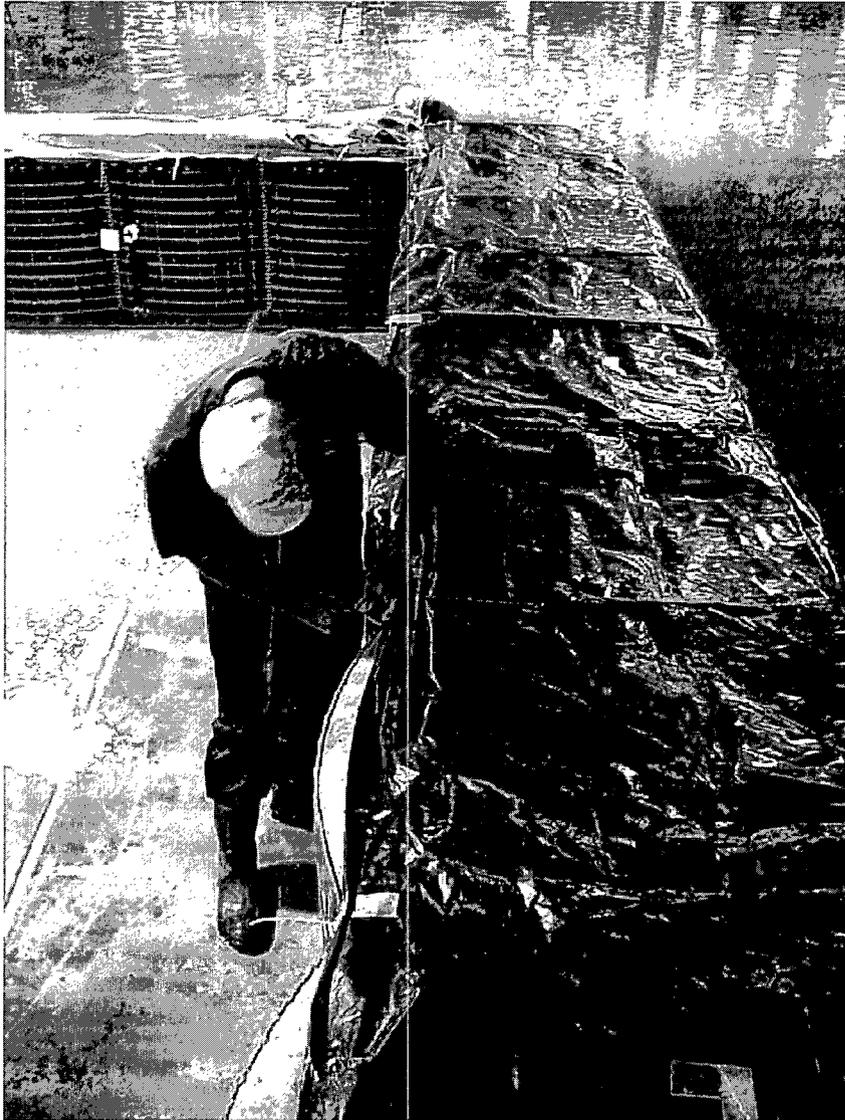
Figure 2-87. Repair 1, view along right wall

Repair 1 was performed prior to the 80 percent small (2- to 3-in.) wave test. It consisted of adding a top membrane fabric over the units, and adding cable ties and wire ties. A four-man crew took 24 min (1.6 man-hours) to do this work. Figure 2-87 shows this work (see also Figures 2-74 and 2-75).

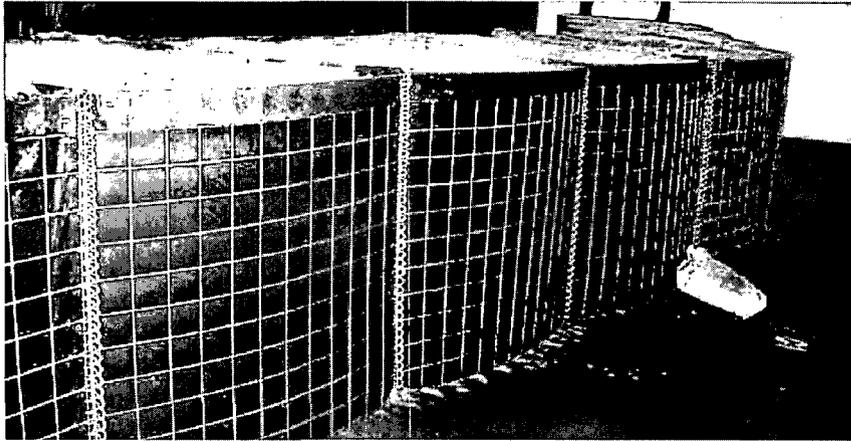
Repair 2 was performed prior to overtopping. It took three men 5 min (0.25 man-hours) to add prefilled sandbags on the pool side for additional protection against joint seepage (Figure 2-88). Repairs 3 and 4 were not needed.

Figure 2-88. Added sandbag along left wall

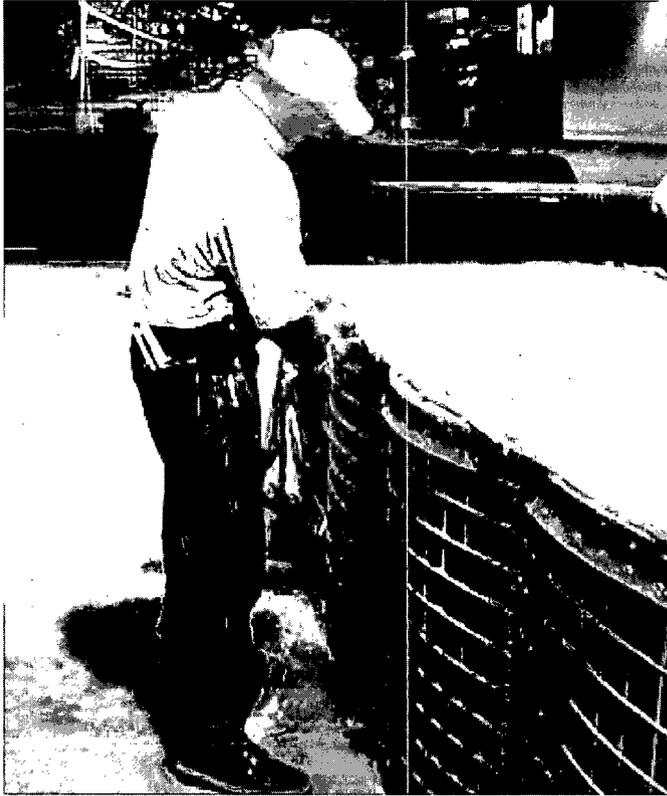
Figure 2-89. Cutting cable ties and removing top cover

Disassembly consisted of removing all cable ties, removing the top cover (Figure 2-89), unhinging the inner and outer walls held with pins in each center partition (Figures 2-90 and 2-91, manually pulling each wall apart (Figures 2-92, 2-93, and 2-94), removing the sand pile (Figure 2-95), and restacking the units onto a pallet (Figure 2-96).

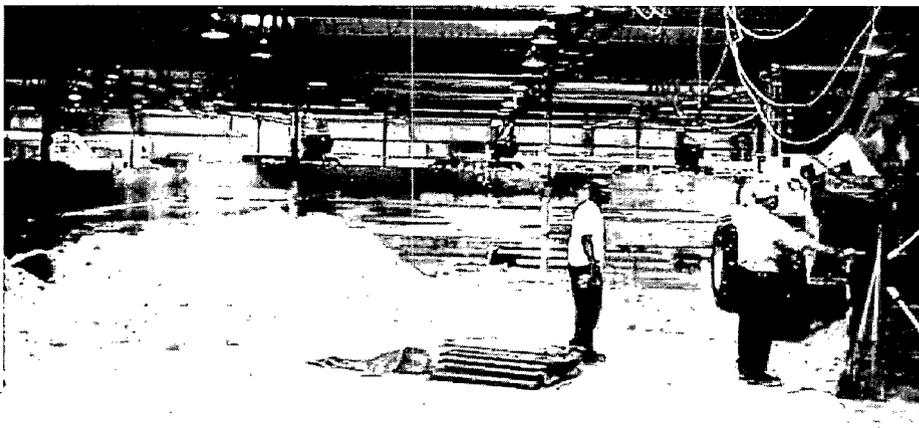
Figure 2-96. Stacked units ready for reuse

The sand was stockpiled for reuse, and the folded units were placed on wooden pallets for reuse. The only nonreusable items were the fabric panels at either end of the 12-ft units. During disassembly, the panels were slit with a knife to facilitate separation after the center partition pin was pulled out. The fabric end panels would then be repaired or replaced prior to reuse.

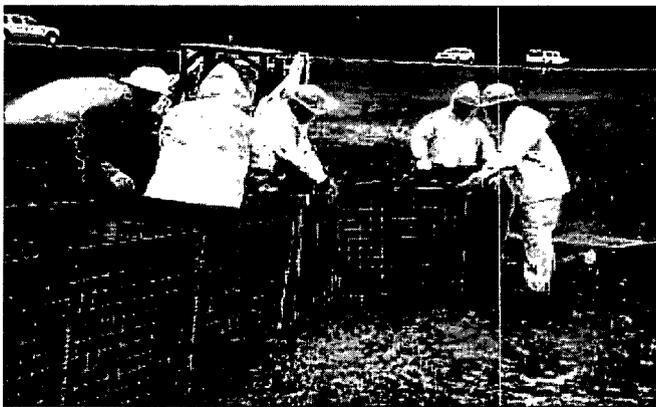
Figure 3-70. Installation of base row units

Construction of the Hesco Bastion Concertainer structure began on the morning of 12 May 2004, in constant rain and mild temperatures. Figure 3-68 is a photograph of the Hesco Bastion site prior to construction. Because the Government laborers and operators were unfamiliar with the product, the Hesco Bastion representative conducted a 23-min training session on the installation process (Figure 3-69). At the completion of the training session, the workers began placing the base row units along the desired alignment (Figure 3-70). In accordance with the construction protocol, about half of the site was graded to bare ground while the other half was left undisturbed with the natural grass and weeds (Figure 3-71). The units were installed according to Hesco instructions as follows.

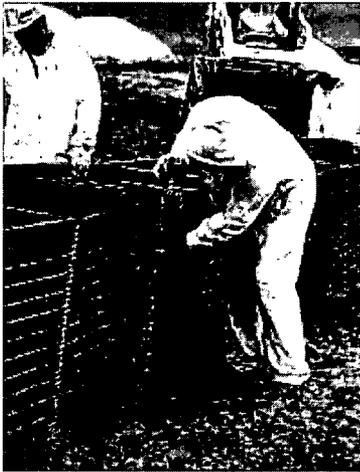
Figure 3-72. Installation of joint pins

Units were pinned together to form a continuous barrier by inserting joint pins through the coils of adjacent units (Figure 3-72): The units also were connected with zip ties placed along the top of adjacent unit end panels. Riverward face units of the structure were placed first, followed by the tieback sections (Figure 3-73). Each unit has a 5-in. liner flap on the bottom. Care was taken to ensure that these flaps were turned to the inside of each unit prior to filling, so that the weight of the sand on the flaps secured the units in place. Once the base row units were placed, the units were filled with sand to within approximately 5 in. of the top (Figure 3-74). The units were not completely filled because the bottom flaps on the top row are turned down and buried into the sand in the base row units. The sand had previously been stockpiled adjacent to the Hesco Bastion site and was placed in the units by two tracked front-end loaders. The laborers spread the sand within the units with shovels and manually compacted the sand by walking on it. Sand was placed in the containers primarily from the protected side of the structure. However, due to the location of the seepage-collection tank in the northeast corner of the structure, the sand in the vicinity of the tank was placed from the riverside.

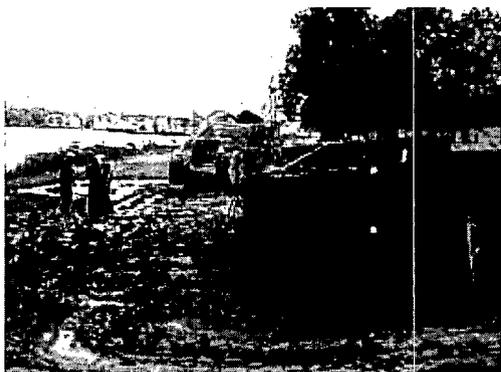
Figure 3-76. Filling top row units with sand

Therefore, he requested and was granted permission to fill portions of the riverward front from the riverside (Figure 3-76). Since the top row units were 2 ft high and the required raise was only 1 ft, the top row units were not completely filled. The amount of fill varied in the top row units but averaged about 18 in. (Figure 3-77).

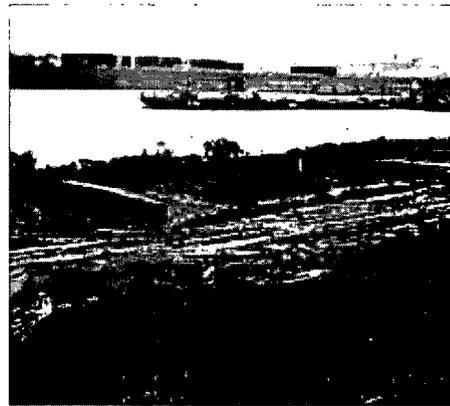
Figure 3-79. Completed structure from protected side

The Hesco Bastion Concertainer units used at the Vicksburg Harbor test site were 3 ft wide when empty. However, as sand was placed in the units, the units began to expand. The cells within the units ranged from 40 to 48 in. wide when the structure was finished. Therefore, the units used for the field test have a footprint of 4 ft. The Hesco Bastion structure required 91 cu yd of sand fill. Also, Hesco Bastion was allowed a 25-ft right of way to construct their structure. Because the structure was filled from the side with tracked Bobcats, the entire 25-ft right of way was used. Figures 3-78 and 3-79 are photographs of the completed Hesco Bastion structure. Once the construction was completed, the Hesco Bastion representative signed a certification that the structure was constructed according to his onsite directions and in accordance with Hesco Bastion's installation specifications.

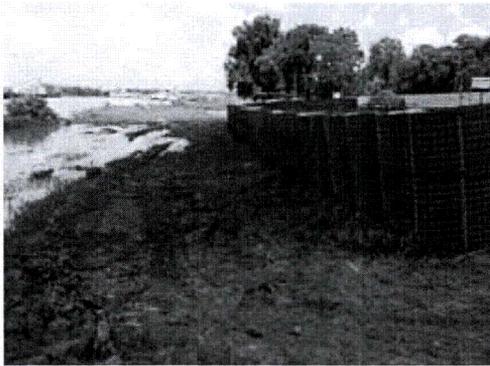
Figure 3-80. 4 June 2004, no water against structure

The Hesco Bastion Concertainer structure was constructed during a time when the river levels were falling. However, by early June, as predicted, the river had begun to rise and by the morning of 5 June approximately 0.3 ft of water was standing against the structure. Figures 3-80 through 3-87 show the Hesco Bastion structure during field testing. As the river continued to rise, the Hesco Bastion structure was subjected to higher water levels. The daily water levels against the structure are given in the figure captions. These water levels were based on 8 a.m. readings for the Mississippi River at the Vicksburg gage. The testing of the Hesco Bastion structure ended on 11 June 2004. The river never rose high enough to overtop the top row units. However, sand in five of the riverside top row cells was at the level to provide exactly 4 ft of protection. On 11 June, the river level rose high enough to overtop the sand in those five cells. The decision was made in collaboration with the Hesco Bastion representative to stop the tests at that point even though the pump capacity had not been exceeded.

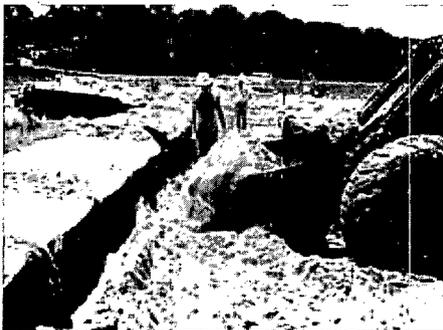
Figure 3-98. Removal of sand from around base row units

(Figure 3-97). This sand was then removed from around the base row units so that they could be removed (Figure 3-98). The base row units were removed by a crew of two Hesco Bastion representatives and four government laborers plus a government equipment operator. The same process was used to remove the base row units that were used to remove the top row units. Most of the base row half units were physically lifted and pulled from the sand by hand (Figure 3-99). However, when the joint-connection pins were pulled from the riverward face of the base row, two half sections were pushed over by the weight of the sand because these units were on sloping ground. The removal crew used the front-end loader and four chains to remove these half sections (Figure 3-100). They also used the front-end loader to pull some of the joint-connection and center-connection pins from the base row units (Figure 3-101).

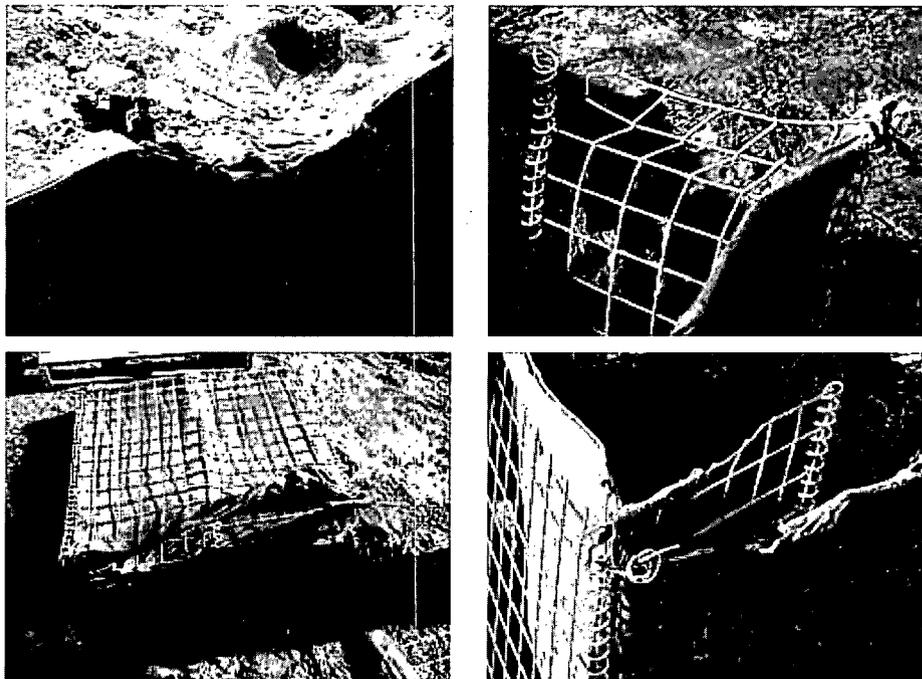
Figure 3-104. Units damaged during removal process

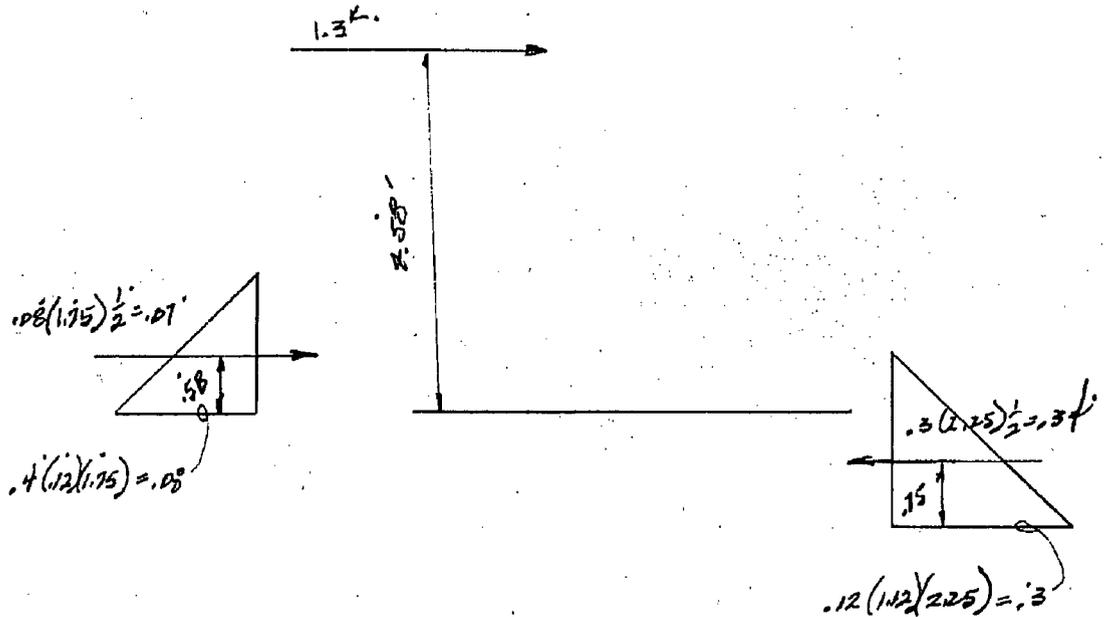
$F_{SOT} = \frac{6.47}{5.95 + 0.04} = 1.1' < 1.5 \equiv$ HOWEVER, THIS LOAD SITUATION IS
 OF SHORT DURATION FROM VEHICLE IMPACT.

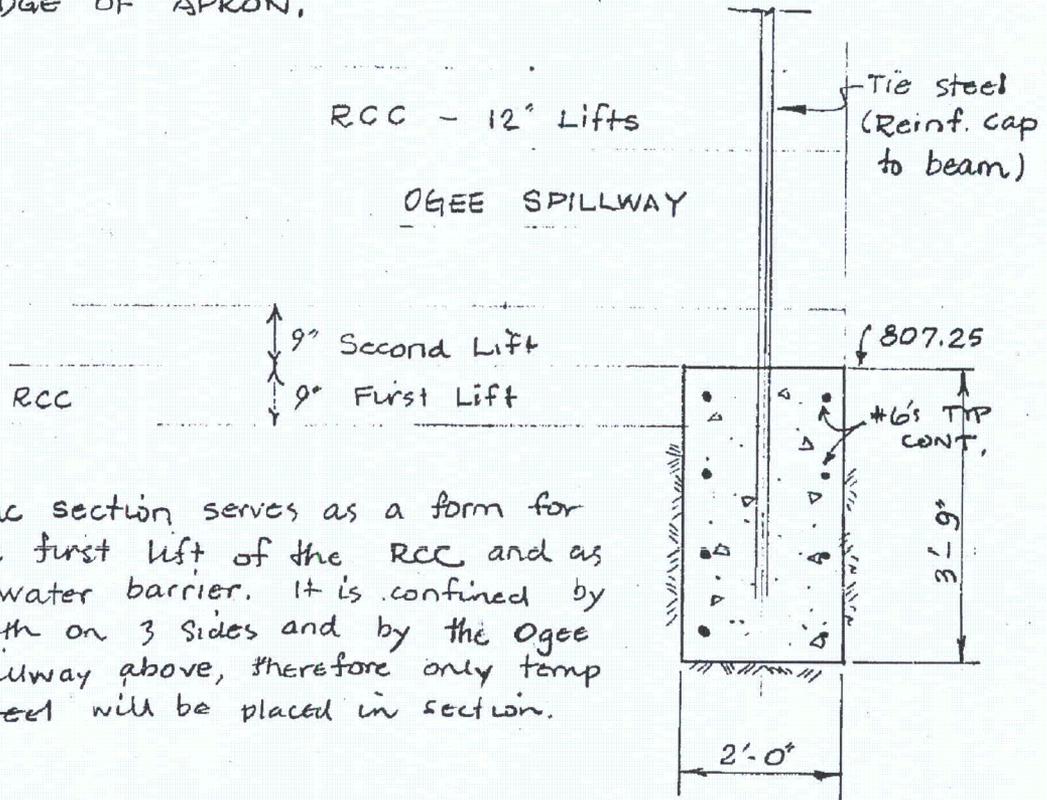
Conc section serves as a form for the first lift of the RCC and as a water barrier. It is confined by earth on 3 sides and by the Ogee Spillway above, therefore only temp steel will be placed in section.
