PSEG Power, LLC
 PSEG Site ESPA
 Part 2, Site Safety Analysis Report

FIGURE 2.4.6-11 Rev 0

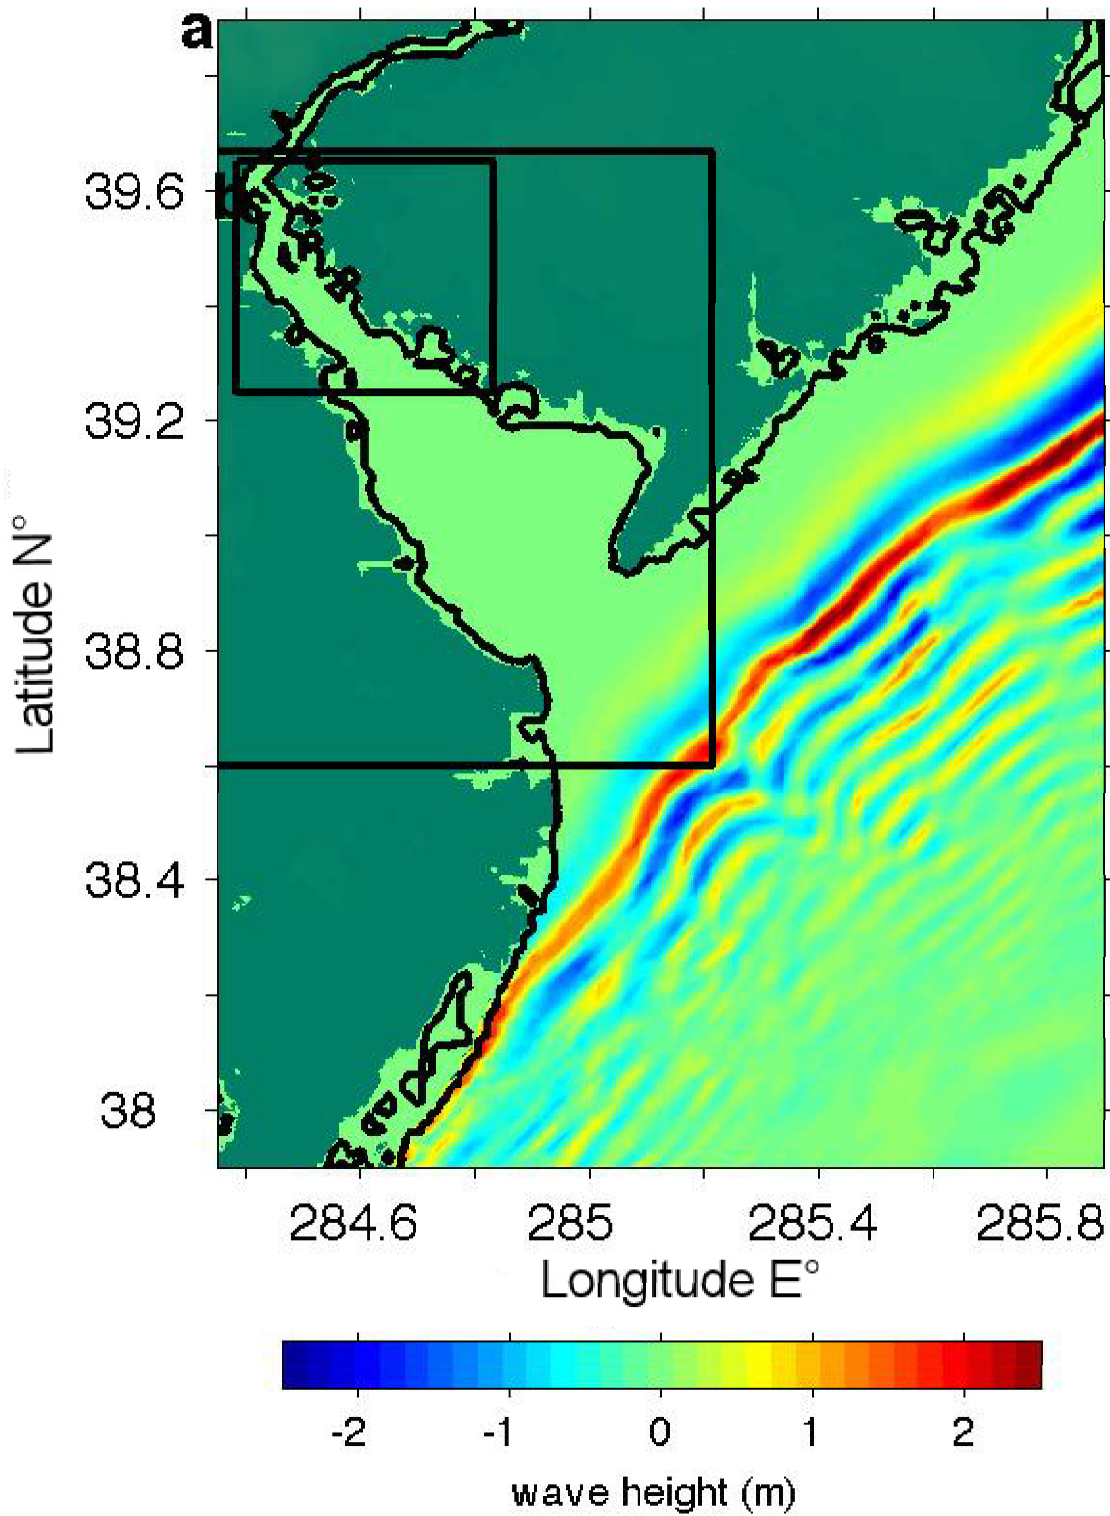
2-D Image for Currituck Slide
 at 02 hours
