PSEG Power, LLC
 PSEG Site ESPA
 Part 2, Site Safety Analysis Report

FIGURE 2.4.6-13 Rev 0

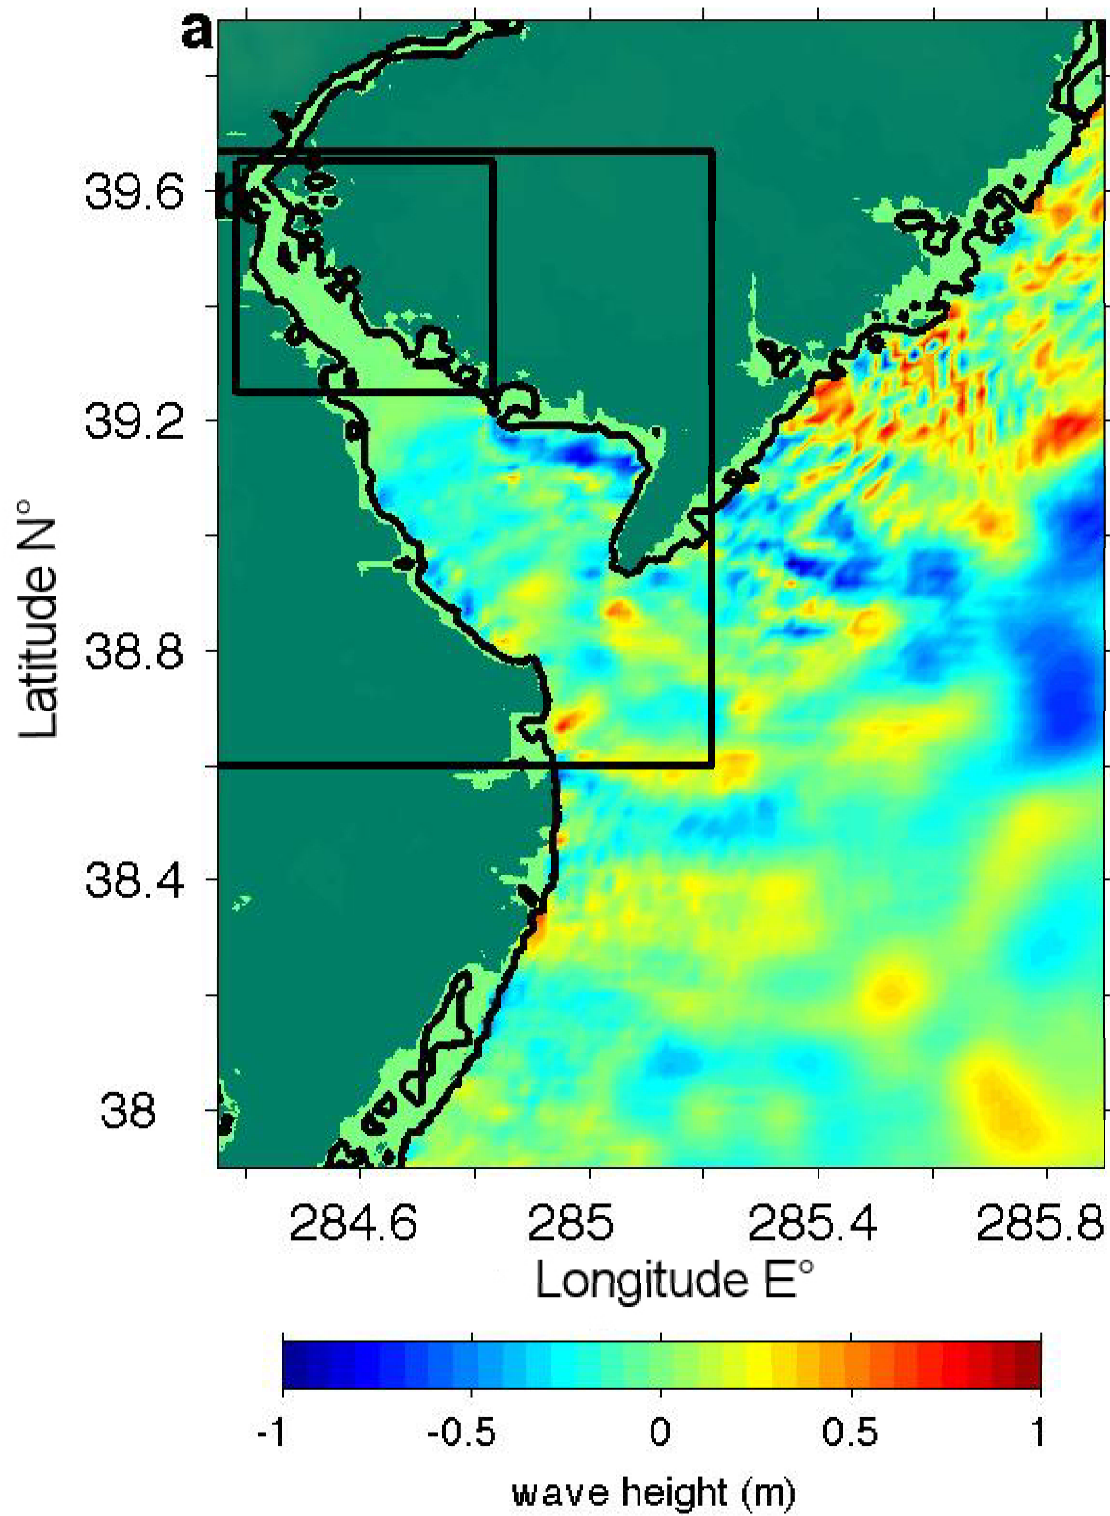
2-D Image for Currituck Slide
 at 04 hours
