PSEG Power, LLC
PSEG Site ESPA
Part 2, Site Safety Analysis Report

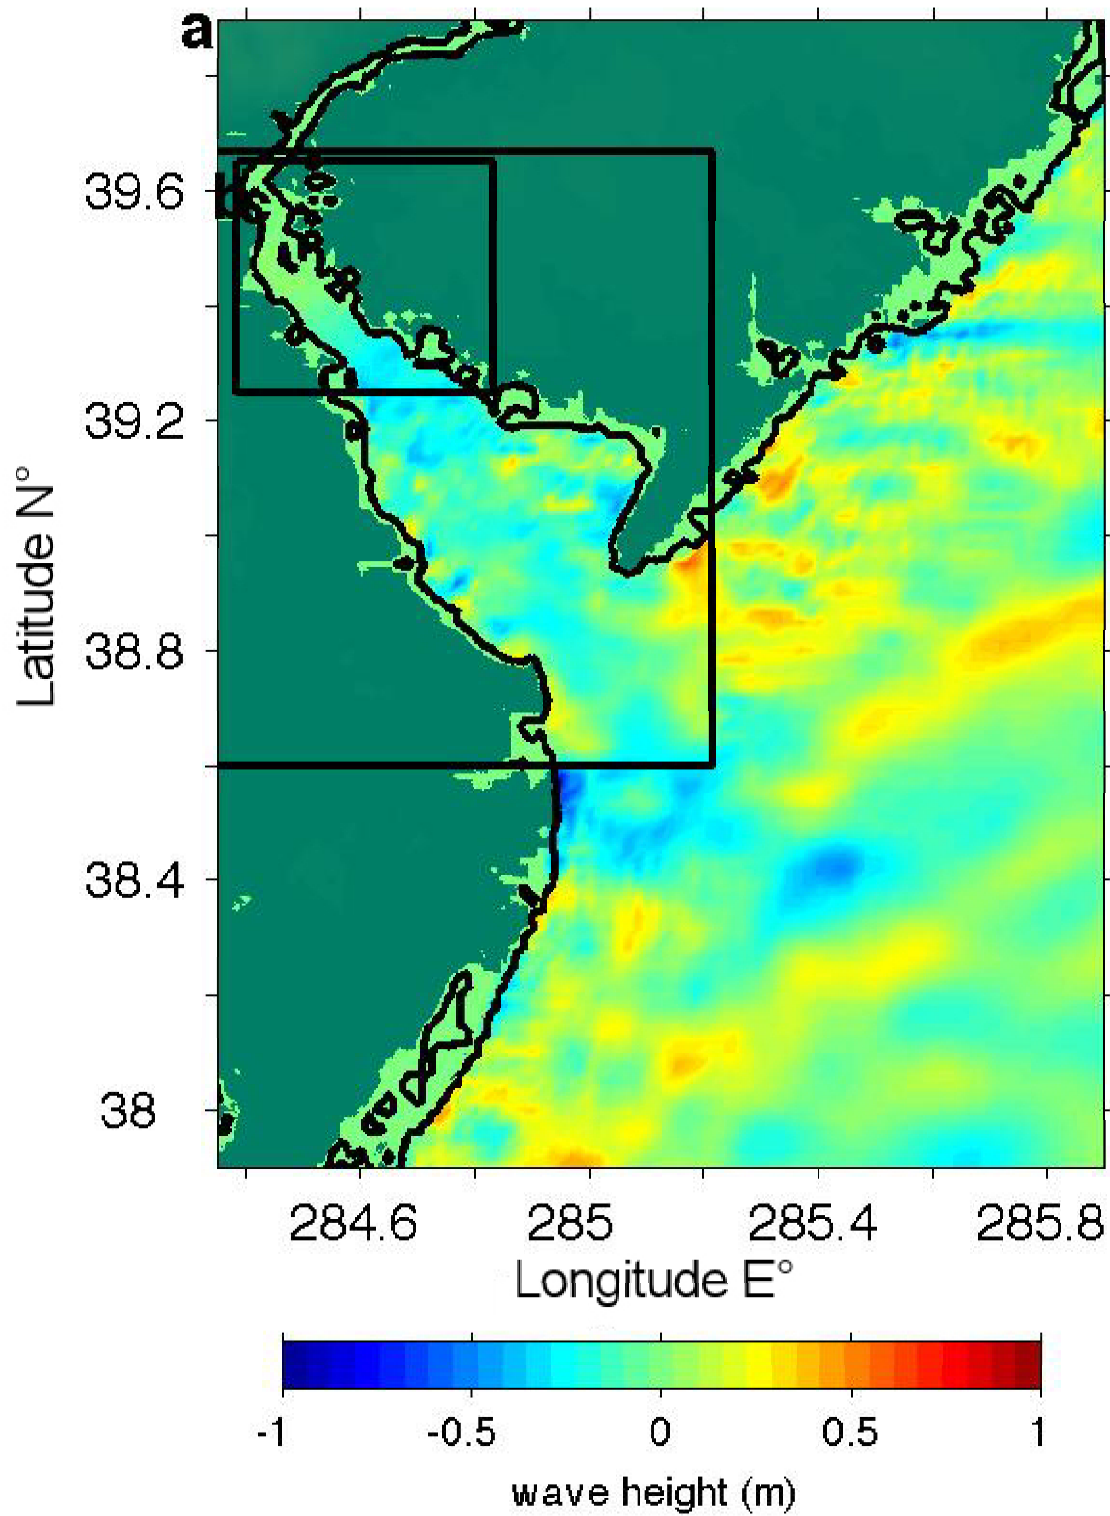
FIGURE 2.4.6-14 Rev 0

2-D Image for Currituck Slide
at 05 hours
