PSEG Power, LLC
PSEG Site ESPA
Part 2, Site Safety Analysis Report

FIGURE 2.4.6-19

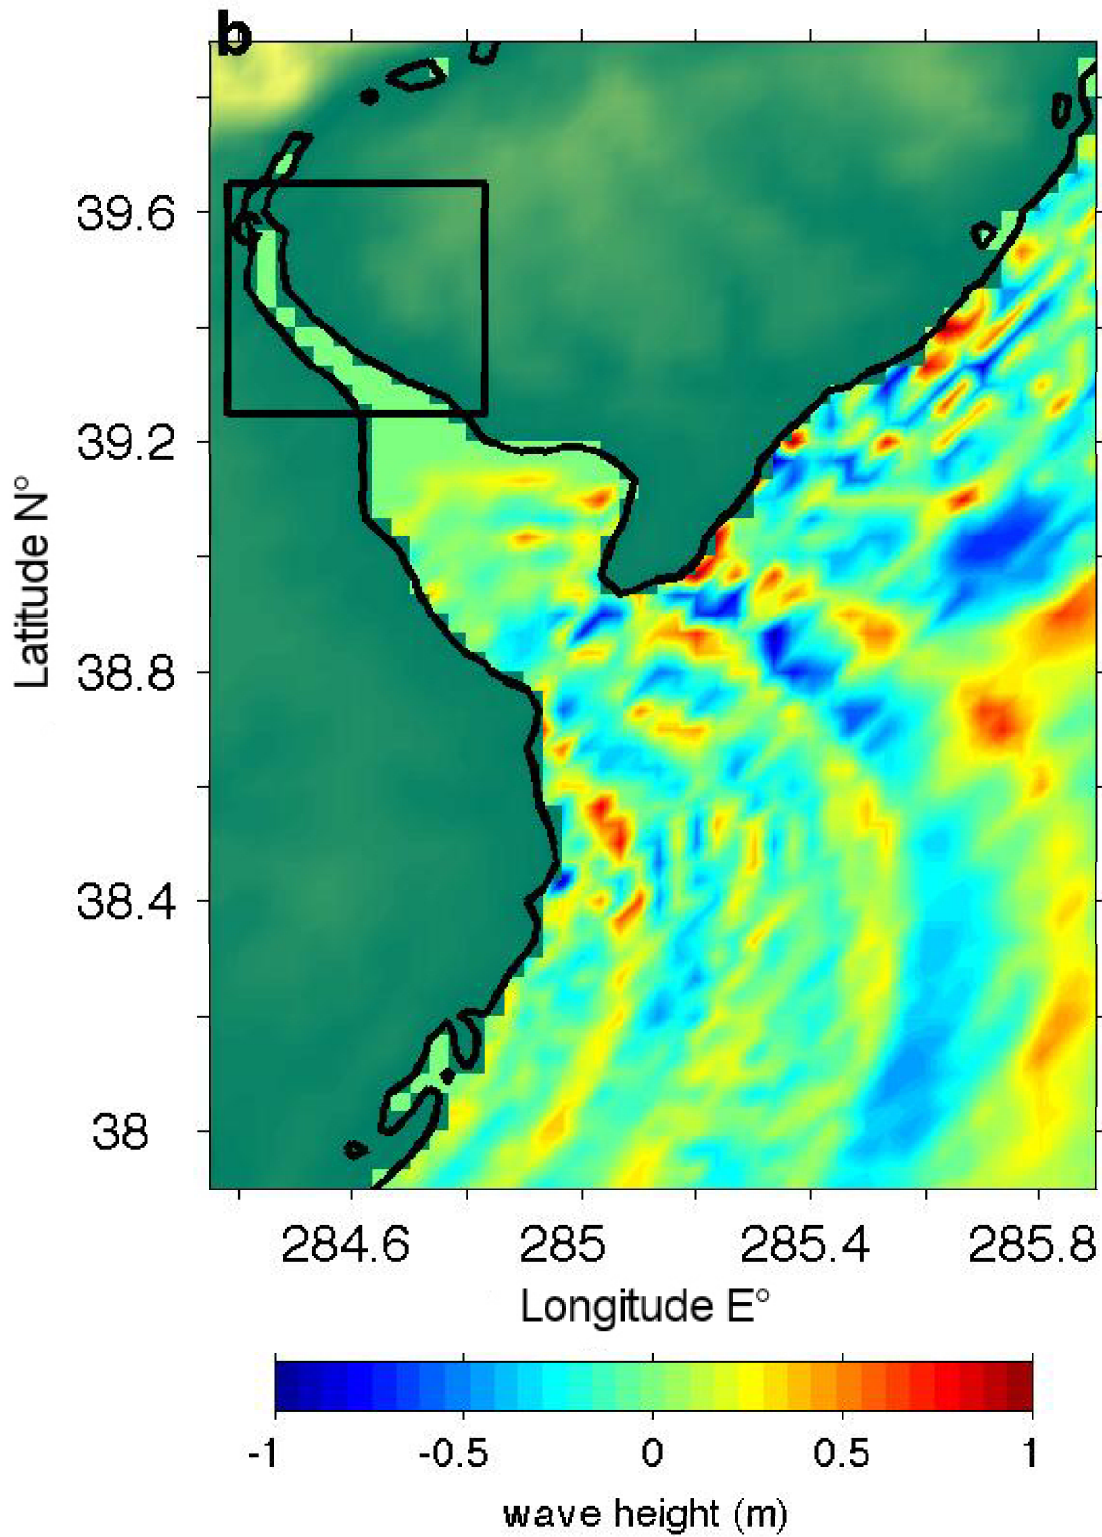
2-D Image for La Palma Slide
at 10 hours
