PSEG Power, LLC
 PSEG Site ESPA
 Part 2, Site Safety Analysis Report

FIGURE 2.4.6-24 Rev 0

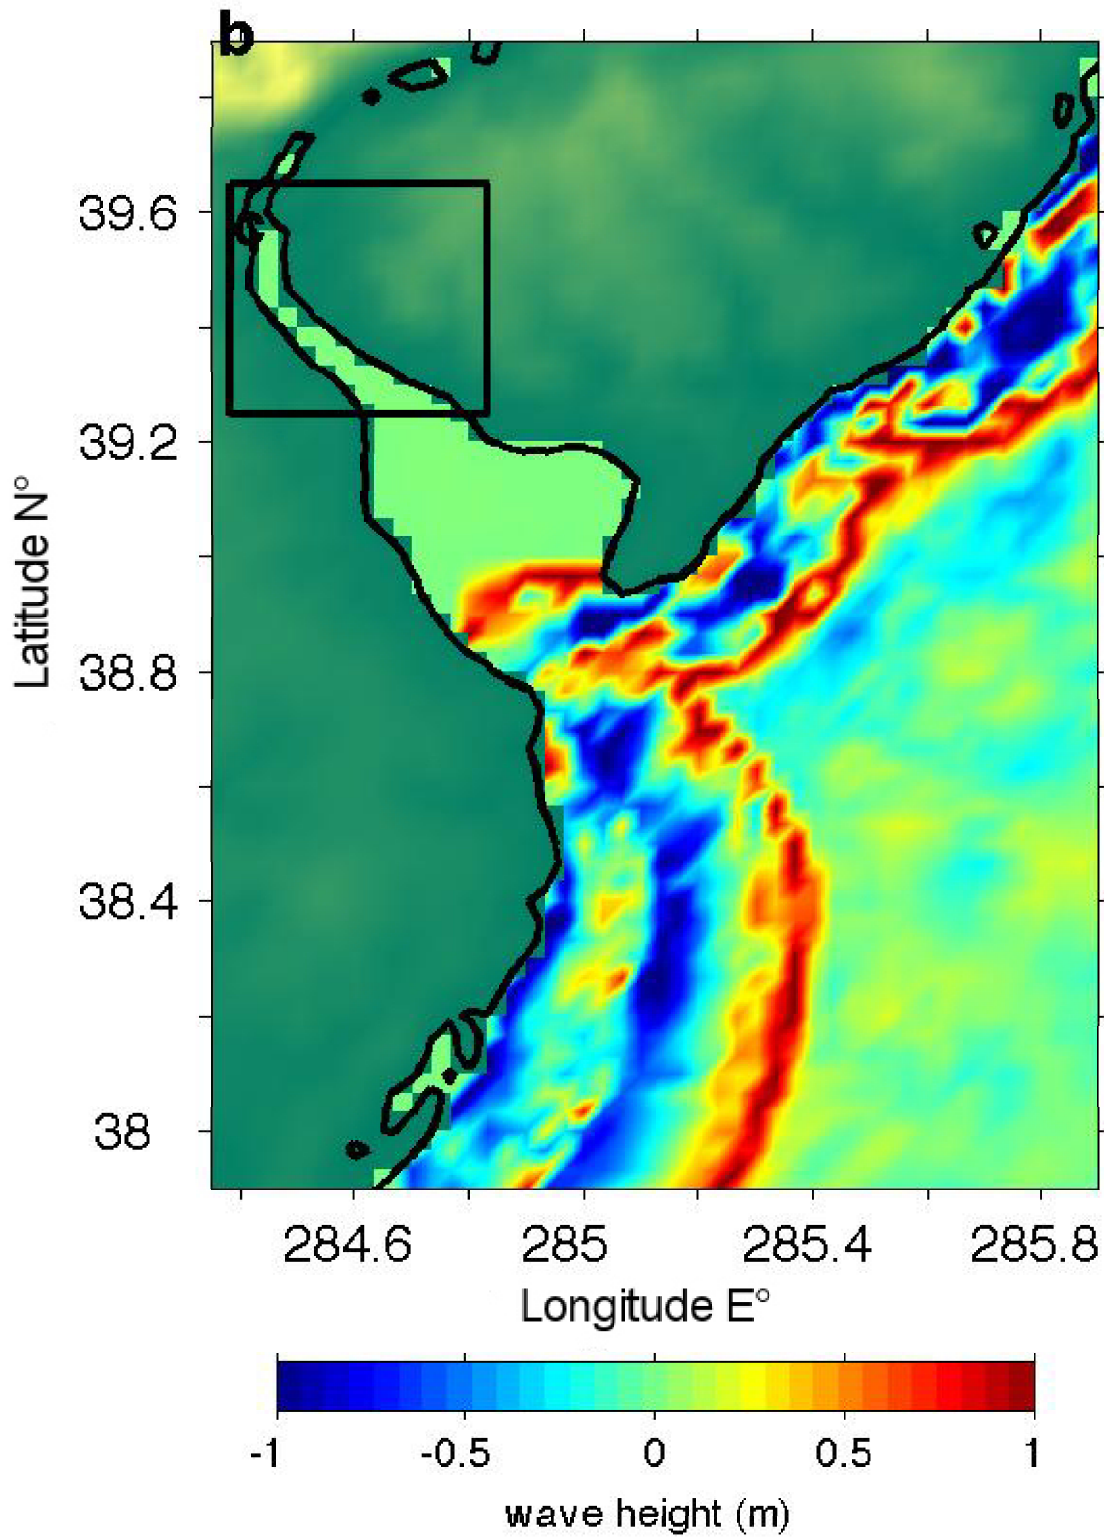
2-D Image for Hispaniola Trench
 Earthquake at 05 hours
