Microstructural Characterizations of Alloy 690: Key Examples

Pacific Northwest National Laboratory

NRC – Industry 2011 Meeting on Alloy 690 Research
June 6-7, 2011 Rockville, MD

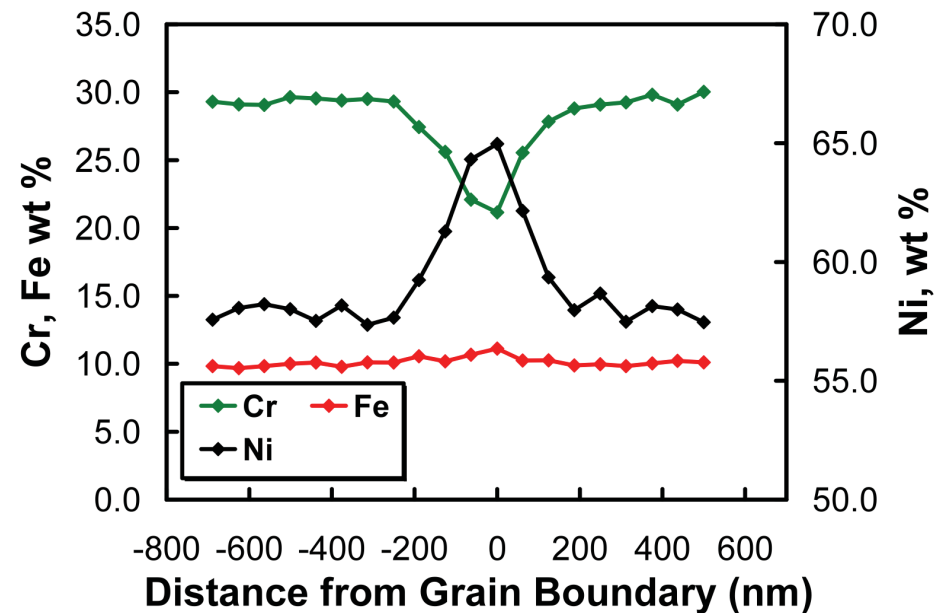
Grain Boundary Cr Depletion in As-Received Alloy 690TT CRDM Tubing Heat RE243

Semi-continuous GB carbides for the as-received alloy 690TT material with significant Cr depletion observed associated with both discrete carbides and cellular $M_{26}C_6$ precipitates.

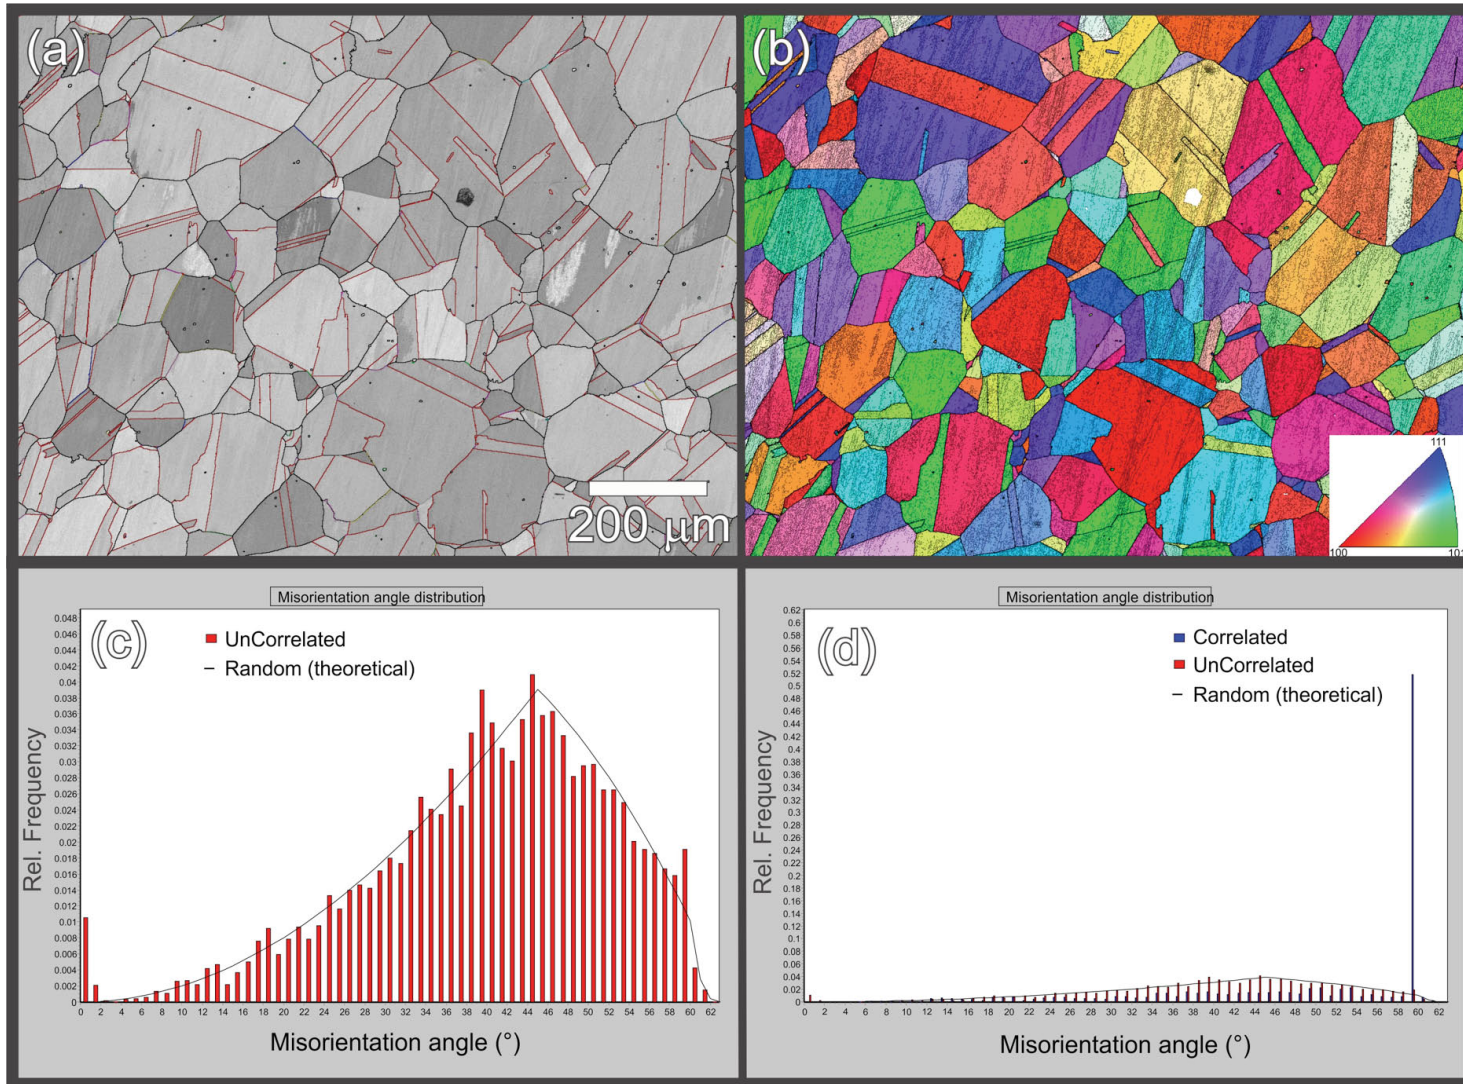
As-Received, Alloy 690TT CRDM Tubing

EBSD shows a high density of twin boundaries, but most grain boundaries (>75%) are random, high-energy boundaries.

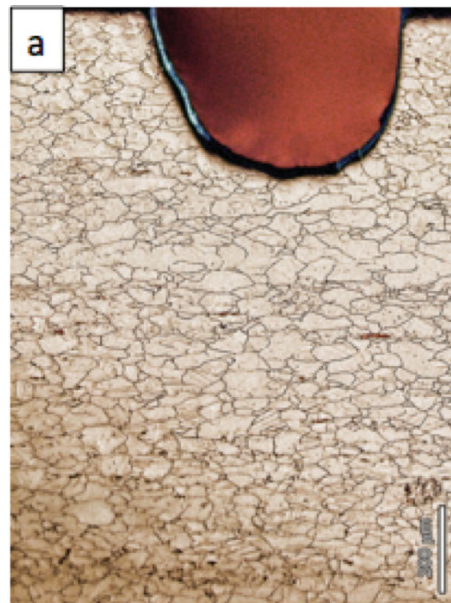
Example Microstructures: ANL 26%CR Plate at Upper Region of Plate

Evidence for compositional banding found in upper region of plate.

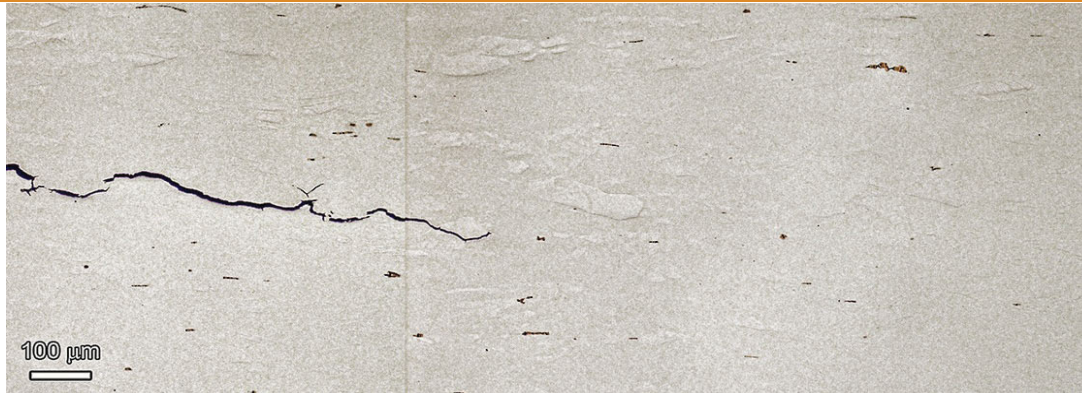
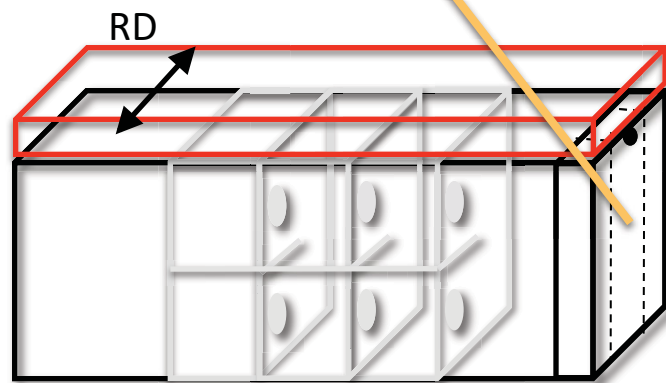
Example Microstructures: ANL 26%CR Plate at Crack Plane

Consistent microstructure, no indication of significant banding in region corresponding to PNNL specimen crack growth plane

Moderate-to-high density of grain boundary carbides

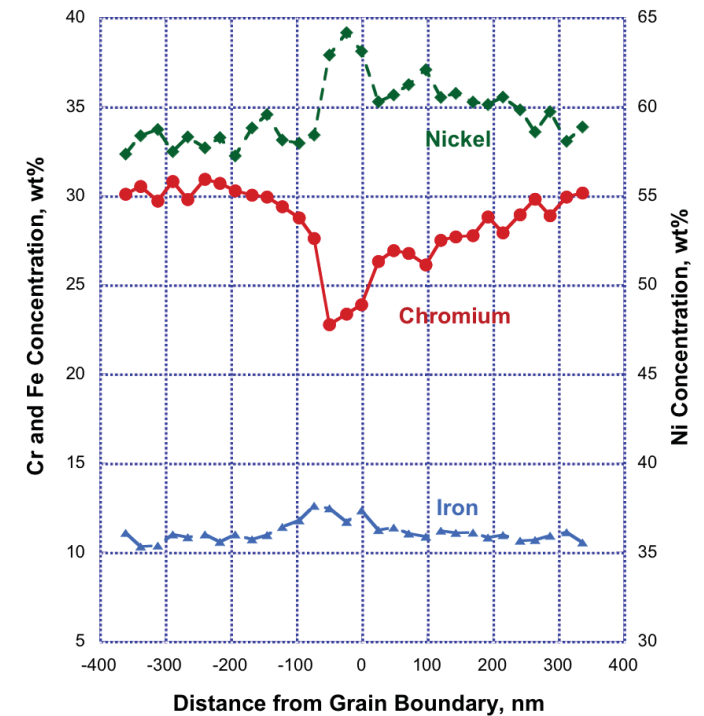
Grain Boundary Microstructure/Chemistry for ANL 26%CR Plate at Crack Plane

Most random grain boundaries have a high density of discrete $M_{23}C_6$ carbides and significant Cr depletion.

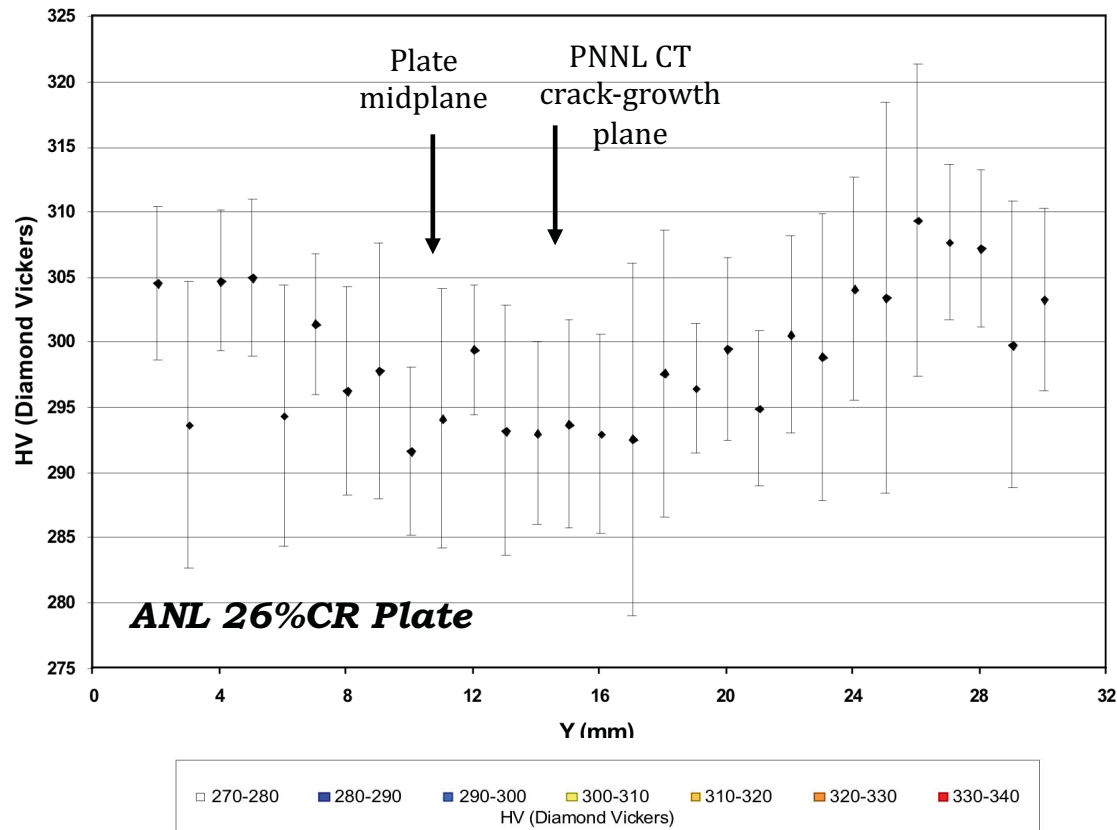
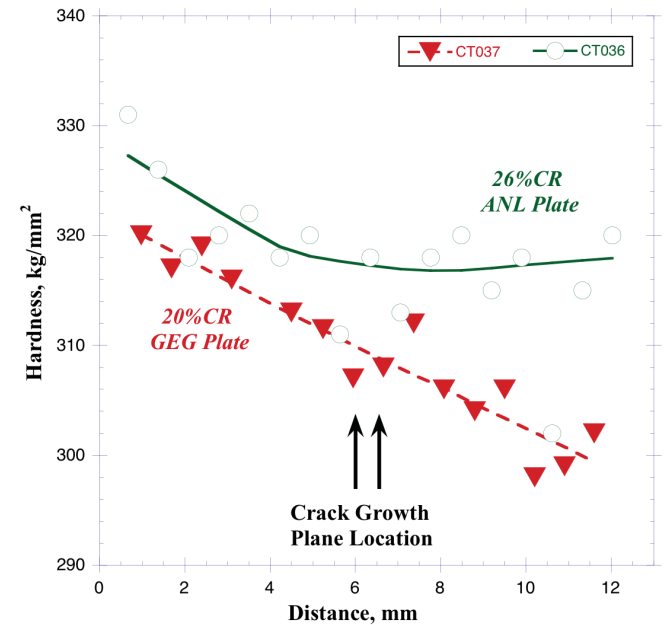
Hardness Measurements for CR Alloy 690 Plate Materials

Considerable variability in thru-thickness hardness for CR plates. Important to establish hardness at SCC crack growth plane.

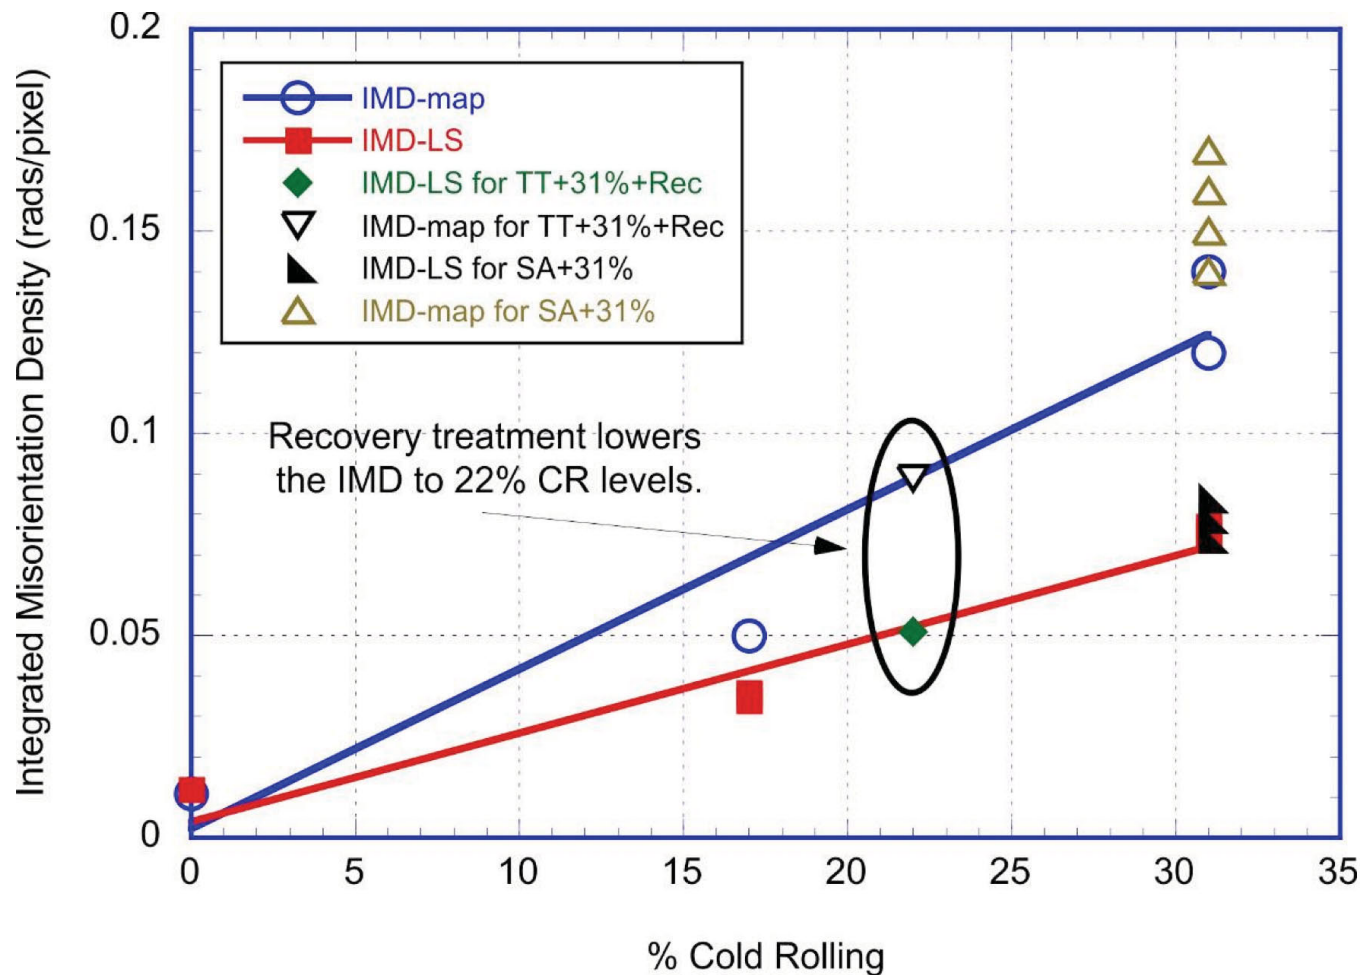
Influence of Cold Rolling on Strain Distributions for Alloy 690TT CRDM Tubing

Data from line scans and maps are included, and both indicate that a linear relationship can be inferred between the integrated misorientation density (IMD) and increasing levels of cold rolling.
