# BWRVIP Operating Experience

Chuck Wirtz, First Energy  
BWRVIP Integration Chairman  
EPRI-NRC Technical Exchange Meeting  
June 8-10, 2011

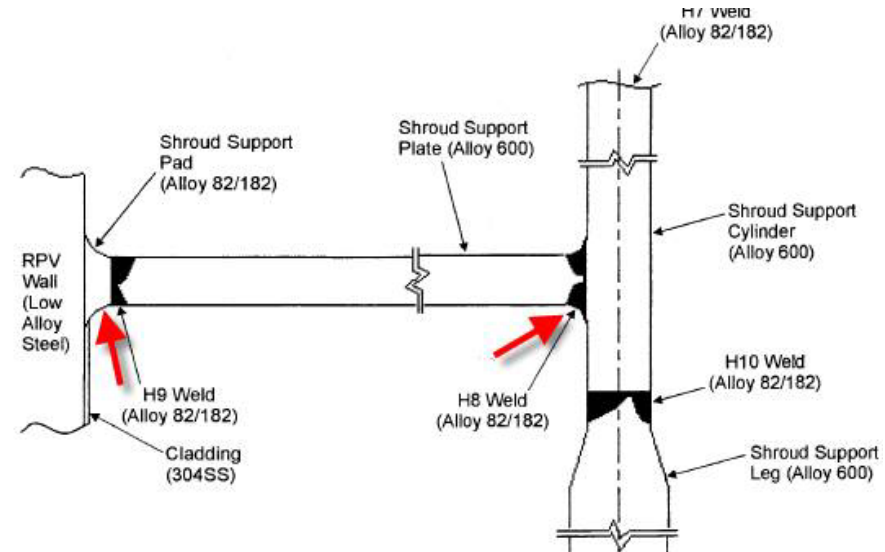
# Monticello Shroud Support

- A significant number of indications were observed extending circumferentially on both welds
  - Note that visual inspections on top side of welds were performed with no reportable indications
- Monticello concluded that indications were in the “scale layer” and not in the weld metal
- Executed a difficult cleaning process with hydrolaze and scraping

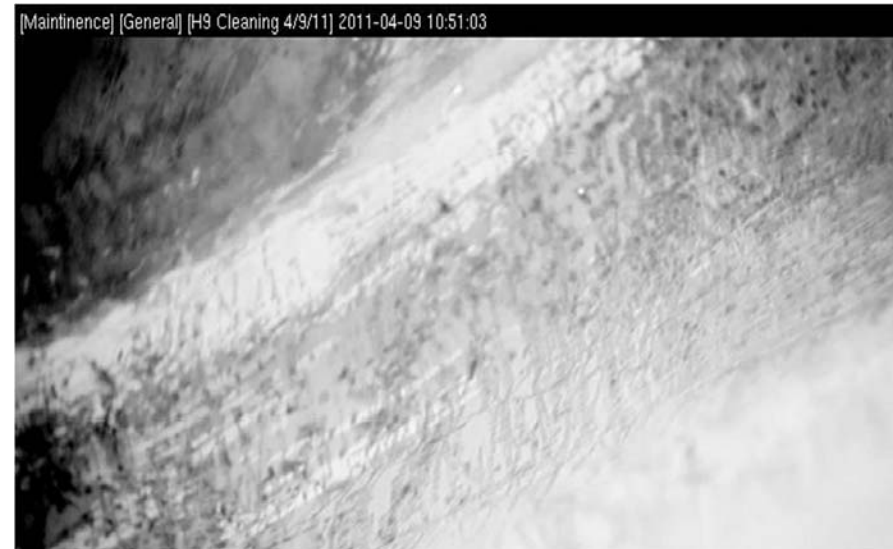
Post Cleaning

- Monticello stated that post cleaning result confirmed theory of cracking in scale - opinions of BWRVIP members are mixed
- Additional exams performed in other jet pump locations and similar indications were observed
- Performed limited UT exam from RPV OD with no reportable indications in RPV shell
- Analyses performed to demonstrate large flaw tolerance in welds

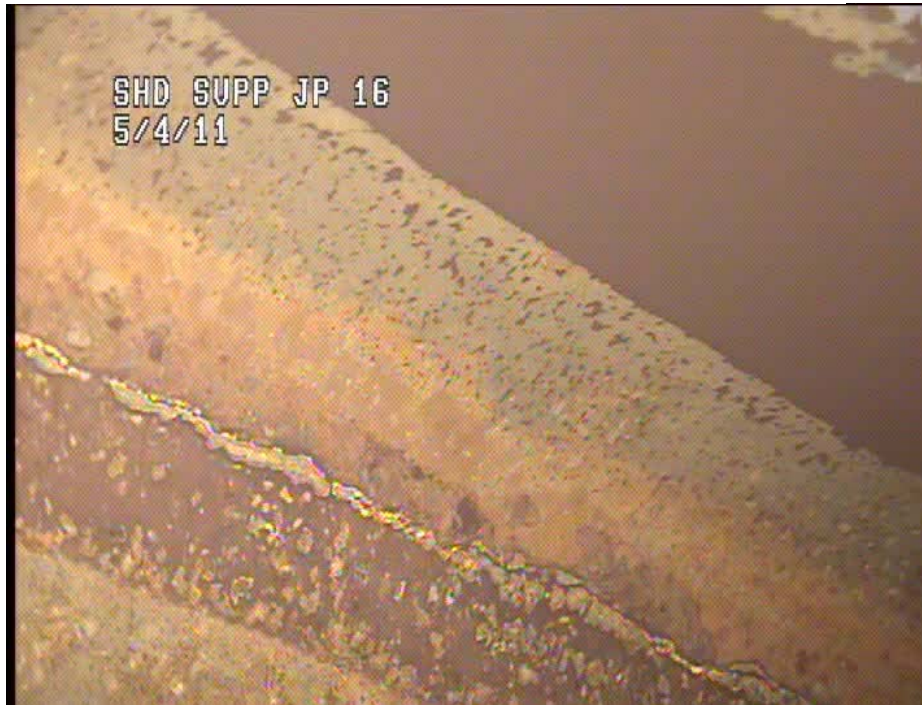
Close-up View Underside H9

- Note the linear indication-like features along the line of scale that is at the lower toe of the H9 weld (where the Inconel weld metal meets the Inconel base metal build-up).
