SUBJECT: Preliminary Assessment No. 38-EH-4949-00, Forest Glen Annex, Walter Reed Army Medical Center, Silver Spring, Maryland, 27-31 March 2000

PRELIMINARY ASSESSMENT NO. 38-EH-4949-00 FOREST GLEN ANNEX WALTER REED ARMY MEDICAL CENTER SILVER SPRING, MARYLAND 27-31 MARCH 2000

EXECUTIVE SUMMARY PRELIMINARY ASSESSMENT NO. 38-EH-4949-00 FOREST GLEN ANNEX WALTER REED ARMY MEDICAL CENTER SILVER SPRING, MARYLAND 27-31 MARCH 2000

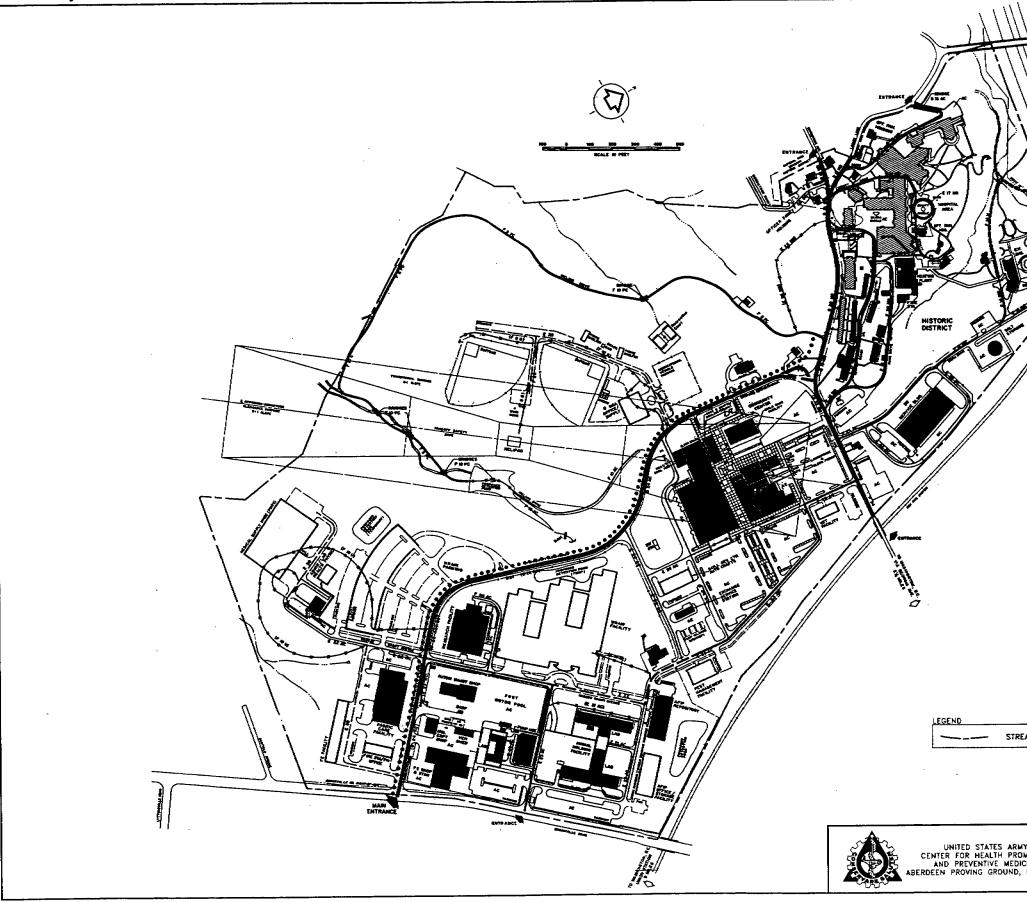
_
·				
Y		FIGU MAP OF FOREST G	RE 2. Len Annex, WRAMC.	
MOTION CINE MARYLAND			EL DINER, DINMU	
MARTLANU	GCL	38-EH-4949-00	MD/FORESTGLEN/FIG2MFGA

the general location of the Forest Glen Annex and Figure 2 is a more detailed map of the installation.

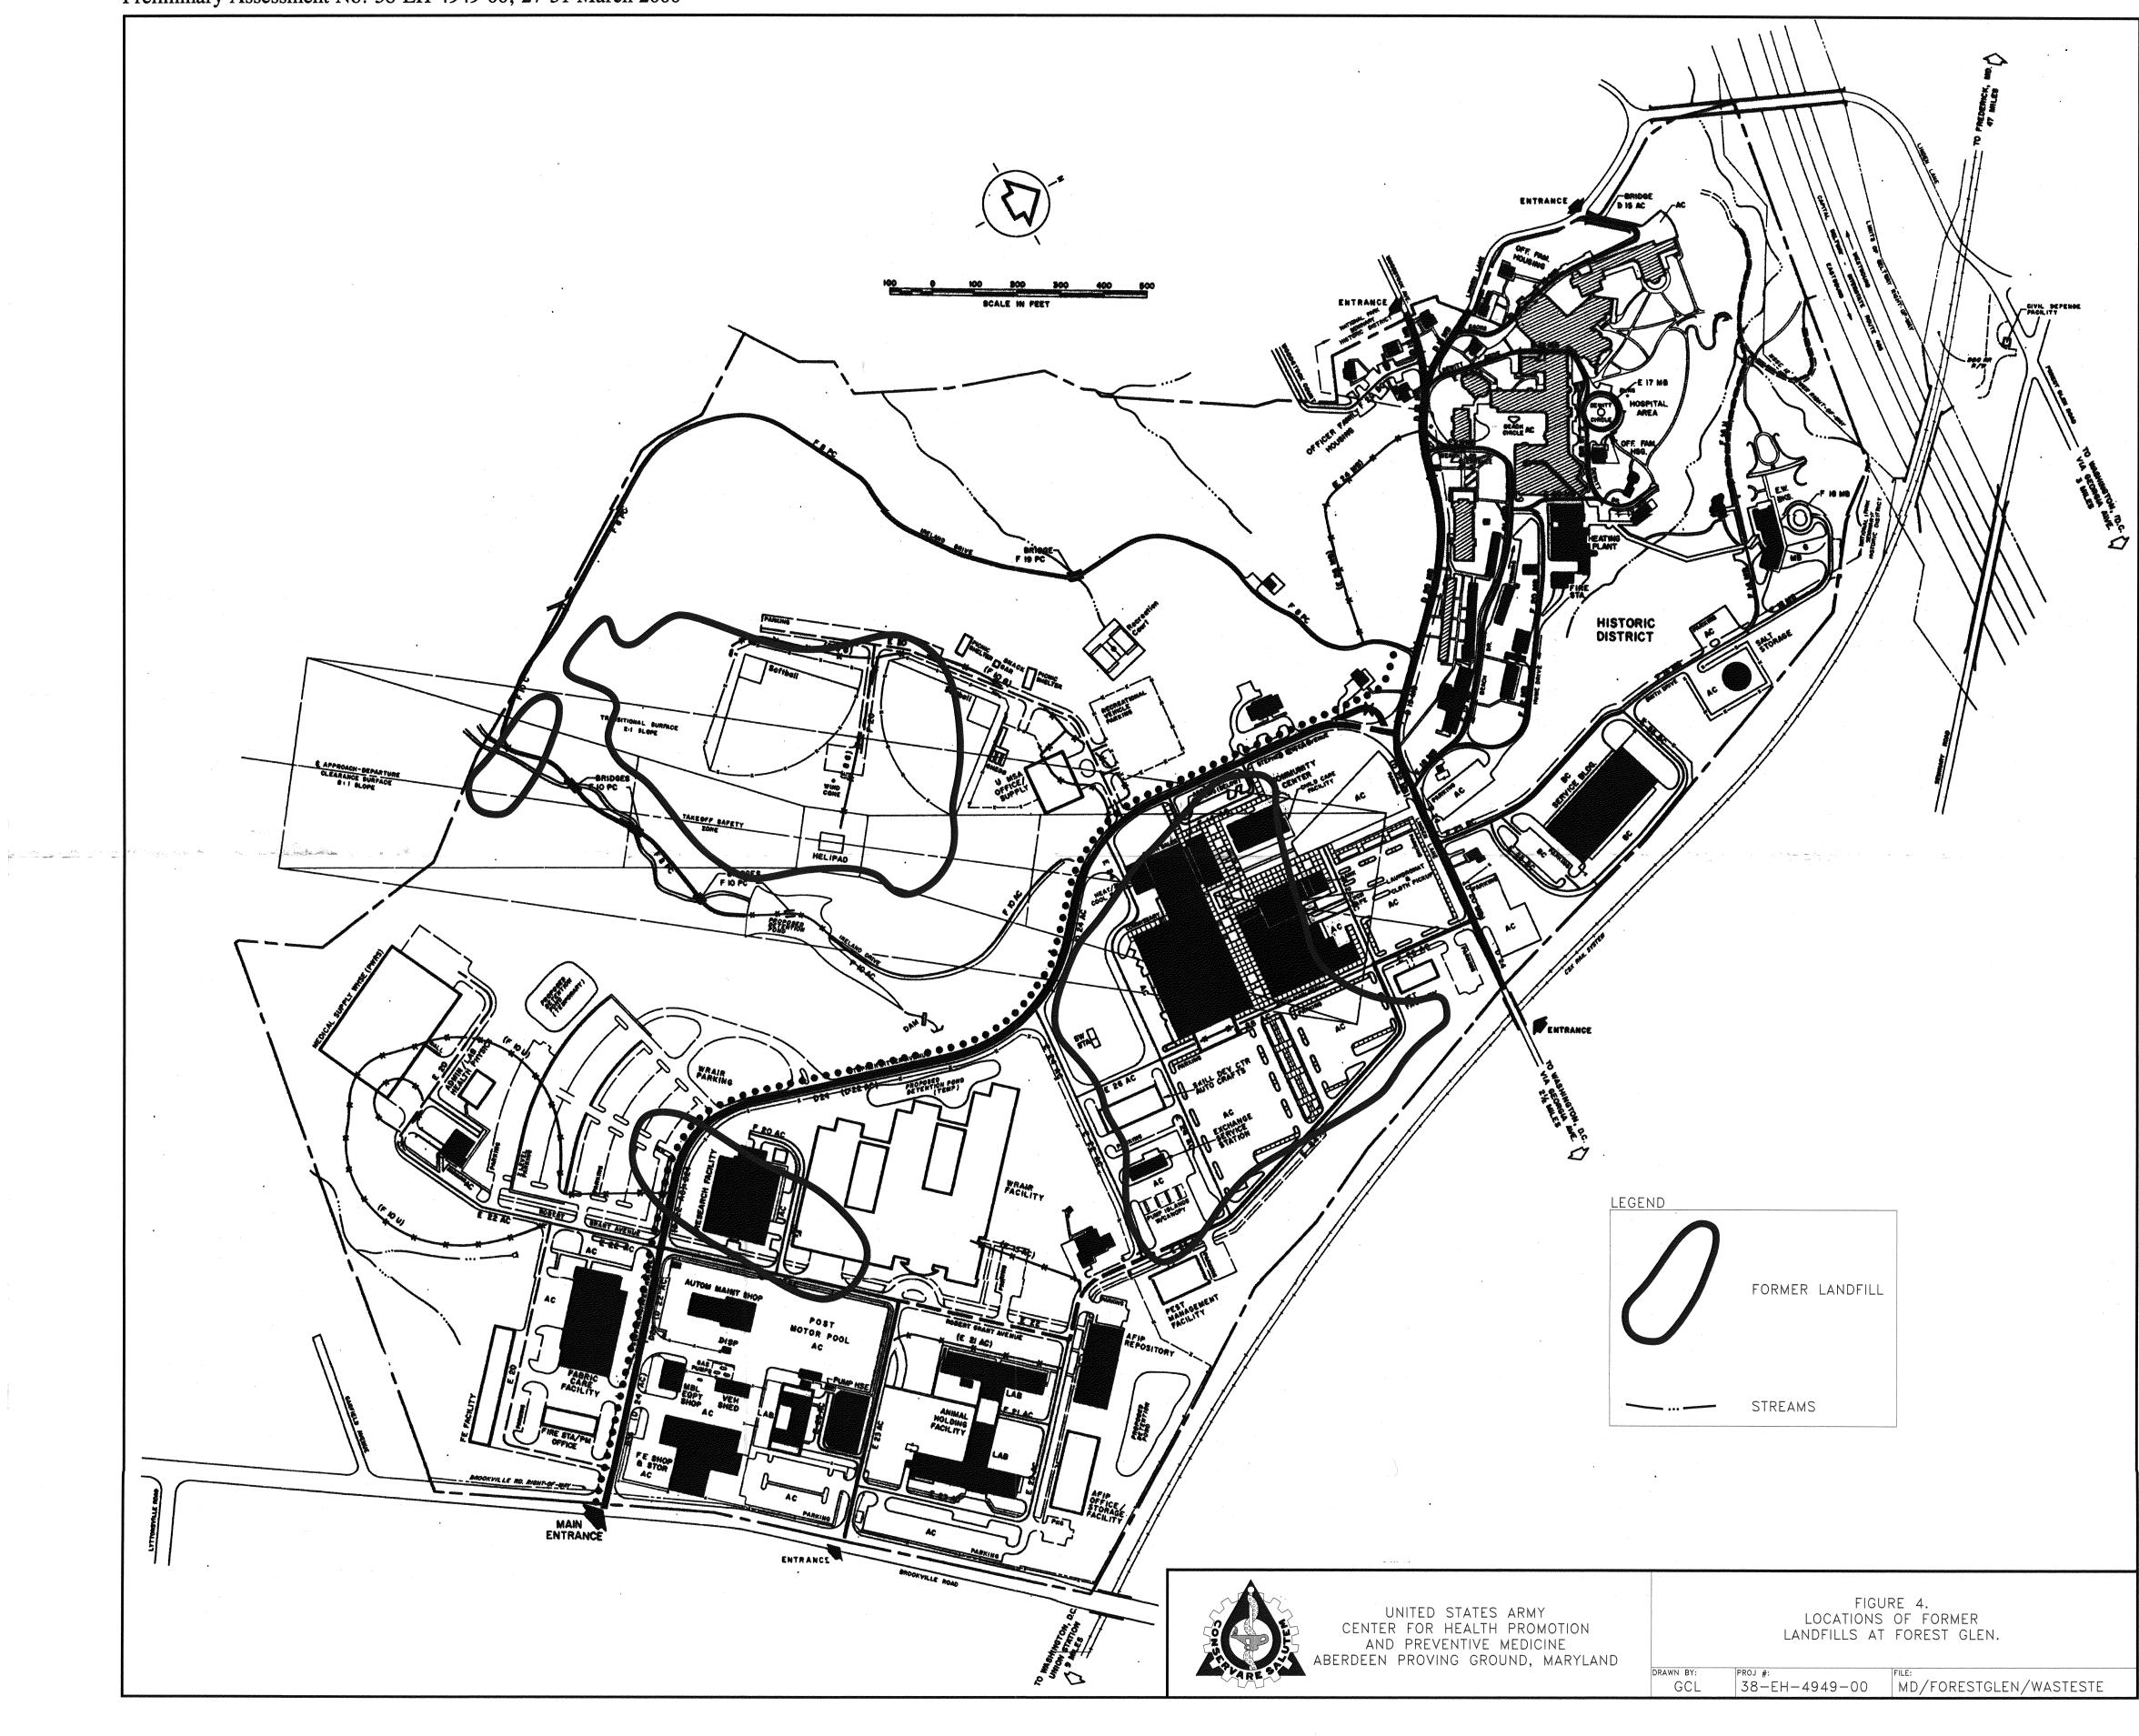
(1) Location. Three former landfills were in the central portion of the installation and one was located in the area of Building 511 and the WRAIR building (Figure 4).

(2) Site Description. No surficial evidence of the landfills was observed. Two ballfields and several buildings are on the former landfill sites.

(3) Operational History and Waste Characteristics. Wastes buried in the landfills include construction debris, medical waste, incinerator ash, household waste, and office waste. The landfills were operated from 1942 until 1966 (reference 7). An undated aerial photo showed active dumping in the landfill where the ballfields are. Medical wastes were uncovered during excavation in the parking lot southwest of the WRAIR building.

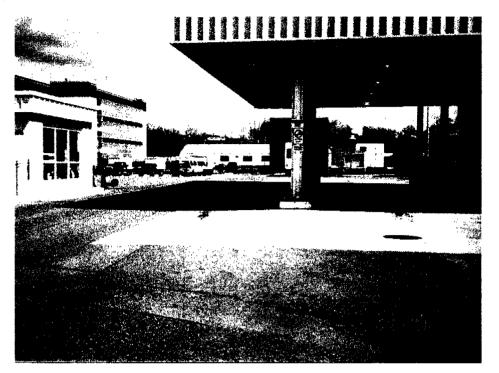
Photograph 5. Fuel pump by Building 604 in the motor pool area. Facing north.

(1) Location. Underground storage tanks (USTs) were by Buildings 505 and 603 (fuel pumps associated with the motor pool in Building 605).

(3) Operational History and Waste Characteristics. Fourteen USTs had been in the area between Building 505 and the motor pool area in 1989. Three tanks were on the southwest end of Building 500. Two of these held 50,000 gallons of gasoline and one held 12,000 gallons of diesel fuel. Two 5,000-gallon gasoline USTs and one 5,000-gallon diesel UST were next to Building 605 (reference 8). Based on the chemical results, it was determined that the diesel tank by Building 500 had leaked and the gasoline tank by Building 605 had leaked. No evidence of other contamination was detected. All of these tanks have been removed. The USTs by Building 605 were replaced in 1994 by a 10,000-gallon gasoline UST and a 10,000-gallon diesel UST. A pump and treat system is being operated near Building 505. The system consists of an oil/water separator followed by an air stripper then a liquid phase carbon filter. Free product is still being removed.

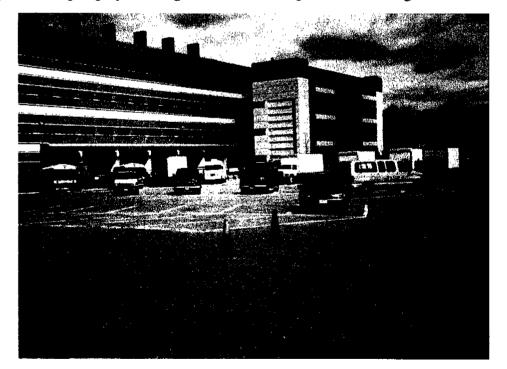
Photograph 6. Walter Reed Army Institute of Research from the motor pool. Fuel pumps are to the right. Medical waste was encountered near the buses to the left.

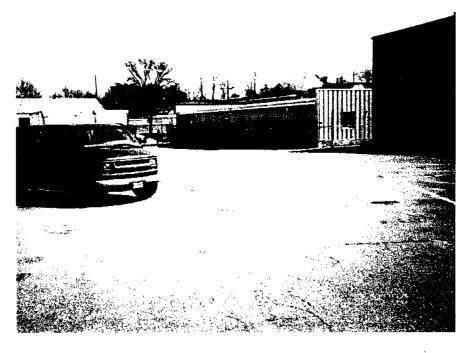
Photograph 7. Motor pool facing east. Pump and treat system is behind tan building.

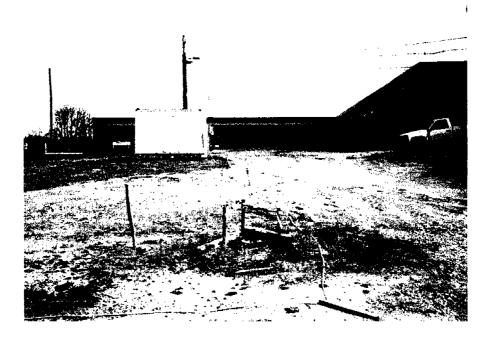
Photograph 8. Pump and treat system is in white shed. Facing east.

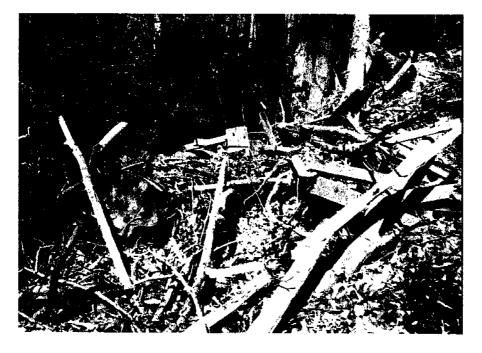
e. Some waste and construction debris were noted at the leaf pile by the ballfields.

Photograph 10. Waste in wooded area west of ballfield, on edge of a cleared area. Waste consisted of metal, wood, and construction debris.

c. Remove waste and construction debris from the leaf pile near the ballfields.

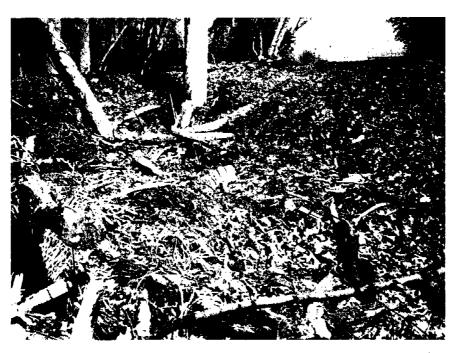
Photograph 11. West of ballfield, in wooded area. Facing cleared area.
