4 SURFACE CRACK CHARACTERIZATION

5 REVIEW OF CRACKING MECHANISMS IN GROUT MONOLITHS AND INTERPRETATION OF CRACKS OBSERVED IN GROUT SPECIMENS

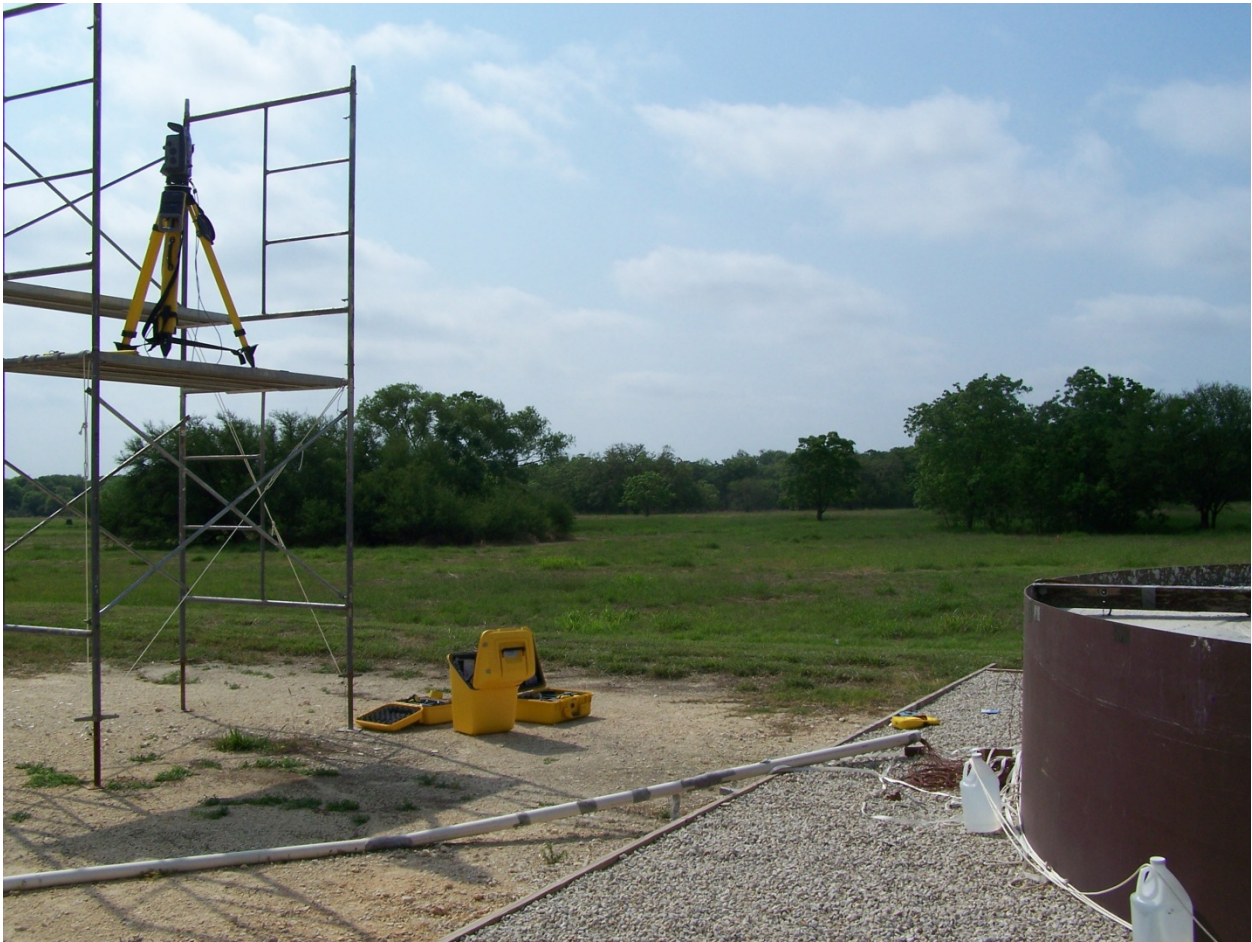
Walter, et al., (2010, Figure 3-10) first measured the topography of the grout surface with a laser scanner mounted on a ground-based tripod, such that it scanned the grout surface at a shallow angle and from a single position. The center of the grout monolith was approximated to be 20 cm [8 in] higher than the lowest point in the northeast quadrant of the tank. The initial laser scanner topographic dataset was improved upon by installing a temporary scaffold (Figure 4-1) on both the east and west ends of the tank, in line with the angle-iron crossbeam that joins the tank halves together (cf. Walter, et al., 2010), such that topographic laser scanner data could be collected from two high-angle perspectives in 180° opposition to minimize blind spots caused by the tank wall. These topographic data were brought into an ArcGIS® database for analysis along with carefully mapped crack aperture distributions for all visible surface cracks.

Figure 4-1. A Scaffold-Mounted Laser Scanner at the East End of the Intermediate-Scale Grout Monolith Was Used To Measure Surface Topography

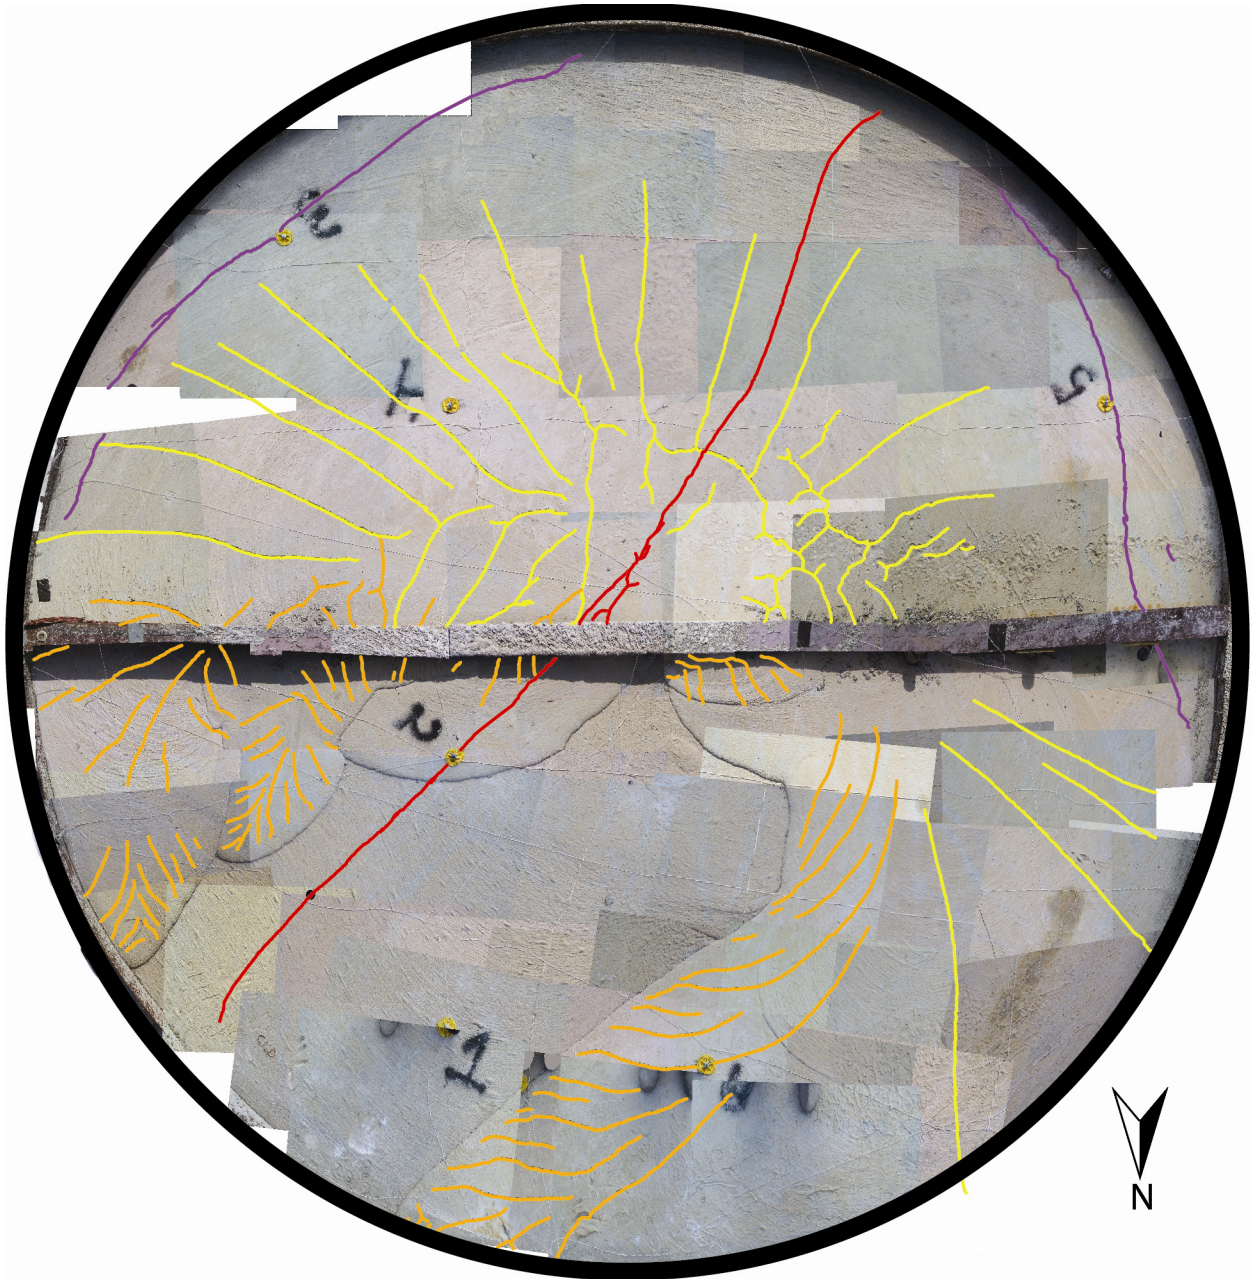
SwRI staff further characterized the 218 surface cracks on the monolith by mapping their locations (Figure 4-2) and apertures (Figure 4-3). Cracks are distributed in fairly distinct sets, including (i) radial to the monolith, (ii) roughly perpendicular to lobe flow fronts, (iii) two *en echelon* bisecting cracks, and (iv) a few cracks/crack families concentric to the monolith edge (Figure 4-2). Cracks that are roughly perpendicular to lobe flow fronts (and thus are roughly orthogonal to surface ripples within the grout flow lobe) commonly terminate between 0 and 10 cm [0 and 25 in] behind the front of the lobe, but occasionally penetrate though the front of a lobe into the underlying grout layer. As such cracks approach the tank liner wall, they are observed to be oriented roughly perpendicular to the wall, similar to the set of radial cracks (Figure 4-2). Aperture varied from <0.5 to 8 mm [<0.02 to 0.31 in], with variation in aperture along crack length (Figure 4-3). Aperture values of at least 4 mm [0.16 in] were found in each quadrant of the monolith.

Figure 4-2. Photomosaic of the 6.1-m [20-ft]-Diameter Intermediate-Scale Grout Monolith With Crack Distribution Patterns Traced and Coreholes 1–6 Shown. Yellow Cracks Belong to the Set That Is Radial to the Monolith, Orange Cracks Belong to the Set That Is Perpendicular to Lobe Flow, Red Cracks Are Two Major *En Echelon* and Several Related Minor Cracks, and Purple Cracks/Crack Families Developed Late Through Coreholes 3 and 5 Concentric to the Monolith Edge.

Two vertical-to-subvertical crack families developed late and tangential to the coreholes from which Core 3 and Core 5 were extracted (Figure 4-2). The throughgoing vertical crack that developed tangential to Corehole 3 was purposefully intersected by Overcore 8 [Figures 3-5(b) and 3-6(b),(d)]. Other cracks bifurcated off the Corehole 3 crack in response to wet coring of Corehole 8. The subvertical crack family that developed tangential to Corehole 5 consists of a long series of *en echelon* cracks (Figure 4-2), one of which is exposed in cross section in the sidewall of the Section One destructive evaluation grid (Figure 3-8). These late-developed cracks/crack families, which were not present during permeability testing of Coreholes 3 and 5, are attributed to dry-coring-induced mechanical stresses, perhaps combined with diurnal tank expansion, contraction, and related differential settlement-induced stresses. The semi-parallel-to-tank-wall orientation of the crack that developed tangential to Corehole 3, combined with its location relative to the angle-iron crossbar, suggests that the formation of this crack is also potentially linked to diurnal expansion and contraction effects. Propagation of and bifurcated splitting off the Corehole 5 crack family was also observed when the Section One wall was removed for grout bonding evaluation (Figures 3-8 and 3-9). The Corehole 5 crack is clearly visible within Corehole 5 and should be further examined borescopically.

Staff further characterized the 218 cracks exposed on the surface of the intermediate-scale grout monolith by mapping their locations and variable apertures. Cracks are distributed in fairly distinct sets, including (i) radial to the monolith, (ii) roughly perpendicular to lobe flow fronts, (iii) two *en echelon* cracks that nearly bisect the monolith into equal halves, and (iv) a few cracks/crack families concentric to the monolith edge. Crack aperture varied from <0.5 to 8 mm

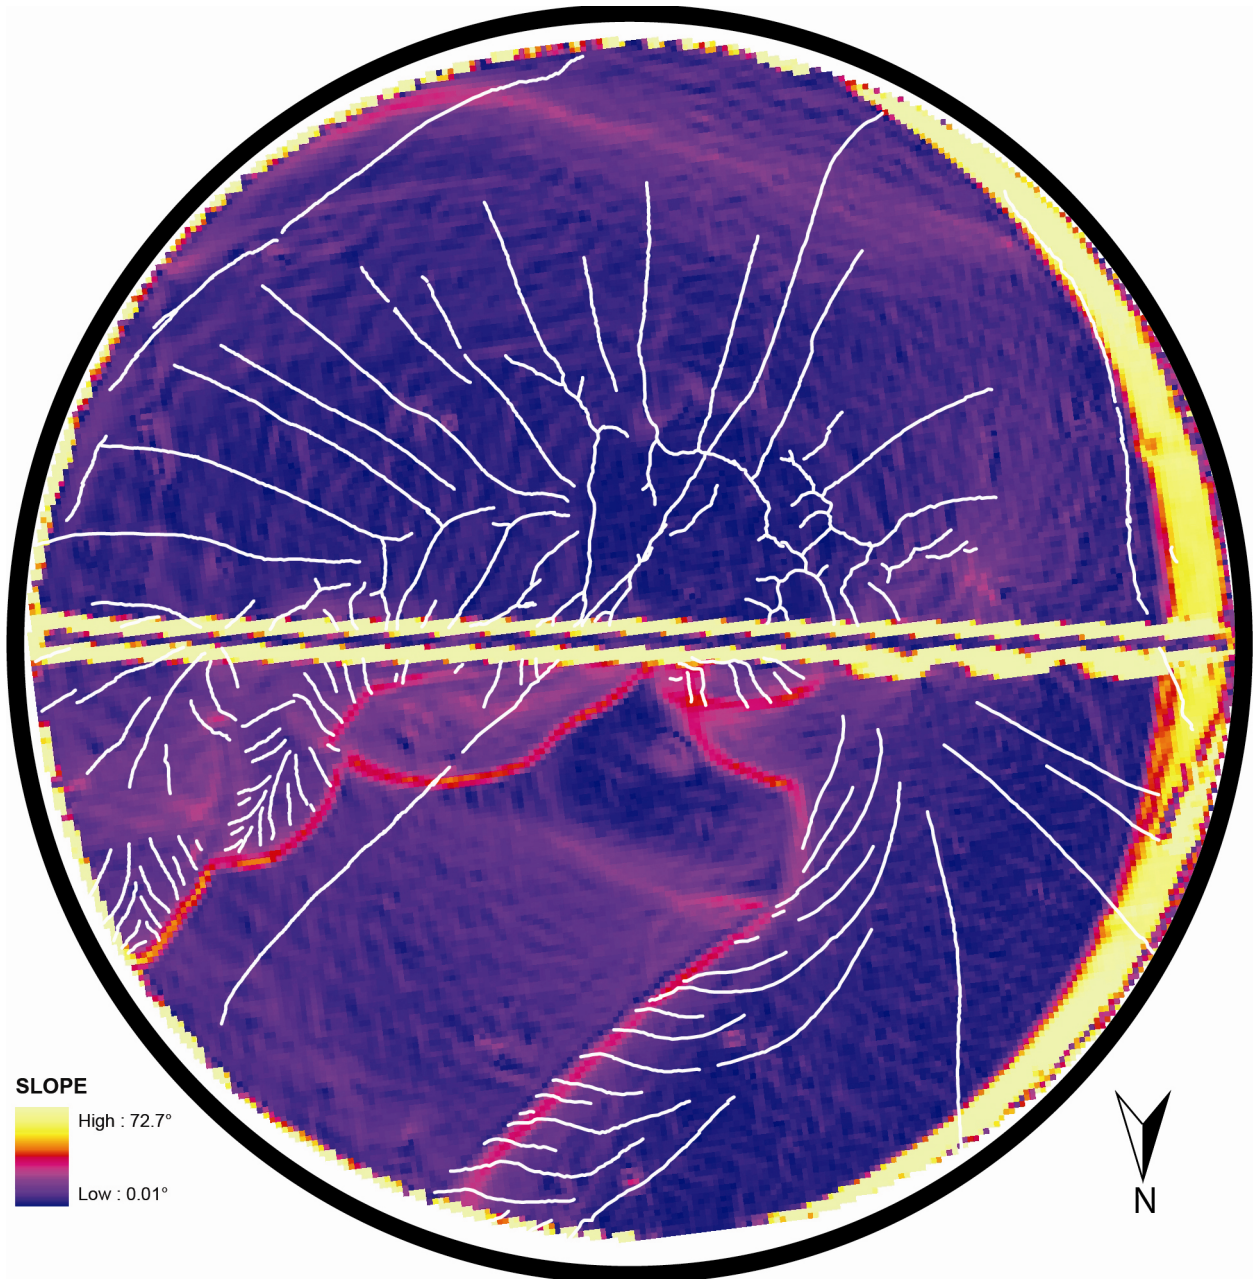
the topography data show less correlation to crack distribution (Figure 4-6). Many cracks terminate at or near the edge of a mounded grout flow lobe.

Figure 4-6. A Slope Map of the 6.1-m [20-ft]-Diameter Intermediate-Scale Grout Monolith With Crack Distribution Patterns in White. Steep Slopes Are Represented by Reds to Yellows; Shallow Slopes Are Represented by Blues to Purples. Bright White and Yellow Values Are Artifacts Caused by the Vertical Tank Liner Walls and the Crossbeam.
