WCAP-14686

Laser Welded Repair of Hybrid Expansion Joint Sleeves for Kewaunee Nuclear Power Plant

August 1996

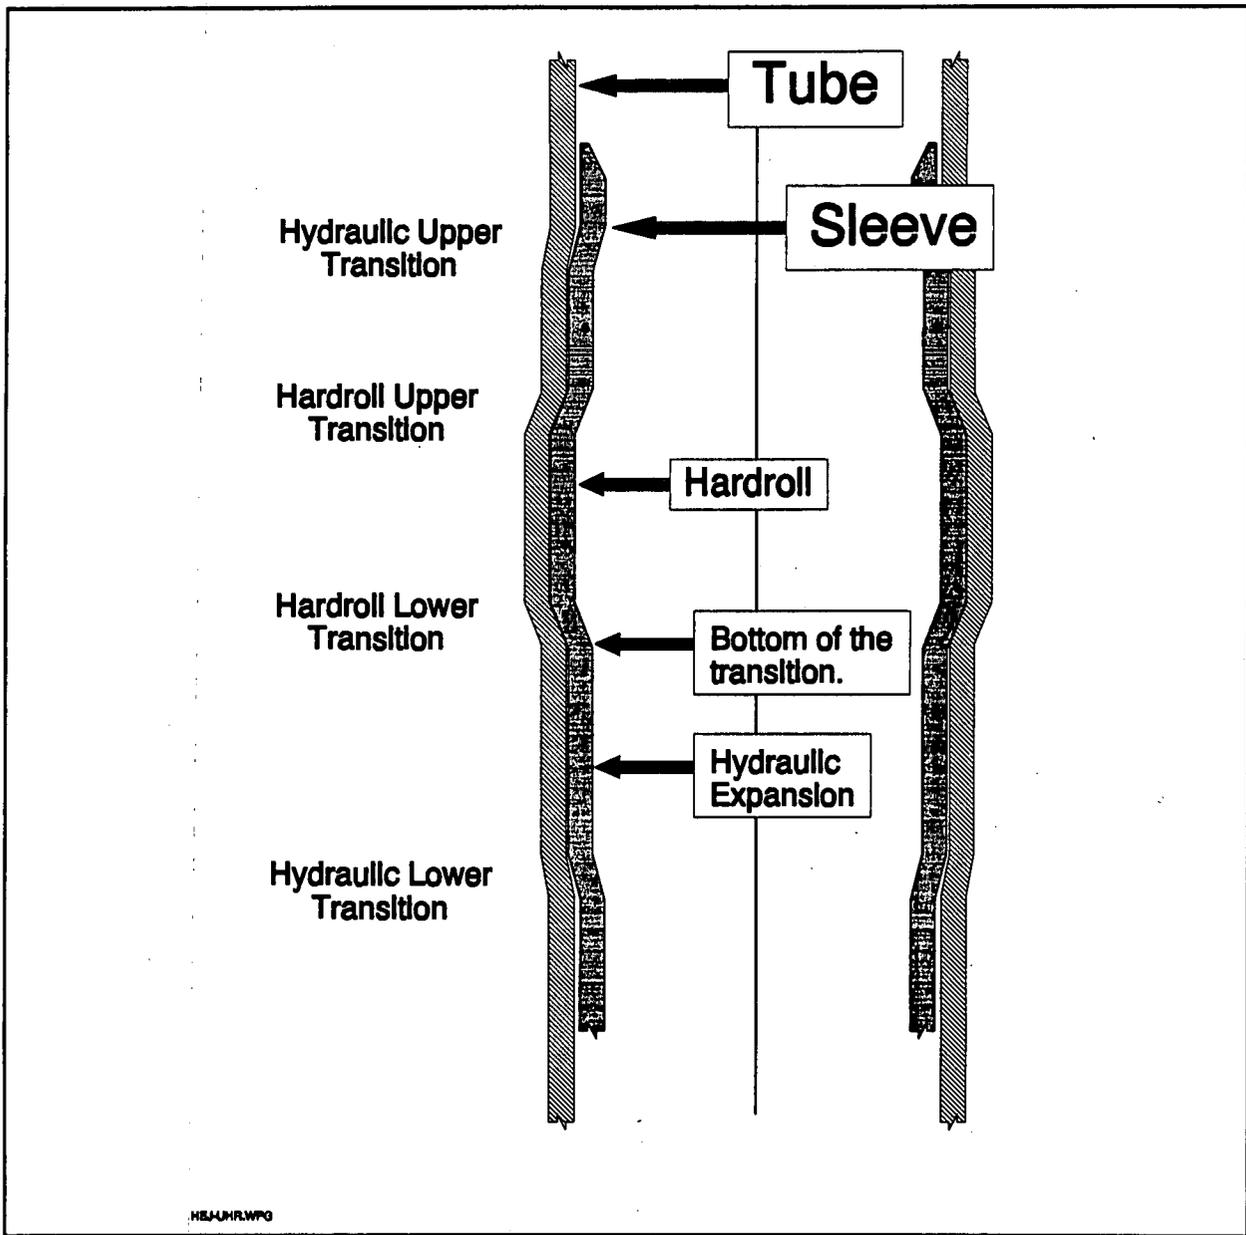
Figure 1-1
Definitions of HEJ Upper Expansion Transitions

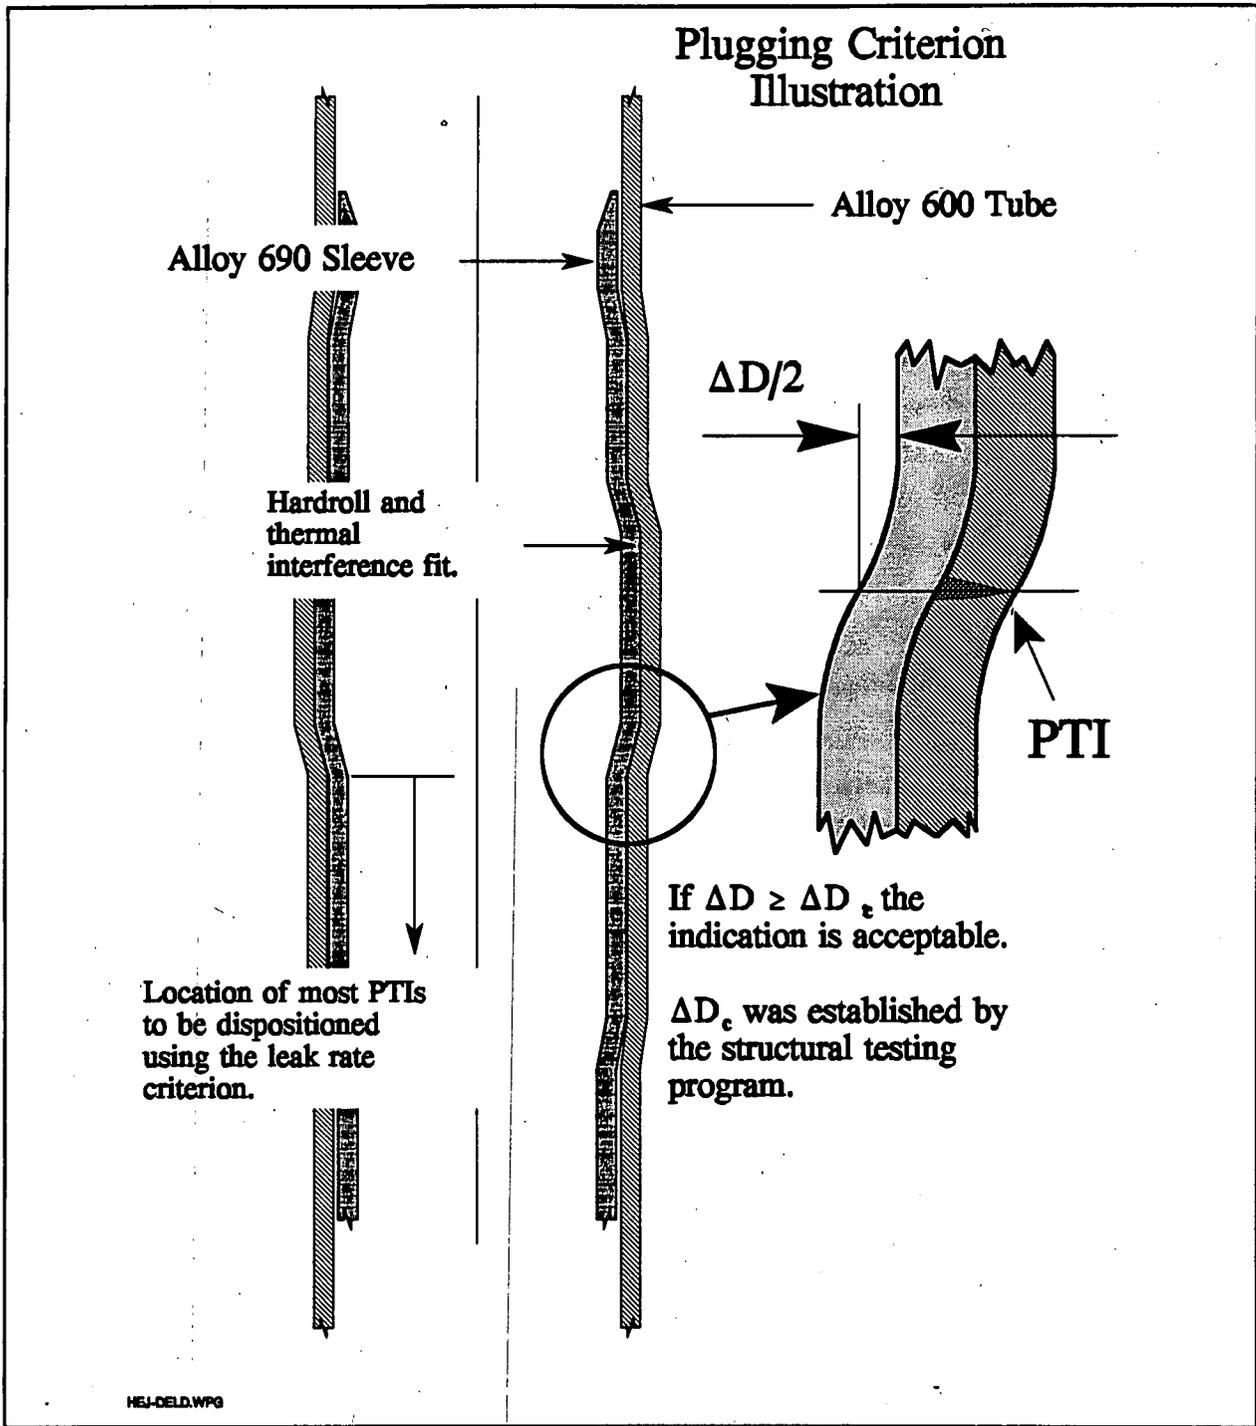
Figure 1-3
 ΔD Criterion for Repair of HEJ Indications

The LWR technique is intended to repair HEJ sleeved tubes with parent tube indications that do not satisfy the criteria discussed in Reference 1-5, "HEJ Sleeved Tube Structural Integrity Criteria: ' ΔD ' Diametral Interference at PTIs". The ΔD criterion supports the conclusion that with a minimum diametral interference of 0.003" (plus an allowance for NDE uncertainty) between the maximum sleeve ID in the roll expansion transition and the sleeve ID adjacent to the parent tube indication (PTI), structural integrity will be provided for all plant conditions. In addition, leakage resistance will be provided with the ΔD criterion such that offsite doses following a postulated main steam line break outside of containment will remain within 10% of the Part 100 guidelines when all leakage sources are considered. Figure 1-3 illustrates the ΔD criterion for Kewaunee HEJ sleeves.

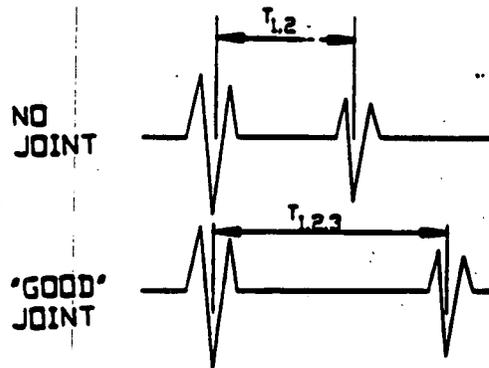
Figure 7-1

IDEALIZED WAVEFORMS

Ultrasonic Inspection of Welded Sleeve Joint
