Westinghouse Energy Systems

KEWAUNEE STEAM GENERATOR
TUBE PLUGGING CRITERIA FOR
ODSCC AT TUBE SUPPORT PLATES

JANUARY, 1993

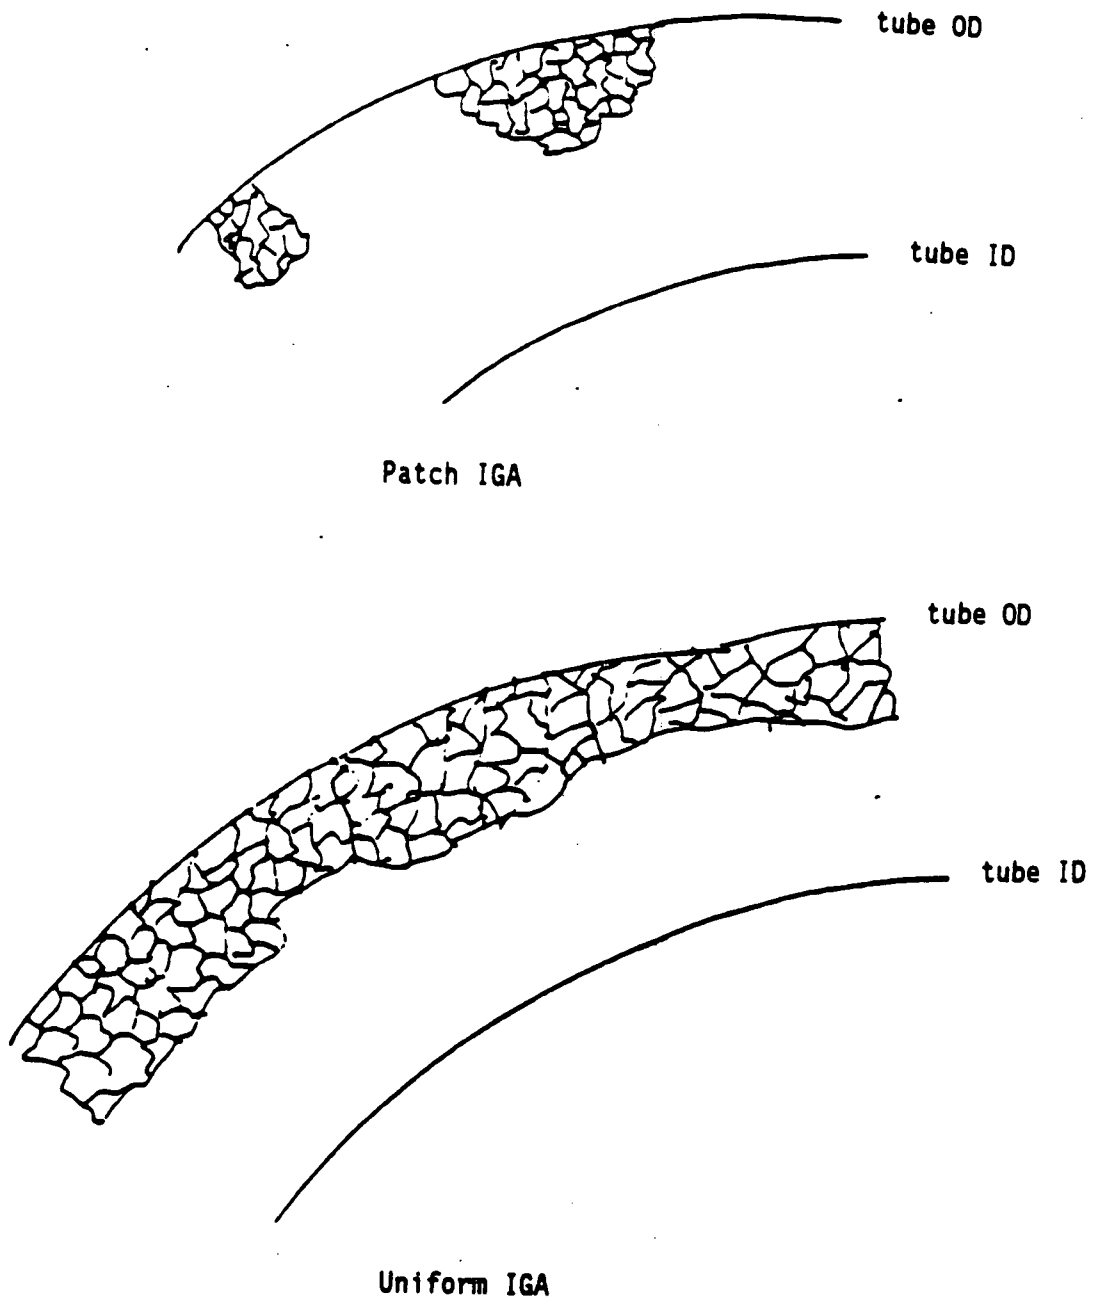
Figure 4-1 Patch and uniform IGA morphology as observed in a transverse tube section. (A similar observation would be made from a longitudinal section.)

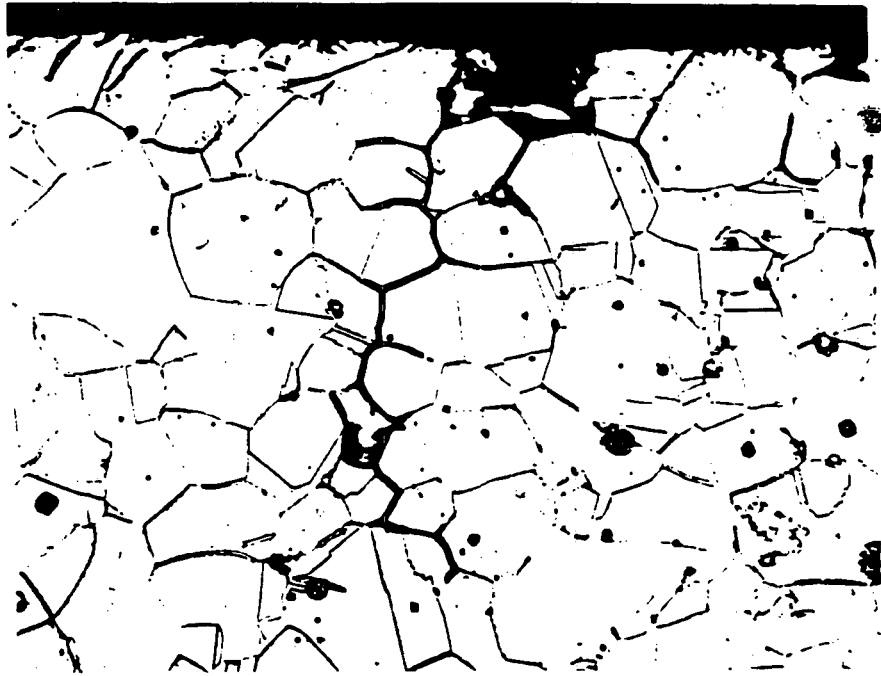
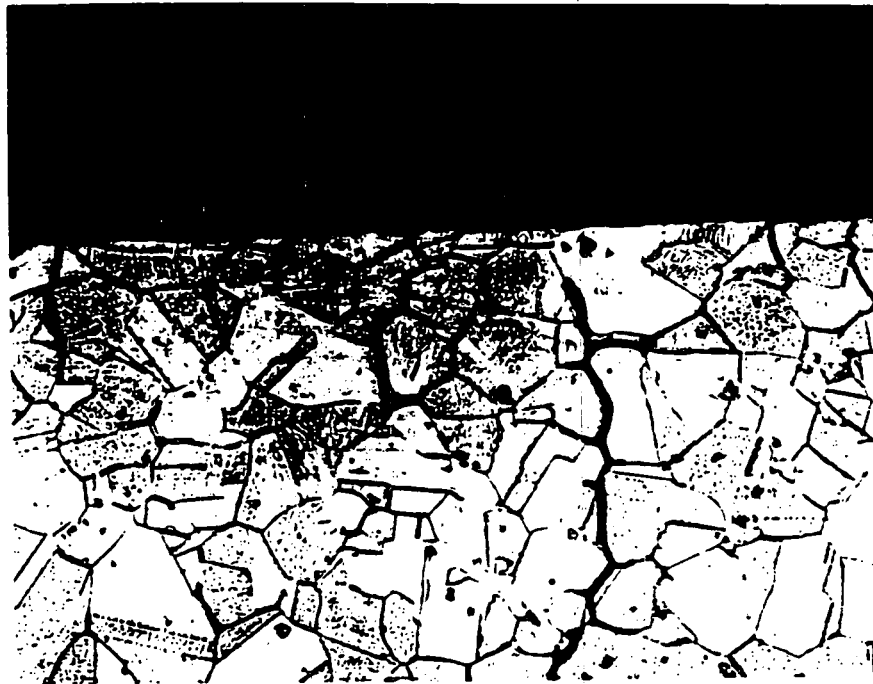
Figure 4-5 Tube R21-C31 from Plant D-1 , first support plate region, transverse OD metallography, Mag. 500X.

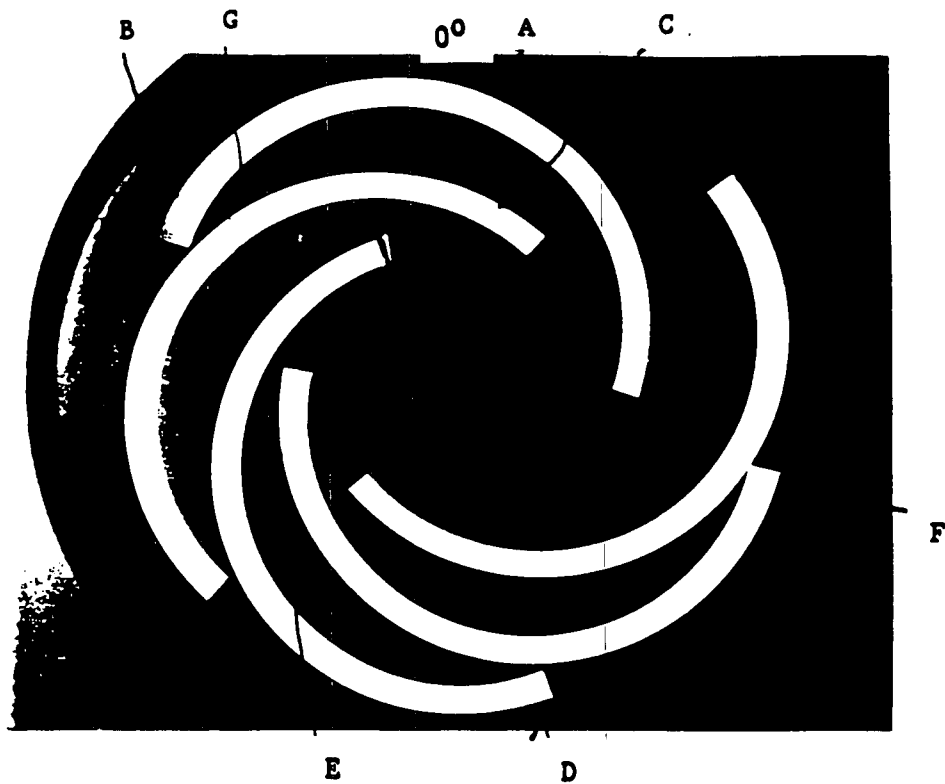
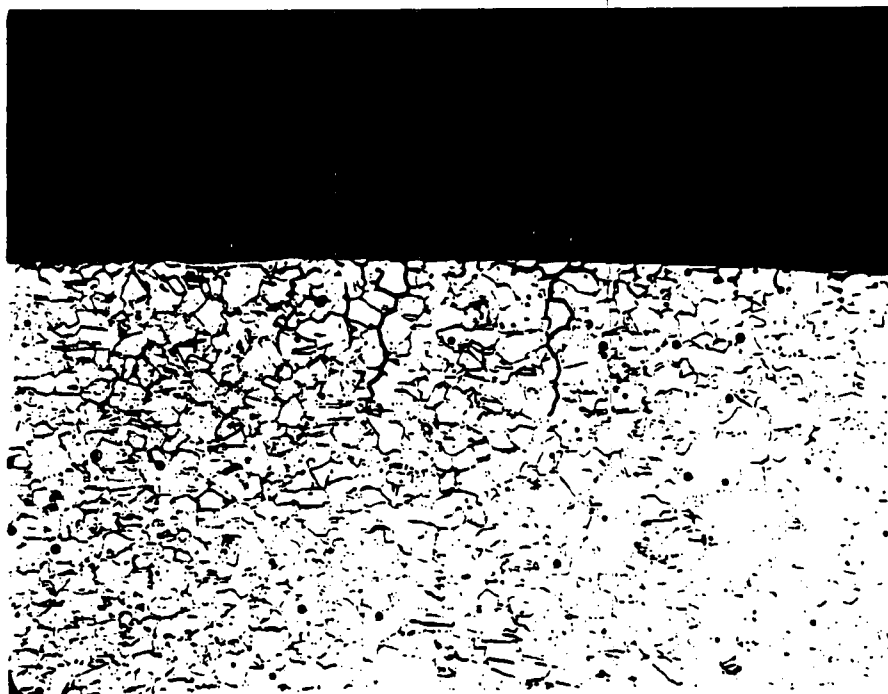
Figure 4-11 Tube R19-C55 from Plant D-2, first support plate region, transverse OD metallography (bottom photo is one of many areas with observed cracking on a series of transverse met. sections different than those shown in Figures 4-9 and 4-10), Mag. 100X (bottom photo).

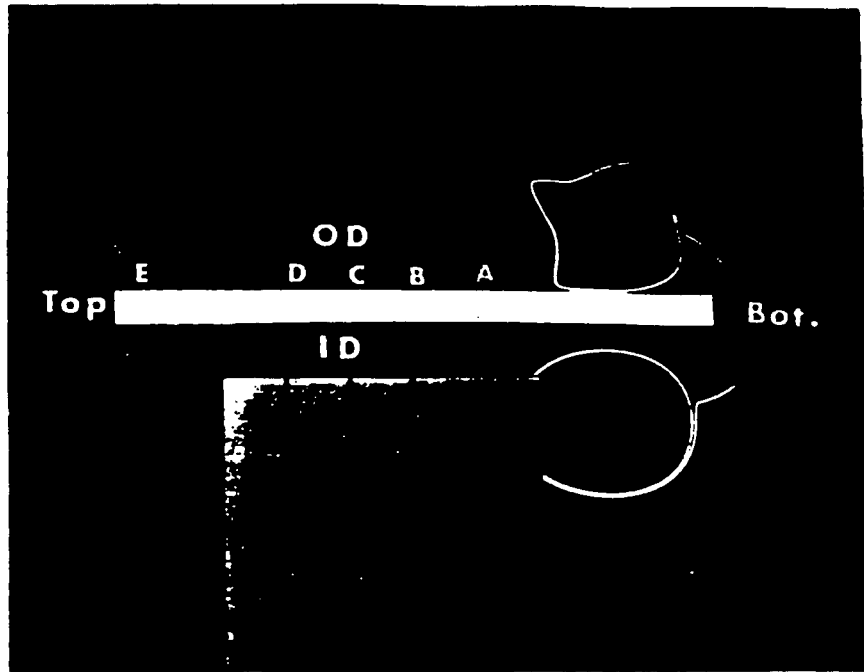
Figure 4-12 Tube R19-C55 from Plant D-2, first support plate region, longitudinal OD metallography, Mag. 100X (bottom photo).

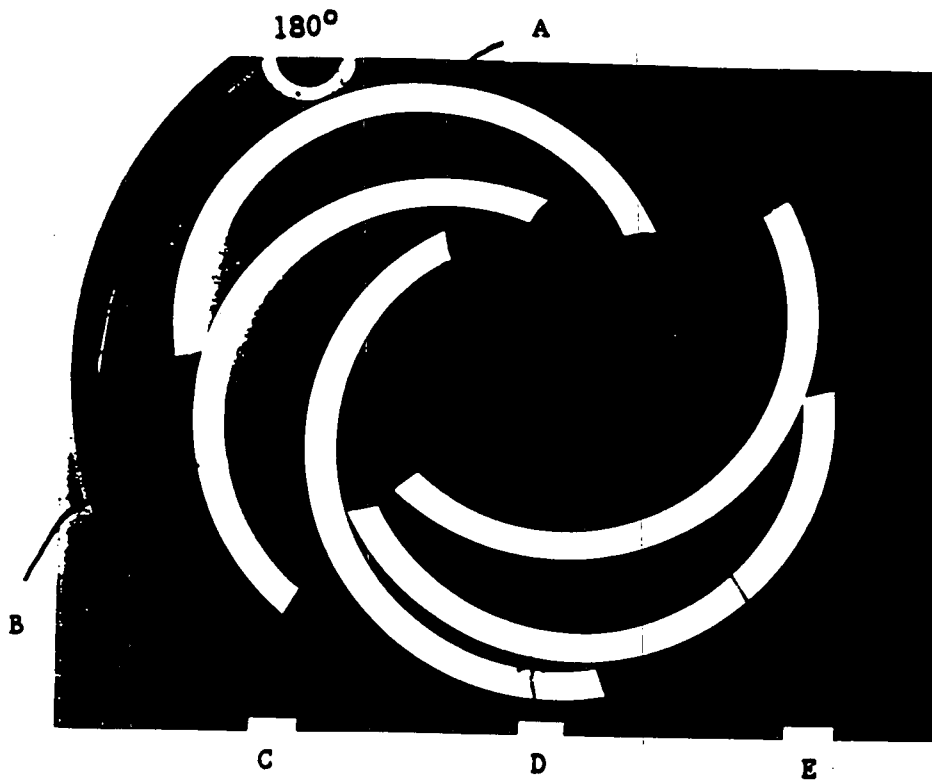
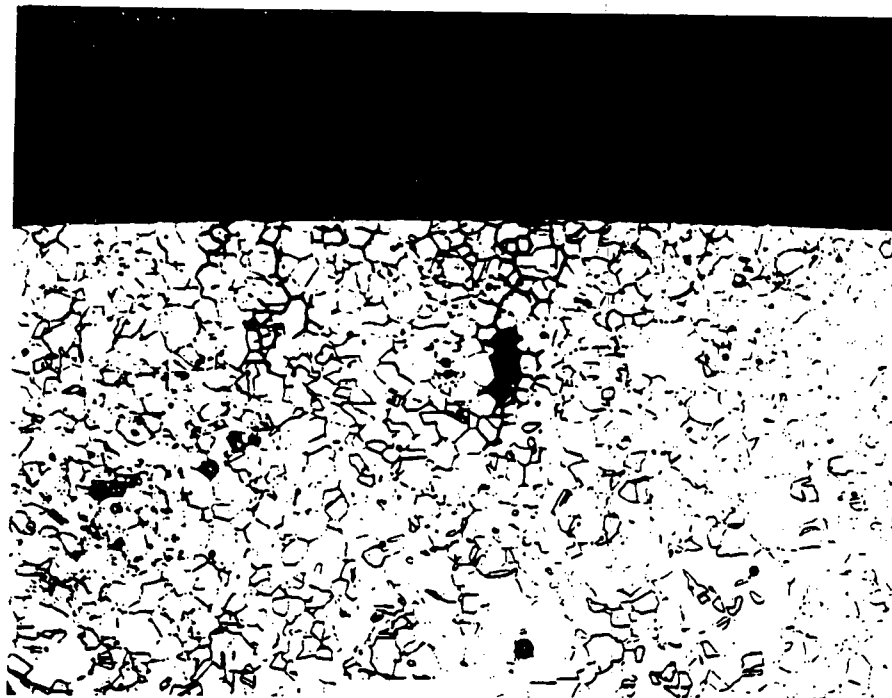
Figure 4-15 Tube R19-C55 from Plant D-2, first support plate region, transverse OD metallography (bottom photo is one of many areas with observed cracking on a series of transverse met. sections different than those shown in Figures 4-13 and 4-14), Mag. 100X (bottom photo).

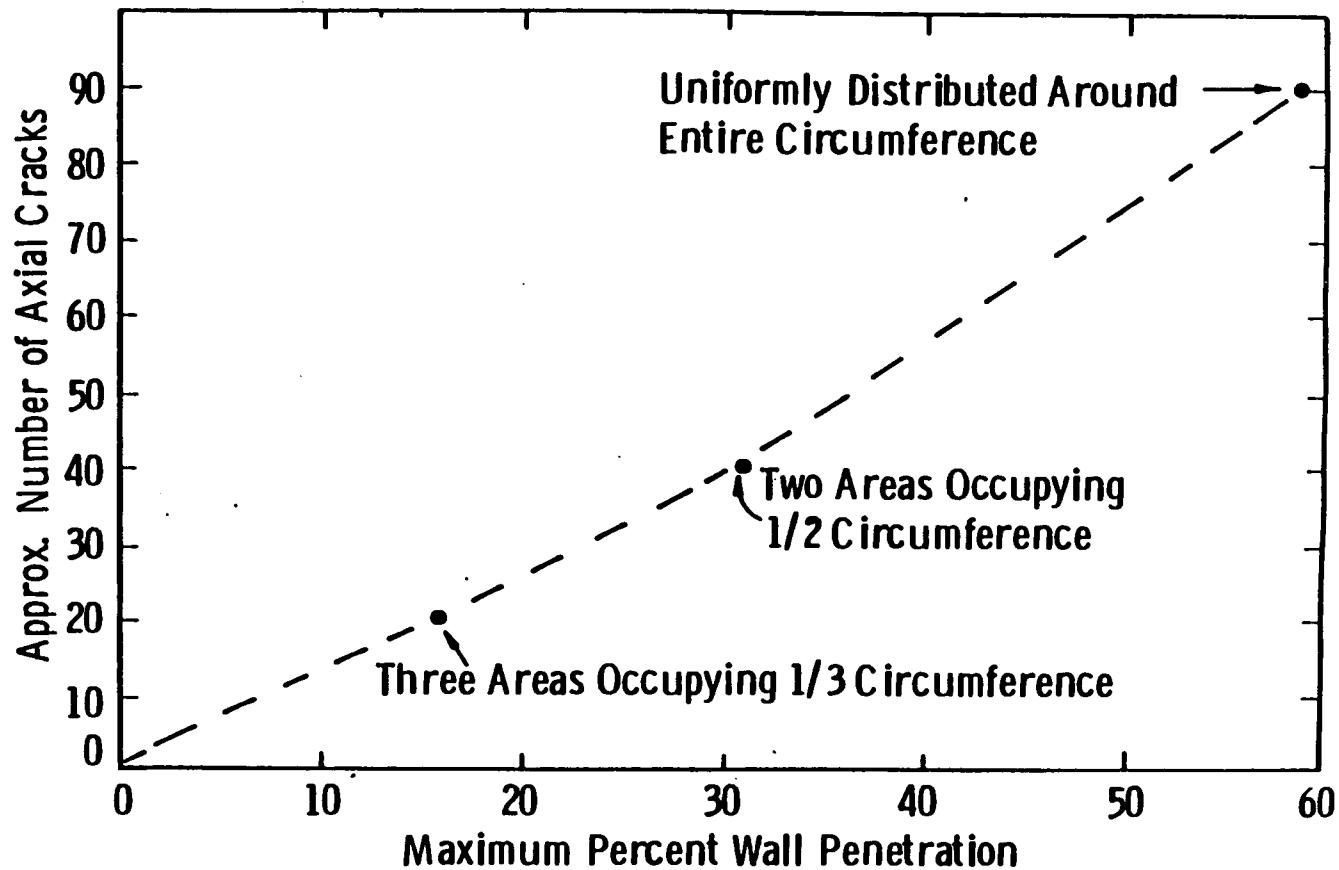
Figure 4-18 Plot of the number of cracks in a transverse plane versus maximum wall penetration for the first, second and third support plate region of tube R7-C38 from Plant D-2.

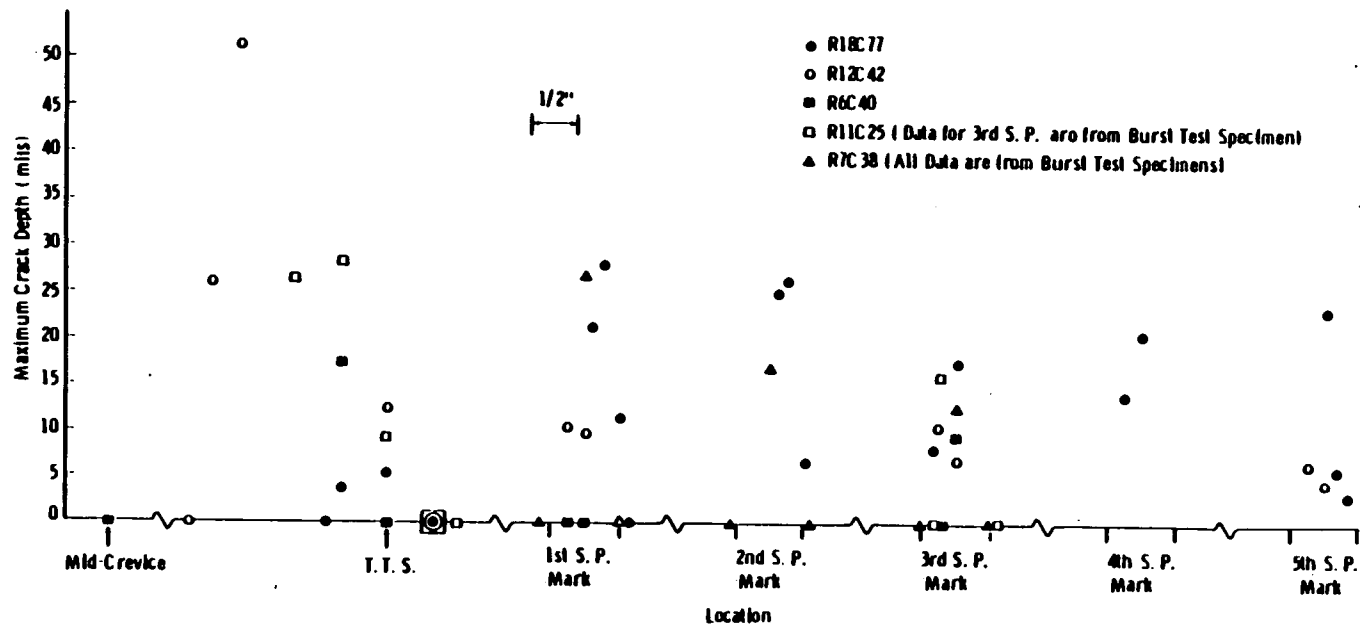
Figure 4-19 Maximum crack depth versus support plate elevation for steam generator tubes examined from Plant D-2.

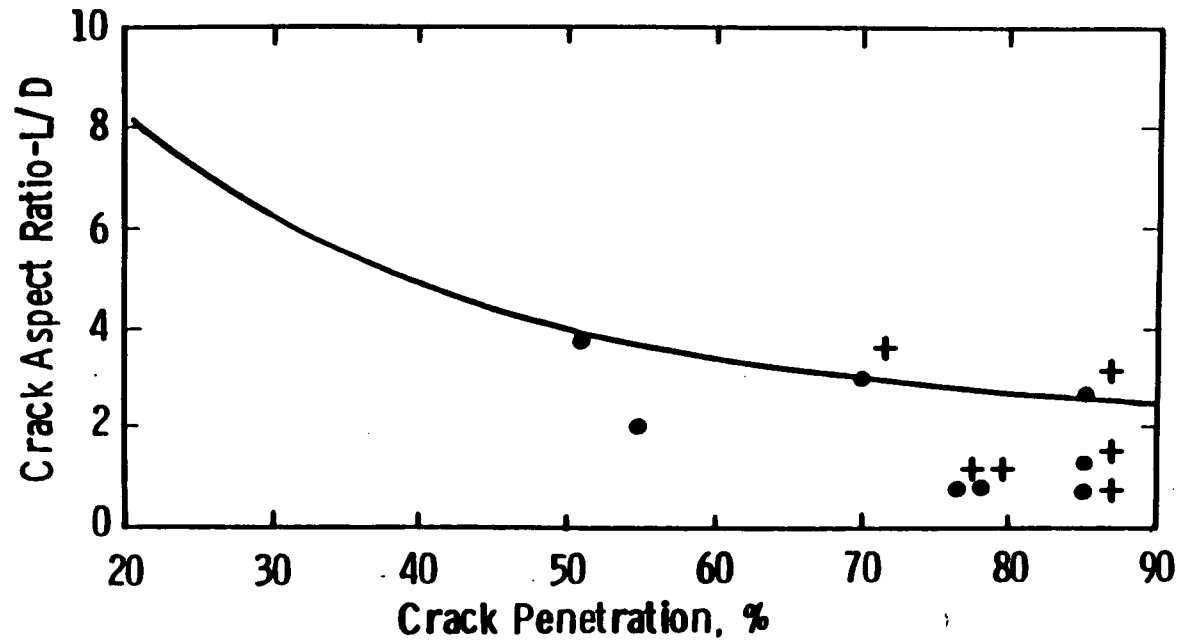
Figure 4-20 Plot of crack aspect ratios versus crack depth as measured in Plant D-2 tube R12-C42.

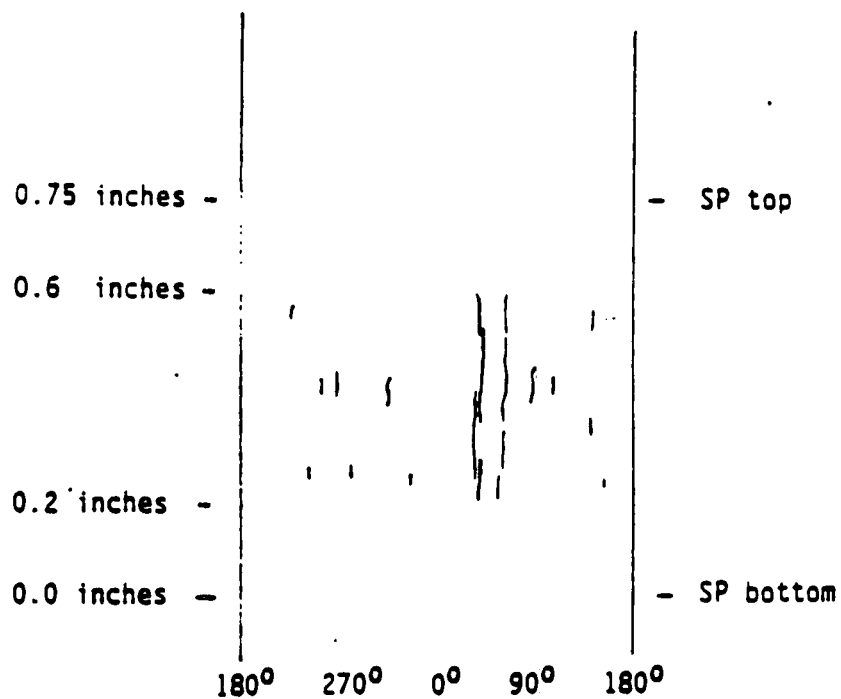
Figure 4 - 31 Description of OD origin corrosion at the first support plate crevice region of tube R4-C73.

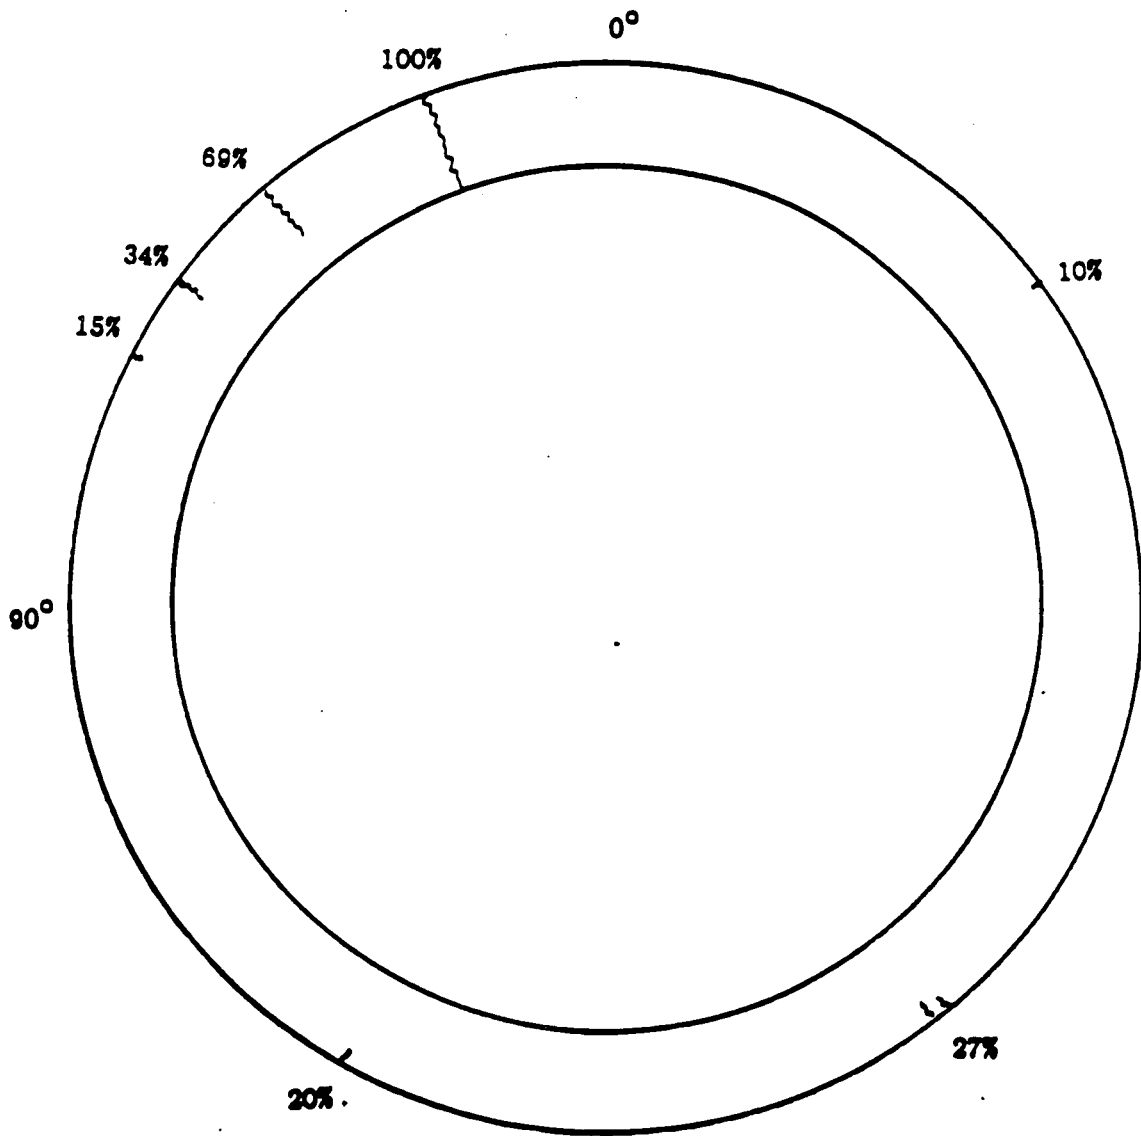
Figure 4 - 32 Sketch of crack distribution and depth within the center of the first support plate intersection in tube R4-C73.

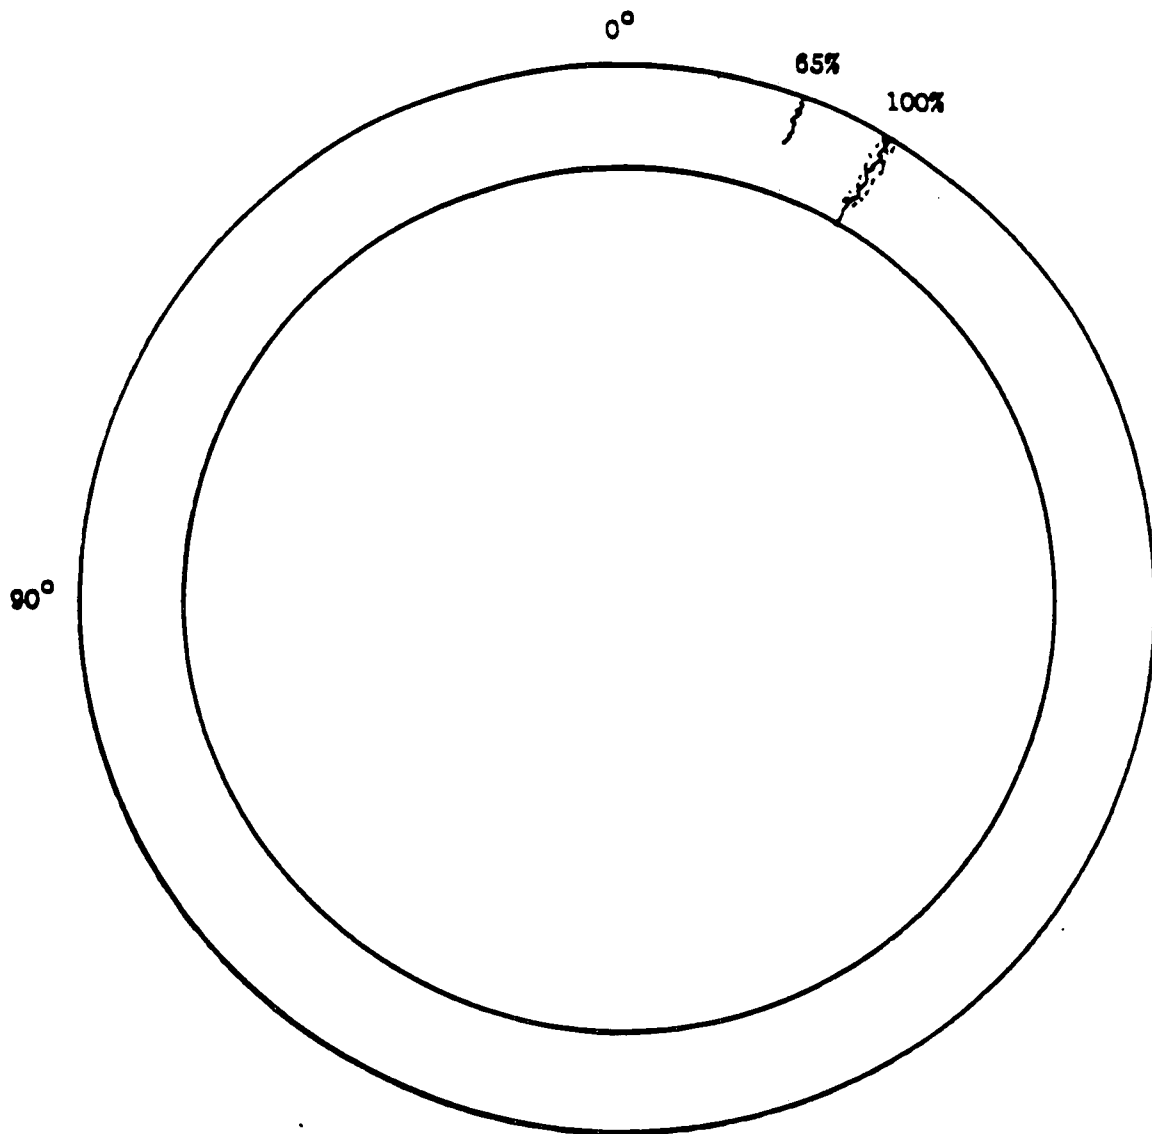
Figure 4 - 35 Sketch of crack distribution and depth within the first support plate crevice region in tube R21-C22.

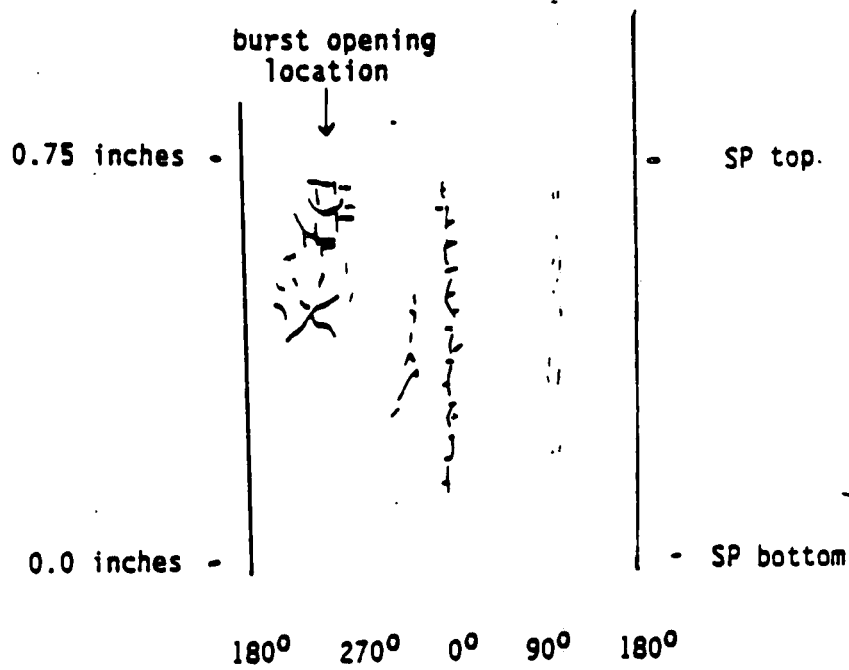
Figure 4 - 37 Description of OD origin corrosion at the first support plate crevice region of tube R38-C46.

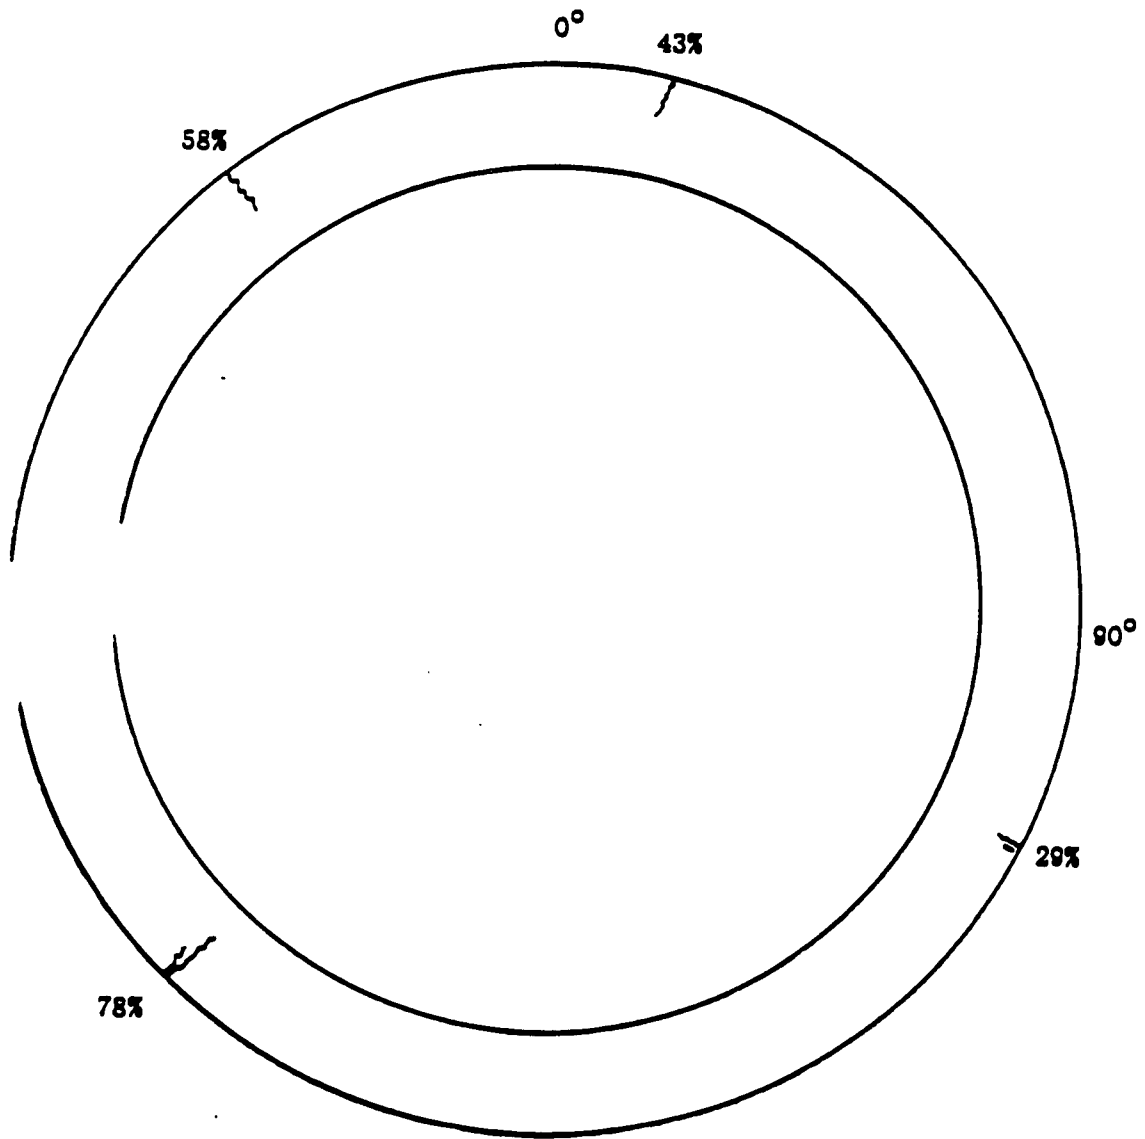
Figure 4 - 38 Summary of distribution and maximum depth of cracks found within the first support plate crevice region of tube R38-C46.

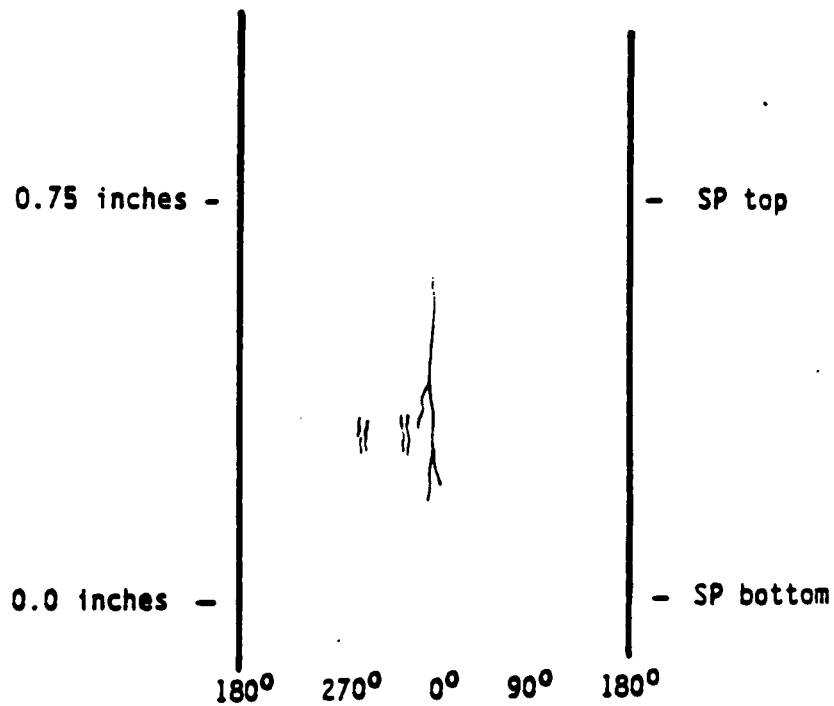
Figure 4 - 40 Summary of crack distribution and morphology observed on the first support plate crevice region of tube R31-C46.

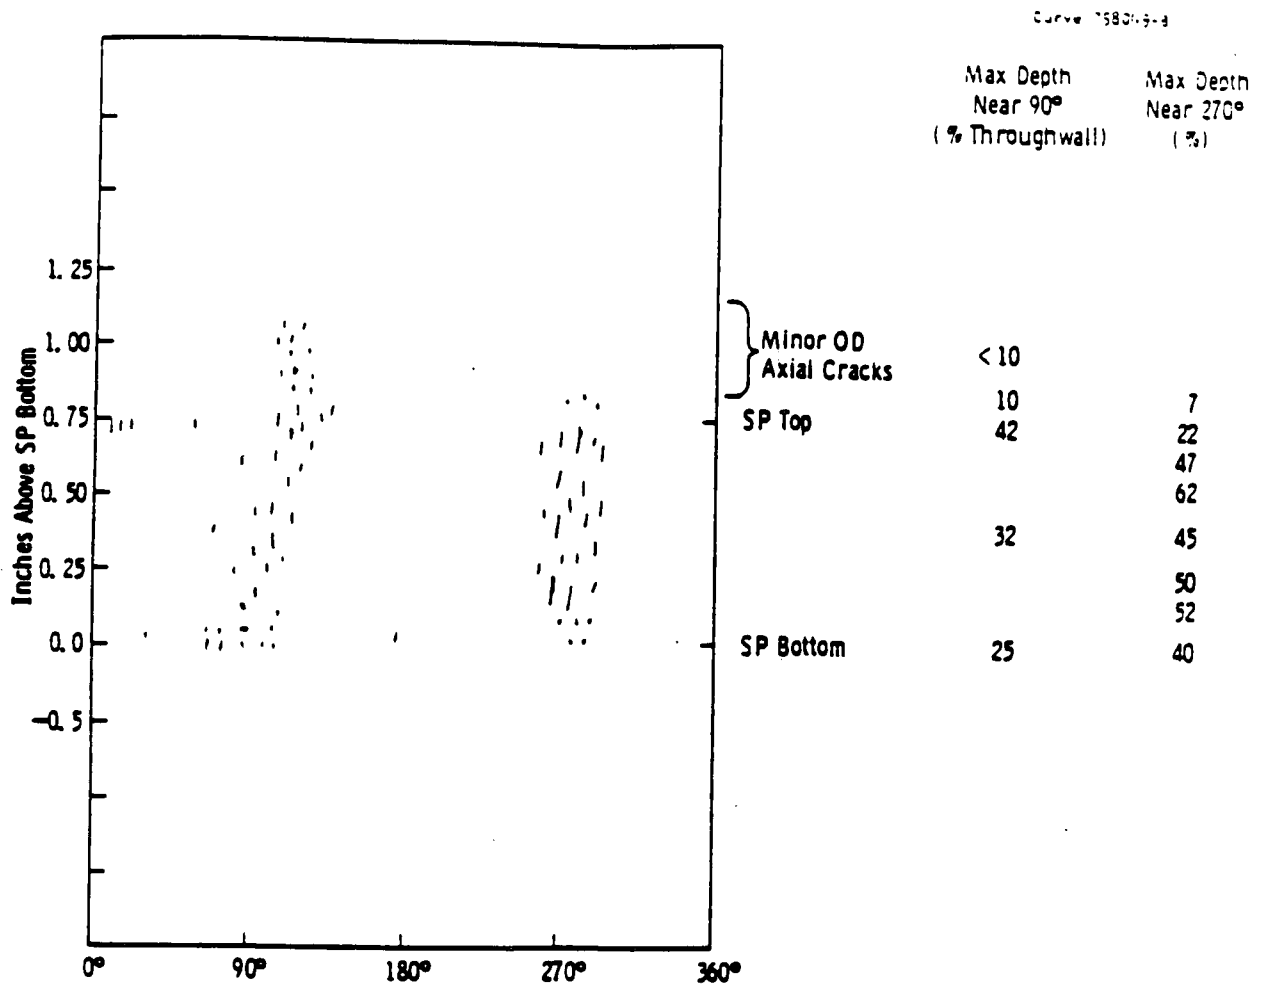
Figure 4 - 45 Crack network location at first support plate region on tube R20-C26 HL.

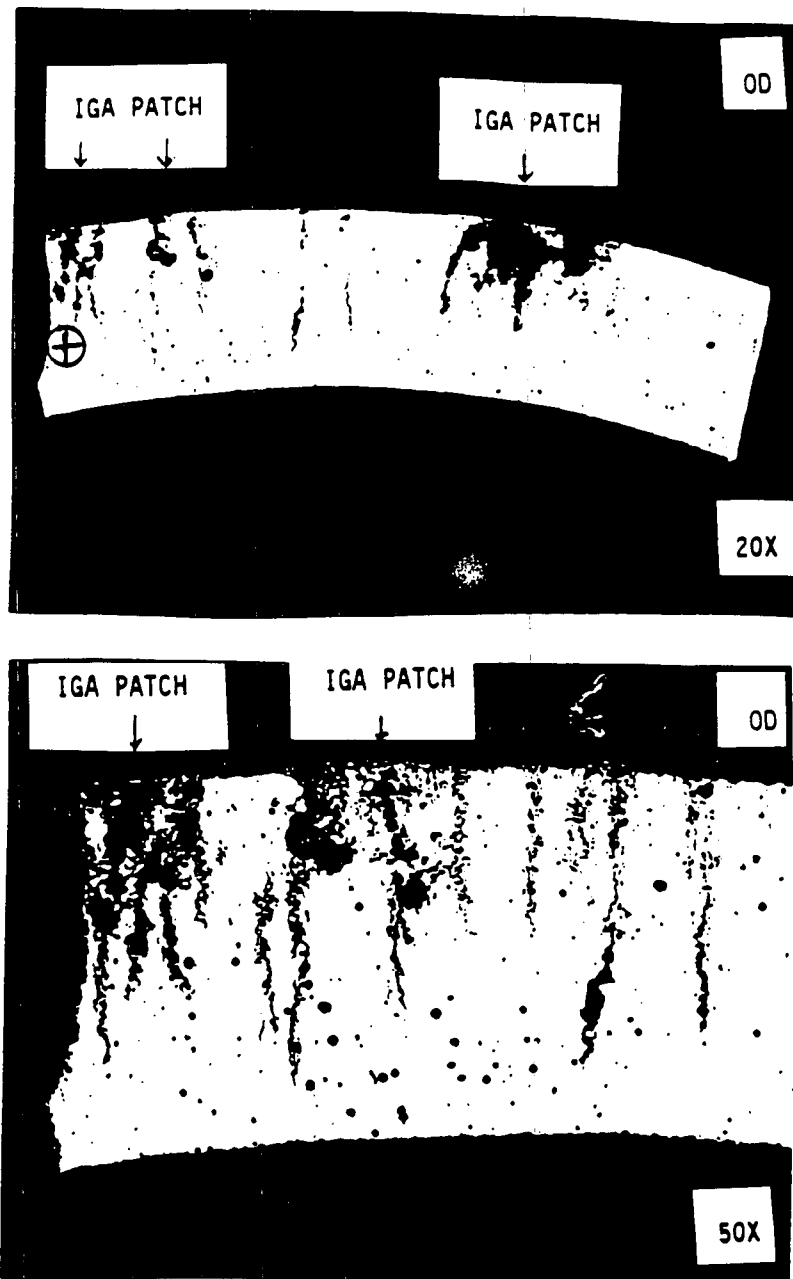
Figure 4 - 49

Transverse optical micrographs obtained just below the circumferential fracture at the center of the support plate. The circumferential location is that where the deepest corrosion was found. The deepest axial IGSCC is 85% through wall and three IGA patches are observed: one 43% through wall and 0.015 inch long, one 33% through wall and 0.05 inch long, and one 28% through wall and 0.015 inch long. The axial IGSCC had IGA aspects to individual cracks. These aspects can be characterized by ratios comparing the crack length (depth from OD surface) to IGA width at the mid-crack location. L/W ratios vary from 6 to 18. Plant L, R12C8

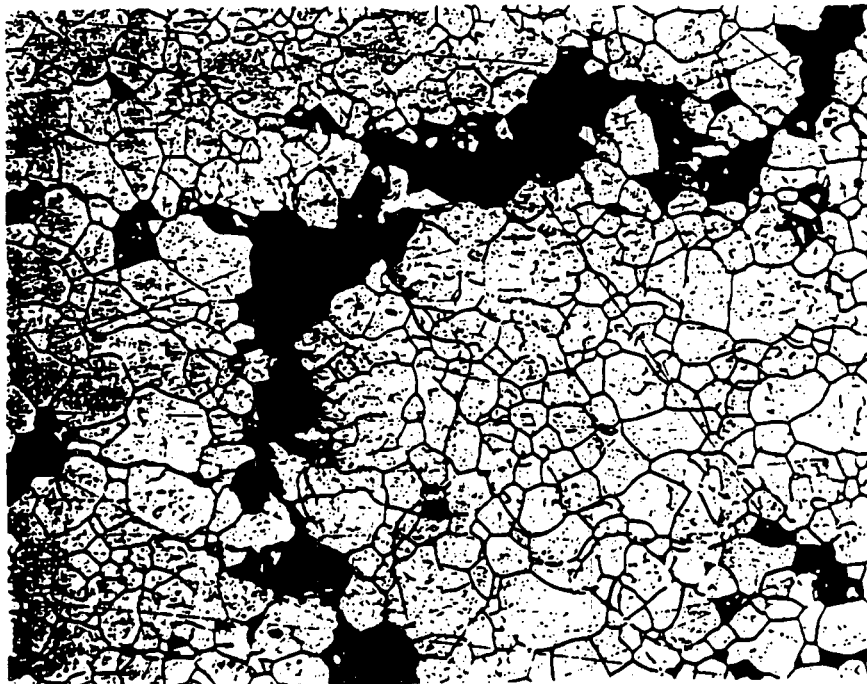
Figure 4 - 53 Higher magnification photomicrographs of the radial section shown in the previous figure. Top photo 50X, bottom 200X

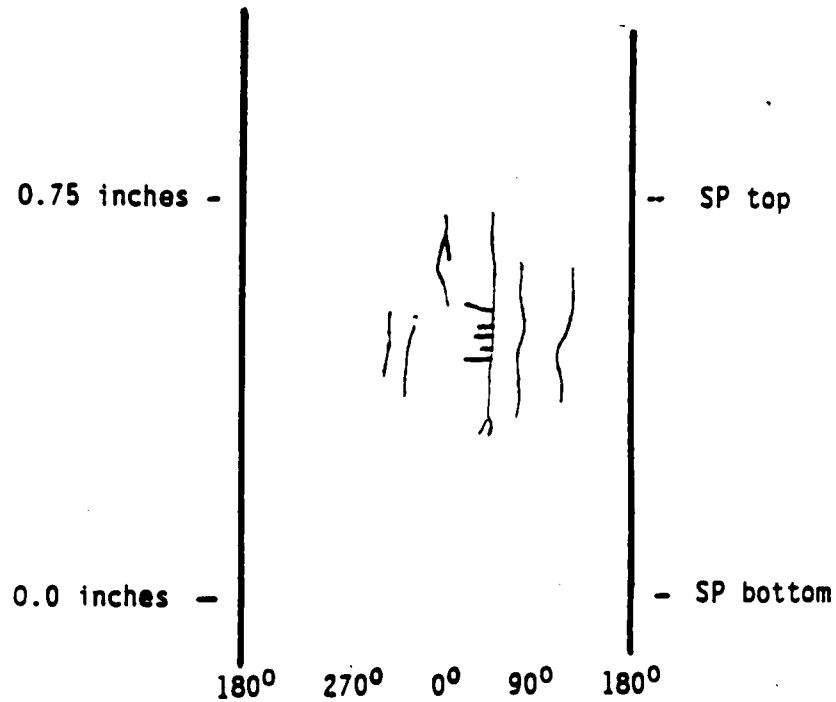
Figure 4 - 56 Description of OD origin corrosion at the fifth support plate crevice region of tube R4-C61, Plant B-1

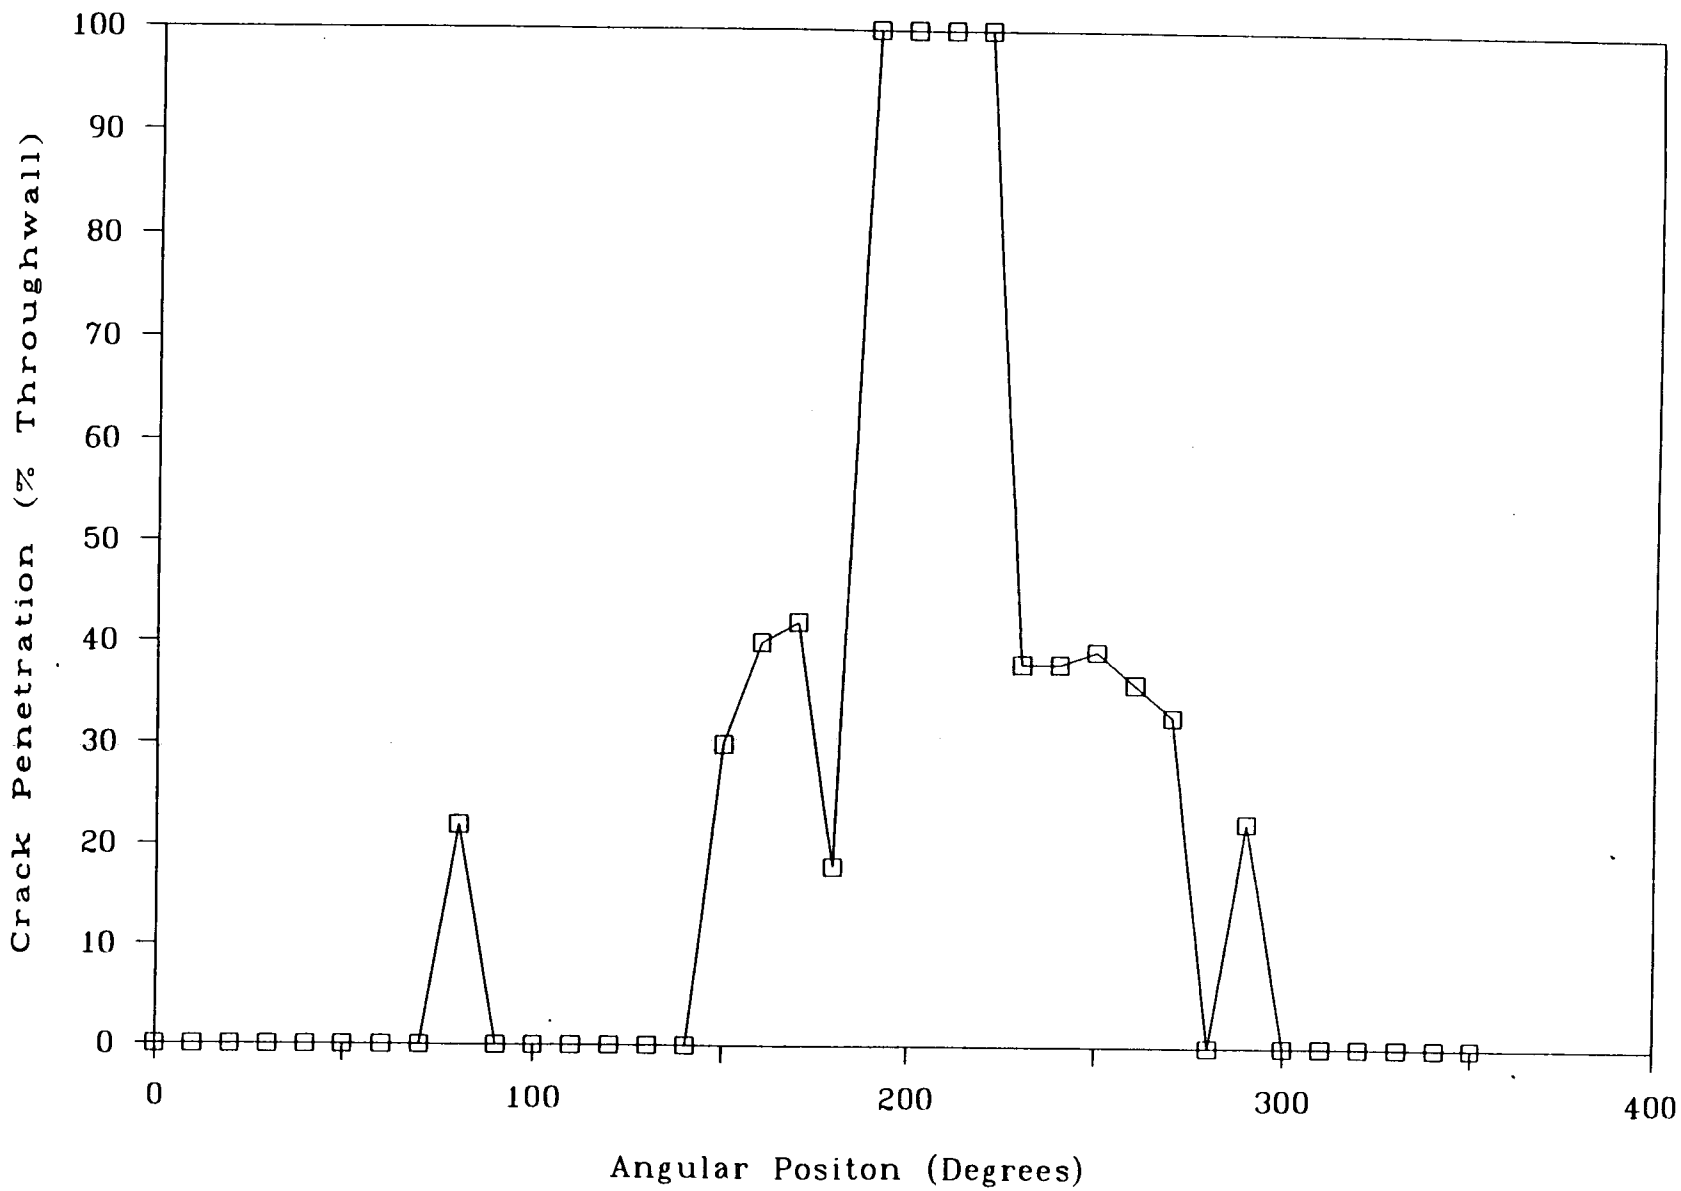
Figure 4-65
 Axial Crack Profile at the Mid-Plane of R16C60
 TSP #2. Plant P

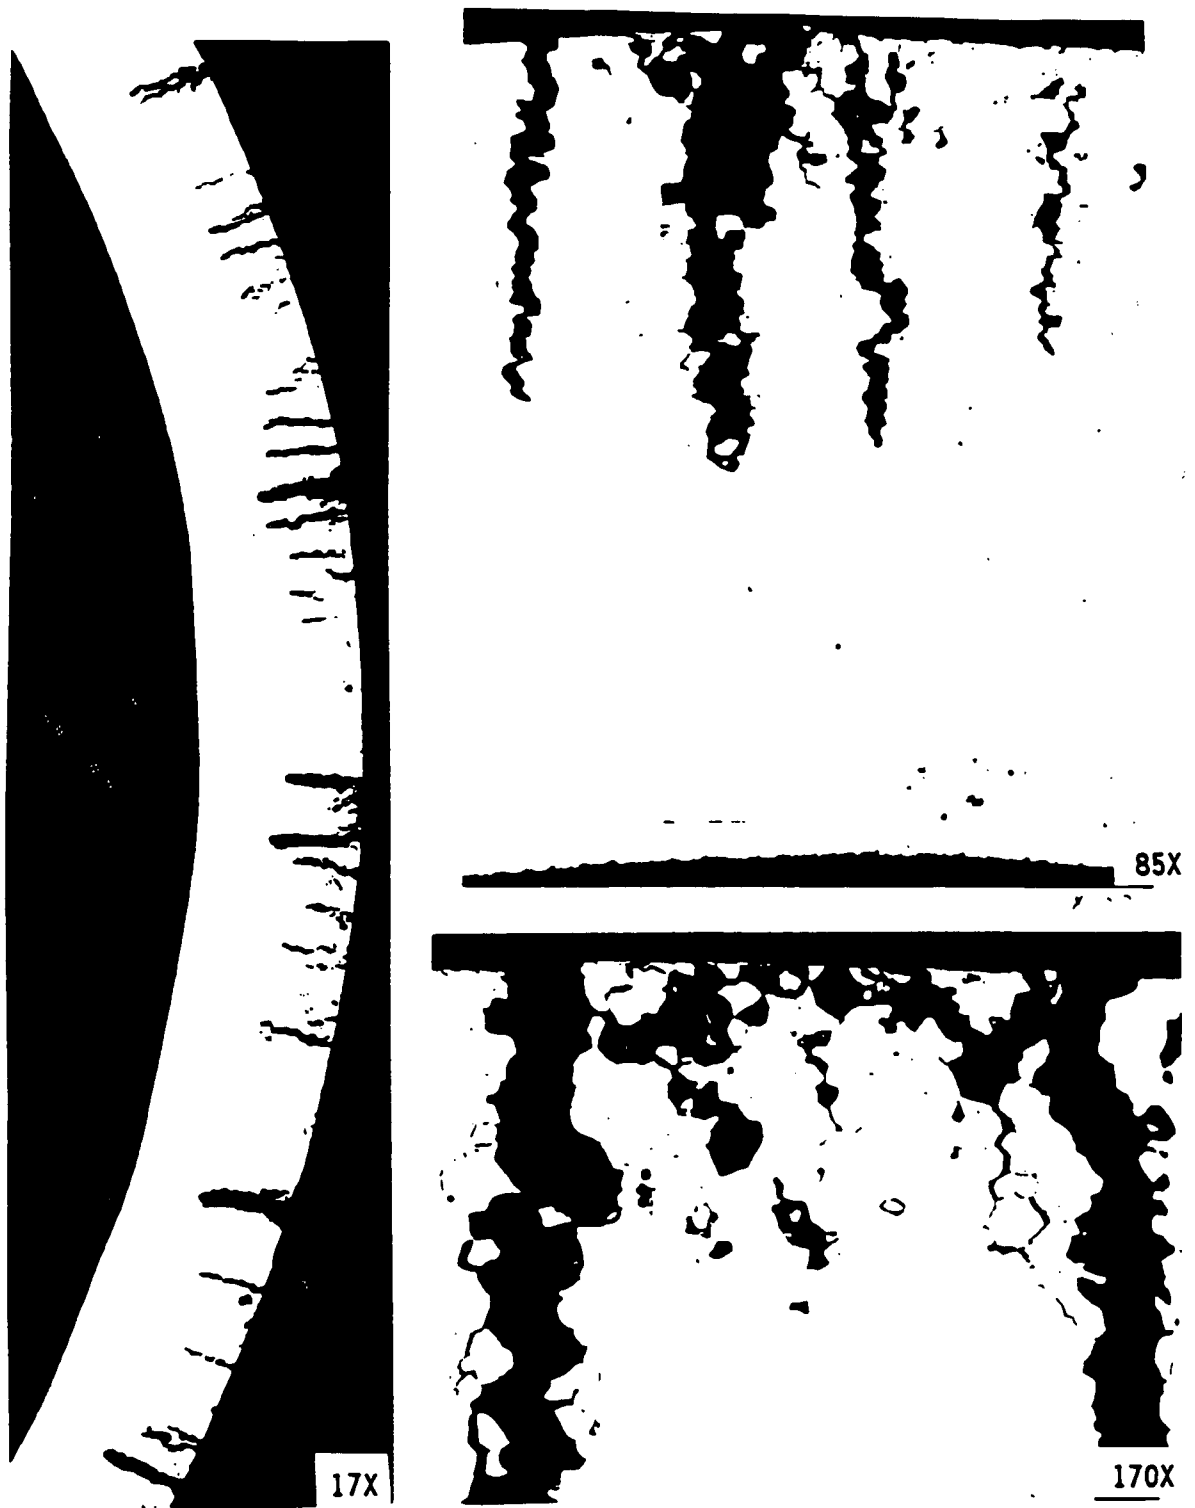
Figure 4-70 Transverse photomicrographs of intergranular corrosion at the second support plate region of tube L8-C74 from Plant J-1
