Westinghouse Energy Systems

KEWAUNEE STEAM GENERATOR
TUBE PLUGGING CRITERIA FOR
ODSCC AT TUBE SUPPORT PLATES

JANUARY, 1993

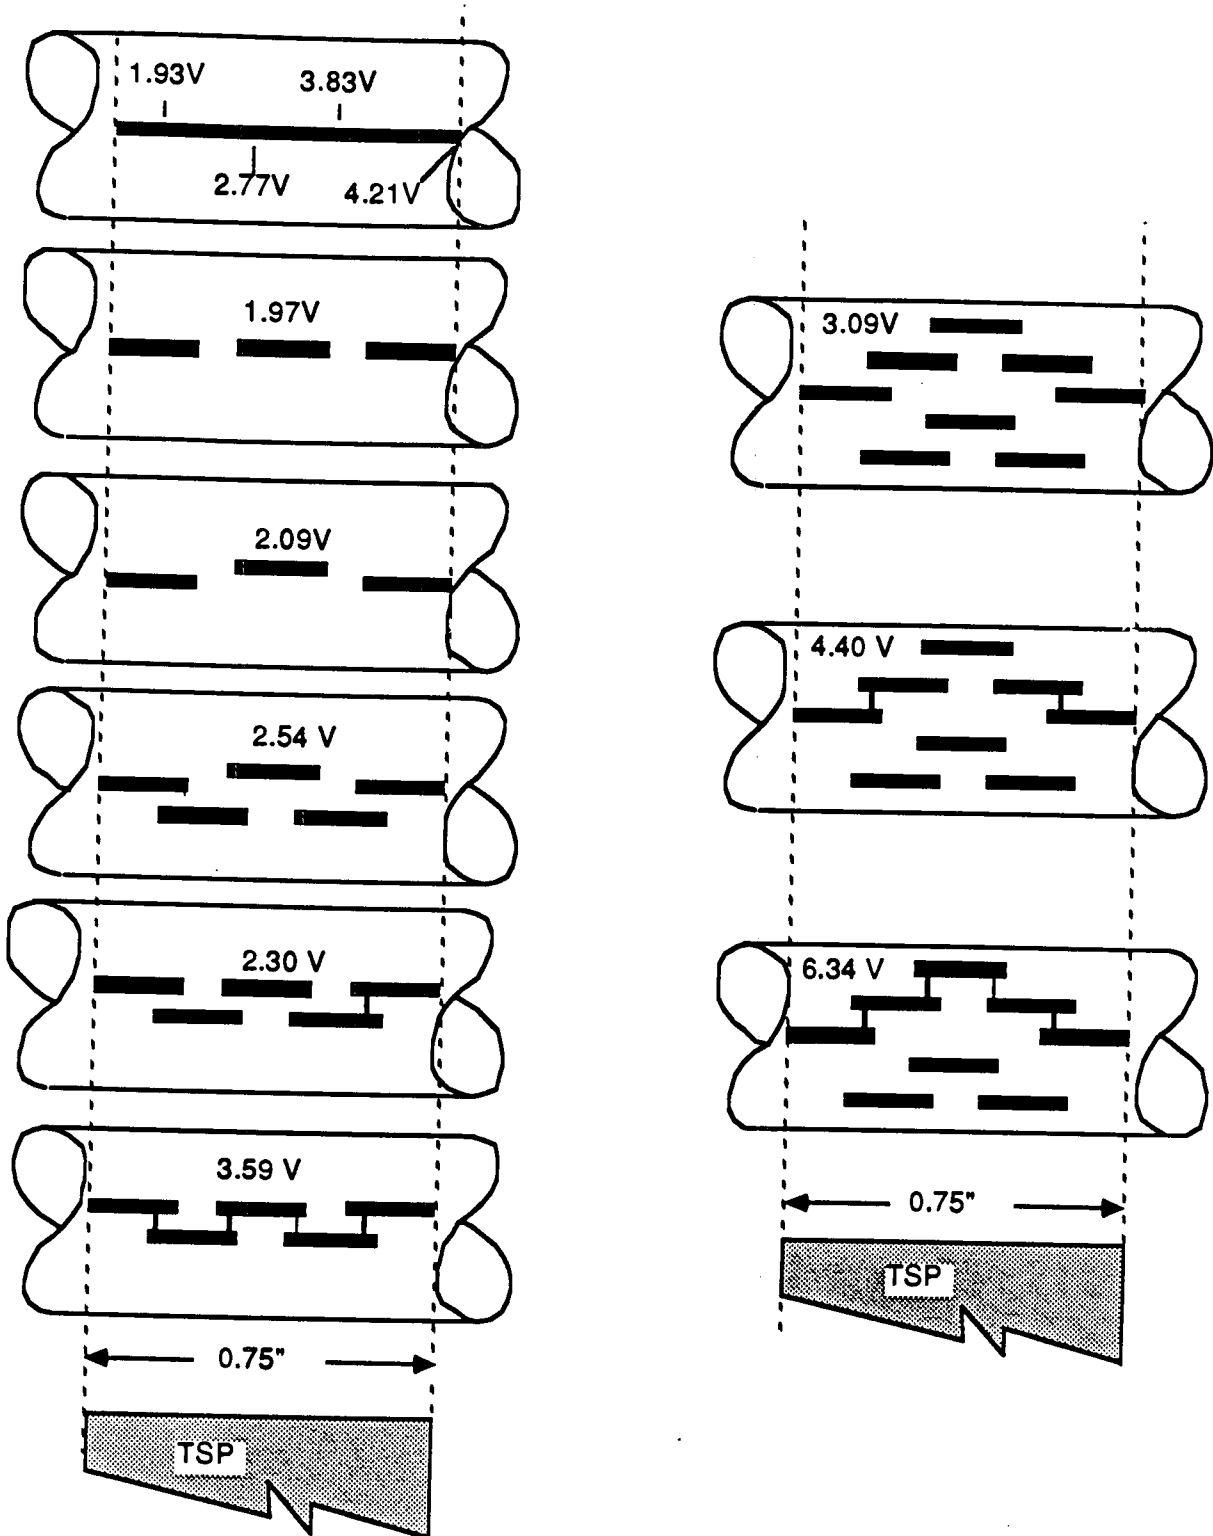
Figure 5-2

Bobbin Coil Voltage Dependence on Slot Length and Depth

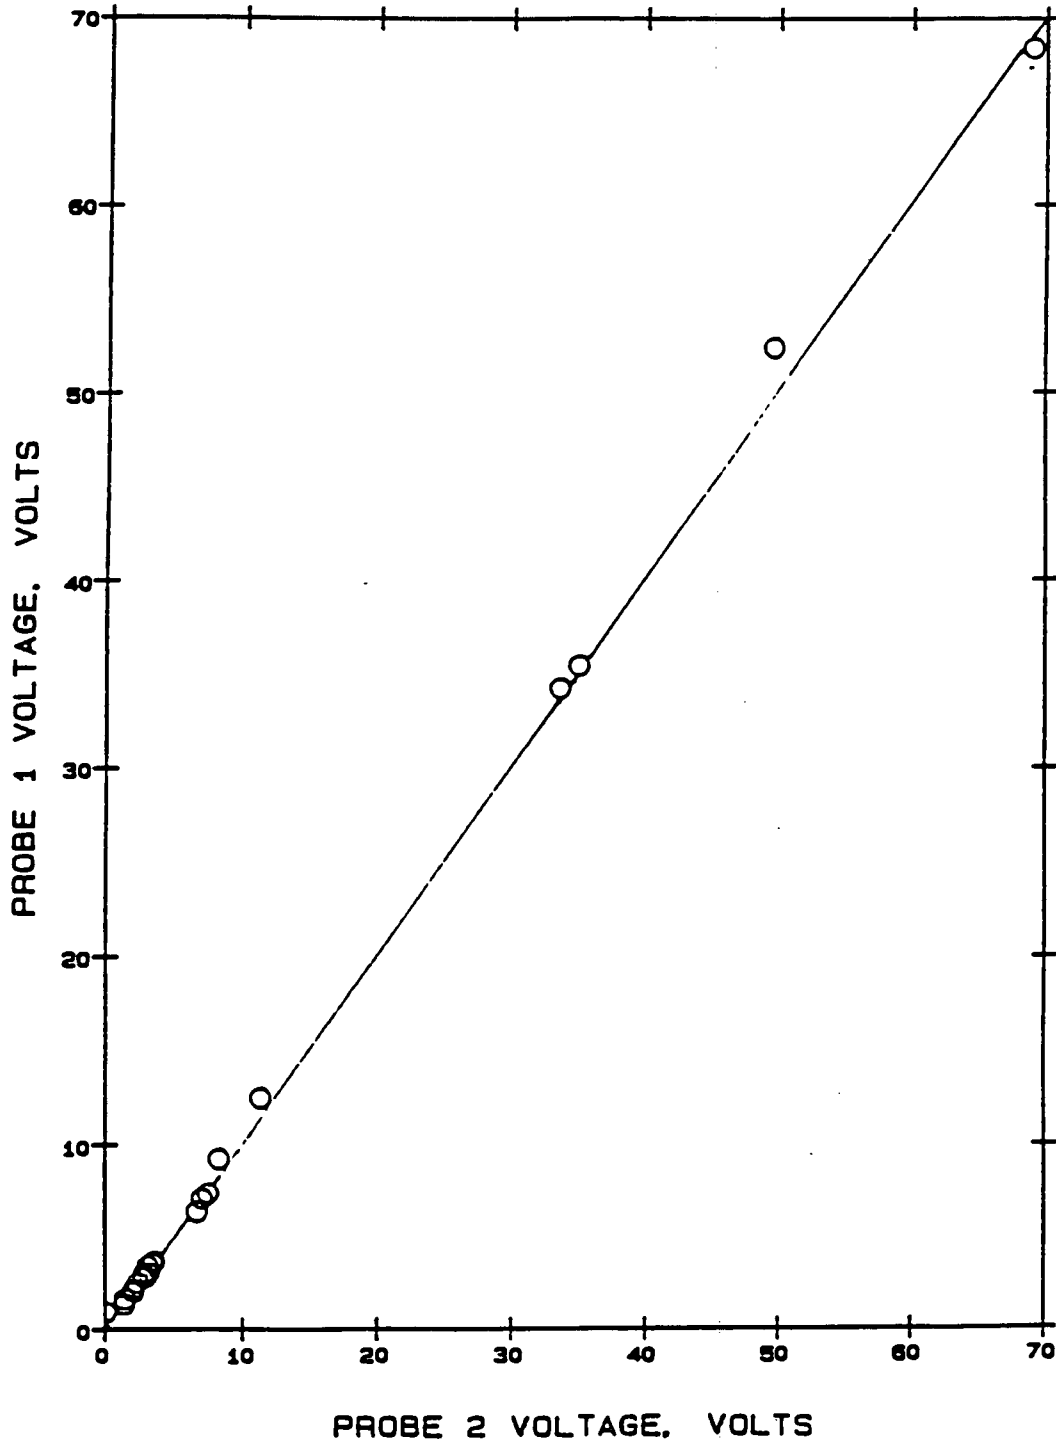
Figure 5-16

Comparison of 400/100 kHz Mix Amplitude Response from Two Probes (Model Boiler Sample)

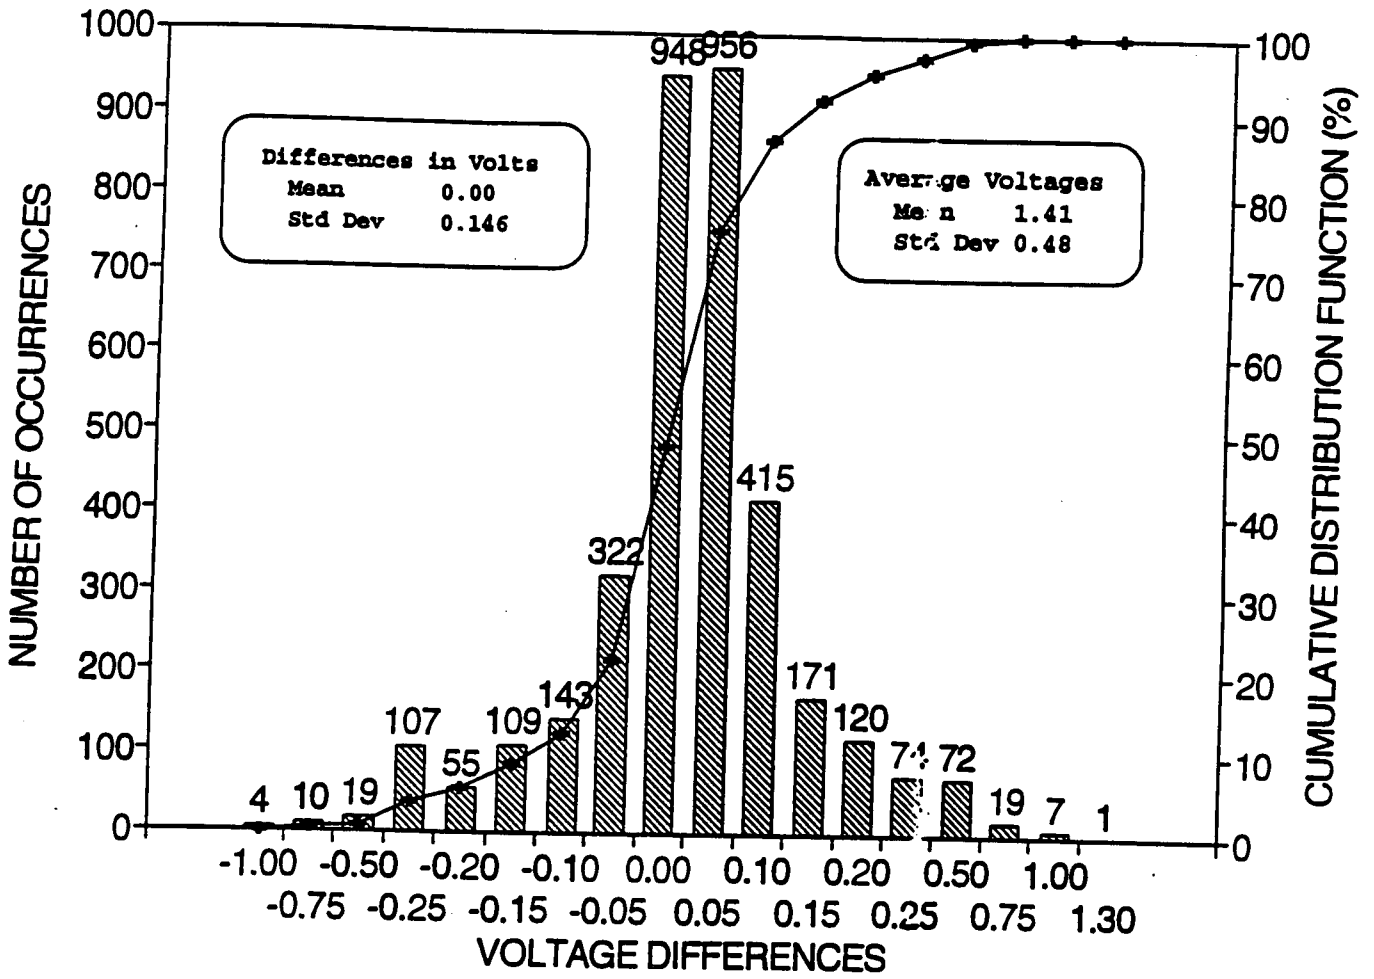
Figure 5-26. Distribution of Voltage Differences Between Individual Analysts and Mean Values

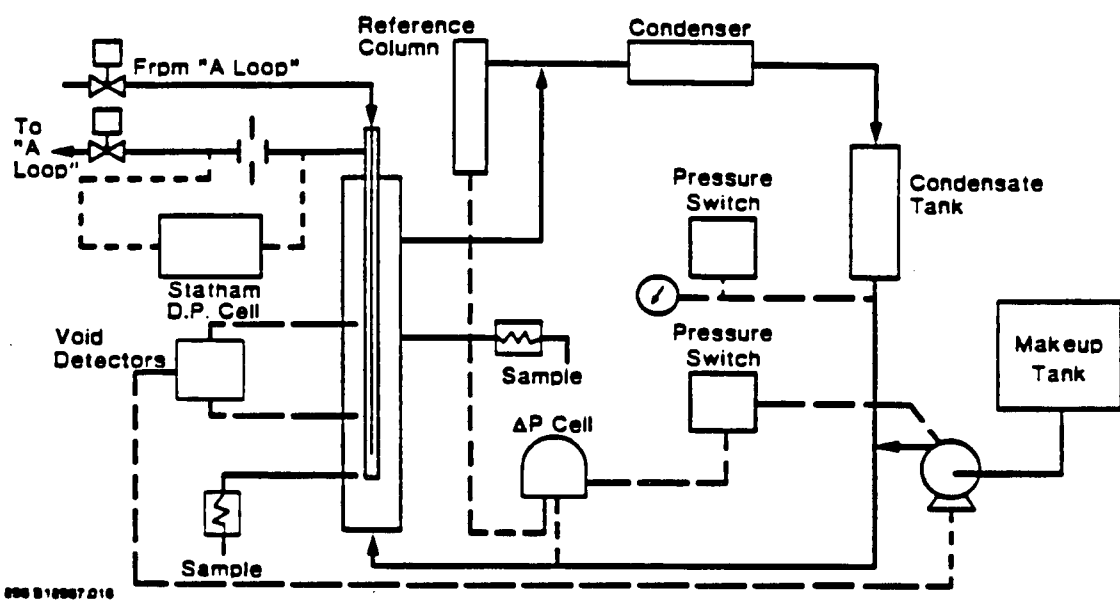
Figure 7-1. Schematic of Model Boiler Facility

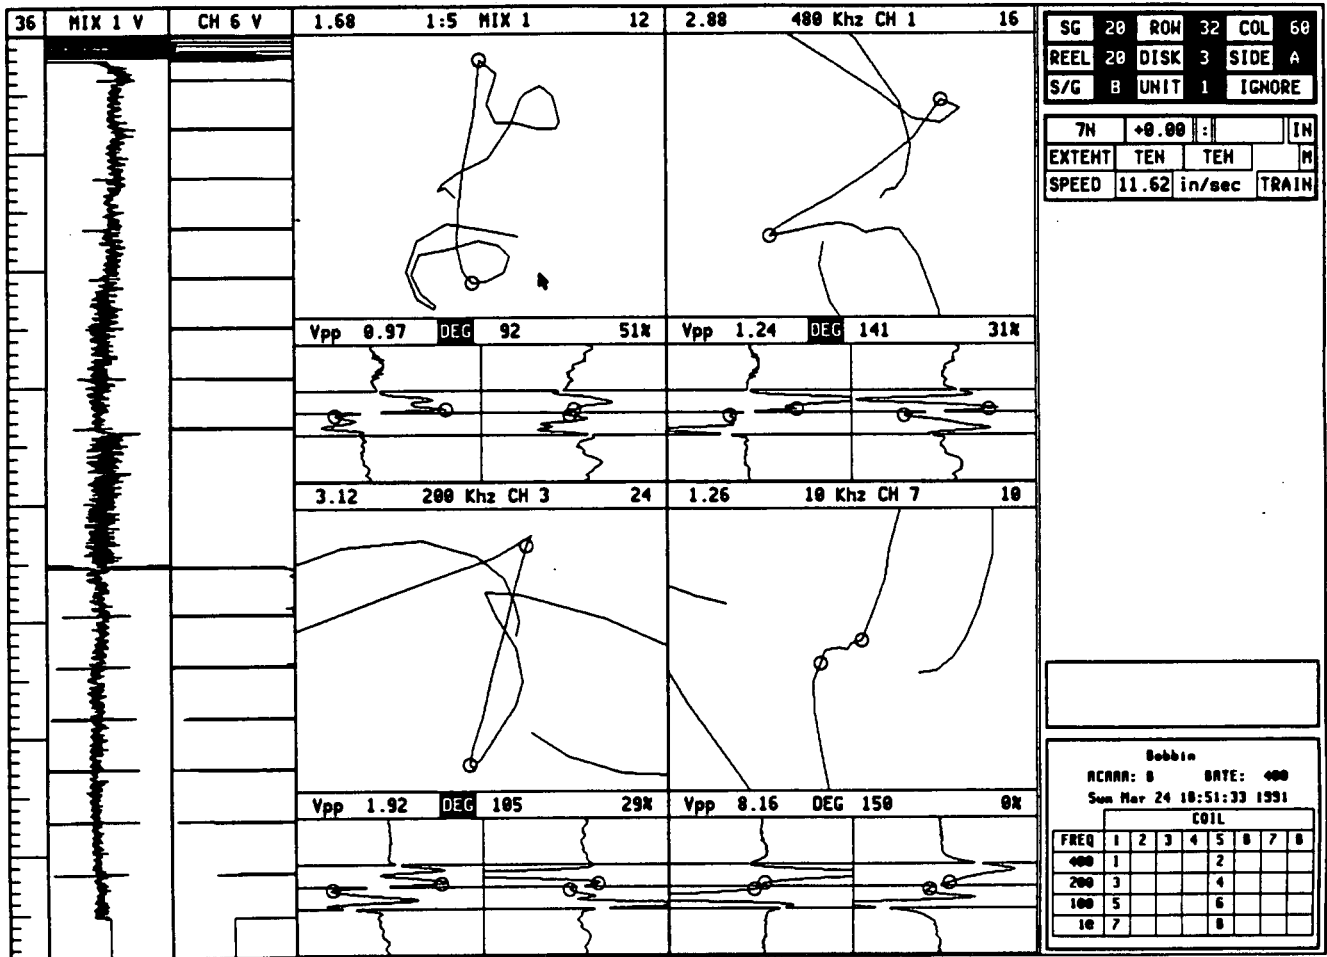
Figure A-1

Bobbin Coil Amplitude of ODSCC at TSP

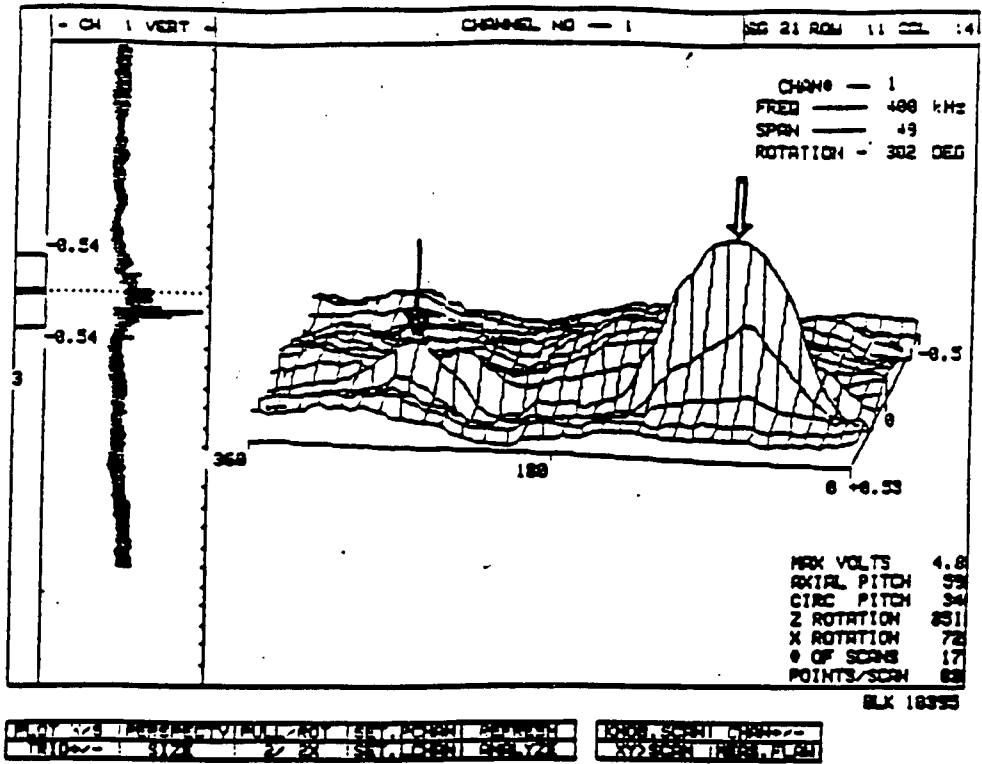
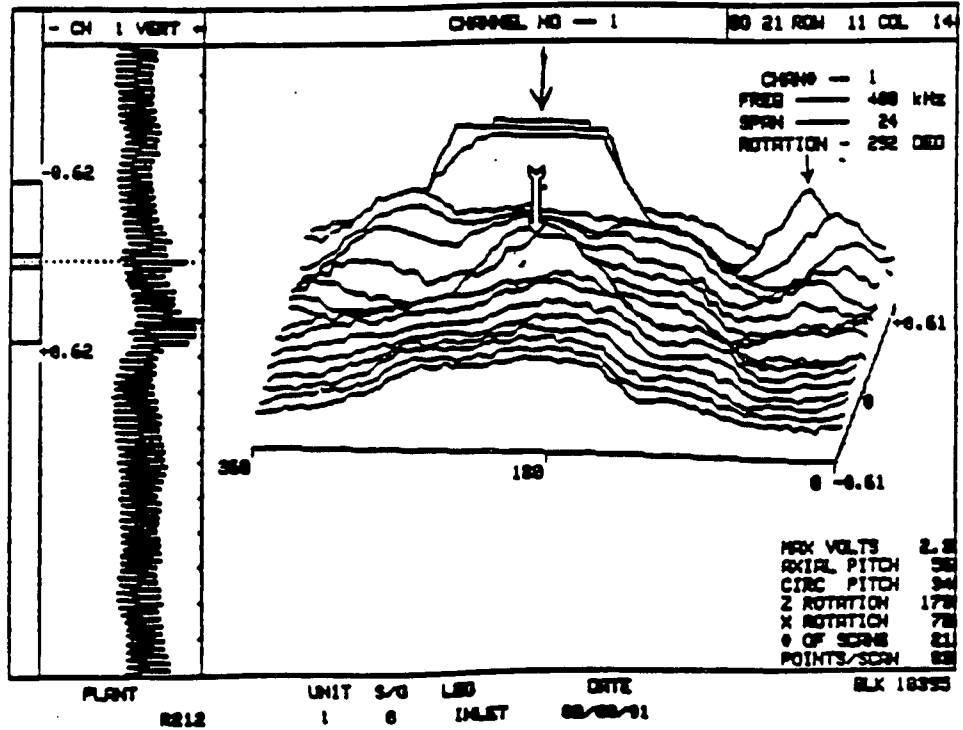
Figure A-21 Example of Rotating Pancake Coil Field Data from Plant A Circumferential ODSCC Indication (COI)
