Comanche Peak Nuclear Power Plant, Units 3 & 4
COL Application
Part 2, FSAR

Figure 2.5.1-227 Ground Based LiDAR Outcrop near CPNPP Dam

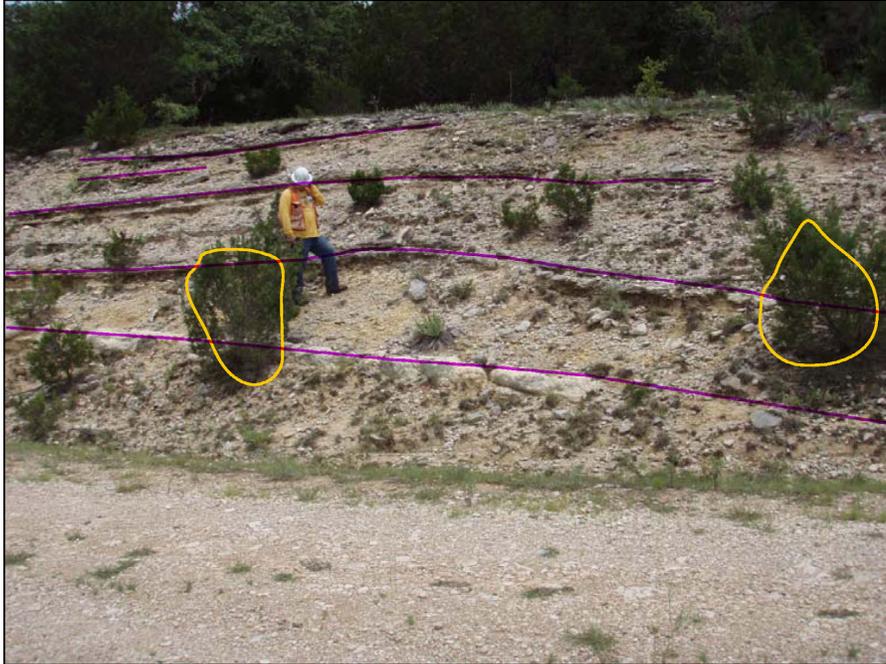
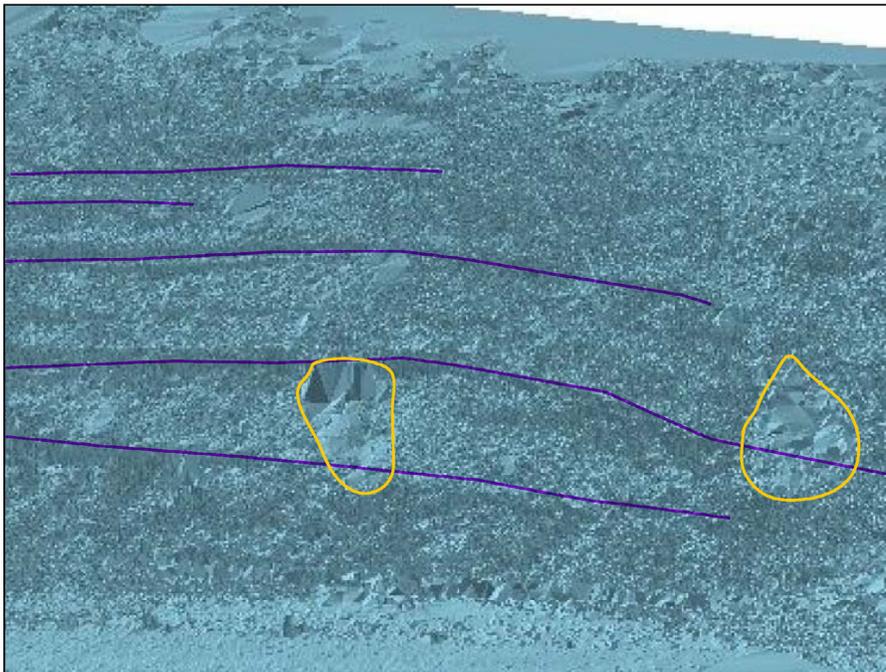
- (Purple lines) are overlain of exposed bedding to show the comparison between the LiDAR image (lower) and the photograph (above).
- (Yellow lines) show poor imaging areas due to vegetation.
