PNNL-17698

## Technical Letter Report

# Assessment of Ultrasonic Phased Array Testing for Cast Austenitic Stainless Steel Pressurizer Surge Line Piping Welds and Thick Section Primary System Cast Piping Welds

JCN N6398, Task 2A

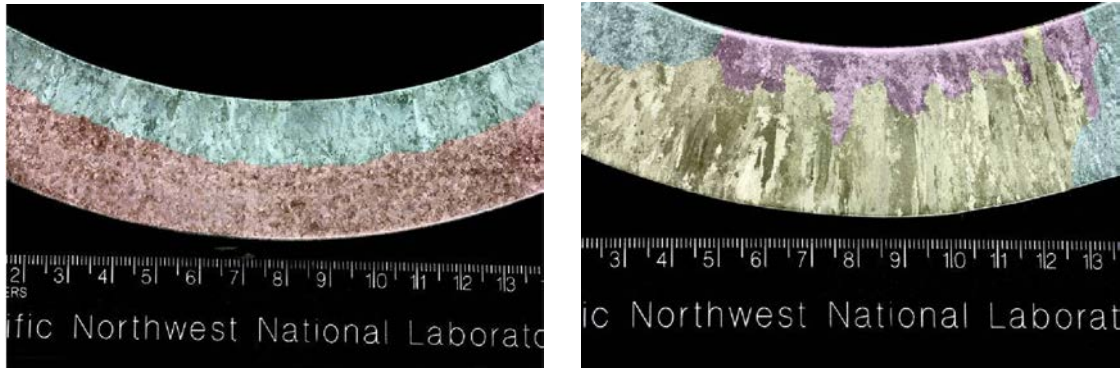
False colors have been added to assist the viewer in judging microstructural variation and banding. Typical grain diameters range in size from approximately 0.04 inch (1 mm) to nearly 0.25 inch (6.35 mm) or more as a function of depth or spatial position in the material. At a 1.5-MHz inspection frequency, the corresponding wavelength in the CASS PZR surge-line material is approximately 0.15 inch (3.8 mm). Thus, the wavelength at this inspection frequency will experience more scattering and more attenuation as the sound field propagates through the material. In contrast, at an 800-kHz inspection frequency, the wavelength in the material is approximately 0.28 inch (7.1 mm). The sound field for the lower inspection frequency will be less sensitive to the effects of grain boundary scattering and attenuation as the wavelength is generally larger than the majority of the grains in the microstructure for this specimen.

**Figure 4.1.** Photographs of Polished and Chemically Etched CASS PZR Ring Segment Showing the Pipe-Side (CCSS) Grain Microstructure (left) and the Elbow-Side (SCSS) Grain Microstructure (right)

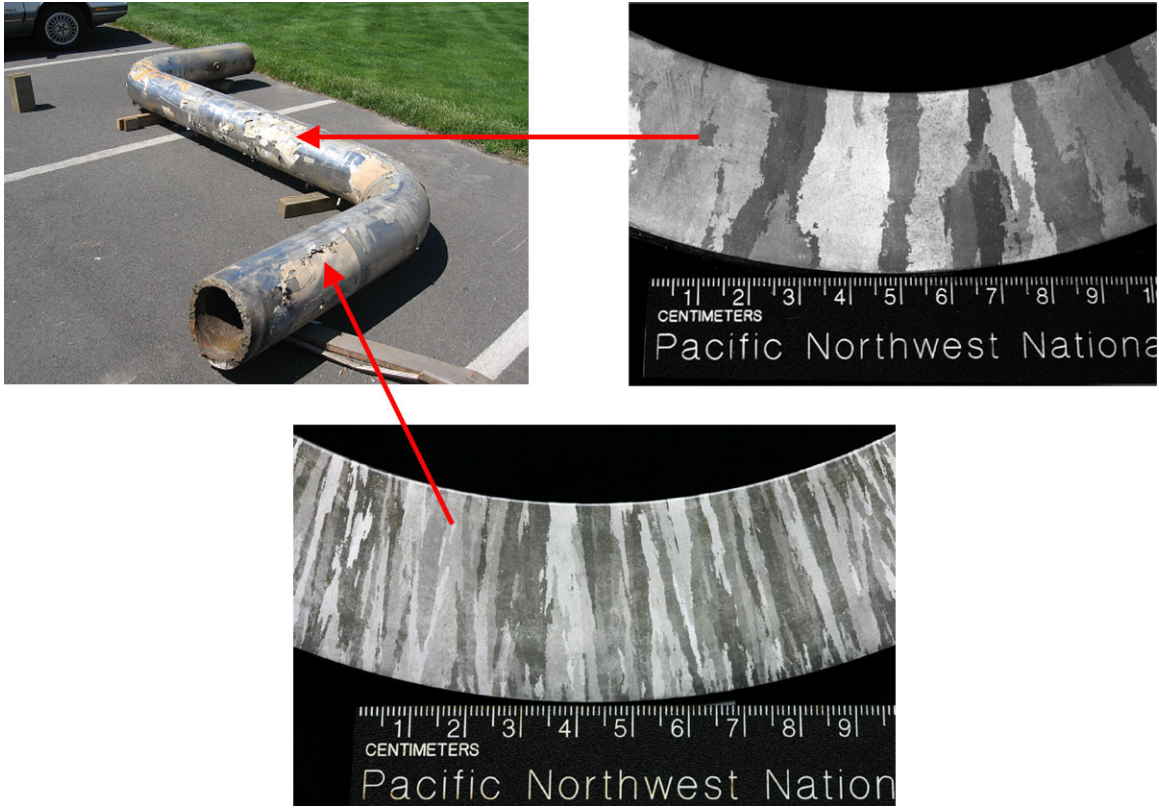
**Figure 4.2.** Photographs of Coarse-Grained Microstructures in a PZR Surge Line at PNNL

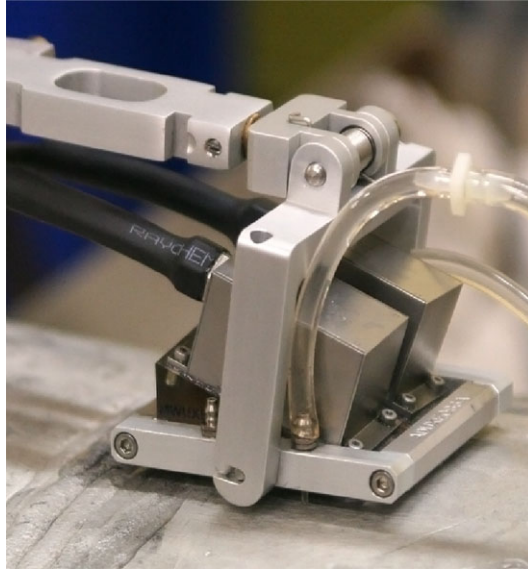
**Figure 5.2.** 1.5-MHz TRL Probe Originally Designed for Wrought Stainless Steel Welds

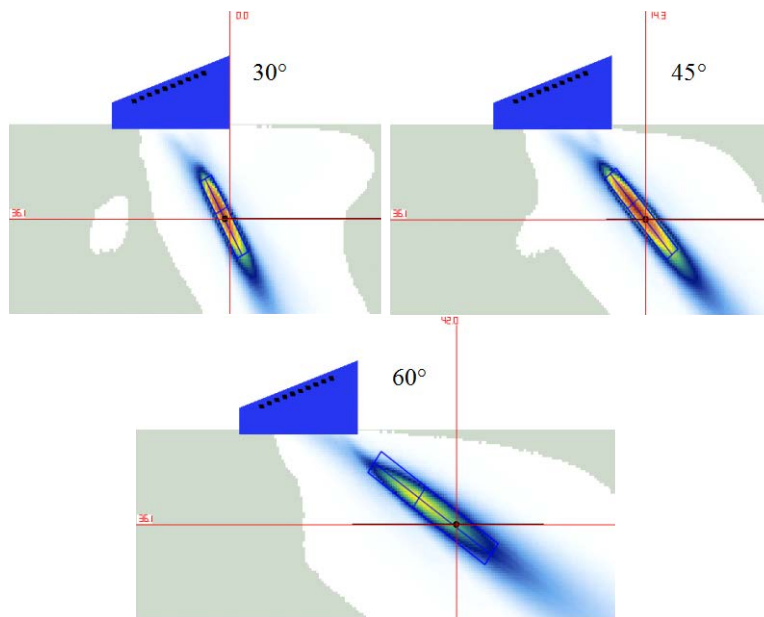
(1.4 inch), is shown in Figure 5.3. The wavelength for a 1.5-MHz probe is 0.15 inches (3.8 mm). The simulation shows the expected beam width to be 0.22 inches (5.5 mm) at 30°, 0.24 inches (6.2 mm) at 45°, and 0.39 inch (9.8 mm) at 60°.

**Figure 5.3.** Simulations of the Beams Created by the 1.5-MHz TRL Arrangement for 30°, 45°, and 60°

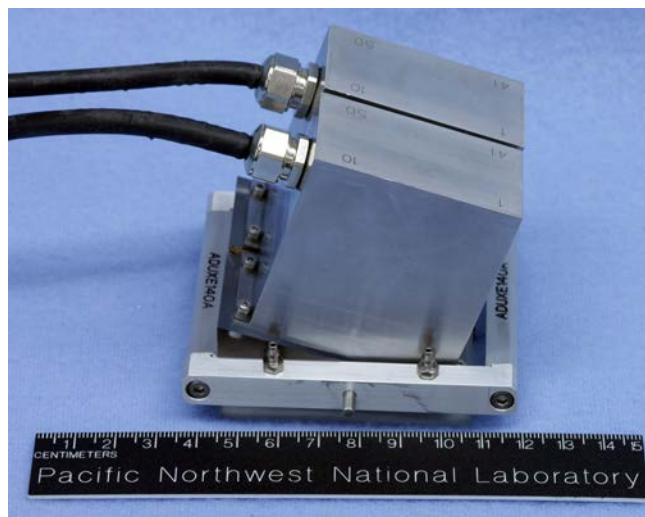
The 800-kHz probe was designed to provide a more optimal wavelength to allow the ultrasound to penetrate the large grain structure of CASS and maintain suitable resolution allowing the probe to resolve smaller flaws. The probes were mounted on a Rexolite<sup>®</sup> wedge side-by-side to operate in a pitch-catch mode and are shown in Figure 5.4. The wedges were separated by cork and held together with an aluminum frame. The wedge dimensions were 63 × 63 mm (2.48 × 2.48 inches). The transmit and receive probes were identical in design and consisted of a 10 × 5 element array with an active area of 43.2 mm × 21.2 mm (1.70 × 0.84 inch) and a greater than or equal to 50% bandwidth. The probes were designed at PNNL for this inspection and built by Imasonic<sup>®</sup>. The wedges were curved to match the approximate 318-mm (12.5-inch) diameter of the surge line piece.

**Figure 5.4.** 800-kHz TRL Probe

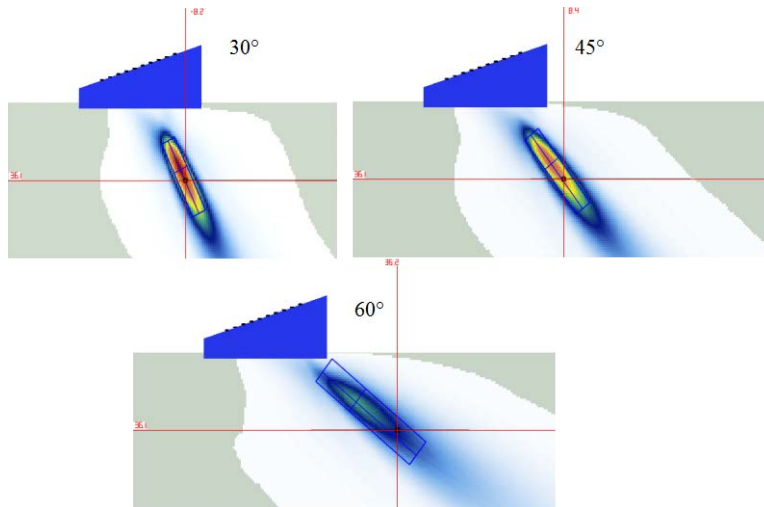
The 800-kHz probe was found to produce a beam with a width of 7 mm (0.28 inch) at 30°, 9 mm (0.35 inch) at 45°, and 13 mm (0.51 inch) at 60°. The 800-kHz probe is able to provide an effective sound field at distances from directly under the probe to a distance of 36 mm (1.42 inch) in front of the wedge. As with the 1.5-MHz probe, the ability of the probe to accurately measure crack width and depth improves the closer to the probe focal spot the flaw is located as this is the location of tightest focusing. Because the 800-kHz beam focal zone does not extend as far out in front of the probe as the 1.5-MHz beam, it needs to be positioned closer to the flaw than the 1.5-MHz probe.

**Figure 5.5.** Simulations of the Beams Created by the 800-kHz TRL Arrangement for 30°, 45°, and 60°

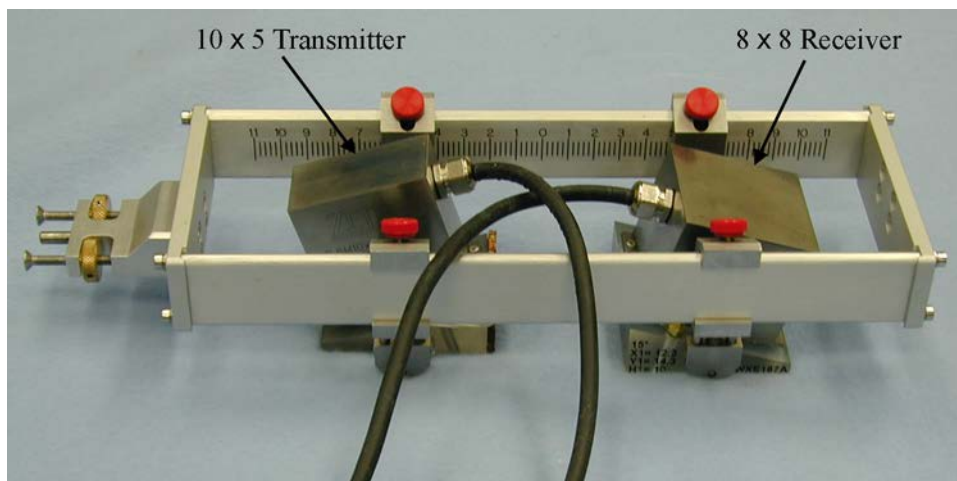
The delta probe used an 800 kHz, 10×5 element probe and an 800 kHz 8×8 element receiver mounted on wedges and held face-to-face in a variable-displacement holder. The delta probe is significantly more complex than the other probes as optimum spacing between probes and position relative to a flaw need to be determined. The transducers and holder are shown in Figure 5.6.

**Figure 5.6.** Delta Probe Arrangement

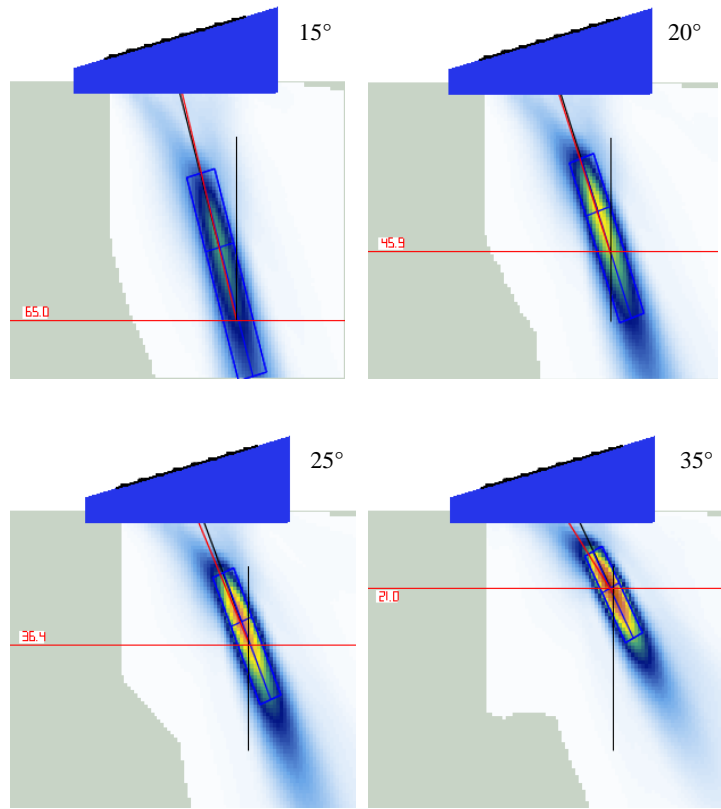
**Figure 5.8.** Simulated Sound Fields for the Receiver Focused 0.5 Inches under the Front of the Wedge

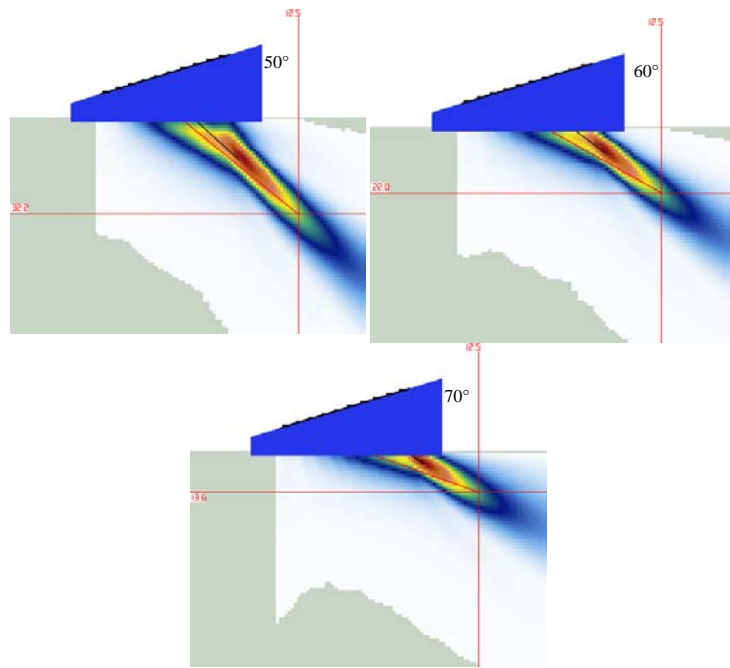
**Figure 5.9.** Simulated Sound Fields for the Transmitter Focused 0.5 Inch in Front of the Wedge

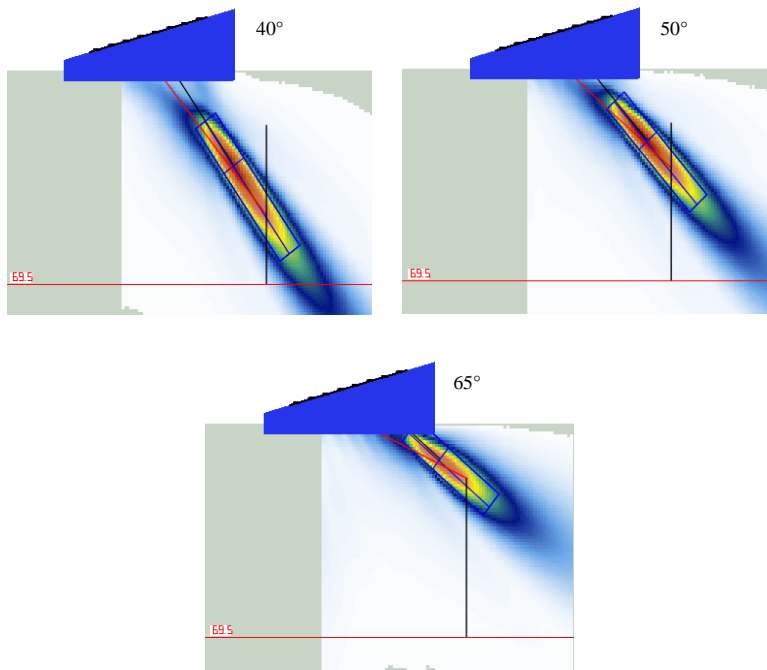
**Figure 5.10.** Simulated Sound Fields for the Receiver Focused 0.5 Inch in Front of the Wedge

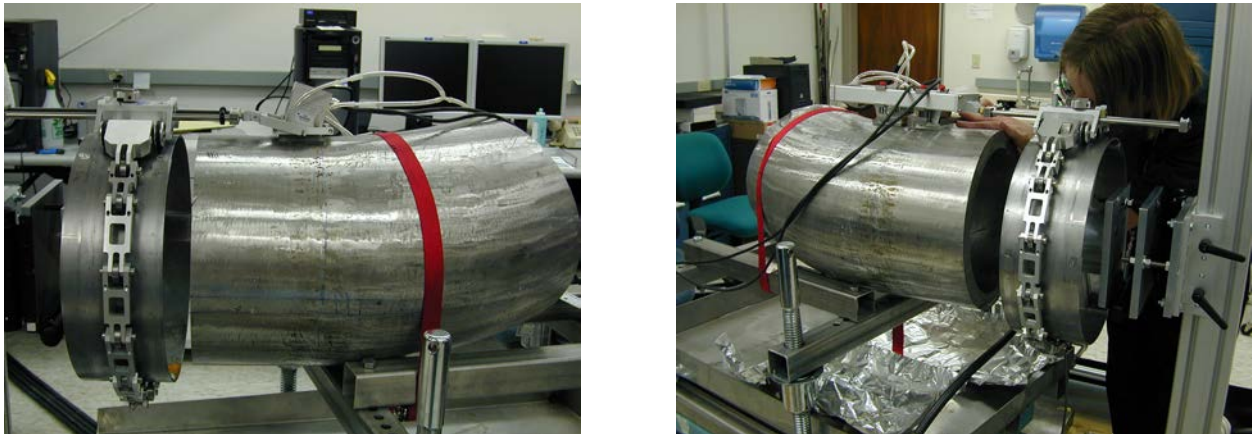
Set-up and laboratory configuration for 800-kHz and 1.5-MHz data acquisition on the PZR surge line required the use of the manual-encoded scanner mounted on an adjustable guide track or ring supported by a custom-designed floor-to-ceiling brace. The setup is shown in Figure 6.1 with the manual scanner on the guide ring section. The probe is mounted on an extension arm which is adjustable along the pipe axis. Two encoders on the manual track scanner provide positional information in either or both the axial and circumferential directions for line and raster scanning

**Figure 6.1.** Photographs of the PZR Surge Line Specimen. Left: Configured for standard PA-UT with the pipe-end on the left and the elbow-end on the right side of the picture. Right: The guide ring and floor-to-ceiling brace are shown to the right.

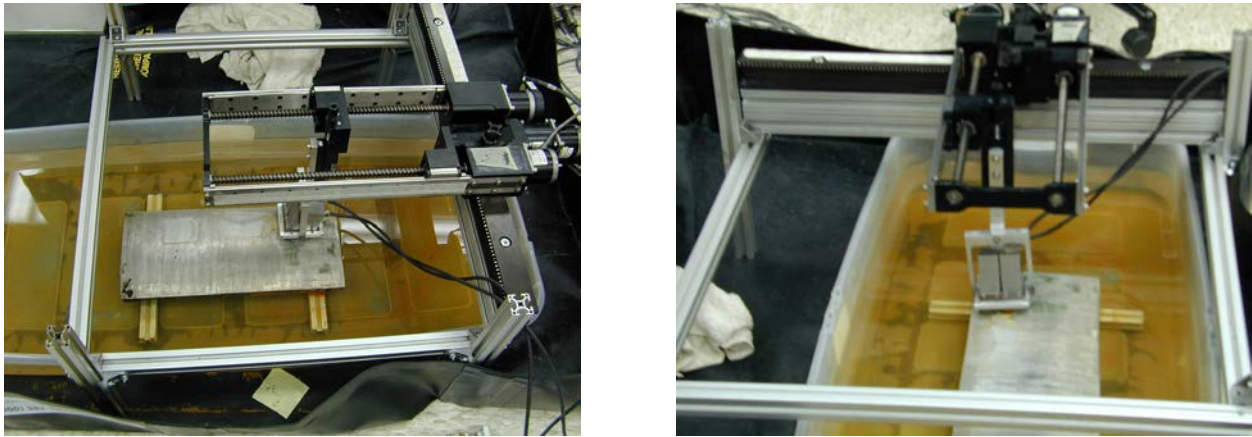
**Figure 6.2.** Top and Front Views of the Immersion Tub Scanning Configuration for the PNNL CASS Specimen Using an Automated X-Y Axis, Flat Peg-Scanner and Spring-Loaded Gimbal Apparatus

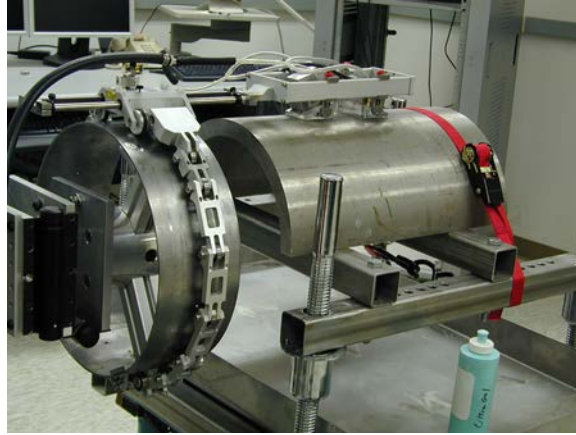
**Figure 6.3.** Photograph of Delta-Technique Configuration Just Prior to Scanning

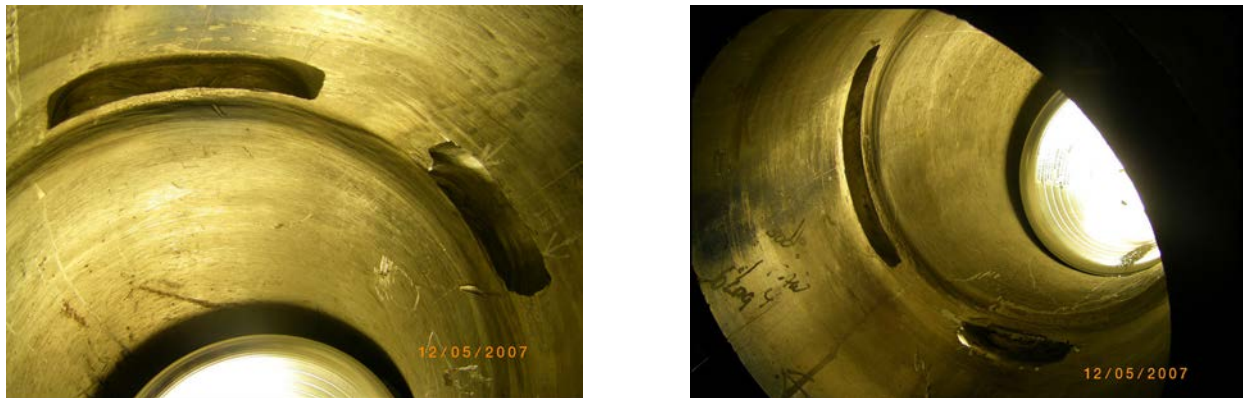
**Figure 7.1.** Photographs of the Inside Surface of the CASS PZR Surge-Line After Excavation and Preparation of the Areas Targeted for Flaw Implantation (courtesy of FlawTech<sup>®</sup>, Inc.)

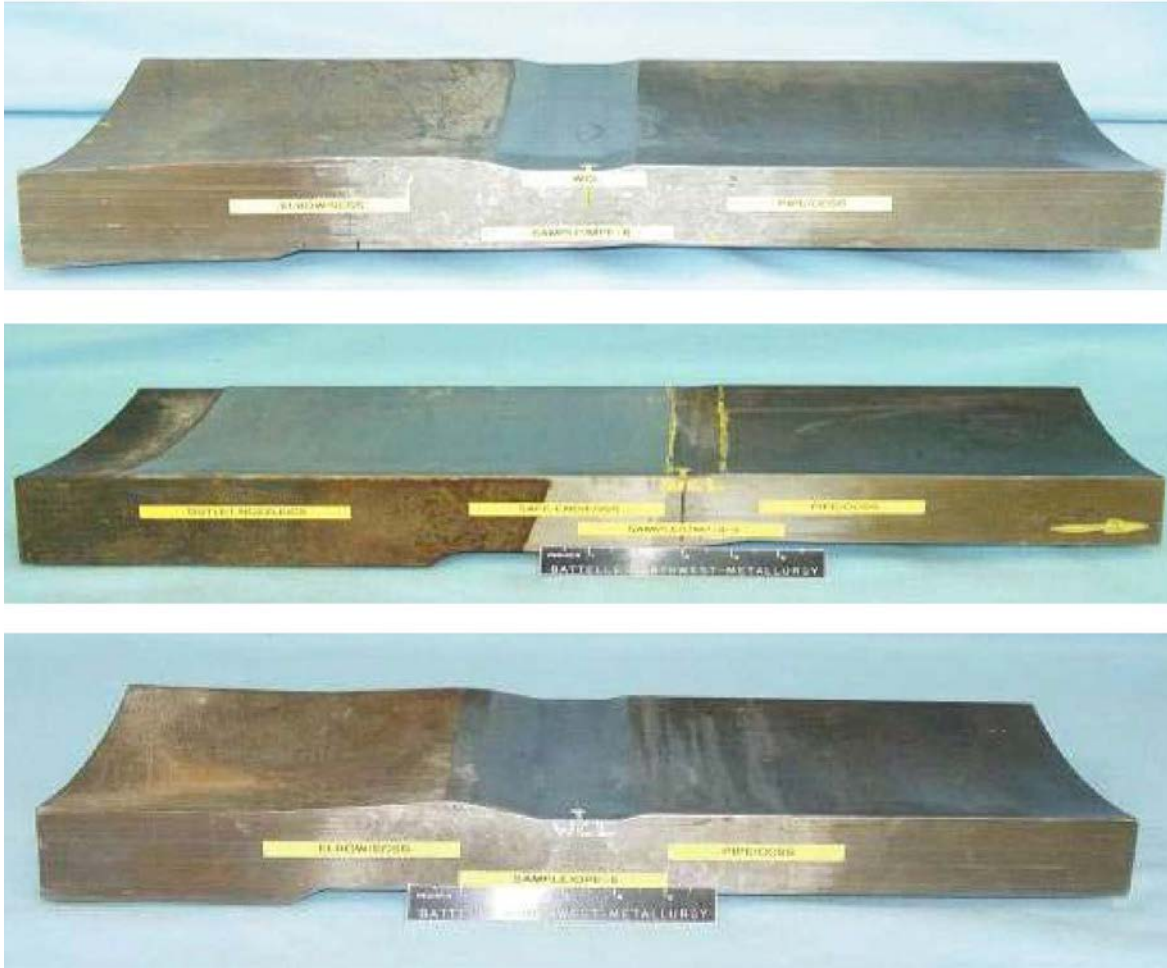
**Figure 7.2.** Photographs of the Three WOG Specimens Examined – (top): WOG specimen MPE-6; (center): WOG specimen ONP-3-5; (bottom): WOG specimen OPE-5

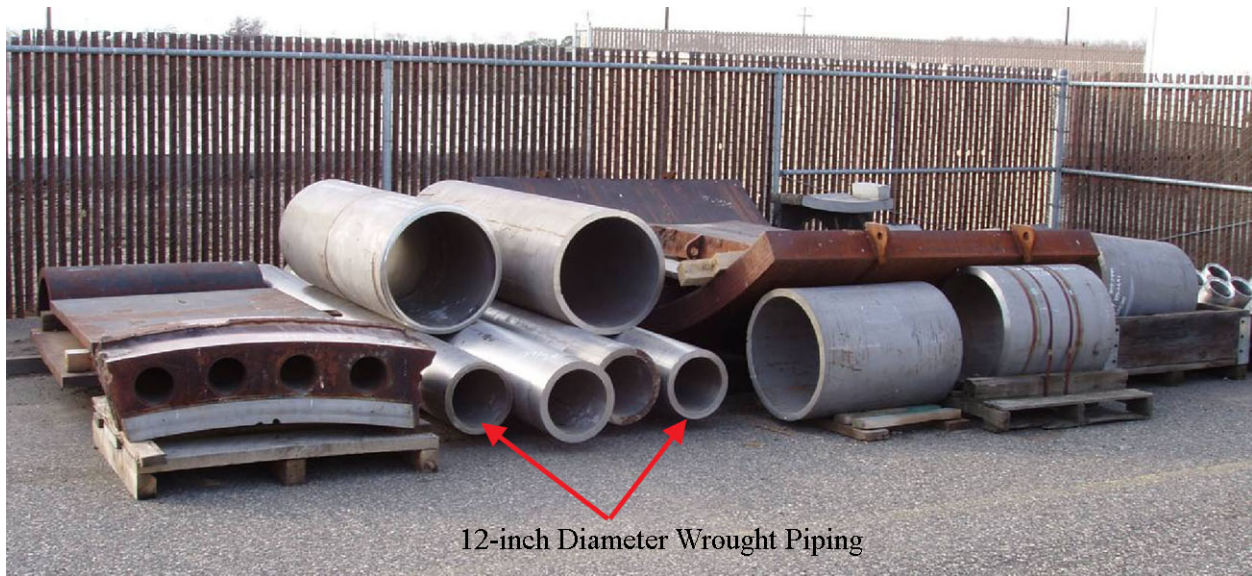
**Figure 7.3.** Photographs of the WSS Parent Material from which the Two Calibration Coupons (with EDM notches) were Extracted

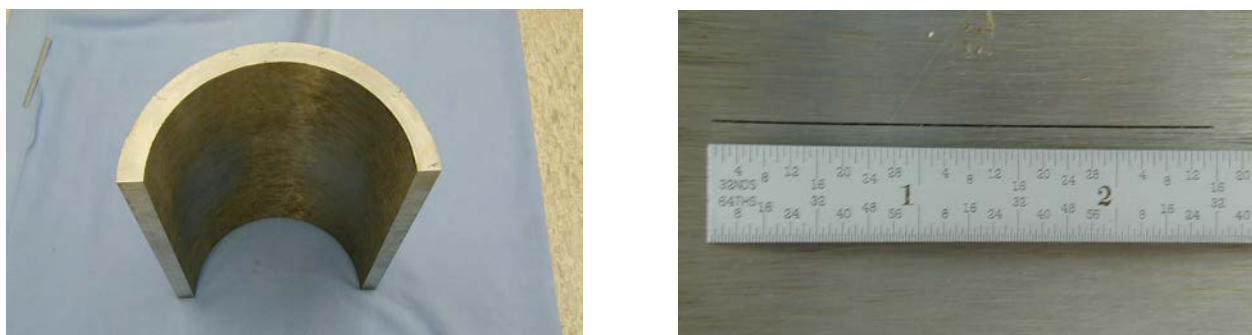
**Figure 7.4.** Photographs of the End View and ID Surface View for One of the WSS Coupons with EDM Notches, Used for Evaluation and Baseline Measurements of the PA Delta-Technique

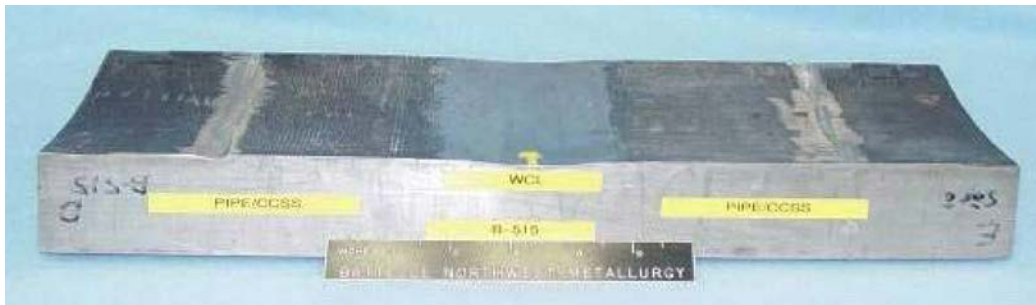
**Figure 7.5.** Photograph of PNNL CASS Specimen B-515

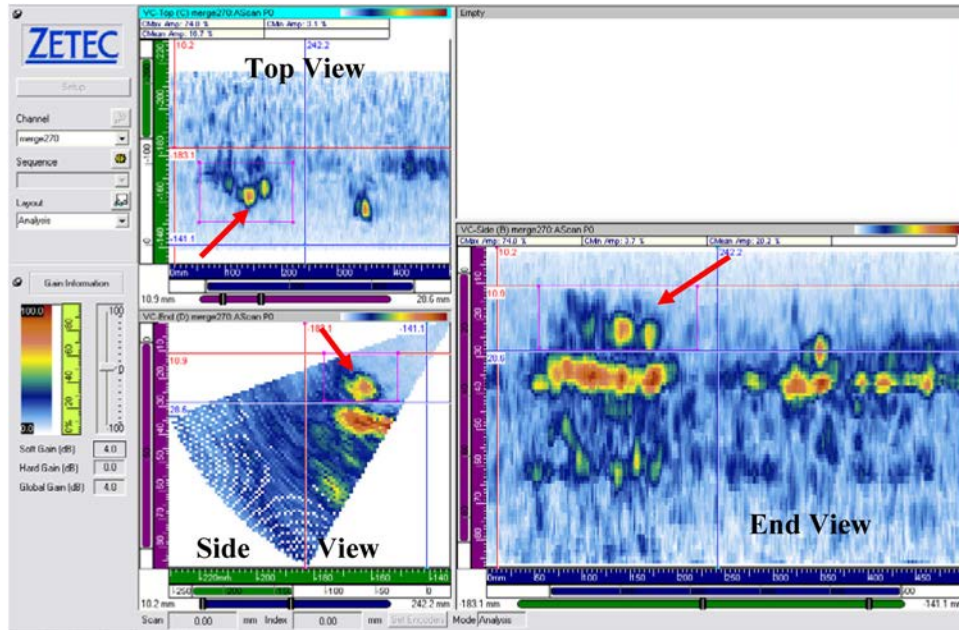
**Figure 8.2.** PZR Surge Line Flaw 1 from the CCSS Pipe Side at an Axial Position of -130 mm. The upper portion of the flaw is boxed in the side and end views providing an isolated view of the upper portion of the flaw in the C-scan, top view.

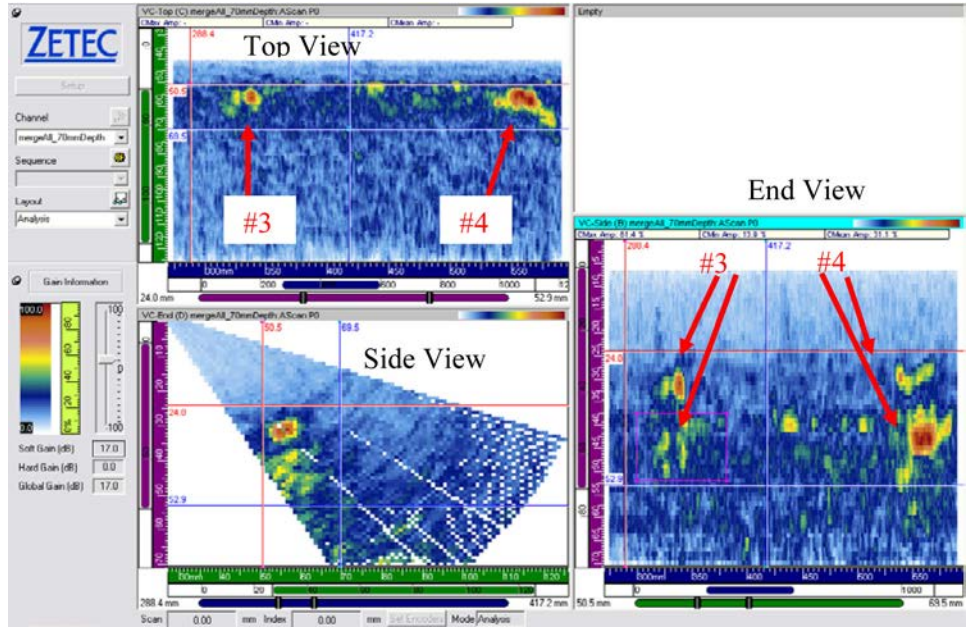
**Figure 8.3.** A Strong Corner Response from Flaw 4 is Shown in the Data and is More Typical of Flaw Responses. Flaw 3 has a strong top of flaw signal and exhibits a weaker corner signal.

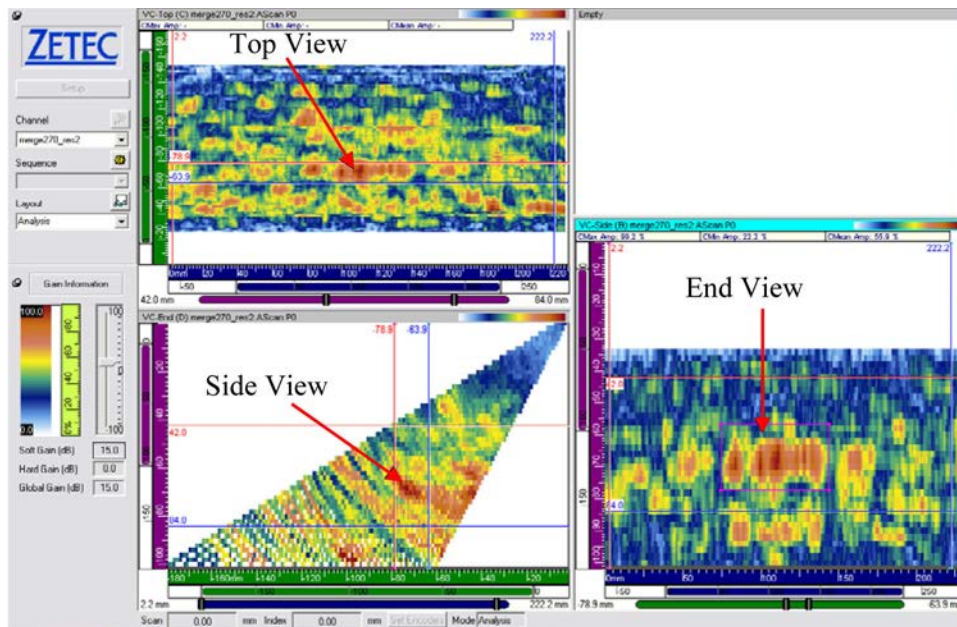
**Figure 9.1.** Thermal Fatigue Crack is Detected in MPE-6; 800-kHz Data from the SCSS Side of the Weld

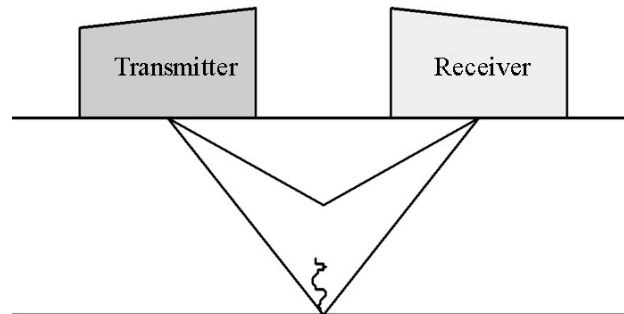
**Figure 10.1.** Example of Probes Positioned Equidistant from Weld Centerline or Flaw

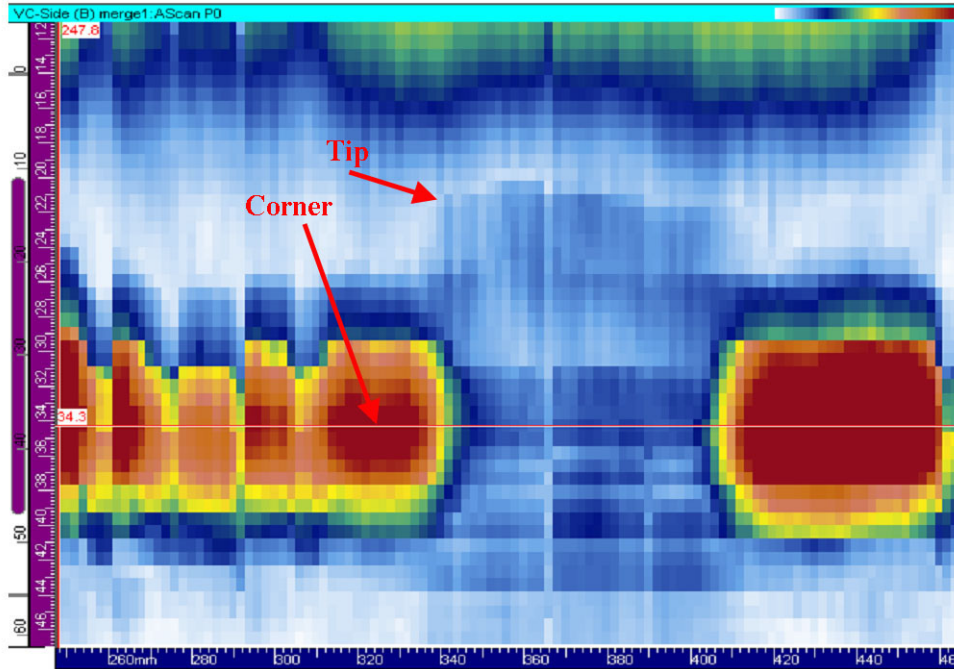
**Figure 10.4.** End-view from the Wrought Stainless Steel 40% EDM Notch Scan. The tip diffracted and backwall signals are marked. Notice the lack of backwall signal in the flaw area.

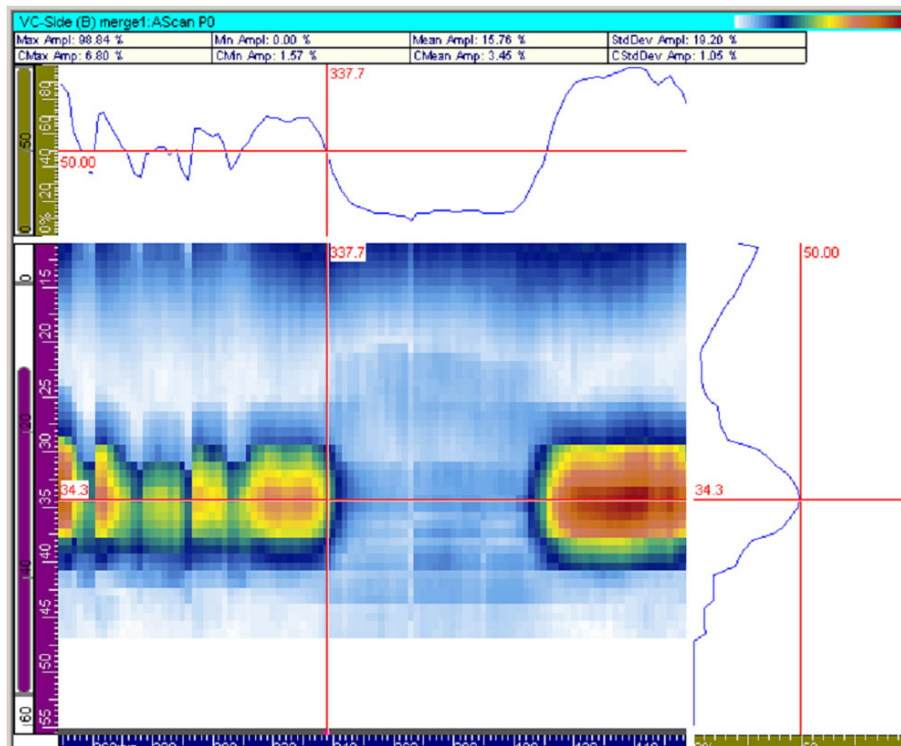
**Figure 10.5.** Notch Length Determination from the Wrought Stainless Steel 40% EDM Notch Data as Determined by Loss of Backwall Signal

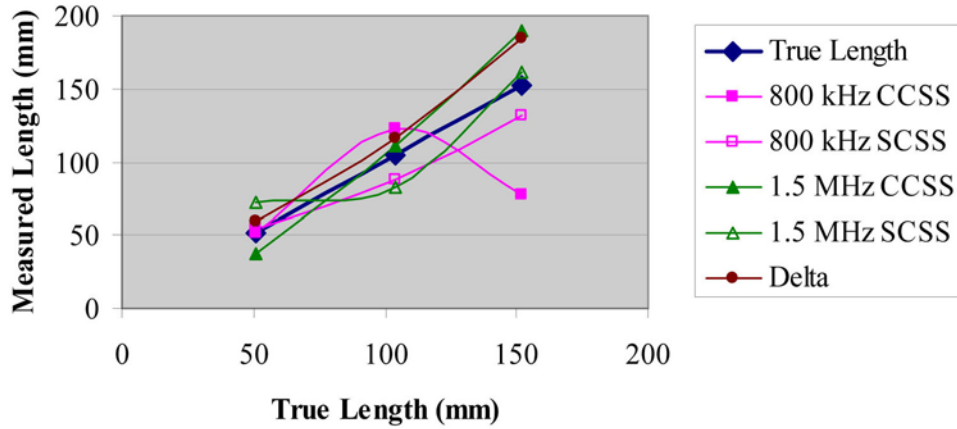
**Figure 10.6.** Measured Flaw Lengths Versus True Flaw Lengths as a Function of Flaw Number on the PZR Surge-Line Specimen Using All Frequencies and Techniques

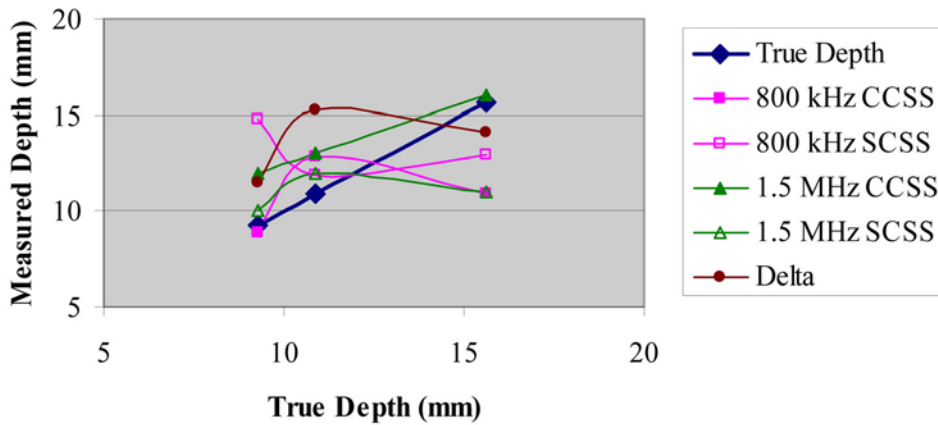
**Figure 10.7.** Measured Flaw Depths Versus True Flaw Depths as a Function of Flaw Number on the PZR Surge-Line Specimen Using All Frequencies and Techniques

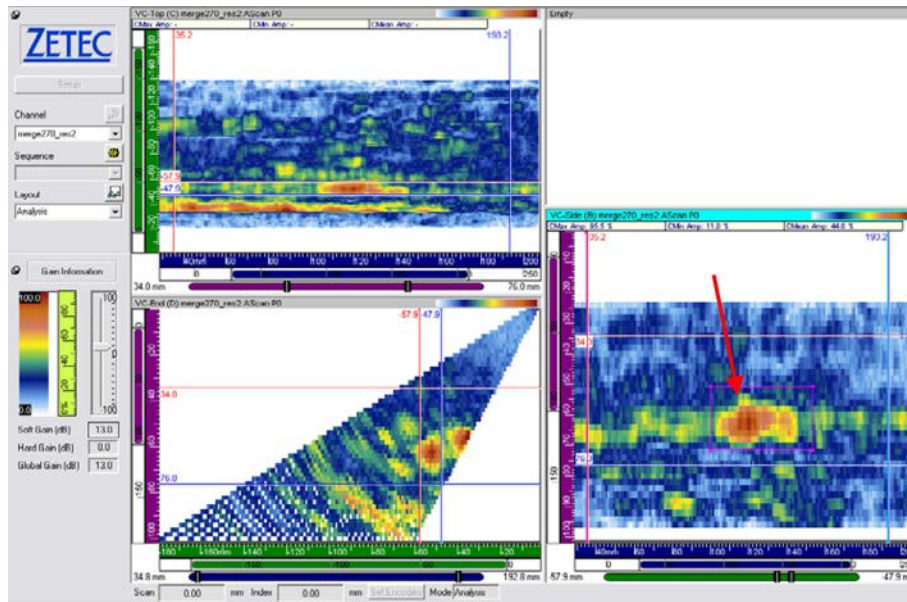
Figure C.3. 800-kHz Data from OPE-5 from the SCSS Side of the Weld. The flaw is detected.

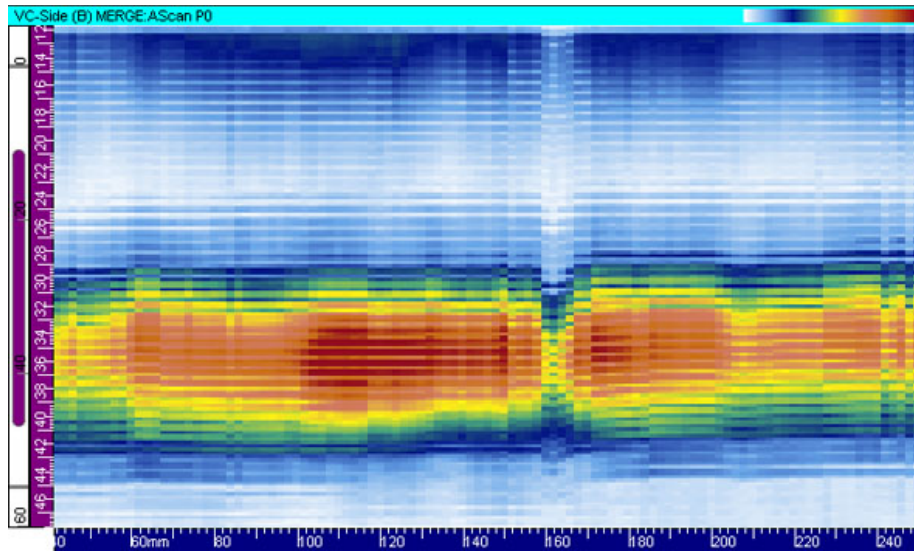
**Figure D.3.** Wrought Stainless, 10% Through-Wall EDM Notch (not detected)

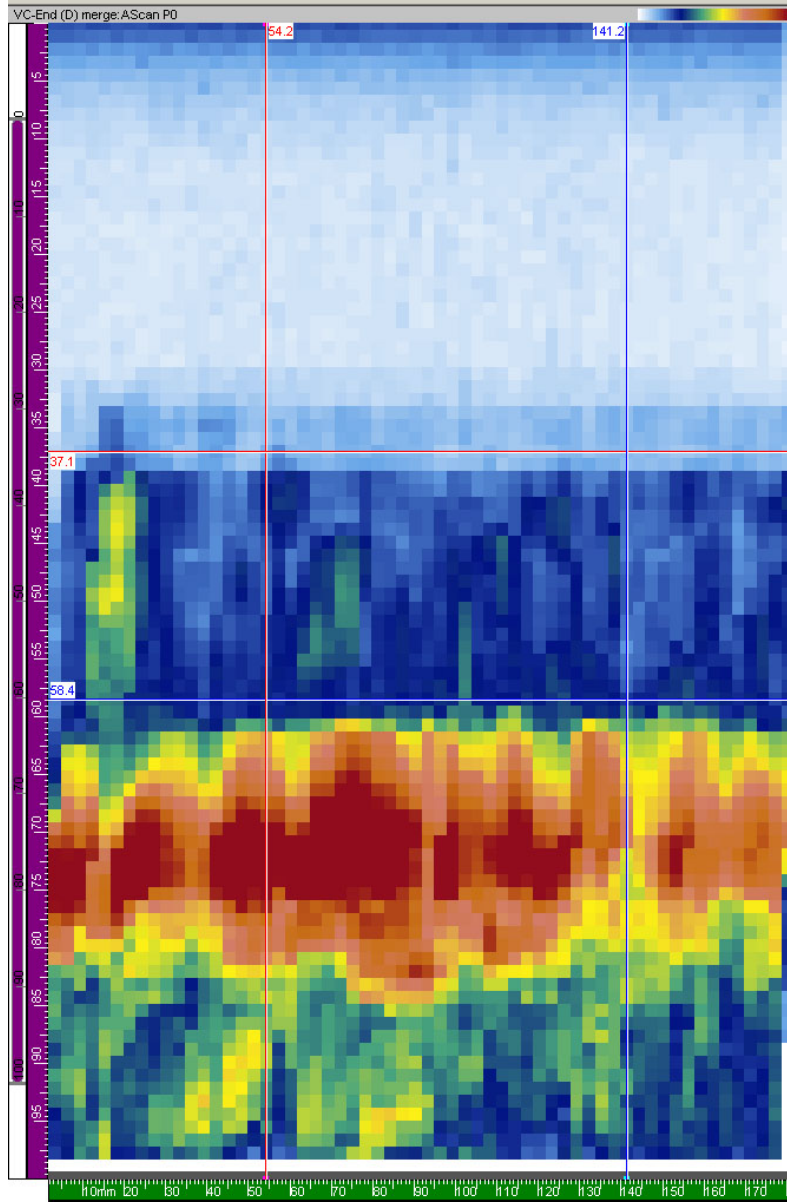
**Figure D.7.** OPE-5, 52° Transmit, 0.6-inch Separation, 15-mm Focal Plane

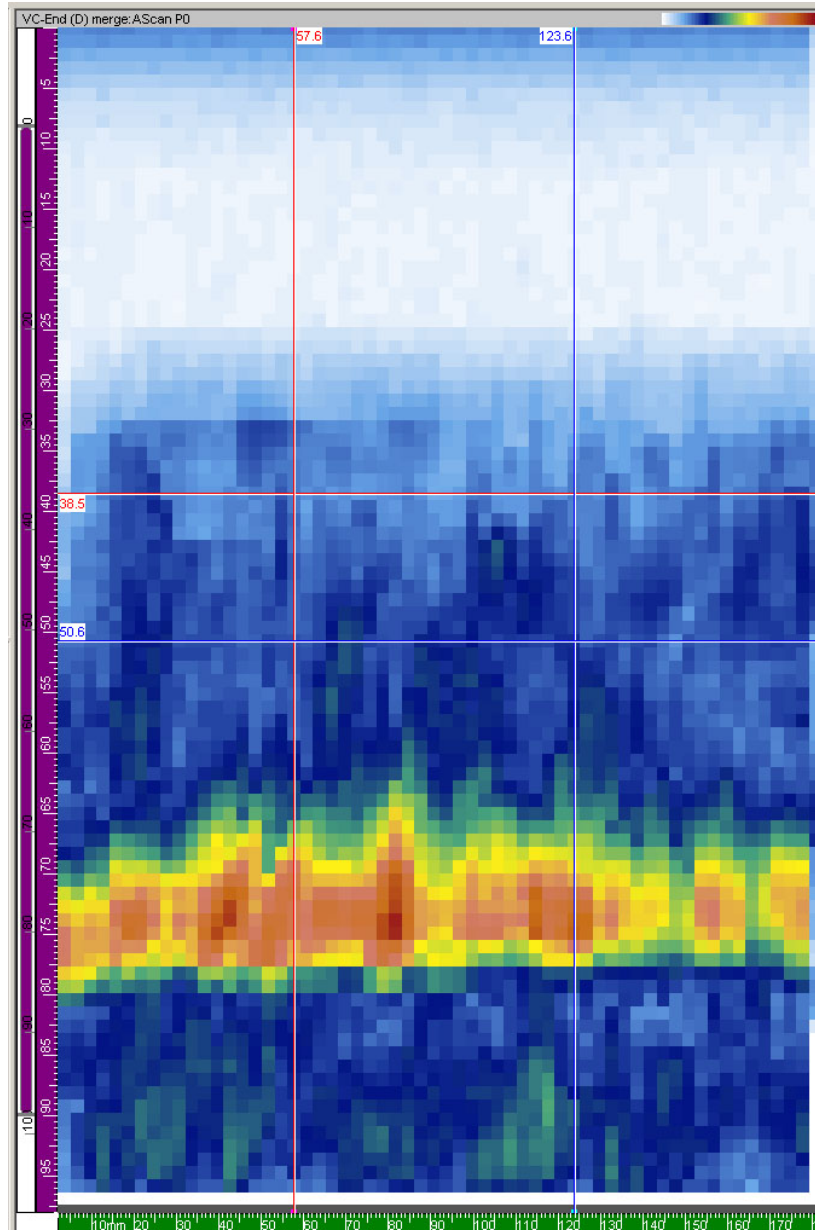
**Figure D.8.** OPE-5, 55° Transmit, 0.65-inch Separation, 15-mm Focal Plane

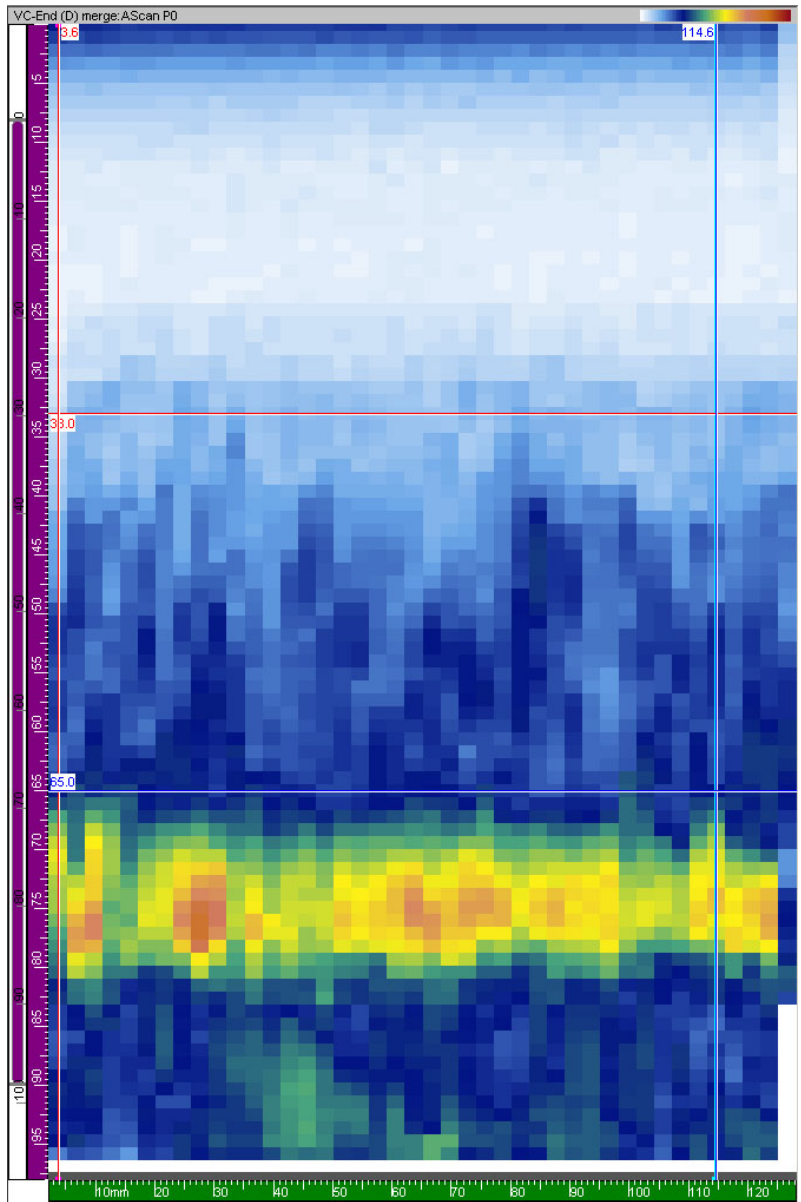
**Figure D9.** PNNL CASS Specimen B-515, 55° Transmit, 0.65-inch Separation, 15-mm Focal Plane
