CORROSION OF ALLOY 22 AND TITANIUM ALLOYS UNDER SEEPAGE WATER DRIPPING CONDITION

**U.S. Nuclear Regulatory Commission
Contract NRC-02-07-006**

**¹Center for Nuclear Waste Regulatory Analyses
San Antonio, Texas**

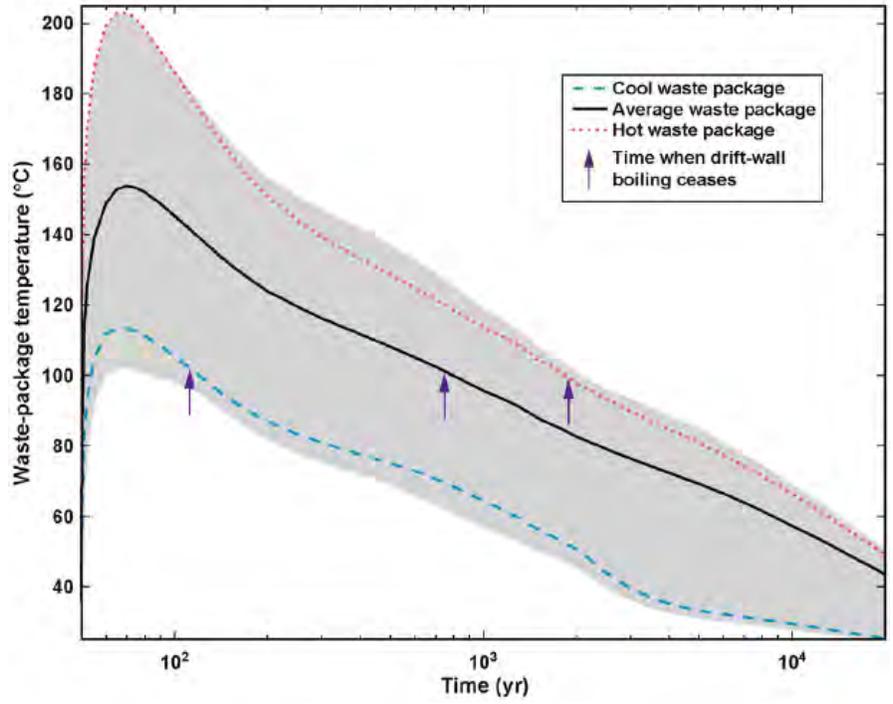
Figure 1-1. Range of Modeled Waste Package Temperature Versus Time in the Yucca Mountain Performance Assessment (Sandia National Laboratories, 2008a)

Figures 1-1 and 1-2 show the modeled ranges of temperature and relative humidity versus time for all waste packages in the proposed Yucca Mountain repository, accounting for uncertainty of host-rock thermal conductivity and percolation flux (Sandia National Laboratories, 2008a). During the first 10,000 years, the waste package temperatures could have a wide range, from a peak of 203 °C [398 °F] to room temperature. In the time period of 1,500 and 10,000 years, there is a possibility that one or a few drip shields could fail by seismic impact, allowing seepage water to contact the waste package (Sandia National Laboratories, 2008a). During this period, the average temperature could range from about 95 to 60 °C [203 to 140 °F] and the average relative humidity could range from approximately 75 to 95 percent. These ranges of modeled temperature and relative humidity were selected for the experimental conditions in this study.

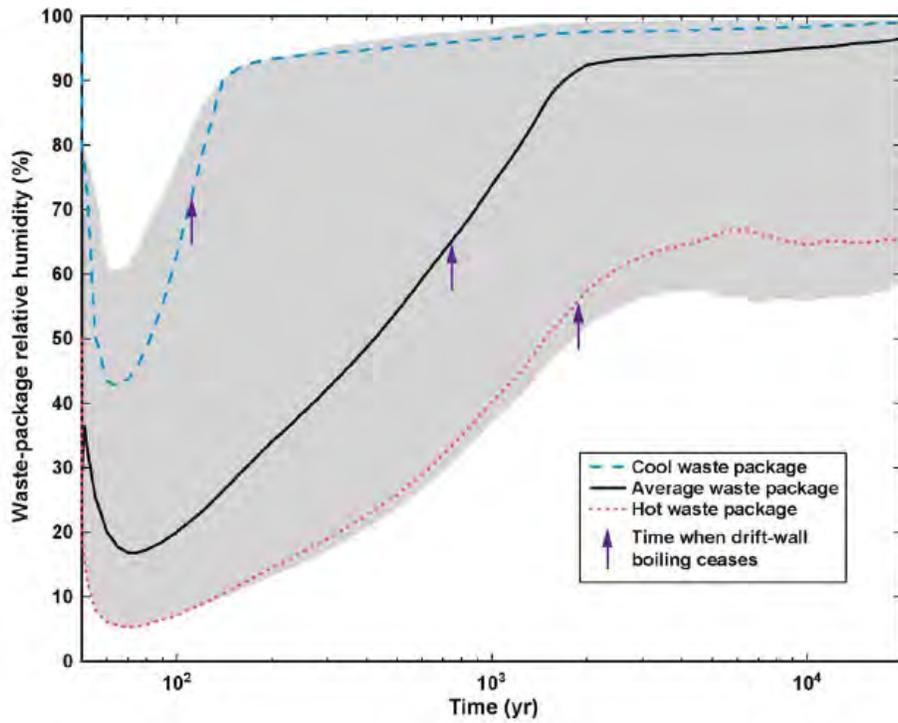
Figure 1-2. Range Modeled of Relative Humidity Versus Time in the Yucca Mountain Performance Assessment (Sandia National Laboratories, 2008a)

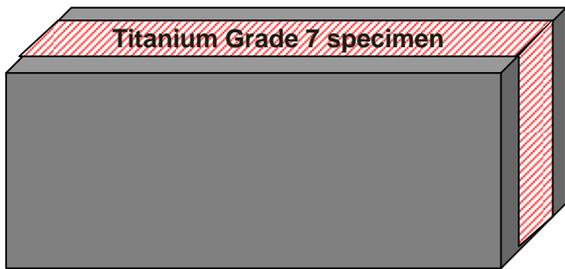
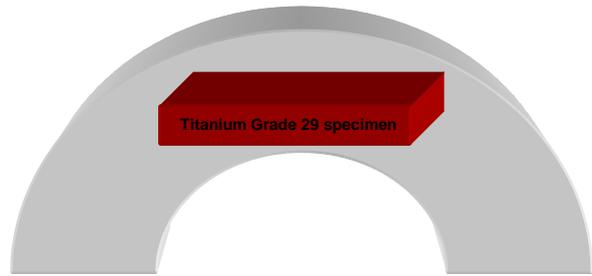
Figure 2-1. (a) Titanium Grade 7 and (b) Titanium Grade 29 Specimens Machined From Original Plate or Pipe Sections

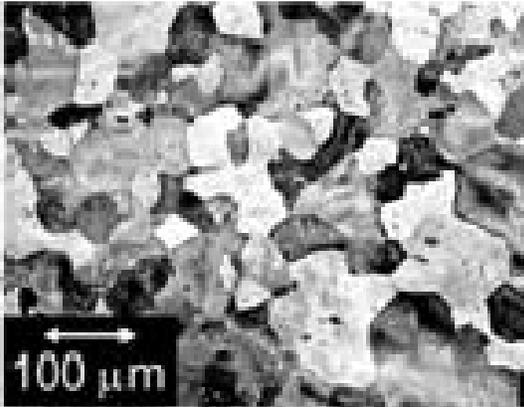
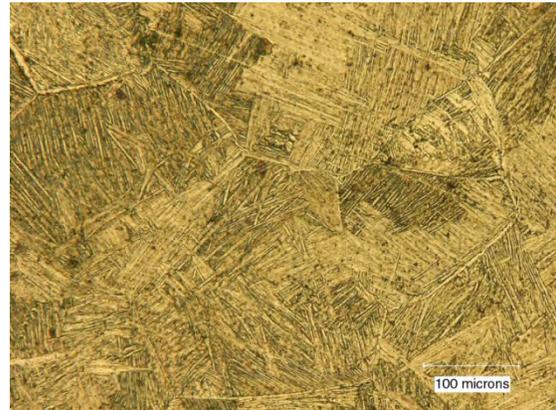
Figure 2-2. Microstructure of (a) Titanium Grade 7 and (b) Titanium Grade 29 Specimens

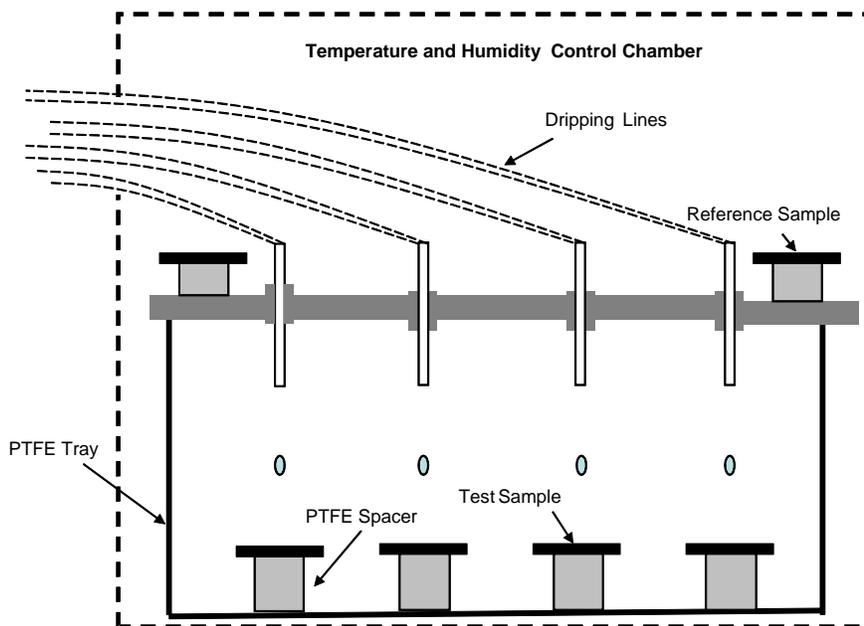
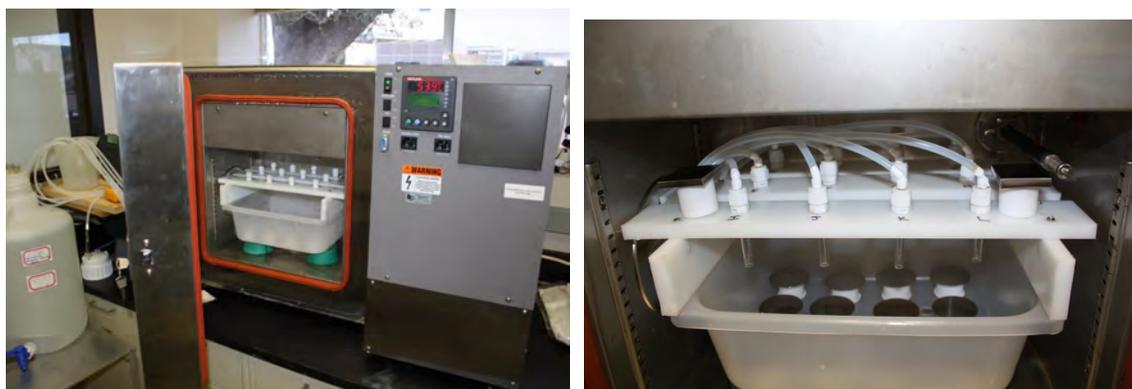
Figure 2-3. Experimental Setup For Dripping Test

The dripping corrosion tests of Alloy 22 and titanium alloys were conducted inside a chamber with a controlled temperature and relative humidity as shown in Figure 2-3. Each test specimen was set on a 3.4 cm [1.3 in] outer diameter polytetrafluoroethylene (PTFE) cylinder spacer. The PTFE cylinders with the test specimens were placed inside a PTFE tray in the chamber. The top of the dripping tubes was located about 10 cm [3.94 in] above the test specimen. The dripping water is simulated seepage water with the chemical composition shown in Table 2-3. Dunn, et al. (2006) used the same composition to represent neutral-type seepage waters in experiments to evaluate the effect of environmental conditions on the performance of the Alloy 22 waste package material. The water was pumped from a reservoir outside of the chamber through PTFE tubing into the chamber and allowed to drip on the test specimens. The temperature and relative humidity were controlled and maintained constant through the testing periods. The temperature and relative humidity near the test specimens were monitored by using additional measurement probes from the outside. The probes of the thermocouple and humidity gauge were extended to be located close to the test specimens. Because the temperature and humidity sensors were located at the edge of the ceiling inside the chamber, it was necessary to confirm the actual temperature and relative humidity to which the test specimens located on the floor inside the chamber were directly exposed.

As schematically shown in Figure 2-3, dripping tests of titanium alloys were conducted inside the same chamber with the same setup as for Alloy 22. Each titanium coupon was set on a 3.4 cm [1.3 in] outer diameter PTFE cylinder with one 4 × 4-cm [1.6 × 1.6-in] side subject to dripping. For the first batch of tests at 80 °C [176 °F] and relative humidity of 85 percent with a test duration of 181 days, 2 coupons for each material were subject to dripping. The dripping rate was approximately 80 mL/day [2.7 oz/day] as shown in Table 2-4. The droplet size was discussed in Chapter 1. For the second batch of tests at 95 °C [203 °F] and relative humidity of 75 percent with a test duration of 64 days, 3 coupons for each material were used for dripping. The dripping water is simulated seepage water, which is the same as that for Alloy 22. For each batch of tests, one additional coupon for each material without dripping was set in the chamber under the same temperature and relative humidity as the reference specimen for comparison.

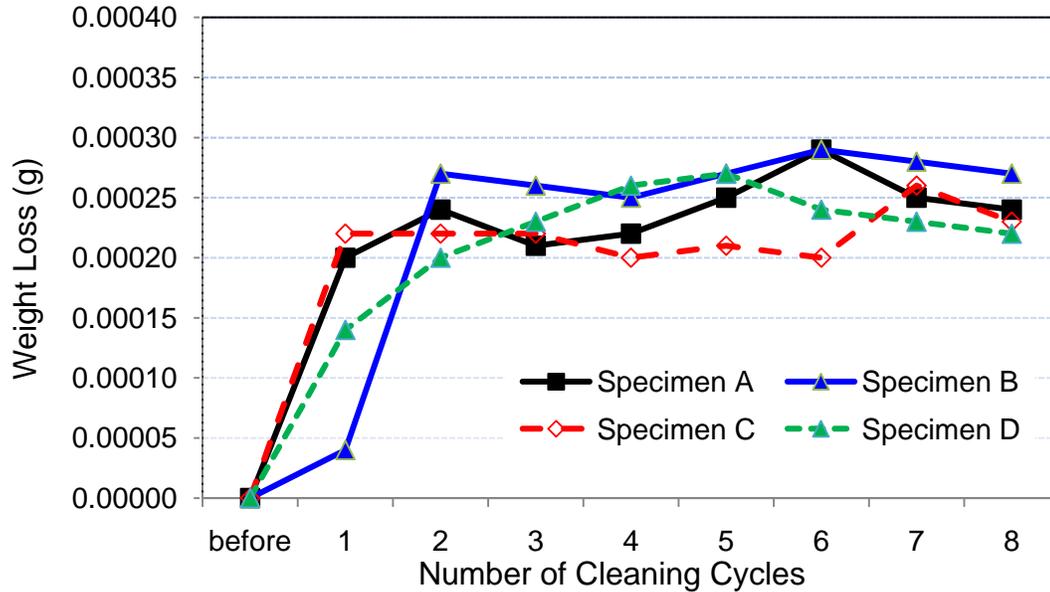
Figure 2-4. Weight Losses of the Corroded Test Specimens Resulting From Repetitive Cleaning Cycles in an ASTM HCl Solution (ASTM International, 2003). The Weight Loss After the Third Cycle of Cleaning Was Used in the Weight Loss Analysis.

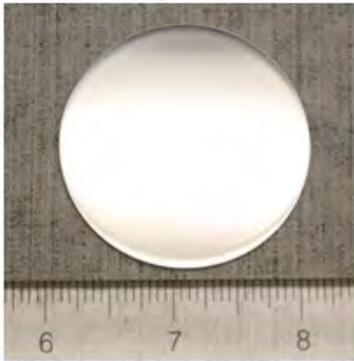
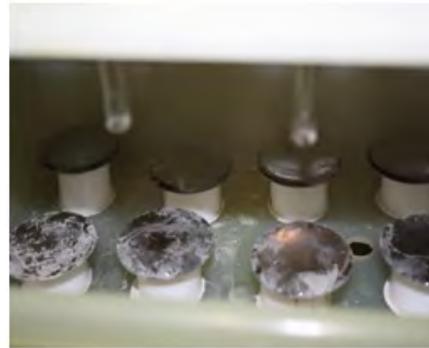
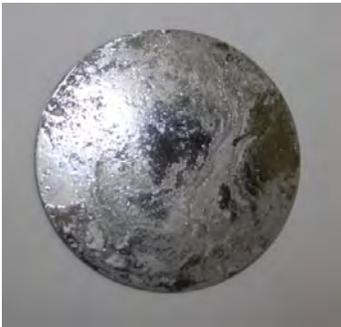
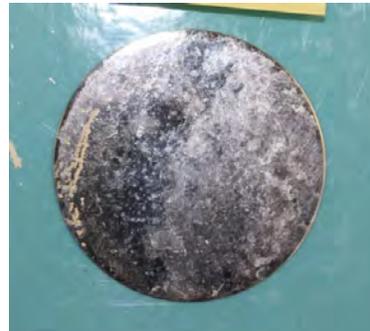
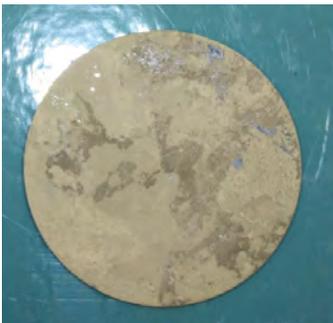
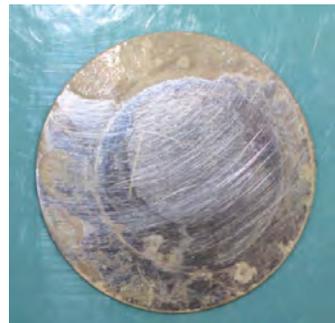
Figure 3-1. Photos of Pre- and Posttest Surfaces of Alloy 22 Tested at 80 °C [176 °F] and 85 Percent Relative Humidity: (a) Before Corrosion Test, (b) Chamber Inside During Dripping, (c) After 35 Days Dripped, (d) After 70 Days Dripped, (e) After 185 Days Dripped (Upper Side), and (f) After 185 Days Dripped (Lower Side)

Figure 3-1 shows the optical photos of the posttest specimens after 35, 70, and 185 days of the dripping tests at 80 °C [176 °F] and relative humidity of 85 percent. Most of the surface areas on the front upper side subjected to water dripping were covered with white salt deposits. The white deposits were also observed on the lower side, particularly the outside area of the PTFE spacer covered inner area as seen in Figure 3-1(f).

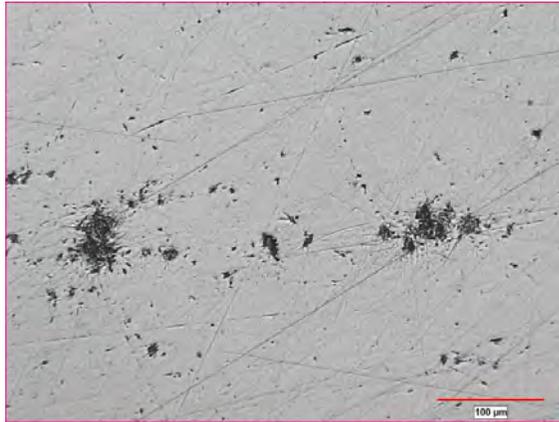
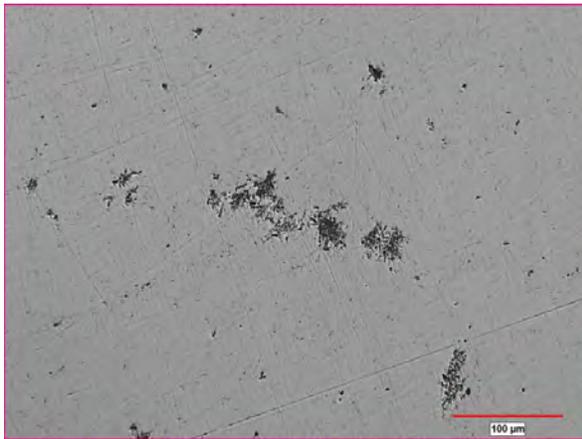
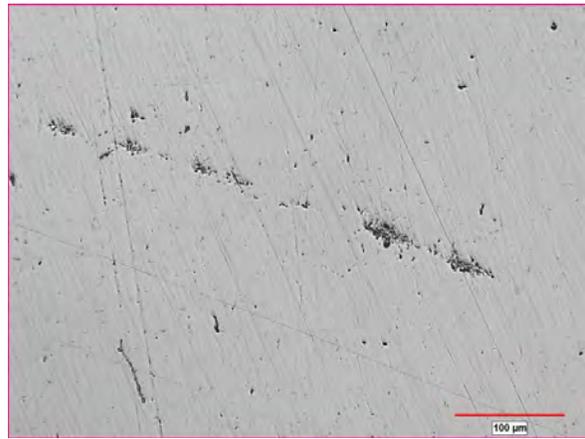
Figure 3-2. Optical Micrographs of Alloy 22 Surfaces Tested at 80 °C [176 °F] and 85 Percent Relative Humidity: (a) After 35 Days Dripped, (b) After 70 Days Dripped, and (c) After 185 Days Dripped

After removing the salt deposits, followed by sample cleaning with HCl solutions, the specimens were examined with an optical microscope. Figure 3-2 shows typical morphologies of the corroded surface of Alloy 22. After 35 days of the dripping test, as shown in Figure 3-2(a), corrosion pits were observed throughout the area exposed to the dripping water. Many small sized pits ranged about 1 to 10 μm [3.94×10^{-5} to 3.94×10^{-4} in] were also present. With dripping for 70 days, as shown in Figure 3-2(b), the surface exhibited similar pits in terms of pit size and popularity. However, pitting appeared to a lesser extent, indicating no growth of nucleated pits. After longer term tests (185 days) the pits appeared to be smaller and shallow. There was no clear evidence of pit propagation. Ashida, et al. (2008) also observed salt deposit formation and localized corrosion (i.e., pitting and intergranular corrosion) on the Alloy 22 surface after 40 days' dripping of saturated concentrated water at 90 °C [194 °F]. However, the microsized pits were not stable and did not grow deep. A similar observation was reported on Alloy 22 tested in saturated acidic water at 80 °C [176 °F] (Badwe, et al., 2006).

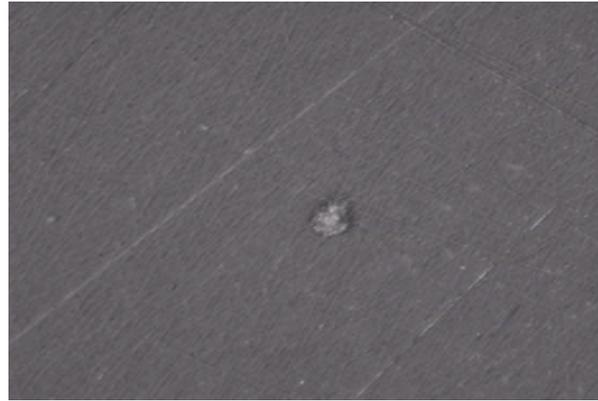
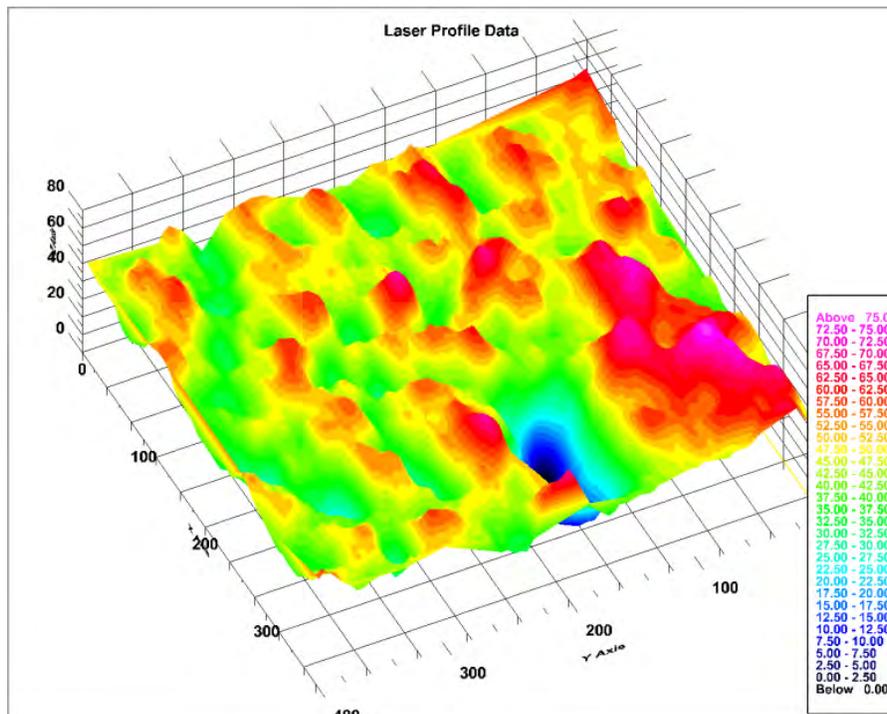
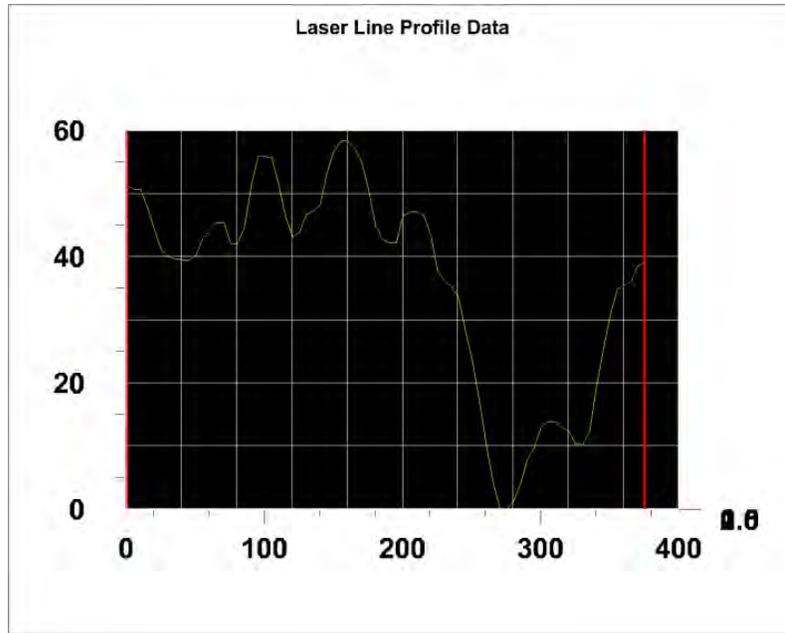
Figure 3-3. Surface Topography of Alloy 22 Specimen After 35 Days Dripped at 80 °C [176 °F] and 85 Percent Relative Humidity: (a) Optical Micrograph, (b) 3-D Laser Scan Profiles of the Pit Area, and (c) 2-D Profiles

Note: The Square Box in (a) Indicates the Laser Scanning Area.

Figure 3-3 (continued). Surface Topography of Alloy 22 Specimen After 35 Days Dripped at 80 °C [176 °F] and 85 Percent Relative Humidity: (a) Optical Micrograph, (b) 3-D Laser Scan Profiles of the Pit Area, and (c) 2-D Profiles

The pits were further analyzed by using a laser profilometer to estimate the pit depth. Figure 3-3(a) shows the typical pit morphology of the corroded surface of Alloy 22 after 35 days' exposure to dripping conditions. As can be seen from both the three-dimensional (3-D) and two-dimensional (2-D) profiles in Figure 3-3(b,c) the pit has a width of roughly 150 μm [5.91×10^{-3} in], with a depth of roughly 40 μm [1.58×10^{-3} in]. These results are similar to those observed from the optical microscopy. Figure 3-4(a) shows the typical pit morphology of the corroded surface of Alloy 22 after 185 days' exposure to the dripping water. Figure 3-3(a) and 3-4(a) are taken at the same magnification. As can be seen from Figure 3-4(a), the pit morphology is not much different from that after 35 days. Figure 3-4(b,c) shows the 2-D and 3-D profiles for the 185-day exposed pit. The pit width is roughly 125 μm [4.92×10^{-3} in], with a

depth roughly 30 μm [1.18×10^{-3} in]. Similar to the results observed from the optical microscopy, there was no evidence of pit propagation.

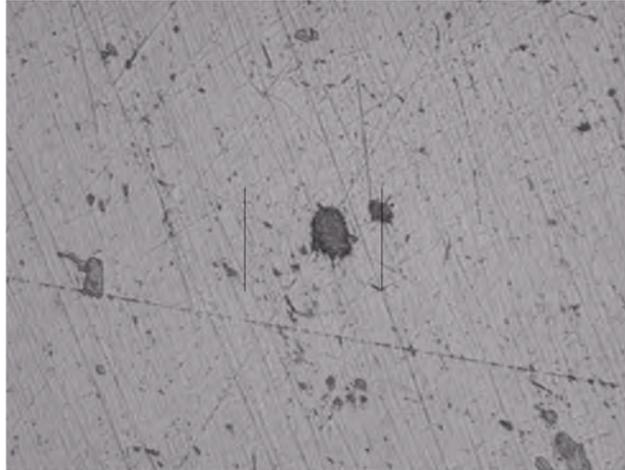
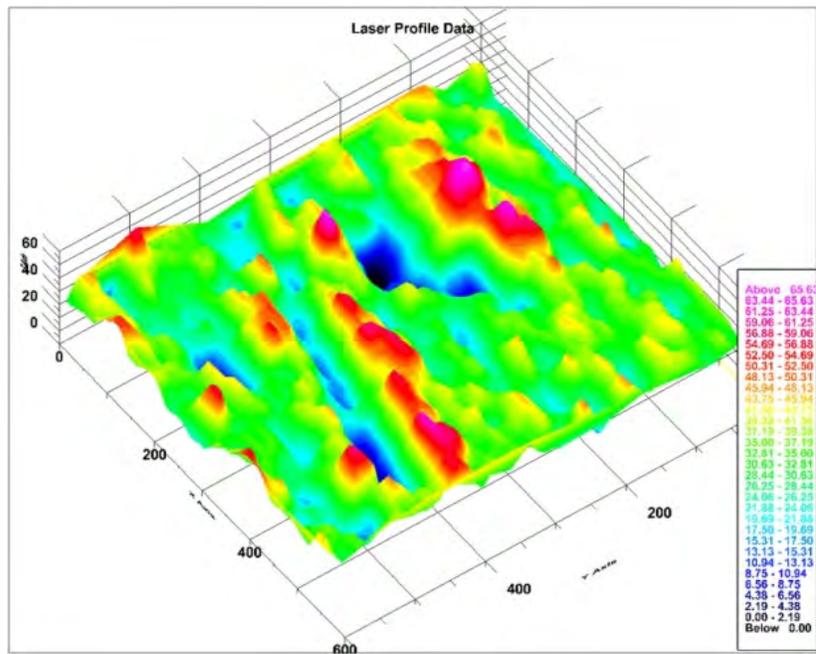
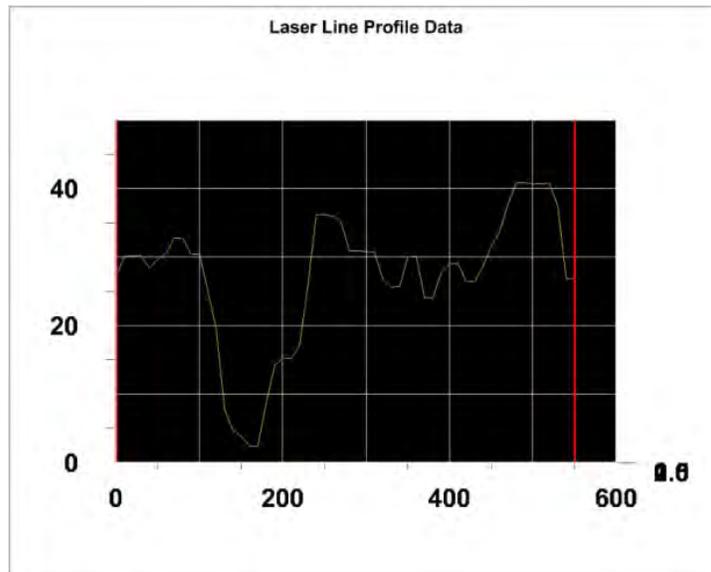
Figure 3-4. Surface Topography of Alloy 22 Specimen After 185 Days Dripped at 80 °C [176 °F] and 85 Percent Relative Humidity: (a) Optical Micrograph, (b) 3-D Laser Scan Profiles of the Pit Area, and (c) 2-D Profiles

The Units in (b) and (c) Indicates x-, y-, z-axes Are Micrometer.

Figure 3-4 (continued). Surface Topography of Alloy 22 Specimen After 185 Days Dripped at 80 °C [176 °F] and 85 Percent Relative Humidity: (a) Optical Micrograph, (b) 3-D Laser Scan Profiles of the Pit Area, and (c) 2-D Profiles

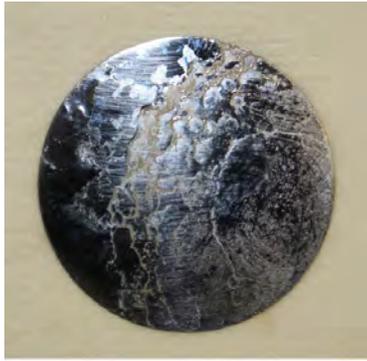
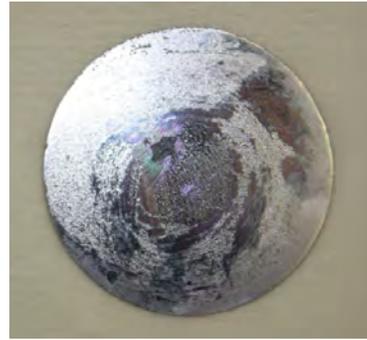
Figure 3-5. Photos of Posttest Surfaces of Alloy 22 After 33 Days Dripped at 95 °C [203 °F] and 75 Percent Relative Humidity for (a) Specimen I and (b) Specimen J

Figure 3-5 shows the posttest Alloy 22 specimens after 33 days of testing at 95 °C [203 °F] and relative humidity of 75 percent. Similar to the observations on Alloy 22 from the first batch, white deposits were also present on the specimens. By removing the deposits, as seen in Figure 3-6(a), the Alloy 22 surface exhibited several corrosion areas with tiny pits. Any changes

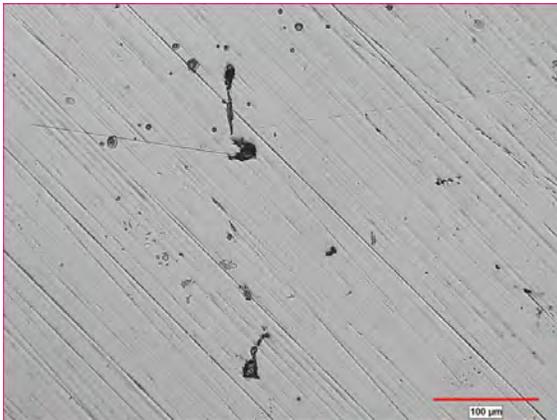
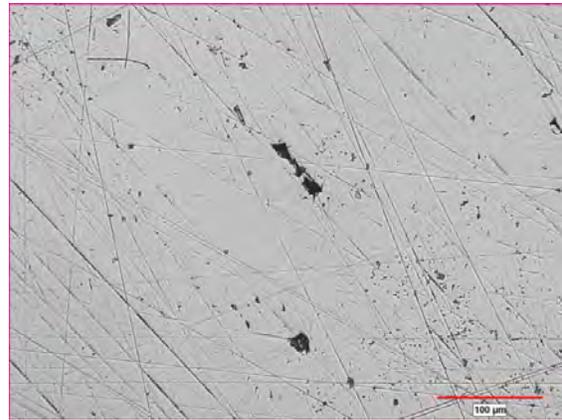
Figure 3-6. Optical Micrographs of Alloy 22 Surfaces Tested at 95 °C [203 °F] and 75 Percent Relative Humidity: (a) After 33 Days Dripped and (b) After 67 Days Dripped

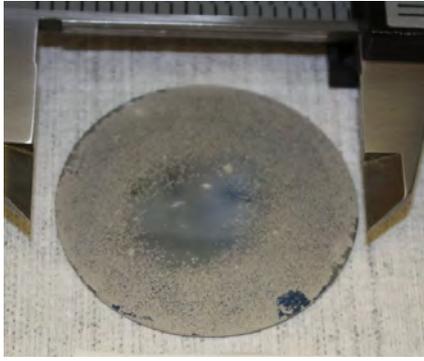
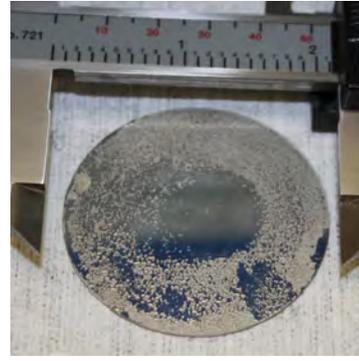
Figure 3-7. Photos of Posttest Surfaces of Alloy 22 After 60 Days Dripped at 60 °C [140 °F] and 95 Percent Relative Humidity for (a) Specimen Q and (b) Specimen R

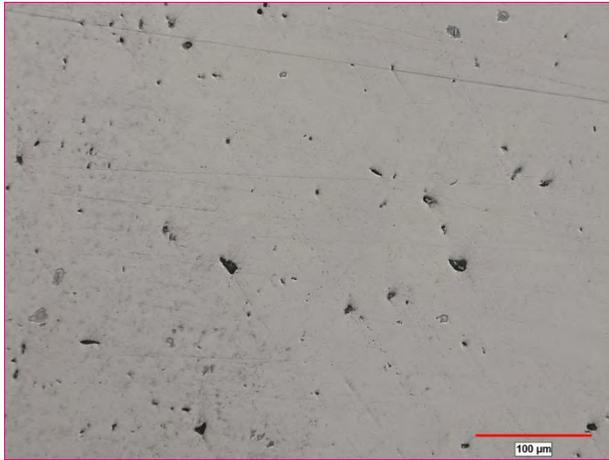
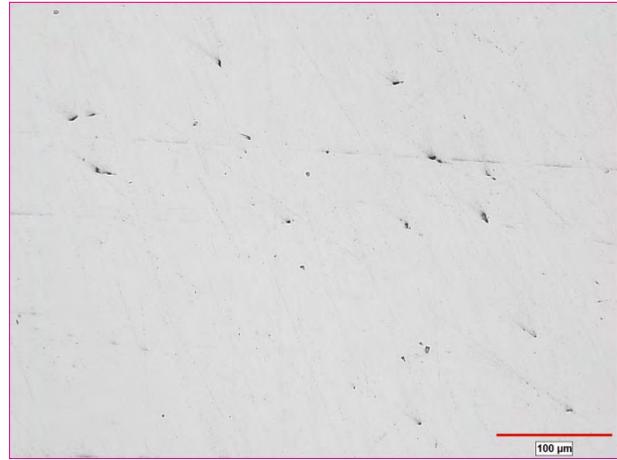
Figure 3-8. Optical Micrographs of Alloy 22 Surfaces Tested at 60 °C [140 °F] and 95 Percent Relative Humidity: (a) After 32 Days Dripped and (b) After 60 Days Dripped

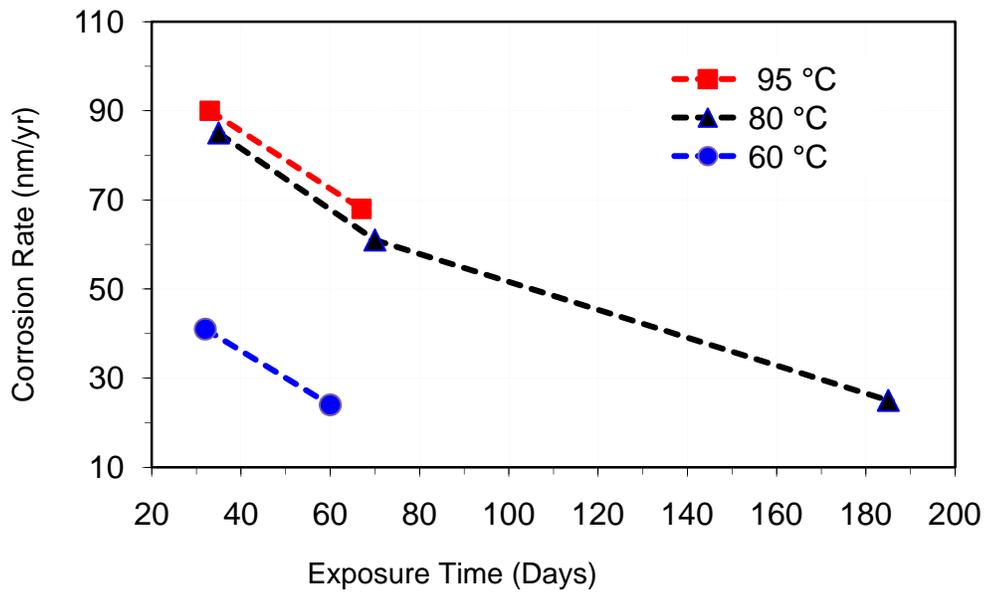
Figure 3-9. Corrosion Rate of Alloy 22 as a Function of Time Tested at Temperatures of 95, 80, and 60 °C [203, 176, and 140 °F]

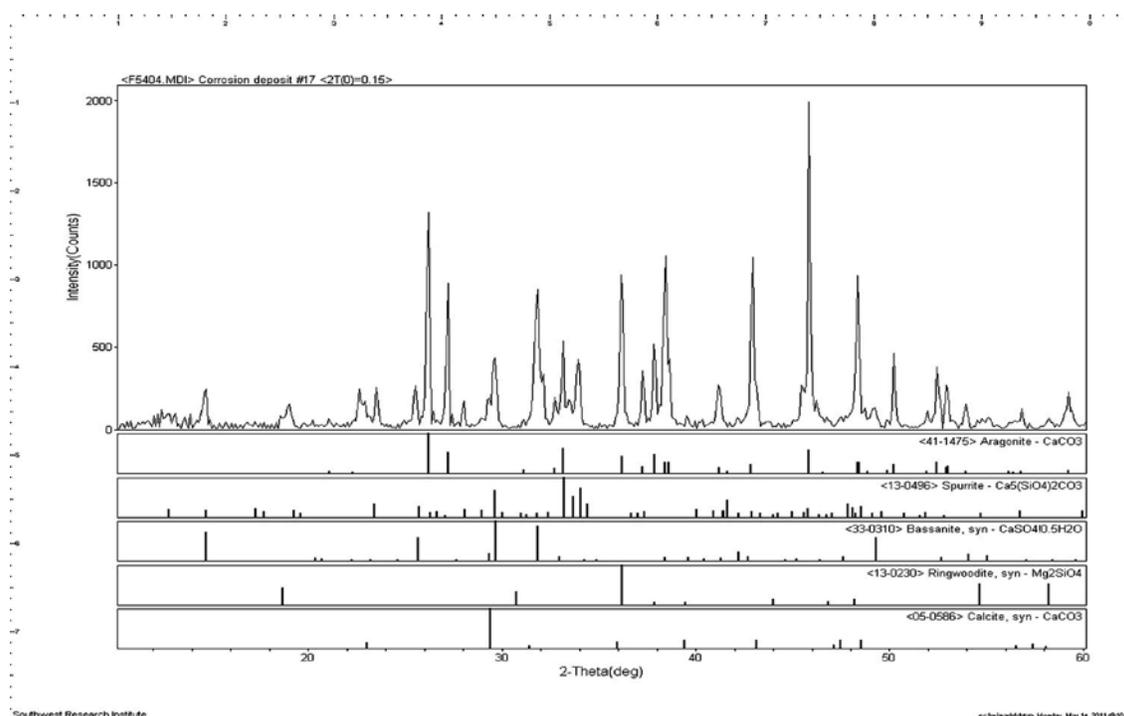
Figure 3-10. X-Ray Diffraction Spectroscopy of Salts Deposited on Alloy 22 Specimen After 32 Days Dripped at 60 °C [140 °F] and 95 Percent Relative Humidity. Also Shown Are the Reference Spectroscopy of Salts That Best Match the Salt Deposit Spectroscopy.

The EDS result is shown in Table 3-5, and the XRD data are shown in Figures 3-10 to 12. The XRD data indicate that the salts are dominantly calcium carbonate. Minor amounts of calcium sulfate, magnesium phosphate, calcium silicate carbonate, and magnesium silicate also could be present. The XRD result is consistent with the EDS data that show calcium and magnesium as the dominant elements in the salt deposit. Based on the EDS results, sodium chloride and sodium sulfate also could be present in the salt deposit but in amounts less than the detection limit of the XRD method. For comparison, OLI Analyzer Studio evaporation simulation indicated the possible formation of calcium carbonate, magnesium carbonate, sodium sulfate, and sodium-calcium sulfate.

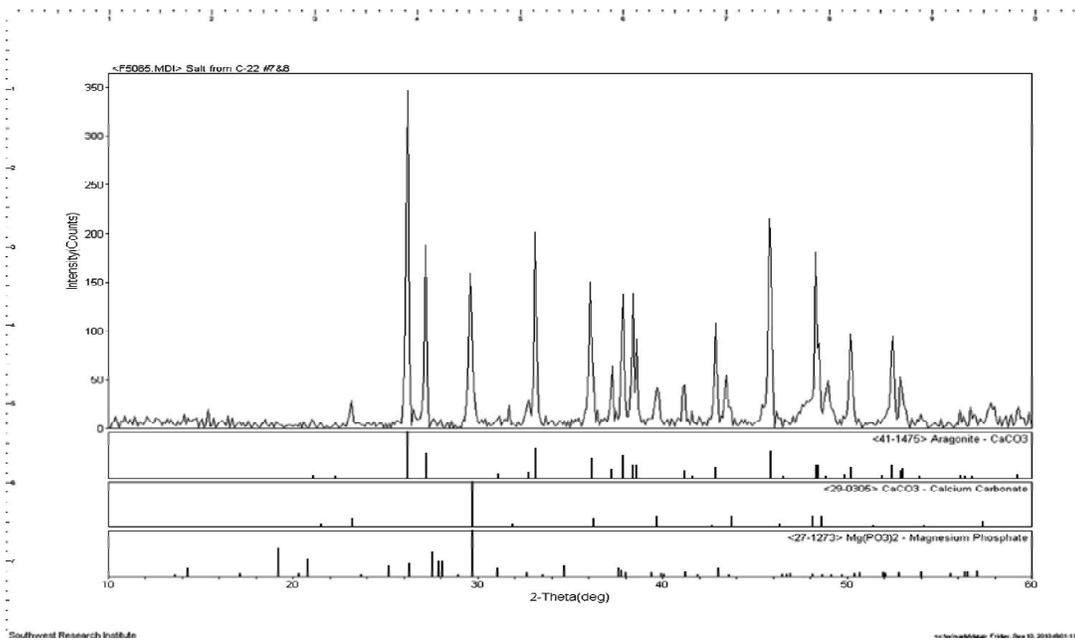
Figure 3-11. X-Ray Diffraction Spectroscopy of Salts Deposited on Alloy 22 Specimen After 185 Days Dripped at 80 °C [176 °F] and 85 Percent Relative Humidity. Also Shown Are the Reference Spectroscopy of Salts That Best Match the Salt Deposit Spectroscopy.

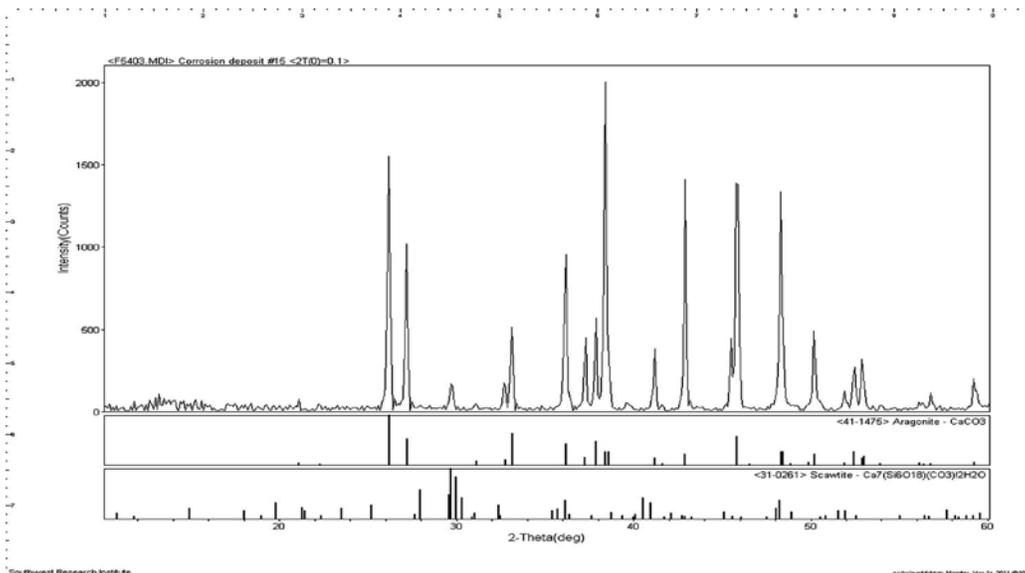
Figure 3-12. X-Ray Diffraction Spectroscopy of Salts Deposited on Alloy 22 Specimen After 67 Days Dripped at 95 °C [203 °F] and 75 Percent Relative Humidity. Also Shown Are the Reference Spectroscopy of Salts That Best Match the Salt Deposit Spectroscopy.

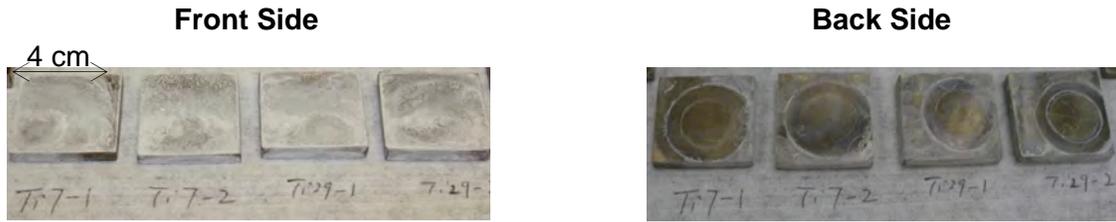
Figure 3-13. First Batch of Posttest Titanium Grades 7 and 29 Specimens at Temperature of 80 °C [176 °F] and Relative Humidity of 85 Percent. The specimen Size Was Approximately 4 × 4 × 0.6 cm³ [1.6 × 1.6 × 0.2 in³].

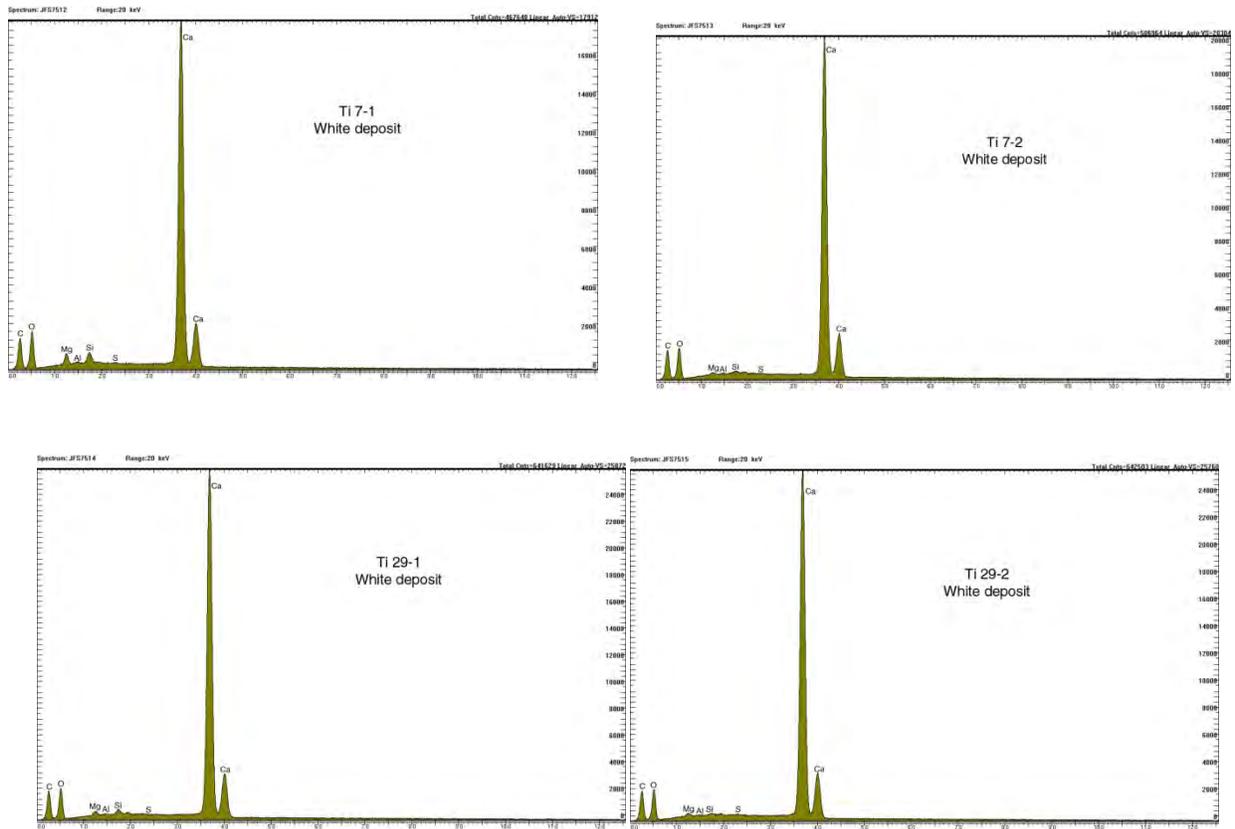
Figure 3-14. Energy-Dispersive X-Ray Spectroscopy of the White Deposits on the First Batch of Posttest Titanium Grades 7 and 29 Specimens Showing That the White Deposits Consist of Calcium, Carbon, Oxygen, Silicon, Sulfur, Aluminum, and Magnesium

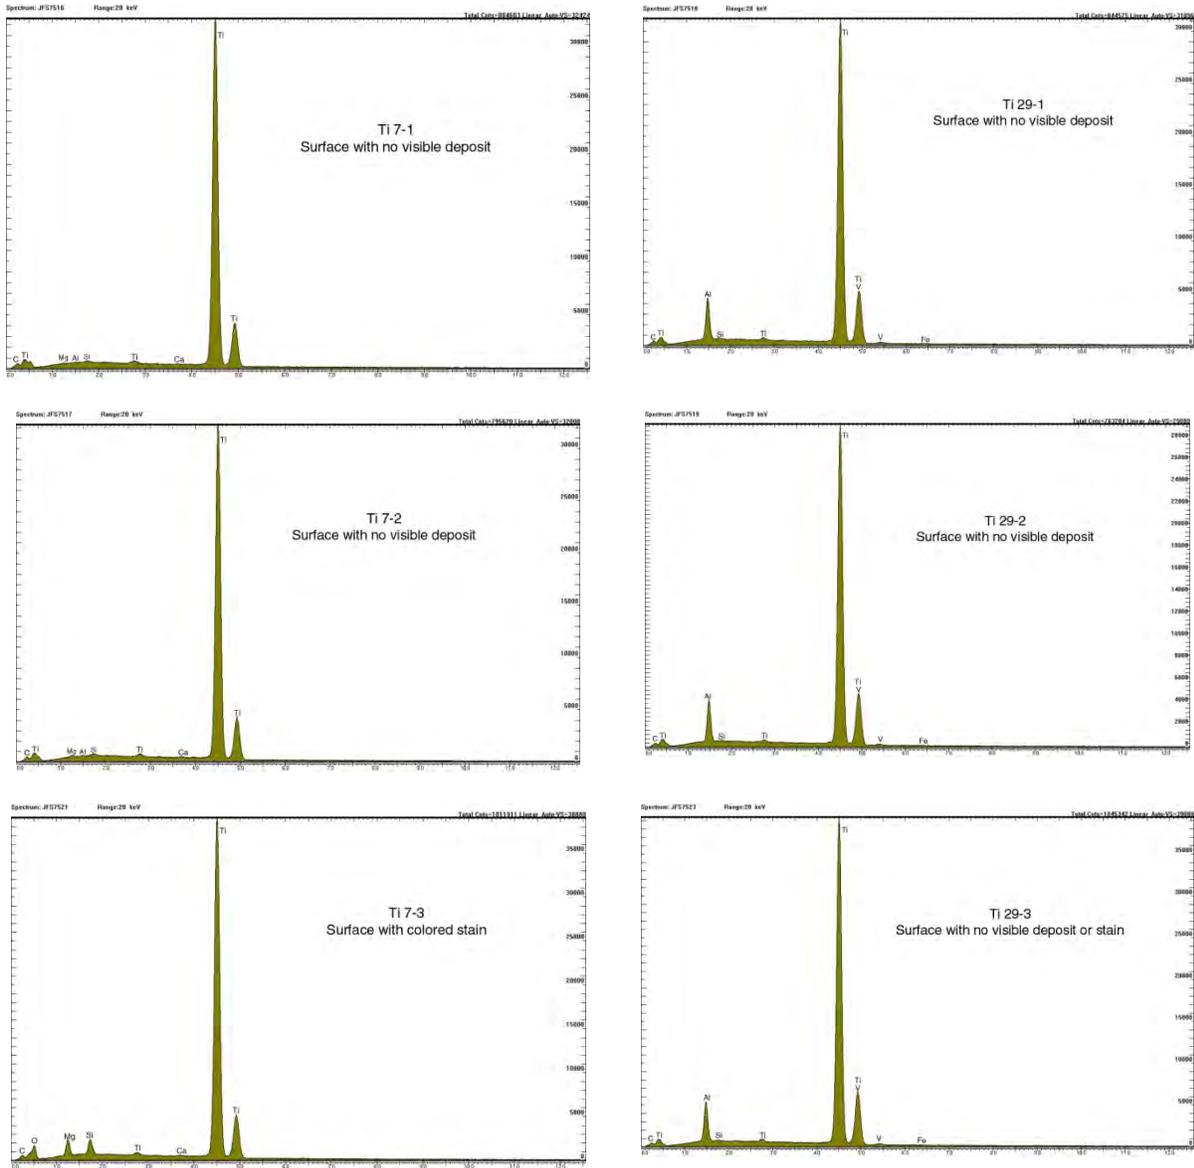
Figure 3-15. Energy-Dispersive X-Ray Spectroscopy of the First Batch of Posttest Titanium Grades 7 and 29 Specimen Surface Without Visible Deposits Showing the Main Constituent to be Elemental Titanium for Titanium Grade 7 and Titanium, Aluminum, and Vanadium for Titanium Grade 29.

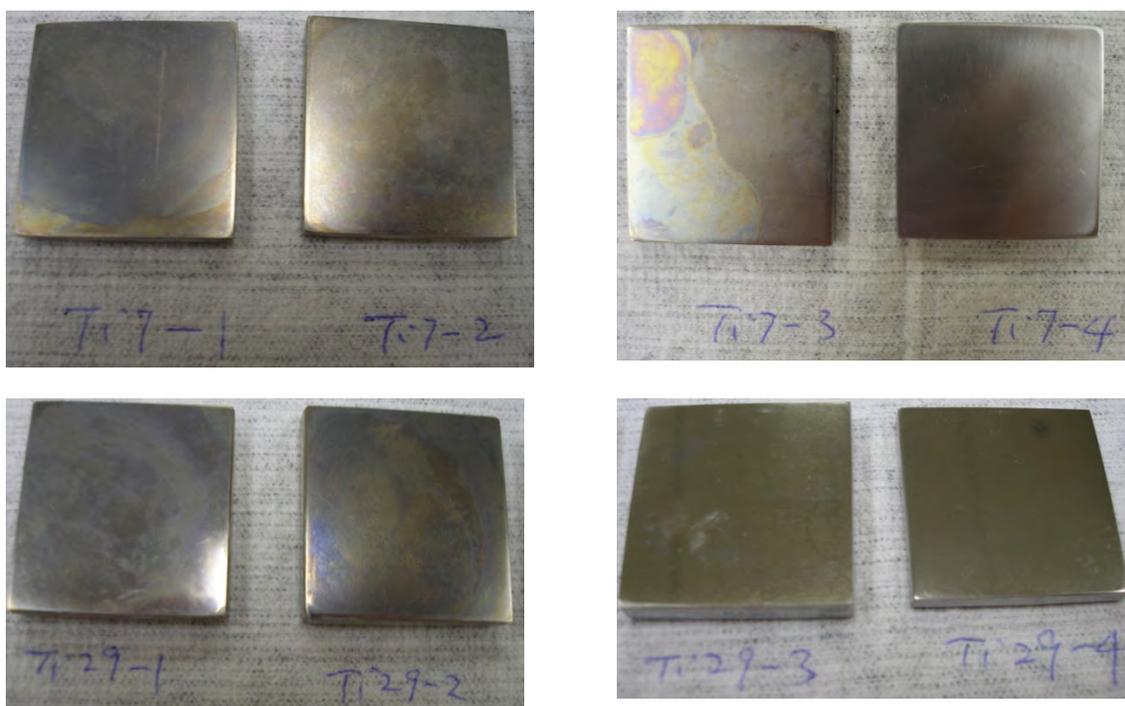
Figure 3-16. Optical Photos of the First Batch Posttest Specimens After Being Cleaned With HCl Solution Showing That All the White Deposits Were Cleaned, But the Thick Oxide Remained

After the removal of white deposits with HCl solution, the specimens were examined with a microscope along with the control specimen. For the tested specimens, there were some localized features protruding on the surface that persisted through the cleaning process. Similar features were shown on the control specimens. Figure 3-19 showed several examples of the localized features. Because both the tested and untested specimens showed similar features and these features were protruding from the surface, these features are not pits or any other localized corrosion form generated from the dripping process since they are features of the material in the as-received condition. They are considered to be artifacts of the manufacturing process or from the surface preparing process.

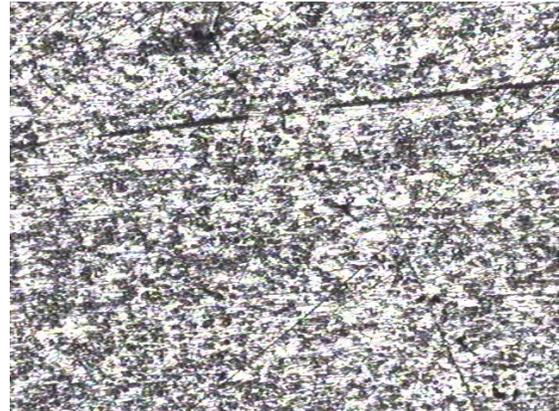
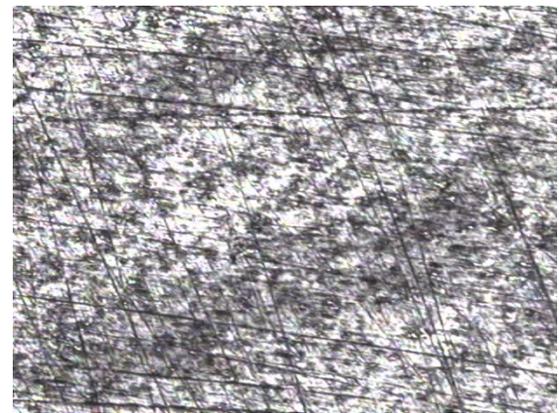
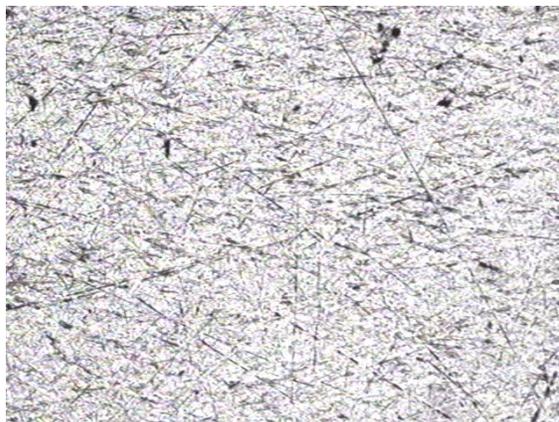
Figure 3-17. Surface of the Third HCl Cleaned Posttest Titanium Specimens Showing That the Dripping Side Was Corroded Uniformly and the Polishing Scratches Were Smoothed Out. However, There Was Less General Corrosion at the Back Side as Evidenced by the Polishing Scratches (Scale Bar Is Not Available, Because of the Limitation of the System).

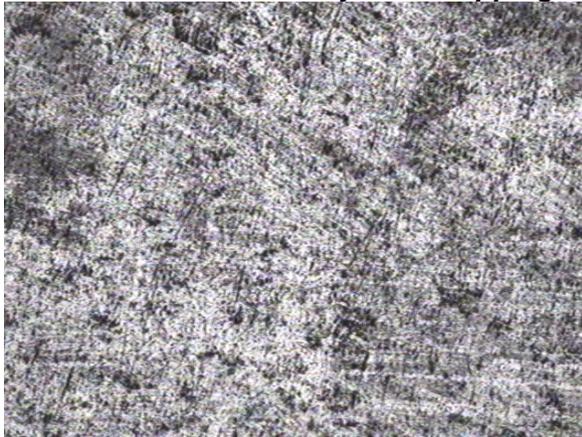
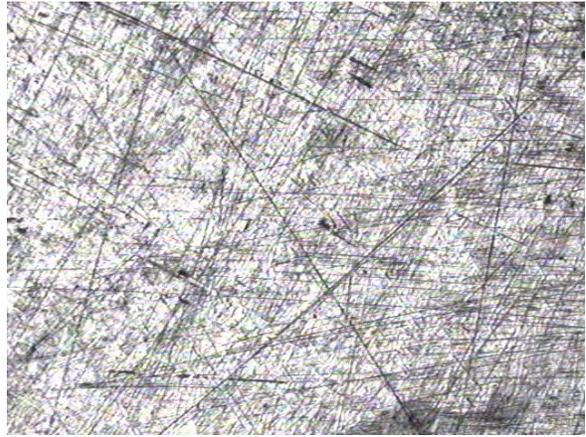
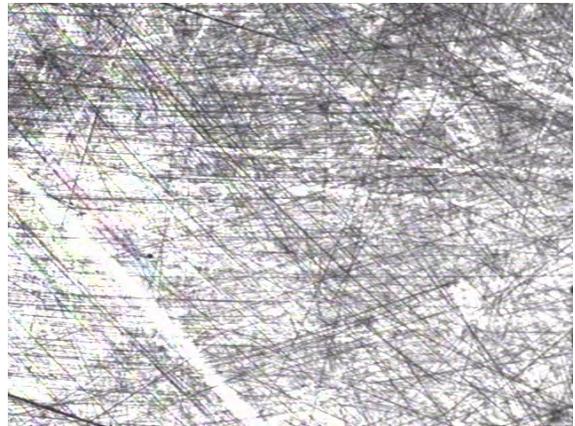
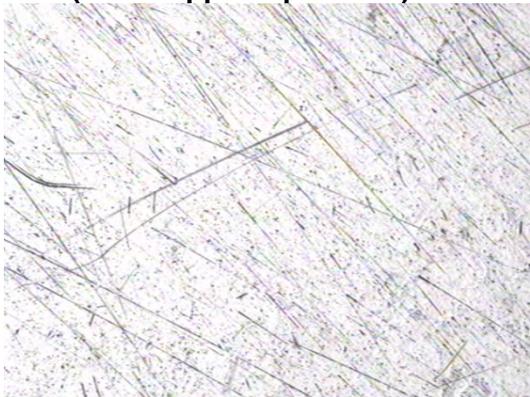
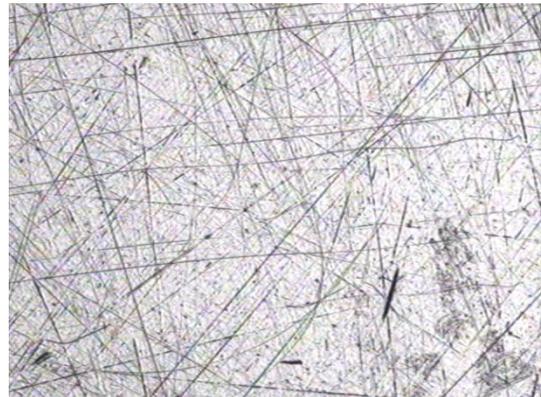
Figure 3-17 (continued). Surface of the Third HCl Cleaned Posttest Titanium Specimens Showing That the Dripping Side Was Corroded Uniformly and the Polishing Scratches Were Smoothed Out. However, There Was Less General Corrosion at the Back Side as Evidenced by the Polishing Scratches (Scale Bar Is Not Available, Because of the Limitation of the System).

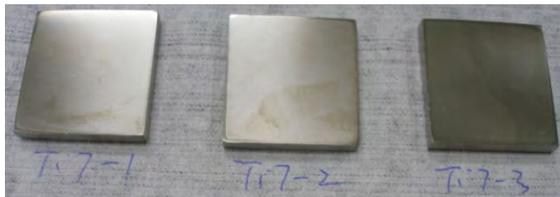
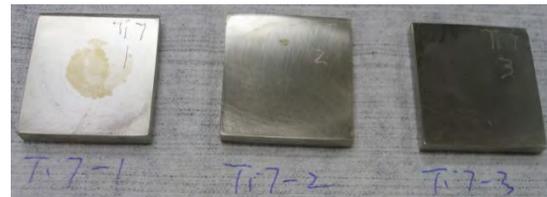
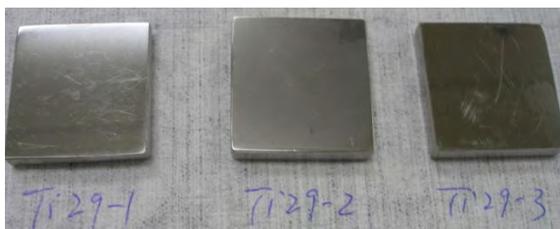
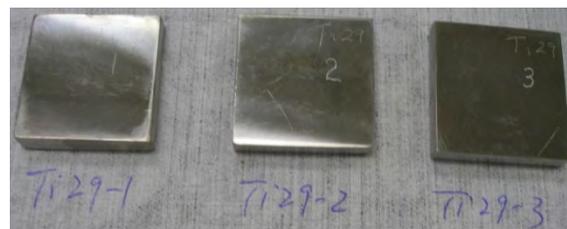
Figure 3-18. Optical Photographs of Specimens After First HNO₃ Solution Cleaning Showing That Most of the Corrosion Products Were Cleaned

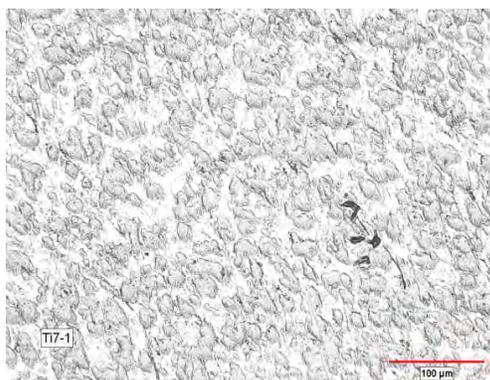
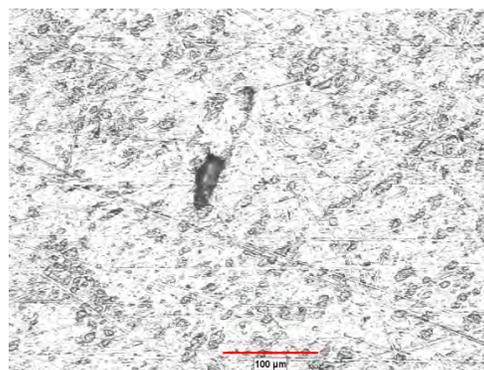
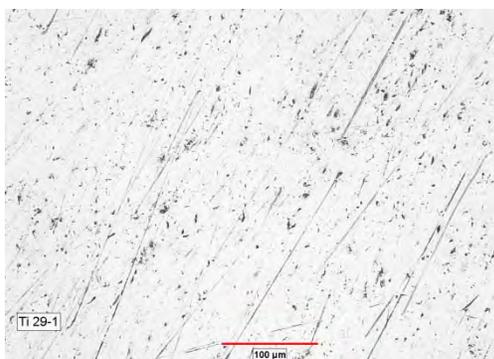
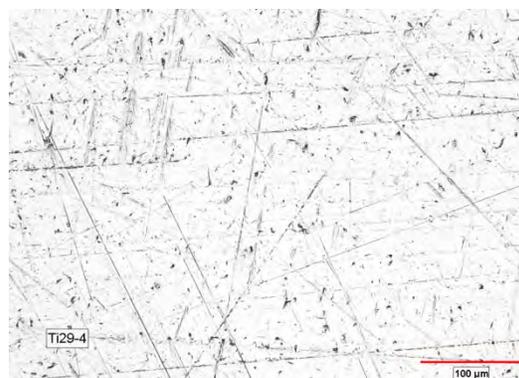
Figure 3-19. Optical Photographs of Second HNO₃-Cleaned Tested and Untested Specimens Showing That the Dripping Test Specimens Had Similar Features as the Untested Control Specimens. The Imperfections Shown on the Posttested Specimens Likely Existed Before the Test and Did Not Result From the Corrosion Process.
